MASSACHUSETTS INSTITUTE OF TECHNOLOGY
INSTRUMENTATION LABORATORY
CAMBRIDGE, MASSACHUSETTS

AG 83-66
February 2, 1966

Subject: Changes Between Prototype and Production CGC/LGC's. (GSEC-5)

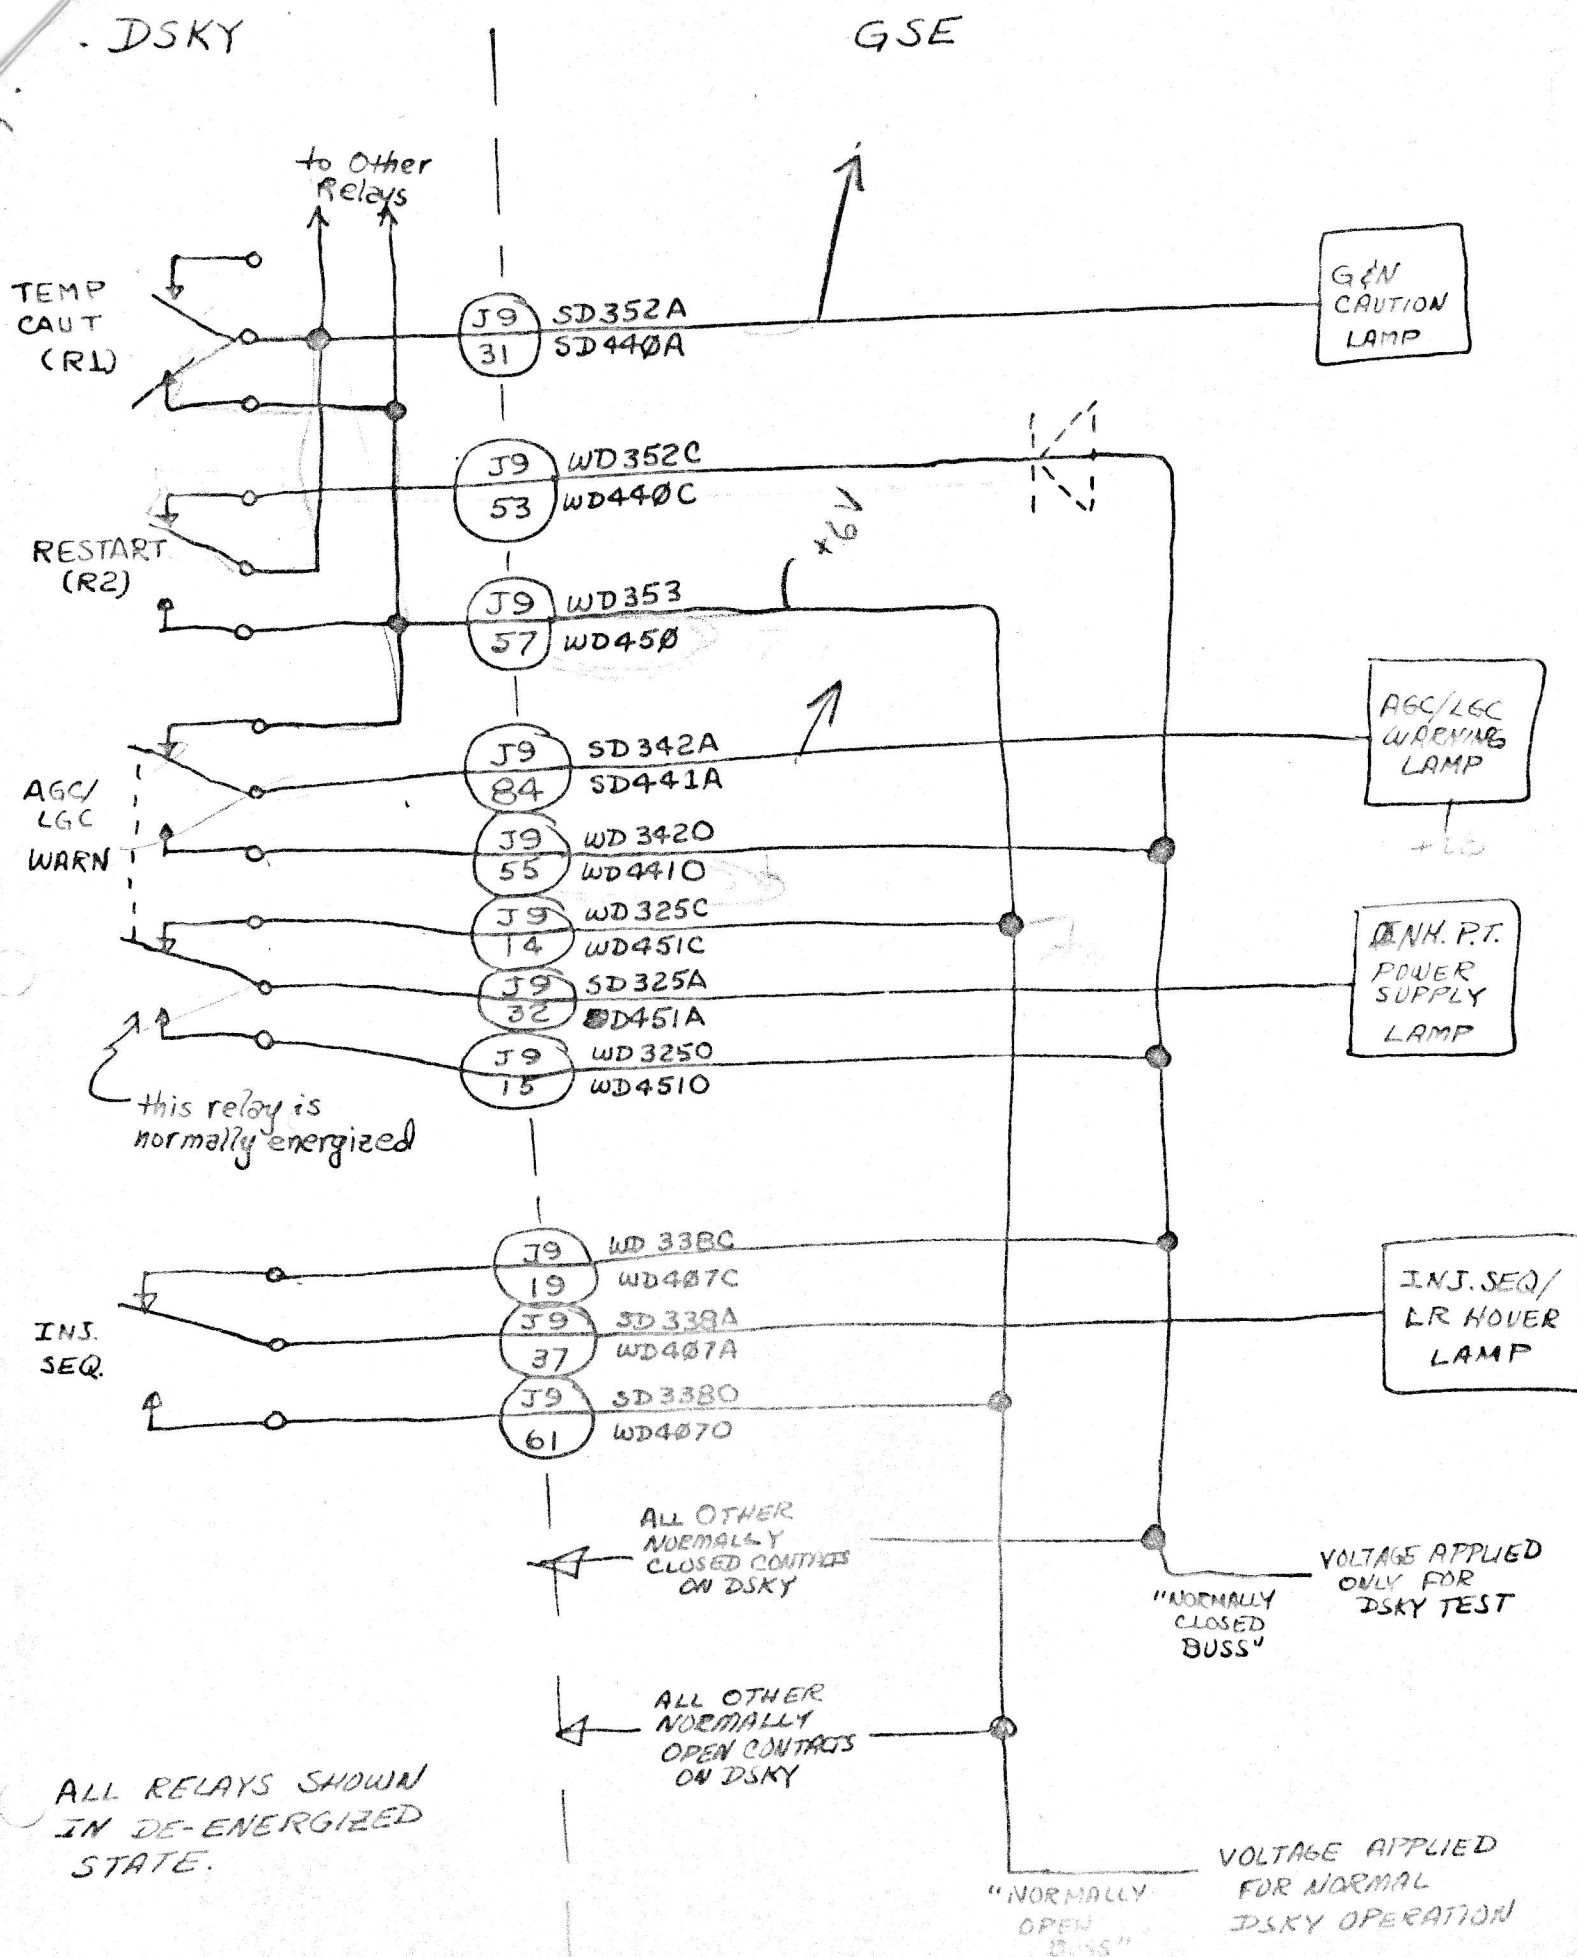
FIGURE 1

This problem was first observed at AC Electronics (reference Apollo Engineering Memorandum AP-M-9942) and is due to the wiring of the DSKY and the method presently used to test the DSKY relay contacts. A simplified signal flow diagram of the DSKY and GSE is shown in Figure 1.

In the GSE all normally open contacts are bussed together ("Normally open buss"), and all normally closed contacts are bussed together ("Normally closed buss"), (except for the exceptions mentioned in paragraph II). The indicator lamps are connected to the arms of the relays. In normal operation a voltage is applied to the "normally open buss", when a relay is energized the voltage reaches the indicator which turns the lamp on. A voltage is applied to the "normally closed buss" only when checking the "NC" contacts of the DSKY.

The problem arises when the TEMP CAUTION relay (R1) is energized and the RESTART relay (R2) is de-energized. A conductive path can be traced from J9-57 to the "NO" side of R1, to the arm of R1, to the arm of R2, to the "NC" side of R2, to J9-55; shorting the "Normally open buss" and the "Normally closed buss" together. This, of course, applies voltage to both sides of the relays, causing most of the indicators to illuminate.

The solution proposed by AC Electronics is to insert a diode between the "Normally closed buss" and J9-53. This situation is also present with the prototype DSKYs.
