D2-117017-7

APOLLO PROGRAM

**FINAL FLIGHT EVALUATION REPORT
APOLLO 10 MISSION**

AUGUST 1969

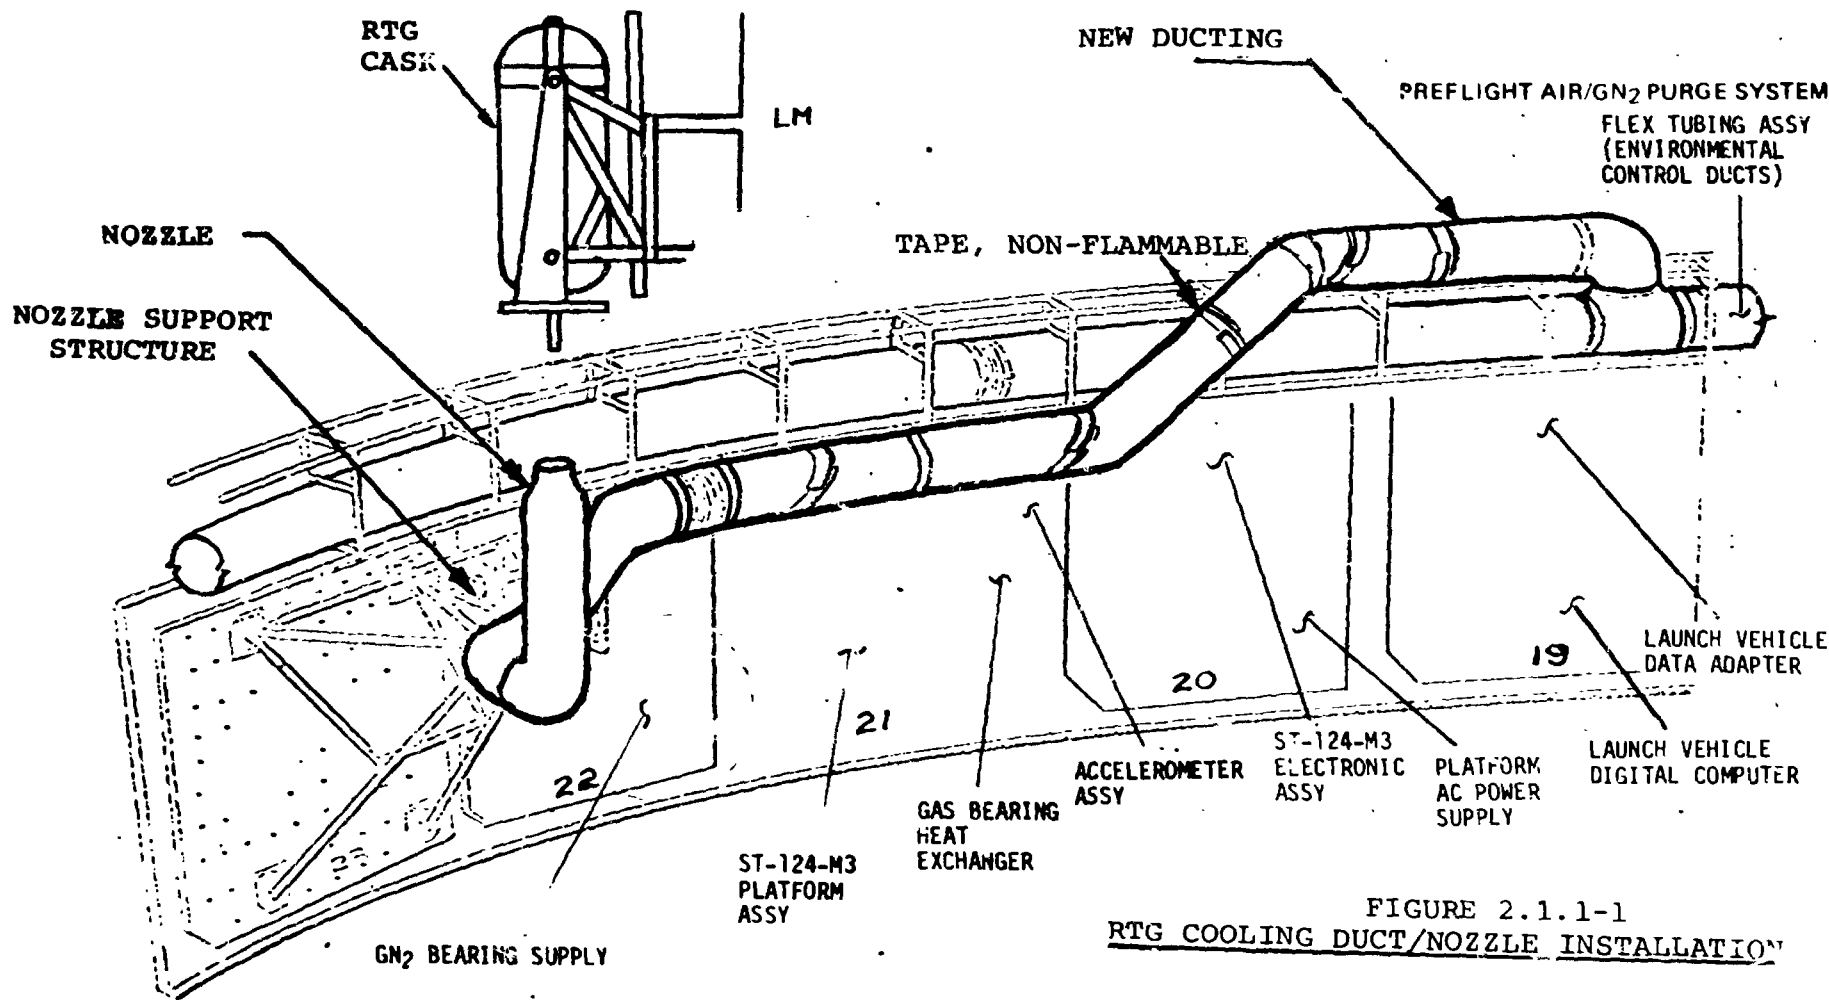
FIGURE 2.1.1-1
RTG COOLING DUCT/NOZZLE INSTALLATION

PROBLEM: AFTER SWITCHOVER FROM AIR TO GN₂, A REDUCTION WAS OBSERVED IN PRESSURE IN THE IU/S-IVB PURGE GASES. THE PRESSURE TRANSDUCER READING ON THE RTG COOLING NOZZLE DECREASED FROM 0.37 PSIG AT T-9:00 TO ALMOST ZERO GAGE PRESSURE AT T-8:30. THE CORRESPONDING GROUND SUPPORT EQUIPMENT (GSE) FLOWRATE INCREASED FROM AN INITIAL VALUE OF 200 LB/MIN TO AN OFF-SCALE VALUE OF MORE THAN 225 LB/MIN. THE UPSTREAM INLET PRESSURE DECREASED FROM 2.15 PSIG TO 1.66 PSIG. THE LOW PRESSURE AT THE INLET TO THE RTG NOZZLE INDICATED LOSS OF FLOW THROUGH THE NOZZLE. THE INCREASE IN FLOWRATE FROM THE GSE WITH A CORRESPONDING DECREASE IN INLET PRESSURE INDICATED THAT AN OPENING HAD OCCURRED SOMEWHERE IN THE PURGE DUCTING. THE ECS PURGE SYSTEM CONTINUED TO FUNCTION ADEQUATELY AS INDICATED BY A STABLE COMPARTMENT TEMPERATURE; THE DUCT FAILURE WAS ASSESSED AS NON-CRITICAL FOR THE APOLLO 10 LAUNCH, AND THE COUNTDOWN PROCEEDED.

MSFC TESTS INDICATE THE ECS AIR/GN₂ PURGE DUCT HAD A MASSIVE GAS LEAK AT THE DUCT JOINT APPROXIMATELY 4 INCHES INSIDE THE STAGE SKIN. THIS JOINT CONSISTED OF A FIBERGLASS DUCT WHICH FIT OVER A SHORT METAL DUCT STUB ATTACHED TO THE IU SKIN. THE FIBERGLASS DUCT WAS RETAINED BY A MARMAN CLAMP, WHICH WAS TORQUED TO 7+1 INCH-POUNDS.

ACTION: AS A RESULT OF THE MSFC TESTS, A SECOND MARMAN CLAMP WILL BE ADDED, AND BOTH CLAMPS WILL BE TORQUED TO 20+2 INCH-POUNDS. THIS CONFIGURATION HAS BEEN TESTED TO 9 TIMES THE NORMAL OPERATING PRESSURE WITH NO FAILURES. THIS CHANGE (IBM ECP 1905) HAS BEEN COMPLETED ON APOLLO 11, AND IT WILL BE ACCOMPLISHED ON ALL SUBSEQUENT LAUNCH VEHICLES.

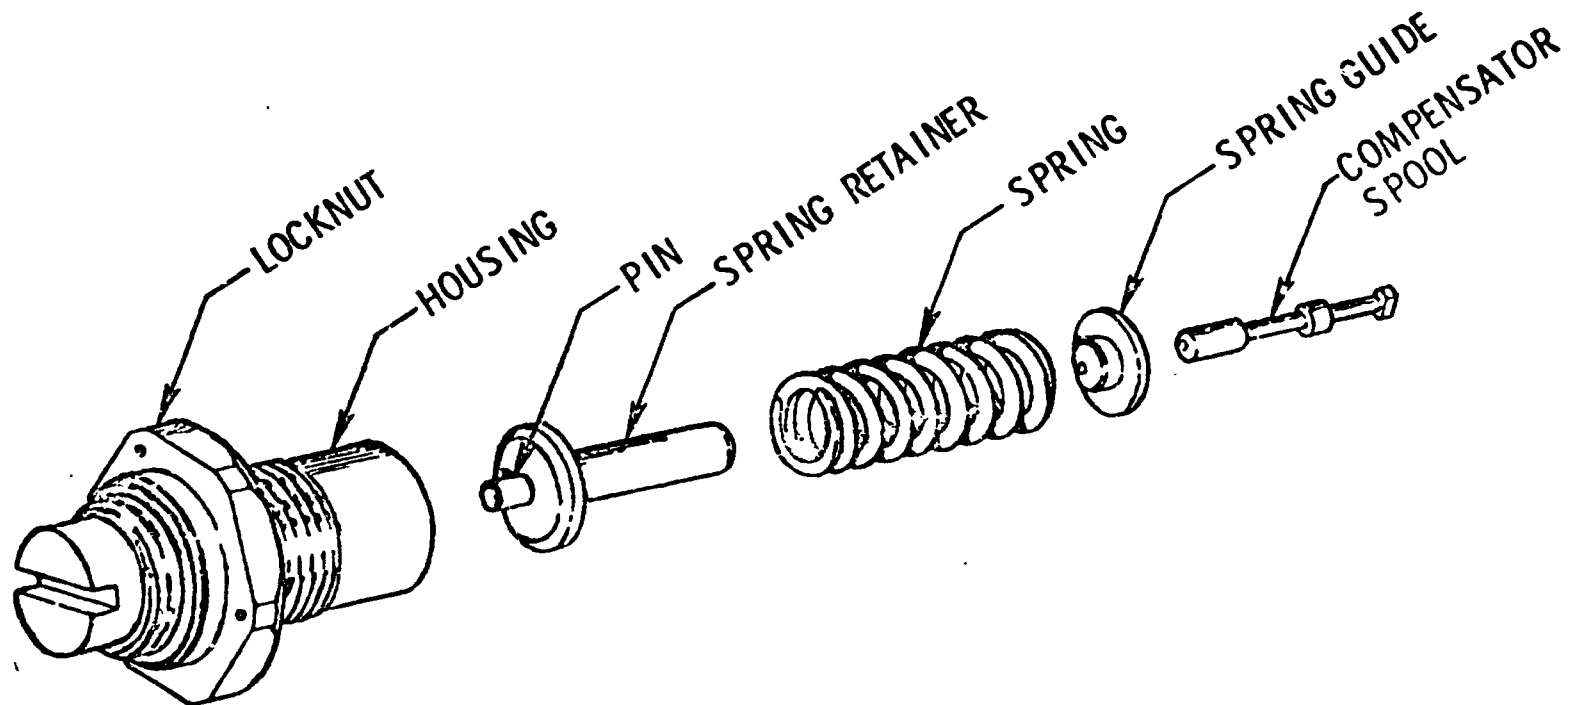
FIGURE 2.1.3-2 PRESSURE COMPENSATOR ASSEMBLY

PROBLEM: DURING THE TLI BURN AND THE PROPELLANT DUMP, THE AUXILIARY HYDRAULIC PUMP OPERATED ABNORMALLY. THE PUMP WAS CAVITATING, HEATING UP, PRESSURIZING THE SYSTEM TOO SLOWLY, AND DRAWING 19 AMPS INSTEAD OF THE EXPECTED 40 AMPS. DURING THE PRESSURIZATION CYCLE AFTER SECOND BURN AND DURING THE PROPELLANT DUMP, THE PUMP CURRENT WAS 15 TO 16 AMPERES AND THE SYSTEM PRESSURE WAS LESS THAN THE 1500 PSI LOWER LIMIT OF THE MEASURING SYSTEM. THERE WAS ENOUGH PRESSURE AVAILABLE, HOWEVER, TO CENTER THE J-2 ENGINE DURING THESE PERIODS.

AN AUXILIARY PUMP GROUND TEST WAS RUN IN AN ATTEMPT TO DUPLICATE THE FLIGHT DATA BY INTRODUCING KNOWN FAILURES. THE PRIME SUSPECT, STRUCTURAL FAILURE OF THE COMPENSATOR SPRING GUIDE, DID PRODUCE SIMILAR DATA. ADDITIONAL FAILURE TESTS (COMPENSATOR SPRING BREAKAGE, VALVE PLATE TORSION SPRING FRACTURE, AND STOP PIN FAILURE) DID NOT DUPLICATE FLIGHT DATA.

ACTION: TESTS WITH A FAILED COMPENSATOR SPRING GUIDE REPRODUCED THE FLIGHT DATA. THE SPRING GUIDES WERE REDESIGNED SOME TIME AGO, BUT IT IS SUSPECTED THE OLD DESIGN FLEW ON AS-505 THE COMPENSATOR SPRING GUIDE ON S-IVB-506 WAS REPLACED BEFORE CDDT TO INSURE ADEQUATE PERFORMANCE DURING THE APOLLO 11 MISSION.

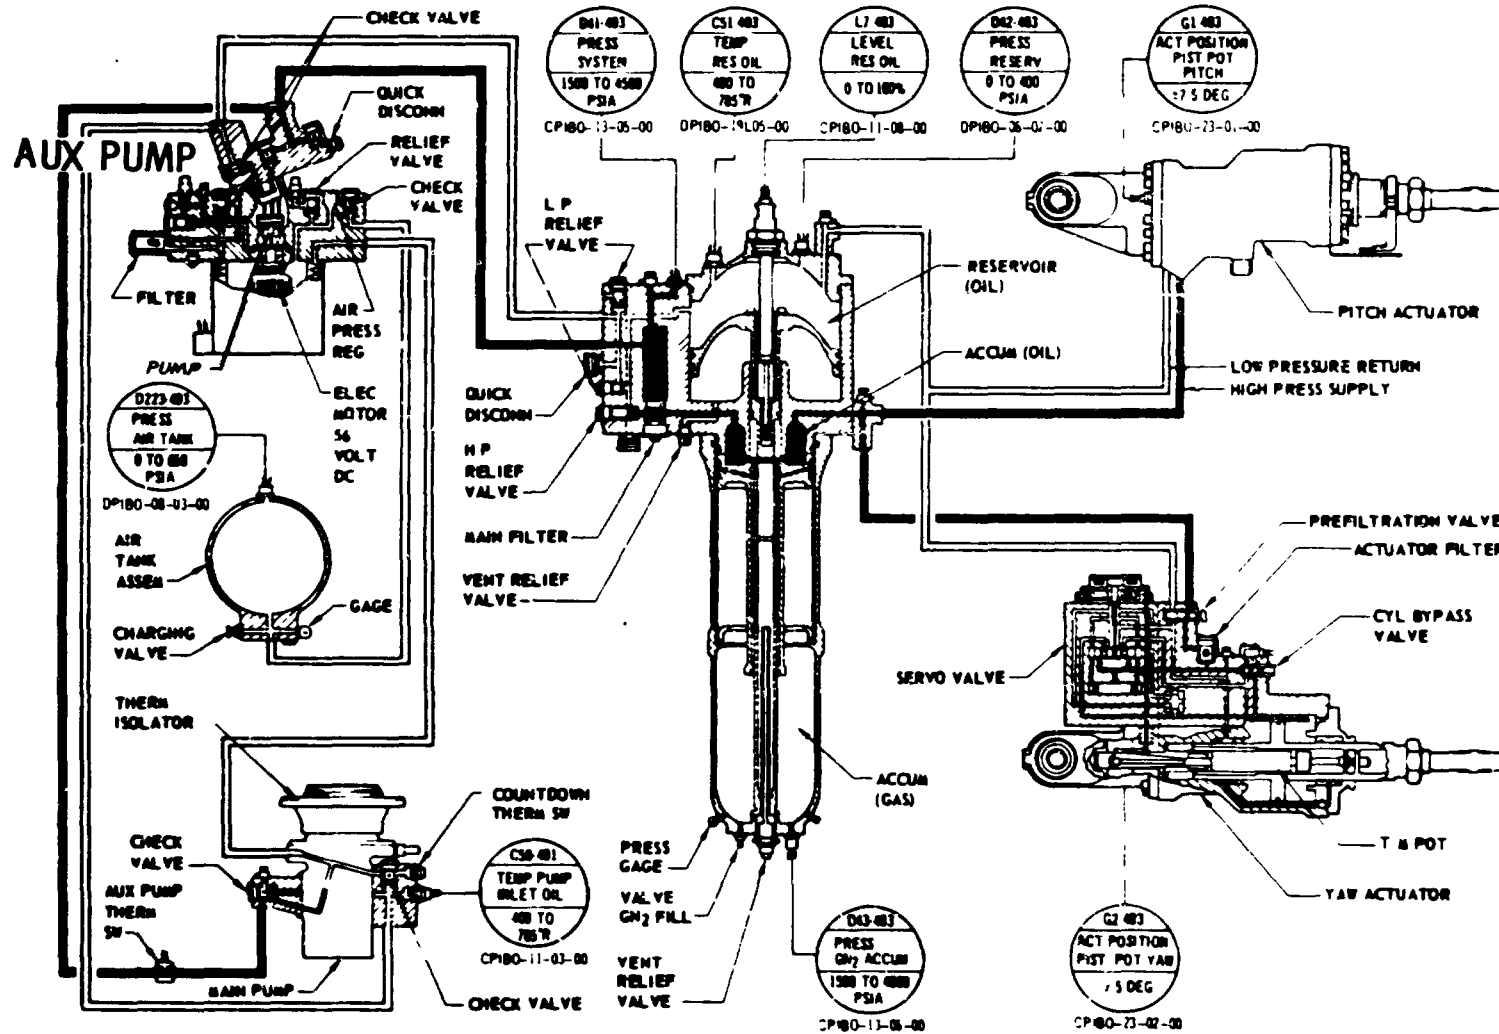
FIGURE 2.1.3-1. S-IVB HYDRAULIC SYSTEM

THE AUXILIARY HYDRAULIC PUMP WAS TURNED ON 6 MINUTES PRIOR TO SECOND BURN. THE ACTUATORS CENTERED THE J-2 ENGINE IN RESPONSE TO THE 3635 PSIA SYSTEM PRESSURE. AT ENGINE IGNITION, THE ACTUATORS RESPONDED NORMALLY TO THE APPLIED GUIDANCE SIGNALS. THE AUXILIARY PUMP RESPONDED BRIEFLY WITH HIGH FLOW TO MEET THIS DEMAND WHILE THE ENGINE DRIVEN PUMP WAS BROUGHT UP TO SPEED. SHORTLY AFTER ENGINE IGNITION, THE ENGINE DRIVEN PUMP OUTPUT PRESSURE EXCEEDED THE NORMAL 3635 PSIA BY 3 PERCENT. THE AUXILIARY PUMP RESPONDED TO THIS EXCESS PRESSURE BY FEATHERING TO THE NO-FLOW CONDITION WITH A CORRESPONDING DROP TO A CONTINUOUS 21 AMPERE DEMAND. AT ABOUT 2:37 GET, THE AUXILIARY PUMP CURRENT DECREASED UNEXPECTEDLY TO 19 AMPERES. THE CURRENT REMAINED AT THIS LEVEL DURING THE 4.1 SECOND INTERVAL FOLLOWING ENGINE CUTOFF INSTEAD OF RISING TO THE NORMAL 40 TO 70 AMPERES.

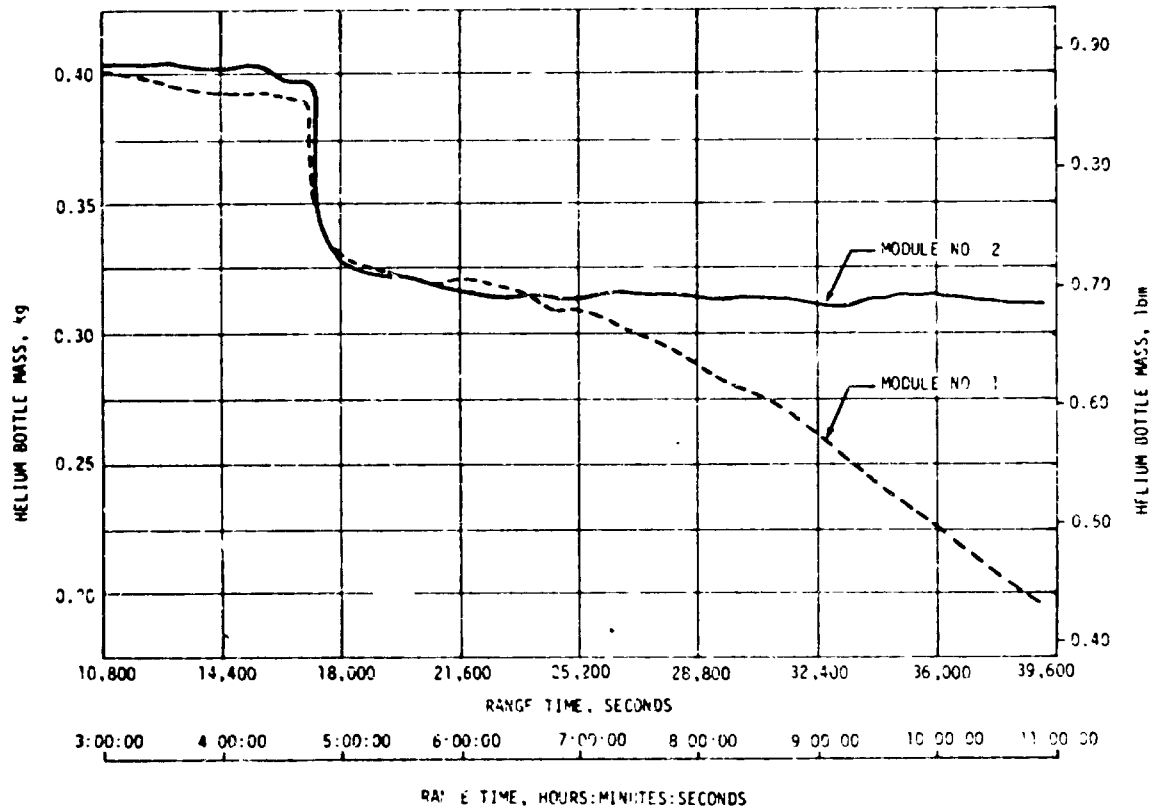
FIG. 2.1.4 S-IVB APS HELIUM BOTTLE MASS

PROBLEM: THE OPERATIONS OF THE APS PRESSURIZATION SYSTEM WAS SATISFACTORY WITH THE EXCEPTION OF A HELIUM LEAK IN MODULE NO. 1. THE LEAK STARTED APPROXIMATELY 6.5 HOURS AFTER LIFTOFF AND EXTENDED THROUGH LOSS OF DATA (10:54:00). THE LEAK RATE AT LOSS OF DATA WAS APPROXIMATELY 3278 SCCM (200 SCIM).

ACTION: AS A RESULT OF A SIMILAR LEAK WHICH OCCURRED ON AS-504 (APOLLO 9), FIVE "O" RINGS IN THE HIGH-PRESSURE HELIUM PLUMBING WERE CHANGED ON APOLLO 10 AND SUBSEQUENT. THE LEAKAGE RATES EXPERIENCED ON APOLLO 9 AND APOLLO 10 WOULD NOT IMPAIR THE ACCOMPLISHMENT OF THE S-IVB PORTION OF THE APOLLO 11 MISSION.

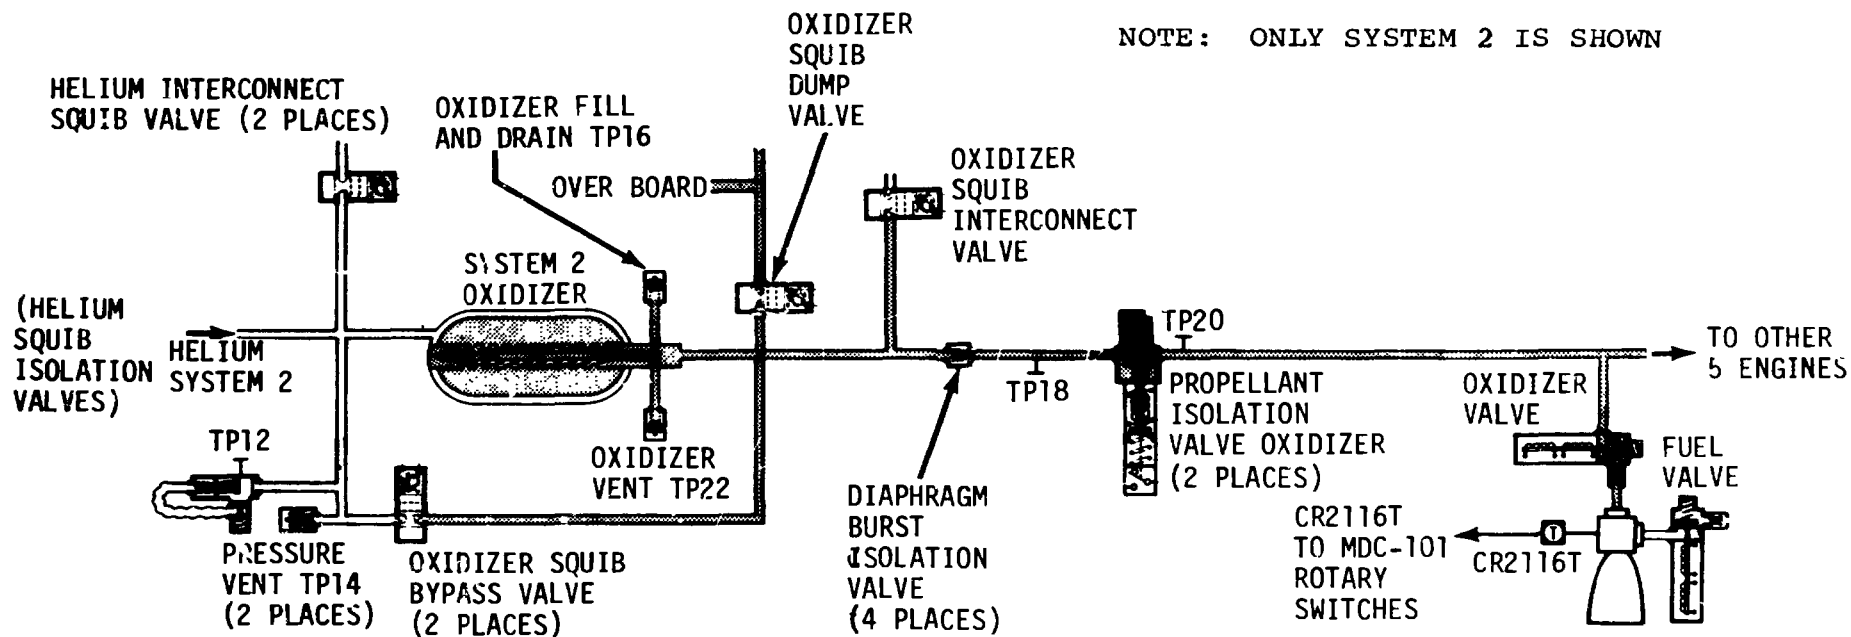
Figure 2.2.2-1. CM RCS OXIDIZER SUPPLY

PROBLEM: DURING THE FINAL SWITCH LIST VERIFICATION, WHEN THE PROPELLANT ISOLATION VALVES OF THE COMMAND MODULE RCS SYSTEM WERE OPENED, THE PRESSURE IN THE CM RCS HELIUM SYSTEM 2 DROPPED FROM 44 PSIA TO 37 PSIA. THIS INDICATED THAT THE OXIDIZER PROPELLANT BURST DIAPHRAGM WAS RUPTURED, ALLOWING OXIDIZER TO FLOW FROM THE TANK INTO THE MANIFOLD WHEN THE ISOLATION VALVE WAS OPENED. THE OXIDIZER ISOLATION VALVE BACKED UP BY THE ENGINE VALVES PREVENTED LOSS OF OXIDIZER, AND THE SYSTEM WAS VISUALLY VERIFIED TO BE LEAK-TIGHT; THEREFORE, IT WAS DECIDED THAT THE SYSTEM WAS ACCEPTABLE FOR FLIGHT. THE ISOLATION VALVES WERE CLOSED AFTER ORBITAL INSERTION. THE ENGINE VALVES WERE THEN OPENED BY MEANS OF THE REACTION CONTROL HEATER CIRCUITS, AND THE OXIDIZER WAS VENTED FROM THE MANIFOLD FOR 25 MINUTES. FOUR PERCENT OF THE OXIDIZER IN SYSTEM 2 WAS LOST, HOWEVER, THE MAXIMUM PREVIOUS PROPELLANT USAGE DURING A MISSION WAS 35% OF ONE SYSTEM. AFTER THE MISSION, THE OXIDIZER AND FUEL BURST DISCS WERE SIMILAR IN PHYSICAL APPEARANCE, INDICATING THAT THE OXIDIZER BURST DISC HAD FAILED BECAUSE OF PRESSURE.

ACTION: CAUTION NOTES HAVE BEEN ADDED TO THE PRELAUNCH CHECKOUT PROCEDURES IN THE PLACES WHERE THE ALLOWABLE LIMITS ON THE BURST DISC (241 +16 PSID IN THE FLOW DIRECTION AND 10 PSID IN THE REVERSE DIRECTION) COULD BE EXCEEDED. TO ALLOW EARLY DETECTION OF ANY SIMILAR PROBLEM IN THE FUTURE, A LEAK CHECK OF THE BURST DISC HAS BEEN ADDED AFTER REACTION CONTROL SYSTEM PROPELLANT SERVICING.

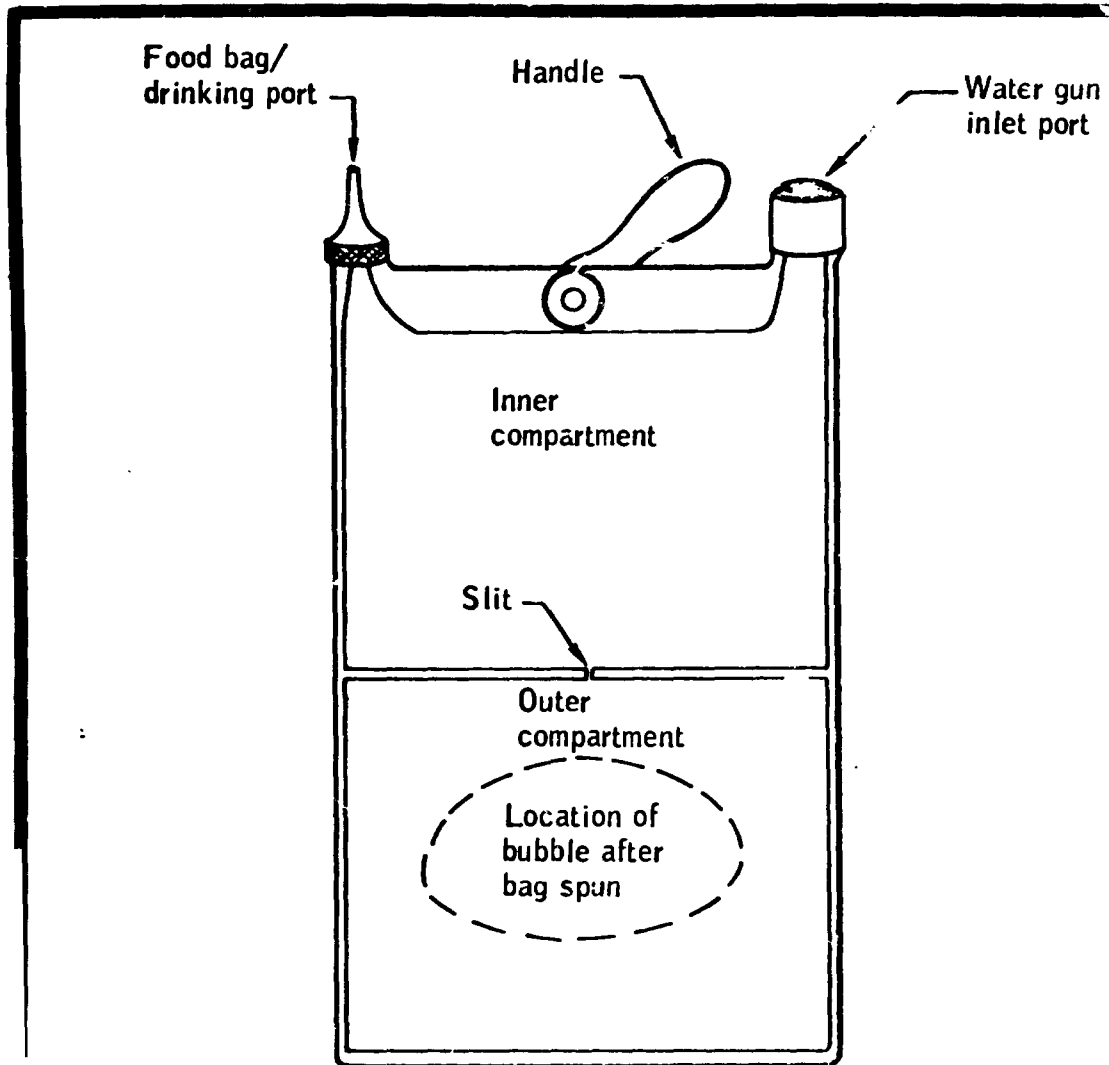
FIG. 2.2.4-1 WATER/GAS
SEPARATION BAG

THIS KIND USED ON
APOLLO 10

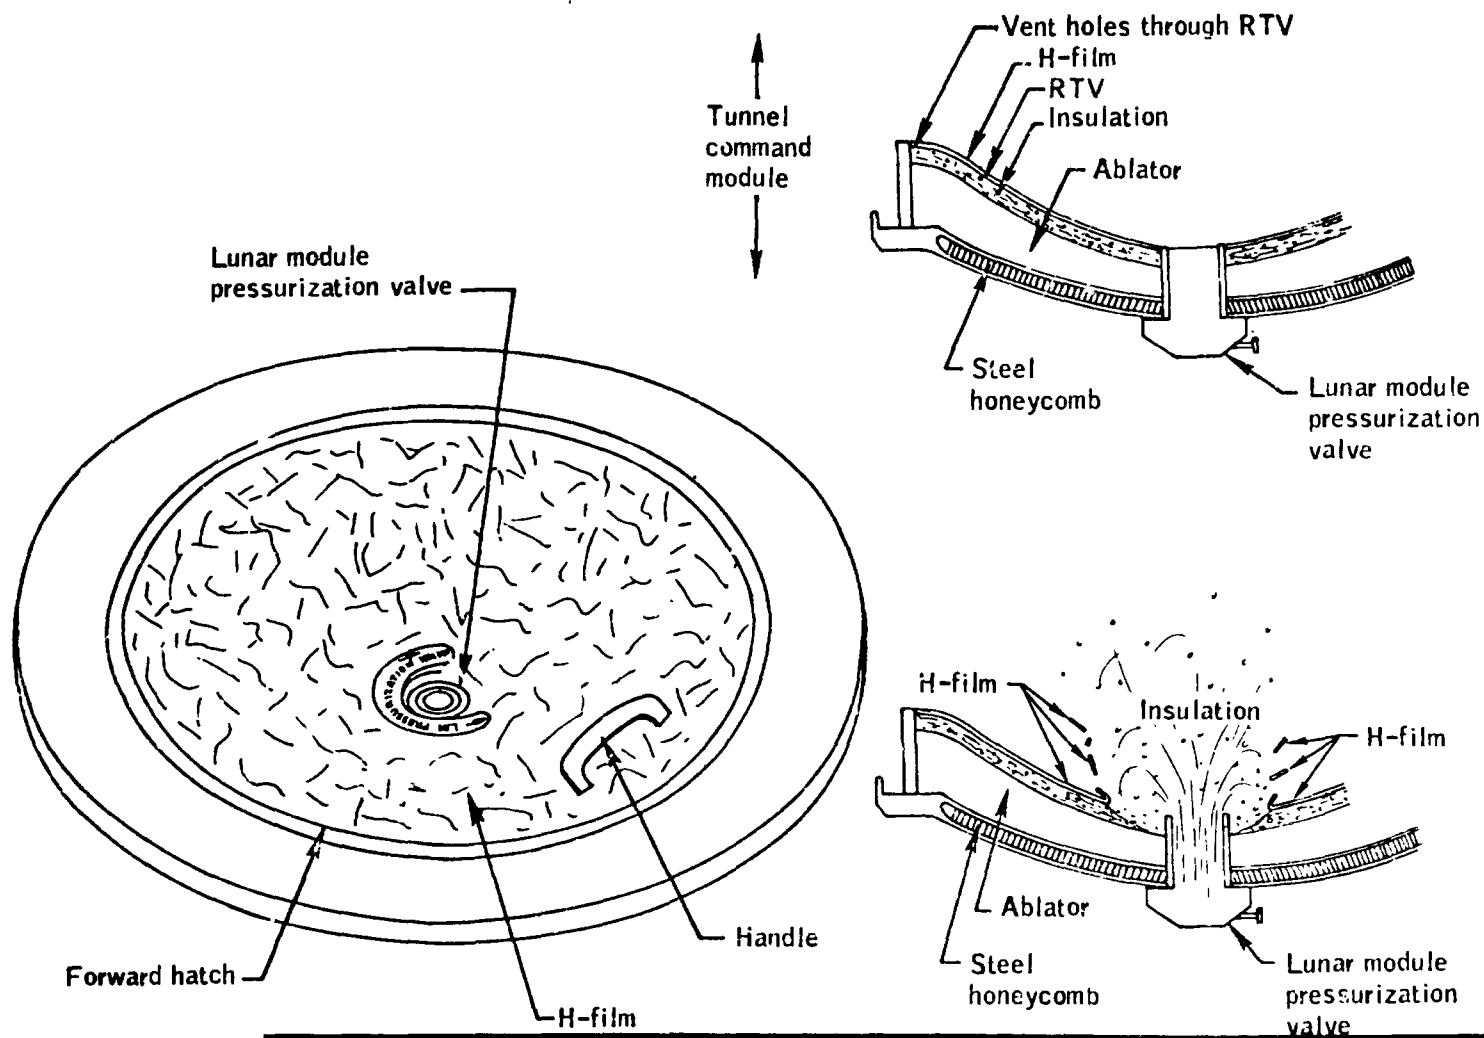
FIG. 2.2.6-1 FORWARD HATCH THERMAL COATING.

PROBLEM: WHEN THE LUNAR MODULE CABIN WAS FIRST PRESSURIZED THE THERMAL COATING ON THE COMMAND MODULE HATCH CAME OFF IN PIECES. THE INSULATION BLANKET VENT HOLES WERE PLUGGED, PRODUCING THE DAMAGE. ONE POSSIBILITY IS THAT THE PREFLIGHT BAKING OF THE HATCH AT 900°F FOR 15 HOURS WEAKENED THE INSULATION TO THE EXTENT THAT INTERNAL PIECES OF INSULATION BROKE LOOSE AND PLUGGED THE HOLES DURING TUNNEL DEPRESSURIZATION. ANOTHER POSSIBILITY IS THAT THE VENT HOLES WERE INADVERTENTLY SEALED WHEN THE INSULATION BLANKET WAS POTTED WITH RTV OR WHEN THE H-FILM TAPE WAS INSTALLED ON THE HATCH SURFACE.

ACTION: ON THE APOLLO 11 COMMAND MODULE, THE INSULATION HAS BEEN DELETED BECAUSE OF THE EFFECTS NOTED AND BECAUSE A REEVALUATION OF THERMAL CONDITIONS HAS SHOWN THAT THE INSULATION IS NOT NECESSARY. HOWEVER, TO MINIMIZE CONDENSATION, A SINGLE LAYER OF H-FILM TAPE HAS BEEN APPLIED OVER THE EXTERIOR SURFACE OF THE HATCH ABLATOR. SOME WATER AND ICE CAN BE EXPECTED ON APOLLO 11 BUT TO A LESSER DEGREE THAN OBSERVED ON APOLLO 10.

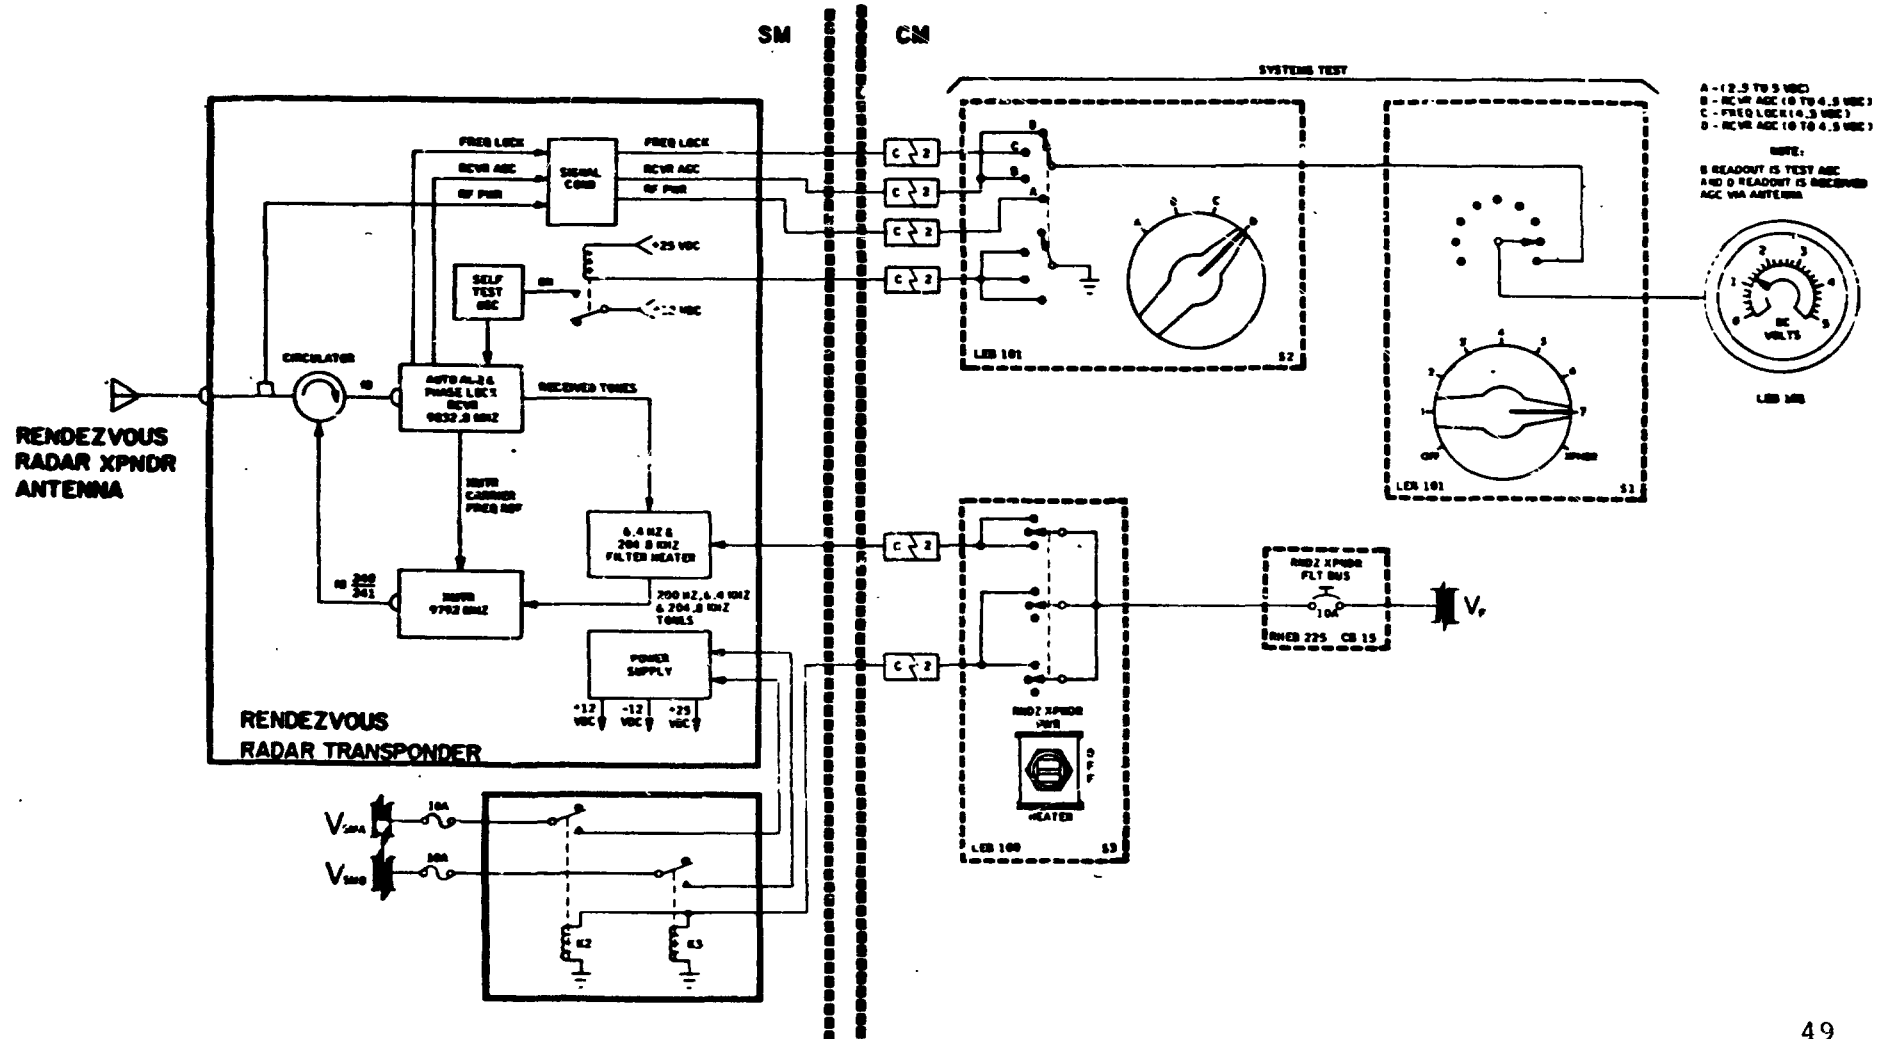
FIGURE 2.2.9-1 RENDEZVOUS RADAR TRANSPONDER CONTROL CIRCUITRY

ACTION: DURING POSTFLIGHT TESTS OF THE SWITCH AND WIRING, NO DEFECTS WERE FOUND, AND THE ANOMALY CANNOT BE ATTRIBUTED TO ANY CM HARDWARE.

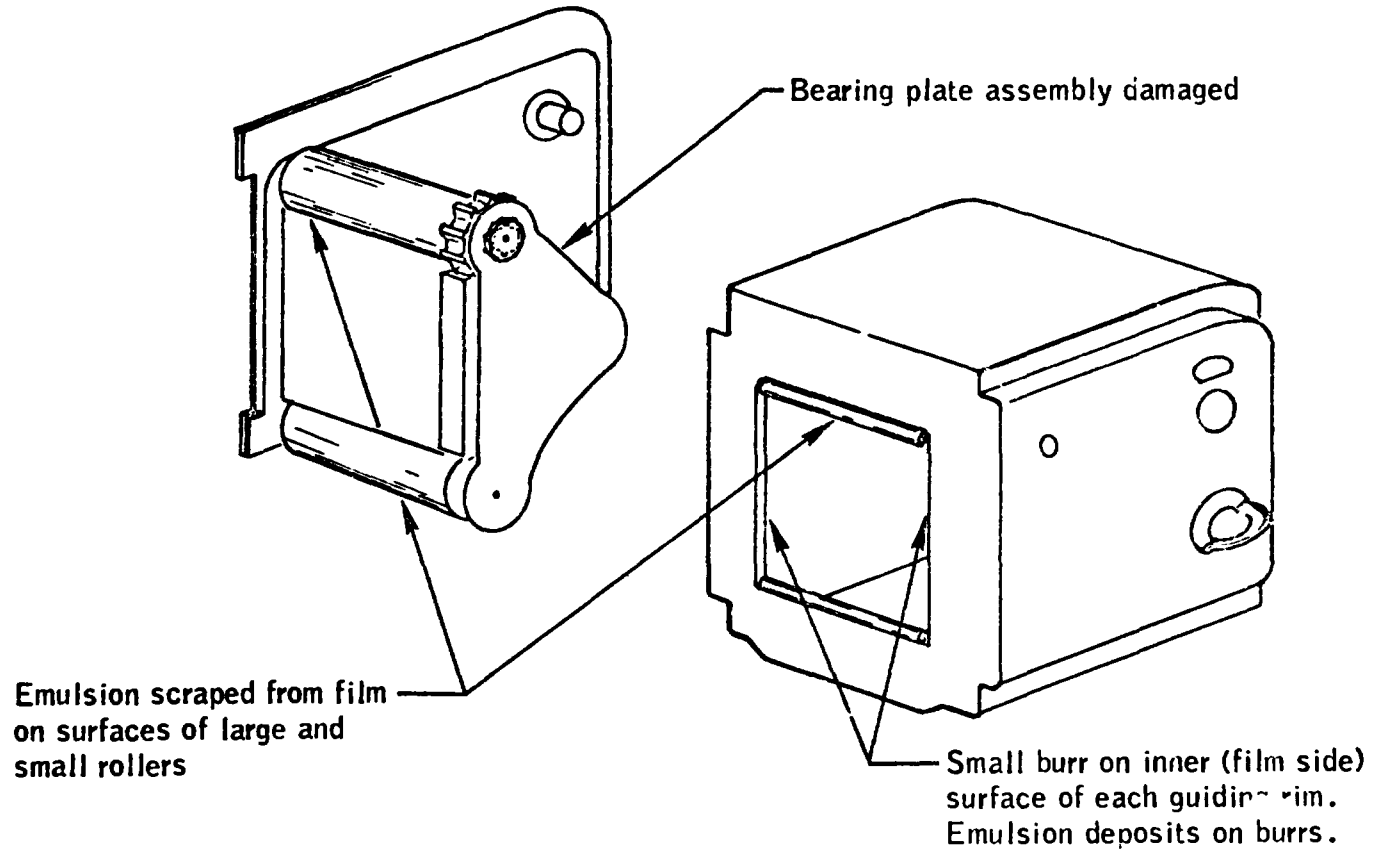
FIG. 2.2.37-1

FAILURE OF 70-MM CAMERA
