MSC-07230

APOLLO 16 MISSION REPORT

MANNED SPACECRAFT CENTER  
HOUSTON, TEXAS  
AUGUST 1972

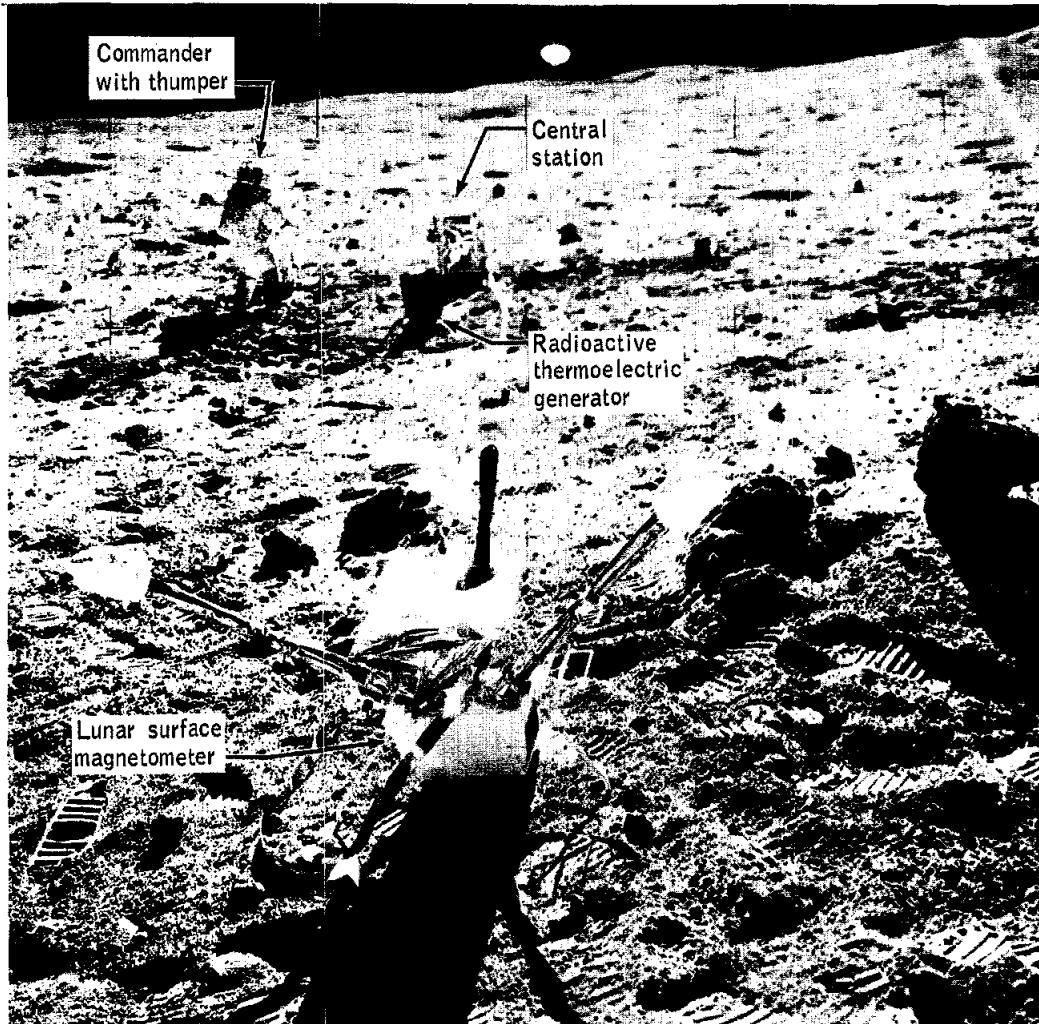
Heat flow probe number 1 was inserted into bore hole number 1 to the full depth and both radiation shields were properly emplaced. While the Commander was working near the central station, he became entangled in the

heat flow experiment electronics cable and broke it loose at the connector to the central station. Further deployment was abandoned and the experiment is inoperable. The details of this failure are given in section 14.4.1.

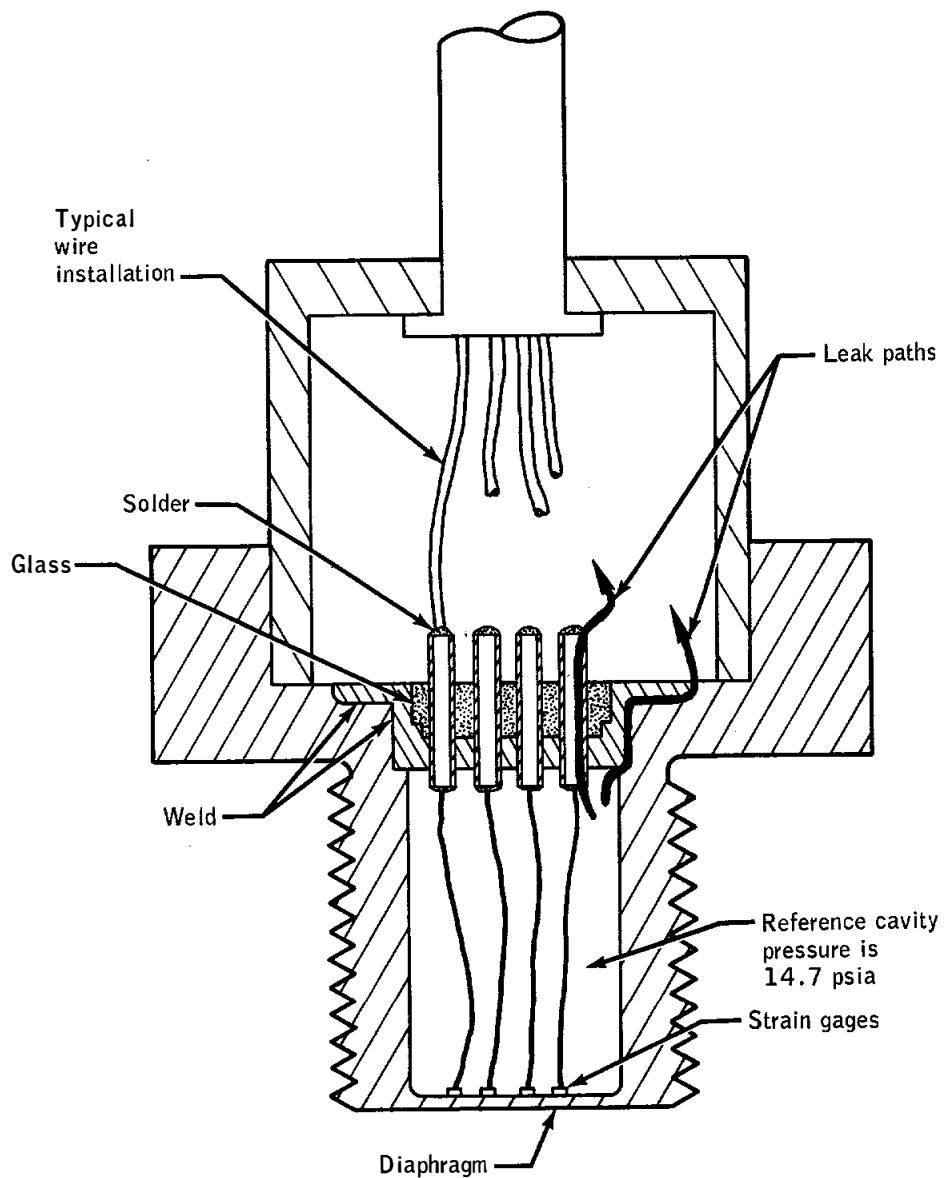
Figure 14-3.- Service propulsion system pressure transducer failure.

the header-to-case weld (fig. 14-3). During altitude chamber tests for Apollo 16 and during the Apollo 12 mission, a similar transducer showed the same type of failure. The Apollo 16 transducer (replaced after the altitude chamber tests) had not had a vacuum check since 1965 to verify that the reference cavity was leak tight. The altitude chamber test is adequate to verify the integrity of this type of pressure transducer.

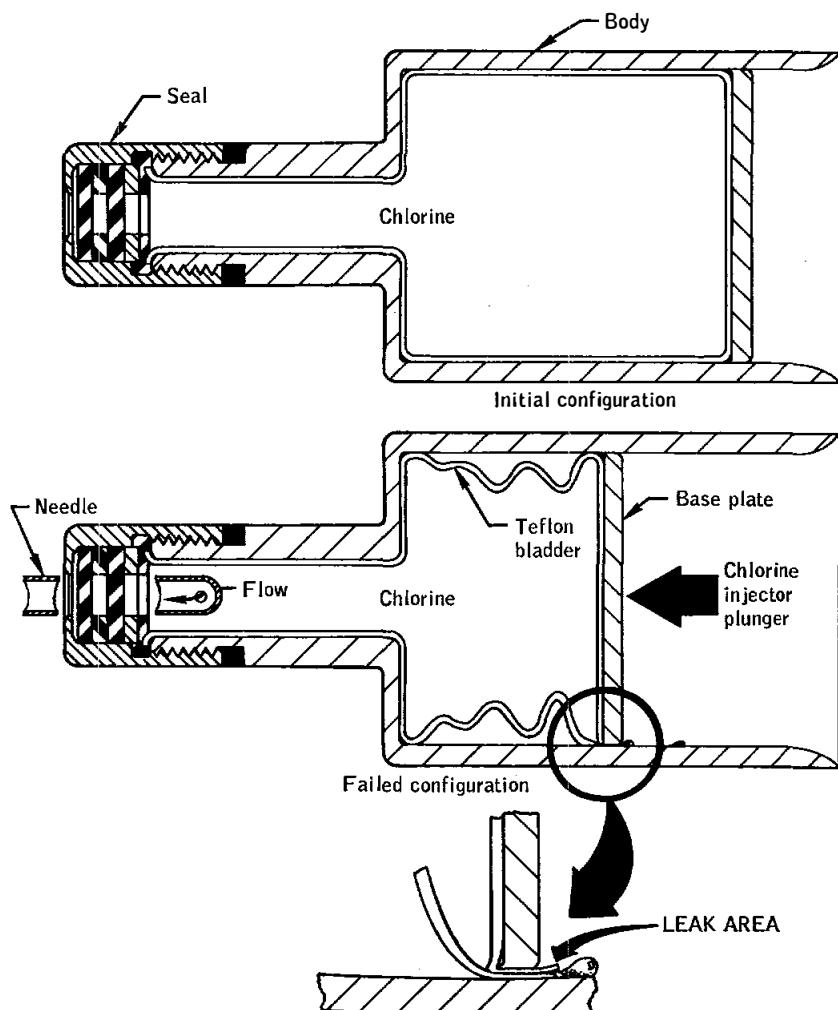
Figure 14-9.- Chlorine ampule failure.

Upon further examination by the crew, the chlorine ampule appeared to be broken (leaking) and the inner bladder was visible after having been extruded past the base plate. Inner bladder extrusion has been observed before but has not been associated with leaks. Figure 14-9 shows typically how the Teflon bladder can be forced past the injector base plate. The body sidewall is not sufficiently rigid to prevent the bladder from extruding around the base plate and being creased, which would be conducive to leaks. Subsequent chlorine injections were satisfactory. The specific ampule which caused the problem was later jettisoned with the lunar module and was not available for postflight inspection.

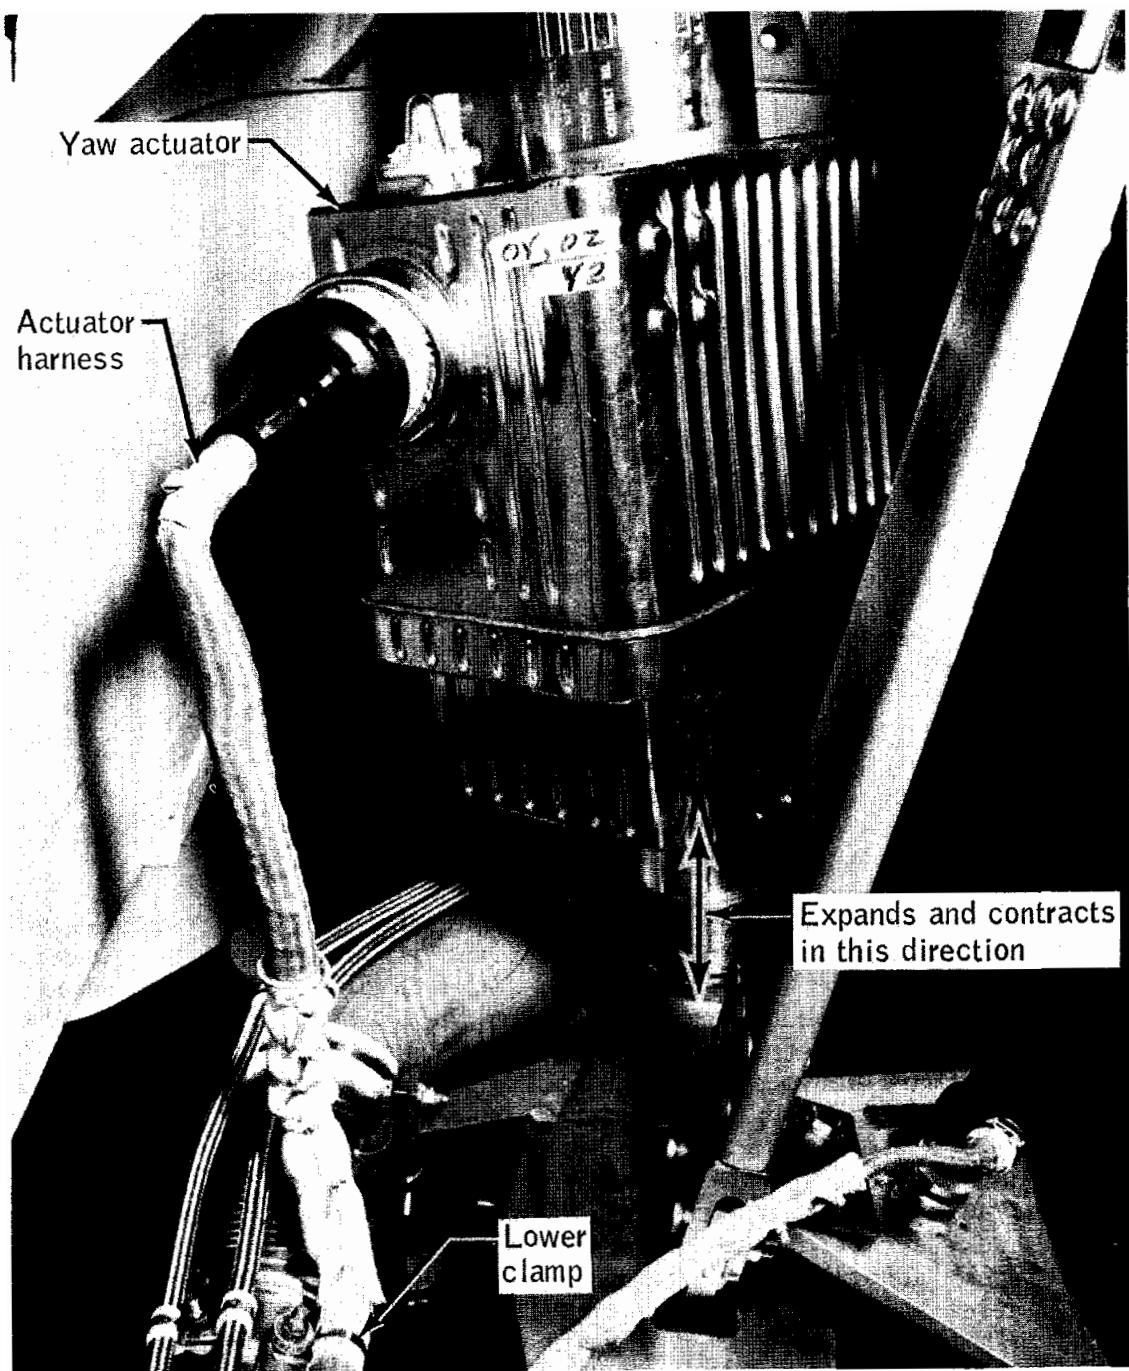
Figure 14-12.- Yaw actuator assembly and interconnecting wiring.

The cause of the failure was an open in the rate feedback loop of the secondary yaw servo system. Postflight testing of command module wiring and connectors and bench testing of the thrust vector servo assembly did not reveal any abnormalities. Therefore, the failure must have occurred in the service module wiring or connectors. Possible pin corrosion on the engine gimbal actuator wiring harness connectors or broken wires in the yaw gimbal wiring loop are the most probable causes of the flight problem. A broken wire would result from inadequate strain relief (see fig. 14-12) due to cable flexing. Wiring harnesses to the actuator assembly on three other vehicles were reviewed and found to move when the engine was gimballed. Motion of the actuator produced a strain on the harness at the lower clamp. The position of this clamp was changed for the remaining vehicles to provide strain relief.

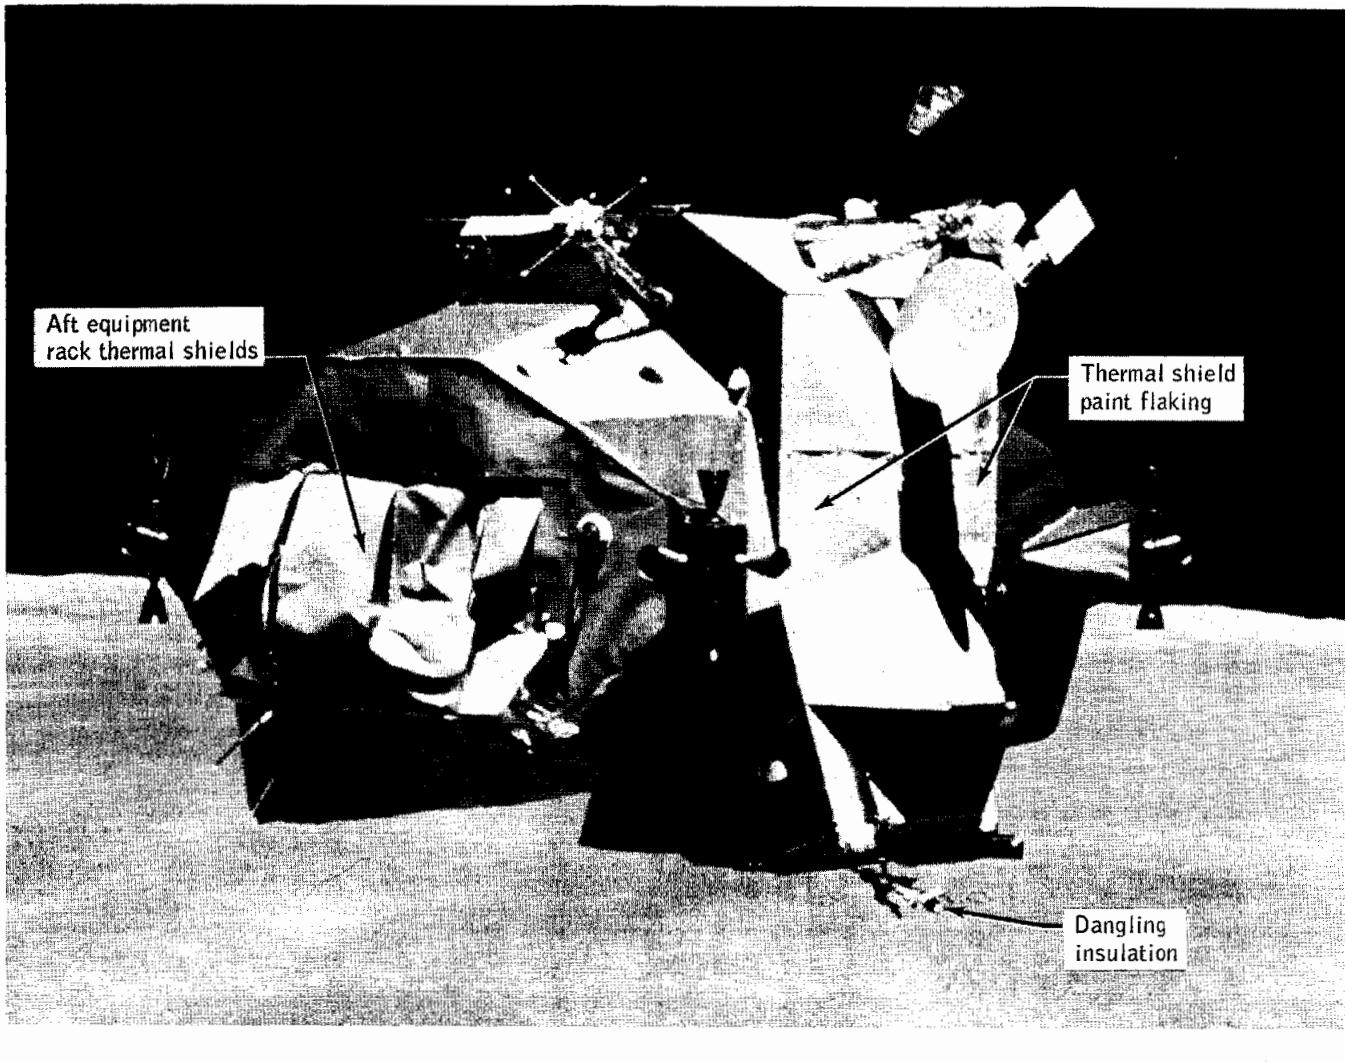
Figure 14-26.- Paint flaking and damaged thermal shield panels.

The most probable cause of the failure was ascent engine exhaust entering the cavity behind these thermal shields. A cross section of the lower edge of the shields is shown in figure 14-27. Analysis shows that the thermal shield which extends below the support tube allows a pressure buildup on the closure shield which exceeds its capability. Once the closure shield failed, the exhaust entered the cavity behind the shield, resulting in a pressure buildup exceeding the capability of the vertical thermal shields. The detailed flight configuration in this area was not tested.
