APOLLO

E-2218

LEAD FAILURE STUDY FOR THE
MOTOROLA 1-MIL WEDGE-BONDED
1006323 TRANSISTOR

DECEMBER 1967

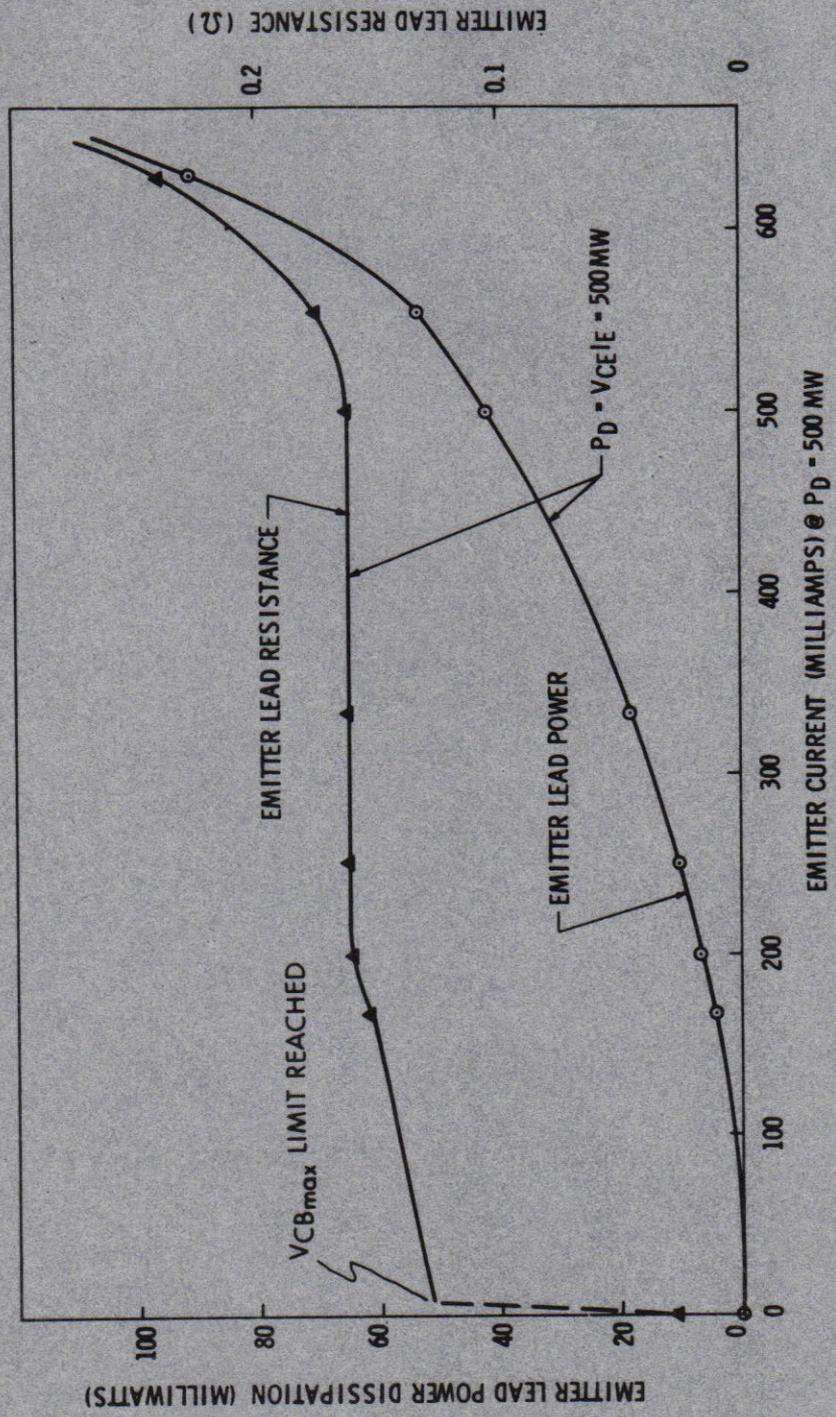
Results of the emitter lead resistance measurements showed that the lead resistance remained relatively constant in the current range of 200 ma to 500 ma (Figs. 1, 2). Above 500 ma, the resistance increased very rapidly indicating a drastic temperature increase and correspondingly higher power dissipation in the lead itself. This condition generally leads to the failure of the unit, as the higher the lead temperature goes, the higher the lead resistance goes which increases lead power dissipation and in turn increases lead temperature. This point of "thermal runaway" was found to occur at a current of approximately 750 ma. This mode of failure of the lead generally leaves the chip intact and in good condition with the lead fused near its midpoint.

Fig. 1 Emitter Lead Res. and Emitter Lead Power Dissipation vs. Emitter Current at 500 mw Chip Power.

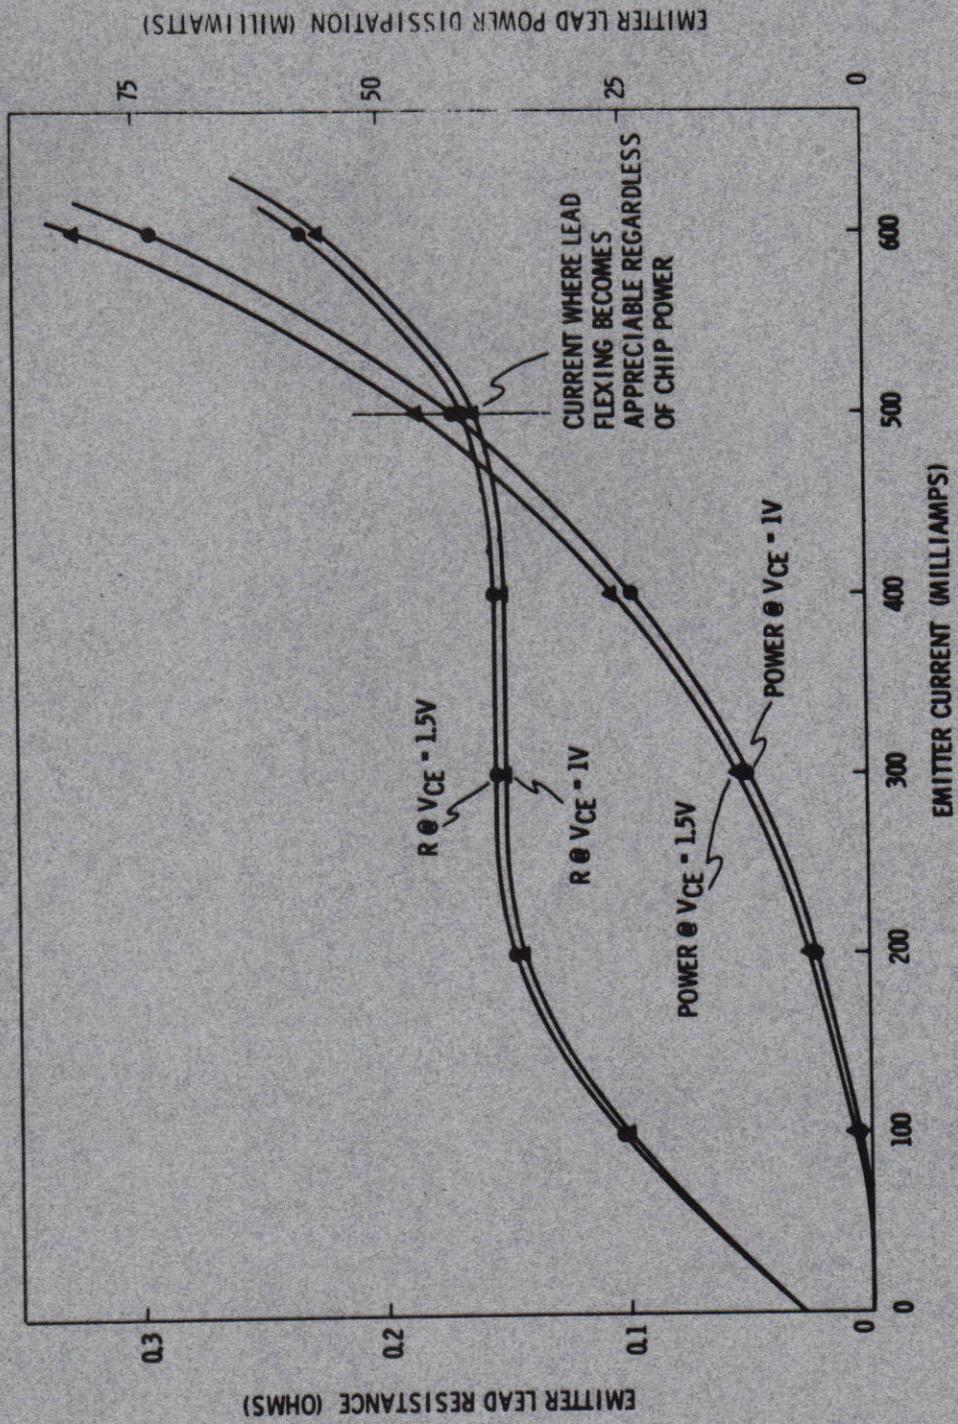
Fig. 2 Emitter Lead Power and Resistance vs. Emitter Current.

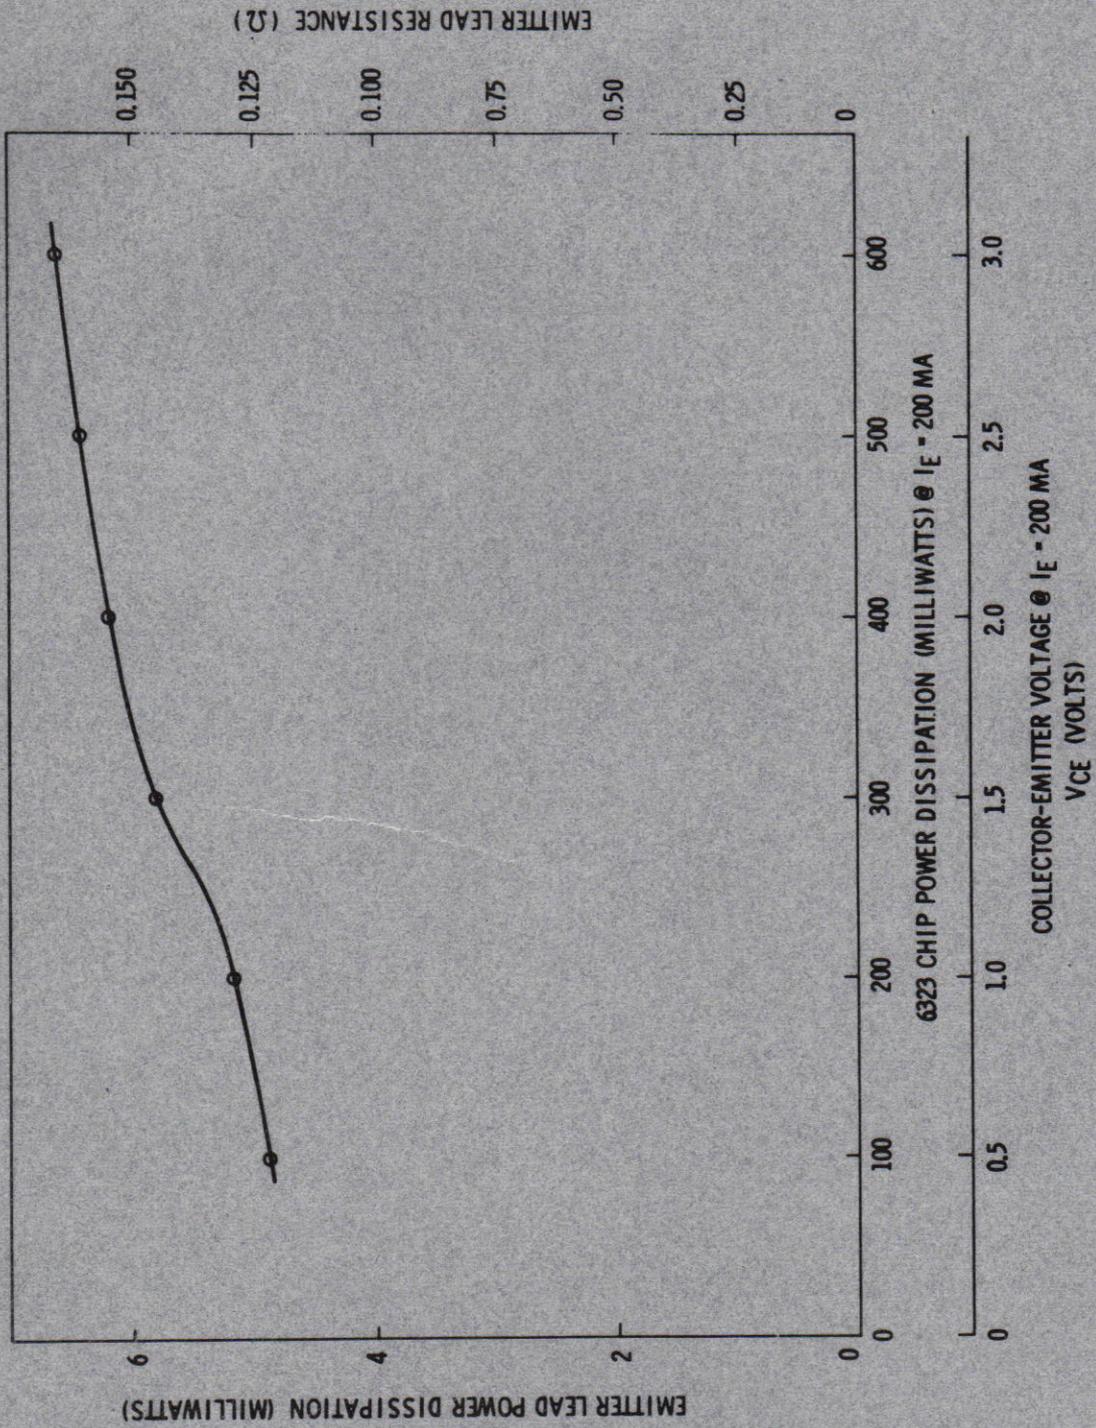
The emitter lead power dissipation was mainly dependent on lead current with only slight dependence on chip power dissipation (Fig. 3). As can be expected, lead power showed a definite correlation to lead temperature and resistance (Fig. 4).

Fig. 3 Emitter Lead Power vs. Chip Power at Constant Emitter Current.

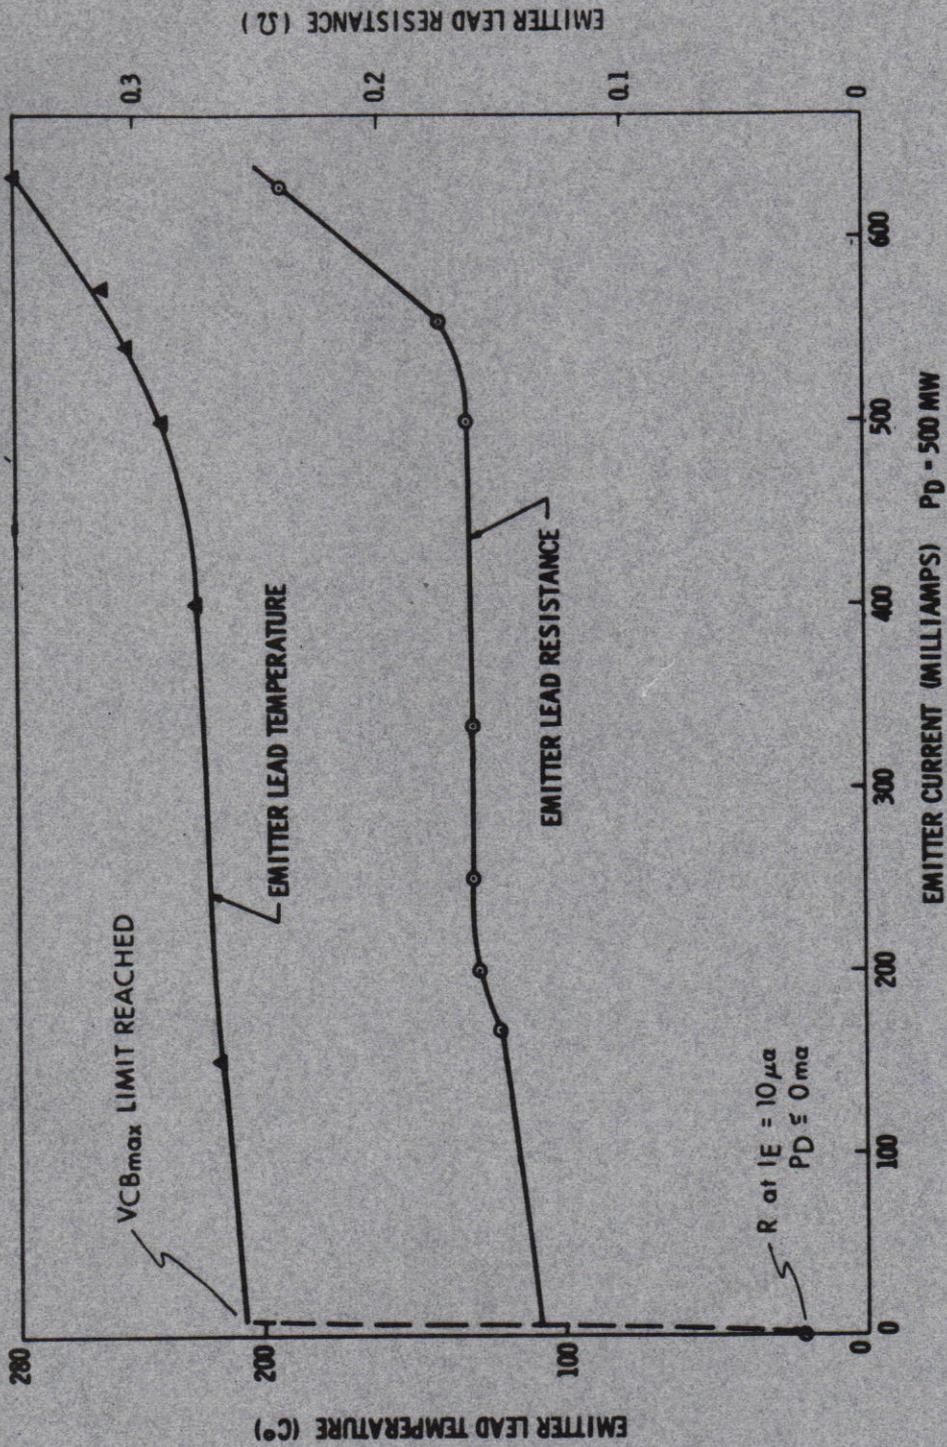
To determine if the Joulian heating in the lead was responsible for the flexing, thermal plots of the time response and temperature distribution of the lead were made. Figure 4 gives the emitter lead temperature as a function of emitter lead current. The thermal time constants of the chip, the lead connected to the chip, and the isolated lead were measured. (Figure 5 gives a typical thermal response of a lead connected to the chip as it occurs in the unit.)

Fig. 4 Emitter Lead Temp. and Resistance vs. Emitter Current at 500 mW Chip Power.

1. Lead current should be limited to 500 ma at most to avoid excessive lead motion.
2. This lead motion seems to be caused by thermal expansion of the lead following the chip temperature generally with small transients occurring at transitions from cooling to heating or vice versa.

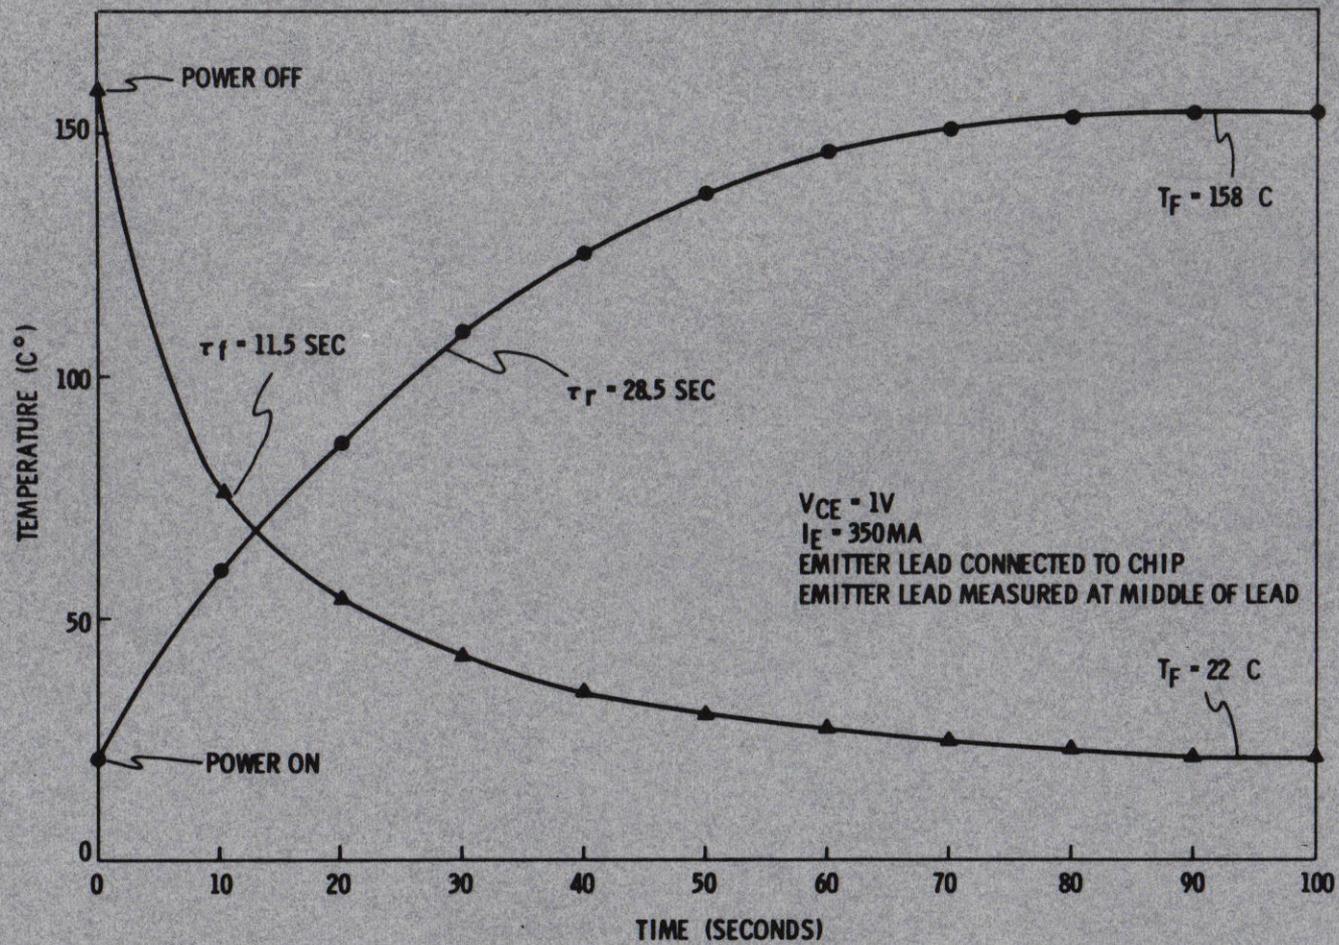
Fig. 5 Thermal Response of Emitter Lead.

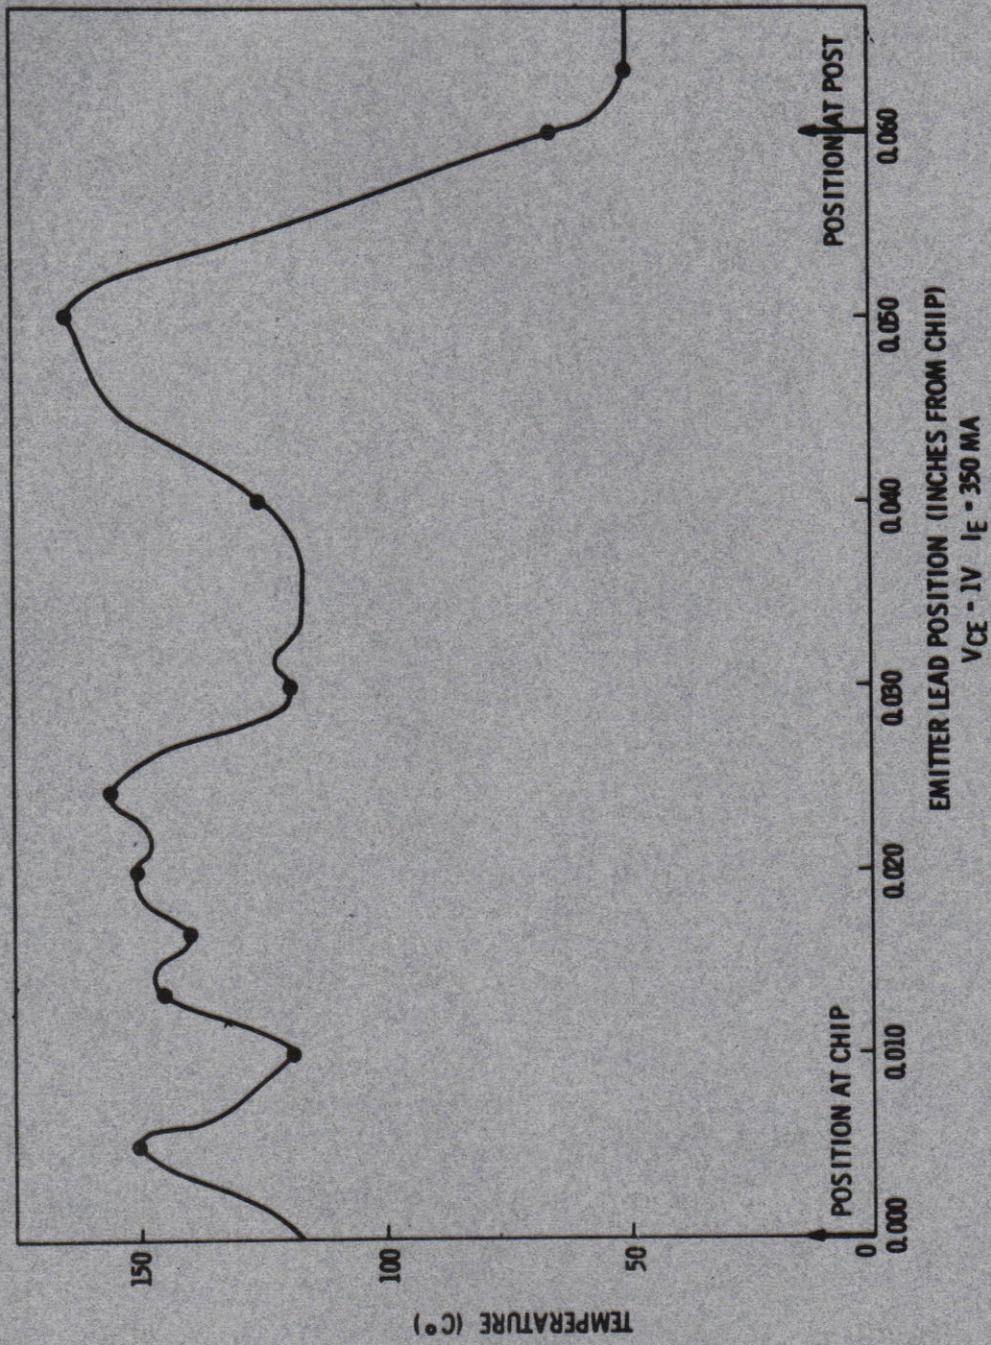
Fig. 6 Emitter Lead Temperature Distribution (at Thermal Equilibrium).

This data indicated that the chip has considerable thermal sinking action on the lead, which would keep the lead temperature fairly close to the chip temperature by heat conduction along the lead. This is supported by the large time constant of the lead when connected to the chip, and the much shorter constant when isolated. Additional evidence is shown by the thermal distribution plot of the lead (Fig. 6), which indicates that most of the lead material is at or near the chip temperature at thermal equilibrium.
