MEMORANDUM

To: Russ Larson
From: Donald Eyles
Subject: Altitude-rate error with EMP 103A
Date: December 1, 1972

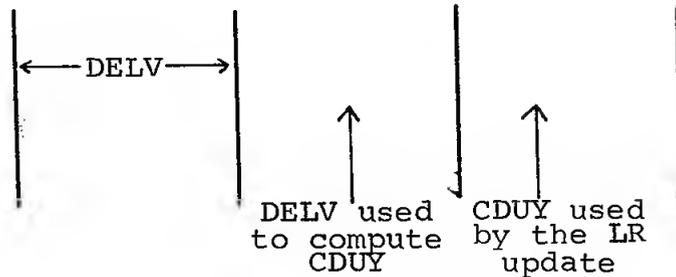
(1) The first stems from the fact that the computed CDUY lags behind the real angle by three seconds. The CDUY computed from the DELV vector is (roughly) valid for the middle of the PIPA interval over which that DELV was accumulated. This angle is computed by the EMP following Servicer during the next PIPA interval, and it is picked up and used by the next Servicer as if it were valid for that PIPTIME. In fact it is valid for a

time about three seconds before that. See the drawing, in which the vertical lines represent PIPTIMES:

If pitch is flown smoothly during P63 the rate-of-change of pitch is about $-.1^{\circ}/s$, and thus the steady-state error from this source is about $.3^{\circ}$ in the wrong direction, i.e. though the mechanism described above it makes the AGC think the LM is descending more slowly than it actually is, by about 10 f/s. Simulations run at MIT bear out these numbers. For rough maneuvers, as when a man is flying N87, the error is less predictable but probably less because there will be periods when pitch is not changing at all and the velocity vector is being updated accurately.
