FROM: Clint Tillman MA&S 25 1331 DATE 31 July 1969

SUBJECT: Program Alarms in Powered Descent - Apollo 11

PROGRAM ALARMS IN POWERED DESCENT - APOLLO 11DISCUSSION OF ALARM CODES OBSERVED AND THEIR MEANING

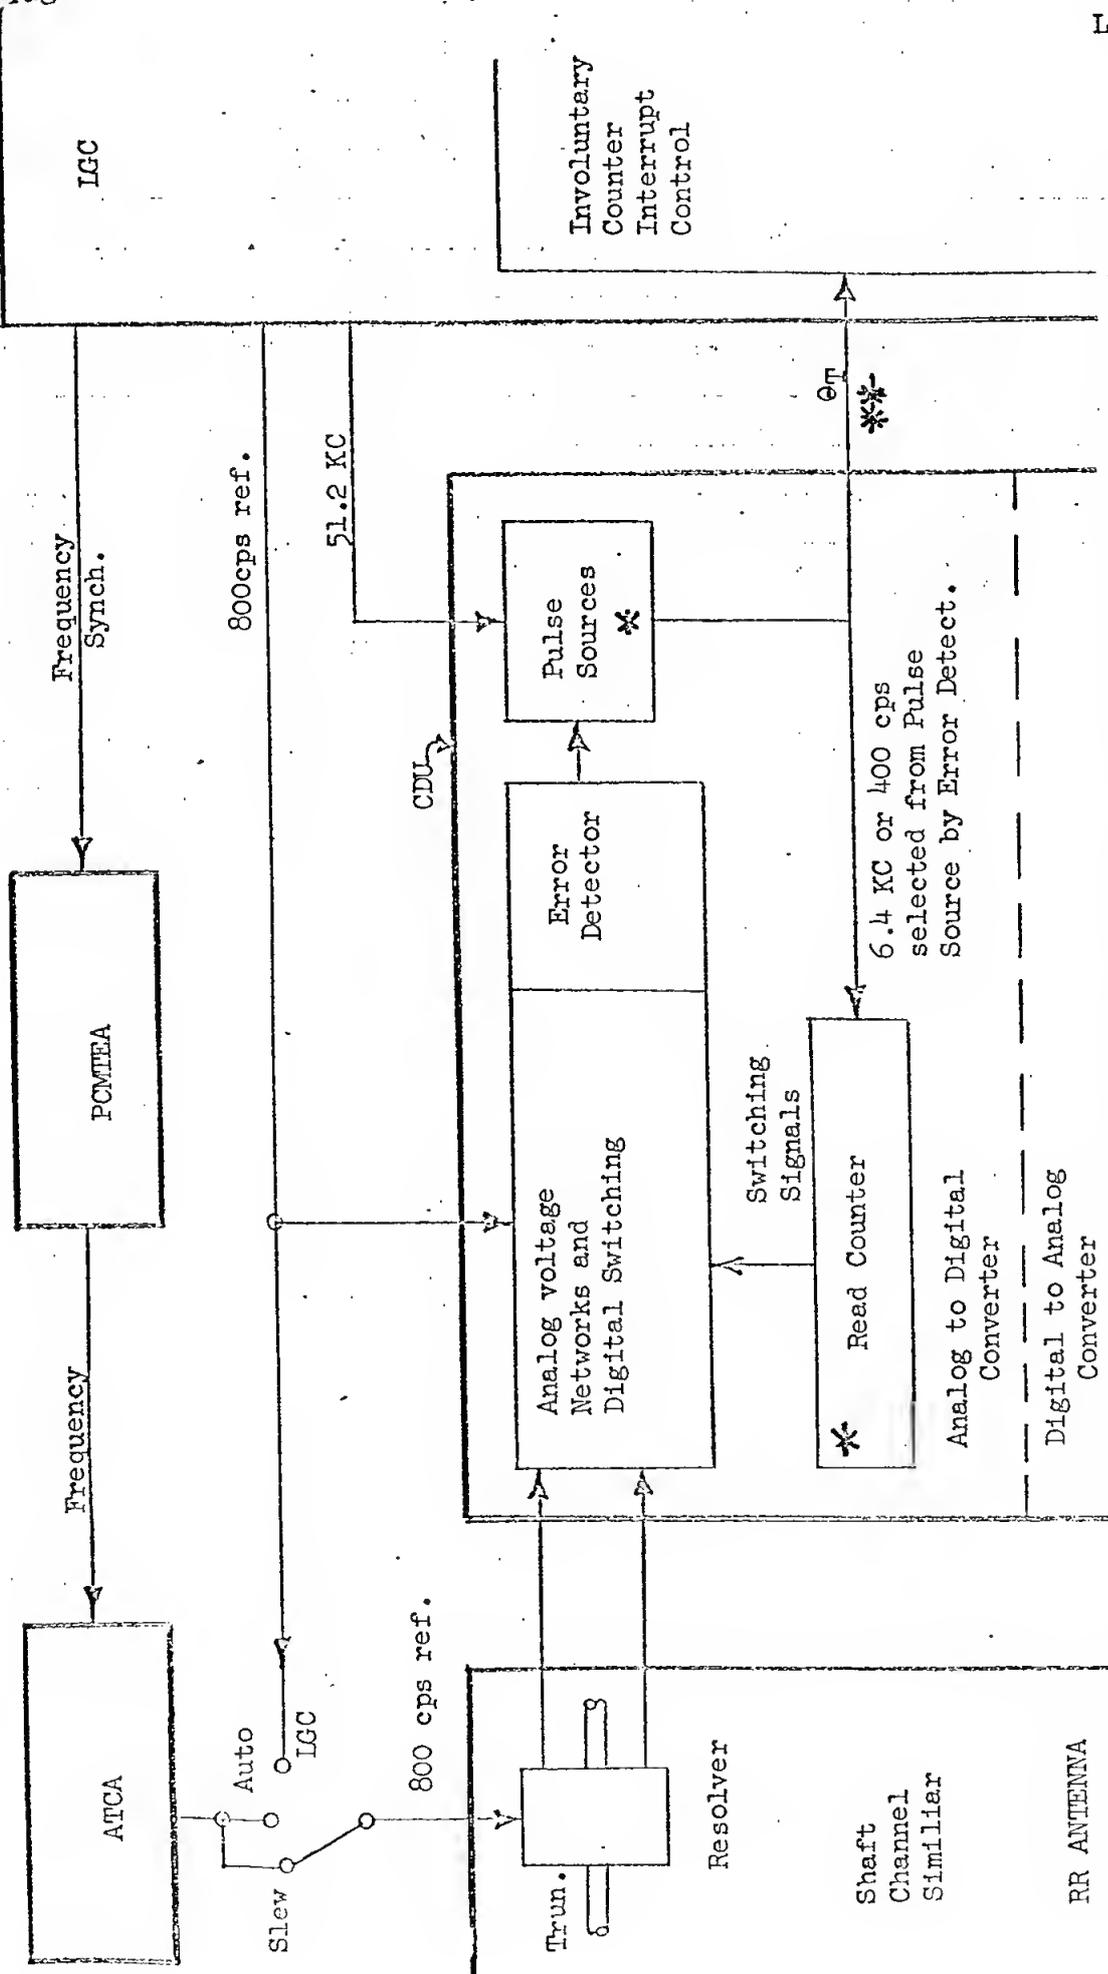
FIG 1. Rough Schematic of RR-CDU-IGC Interface.

It has been determined that the RR-CDU-IGC interface was so configured during powered descent that the CDU's (shaft and trunnion) were receiving inputs (analog) signals that caused them to "slew" in an attempt to digitize the inputs. That is, they selected the 6.4 KC pulse train to drive the read counter and the IGC. For both channels this means 12,800 counter interrupts must be handled by the IGC per second. At about 12 μ secs each this takes about .15 seconds per second or a 15% real time overhead burden on CP time. This is 5% above the 10% TLOSS used in verification. P63 could not handle this in the presence of a monitor verb and P64 was marginal at this level (15%).

Figure 1 roughly schematizes the situation. When the RR panel switch is in IGC the RR resolvers receive their 800 cps reference from the Primary System. In SLEW or AUTO, however, they receive this reference from the ATCA. This voltage is frequency controlled by the Primary System through its control of the PCMTEA, but it is not phase controlled nor is it of the same magnitude wave form. These features of the resolver input to the CDU A/D converter section when not in IGC caused the CDU to "SLEW" (digitally). Note that neither RR ON/OFF or mode controls affect the CDU-IGC $\Delta\theta$ interface. Also the RR breakers do not control the reference voltage connection from the ATCA to the resolvers. Data shows the RR was not in IGC during this period and also that the RR CDU Fail Discrete (CH30B07) was present. This discrete is set by a number of problems one of which is an excessive error condition.

* RR CDU ZERO Mode (Presence of CH 12 BOI) holds the Read Counter Reset and disables gating out of pulses to the Read Counter and the LGC

** Our RR Shaft and Trunnion angle data from FMES replaces the normal CDU output here.

LUMINARY 1B, which will be tested in the FCI lab shortly, contains two changes pertinent to the subject at hand. One, covered by PCR 814, provides for a modified V57 which incorporates a display of N68, thereby doing away with any need for a monitor verb. MIT/IL estimated in the PCR a 5% computer time saving. The second was a change resulting from Apollo 11, PCR 848, which provides for issuing RR CDU ZERO's while the RR is not in LGC. This CDU mode should have the effect of preventing any digitizing of an input to the CDU. In order to properly test this arrangement the CDU-LGC interface should be in, indicating we need an arrangement inputting the analog end of the CDU's.
