Integrated In-flight Anomalies (IFAs)

STS-126-I-001 – SM GPC Failure to Send GCIL Commands

IFA STS-126-I-001 Causal Analysis

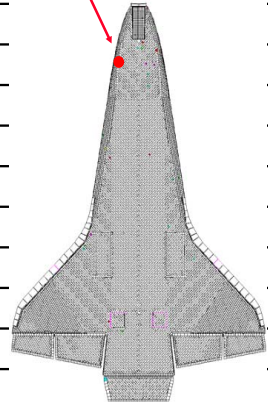
STS-126 Putty Loss Location

- One putty repair was liberated during STS-126
 - The masses were consistent with the masses provided in NSTS-60559

STS-121	5	0	0.0003-0.0021		
STS-115	8	2	0.0000-0.0061		
STS-116	5	0	0.0008-0.0026		
STS-117	10	1	0.0001-0.0120		
STS-118	8	3	0.0001-0.0019		
STS-120	5	0	0.0003-0.0010		
STS-122	2	0	0.0022-0.0059		
STS-123	5	0	0.0004-0.016		
STS-124	2	0	0.0029-0.0065		
STS-126	1	0	0.0045		V070-391018-177 / Defined undercuts are still solid/ There is an adjacent putty repair Outside of the RCC transport area

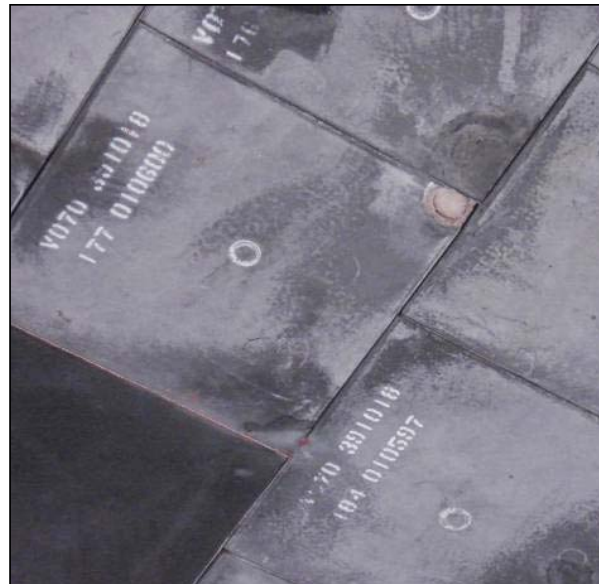
STS-126 Missing Putty Repair

- V070-391018-177
- Missing, defined undercuts still solid
- There is an adjacent putty repair
- Outside of the RCC transport area

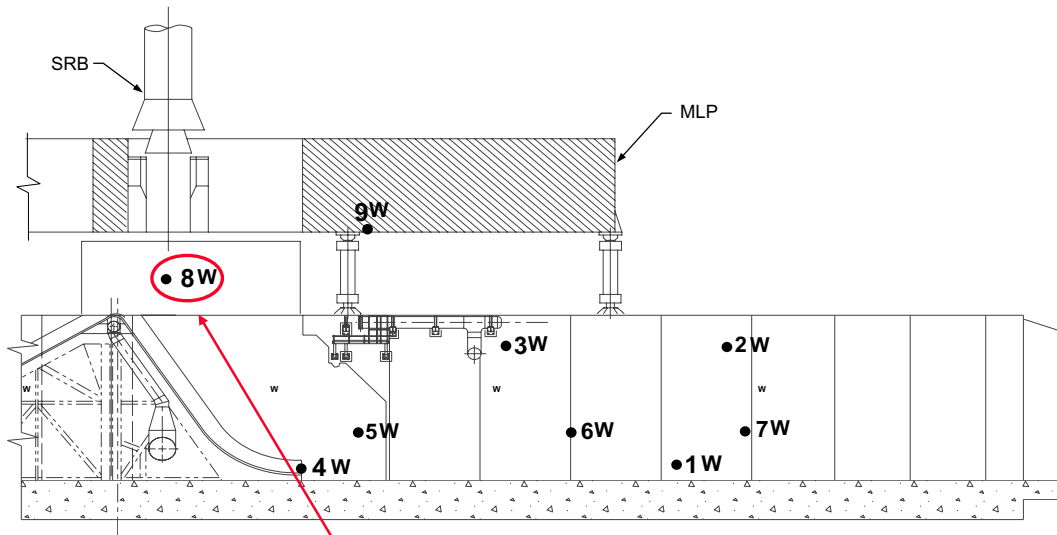
Instrumentation Location Points – West Side of SRB Flame Trench

Maximum Pressure (KFDP A007A) = location 8W

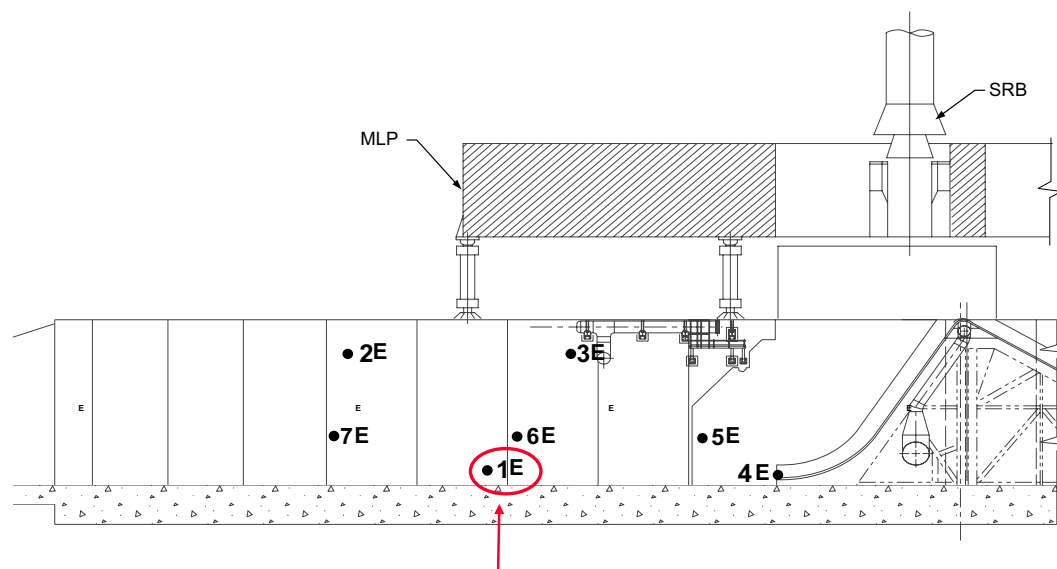
Instrumentation Location Points – East Side of SRB Flame Trench

Minimum Pressure (KFDP A011A) = location 1E

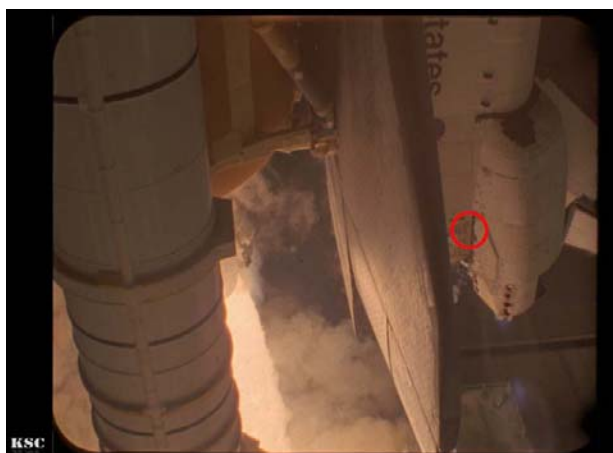
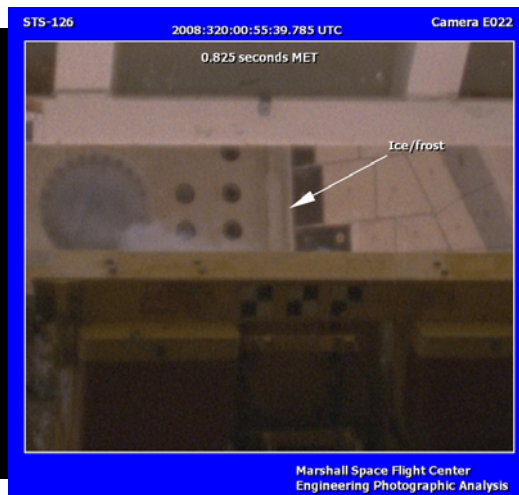
STS-126-I-002 – Debris Released from near the T-0 Plate (Cont)

- **Background**
 - Ice/frost debris, 11.5" x 2" in size, was observed to liberate from the orbiter near the location of the Liquid Hydrogen (LH2) T-0 umbilical at ~27 seconds MET. In this area.
- **Approach**
 - Purge test on MLP 1 LH2 Tail Service Mast (TSM) Umbilical Helium flow test completed.
 - Inspection of T-0 Umbilical Carrier plate perimeter seal interface on OV-103 T-0 Plate completed.
 - Debris Transport Analysis (DTA) of ice/frost release in work to characterize risk.
 - Fault Tree Analysis and Block closure is in work.
 - Assessing Ground Support Equipment (GSE) H/W and process options to prevent ice/frost or have it liberate at/before T-0.
- **Status**
 - DTA, fault tree, and GSE assessments in work.
 - ECD: 1/20/09

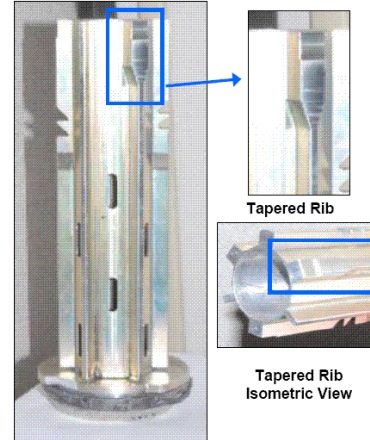
Plunger Feature Utilized for Stop Block

- **Background**
 - DCS plunger and spring exited through bore hole and became lift-off debris.
- **Approach**
 - SRB design change added additional mechanism (tapered rib) to retain spring/plunger assembly in the event of failure of the primary retention design (plunger shoulder).
- **Results**
 - Certification tests complete. Documentation in work.
- **Status**
 - Awaiting Field Engineering Change approval before closing IIFA
 - Potential waiver on primary retention design (plunger shoulder) factor of safety
 - ECD: 1/20/09
