SPACE SHUTTLE PROGRAM
Space Shuttle Systems Engineering and Integration Office
NASA Johnson Space Center, Houston, Texas

STS-122

SSP Flight Readiness Review

MS/Don Noah
November 13, 2007

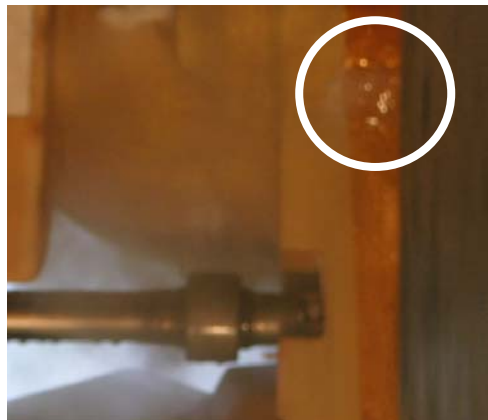
- STS-120-I-001: Umbilical Ice exceeded limits of NSTS08303
 - Required a Day of Launch waiver for visibly hard ice
 - STS-122 Goal:
 - The requirements in NSTS08303 will remain unchanged (no visible hard ice)
 - SE&I will complete and review Umbilical Ice PRA and Orbiter deterministic assessment for various shapes and masses to determine an allowable mass for hard ice
 - Results will be available should a DOL waiver be necessary
 - Post STS-122:
 - SE&I will update NSTS08303 with umbilical ice mass allowables based on PRA analysis and/or Orbiter deterministic analysis

**LH2 Umbilical Ice
on STS-120**

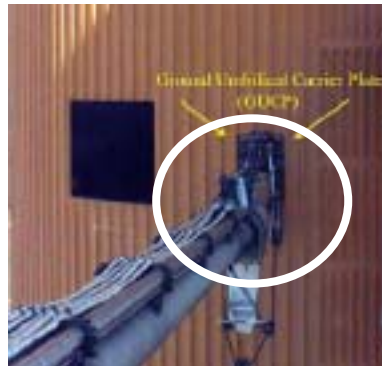
- STS-120-I-002: Ground Umbilical Carrier Plate (GUCP) Ice/Foam loss
 - “Ice Bridging” is considered unacceptable per NSTS08303
 - The Final Inspection Team did not observe “Ice Bridging” before launch

- However, High Speed Imagery review did reveal “Ice Bridging”
 - Addition of Color Cameras to replace Blank & White under consideration
 - STS-122 Goal:

- Requirements in NSTS08303 for GUCP Ice Bridging remain unchanged for STS-122
 - The GUCP is located at 120 degrees phi, which is outside the +/-110 degree phi for transport for either foam or ice and therefore not an Ascent debris threat due to no transport

- These results have been reviewed and documented at the DIG
 - Post STS-122:
 - Update NSTS08303 to declare “ice bridging” acceptable for ascent and liftoff

- Update IDBR-01 to state that there is residual Liftoff only risk from a specific set of ice conditions, winds and rebound that could have potential transport to the Orbiter

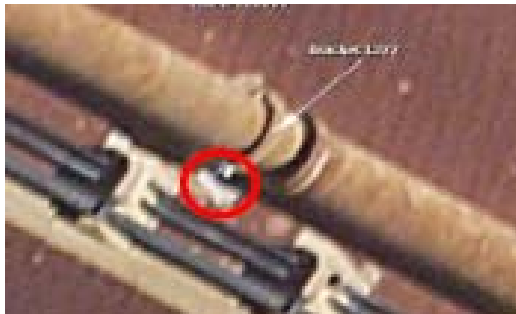
- STS-120-I-005: Debris Release on Outboard side of LO2 Feedline at ~277 sec
 - Multiple release were observed outboard of the LO2 Feedline Bracket at Xt1377
 - The total liberated mass (0.025 lbm) exceeded the NSTS60559 risk assessment mass for releases after 135 seconds
 - Risk assessment mass considers only the Void DeltaP failure mode
 - The failure mechanism was attributed to cryopumping
 - Consistent with cryopumping timeframe
 - The CR (S063369) to change the risk assessment mass for the cryopumping failure mode has been submitted and approved at the 11/5/07 DIG

Outboard LO2 Feedline Bracket
Acreage Loss at Xt1377

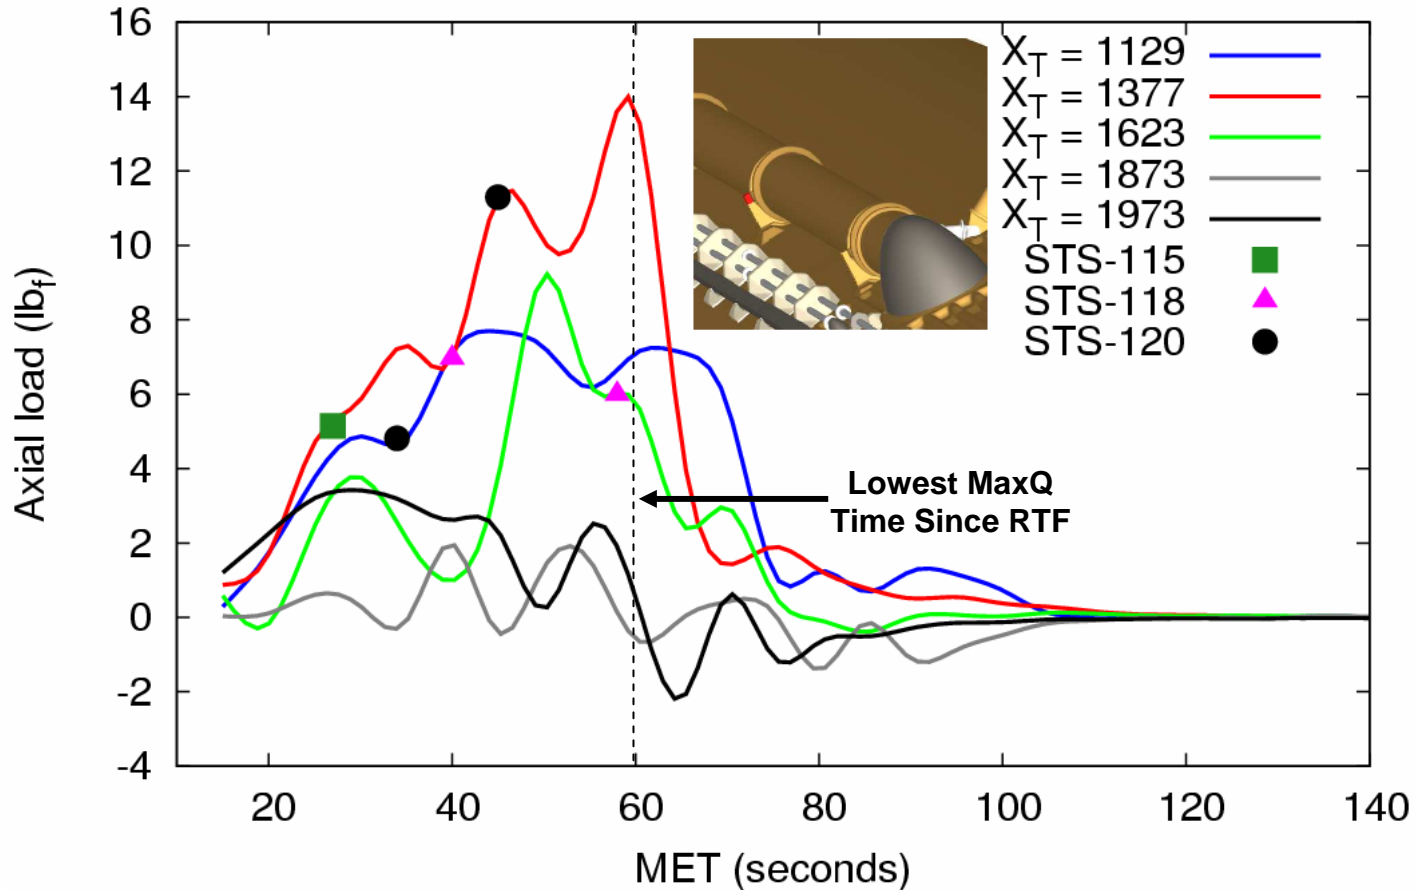
<h1>LO₂ Feedline Bracket Losses as a Function of Airload</h1>		Presenter MS2/Jim Peters	
		Date Nov. 13, 2007	Page 18

All the observed losses identified with release times since RTF were before MaxQ

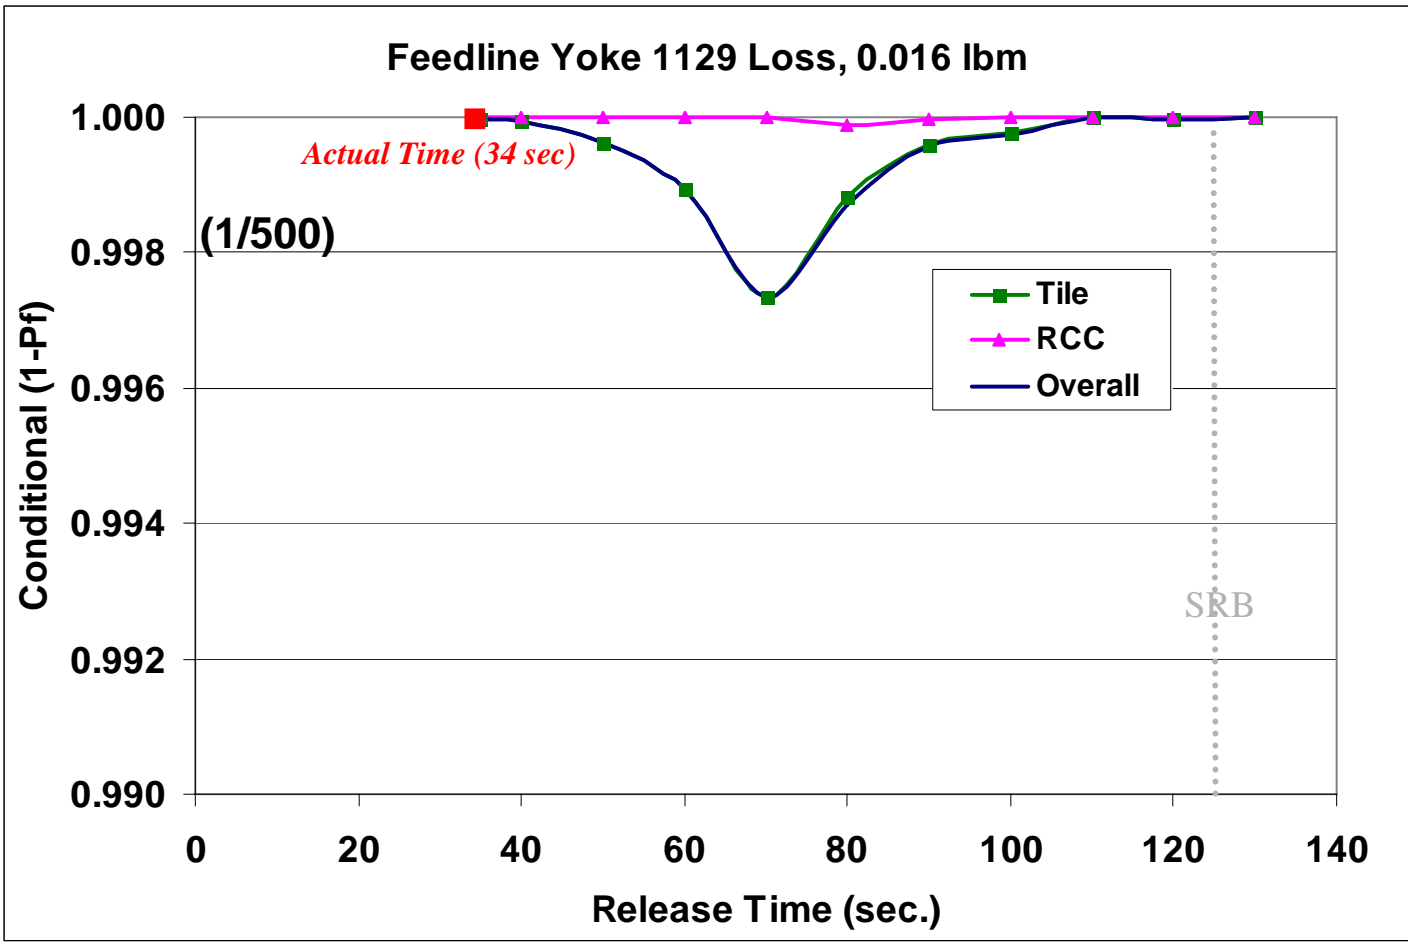
STS-120 Reconstruction of Xt1129 Feedline Yoke Loss

The low probability before MaxQ is due to the relatively low velocities along with flying negative alpha, which results in fewer impacts as long as rebound is not considered

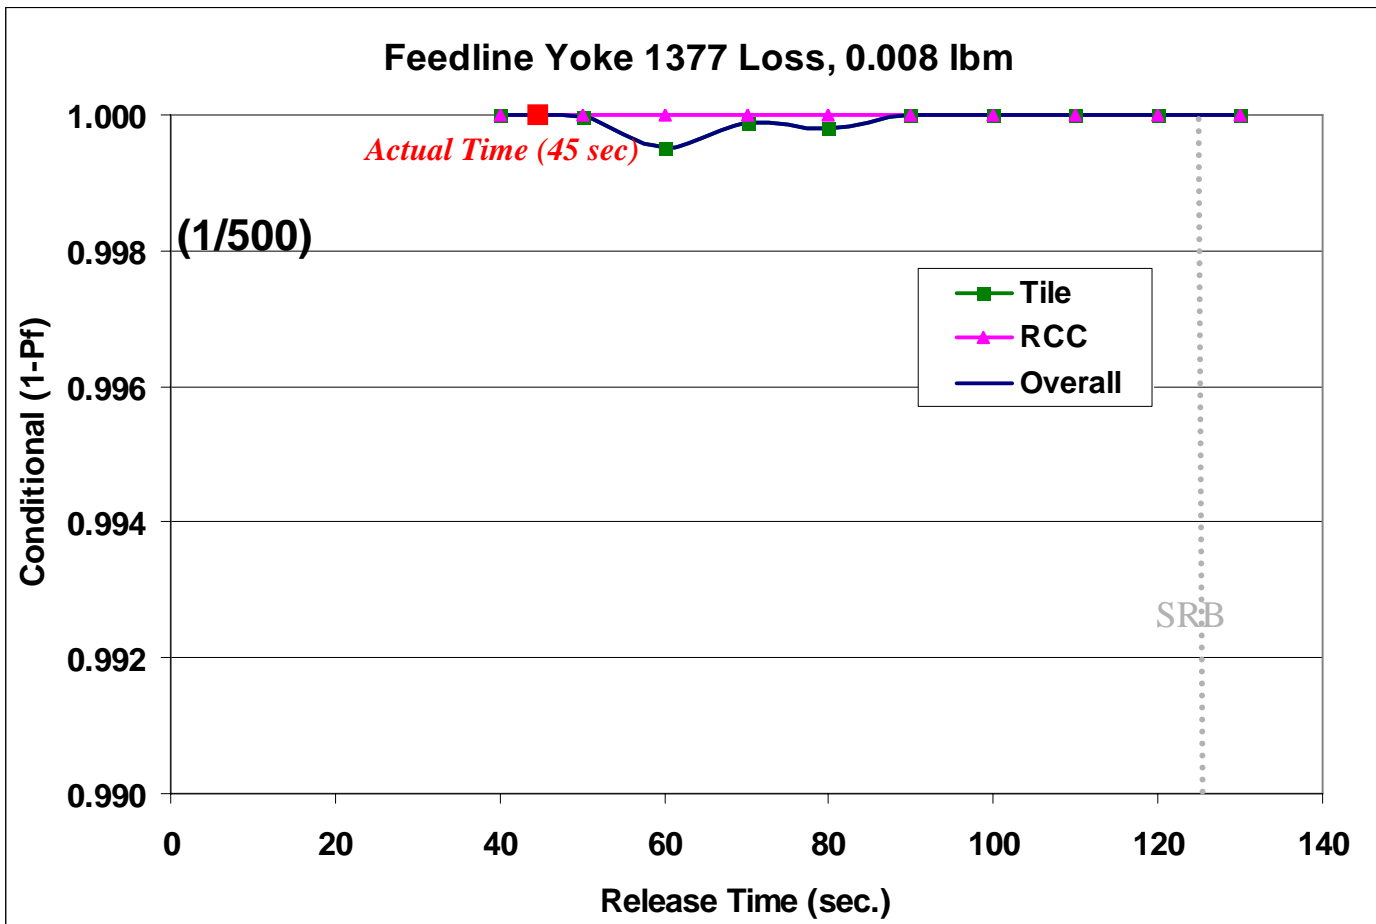
<h1>STS-120 Reconstruction of Xt1377 Feedline Yoke Loss</h1>		Presenter MS2/Jim Peters	
		Date Nov. 13, 2007	Page 20

The low probability before MaxQ is due to the relatively low velocities along with flying negative alpha, which results in fewer impacts as long as rebound is not considered

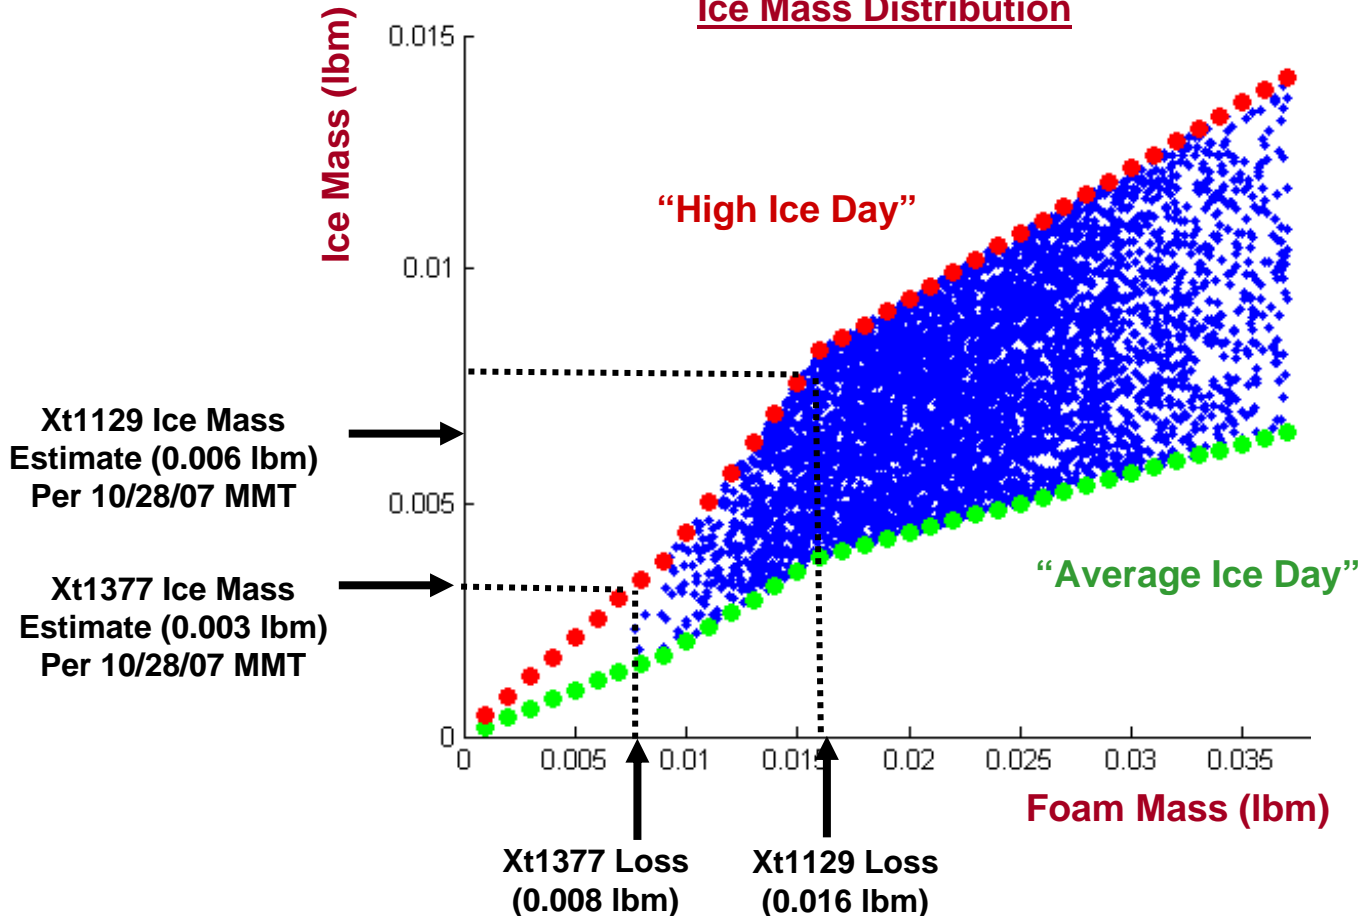
LO2 Feedline Yoke and Ice Liberation Model

- Model Assumes that Ice Debris is a Function of Foam Mass
 - The highest Ice-to-Foam mass percentage is 30% on the “High Ice Day”
 - Curve based on Ice Testing at MSFC and ET Project analysis

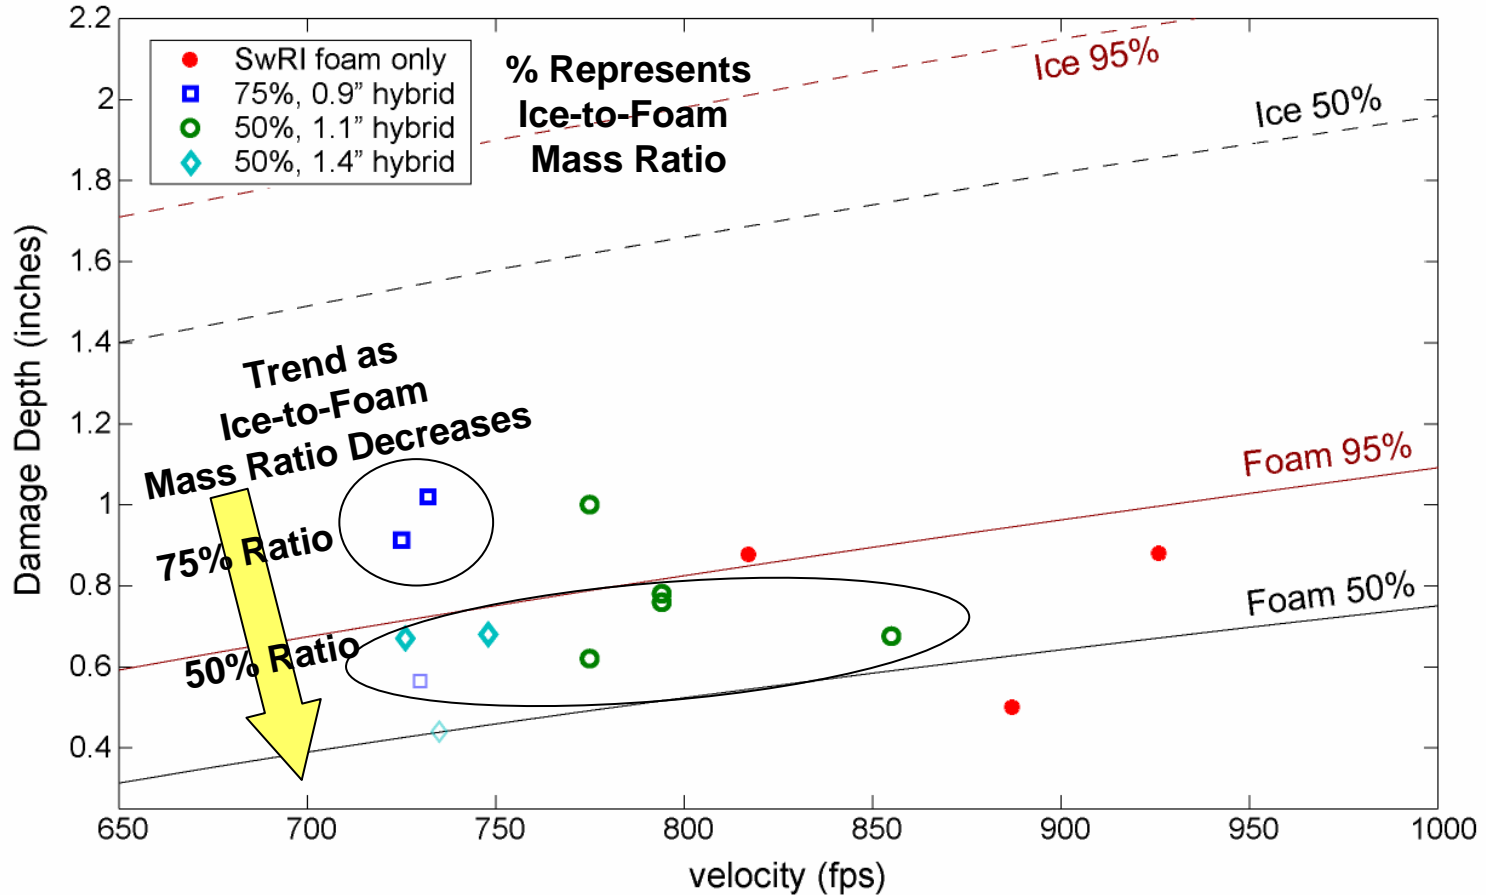
“Mixed Ice/Foam” Impact Testing (0.004 lbm)		Presenter MS2/Jim Peters	
		Date Nov. 13, 2007	Page 22

The maximum ice-to-foam mass ratio for even high ice days, like that of STS-120 (~30% ice), are below the impact test levels (50% ice)

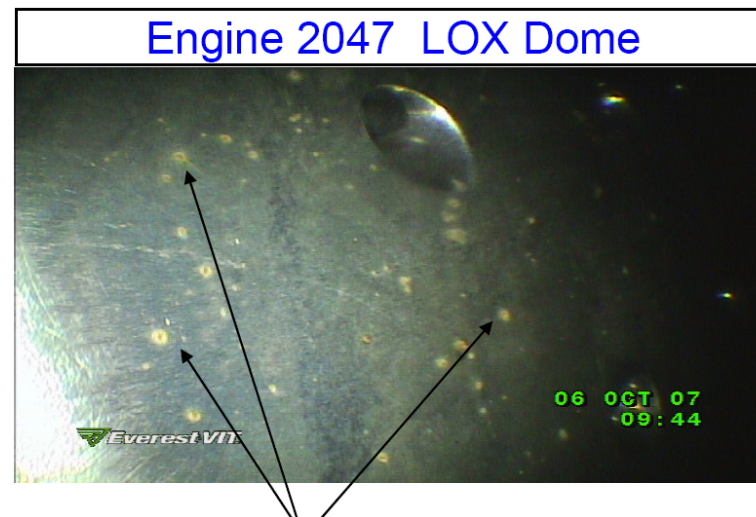
- Small (~250-1500 μ) rust stains were found in all three engines (2047, 2051, 2045) main injector LOX domes during post flight inspections
- Particle size ranges from 30 to 50 μ
- Analysis indicates particles are iron oxide (rust)
 - Most likely stemming from corrosion of low alloy based steel such as 4100 series or carbon steel
 - Unoxidized iron particles would be 2 to 3 times smaller than oxidized particles
- Source of contamination is unknown
- MLP-1 is common to STS-118 and STS-122
- SSME 2047 is ME-1 on STS-123

Iron Oxide Particles

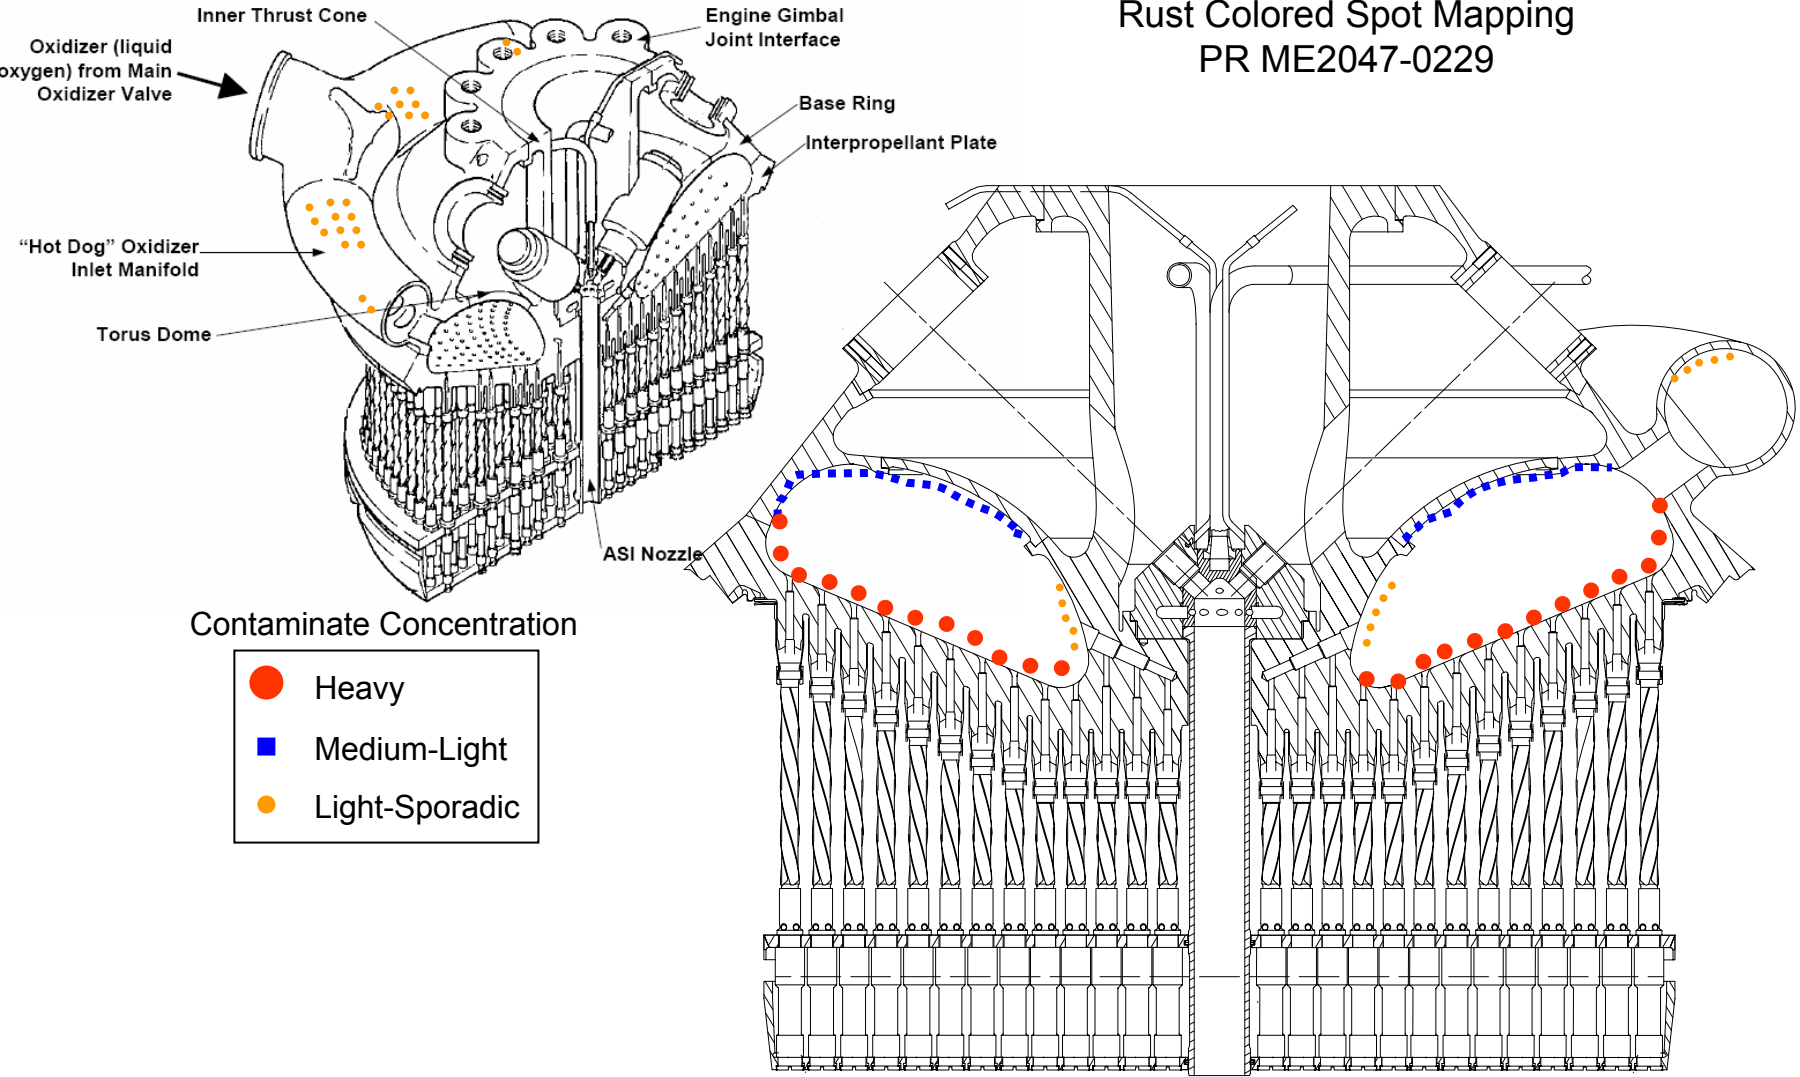
ME2047 Main Injector LOX Dome
Rust Colored Spot Mapping
PR ME2047-0229

Note: Contamination evenly concentrated 360°

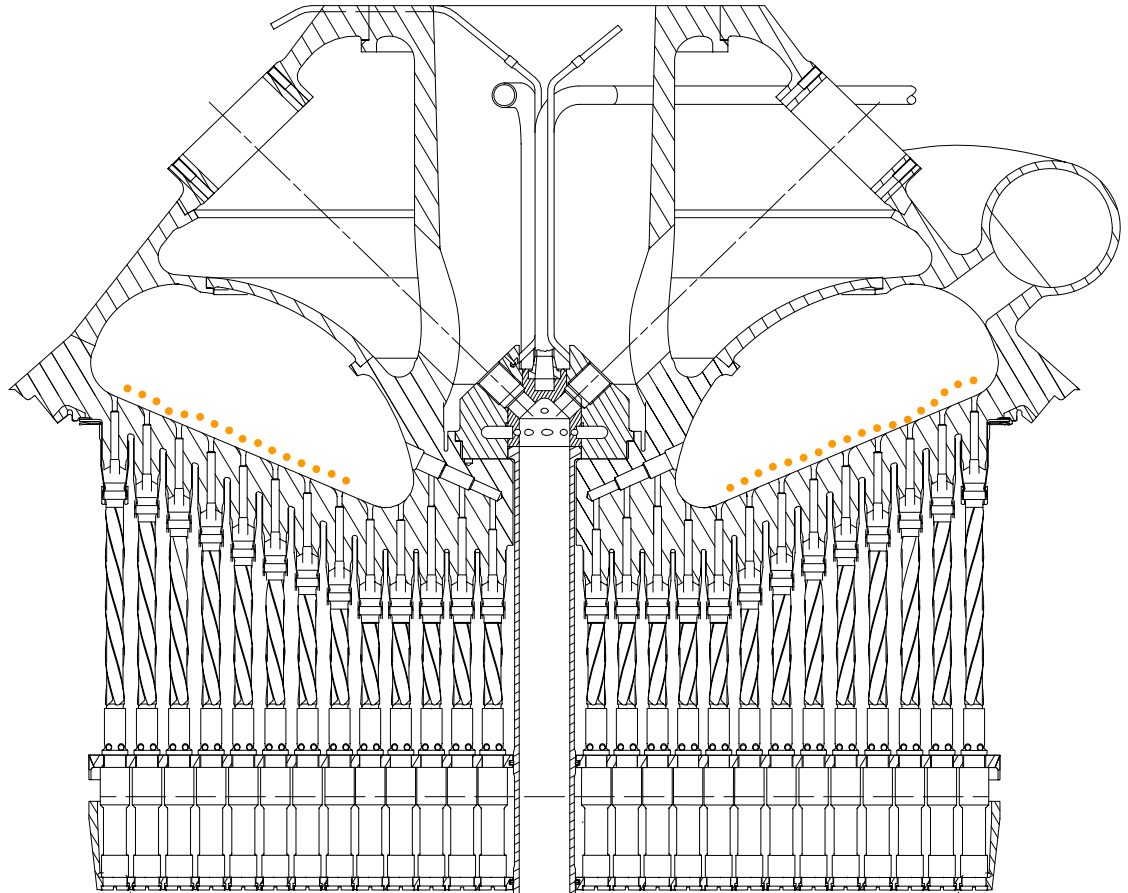
ME2051 Main Injector LOX Dome
Rust Colored Spot Mapping
PR ME2051-0210

Note: Contamination is evenly distributed 360°

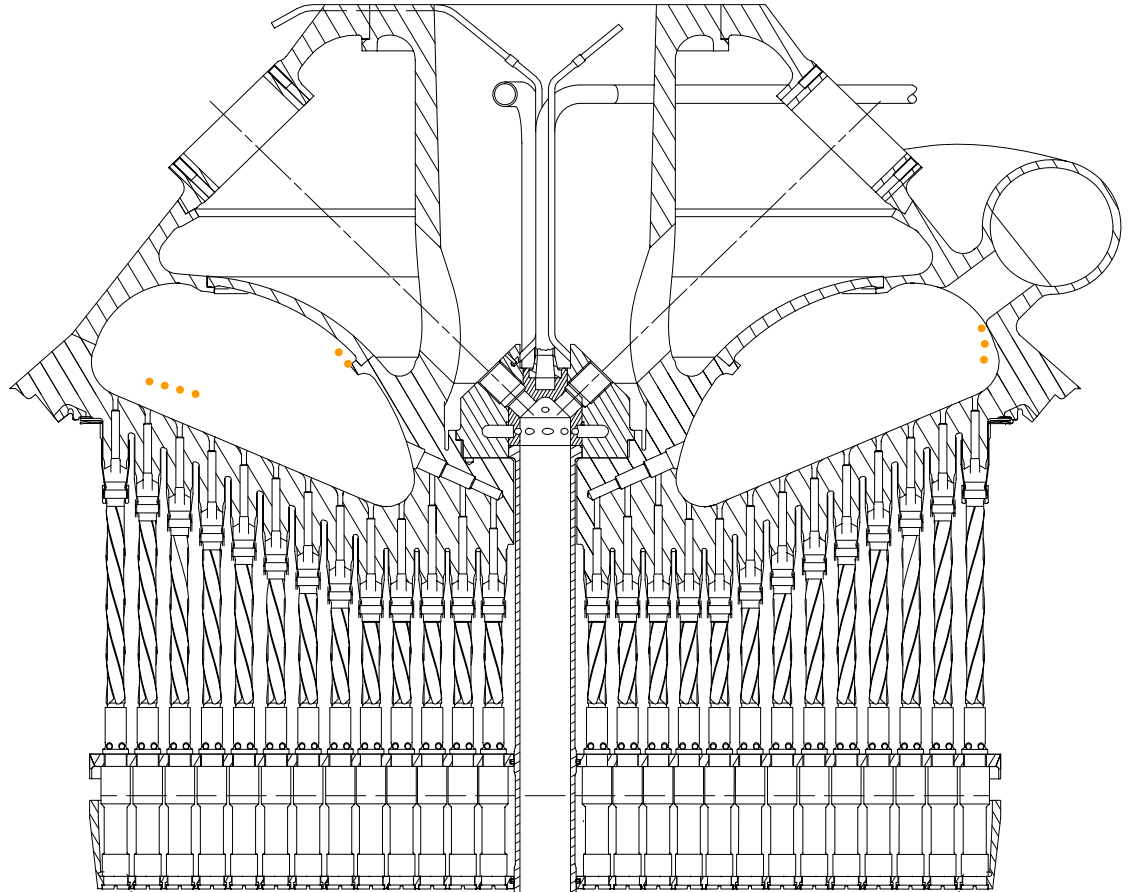
ME2045 Main Injector LOX Dome
Rust Colored Spot Mapping
PR ME2045-0291

ME2045 spot count is < 10 spots
