Space Shuttle Flight Software Potential Loss of Crew Errors

James K. Orr

Purpose

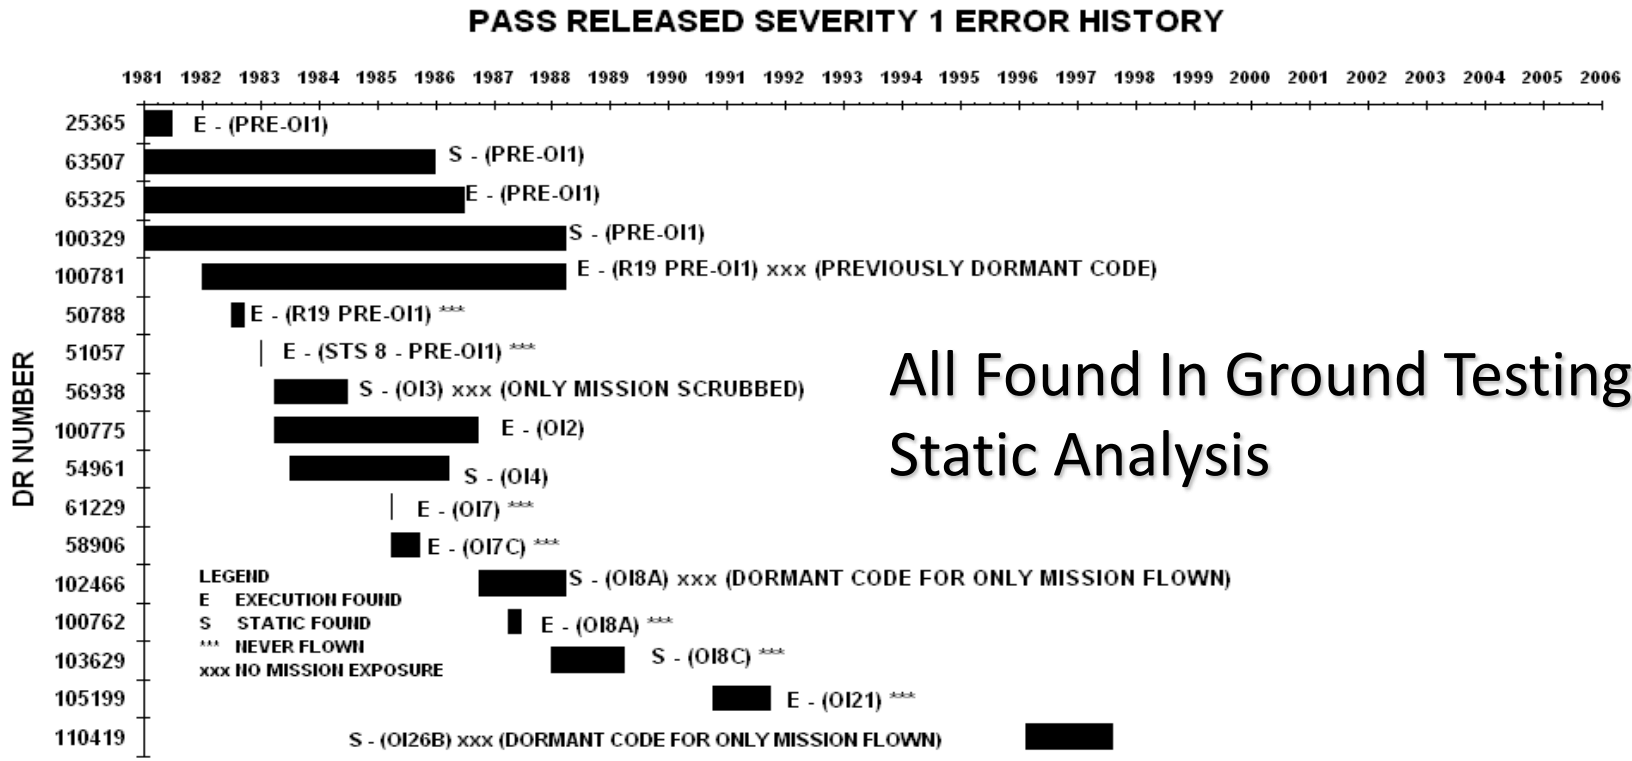
PASS Released Severity 1 Error History

All Found In Ground Testing or Static Analysis

NOTE: BARS BEGIN AT DATE OF DR INTRODUCTION AND TERMINATE AT DATE OF DETECTION (DOES NOT INCLUDE SEV 111 DRs WHICH ARE A SUBCATEGORY OF SEV 3 DRs)
