STS-2 GNC POST FLIGHT REPORT

Attached is the GNC STS-2 post flight report. The report is broken into four individual software areas, two significant FTOs, and seventeen individual hardware subsystems. Each report is divided into a system performance which includes an anomaly analysis, lesson learned, and a recommendations section. It is intended that this report becomes a working document as a reference for future system evaluation.

The reports include the analysis, to date, of the known GNC STS-2 anomalies. These are:

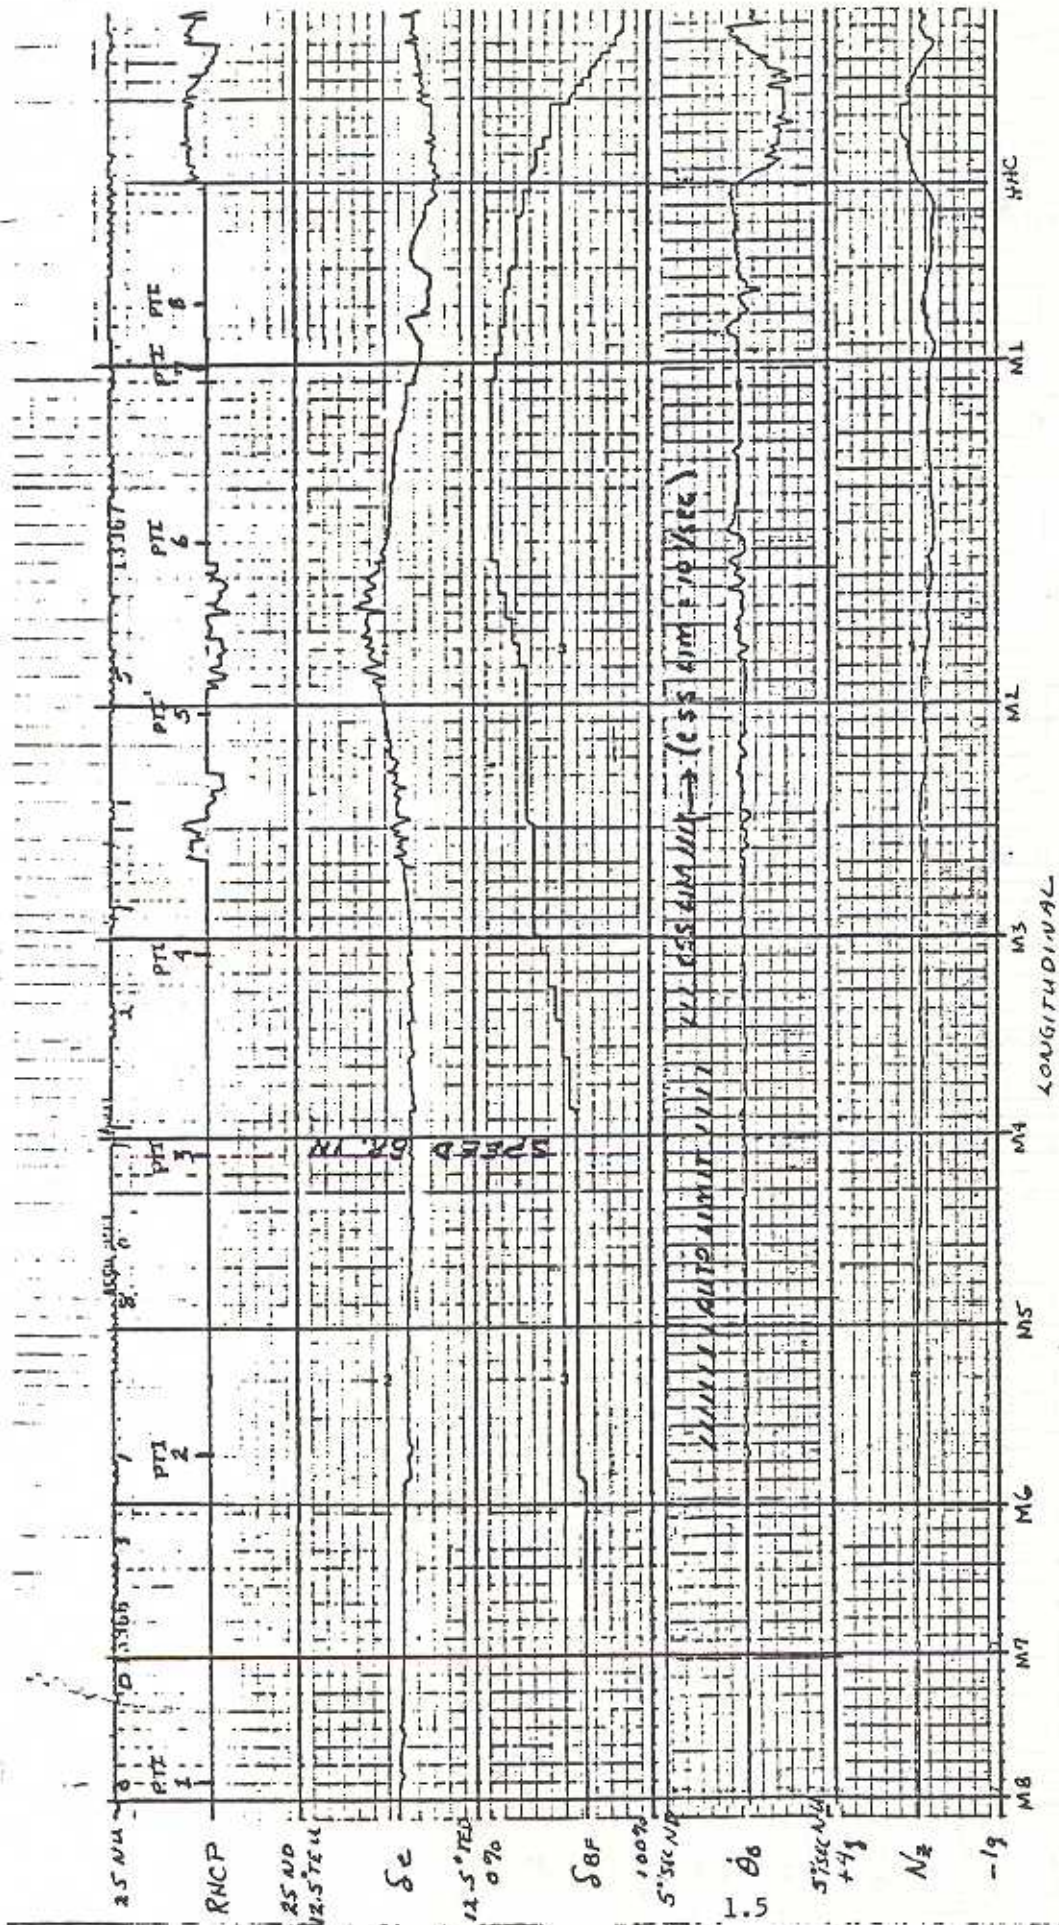
fig. 2

Dynamic Response- The short term (dynamic) performance of the DAP was evaluated by looking at effector and orbiter responses to manual and auto commands issued by guidance and RHCs. Figure 2 and figure 3 are time histories of FCS parameters observed between M8 and HAC intercept. Longitudinal and LAT/DIR responses to manual RHC inputs can best be seen in the HAC acquisition maneuver. LAT/DIR response to auto guidance commands are observed in the YJet firings, aerosurface deflections and body rates during roll reversals 3 and 4. Reversal 1 was completed in CSS to preclude recurrence of the STS-1 lateral oscillation. Reversal 4 clearly shows the rudder participation following its activation at M 3.5. In this case the DAP only fired 3 jets over a shorter time, instead of the 4 used in previous reversals, to establish the I-Loaded 5 °/sec roll rate. The lateral axis also shows the responses to the PTIs. Generally all responses appeared fast and well damped. Jet and aerosurface commands were in all cases appropriate to achieve the I-Loaded values with the steady state rates falling very close to these values. The performance of the DAP as manifested in the dynamic responses of the effectors and body rates to commands appeared satisfactory.

Flight Rule/Rate limit violations- DAP adherence to the operational limitations as published on pages 8-9 through 8-11 of the Flight Rules was evaluated since these limits exceed the I-Loads. These limits are shown graphically on figures 2, 3 and 5. No violations were observed with the possible exception of PTI-3. This PTI may have exceeded the 5 deg/sec roll rate limitation above M=1.5 by as much as 1.5 deg/sec. This was a transient excursion of less than one second and is not considered significant. DAP adherence to the I-Loaded limits was satisfactory.

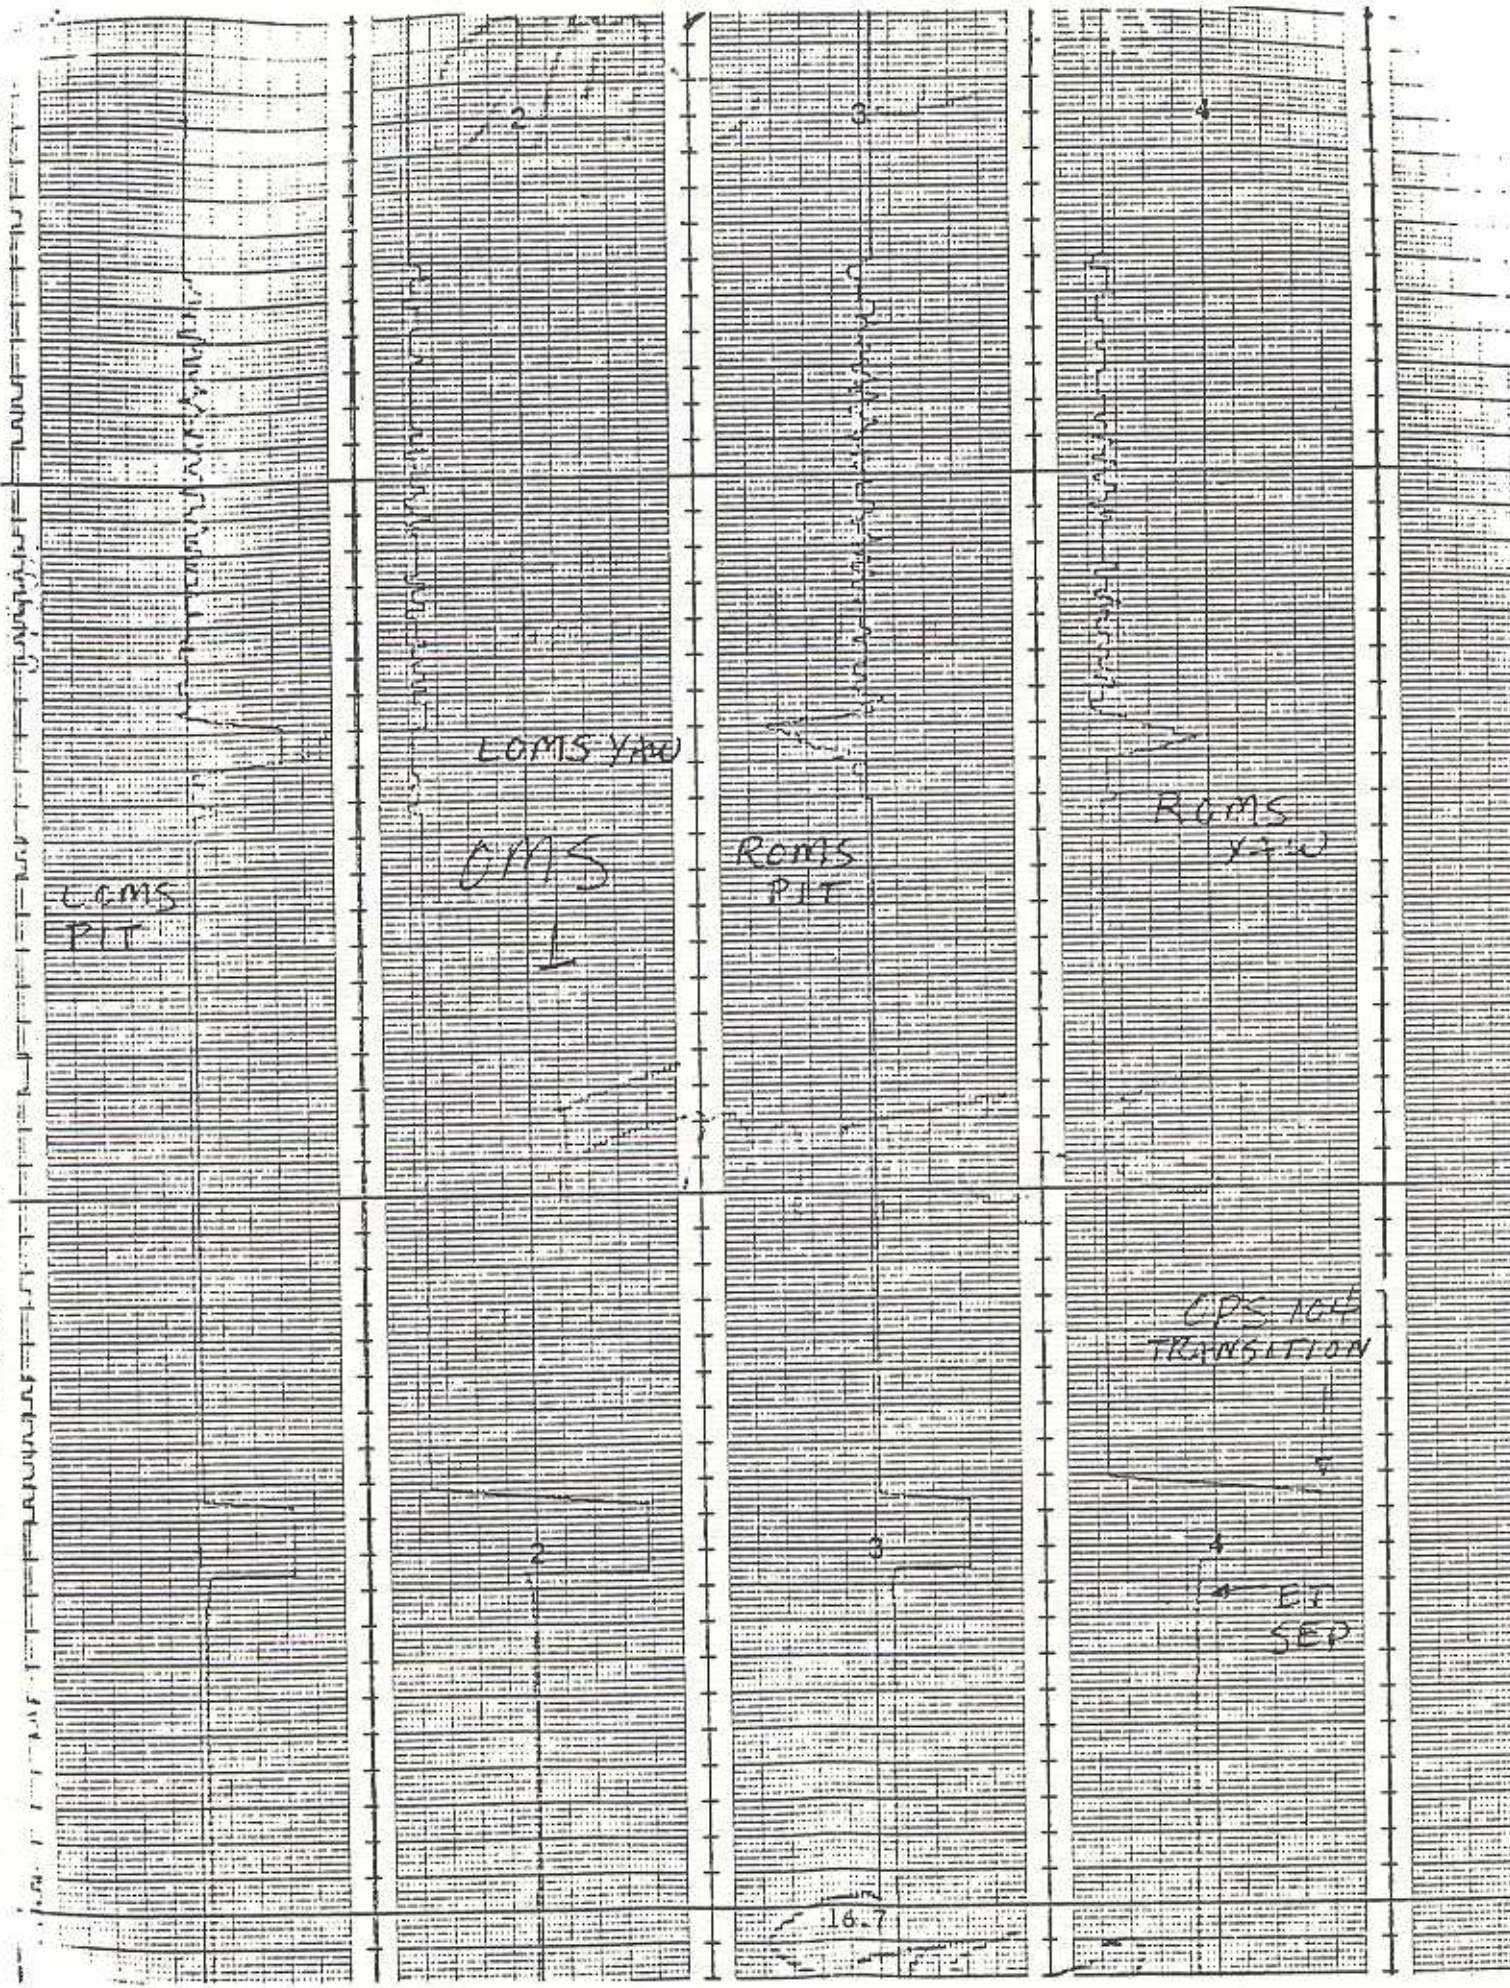
16.6
TABLE 1

The SRB's functioned as expected with no noted anomalies. Table 1. below contains flight data of selected SRB parameters and times. Some of this data was recorded real time on strip chart recorders. The remainder of the data was collected from super thrift. Strip-chart recorder data provides an excellent record of the trend of SRB actuator secondary delta pressure throughout the period of operation. Super thrift data complemented the delta P's collected on SCR's but some parameters (actuator selected commands, position feedbacks, driver currents) are not available on super thrift until several days after flight.
