STS-4 GNC Postflight Report

The enclosed STS-4 GNC postflight report is limited in scope to analysis of systems anomalies and discussion of topics which we believe need attention.

TABLE OF CONTENTS

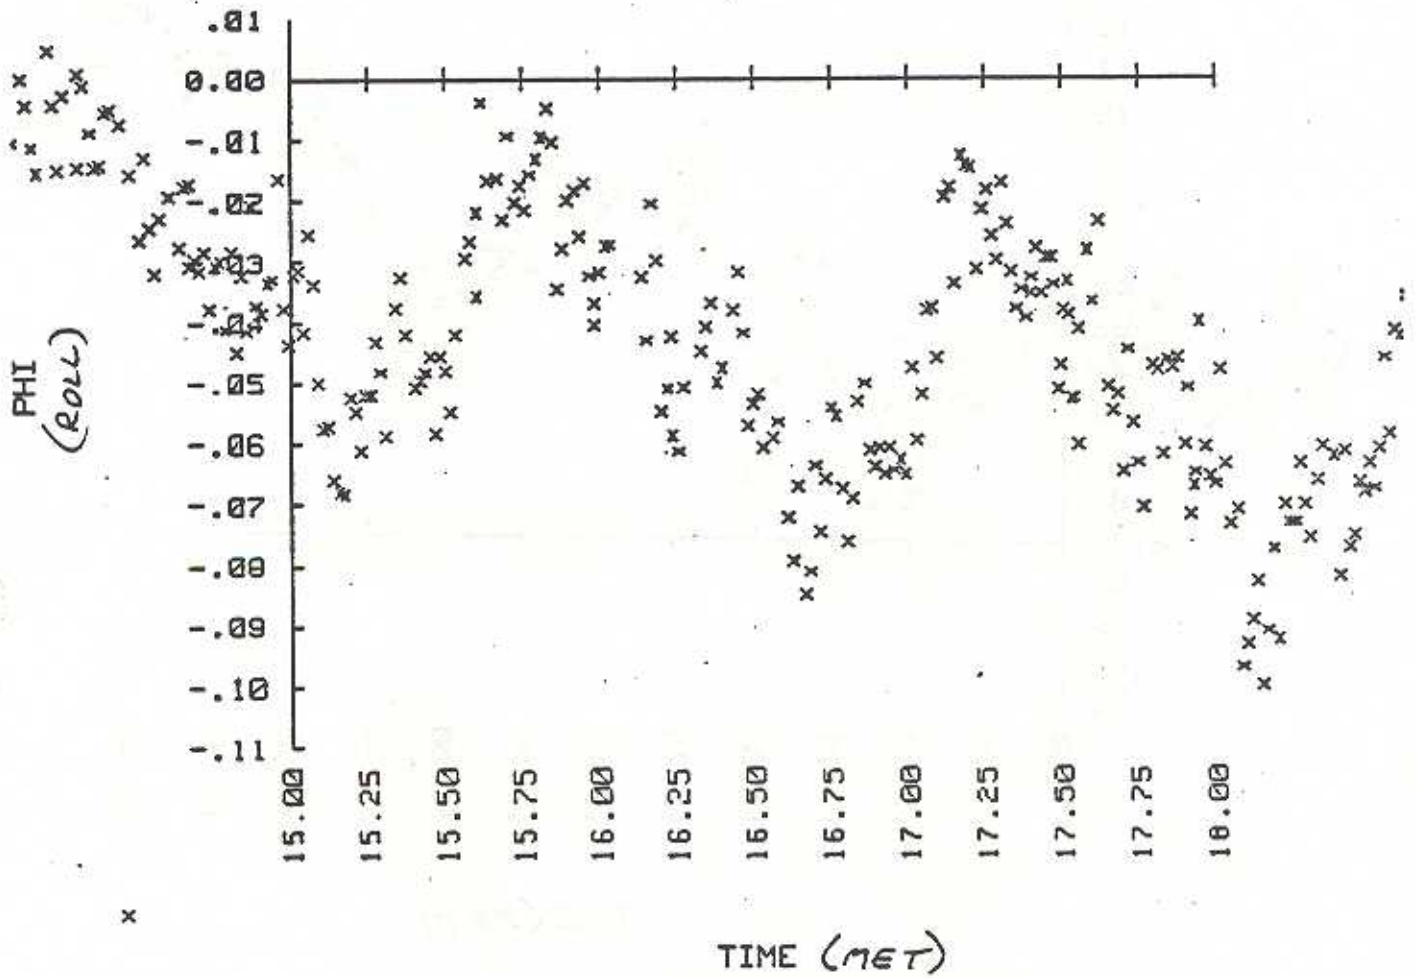
FIG 2.1.1

Introduction - During the first three flights, we observed that the star alignment data, namely the misalignment angles for each IMU axis, varied as the star pair on which they were based varied. This was most notably observed on STS-3, but has also been seen on STS-1 and STS-2.

Description of the Problem - If the star alignment system was perfect, the IMU misalignment angles (torquing angles) would be exactly the same for different star pairs (which means different vehicle attitudes), discounting the effects of platform drift. The phenomena observed on STS-3 demonstrated that our system is certainly less than perfect, and occasionally outside of the 3σ spec performance limits. On STS-3, the thermal attitudes flown allowed the star trackers to sweep large portions of the sky and acquire many stars of opportunity. Torquing angles generated by a star pair were computed by the onboard software. As the vehicle continued to rotate, a new star pair was acquired and new torquing angles were generated. Even though these sets of data were computed only a few minutes apart, the variation between the two angles for a given axis was as large as .09 deg. The 1σ specification for the process of measuring the torquing angles is .02 deg. If we assume errors on both measurements, then the 3σ spec would be .075 deg.

STS-4 Performance - Unfortunately, the attitudes flown during STS-4 were not favorable for the acquisition of stars of opportunity; therefore, we don't have the data base we had on STS-3. In addition to the unfavorable attitudes, we were also hamstrung by the star tracker's shutters being latched shut by the target suppress bit in the tracker. The attitudes being flown on STS-5 look more favorable for stars of opportunity and the target suppress bit should no longer be a problem because of a software change.

Conclusion and Recommendations - Although there is a wide disparity of opinion concerning the variations in torquing angles. We believe that they are caused by errors in the IMU resolver reads of the gimbals angles. This is substantiated by the enclosed plots which show a sinusoidal behavior of the IMU attitude differences (figures 2.1.1, 2.1.2, 2.1.3) during a period on STS-2 where the vehicle was flying a -ZLV attitude. The period of the oscillations match the orbital period (90 min), which says that as the gimbals rotate with the vehicle, a non-linear attitude is output by the IMUs. This type of behavior will cause the variations we see in the torquing angles. Also enclosed is 30 minutes of data (figure 2.1.4) during a PTC period of STS-4. Although there is not enough data to be conclusive, the same sinusoidal behavior is suggested. Because of these variations in torquing angles and the sinusoidal nature of the attitude outputs, we are considering a recommendation to E&D that the IMUs on OV-102 be tested in the JSC ISL lab. Since OV-102 will be down for mods, this will be an excellent opportunity to try to correlate ground testing with the type of behavior observed during the five flights.

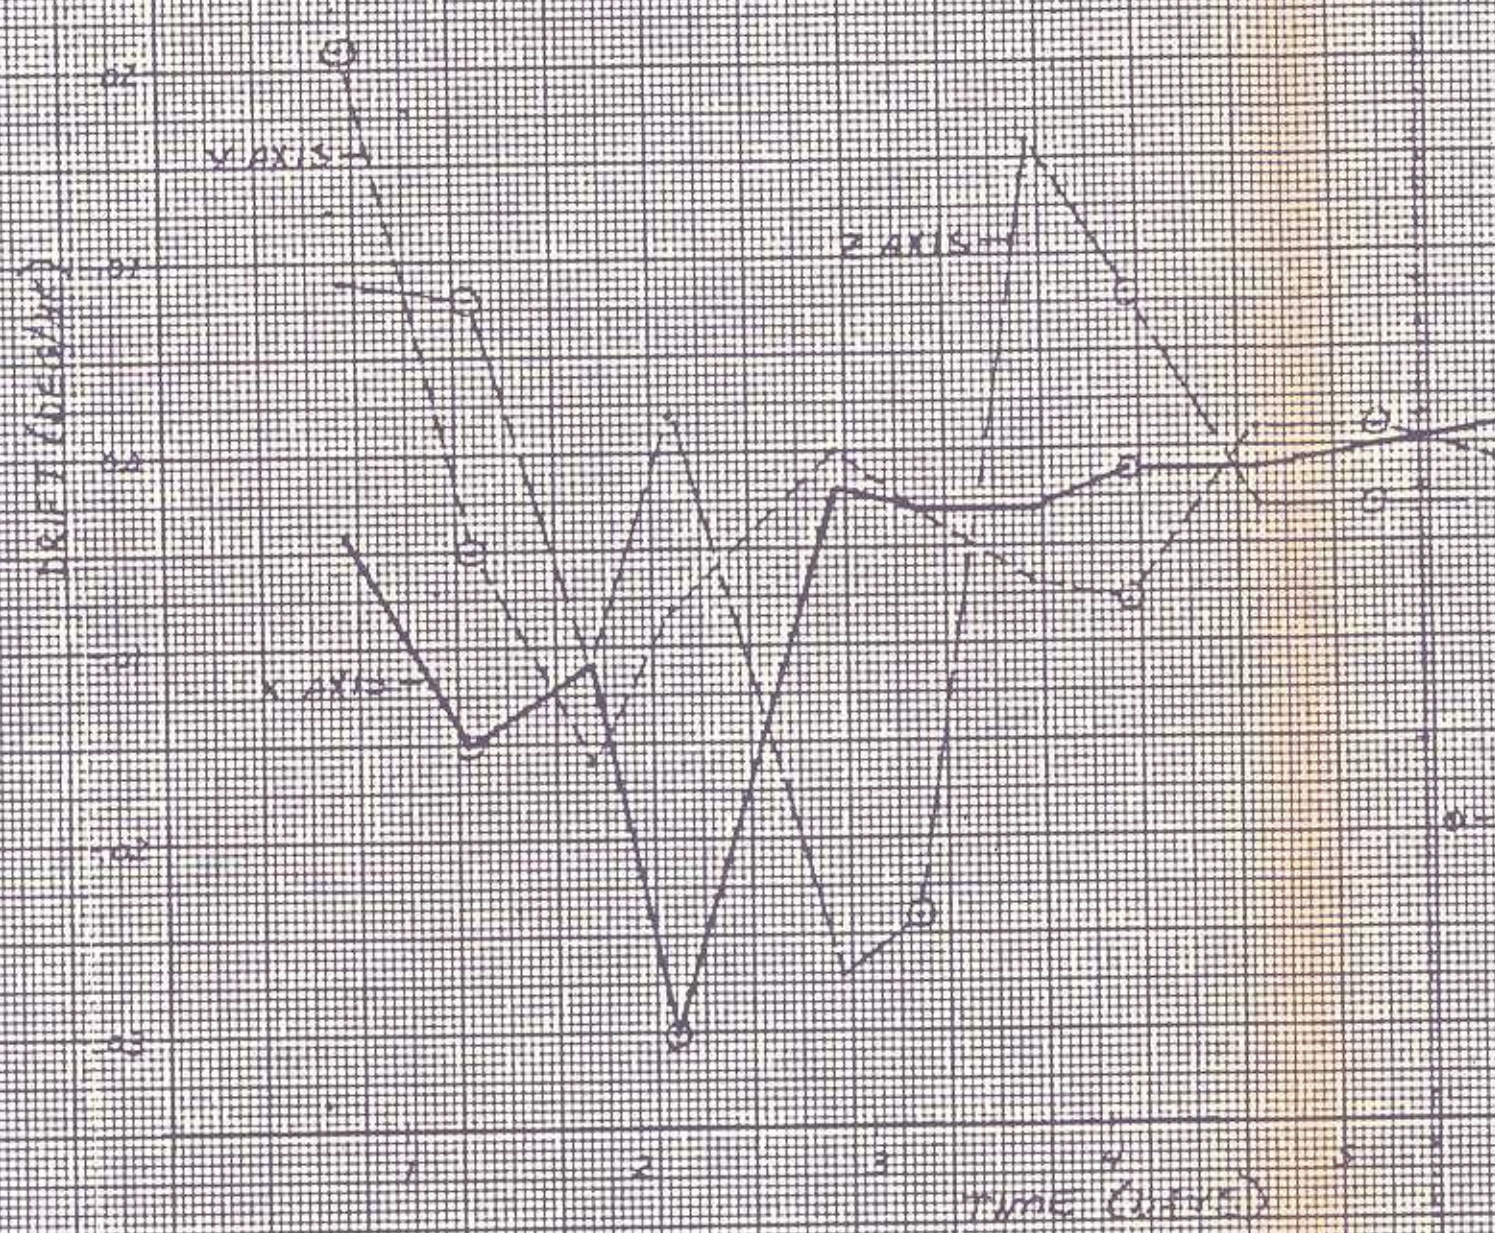
IMU 1 DRIFT
 AS MEASURED BY STAR ALGORS
 FIG 2.2.1

Description of the Problem - The on-orbit drift performance of the IMUs has been outstanding ($< 1\sigma$) when the vehicle has flown in the same orientation for long periods of time. For example, on STS-3 when the vehicle flew the nose sun attitude for such a long period of time, we were able to calibrate the drift so well that we went 27 hours without an alignment. When we changed from the nose sun attitude to the top sun attitude, though, almost every axis of the 3 IMUs required compensation to negate the new drifts. IMU 3Z was most susceptible to this "orientation sensitivity," the magnitude of the drift change being .06 deg/hr.

STS-4 Performance - As shown on the enclosed plots (figures 2.2.1, 2.2.2, 2.2.3), the measured IMU drift did vary and several updates were necessary to maintain the drift at a less than 1σ level. IMU 1 Z shifted by .03 deg/hr when the attitude changed from a tail sun to bottom sun attitude in the 2-3 day MET time period. During this same period IMU 3 Z shifted by .04 deg/hr. These two shifts were the largest observed, although several other smaller attitude dependent shifts were observed. During the long tail sun period, the IMU drifts were extremely small, once again showing that the drift performance is excellent when the vehicle stays in a given attitude for an extended period.

Conclusions and Recommendations - The IMUs do demonstrate an orientation sensitivity which can cause drift changes as high as 3σ (.06 deg/hr/axis). These changes necessitate continual monitoring of IMU drifts and many gyro bias compensation updates per flight. Given some dedicated ground testing, this orientation sensitivity could be measured and compensated for in the software. To this end, we are again considering this problem as part of the justification for testing them here at JSC. We are hoping to understand the significance of this orientation sensitivity and we also hope to determine its repeatability/predictability.

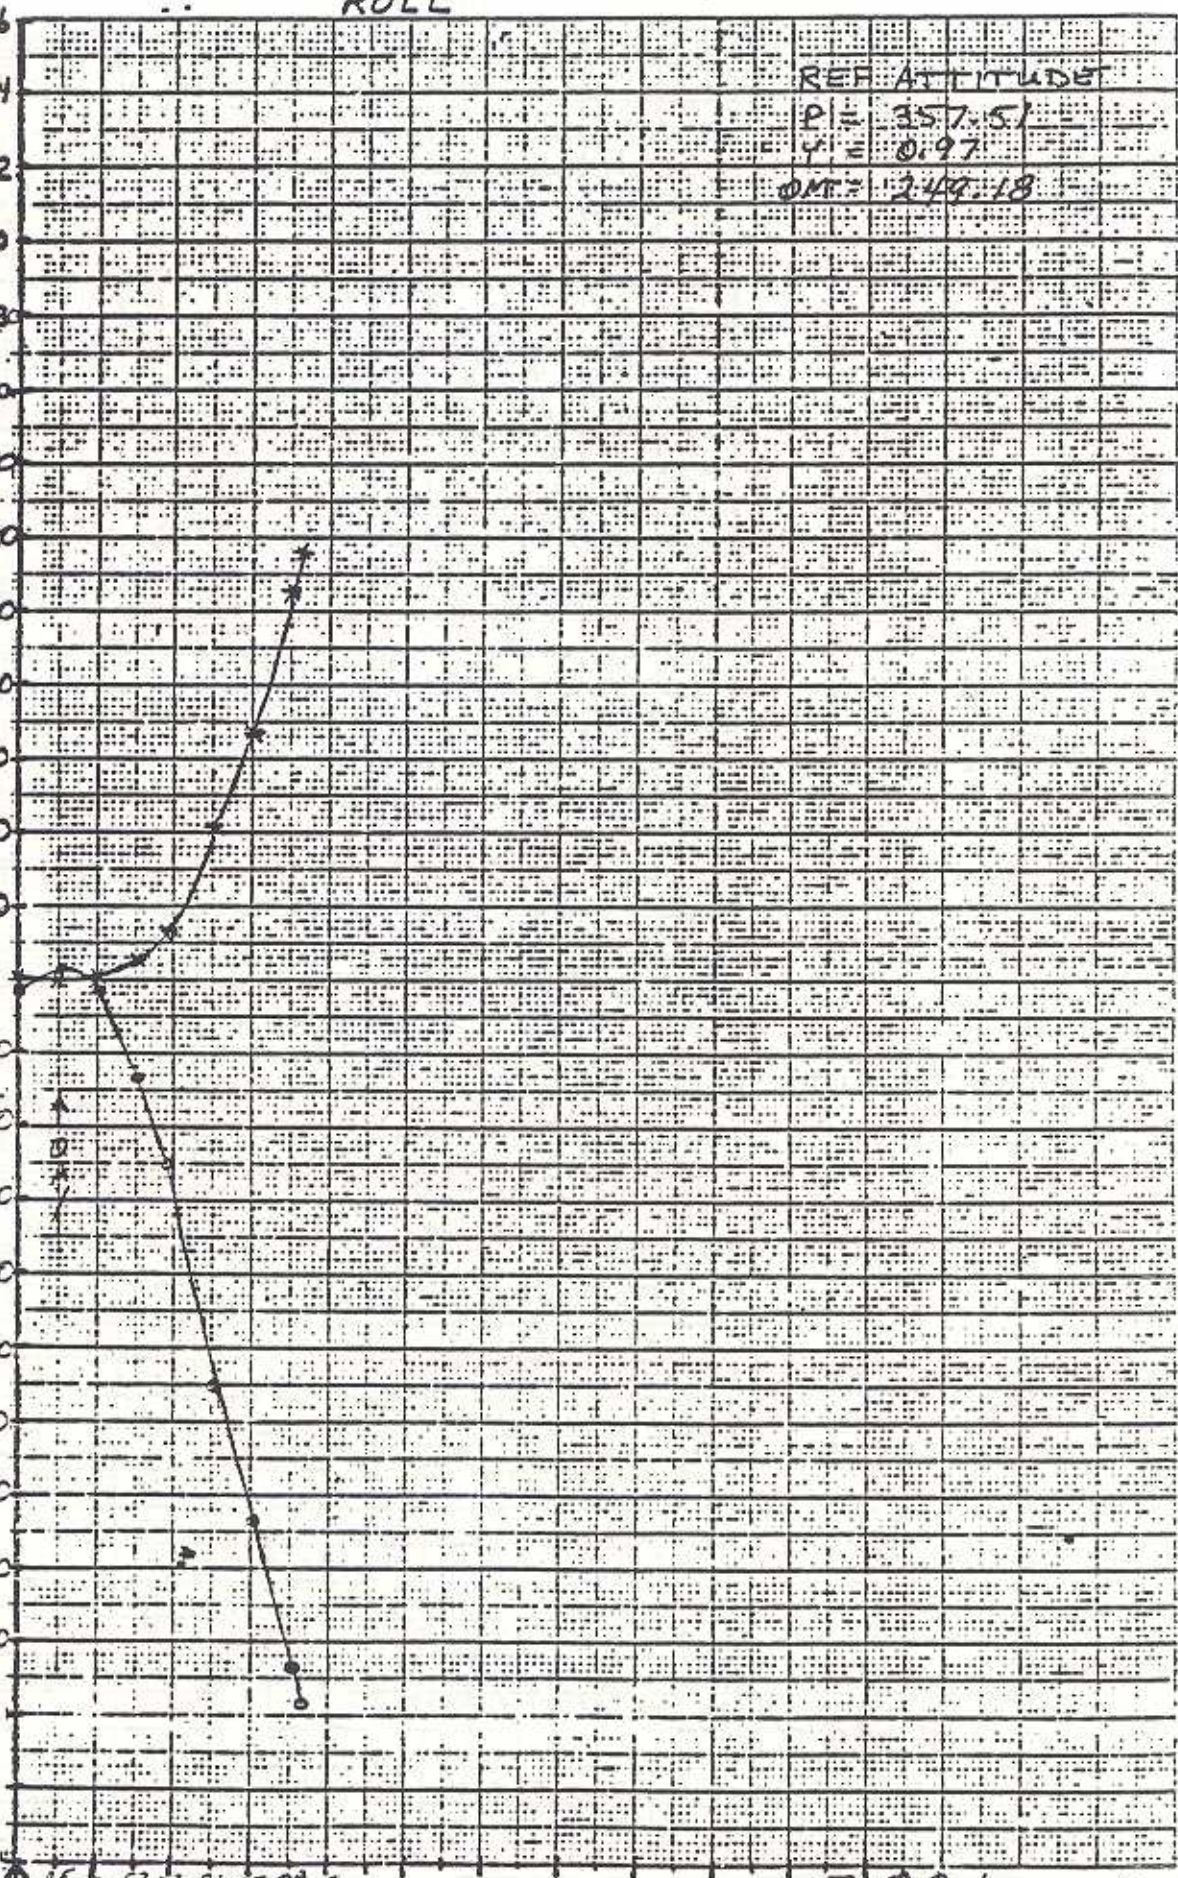
FIG 3.1

3.1.1 Day One - The day one gravity gradient (gg) test was started at 178:20:41:00 at a pitch, yaw, omicron of 357.51, 0.97, and 249.18 degrees respectively. This test was unsuccessful. There were unknown forces much greater than gravity gradient forces acting on the vehicle and all three axes were divergent. The initial attempt was terminated at 178:21:10:00 with maximum attitude errors in roll, pitch, yaw of 117 degrees, -13.6 degrees, and 18.9 degrees respectively. The maximum rate errors seen in roll, pitch, yaw were -0.196 degree/sec., 0.055 degree/sec., and 0.085 degree/sec respectively. (See figures 3.1, 3.2, 3.3).

There was an apparent correlation between the force acting upon the Orbiter and the sunlight striking the vehicle. The first attempt to establish gravity gradient was started at sunrise and was immediately divergent. The second attempt was started at sunset with less divergence noted through the night pass. However, at sunrise the Orbiter diverge immediately (see figure 3.7, 3.8). At this point there was a suspected vent occurring on the vehicle which became more active as the vehicle entered sunlight. Venting of any sort violates the general guidelines for establishing gravity gradient equilibrium. The DAP errors were monitored throughout the sleep period with the same correlation noted between a venting force and sunlight. Attempts to isolate the location of the venting force were undertaken. It seems that the venting force provided a roll torque of approximately 1.76 ft/lbs, and was located in a plane through the center of gravity containing a body vector pitch of 13 ± 10 degrees and a yaw of 76 ± 10 degrees. The approximate location of the venting force would be located near the center of gravity in the

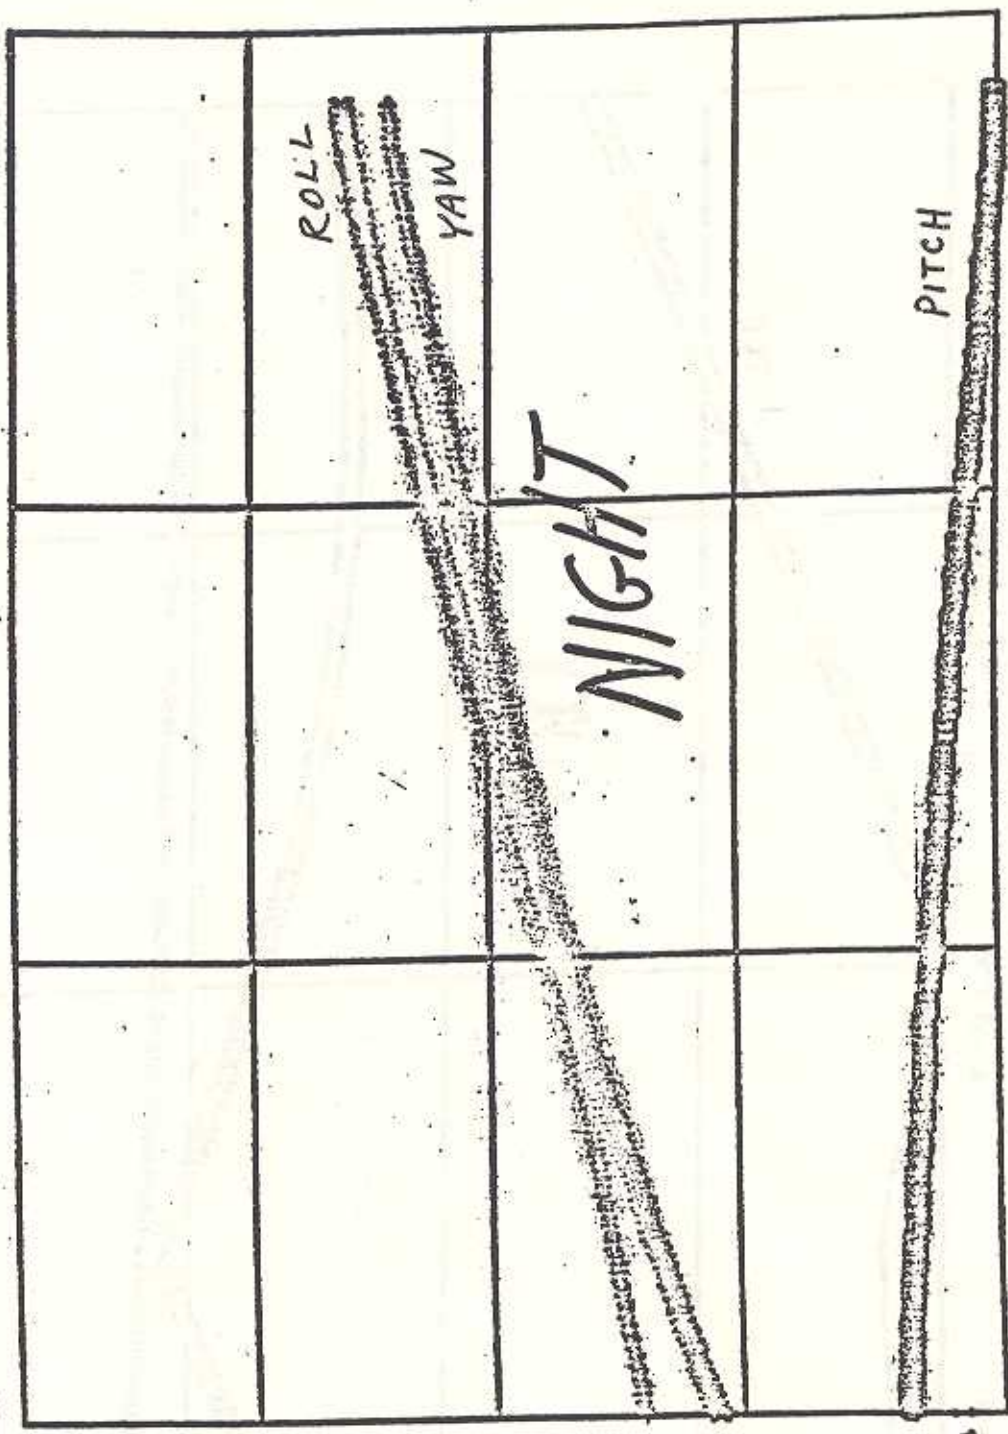
FIG 3.8

- 3.1.2 Day Two - The day two gg test was changed from 12 hours period to a $5\frac{1}{2}$ hour test late in the day. The large unknown forces appeared to have become significantly smaller. The gg test was started at 179:16:23:00 at a pitch, yaw, omicron of 357.51, 0.97, and 245 degrees respectively. This test can be considered successful with a stable gg attitude biased off slightly in the negative error direction. The maximum attitude errors seen in roll, pitch, yaw were -25.19, -3.33, and -7.93 degrees respectively. The period of oscillations was 56 minutes in pitch and yaw and 109 minutes in roll. Looking primarily at the roll axis, the first 2 hours of data is under the influence of the gg release conditions. After 2 hours, roll appears to be stabilizing around a new reference point (-4 degree error), but there is only $1\frac{1}{2}$ cycles of data on which to make that conclusion. Both pitch and yaw look stable around slightly negative errors of -0.5 and -1.5 degrees respectively. Using these errors a new gg start attitude was determined to be pitch, yaw, omicron of 357.58, 1.14 and 249 degrees respectively (see figures 3.9, 3.10, 3.11).
