# STS-1 Orbiter Final Mission Report

August 1981

STS-1 ORBITER  
FINAL  
MISSION REPORT

PREPARED BY  
Mission Evaluation Team

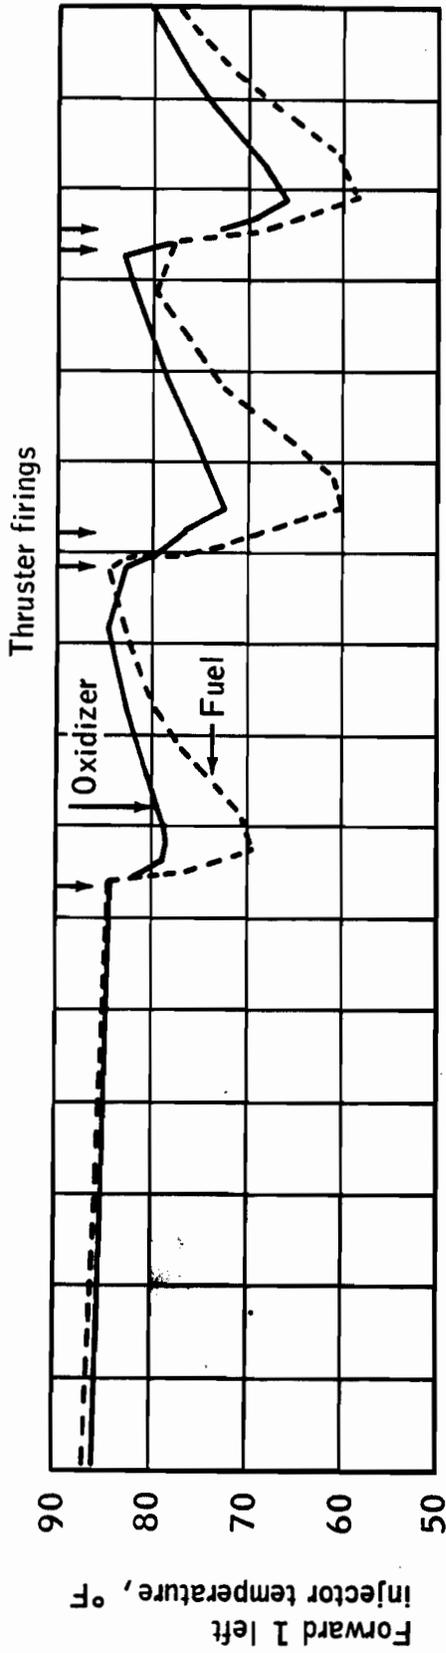
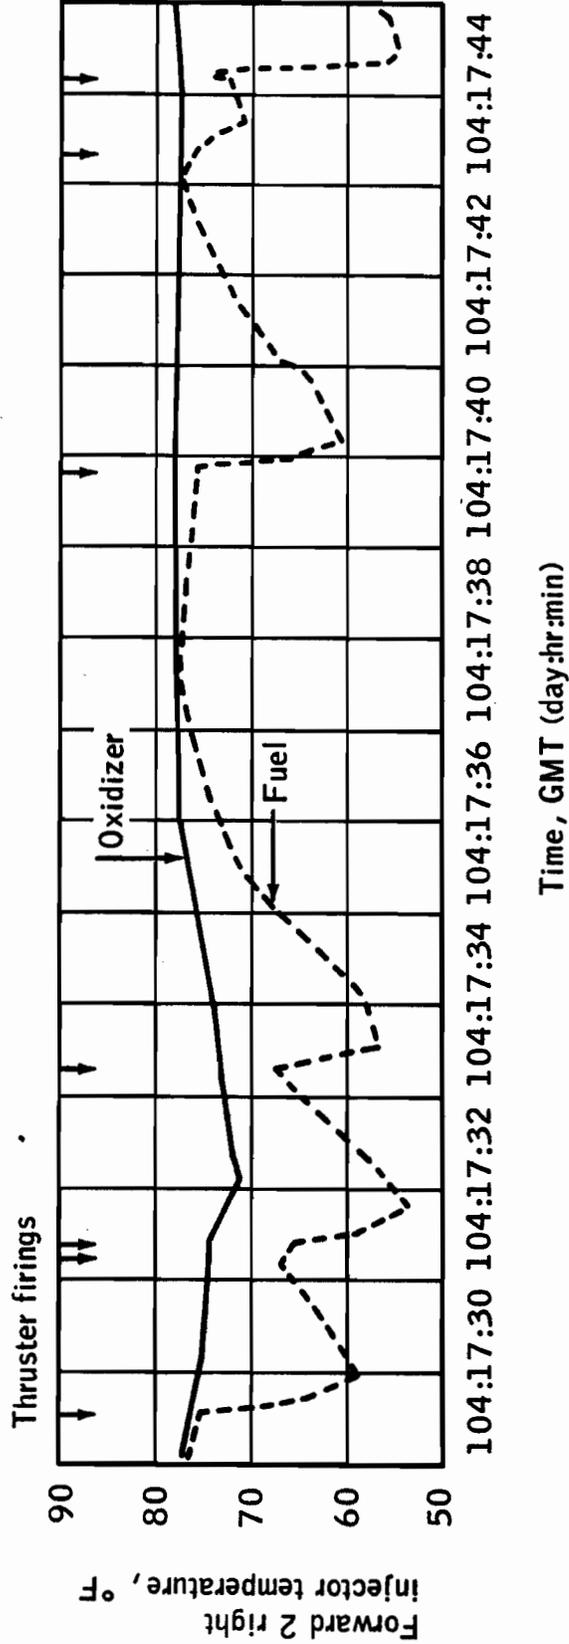
The oxidizer leak detector on thruster forward 2 right (F2R) did not track the transient evaporation cooldown that occurred on the fuel leak detector. An apparent thermal open exists between the oxidizer leak detector and the injector tube, and, therefore, a large thermal lag exists between the tube temperature and what the leak detector senses (fig. 2-4). See section 8.0, flight test problem report 50, for a discussion of this anomaly.

Figure 2-4.- Oxidizer leak detector - injector tube thermal log data.

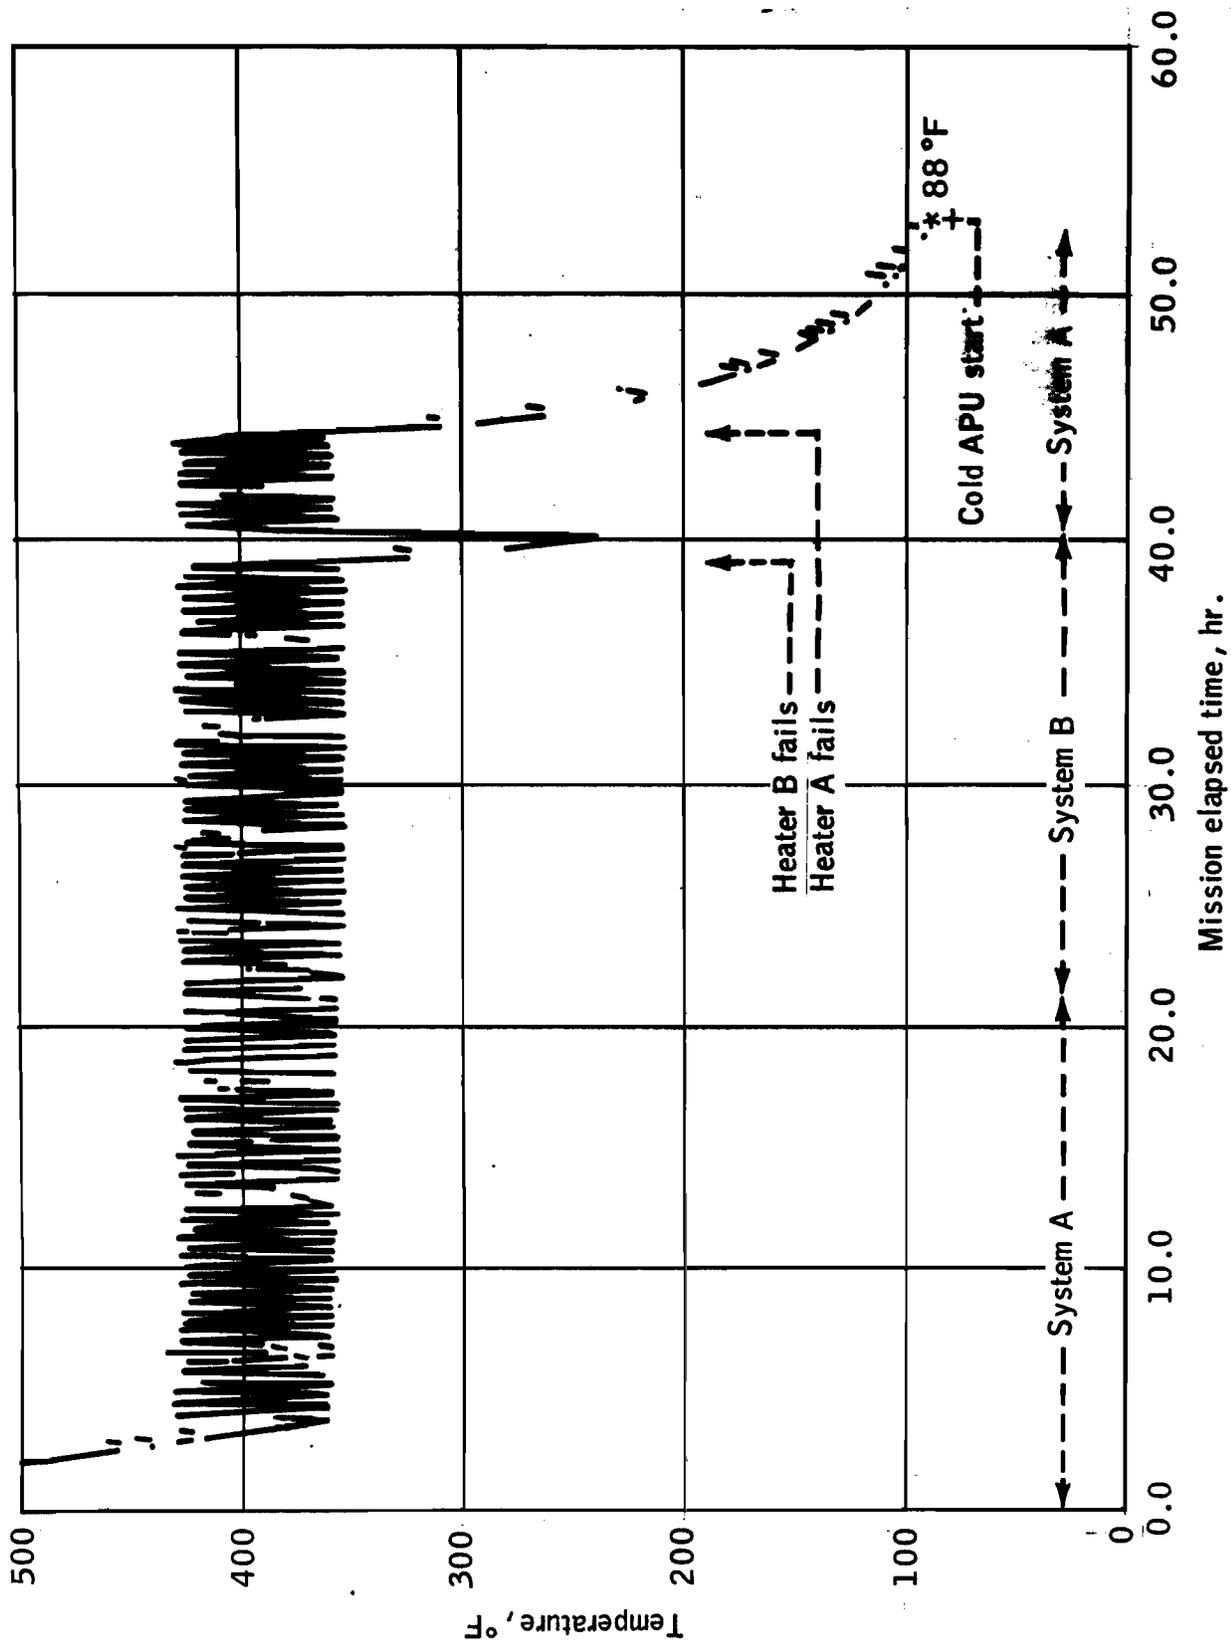
Failures occurred in both of the APU 2 gas generator heaters. Both failures occurred late in the mission, as shown in figure 2-5 (see section 8.0, flight test problem report 19). The fuel pump and valve temperatures were 75° to 80° F, and the gas generator temperature was 88° F at APU start. The cool gas generator temperature necessitated a "start override" start of APU 2, and this initiated 209 sec of injector cooling before starting. APU 2 started within 4 sec after the cooling cycle was completed.

Figure 2-5.- APU gas generator heater failures
