# **STS-117 SPACE SHUTTLE MISSION REPORT**

January 2008

**National Aeronautics and  
Space Administration**

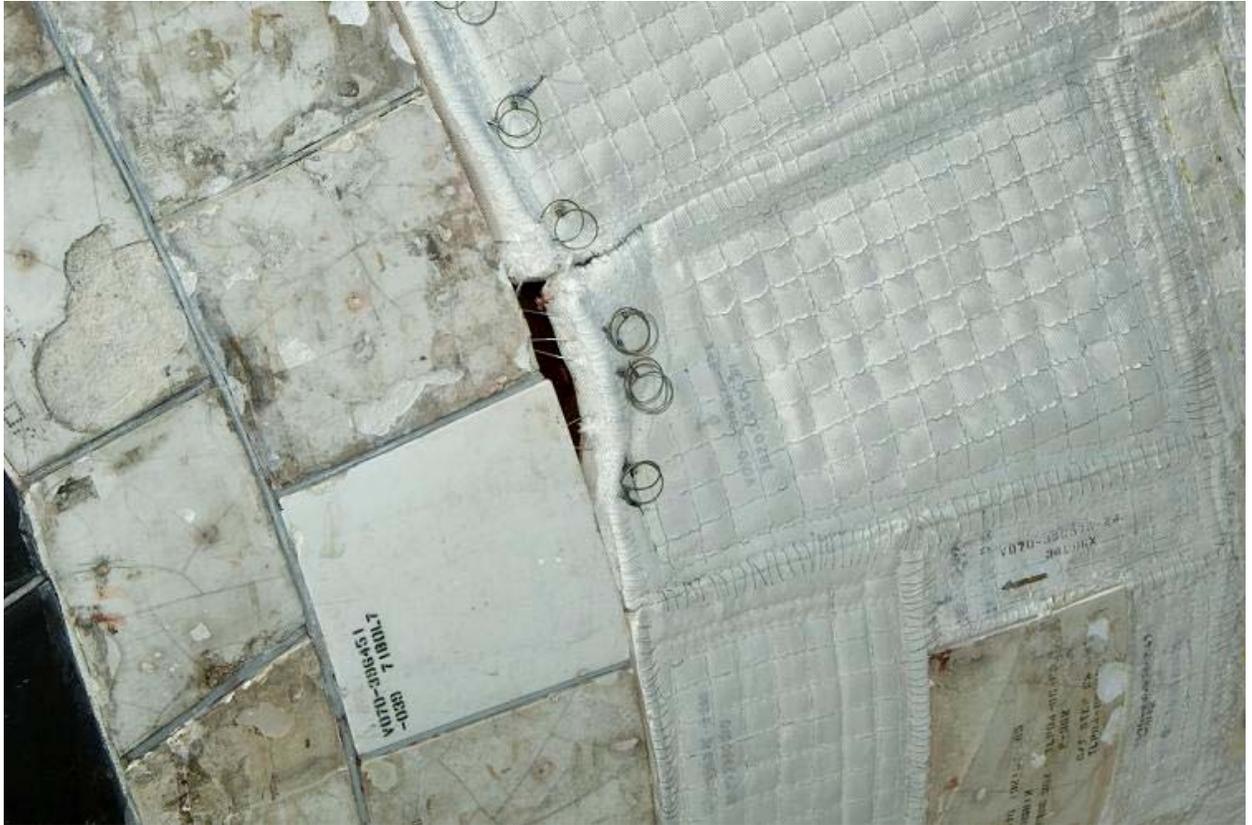
During the post-ascent survey on FD 1, the crew reported that a blanket on the port Orbiter Maneuvering System (OMS) pod was turned-up and extended upward about 4 to 5 in (IFA STS-117-V-02). The crew photographed the area of damage and the downlinked the images were provided to the Damage Assessment Team (DAT) for assessment.

Post-flight view of port OMS blanket repair.

A major activity was the planning and developing of procedures for the repair of the port OMS blanket. The MMT decided that the Port OMS pod blanket repair would be performed during the third EVA on Flight Day 8. The repair option selected used the Nichrome pins from the TPS overlay repair kit and staples from the medical kit stapler to secure the blanket.

The Damage Assessment Team completed their analysis and cleared all Thermal TPS tiles, blankets, and gap fillers, including the repair of the left OMS pod blanket.
