STS-118 SPACE SHUTTLE MISSION REPORT

March 2008

**National Aeronautics and
Space Administration**

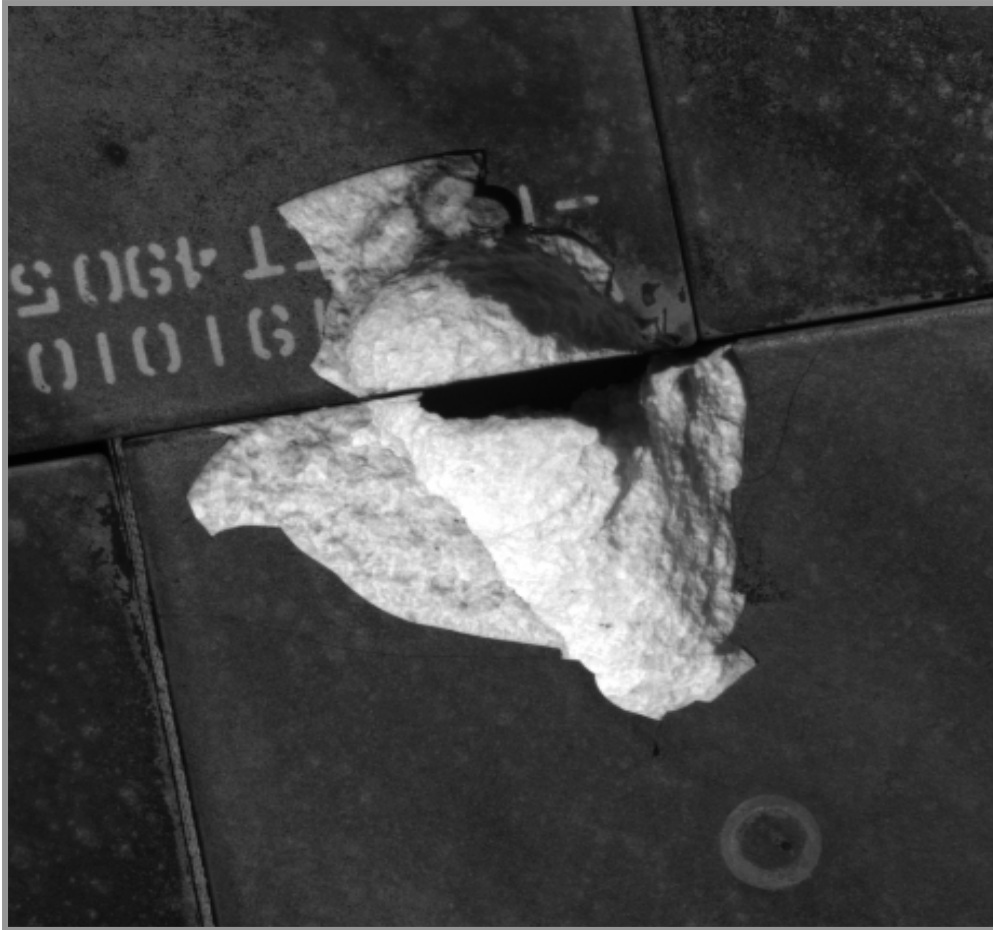
As of FD6, only one area remained to be cleared by the DAT; a gouge approximately 3.54 by 2.76 in. located in the torque box approximately 19 inches outboard of the wing root on the right wing. The cavity damage-site volume with the area that exposes the filler bar required that the thermal models be modified to precisely account for these effects. The Focused Inspection imagery obtained the detailed geometry of the cavity. The three smaller damage-sites had been cleared. A digital camera image, obtained during the Focused Inspection, of the right main landing gear thermal barrier showed that the barrier was intact.

The DAT presented an initial assessment for the 3.54 by 2.76 in tile-damage area. The site was the only one of the five Focused Inspections sites that had not been cleared for entry.

The DAT continued the tile-damage assessment activities. Further review of the test article from the Arc Jet Facility that simulated the un-repaired damage indicated that there was no breach of structure or any sign of tile-bond failure, and the exposed filler bar was charred but intact. There was significant damage to the downstream tile that may be attributed to the high localized-heating of the aft-cavity lip.

On FD 5, the OBSS was unberthed by the SSRMS and handed off to the SRMS to perform the focused inspection of five TPS damage sites of the underside of the Orbiter. The inspection imagery obtained the detailed geometry of the 3.54 by 2.76 in cavity on the Orbiter TPS. A photograph showing the picture obtained during the focused inspection is provided on the following page. The DAT 's analytical assessment of the tile damage site showed that the filler bar was exposed and this

condition required that thermal models be modified to precisely account for these effects. As a result, new tests were required in the Arc Jet Facility and in a vacuum chamber.

The test article with the STA-54 tile-repair material applied in Denver was transported back to JSC. The test article was not tested in the Arc Jet facility since the MMT decision was made to not perform the tile repair. The DAT cleared the 3.54 by 2.76 in tile-damage area for entry.
