STS-126 SPACE SHUTTLE MISSION REPORT

August 2009

**National Aeronautics and
Space Administration**

**Lyndon B. Johnson Space Center
Houston, Texas**

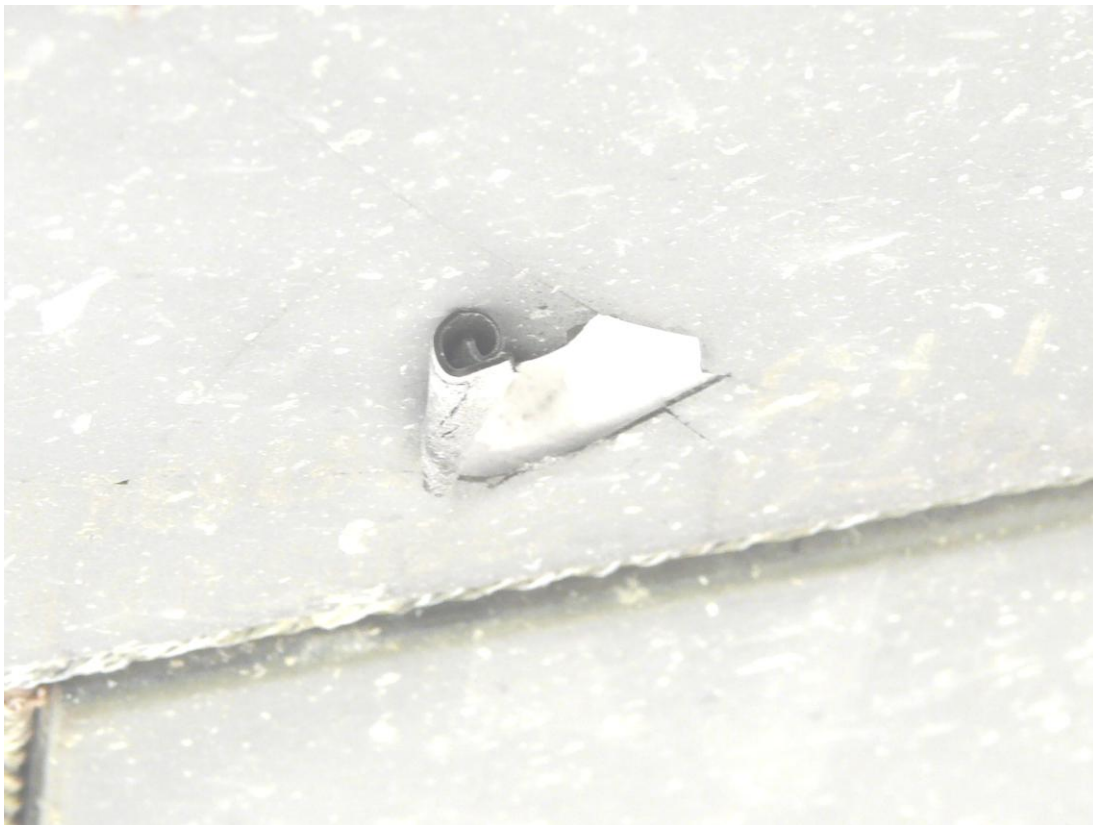
An interesting tile defect was observed on the Orbiter body flap. The ceramic coating appears to have been rolled back from an impact and has formed a scroll-type shape. The following photograph shows the extent of the damage.

Impact Damage to the Body Flap
