STS-2 Orbiter Mission Report

February 1982

National Aeronautics and
Space Administration

Lyndon B. Johnson Space Center
Houston, Texas

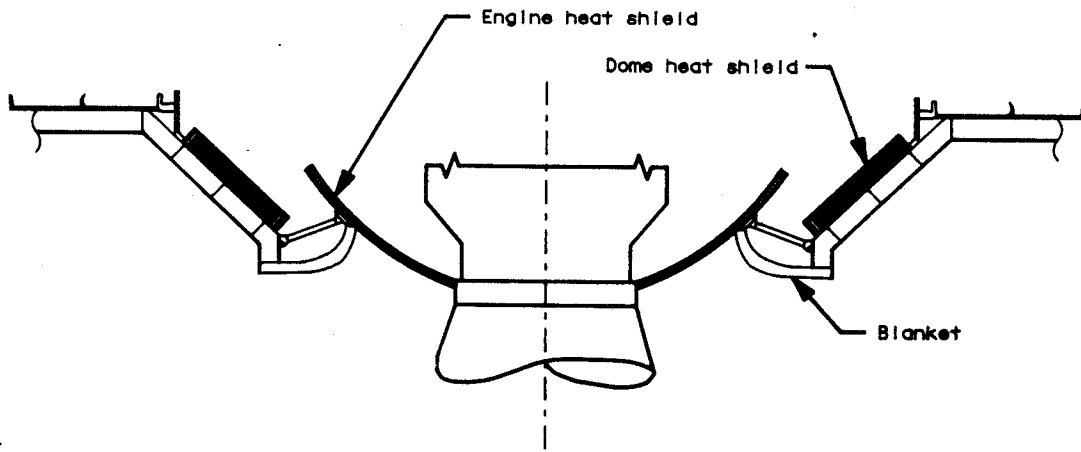
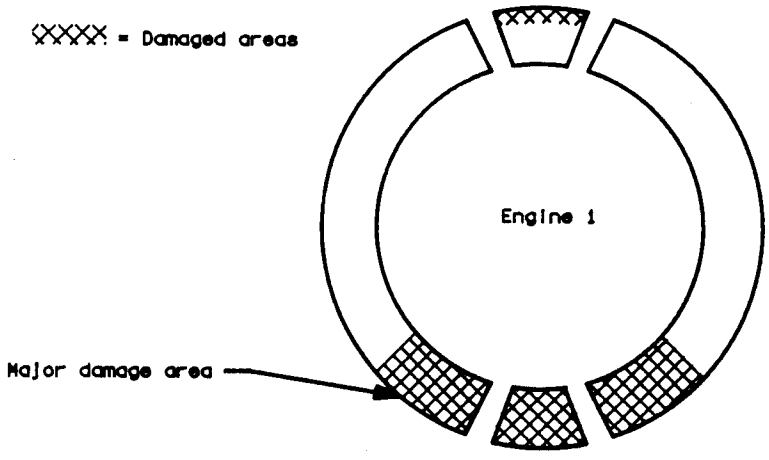
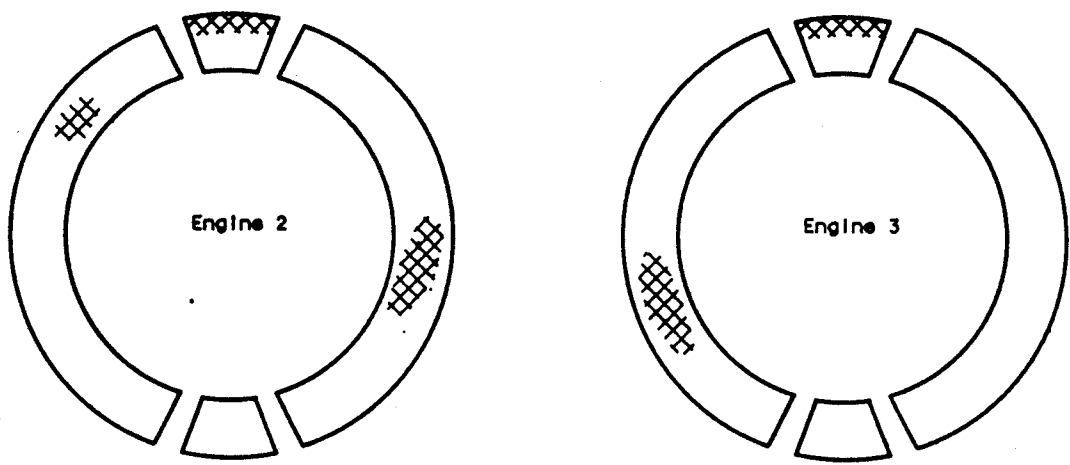
Figure 2-20.- Heat shield damage in main engine area.

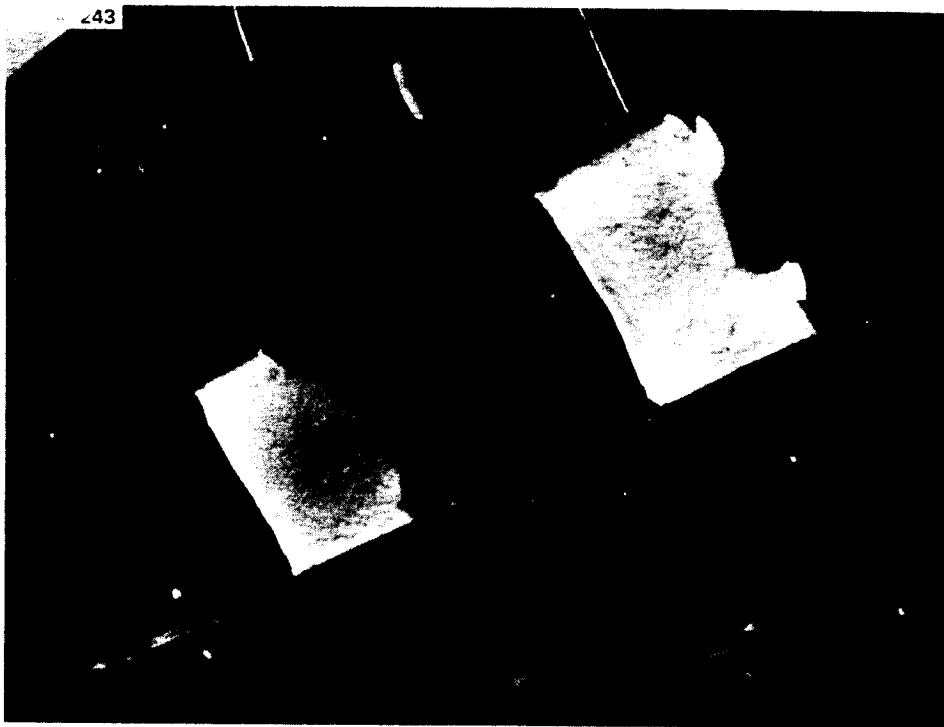
Figure 2-46.- Tiles with more than 50 percent of outer surface missing to a depth of 0.4 in.

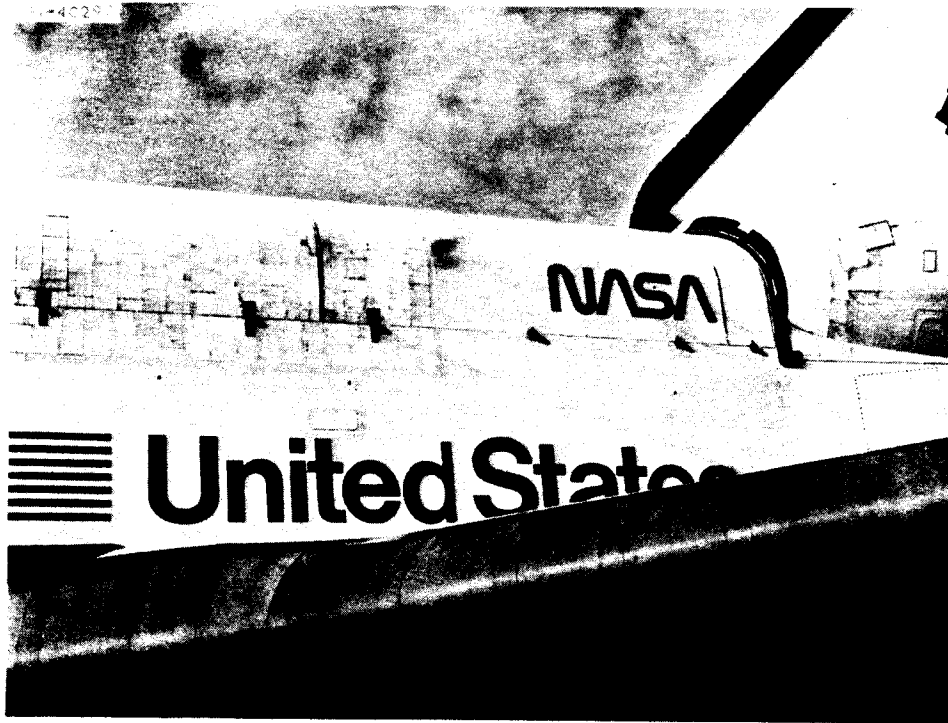
Figure 2-47.- Overheating of FRSI on aft Section of payload bay door.
