STS-3 Orbiter Mission Report

June 1982

Lyndon B. Johnson Space Center
Houston, Texas

STS-3 ORBITER
MISSION REPORT

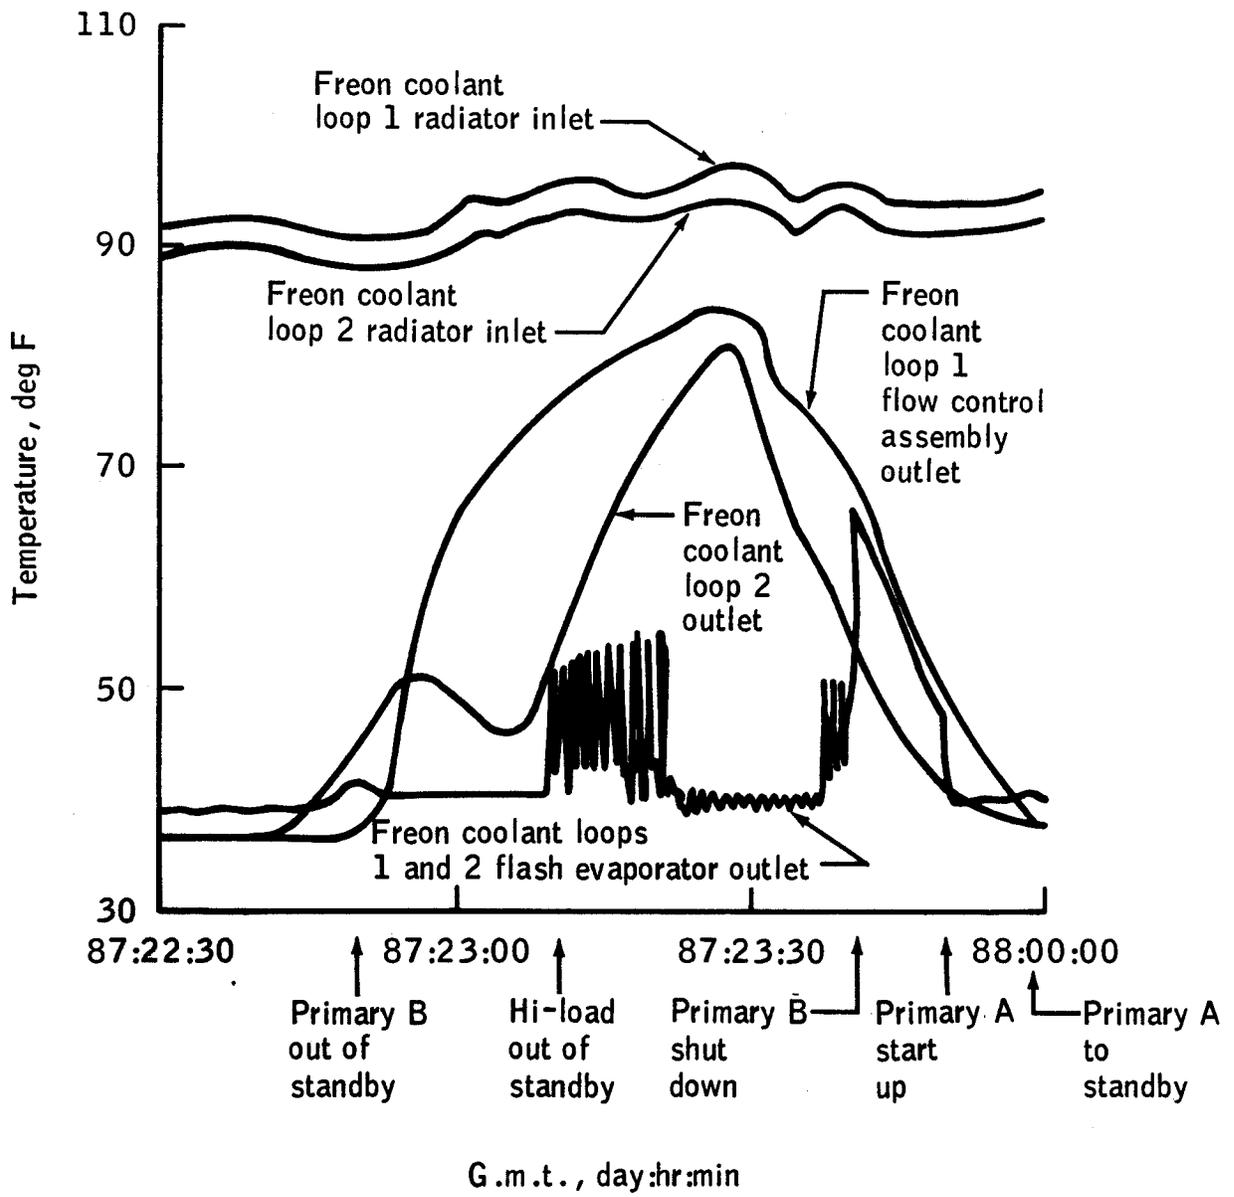
Figure 2-5.- Flash evaporator system primary B shutdown.

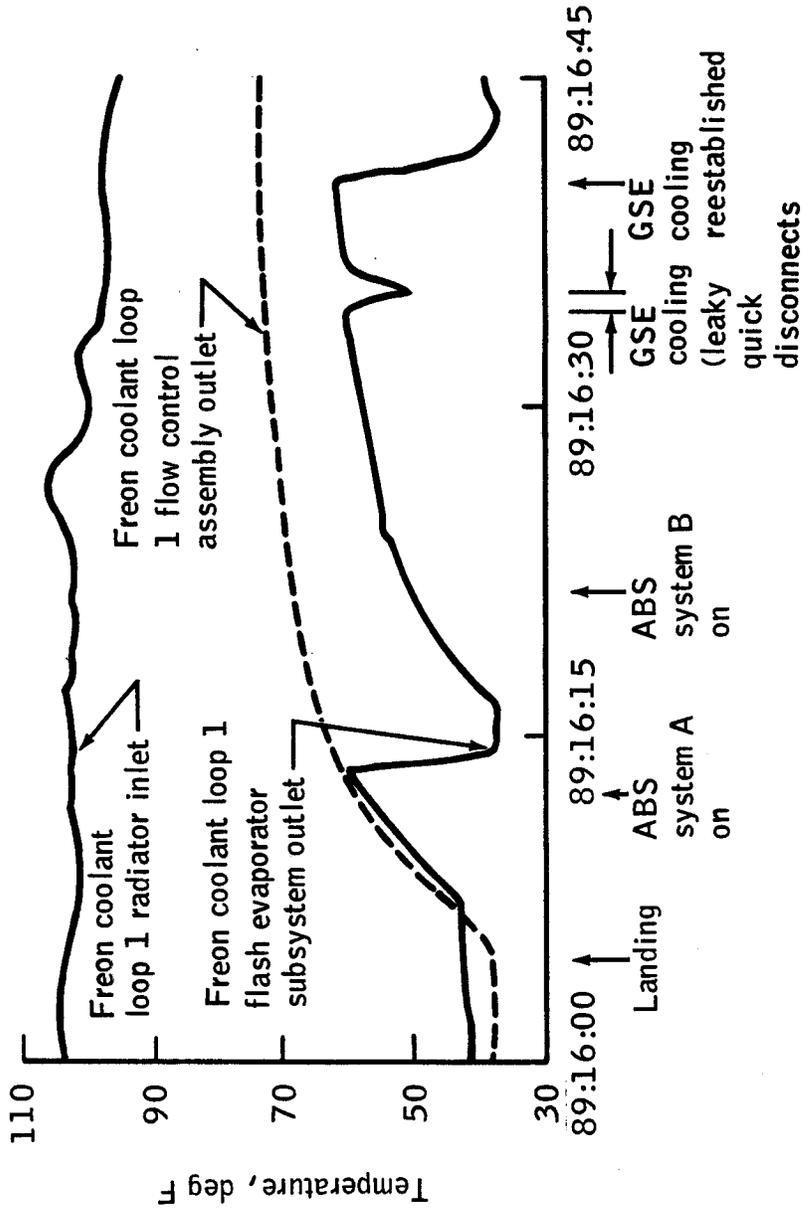
Figure 2-6.- Ammonia boiler subsystem (ABS) postlanding anomaly.

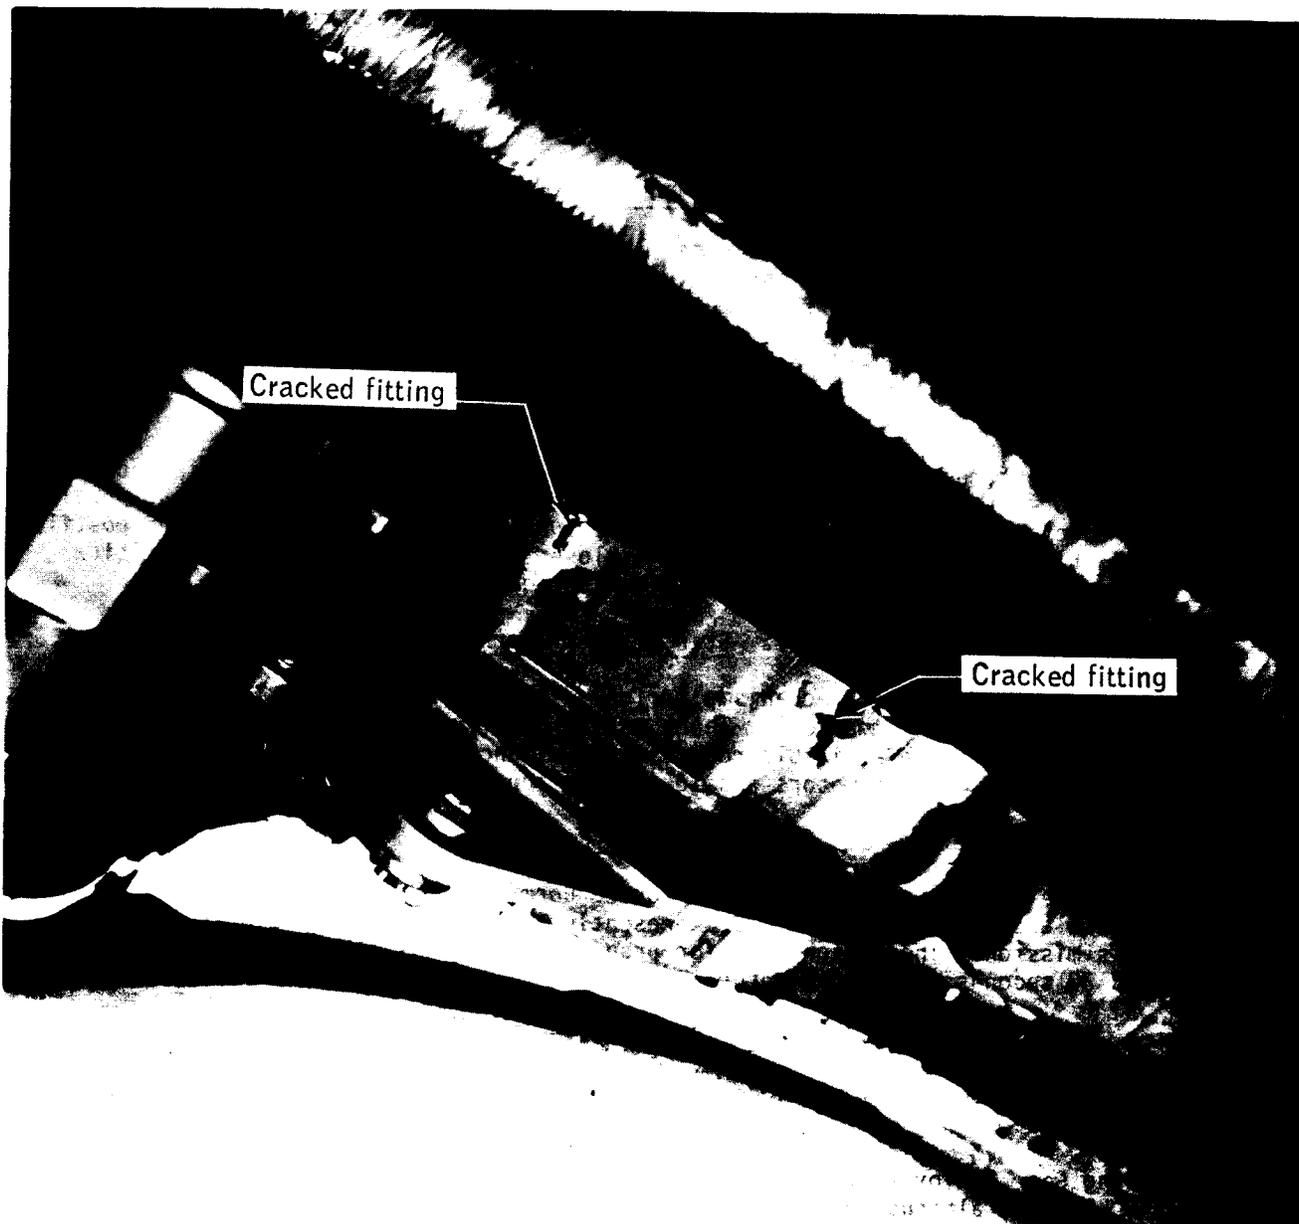
Figure 2-8.- Payload bay door hardware failure.

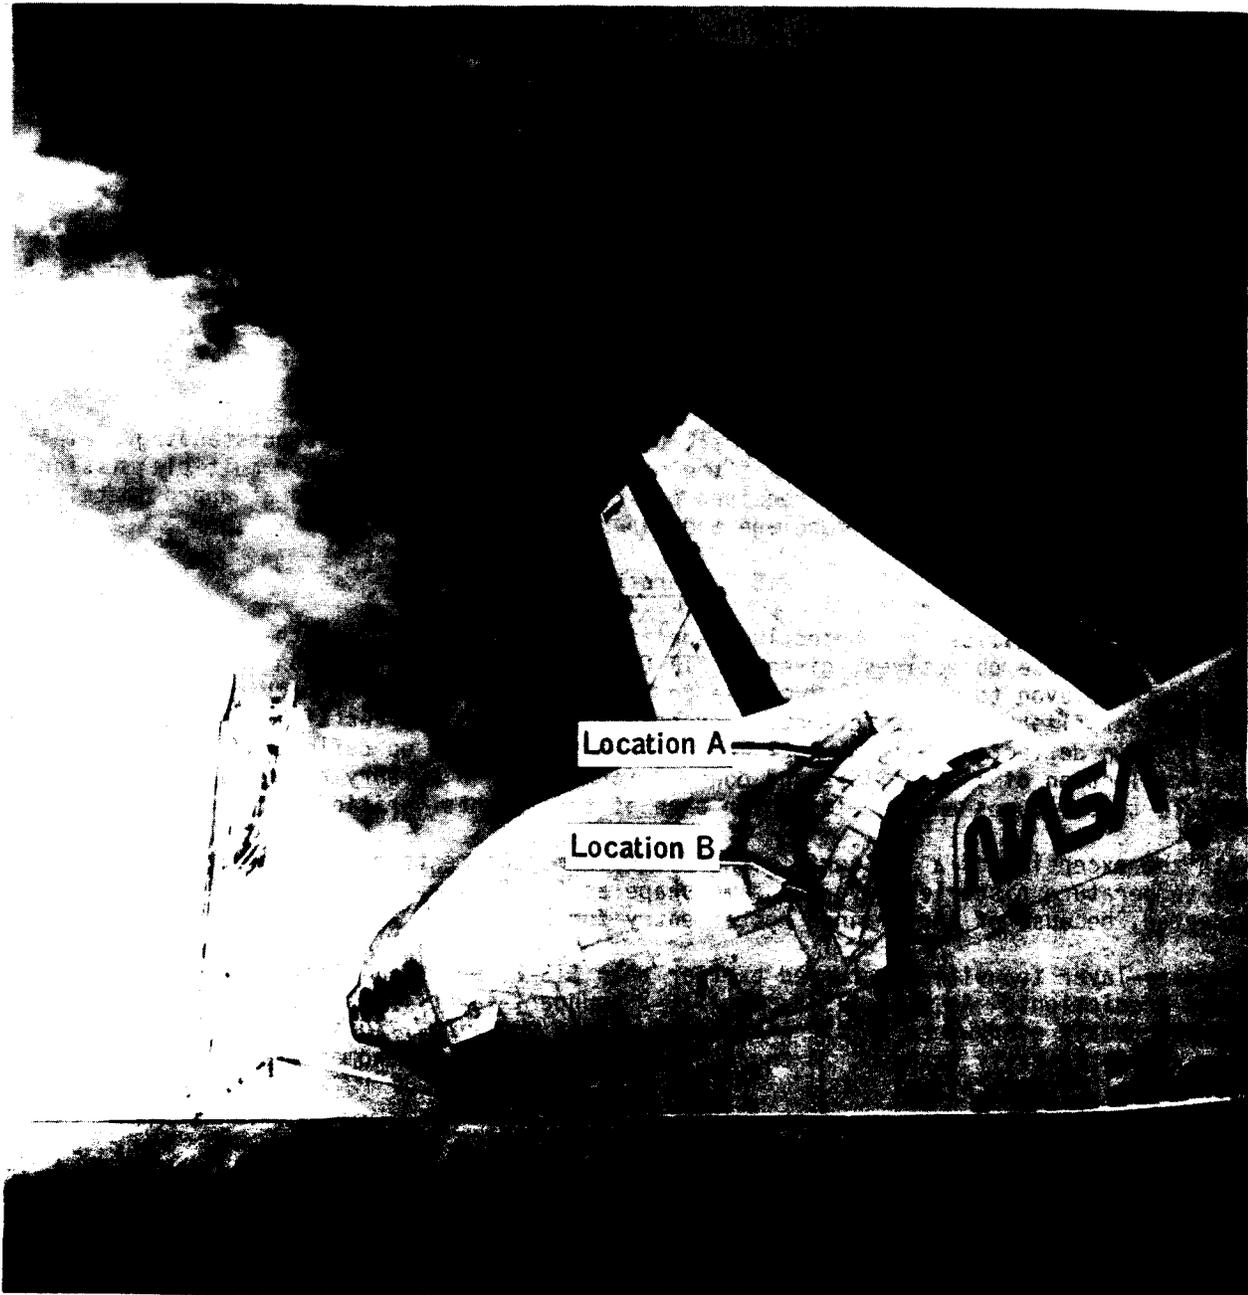
- e. Two locations on the right OMS pod experienced minor overtemperatures of the graphite epoxy structure (figure 2-21). The damage at location A resulted from excessive shrinkage of the FRSI at the FRSI/LRSI (low temperature reusable surface insulation) interface. This resulted in a 0.5-inch diameter delamination of the graphite epoxy facesheet. The damage at location B was the result of the loss of a small corner of the LRSI tile. The graphite epoxy damage was similar to location A. Both locations were repaired.

Figure 2-21.- Over temperature locations on right OMS pod.

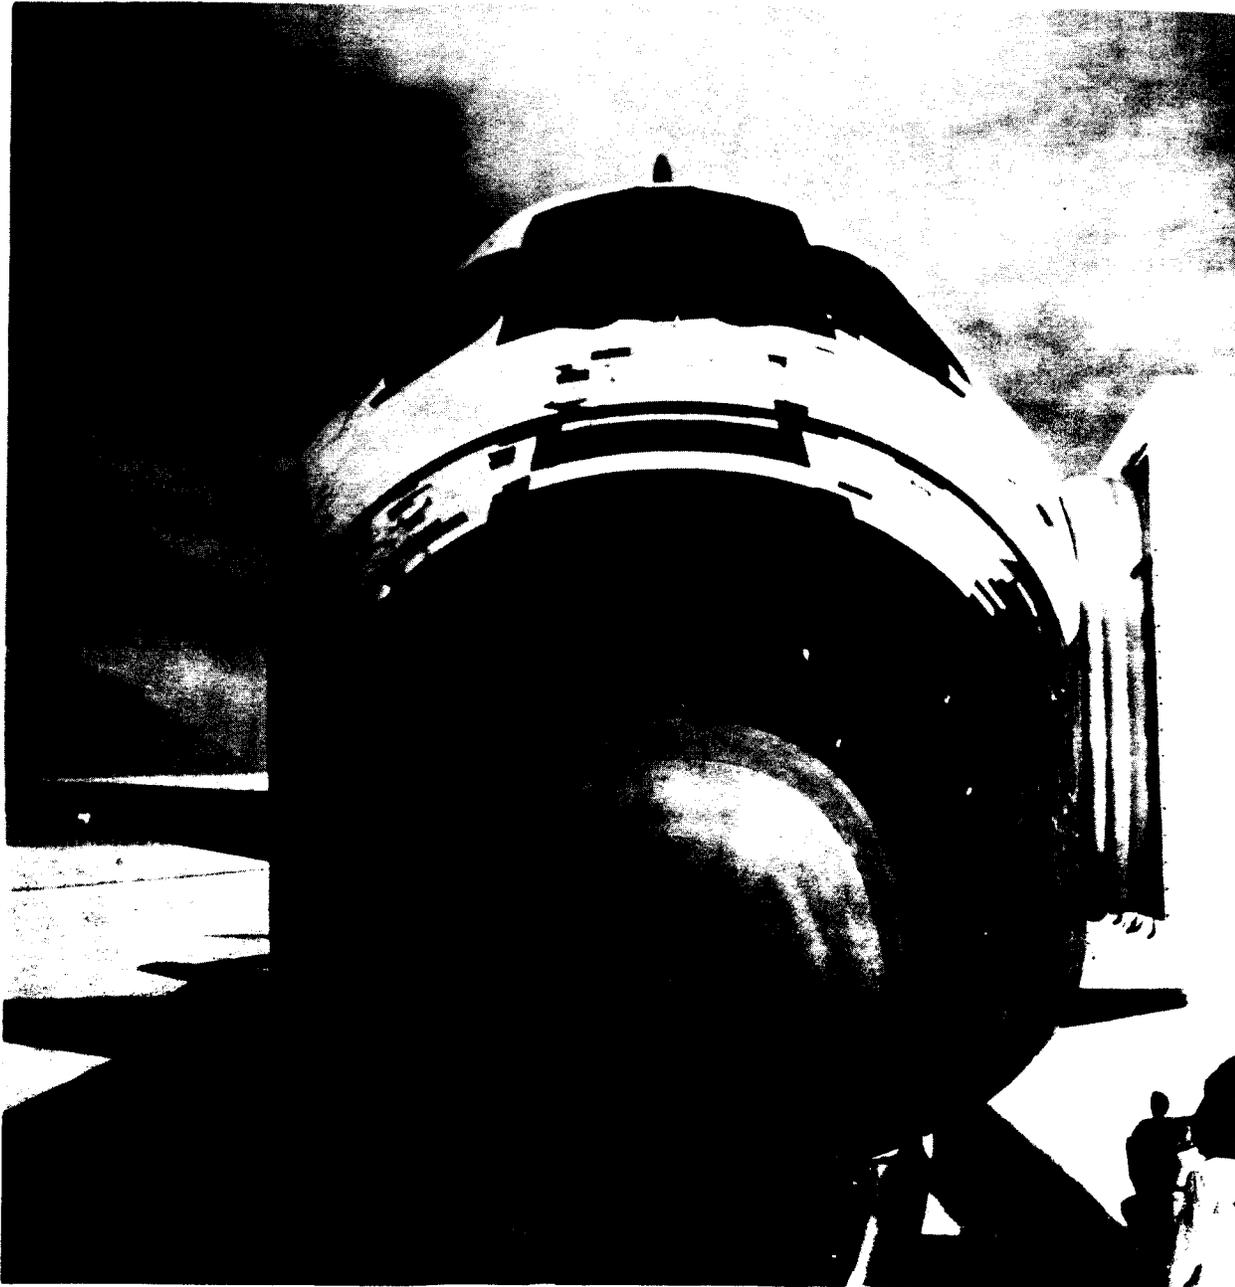
f. Twenty-one full tiles and 16 pieces of tiles were found missing on the upper forward fuselage (figures 2-22 and 2-23). Very little evidence of entry heating was noted in the tile cavities (minor scorching of the exposed SIP (strain isolator pad) edges in two locations). No structural damage occurred in the regions of the lost tiles. In each case, the tile or piece of tile was undensified and was a tile requiring a bond to the filler bar for positive structural attachment margin. The specific causes are under investigation (Section 7.0, flight test problem report 16). All of the tiles on the upper forward fuselage are being densified prior to STS-4.

Figure 2-22.- Tile losses on forward fuselage.

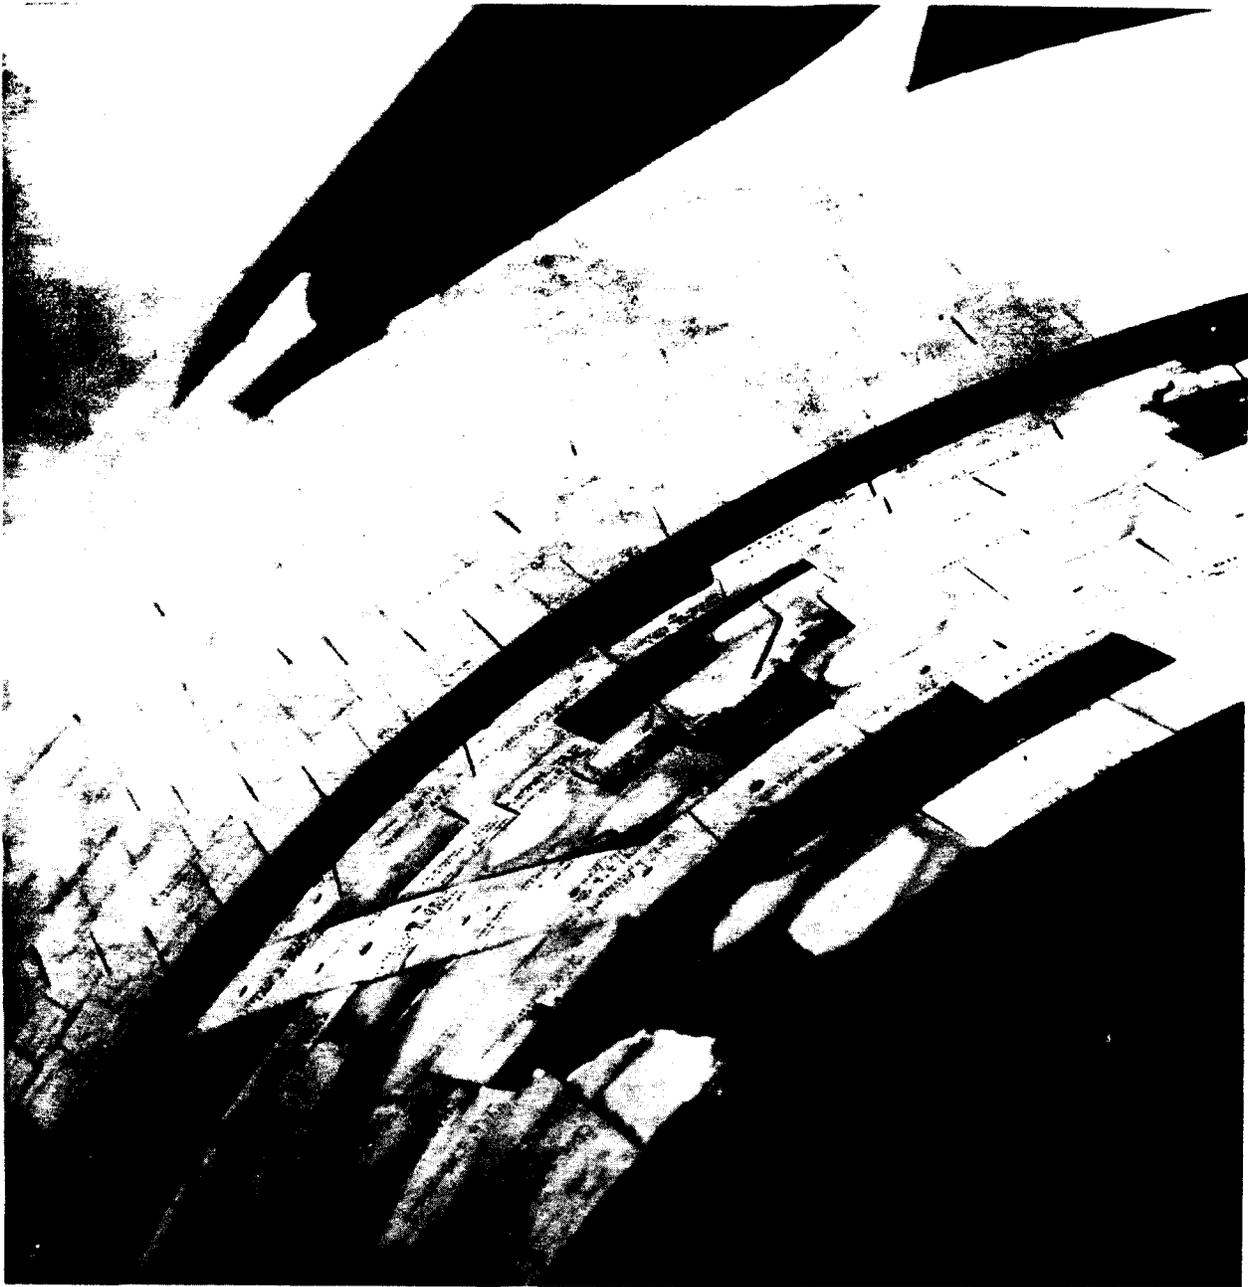
Figure 2-23.- Detailed photograph of tile damage on right forward fuselage .

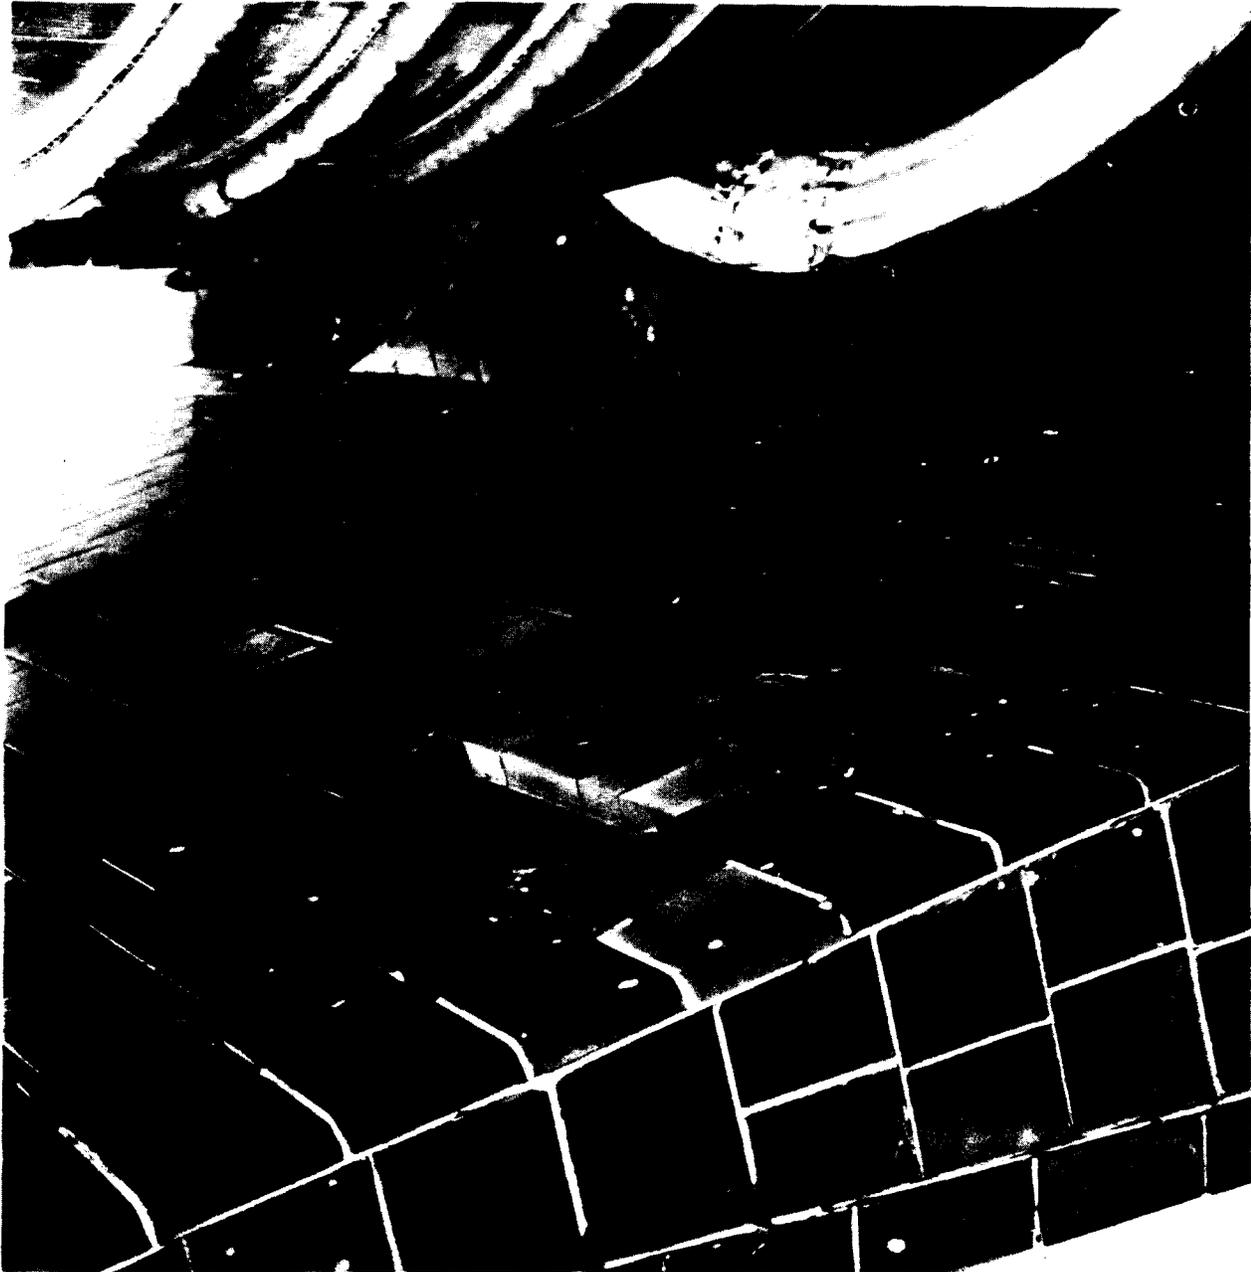
Figure 2-24.- Tile damage on upper body flap.
