STS-4 Orbiter Mission Report

September 1982

STS-4 ORBITER

MISSION REPORT

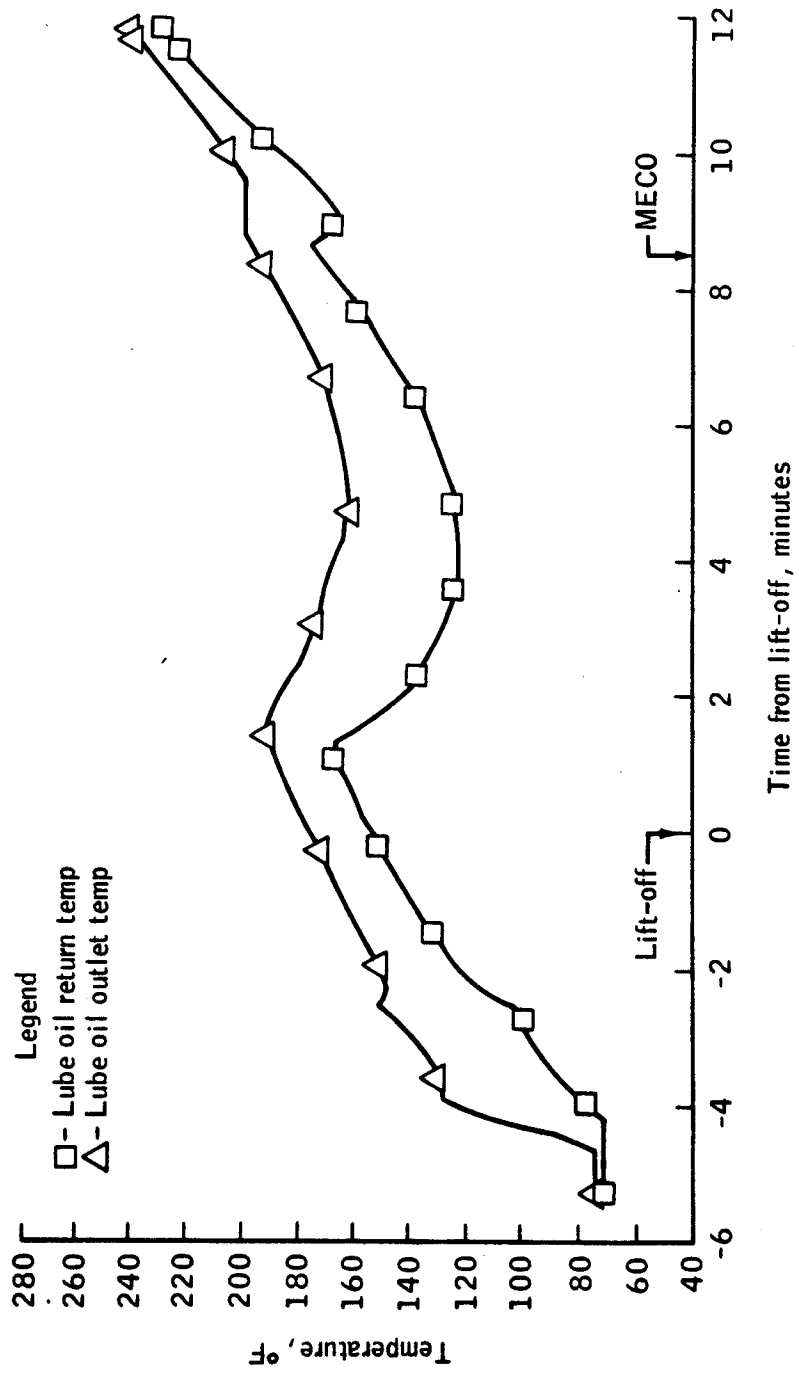
Figure 2-5.- Water spray boiler 3 performance.

The APU 3 lubrication oil temperature, after reaching 178° F at MECO, dropped 10° F due to excess water in the boiler passing over the lubrication oil tube bundle as it exits the boiler. The slope of the lubrication oil temperature profile, after MECO, matches systems 1 and 2 after flashoff, indicating that most of the free water was dumped. The lubrication oil temperatures passed through the control point (253° F) as the boiler temperature reached the triple point and no cooling occurred. It was concluded that WSB 3 froze up at 178:15:12:45 G.m.t. A theory existed that the freeze-up would not occur in zero g. The WSB 3 thawed 1 minute later and drove the lubrication oil temperature down to 230° F. This undershoot is typical of the WSB design and similar to WSB 3 on the STS-1 flight.

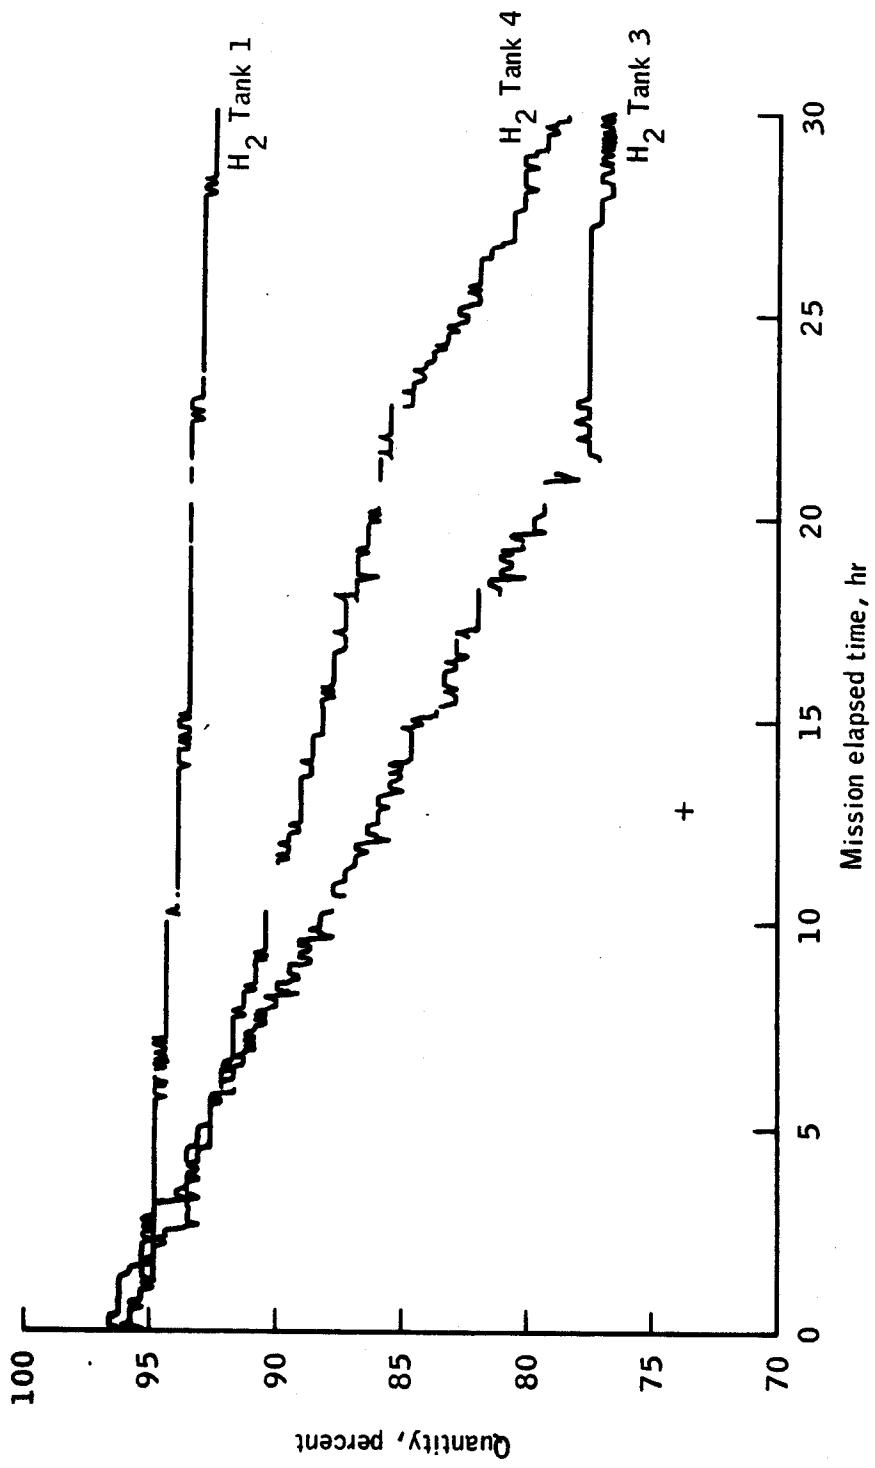
Figure 2-6.- Hydrogen tank quantity differences.

During the first 24 hours of the mission, it was noticed that H₂ tank 4 quantity was lagging tank 3 by an increasing amount (see fig. 2-6). The two tanks were being managed identically so that their quantities should have matched within 5 percent. A heater failure was suspected when it was noted (27 hours m.e.t.) during a heater cycle, tank 4 pressure rose at half the rate of tank 3 (Section 5.0, flight test problem 7).

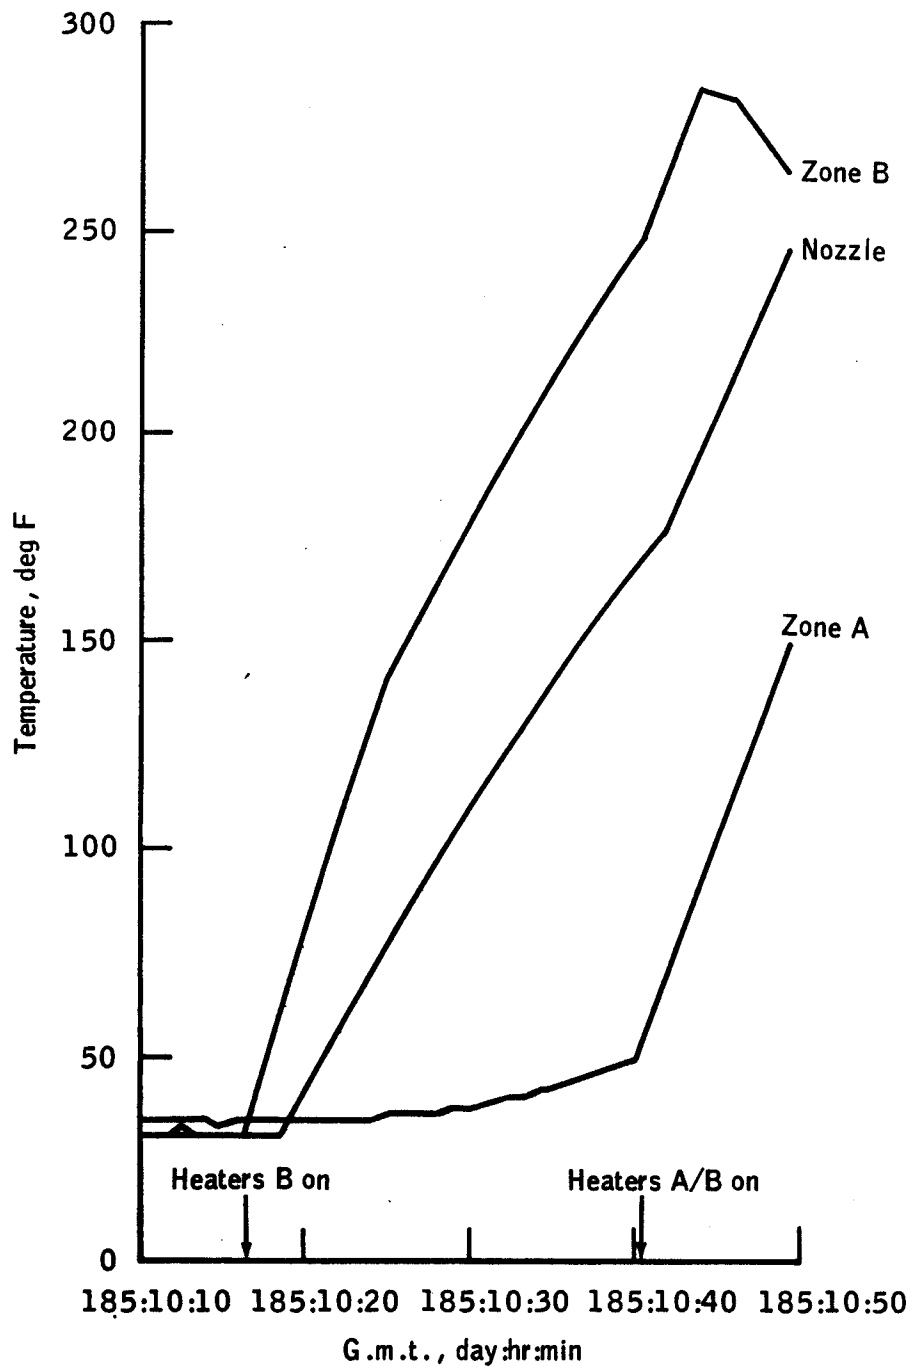
Figure 2-18.- High load flash evaporator subsystem duct heater anomaly.

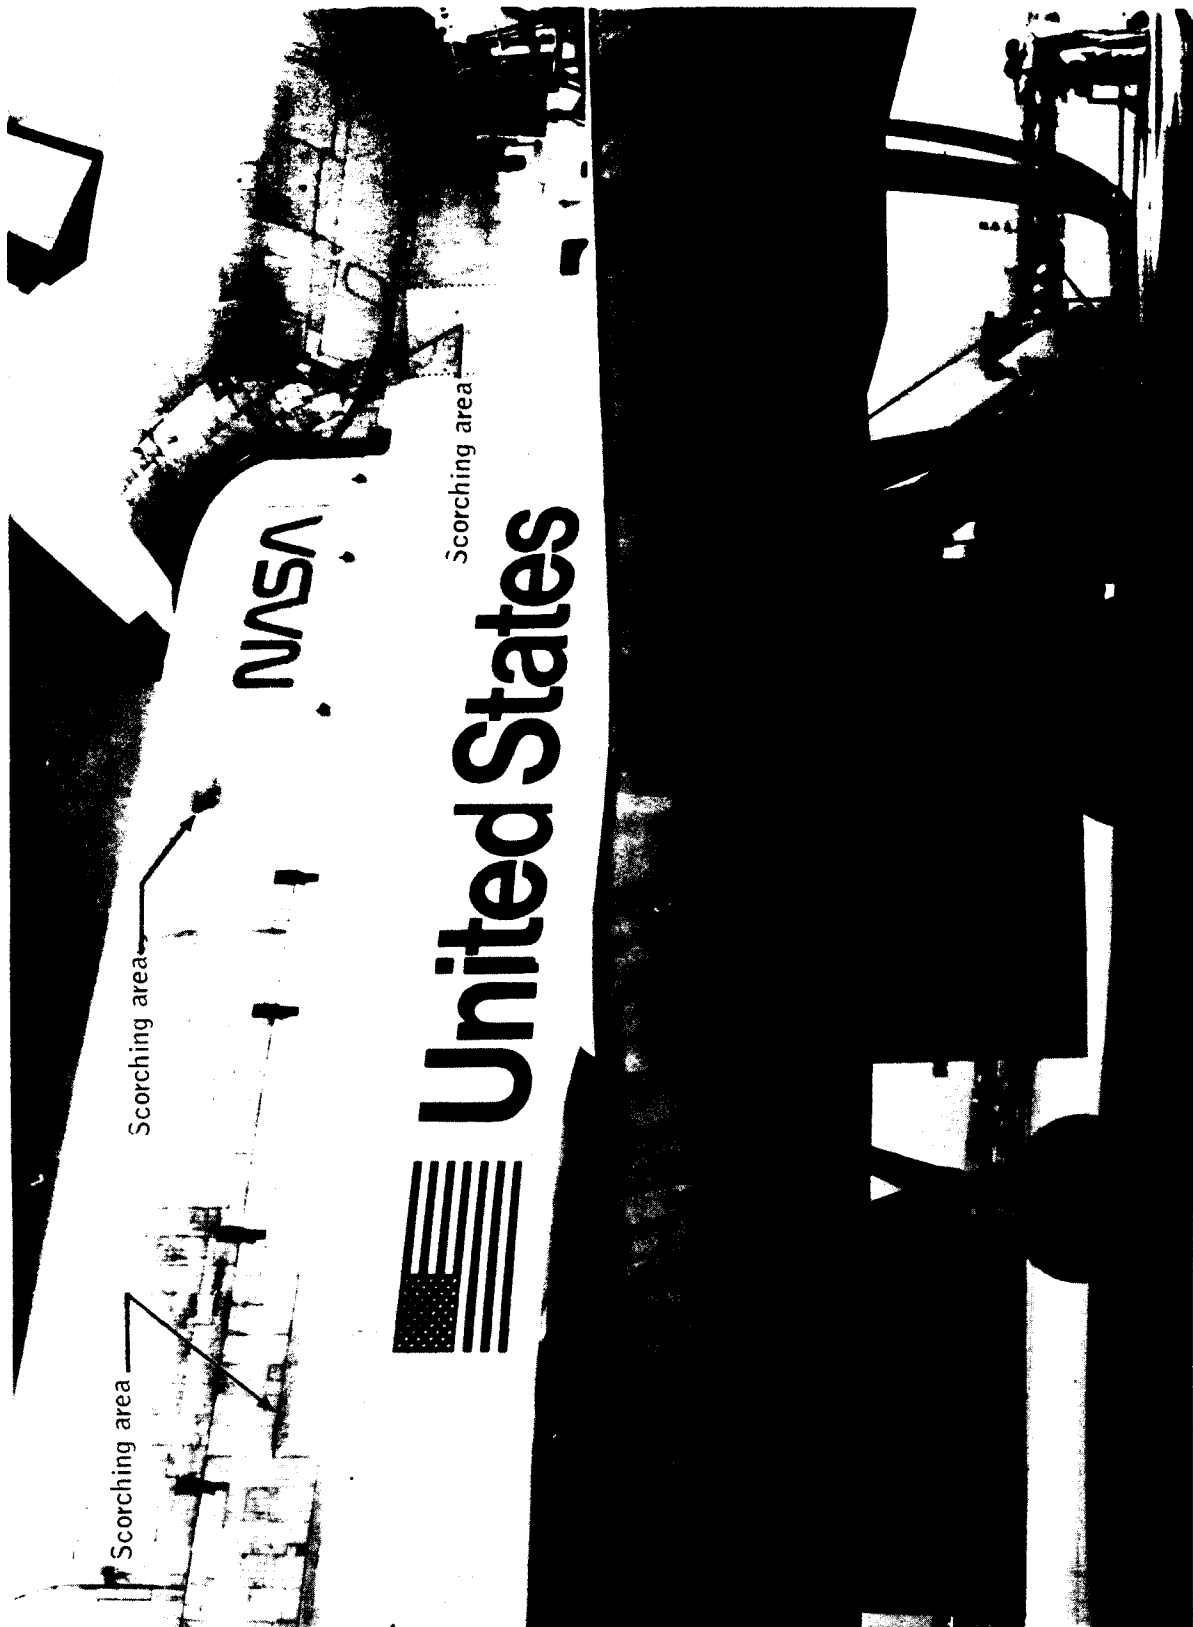
Figure 2-31 . - Areas of scorching on midfuselage , payload bay door , and OMS pod .
