STS-133 SSP Flight Readiness Review

MS/Terri Murphy
October 6, 2010

Issues & Integrated In Flight Anomalies

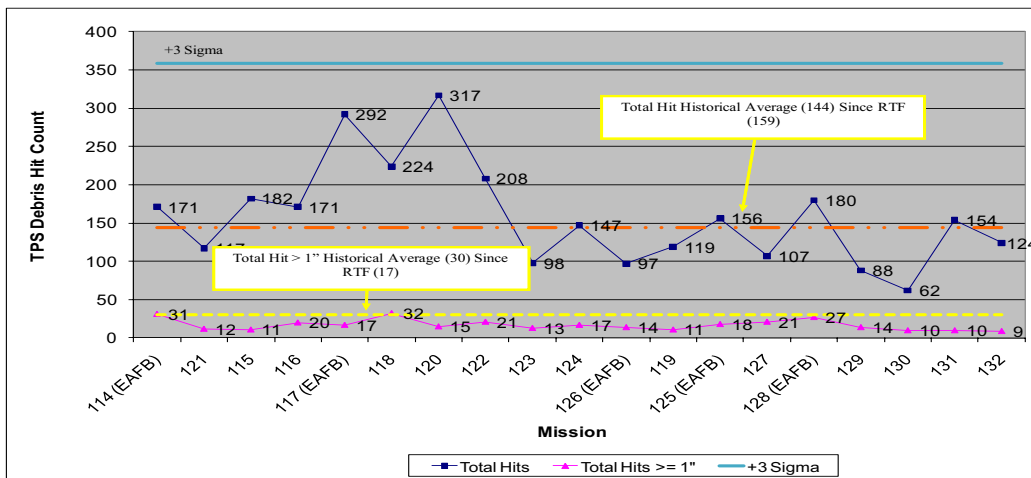
Orbiter Debris Impact summary STS-132, OV-104

- **Total # of TPS Hits = 124 / TPS Hits w/damage > 1" = 9** (4 lower surface, 4 L OMS, 1 R OMS, 0 windows)
- **Prior to RTF Average for >1" = 30.5 per flight / Average Since RTF = 17 per flight**

- **STS-132 elliptical volume Hits>1" = 0.608 in³ / RTF Average = 2.294 in³**
- **STS-132 Total elliptical volume ALL Hits = 0.984 in³ / RTF Average = 3.330 in³**

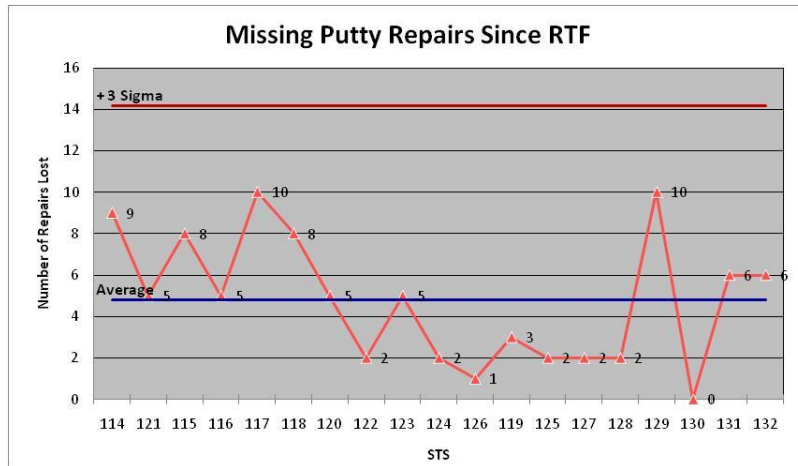
STS-132 Putty Repair Debris Summary		Presenter	MS/ Doug Drewry
		Date	10/6/10

- TPS putty repairs are listed as expected debris in NSTS 60559
- Putty Repair loss is listed in IDBR-01 as cause AK and carried as an Infrequent/Catastrophic Risk primarily because Windows have zero capability for impacts
 - Since RTF, 3 losses have had transport to windows – largest mass was 0.0009 lbs
 - No losses w/transport to windows on STS-132
- Six losses experienced during STS-132
 - Limited to small masses, consistent with historical distribution in NSTS 60559

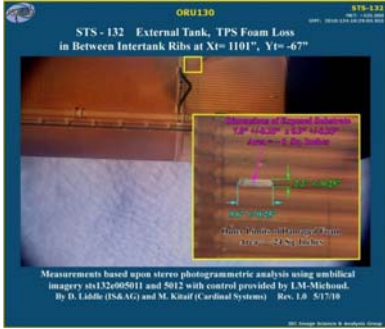
IFA Number : Title Description	STS-133 Status and Rationale
<p>•STS-132-I-002: Missing ET TPS on Intertank Stringer Outboard of Port Bipod</p> <p>•ET TPS loss on intertank stringer outboard of port bipod strut at ~ MET-129 sec.</p> <p>•Mass of loss exceeds the NSTS-60559 risk assessment mass for Void delta P.</p>

<ul style="list-style-type: none"> •The failure mode was most likely poor TPS bond adhesion •While many previous ET foam losses appeared to correlate with the location of the cleaning platforms, ET-136 (STS-132) did not. •In the absence of a root cause or a conclusive correlation to tank processing, the ET will need to be cleared for each flight based on the bond adhesion tests conducted. •A special TIM was held at MAF 3/4/10 to determine the approach for developing a PRA to quantify the risk to Special Tile & RCC. •The PRA indicates a probability of the IT foam exceeding the damage capability of tile to be 1 in 700. •The documented risk posture remains unchanged and no constraints for STS-133. <p>•Status – Closed</p>

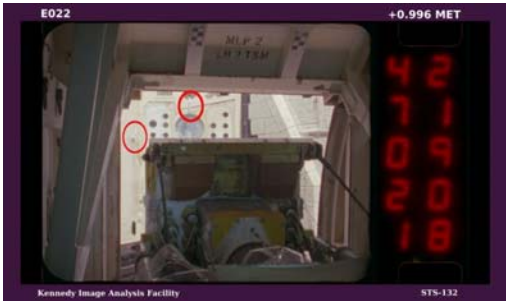
IFA Number : Title Description	STS-133 Status and Rationale
<p>•STS-132-I-003: Ice Observed on the T-0 Umbilical at Retraction</p> <p>•Ice visible on the Orbiter at two locations after LH2 T-0 umbilical retraction. Size of ice - external to seal ~5.5 x 1.9 x 0.2 in (left), internal to seal ~6.2 x 1.4 x 0.3 in (right)</p>

<ul style="list-style-type: none"> •Ice/Frost build-up inside and outside the peripheral seal on the LH2 T-0 umbilical has been observed on previous flights. •Mitigation from previous flights was an enhanced installation and verification process. •For STS-132, gray RTV was applied per drawing to seal the peripheral seal splice joints without contacting the DAPCO 235 seal. •However, this application process left a leak path between the DAPCO 235 and the gray RTV. •Drawing and OMI were updated to improve the gray RTV application process by applying the RTV along the sides of the peripheral seal upper splice plate and abutting to the DAPCO 235 seal thereby eliminating the open flow path into the seal cavity. •T-0 internal ice remains unexpected debris; no changes will be required to IDBR-01. <p>•Status – Closed</p>

- **STS-132-I-003 (LH2 T-0 Umbilical Internal Ice):** Inspection of hardware and water intrusion test showed leak path leading to location where internal ice was seen; procedures have been modified to improve RTV application to eliminate the open flow path into the seal cavity. **CLOSED 08/18/10**

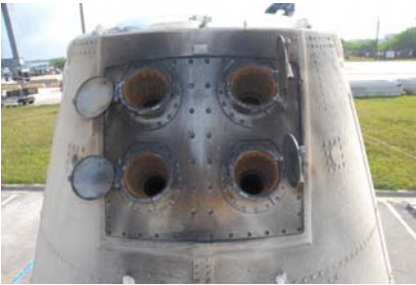
IFA Number : Title Description	STS-133 Status and Rationale
<p>▪STS-132-I-004: RTV-133 Partially Missing with Darkened Substrate from Forward Booster Separation Motor (BSM)</p> <p>•During RSRB Post-flight assessment, a piece of RTV-133 was discovered missing from the forward left-hand upper-right Booster Separation Motor (BSM) exit cone location.</p> <p>•The missing piece of RTV was approximately ¼” x ¼” x 5” long with an estimated mass of 0.01 lbm.</p>

<ul style="list-style-type: none"> •For the subject observation, the region on the closure plate exposed by the missing RTV was reported to have sooting and heating effects. •RTV can be concluded to not liberate during ascent, the cause of the observed sooted substrate condition was determined to not occur earlier than two minutes past SRB separation. •The discoloration on the BSM closure plates supports the possibility of late descent environments causing closure plate de-bonds. •There is no expected increase in risk of debris liberation on ascent. •RTV-133 remains unexpected debris; no changes will be required to IDBR-01 <p>Status – Closed</p>

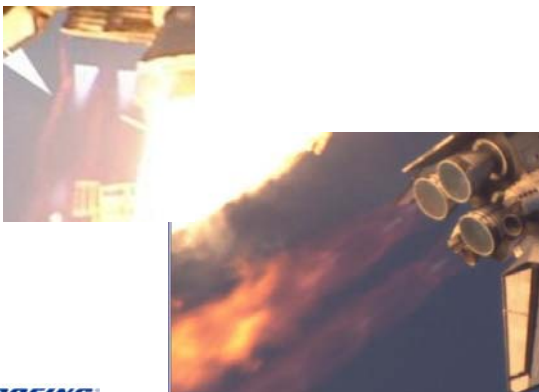
IFA Number : Title Description	STS-133 Status and Rationale
<p>▪STS-132-I-005: Multiple Streaks Observed in SSME Plumes</p> <p>•STS-132 post launch imagery review of ground based film and high definition cameras identified a greater number of streaks than usual in the Space Shuttle Main Engine (SSME) exhaust plumes at 4.6 sec MET and between 16.1 – 54.4 sec MET.</p>

<ul style="list-style-type: none"> •Streaks are possible indicators of abnormal events, and have also been attributed to external debris sources (e.g. foam, ice, etc) falling into the plume path which is not an abnormal event. •Streaks were observed in all three SSME plumes, but when streaks were reviewed individually, they weren't unusual compared to past experience. •A single root cause has not been identified; however, the following have been considered as potential sources : degraded Flow Recirculation Inhibitor (SSME2), degraded Dome Heat Shield blanket (SSME1), RCS thruster cover paper, base heat shield tile damages/dings, ET TPS, SRB TPS, Viton-Coated Nylon, Ice/Frost, and minor camera configuration setting changes. No vehicle performance or MPS related anomalies or contaminants were identified during investigation. •Although a root cause has not been identified, the risk is considered acceptable because the potential contributors, listed above, are not a safety of flight concern. <p>Status – Closed</p>
