STS-134 SSP Flight Readiness Review

MS/Anthony Griffith March 31, 2011

STS-133-I-004: Debris Released from LH2 Flange Area near the Bipod

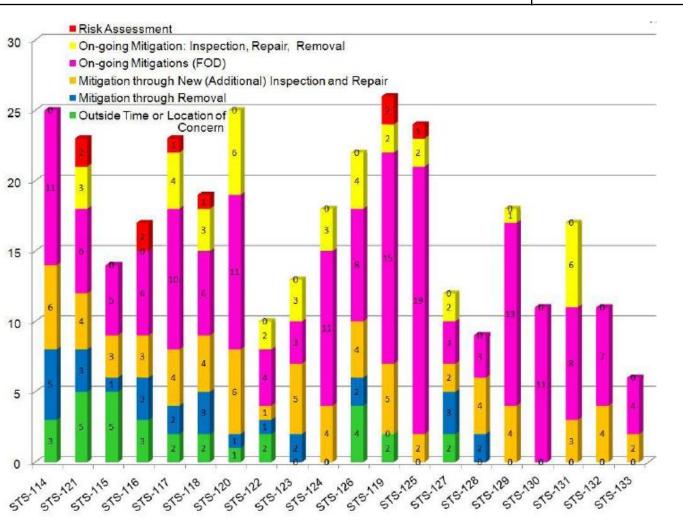
Does Not Include Rust

• Total # of TPS Hits = 56 / TPS Hits w/damage > 1" = 6 (5 lower surface, 1 window)

• Prior to RTF Average for >1" = 30.5 per flight / Average Since RTF = 16 per flight

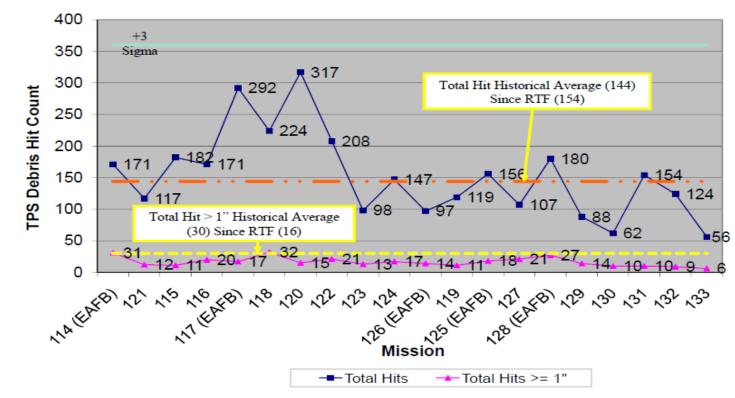
- STS-133 elliptical volume Hits>1" = 0.246 in³ / RTF Average = 2.192 in³
- STS-133 Total elliptical volume ALL Hits = 0.474 in³ / RTF Average = 3.187 in³

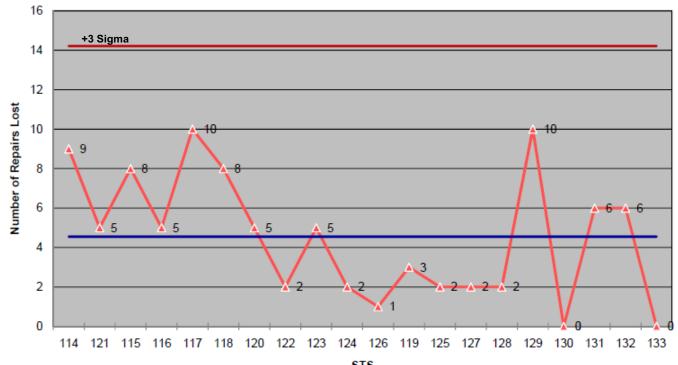
Missing Putty Repairs Since RTF

- TPS putty repairs are listed as expected debris in NSTS 60559
- Putty Repair loss is listed in IDBR-01 as cause AK and carried as an Infrequent/Catastrophic **Risk primarily because Windows have zero capability for impacts**

Since RTF, 3 losses have had transport to windows – largest mass was 0.0009 lbs

ZERO losses experienced during STS-133

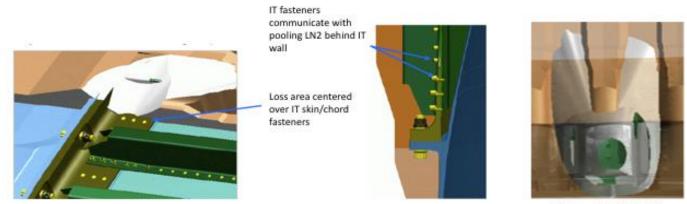
CATIA Model Showing STS-133 TPS Loss

CATIA model of STS-133 loss shown with underlying structure

- Footprint of the base of the divot encompasses two or possibly three fasteners that pass through both the lower chord and skin.
- These fasteners provide a leak path to the pooling LN2 that forms in the Intertank/LH2 flange area.

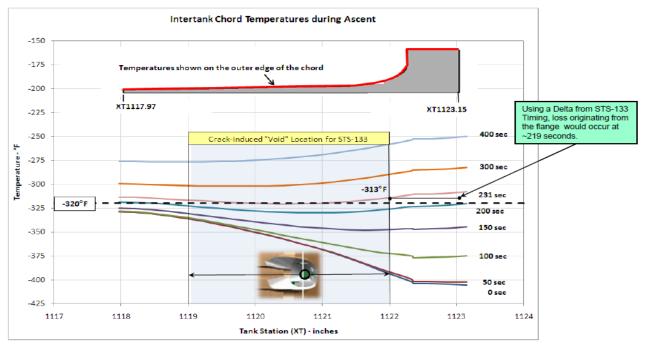
As shown in the thermal assessment, the entire Intertank Chord remains below the saturation temperature of N₂ at 1 atm (-320°F) through 190s MET.

- At the time of the STS-133 foam loss, the highest predicted temperature in the void was -313°F (consistent with a nitrogen saturation pressure of 23 psia).
- Foam debris originating at the Intertank chord would be expected to occur no earlier than 190 sec. if it occurred at an internal void pressure of 1 atm

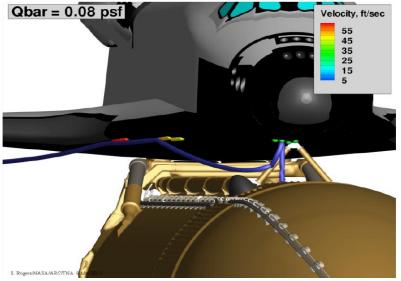
- This is a known failure mode with a well understood mechanism
 - Proposed mitigations were not implemented in RTF flange modifications due to marginal benefits, risk of unintended consequences, and since considered a low debris risk (late time of release)
- Aero and Transport analysis has shown there is a low probability of experiencing significant TPS damage from these late releases.
 - STS-133 analysis indicated all impacts were below the TPS threshold and no damage was predicted.

- Analysis is substantiated by 2006 SSP Aero Panel Study that indicated no critical damage to Orbiter Tile or RCC for debris smaller than 0.4 lbm. after 166 sec. MET.
- Pop-off velocities were reviewed for small to large masses and all remained below Orbiter damage thresholds.

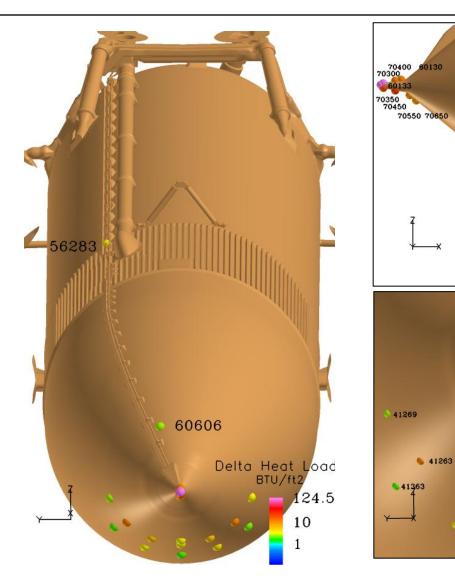
ET Total Heat Load BP Exceedances

- PE Certification was selected by the Program as the best approach
 - Limited the PE Certification run matrix based on current manifest (in back up)
- Impacts to Elements:
 - ET
 - 23 heat load exceedances on mainly nose cone area
 - Thermal Panel discussions suggest new environment within element capability
 - ET analysis is in work
 - Orbiter
 - Wing Leading Edge (WLE) has ~25 heat rate and ~91 heat load exceedances
 - WLE exceedances are in family with STS-133 mission assessment and expected to be cleared by comparison with hardware temperature limit
 - RTLS case caused small exceedances to five OMS Pod loads Body Points (BP) (max increase 2.41%) and fourteen Vertical Tail loads BP (max increase 3.33%)
 - Orbiter analysis is in work
