# STS-117 MDM OA2 Card 5 Failure

Presenter: Tim Reith

Date:  
06/15/2007

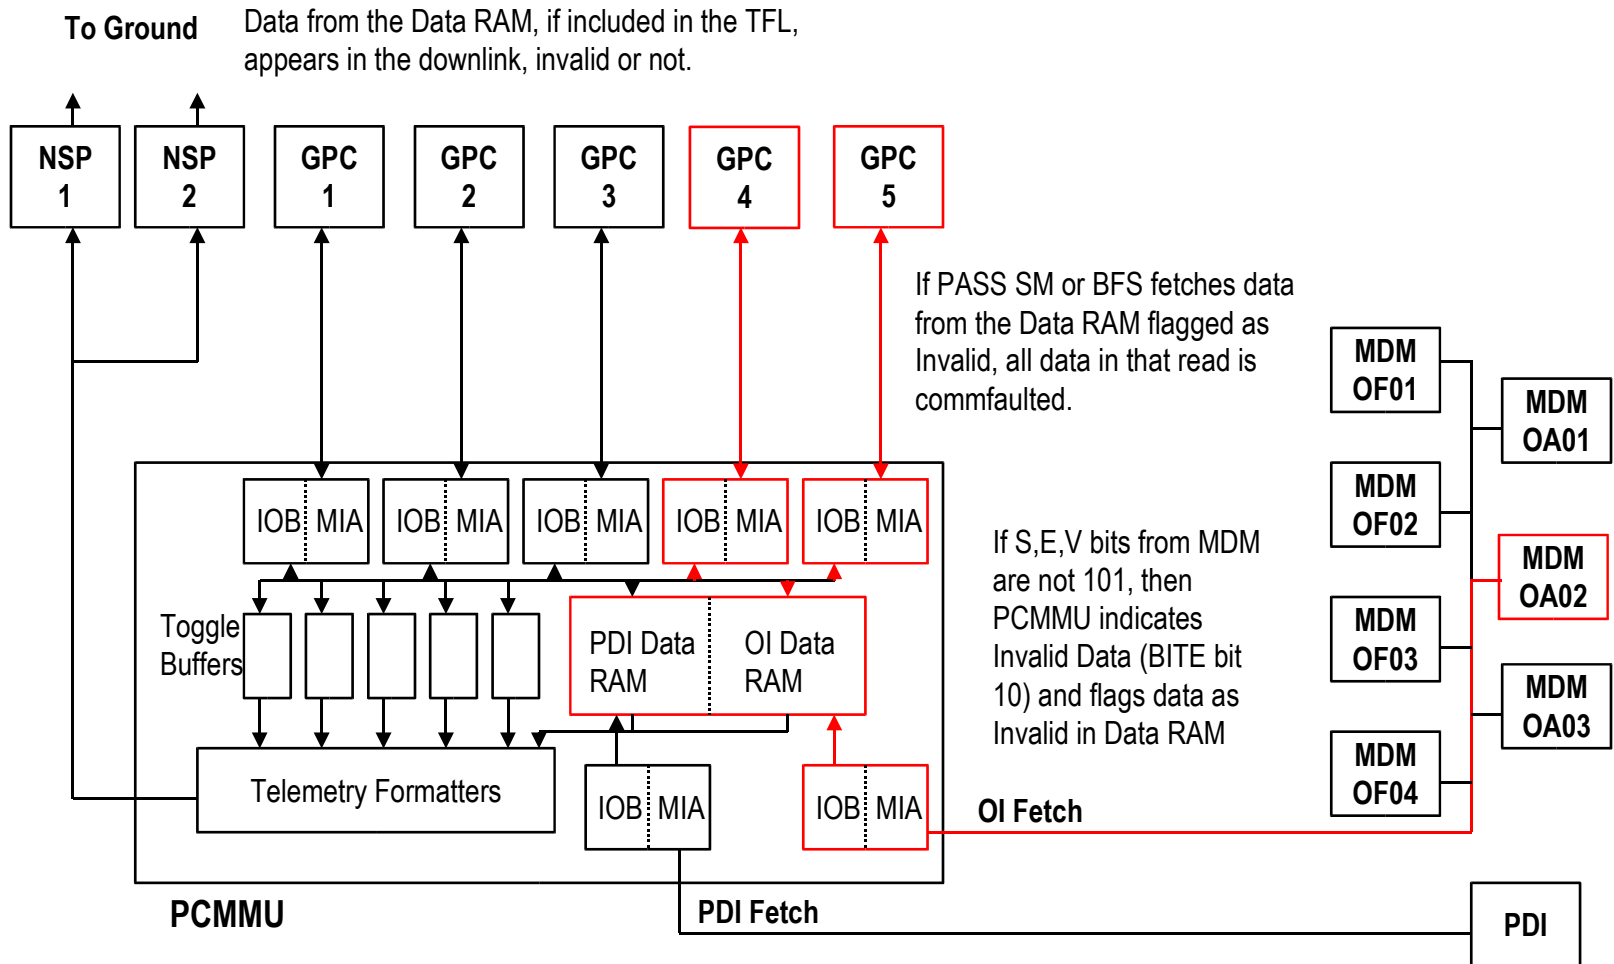
## Data processing block diagram

- At GMT 163/07:54:41, card 5 in MDM OA2 fails (BITE failed)
- At GMT 163/07:54:43, SM alert “S62 BCE BYP OA” annunciated
  - All OA2 SM read 1 words (31) are commfaulted and bypassed

- Parameters from cards 2, 4, & 6 are also in this read
    - Included in this effect is V46R0235A (APU 2 turbine speed) from card 6
- Commfaulted V46R0235A (APU 2 turbine speed) triggers limit set change for V46P0253A (APU 2 gearbox lube oil press)

- Limit set change in effect after defined delay of 9.6 seconds
- New limit set is nominal ascent/entry limits for V46P0253A (APU 2 gearbox lube oil press) - Current value at that time violated lower limit

- Noise filtering delays annunciation for 13.4 seconds
- At GMT 163/07:55:06, PASS SM annunciates “S86 APU GBX P 2”
  - Total delay  $9.6 + 13.4 = 23$  seconds from “S62 BCE BYP OA”
