NASA/CR-2007-213697

Lessons Learned From Seven Space Shuttle Missions

John Goodman
United Space Alliance
Houston, Texas 77058

January 2007

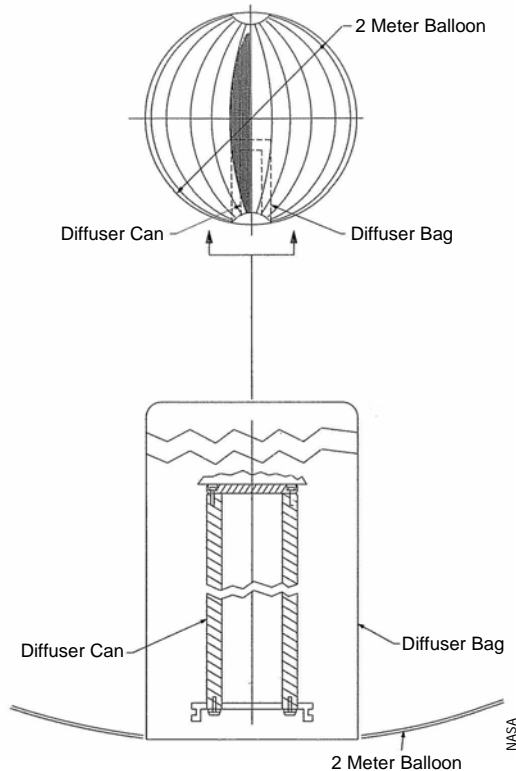
Figure 2 Engineering drawing of the IRT balloon and inflation system.

A post-flight investigation revealed that a lanyard connection failed open which prevented activation of a delayed action pyrotechnic charge that would have triggered the stave cable cutter sequence. An improper crimping tool was used when the lanyard assembly was manufactured. A different type of lanyard connection that was less susceptible to failure should have been used.

- **Quality control during manufacture should be rigorous enough to ensure that proper tools, procedures, and materials are used.** Malfunctions can result in degraded system performance or system failure that could negatively impact mission success or safety of flight.
- **Choose component designs and system architectures that lower the risk of failure and enable the system to function within requirements in the presence of failures.** Some proposed component designs and system architectures may be more robust than others.

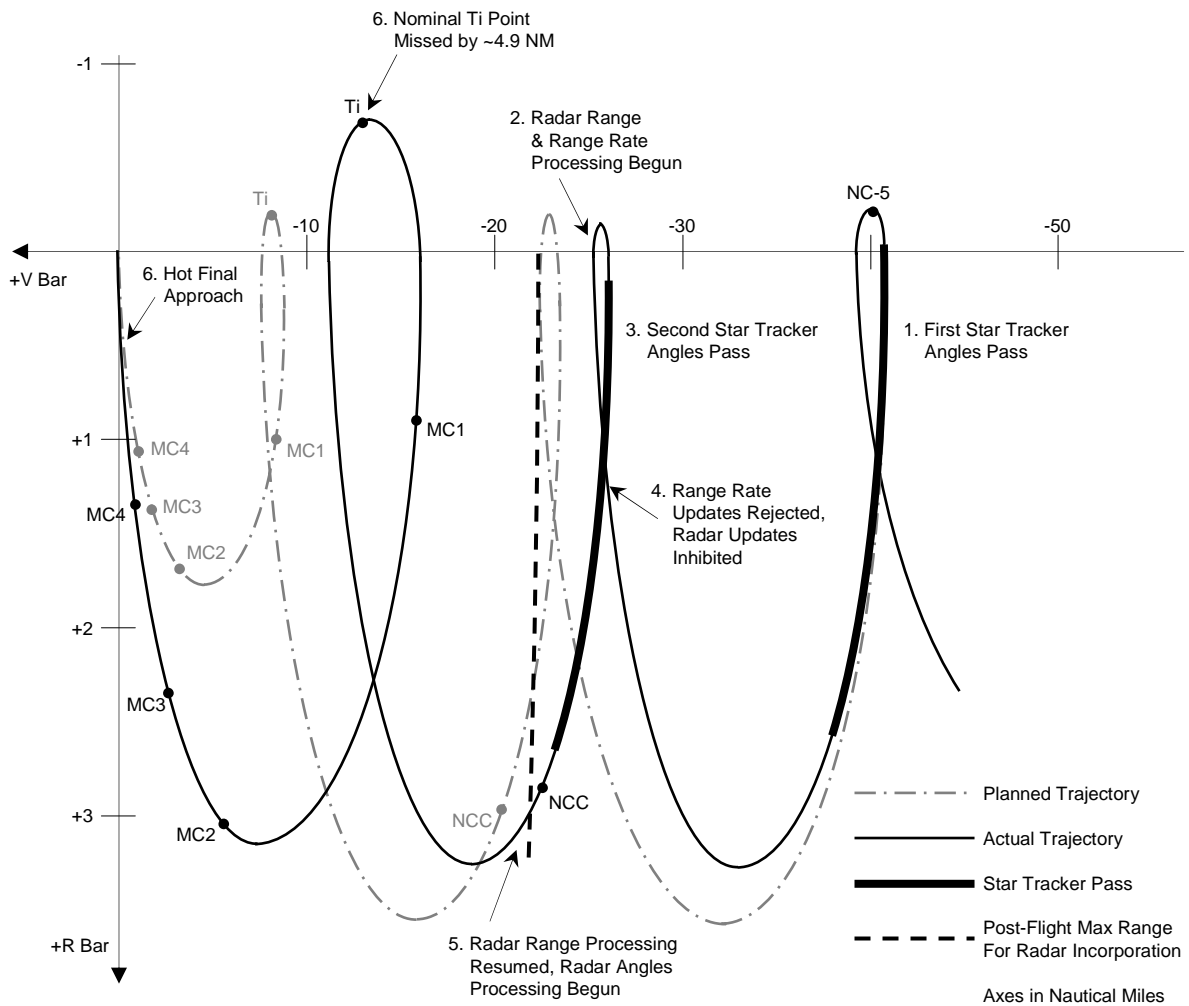
Figure 12 Relative motion plot illustrating the planned and actual trajectories during the STS-32 rendezvous with LDEF.

The onboard solution for the NCC maneuver (Figure 12) was 4 feet/second higher than expected, but was burned. After the NCC burn, radar range, range rate, and angles were processed (Figure 12, Item 5). However, several range rate spikes led to Mission Control to ask the crew to inhibit range rate processing. Radar range and angles continued to be processed for the rest of the rendezvous. Onboard rendezvous navigation filter performance during the rest of the rendezvous was as expected. The larger NCC burn resulted in a miss of the desired point of the next burn, Transition Initiation (Ti) by about 4.9 nautical miles (Figure 12, Item 6).

Post-flight analysis indicated that the star tracker data alone would have provided accurate data for a satisfactory NCC burn solution. It was discovered that at extreme range (but still shorter than the maximum tracking range based on signal strength) a variable range measurement bias was introduced by the radar hardware. The bias, which increases with increasing range, corrupts both range and range rate measurements while the signal strength remained acceptable. This maximum effective range of the radar was a design limitation concerning transmission pulse timing rather than a performance limitation on signal strength. This maximum effective range defined by the introduction of the bias fell between the certified maximum range and the maximum tracking range (Figure 16). While radar data was good when lock-on was achieved (Figure 12, Item 2), the maximum effective range was exceeded during the second star tracker pass (Figure 12, item 3), which led to the biased

range and range rate measurements, and the rejection of two range rate measurements by the navigation filter (Figure 12, Item 4, and Figure 13).

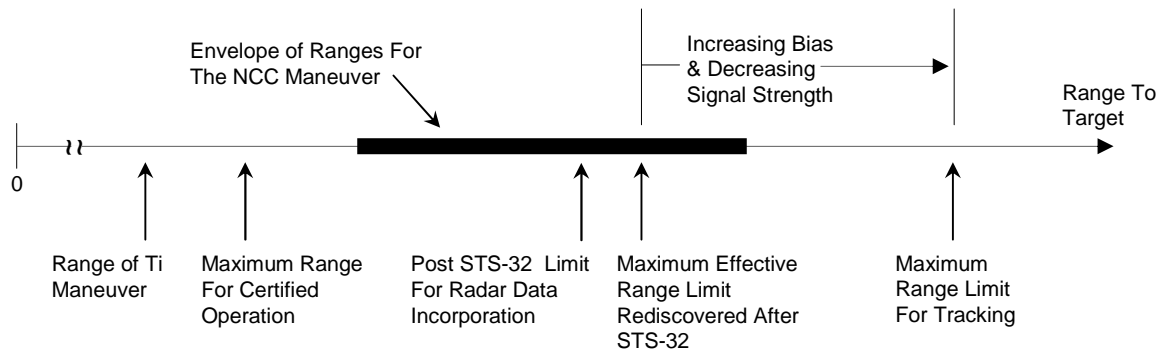
Figure 16 Certified, effective, and maximum tracking ranges of the rendezvous radar. Range at the NCC maneuver is trajectory dependent.

In addition, signal strength at the long ranges during STS-32 was found to be lower (but still acceptable) and signals noisier than at closer ranges (after NCC) at which radar data was normally processed. STS-51I was the only other mission during which radar data was acquired before the effective range limit. However, the range from *Discovery* to the SYNCOM decreased to below the maximum effective radar range before data was incorporated into navigation, thus avoiding the radar measurement bias (Table 2).

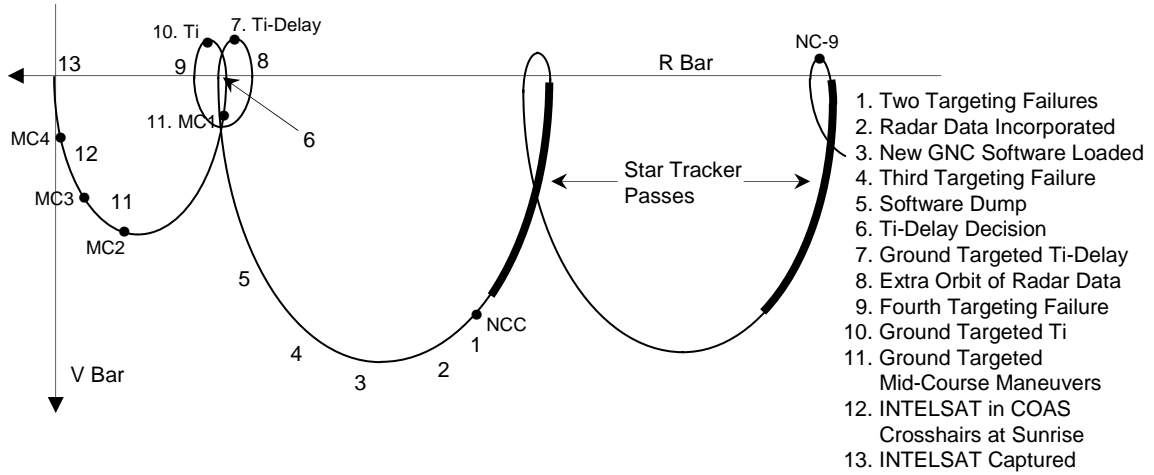
Figure 29 Sequence of events during the third rendezvous of STS-49.

After *Endeavour* began its return to INTELSAT, two star tracker passes and a midcourse correction (NCC) maneuver were successfully performed (Figure 29). However, a targeting attempt soon after NCC for the next maneuver, Transition Initiation (Ti[‡]), failed to converge on a solution (item 1 in Figure 29, Figure 30).

After the Mission Control computed Ti-Delay was performed (item 7 in Figure 29), two on-board troubleshooting Ti targeting attempts succeeded while another failed. The Ti and subsequent maneuvers were performed using burn solutions voiced to the crew from Mission Control. At orbital sunrise, just before the start of the proximity operations phase, the *Endeavour* commander reported that INTELSAT was in the cross hairs of the Crew Optical Alignment Sight (device on the left side of Figure 27), indicating a nominal approach trajectory for initiating proximity operations (item 12 in Figure 29, Figure 32).

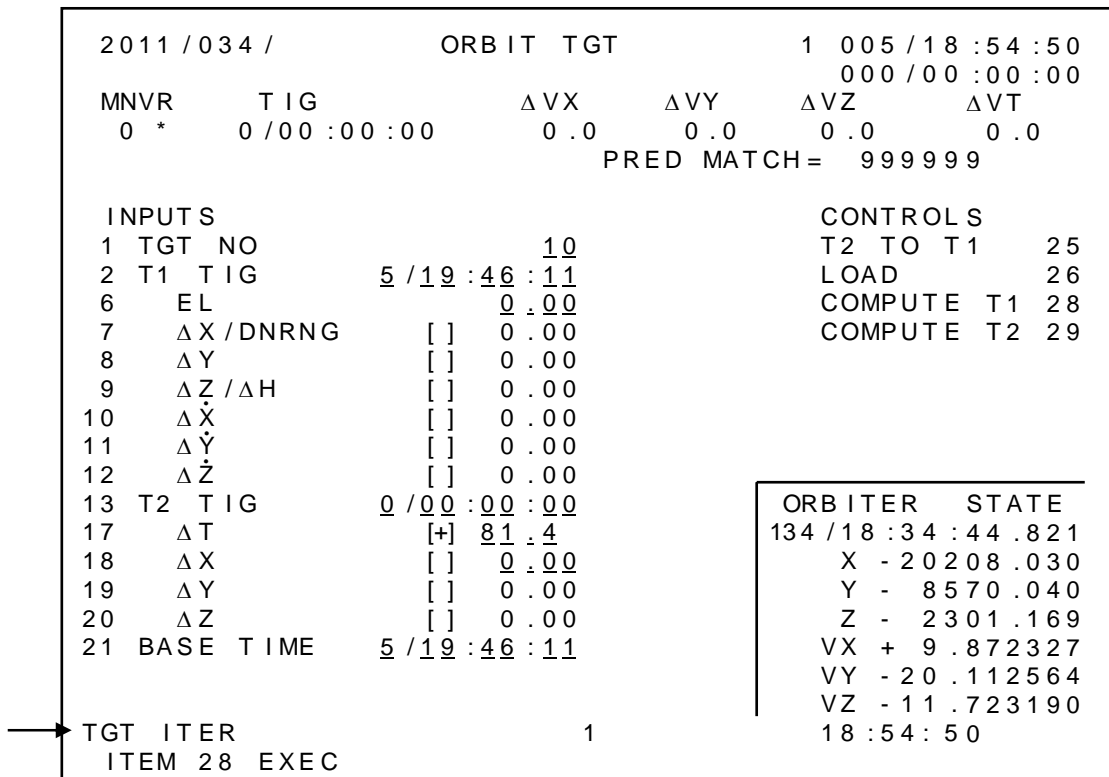
Figure 30 Failed Ti targeting attempt recreated by the author during the investigation using the Software Production Facility.¹⁵ Arrow indicates alarm message seen by the crew on *Endeavour*.

Mission Control rendezvous and shuttle software specialists quickly identified the source of the targeting failure to a specific area of the Lambert targeting code. Radar data was obtained and incorporated into the shuttle navigation solution. In case the Guidance, Navigation, and Control (GNC) software had become corrupted, the crew reloaded new GNC software from the Mass Memory Units into the GNC computers. However, the targeting failure occurred again after the software reload (Figure 31). The GNC software was then transmitted to Mission Control for further offline analysis. The anomaly was particularly puzzling as the Lambert targeting task had been successfully executed 35 times previously during this mission.

While the Flight Day 7 rendezvous was still in progress, a software investigation involving several NASA and contractor organizations was initiated.^{16,17} The failure of the targeting algorithm to converge was isolated to the use of one double precision and two single precision parameters in a double precision mid-value selection library function.¹⁸ To ensure the successful completion of the remaining mission activities and the safe return of *Endeavour* to Earth, the orbit and entry GNC software was examined to determine if there were any other cases of mixed precision use that could cause problems. Ascent GNC software was also examined. No other instances of mixed precision use were found.

In 1989, three years before STS-49 flew, it was discovered that a double precision mid-value selection library function actually operated on the three input parameters as if they were single precision. An analysis of all uses of the function in the flight software was performed and the function was corrected so that all inputs were treated as double precision. STS-49 was the first mission to fly a rendezvous after the correction had been made. It should be noted that the targeting failure did not occur before the flight in the extensive software and integrated avionics testing processes (conducted in multiple facilities using shuttle flight computers). The failure did not occur during integrated simulations with Mission Control and the crew in a simulator, nor did it occur in the 35 previous executions of Lambert targeting during STS-49. The investigation also found that the Ti maneuver was the only one susceptible to the anomaly. The mid-course maneuvers could have been targeted on-board rather than by Mission Control.

The next rendezvous mission, STS-56 (April 1993), used the same software version as STS-49. A set of convergence criteria was set to more liberal values to prevent the anomaly from occurring. No targeting failures occurred during the mission. STS-57 (June-July 1993) was the first flight of a new software version that included a source code fix for the STS-49 anomaly and a code change to improve convergence on a burn solution. Lambert targeting software used during the STS-57 retrieval of the European Space Agency EURECA satellite performed with no difficulties.

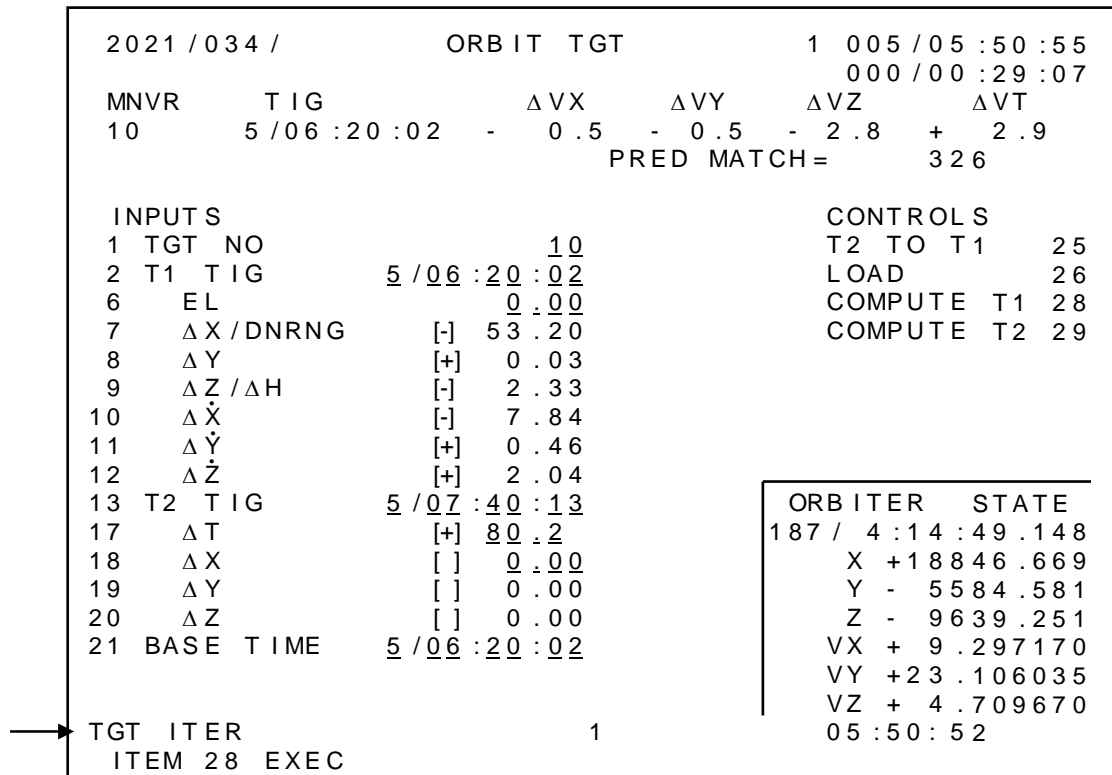
Figure 41 Failed Ti targeting attempt recreated before the 1993 launch of *Discovery* on STS-51.

By Friday morning, the failure had been duplicated by the author in the Shuttle Software Production Facility using shuttle software and a shuttle flight computer (Figure 41).¹⁵ Data was distributed to all parties involved in the investigation that morning. By 5 pm on Saturday the 11th, the source of the failure had been identified as a rare numerical condition associated with the convergence improvement code introduced after STS-49. It was limited to rendezvous targeting, would not impact any other software functions or flight phases, and was not a constraint to the upcoming mission. Should the failure occur during the STS-51 rendezvous, a procedural work-around was developed and the STS-51 crew was briefed on the procedure the day before the launch.

The STS-51 rendezvous with ORFEUS-SPAS was successfully conducted with no targeting failures occurring during the mission (Figures 42 and 43). Post flight, another investigation resulted in a software change to prevent the new anomaly from reoccurring. Analysis showed that the occurrence of this anomaly was less frequent than the STS-49 anomaly. Starting with the first rendezvous mission after STS-49 (STS-56, April 1993) through STS-114 (July-August of 2005), 45 shuttle missions have exercised the Lambert targeting software with no software anomalies occurring in flight. In addition, none have occurred in software testing and pre-mission training simulations since the fall of 1993.

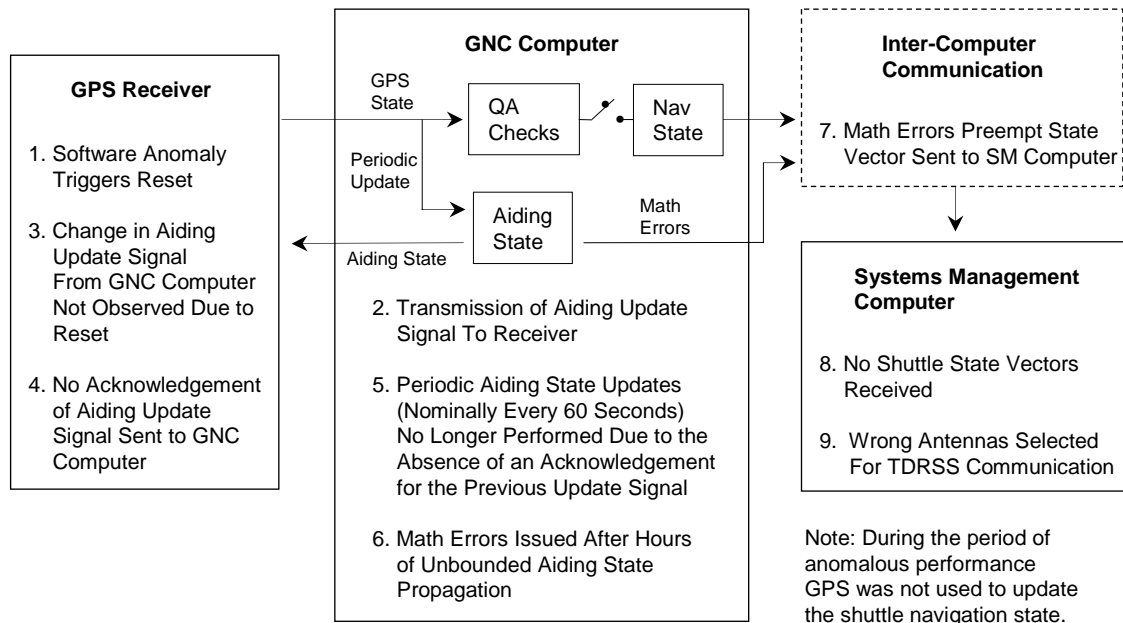
Figure 49 STS-91 GPS and shuttle software anomalies.

Consequently, after about 8 hours of propagation, the inaccuracy in the aiding vector exceeded computation limits. The GNC computer issued a large number of mathematical conversion errors at a high rate over the avionics system communications bus. The large number of error messages prevented the transmission of shuttle state vectors from the

Significant changes were made to the shuttle/GPS integration and certification process. The contract with the GPS vendor was changed so the vendor could participate in the project at a higher level. Expanded vendor involvement after STS-91 brought much needed design insight to the project, that greatly aided issue identification and resolution for STS-91 and subsequent shuttle missions and laboratory testing. Weekly teleconferences involving all project participants were conducted. Face-to-face meetings were held at the Johnson Space Center two to four times a year. Issue tracking and visibility was enhanced. Since the GPS receiver software had originally been developed at government expense, the Shuttle Program was able to get access to the source code. The NASA Independent Verification and Validation contractor began a review of GPS receiver source code which included reviewing changes made in support of the shuttle integration. Shuttle Program personnel gained access to receiver software requirements documents. Additional interim receiver software versions were planned and additional flight and ground testing was conducted to resolve issues and verify software performance. In addition to GPS receiver telemetry sent to Mission Control, a laptop computer was carried on many shuttle flights after STS-91 to record receiver instrumentation port data. This data was instrumental in allowing the GPS receiver vendor to quickly diagnose GPS software problems with complex root causes.
