2/28/25: I've chosen my 9 week project as rebuilding this Hewlett Packard 200CD Oscillator. The goal is to get this oscillator functioning within its specifications after doing a calibration on it. The first part of this project includes doing an initial calibration to figure out what parts are not functioning up to spec. I am fortunate to have found a manual for this oscillator fit with a calibration procedure and schematics- as well as a parts list telling me each value of the components. Today I connected it to the calibrator and tested it in XY mode on the oscilloscope. Running the oscillator for about an hour the error had ended up at around .7% error read off of the calibrator. A few things to note from today was that the output sine wave was showing some noise from the AC power grid and I'd definitely like to get rid of that. Also the amplitude knob was very shaky when the amplitude was being changed. So that will need to be checked out as well. I was able to find some tubes on ebay so I could have some backups in the unforeseen circumstance one breaks. I have also found replacements for the electrolytic capacitors in the power supply and the one on the output of the amplifi

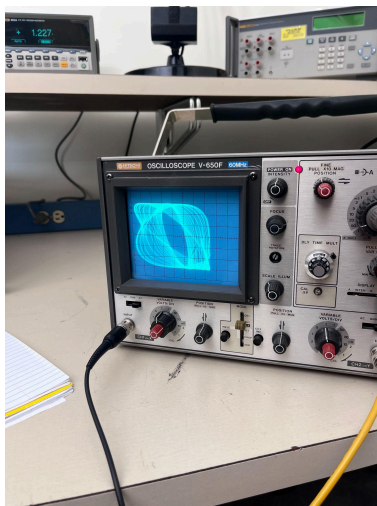
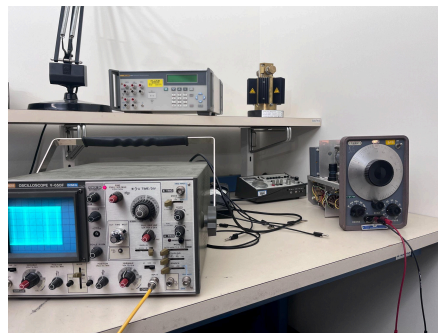
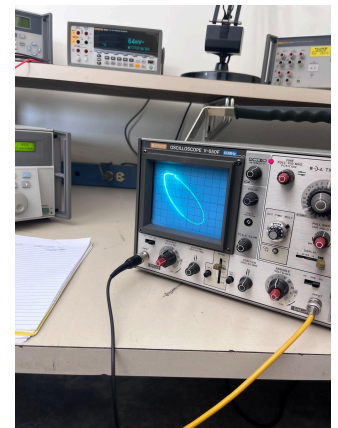
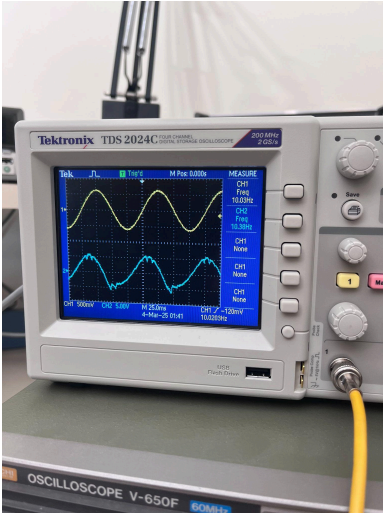
1. The HP oscillator's output tends to vary based on scope readings. This seems to happen more and more as frequency goes up. Whether this be finding a slow moving lissajous and having it move faster without touching any frequency control or seeing a number measured by a digital oscilloscope changing it seems apparent using both types of scope.
2. The (which at this time we are blaming on tube heater noise or power supply) noise seen makes the high frequency lissajous difficult to capture.
3. Small amounts of distortion are seen at the peaks of the oscillator's output when set at 10 Hz.

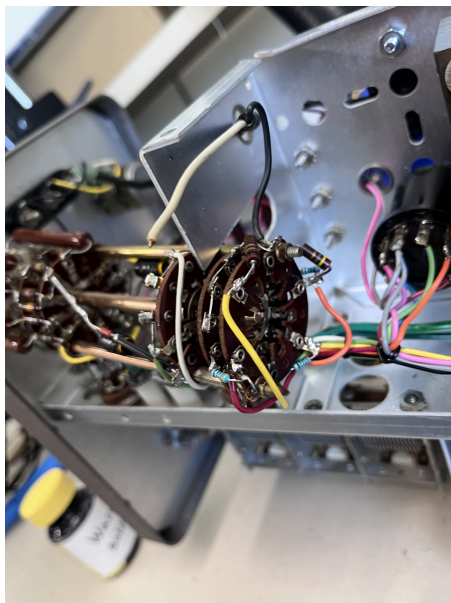
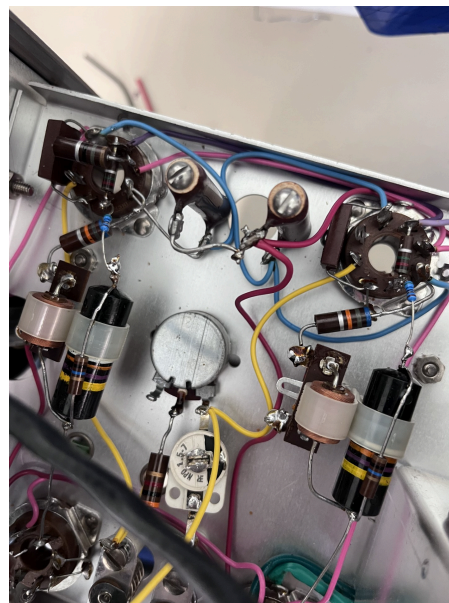
4/4/25: I was lucky that spring break was between last lab day and today because it took 10 days for the resistors to show up. I got them replaced today. I ended up unbolting the switch deck in order to get to one of the 300 Ohm resistors. It was pretty difficult to get to. I also realised I'd leave the deck removed for next week because it will make the cleaning easier. The new resistors are the blue ones shown in the pictures below.

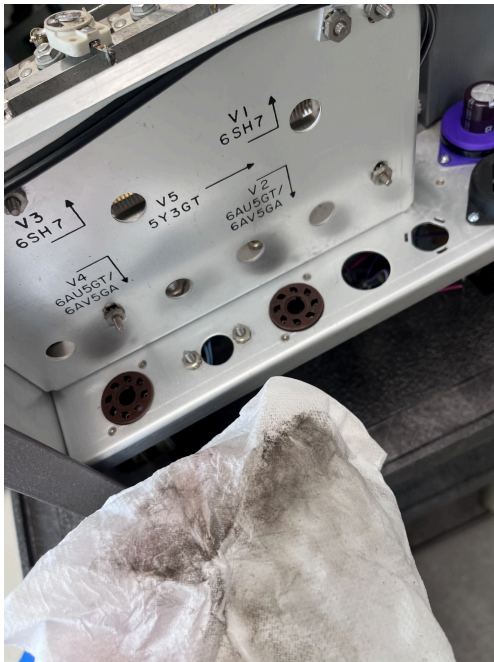
4/11/25: Today I finished cleaning the rotary decks to the best of my ability. I will not be taking the switch apart because the manual says that it is replaced as an assembly and I think that would mean that it cannot be disassembled easily. I did take an alcohol soaked paper towel and wiped all of the dust off where it has settled over the years. (pictured below) I lastly took a spray can of air and used that to blow out the dust between the variable capacitor plates. I believe this cleaning of the rotary switch resistor decks and the capacitor plates will aid in a more stable frequency for the oscillator. This thing started out as being very clean for being almost 70 years old but it looks so much better now.

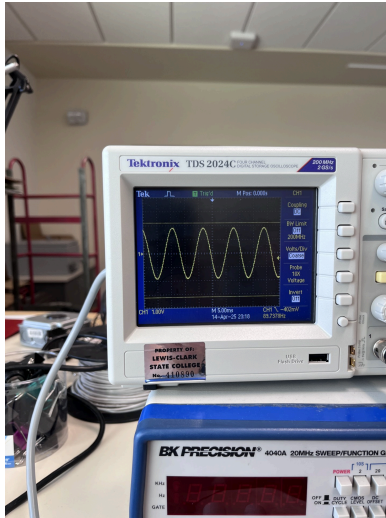
4/14/25: Today I finished connecting the capacitors in the power supply. After getting all bare wires (That I installed) shrink tubed I put the tubes back in, including the new rectifier tube and powered it up. I am very happy to say that a very large improvement was seen when powering it bad up. Below is a picture of the output sine wave with the oscillator set at 90 Hz as you can see the picture shows 89.73 Hz and the wave is much cleaner than It was before.

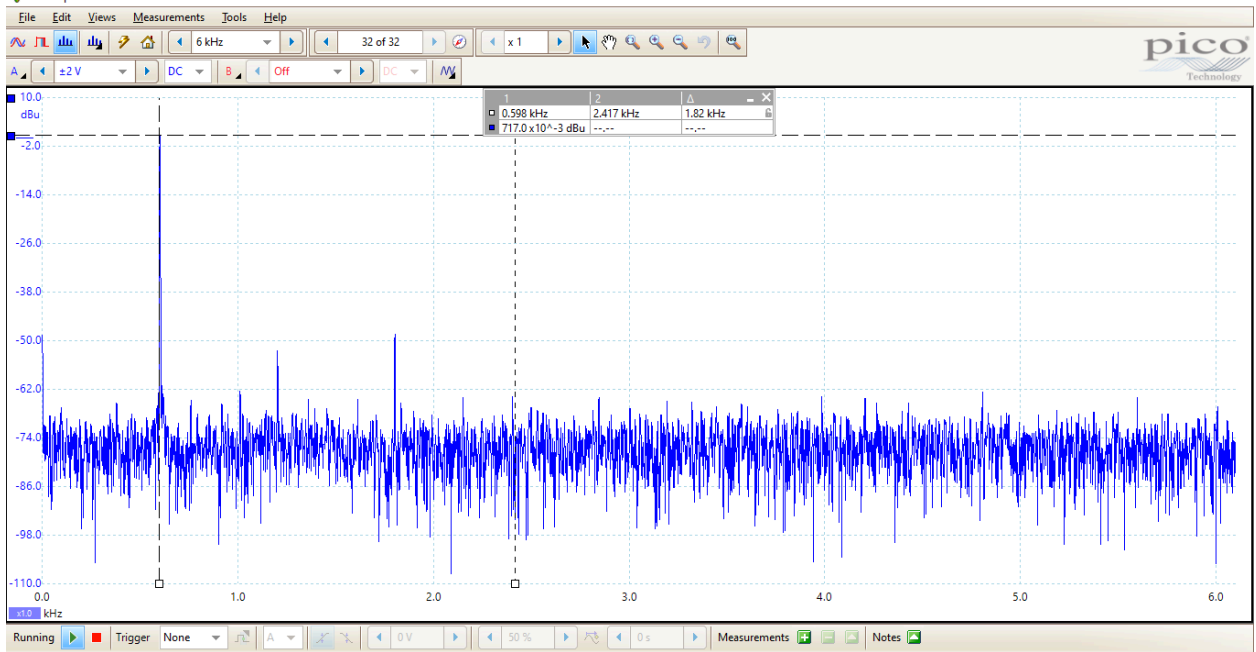
is the 25 setting on the 10k range (or 250kHz) It ended up being my greatest error with an error of 0.92% the maximum accuracy error for the oscillator is + or - 2%. (See supplemental tables of data findings.) Here is a spectrum analysis of 600 Hz showing a strong fundamental frequency and with harmonics at 1200 and 1800 Hz for the 2nd and 3rd harmonics.
