## Memorandum

TO : Flight Director, Apollo 11

DATE: AUG 4 1969

SUBJECT: Apollo 11 Postflight Report

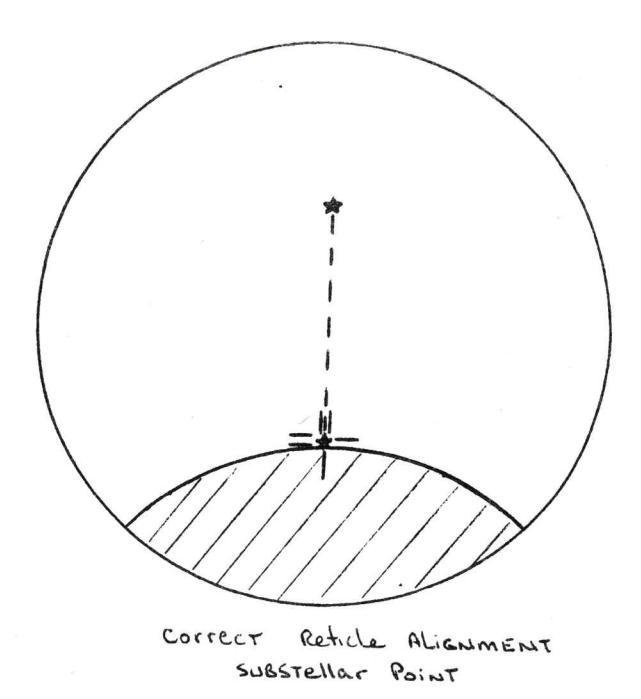
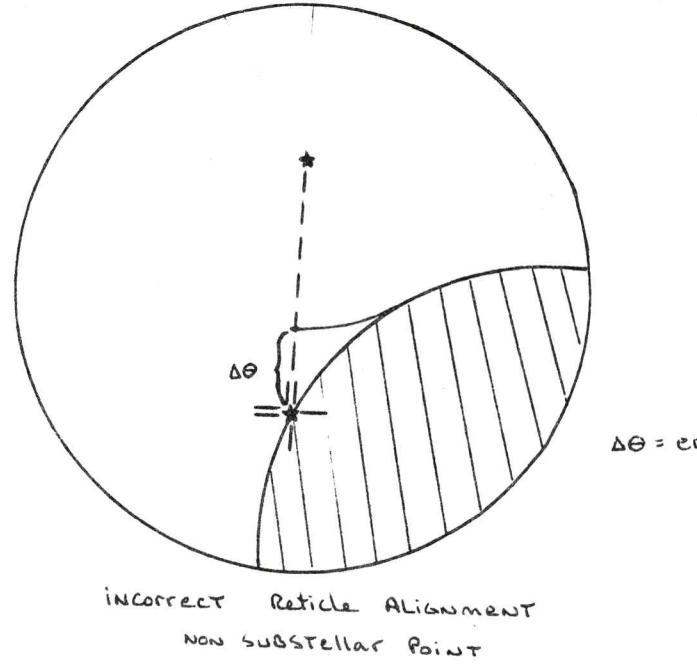
FIGURE 1

(1) The first exercise of the star/horizon sightings was degraded by improper measurements. The major error in the measurements was taking marks with the star aligned on the horizon at a point other than the substellar point. In basic terms, the substellar point is that point on the horizon nearest the star being sighted. When the star is superimposed on the horizon at the substellar point, the axis of trunnion rotation is perpendicular to the radius vector to that point. With this condition satisfied, the horizon appears parallel with the M-line of the sextant reticle (see figure 1). When the star is superimposed on the horizon at some other point, the reticle M-line is not parallel to the horizon and the trunnion angle required becomes larger.

(2) Additionally, the sextant trunnion calibration was performed twice but never accepted. For each calibration, the trunnion bias was determined as -0.003 degree. Although small, the failure to accept this bias introduced another error to the sightings. With the erroneous trunnion measurements, the CMC estimated the spacecraft state to be on a cone with a half angle larger than it actually was. Thus, the range and velocity adjustments,  $\Delta R$  and  $\Delta V$ , were quite large.

DO = error in trummion
