REPORT ON THE ENGINEERING ANALYSIS OF THE CSM 109 APOLLO 13 MISSION

July, 1970

Flight Test Requirements and Evaluation Unit 093-201

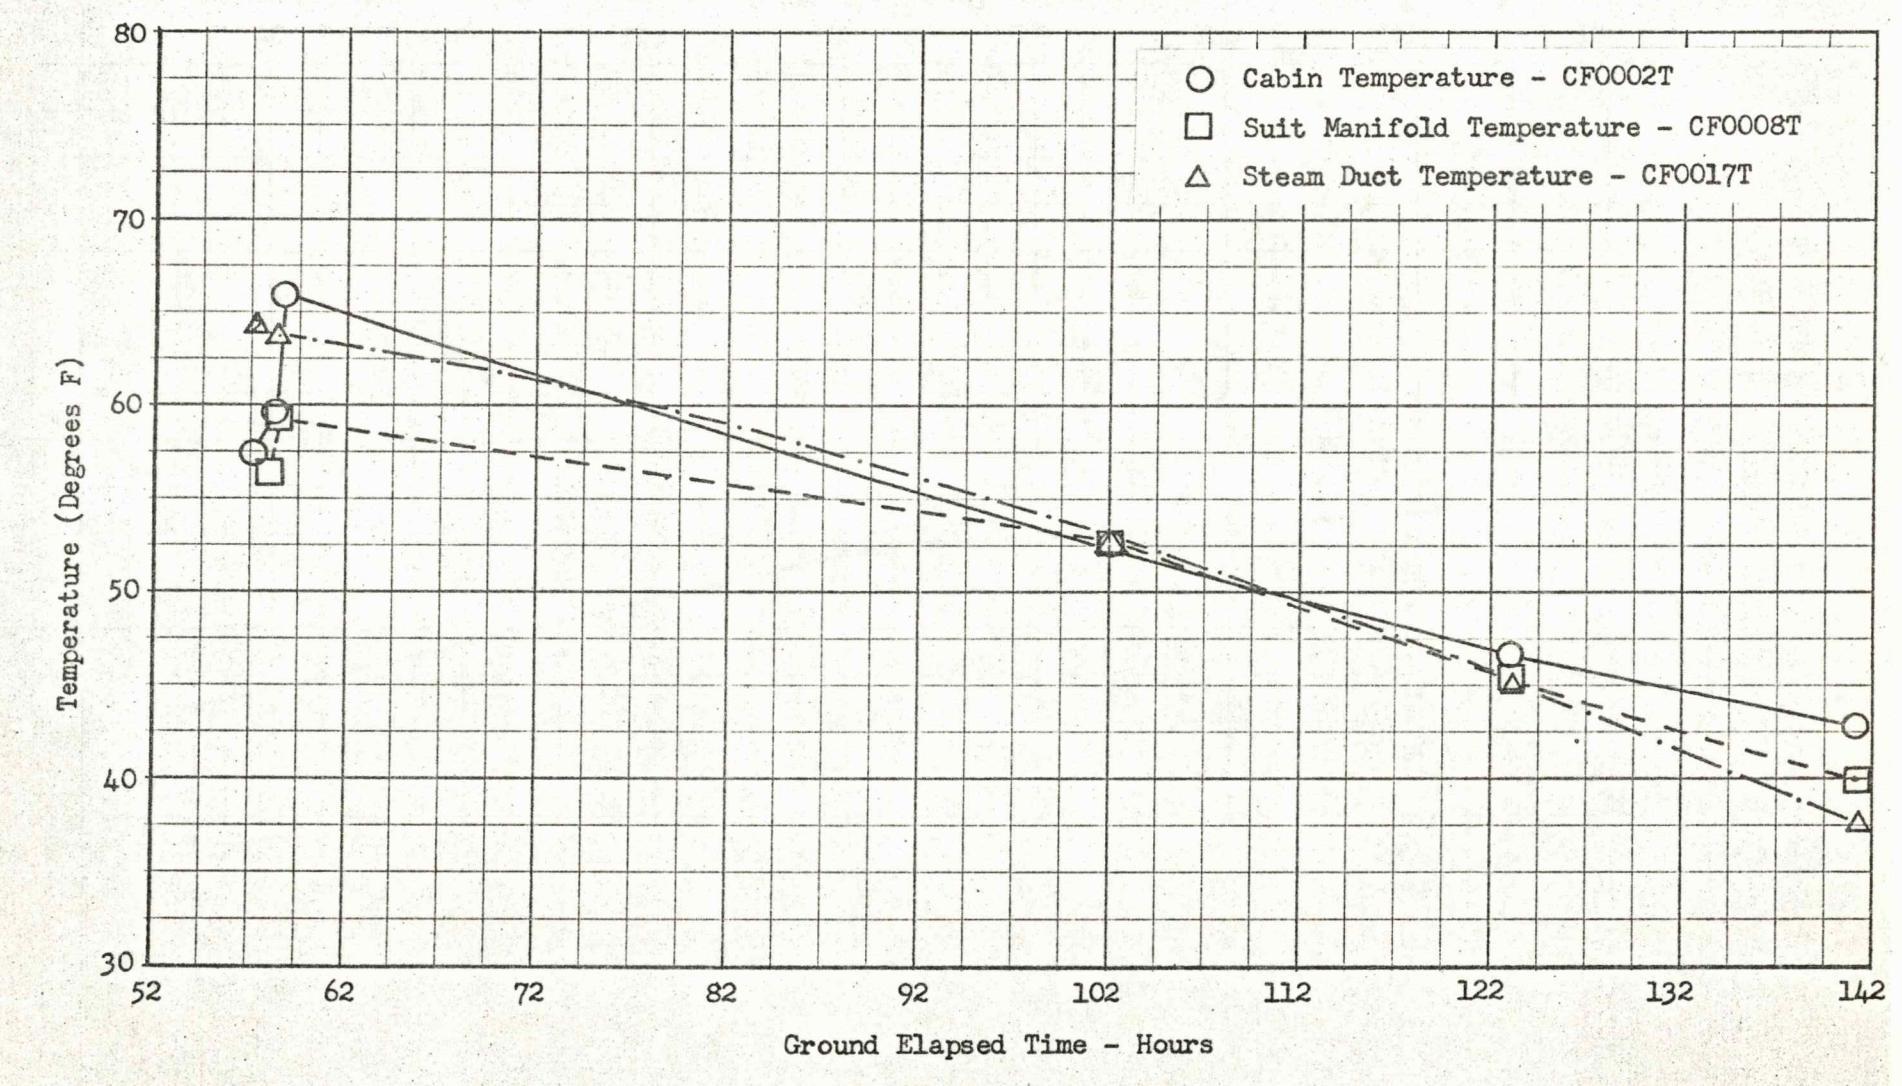
Figure 4.8-2 Apollo 13 Command Module Cabin Temperature Following ECS Powerdown

Following powerdown, command module temperatures dropped at the rate of approximately eight degrees F per day, and were still falling at powerup for entry. No sign of thermal equilibrium was evidenced after 83 hours of unpowered flight. The cabin temperature of the active lunar module was about 10 degrees above the command module cabin. Temperature plots for the command module environment during the passive mode are presented in Figure 4.8-2.

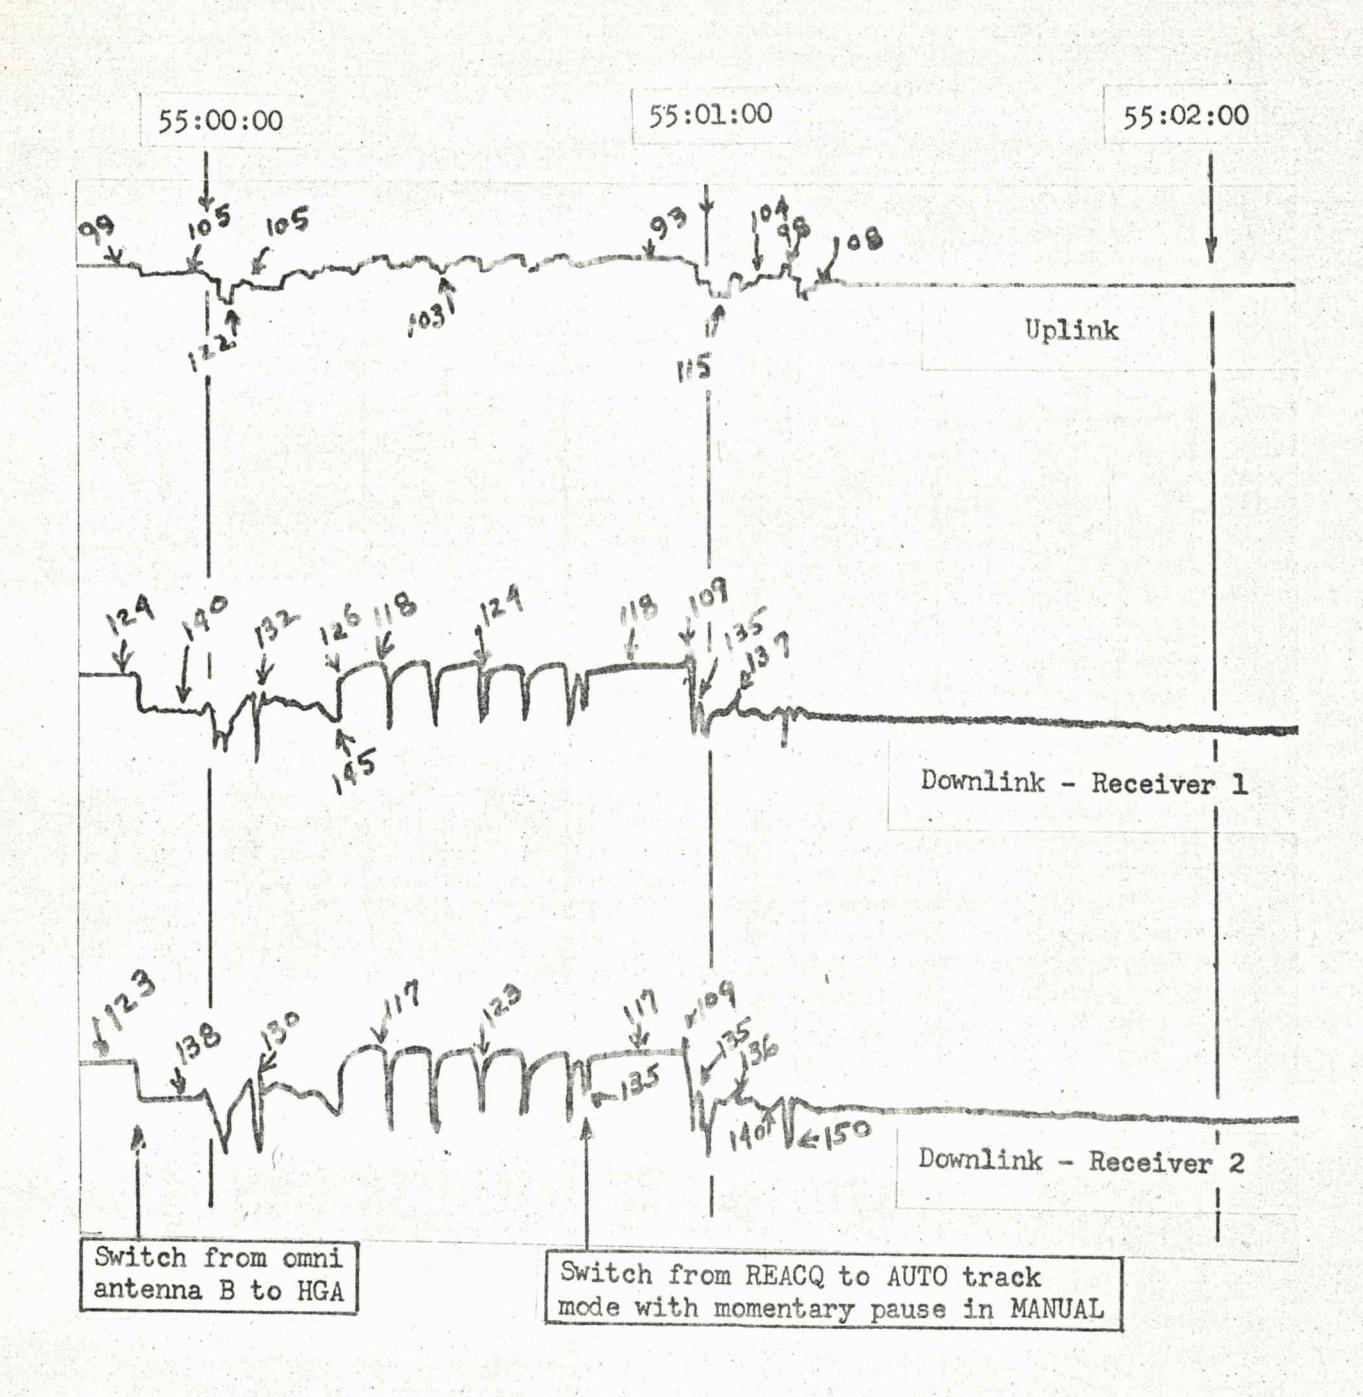
Figure 4.9-4 Apollo 13 Signal Strengths - 55:00:00 to 55:02:00

The quality of the PCM data received and recorded at the various sites was generally good. The panel from bay 4 of the service module, which was blown away by the pressure wave associated with failure of the oxygen tank, struck the high-gain antenna and caused data breakup and loss for approximately two seconds immediately following the failure.

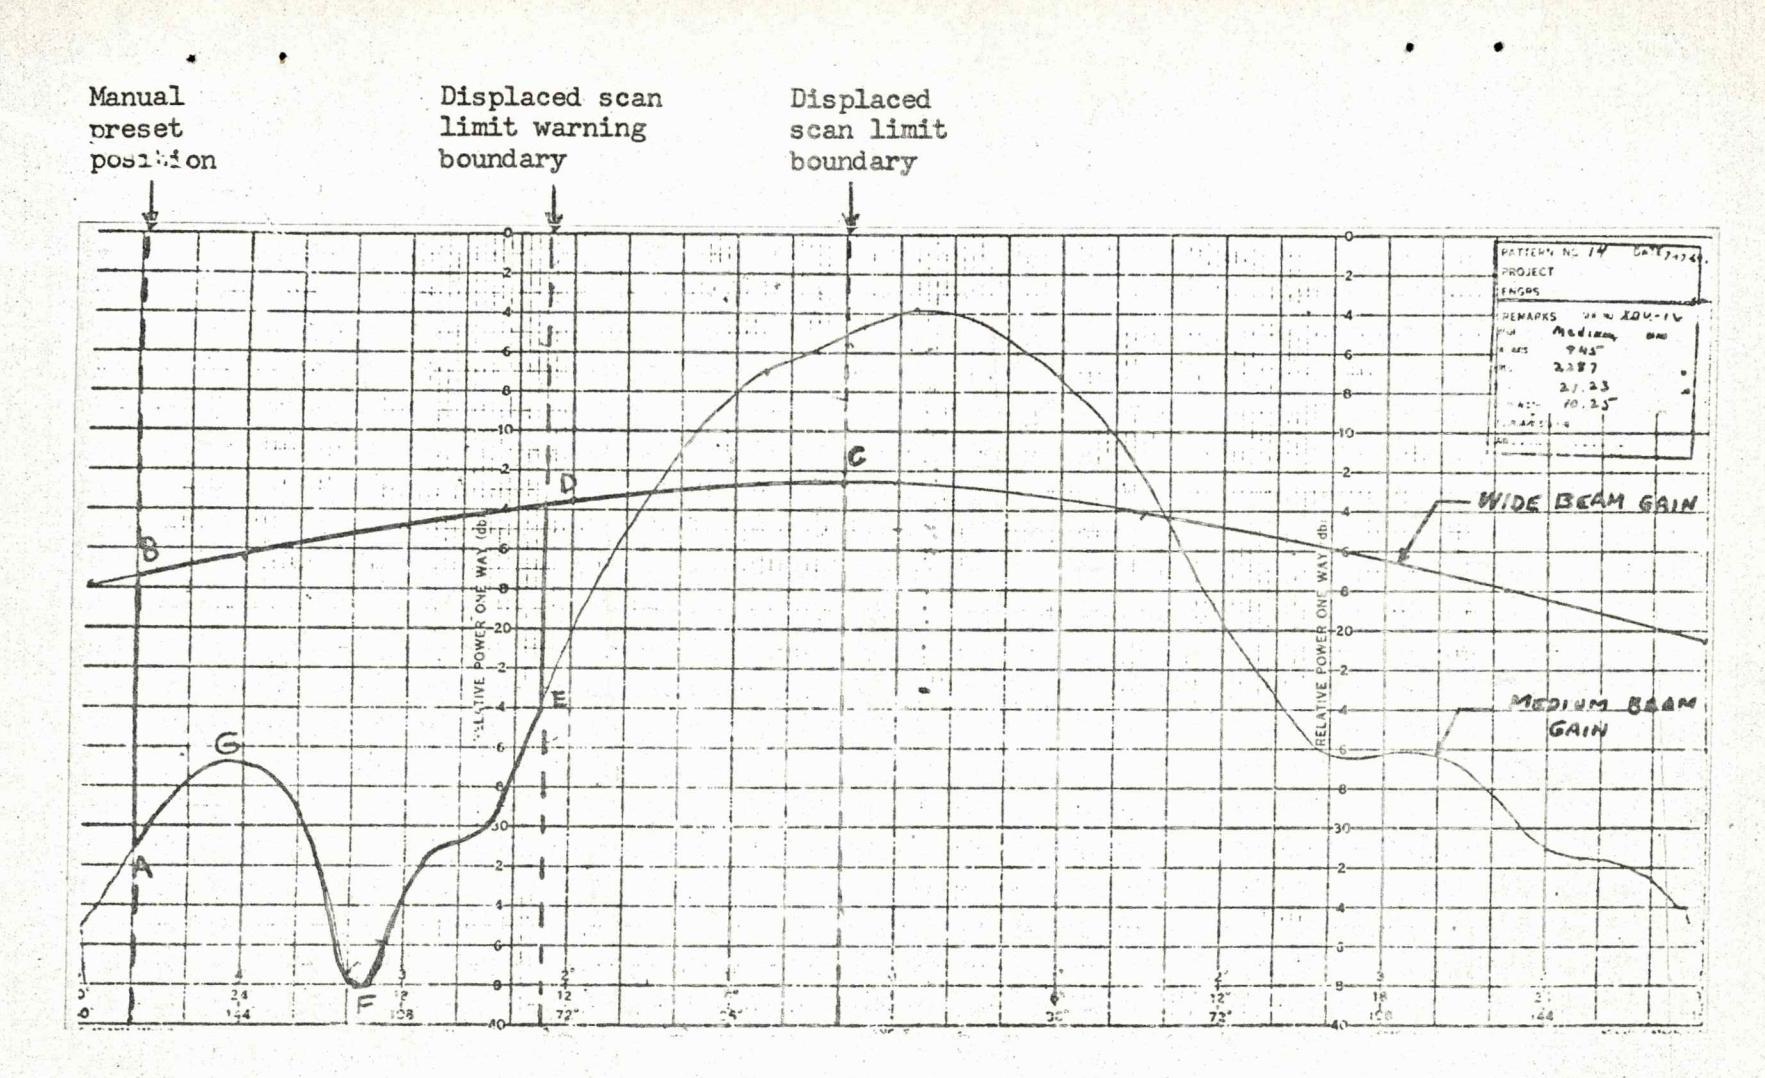
Figure 4.9-12 Apollo 13 HGA motion to produce gain excursions shown in Figure 4.9-4.

1. Path C-D-E-F-G-A results from manual slewing in auto-reacquisition mode.

2. Path A-B results from change from manual to auto mode of auto-reacquisition.
