**OPERATIONAL EXPERIENCE OF FAST BATTLESHIPS;
WORLD WAR II, KOREA, VIETNAM**

**Compiled and edited,
with introduction and notes, by
John C. Reilly, Jr.**

**NAVAL HISTORICAL CENTER
Department of the Navy
WASHINGTON: 1989**

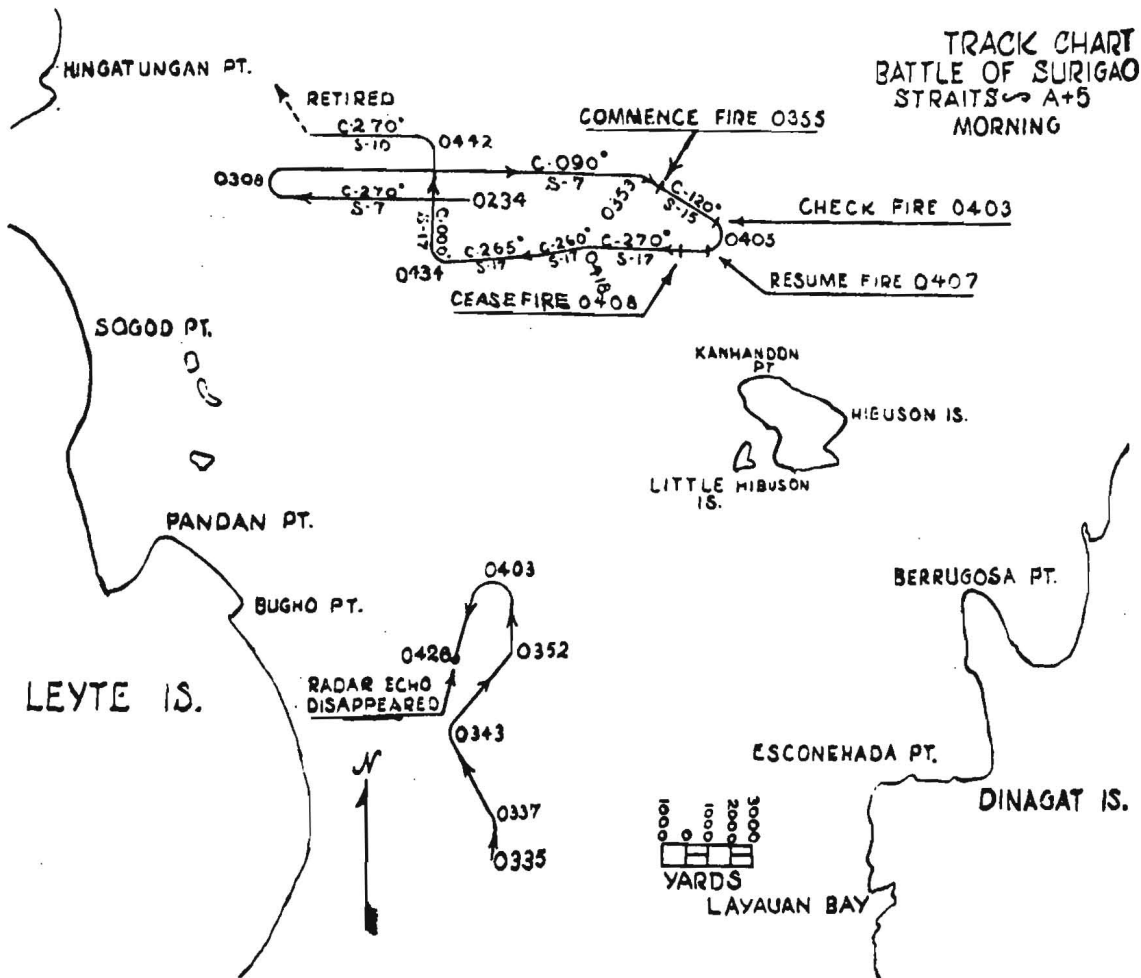
Track chart from TENNESSEE's Action Report

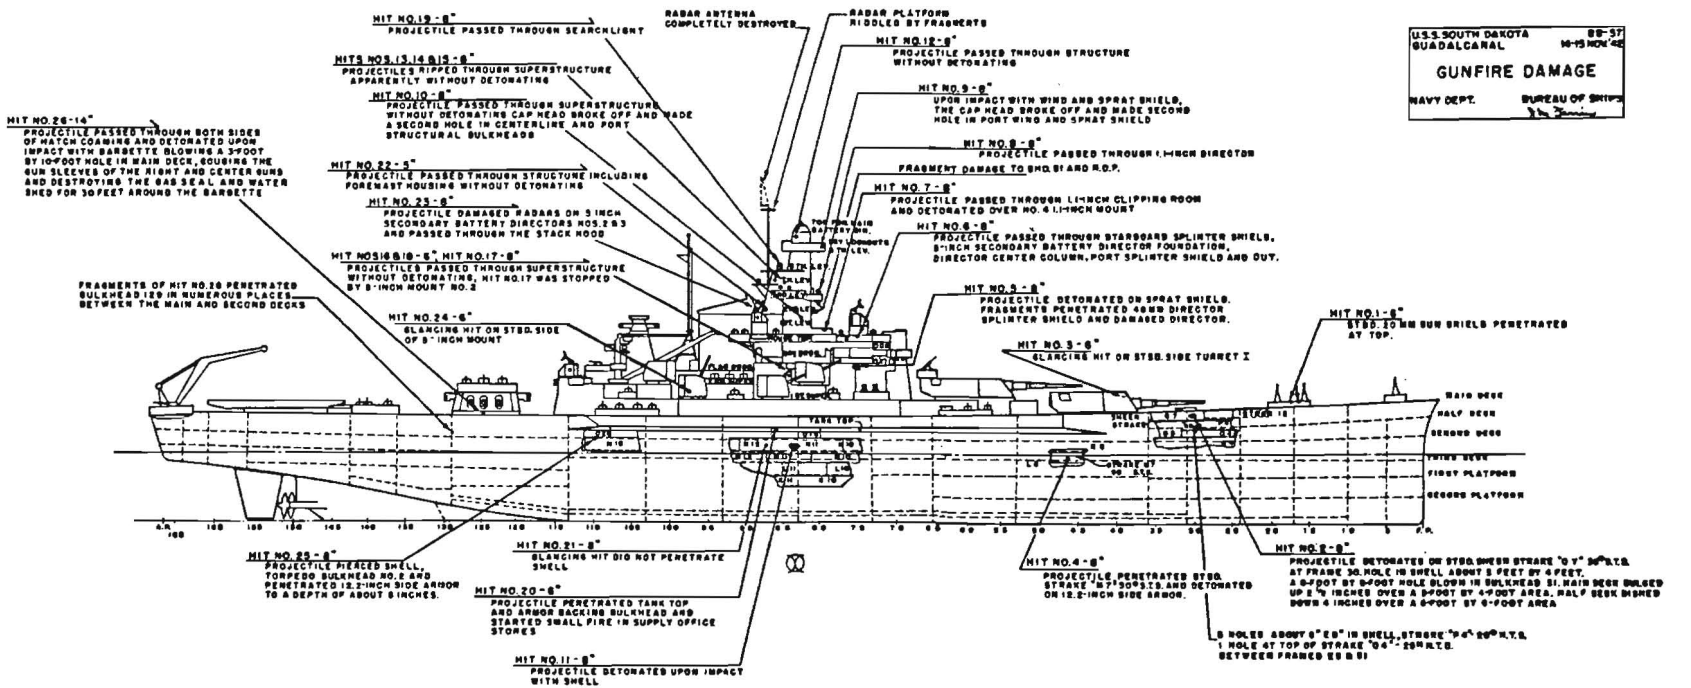
Battle damage to NORTH CAROLINA and SOUTH DAKOTA. F.P. and A.P., in these drawings, indicate the forward and after perpendiculars, the extremities of the waterline. The distance between these is the length used in making design calculations. Numerals are location of frames, spaced 4 feet apart. Frame numbers are used to locate points along the longitudinal axis of a ship.

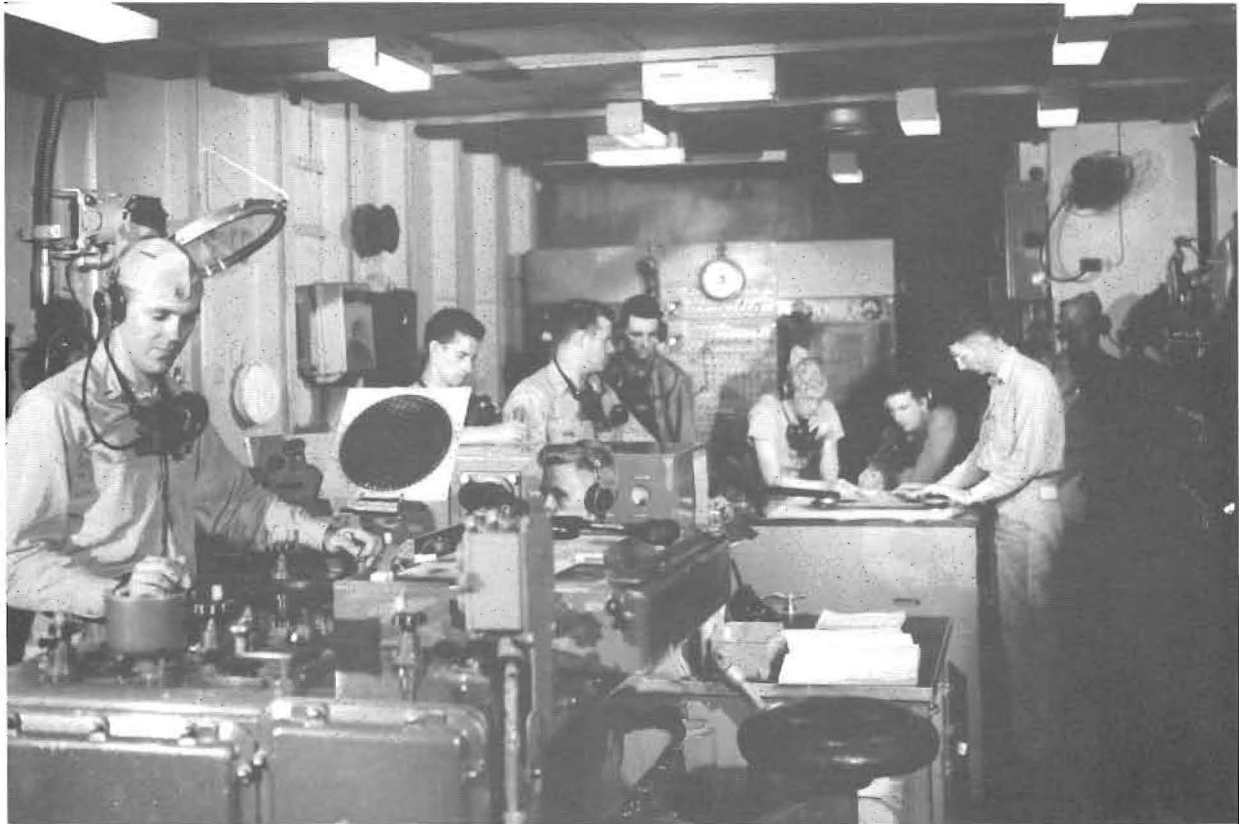
One of MISSOURI's two main-battery plotting rooms. Here, many inputs are combined to produce continuous train and elevation orders to the guns. (See p. 164.)
