# U. S. S. CHESTER (CA27)

## TORPEDO DAMAGE

# U. S. S. MINNEAPOLIS (CA36)

WAR DAMAGE REPORT No. 36

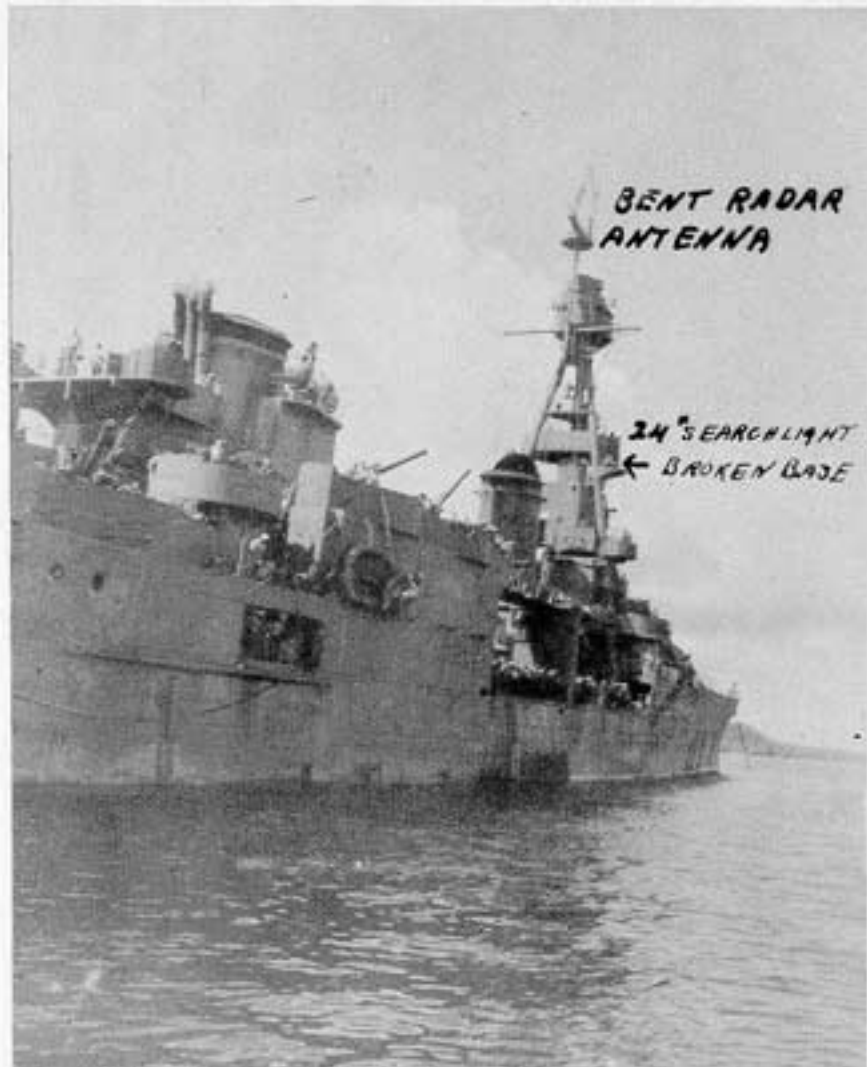
Photo 1: USS CHESTER - General view from starboard quarter showing armor plate missing above hole, broken searchlight, bent radar and damaged life rafts.

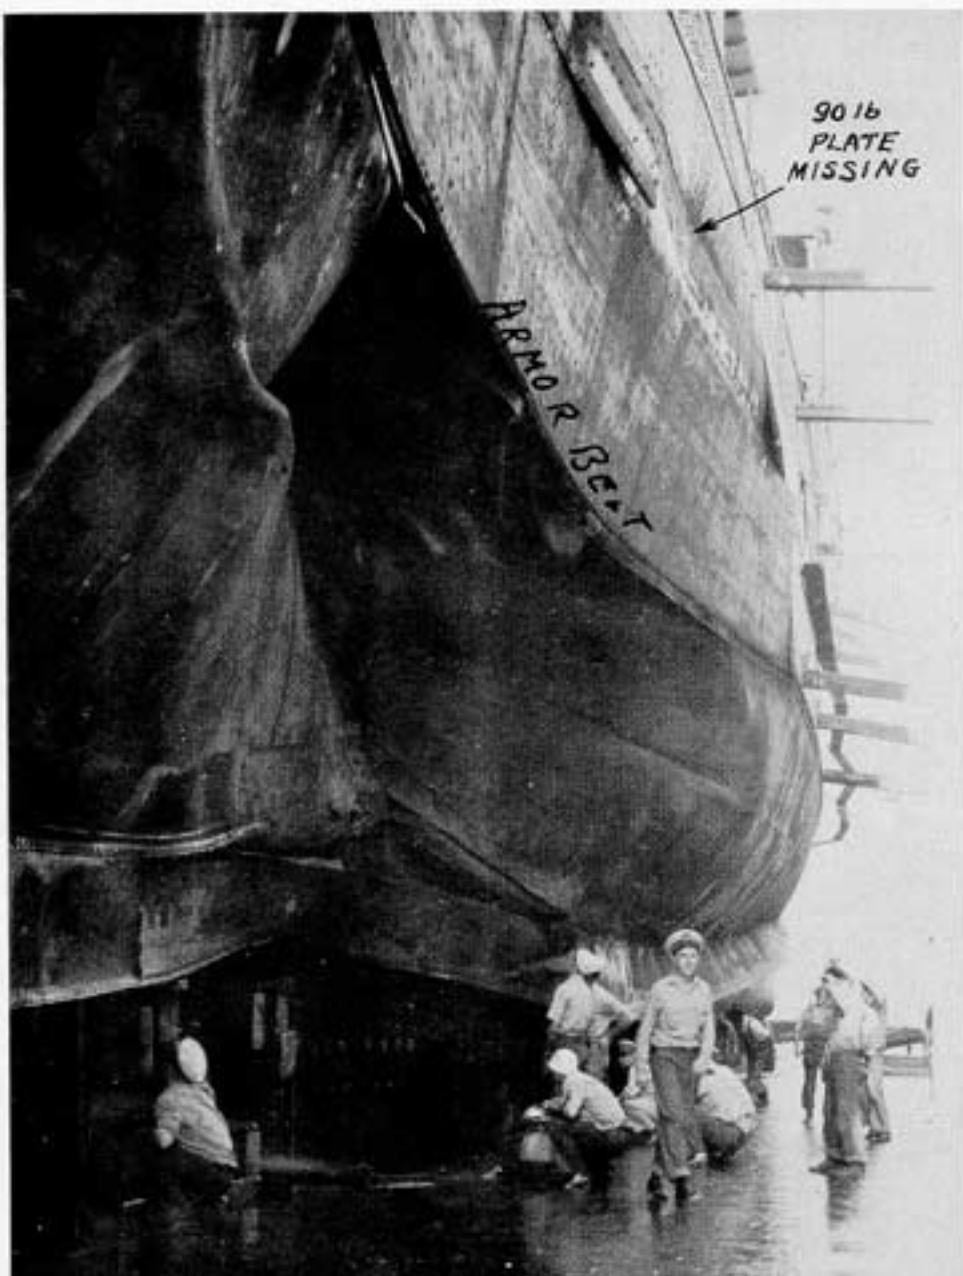
Photo 2: USS CHESTER - View of torpedo hole from dry dock floor.

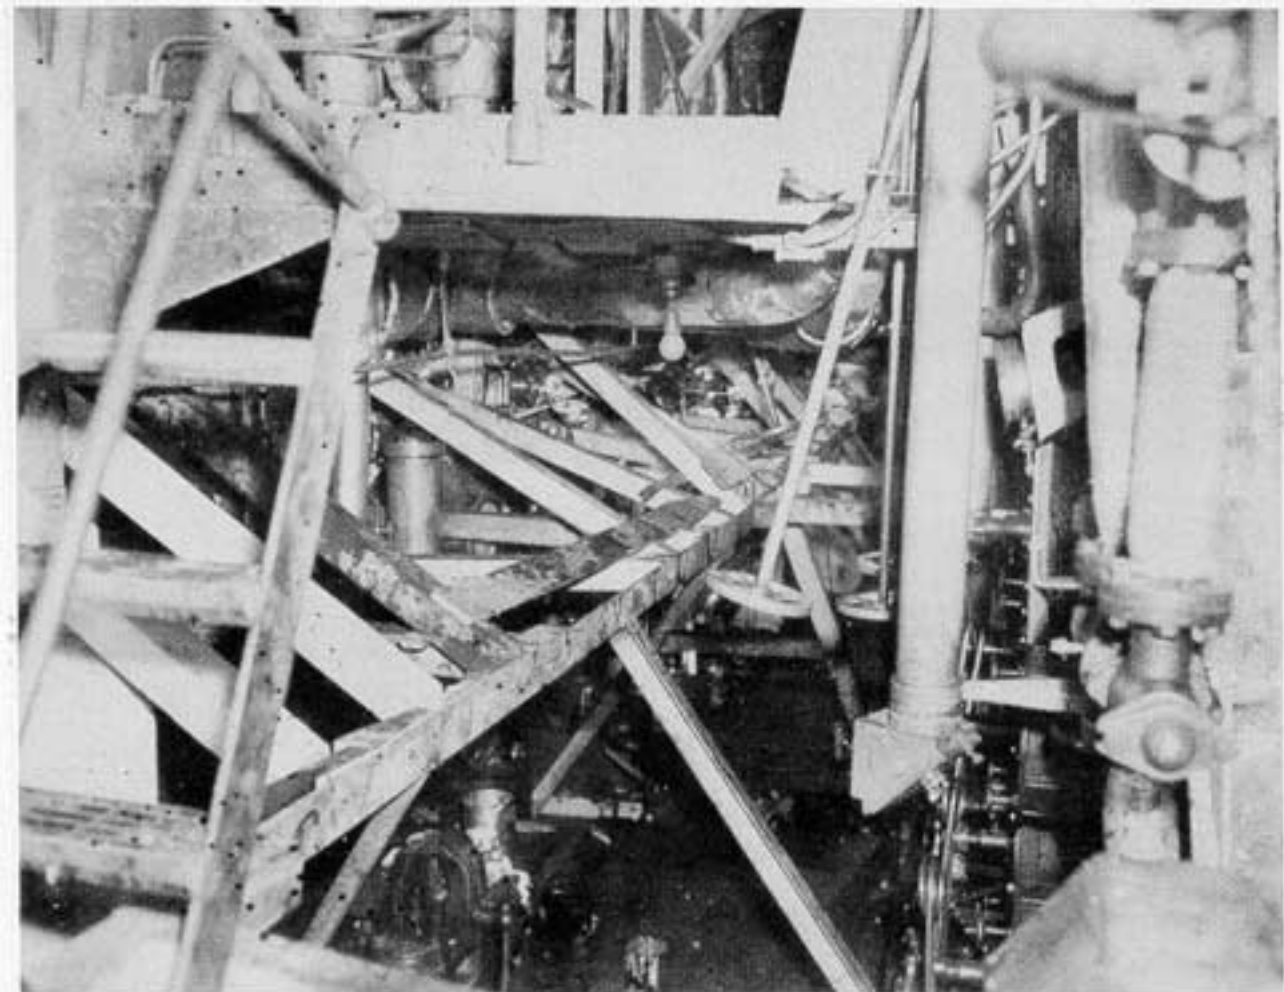
Photo 13: USS CHESTER - No. 2 fireroom from starboard gratings showing part of the upper course of shoring on bulkhead 64.

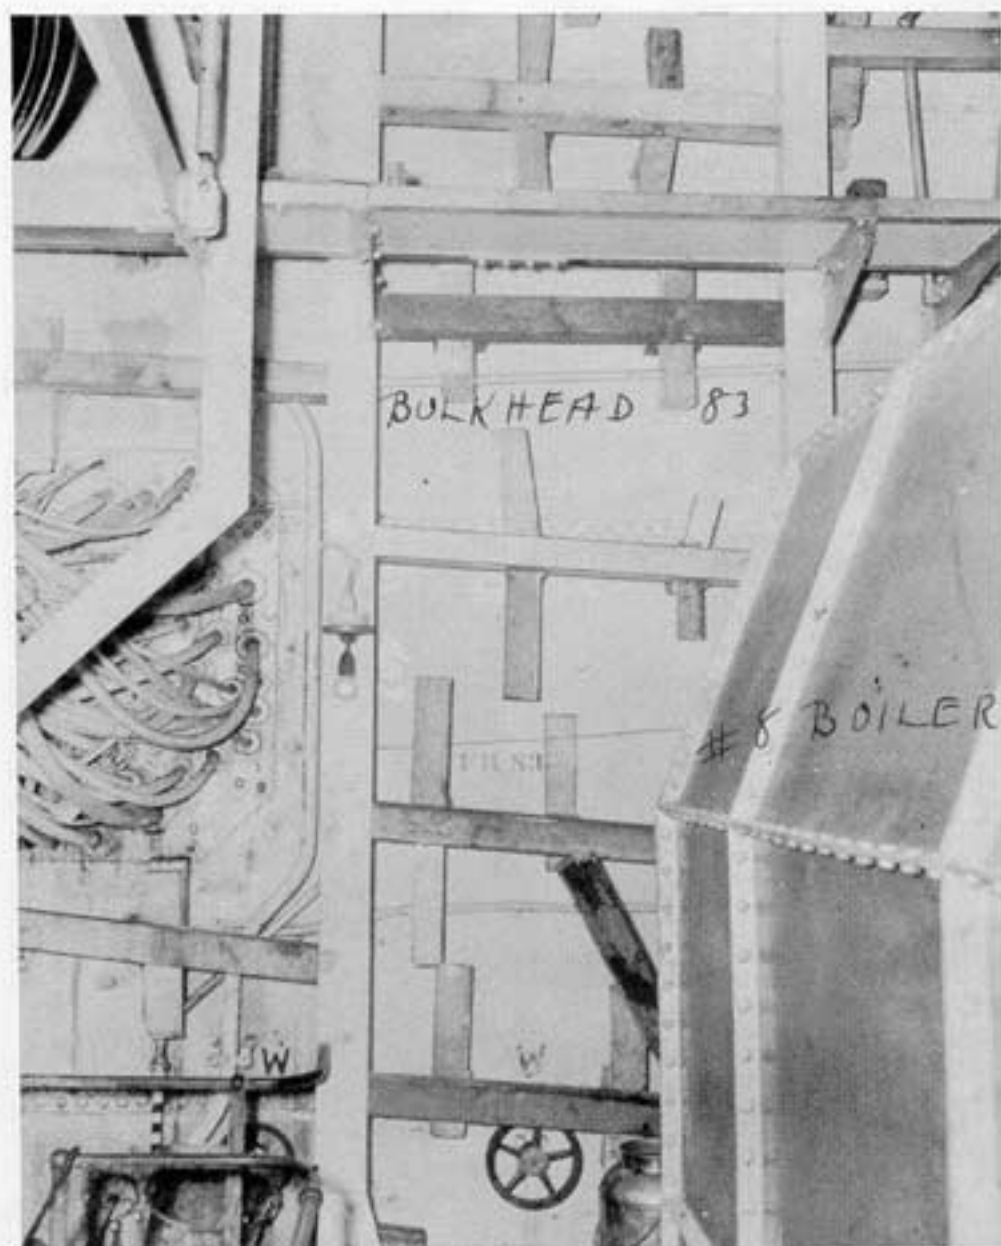
Photo 14: USS CHESTER - No. 4 fireroom looking forward and showing the shoring between stiffeners on bulkhead 83.

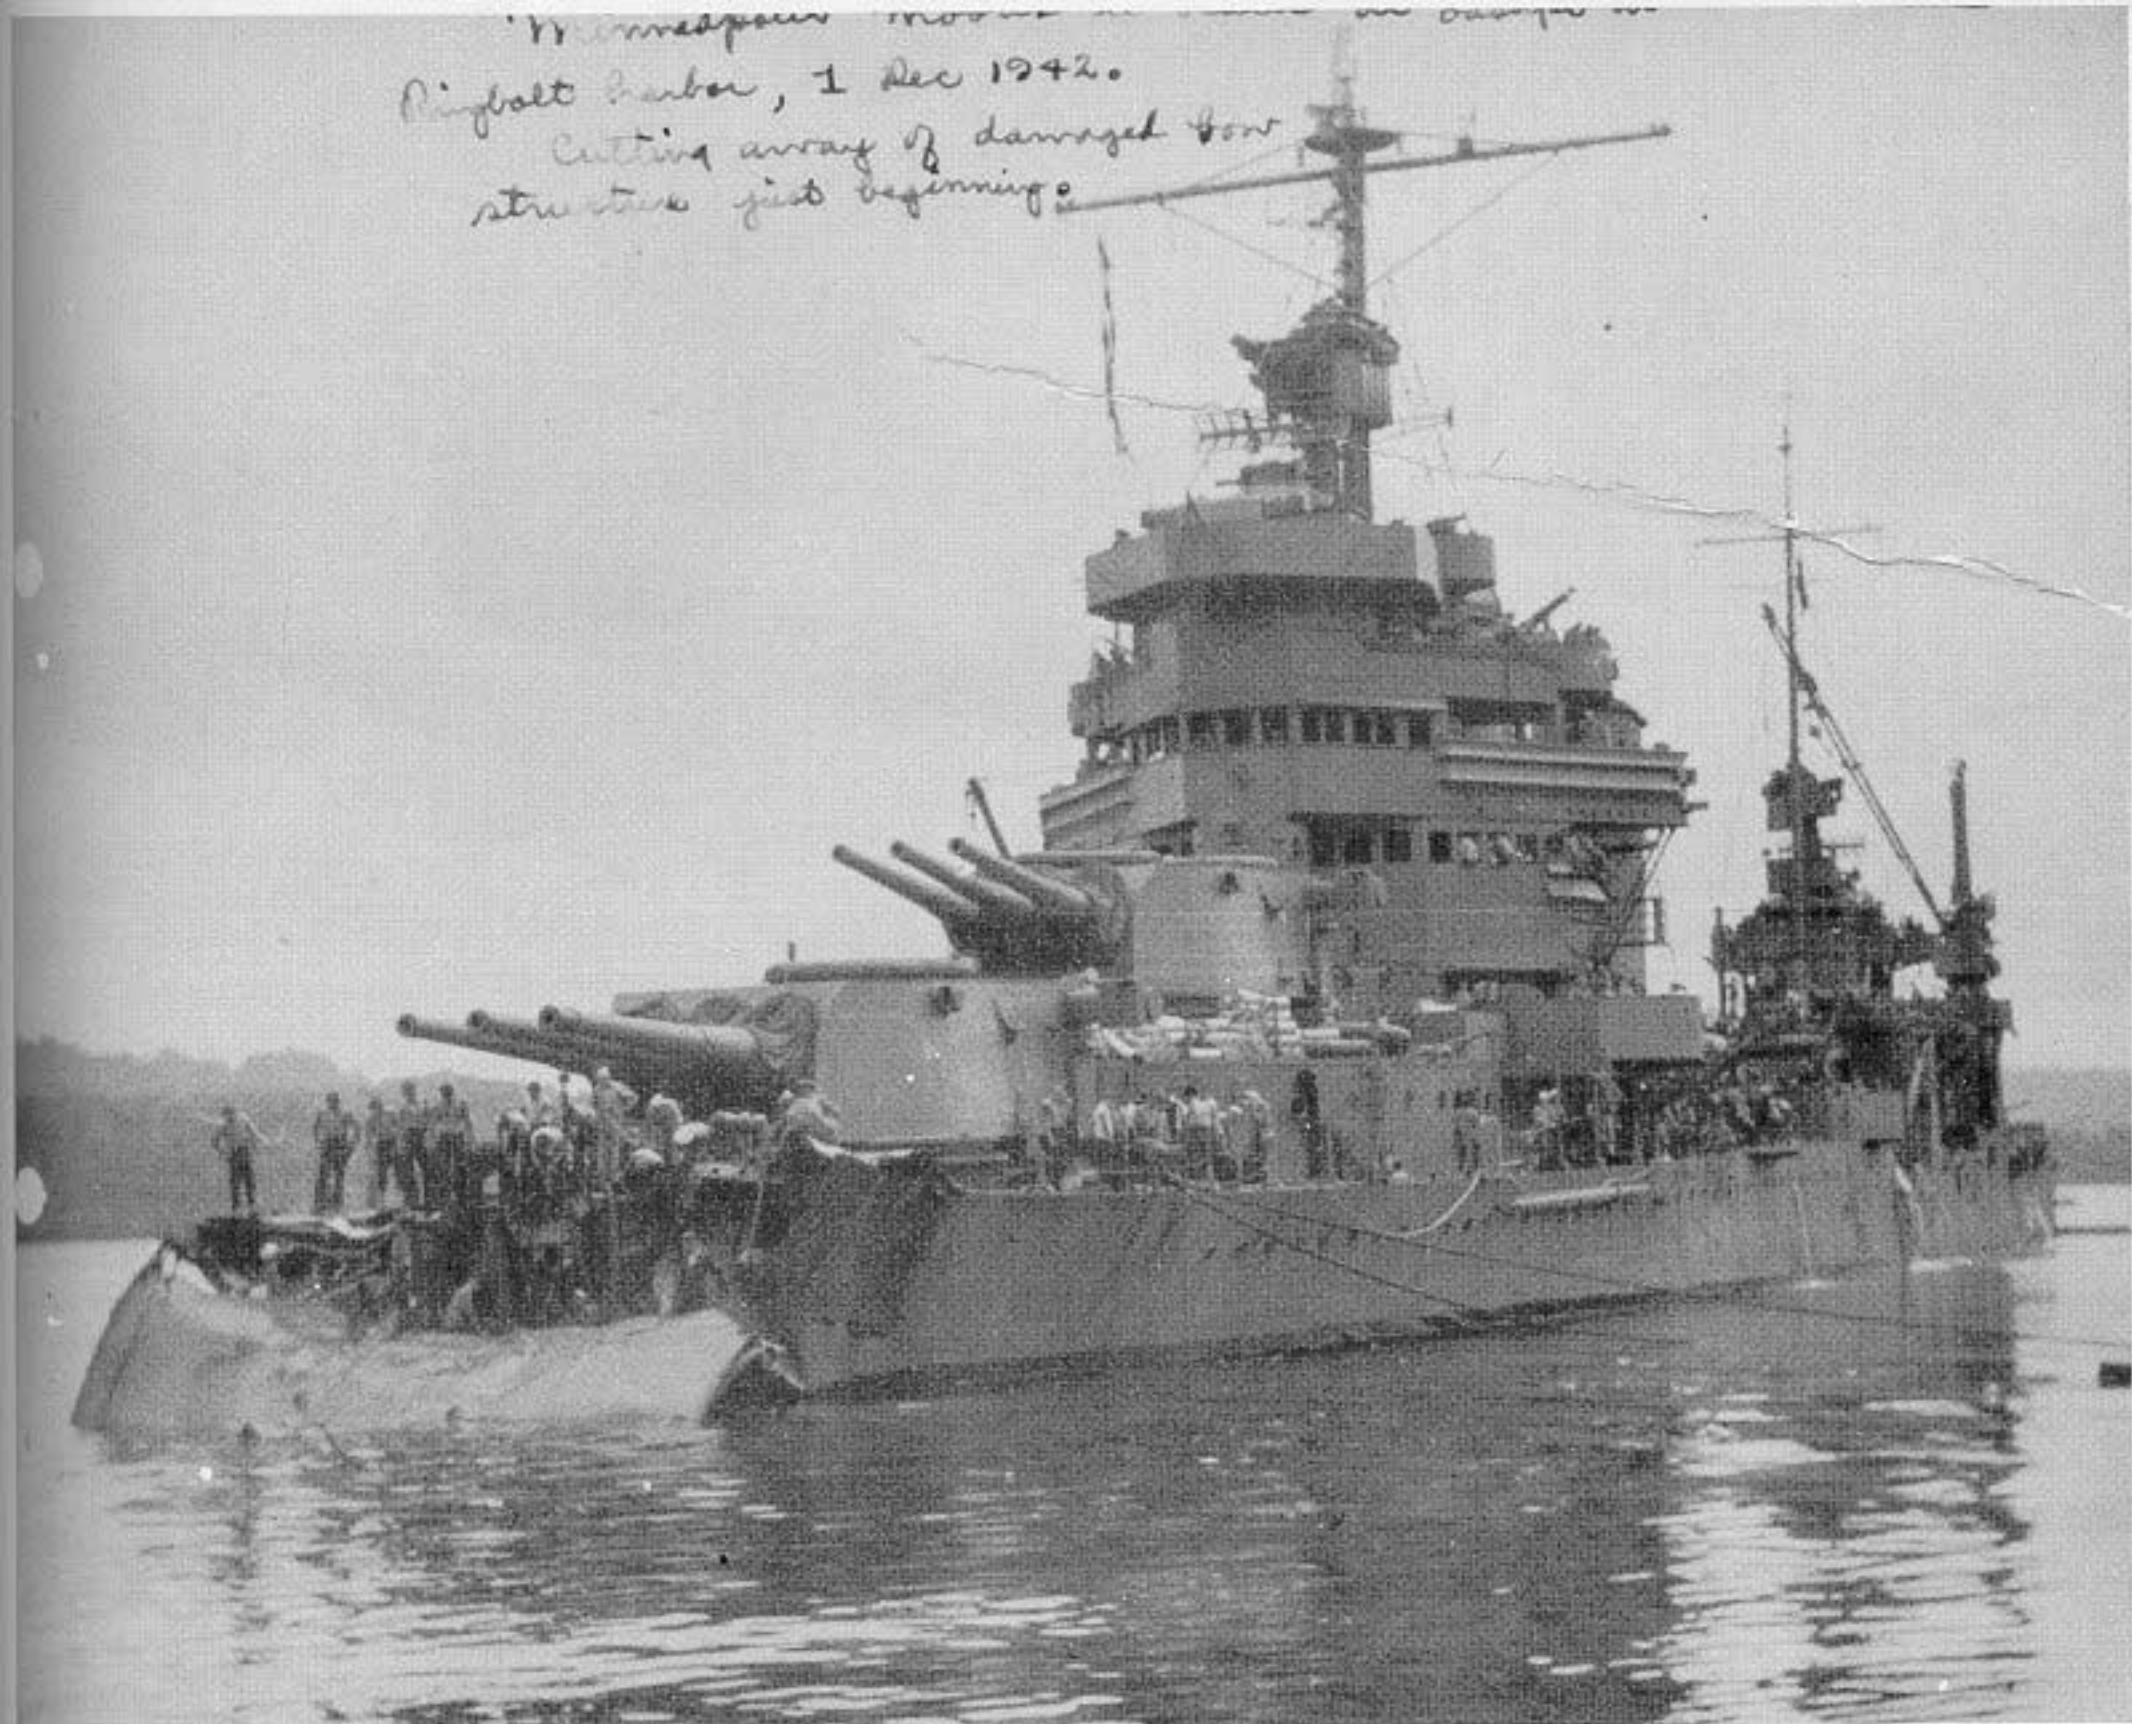
*Minneapolis moving on barge in  
Ringbolt harbor, 1 Dec 1942  
Cutting away of damaged bow  
structure just beginning.*

Photo No.15: USS MINNEAPOLIS - View of damaged bow before it was cut away.

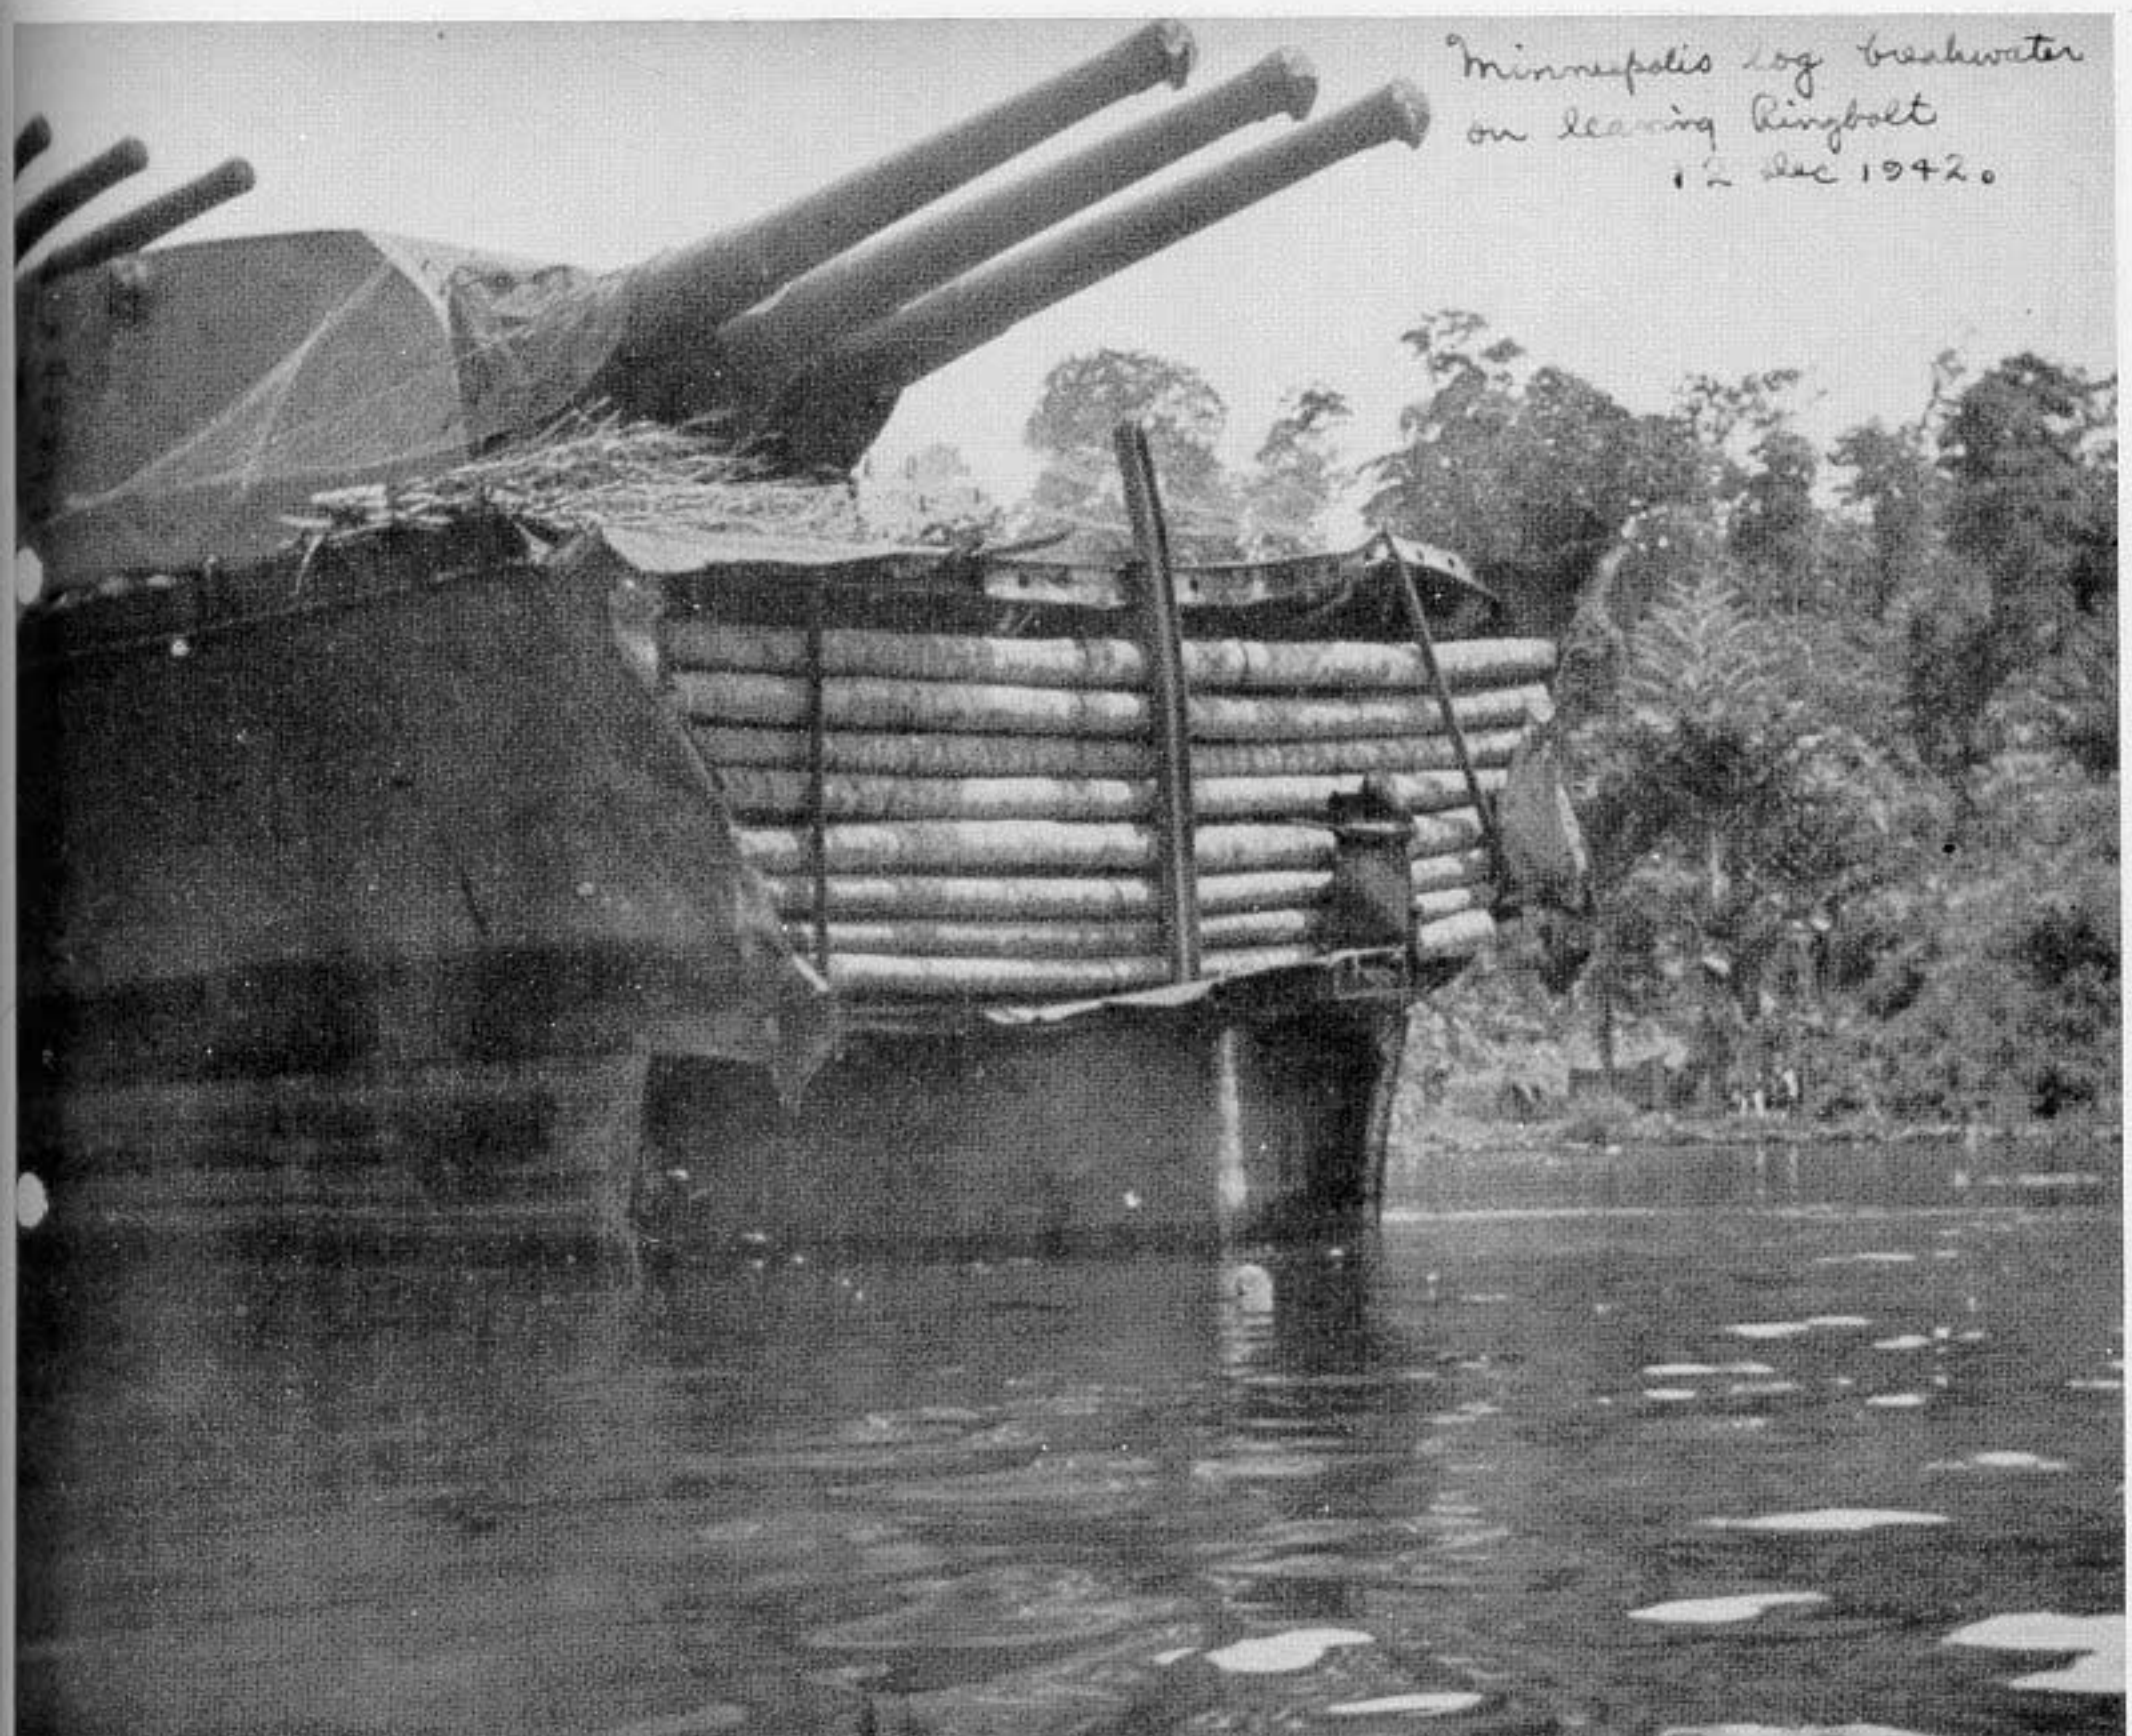
*Minneapolis log breakwater  
on leaving Ringbolt  
12 Dec 1942.*

Photo No.16: USS MINNEAPOLIS - View of log breakwater.

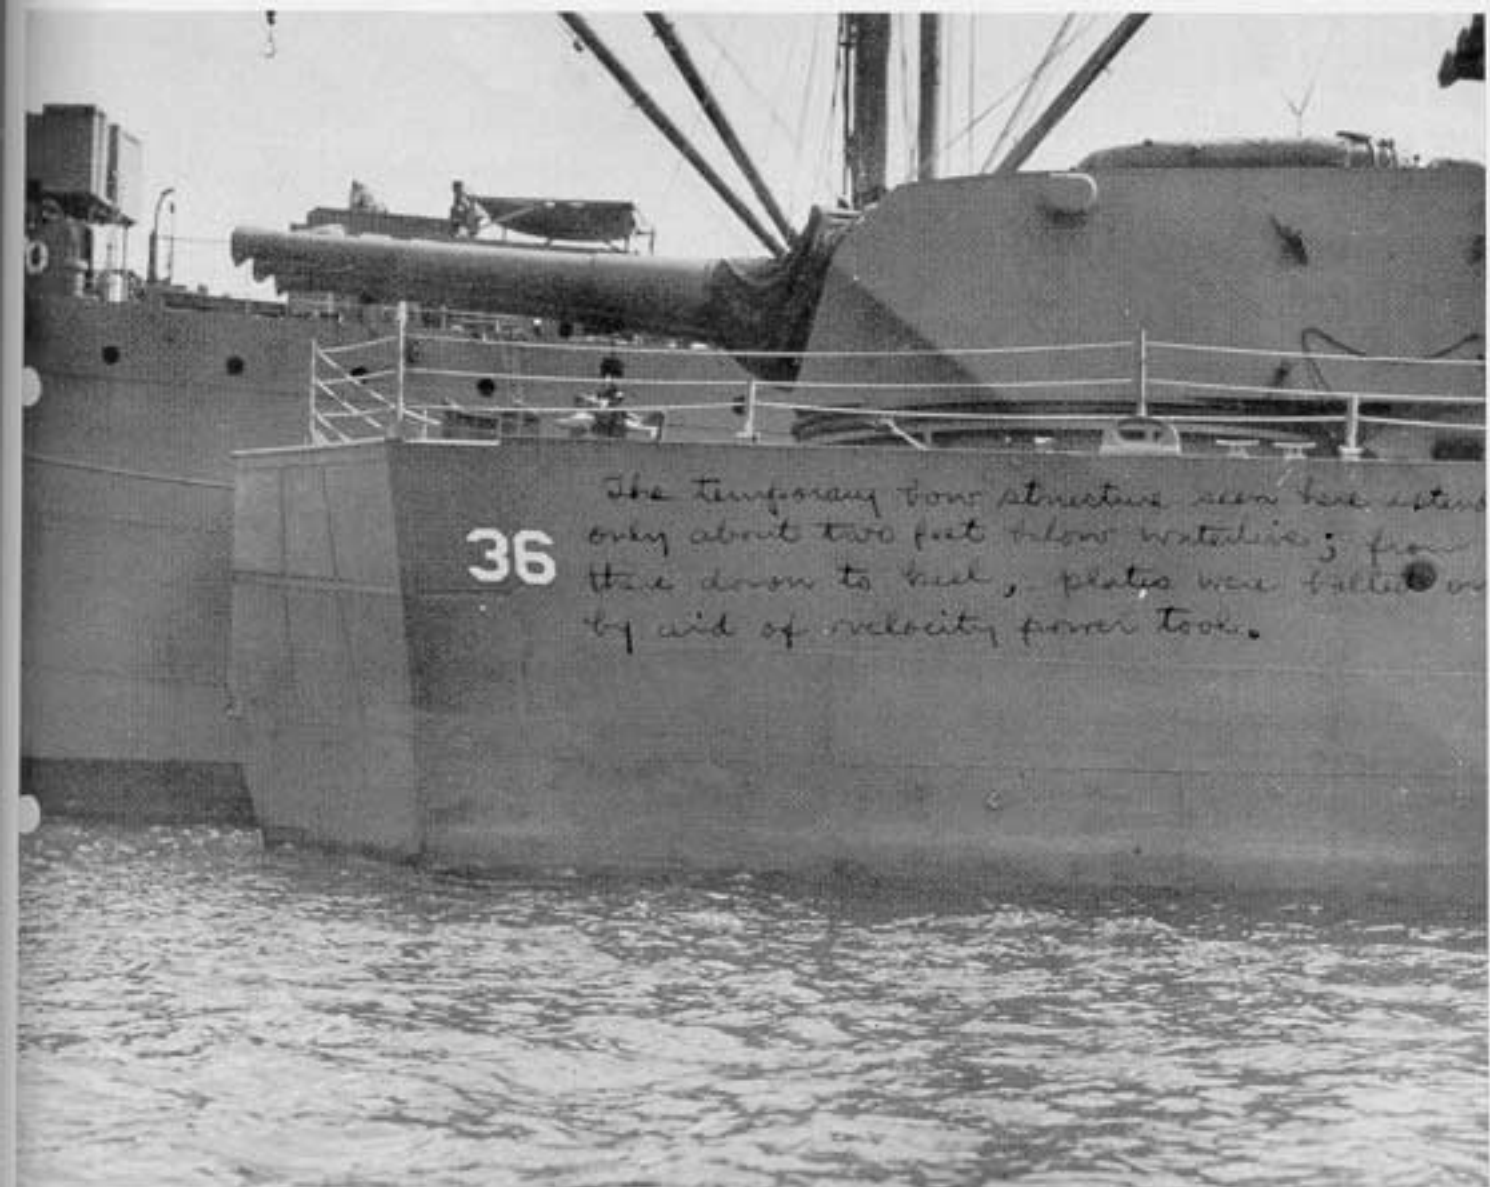
Photo No.17: USS MINNEAPOLIS - View of temporary bow.

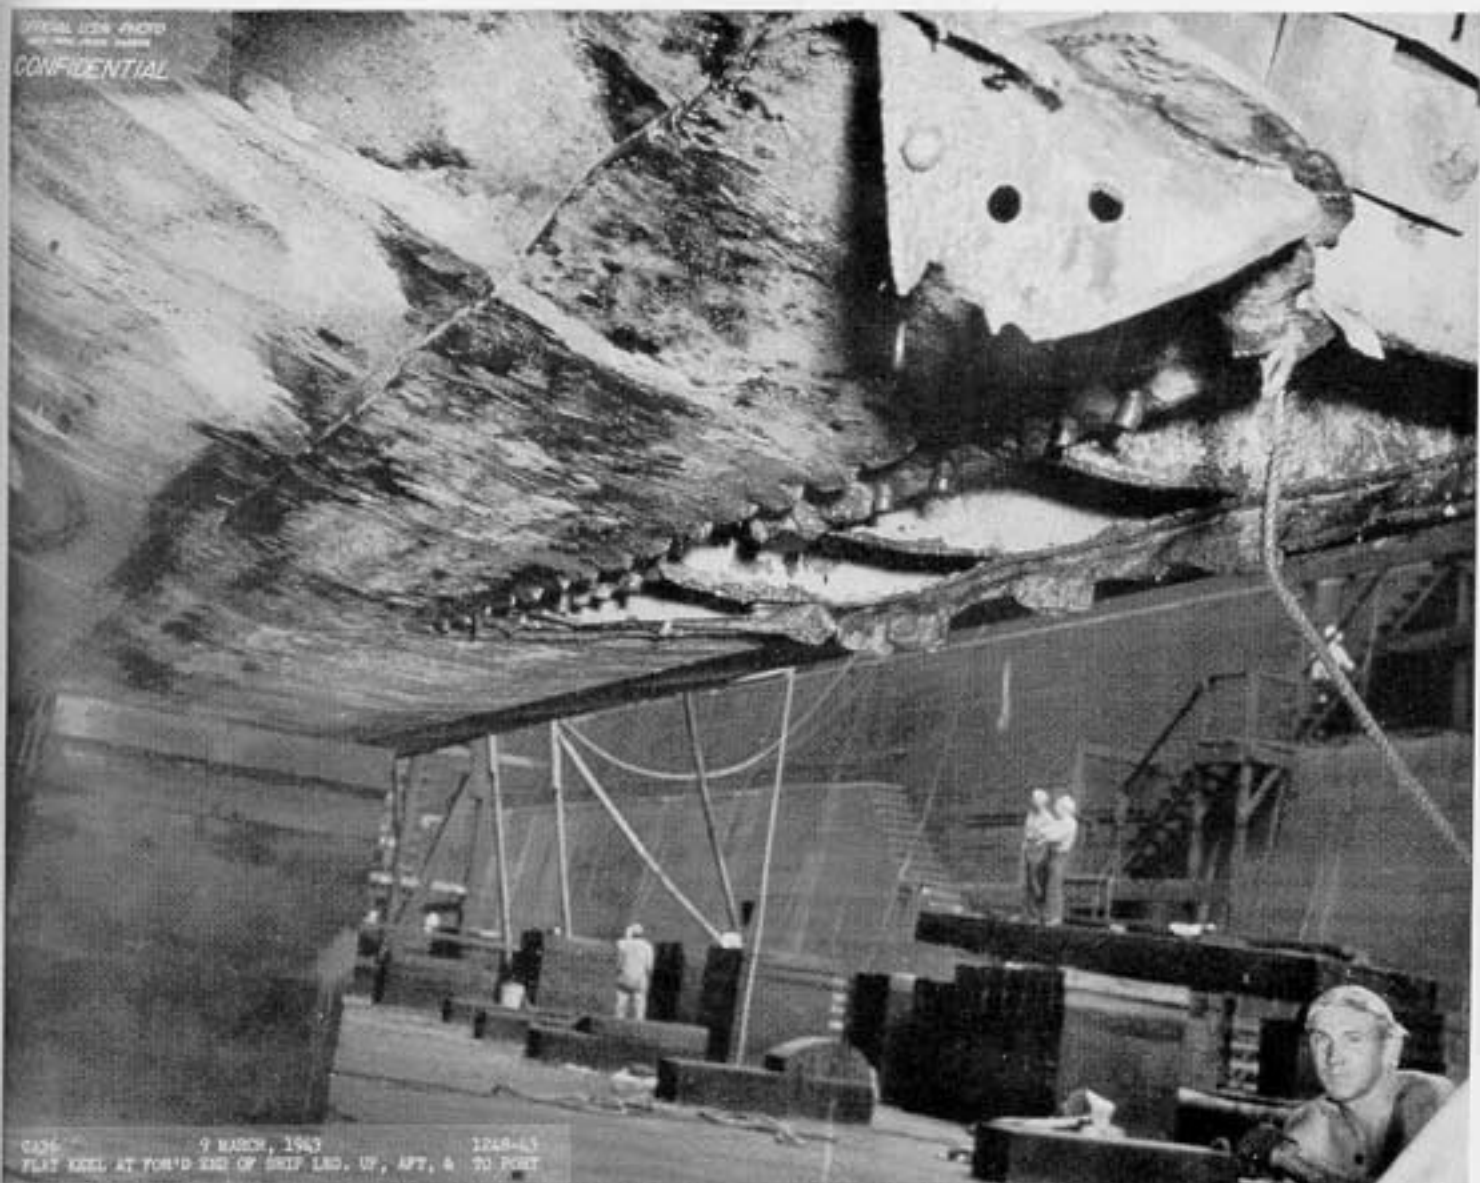
Photo No.18: USS MINNEAPOLIS - Flat keel frame 20 looking aft and to port.

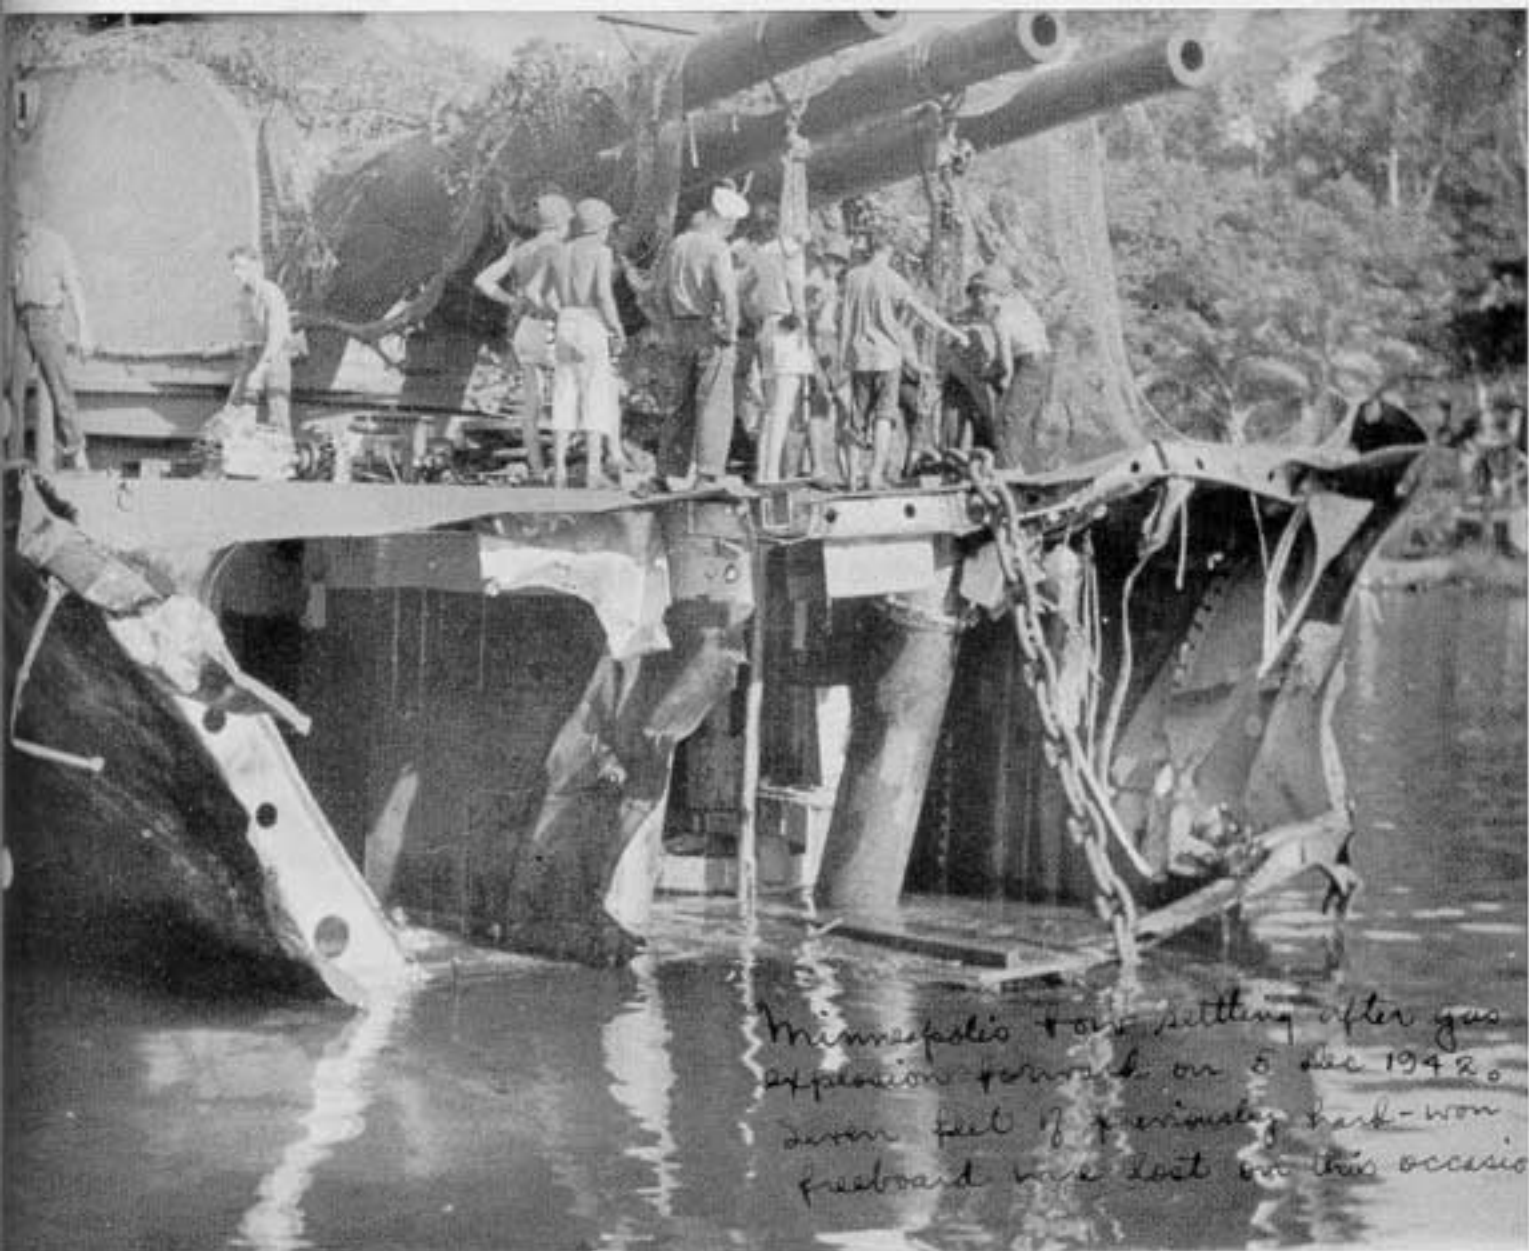
Photo No.19: USS MINNEAPOLIS - Looking aft at frame 20 just after gas explosion which caused draft to increase. Note water level at main deck.

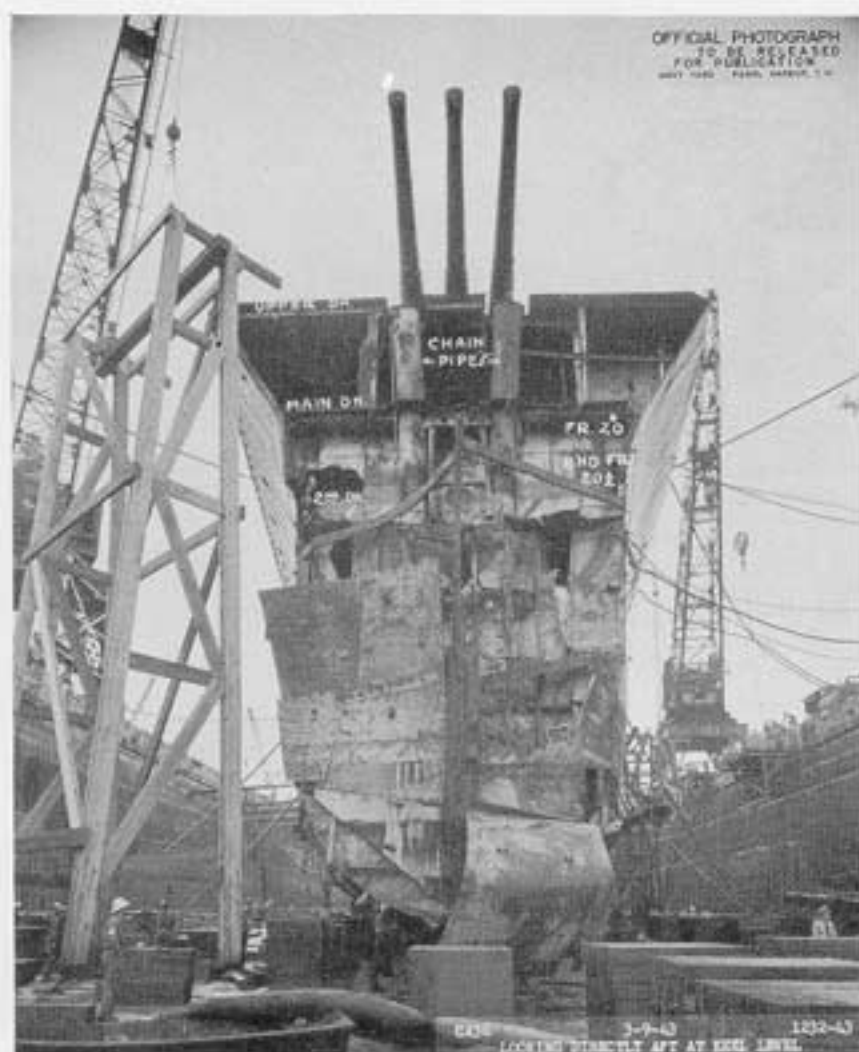
Photo No.20: USS MINNEAPOLIS - Bow after drydocking. Upper part of temporary bow has been removed; temporary bolted plates intact on starboard side.

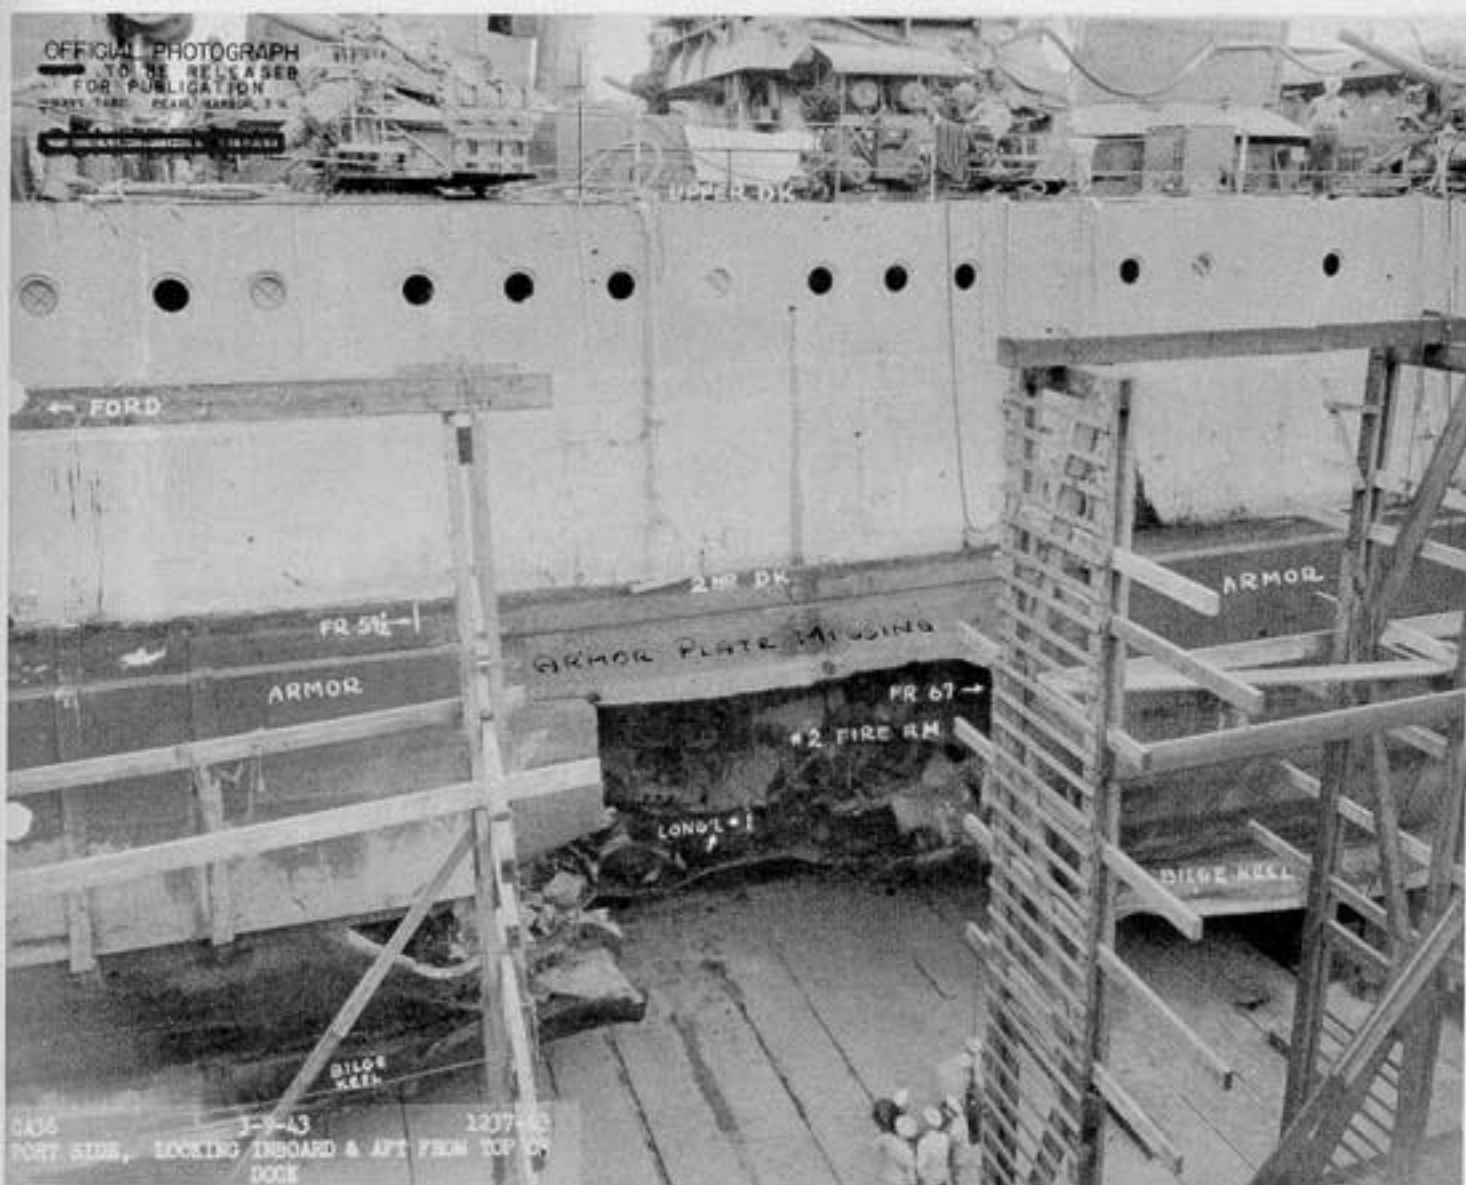
Photo No.21: USS MINNEAPOLIS - Port side looking inboard and aft abreast Nos. 1 and 2 firerooms.

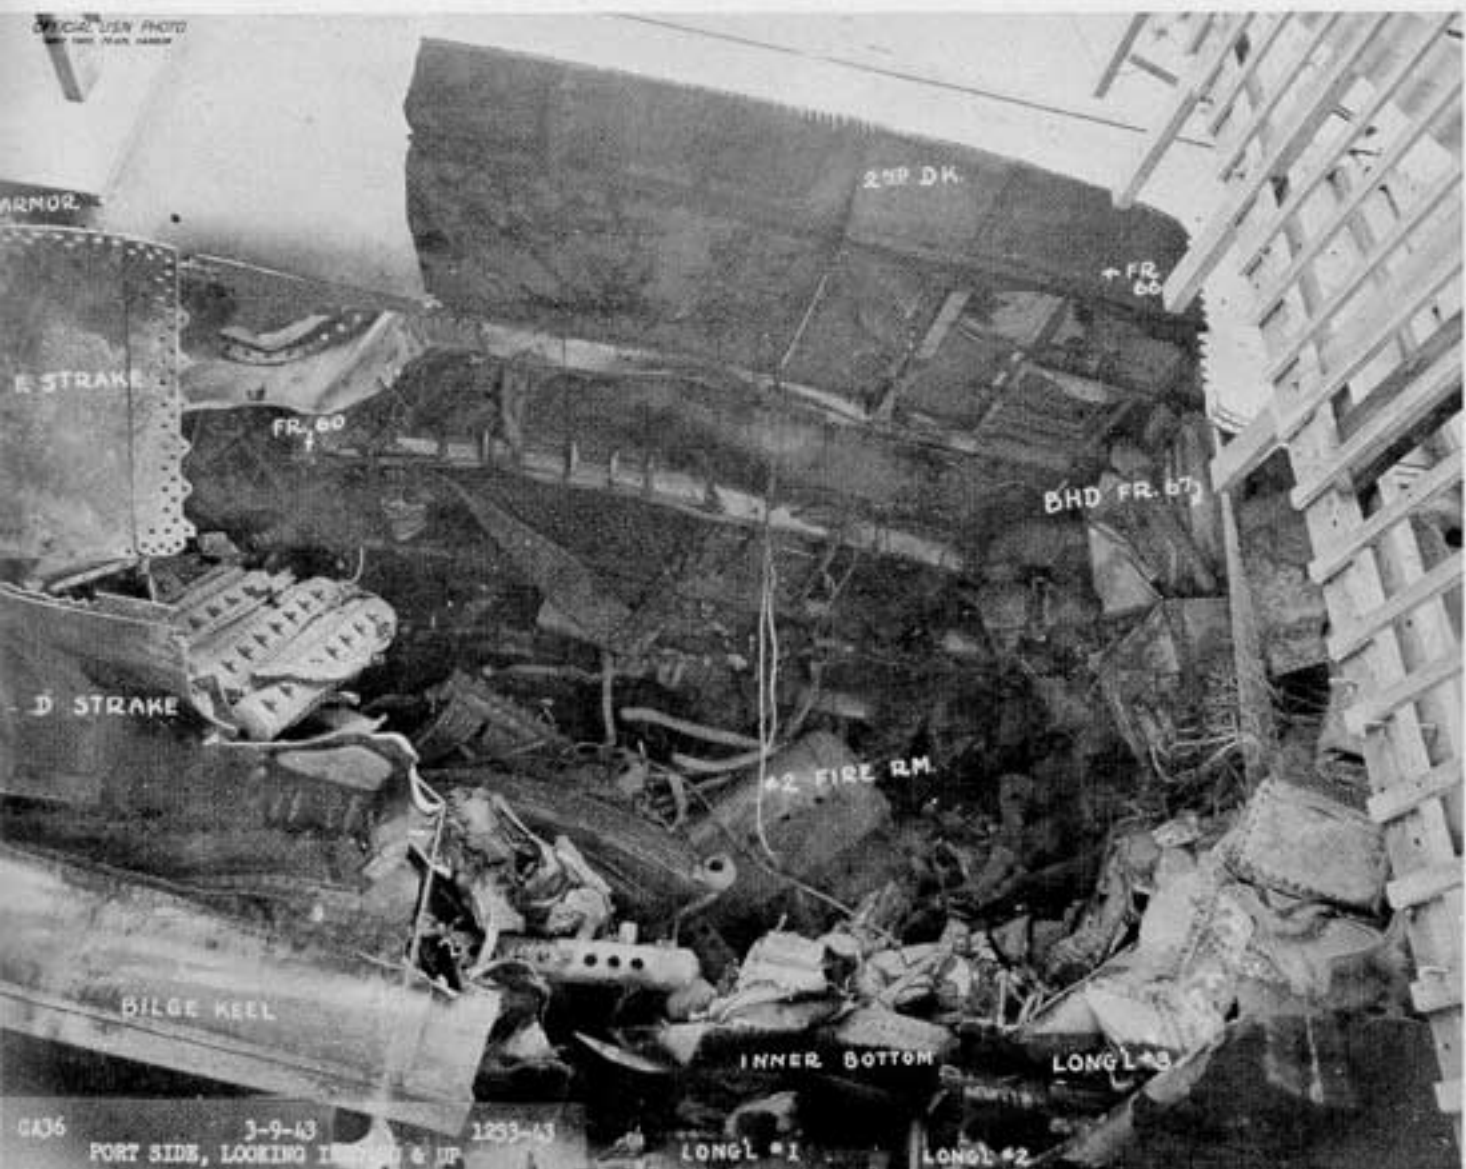
Photo No.22: USS MINNEAPOLIS - Port side looking aft No. 2 fireroom.
