# U. S. S. CHESTER (CA27)

## TORPEDO DAMAGE

# U. S. S. MINNEAPOLIS (CA36)

WAR DAMAGE REPORT No. 36

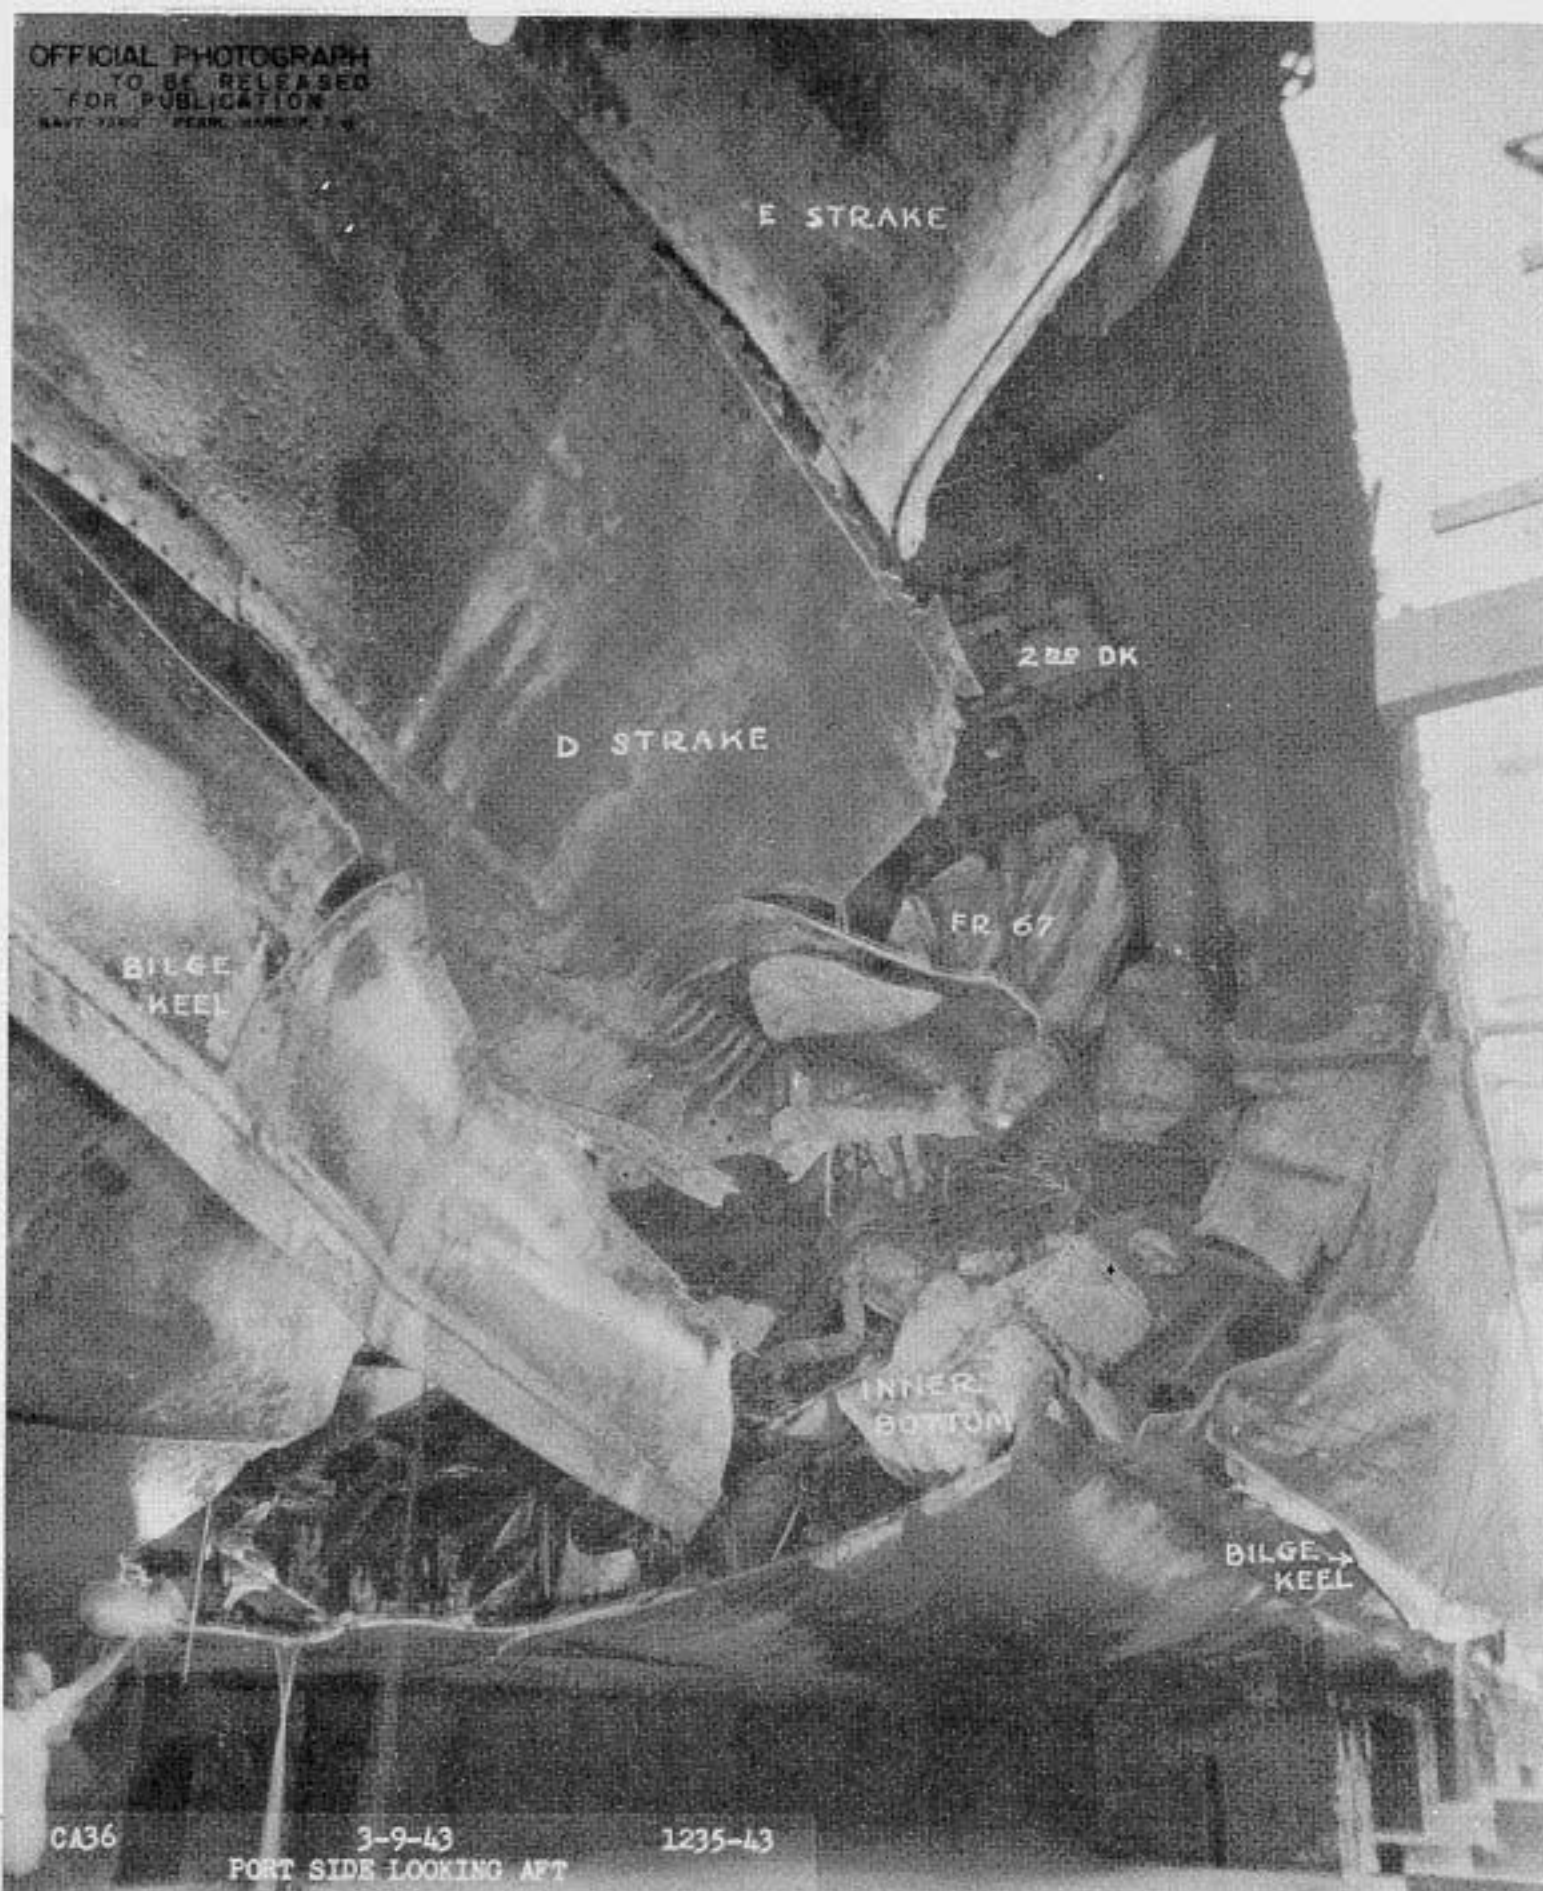
Photo No.23: USS MINNEAPOLIS - Port side looking inboard and up No. 2 fireroom.

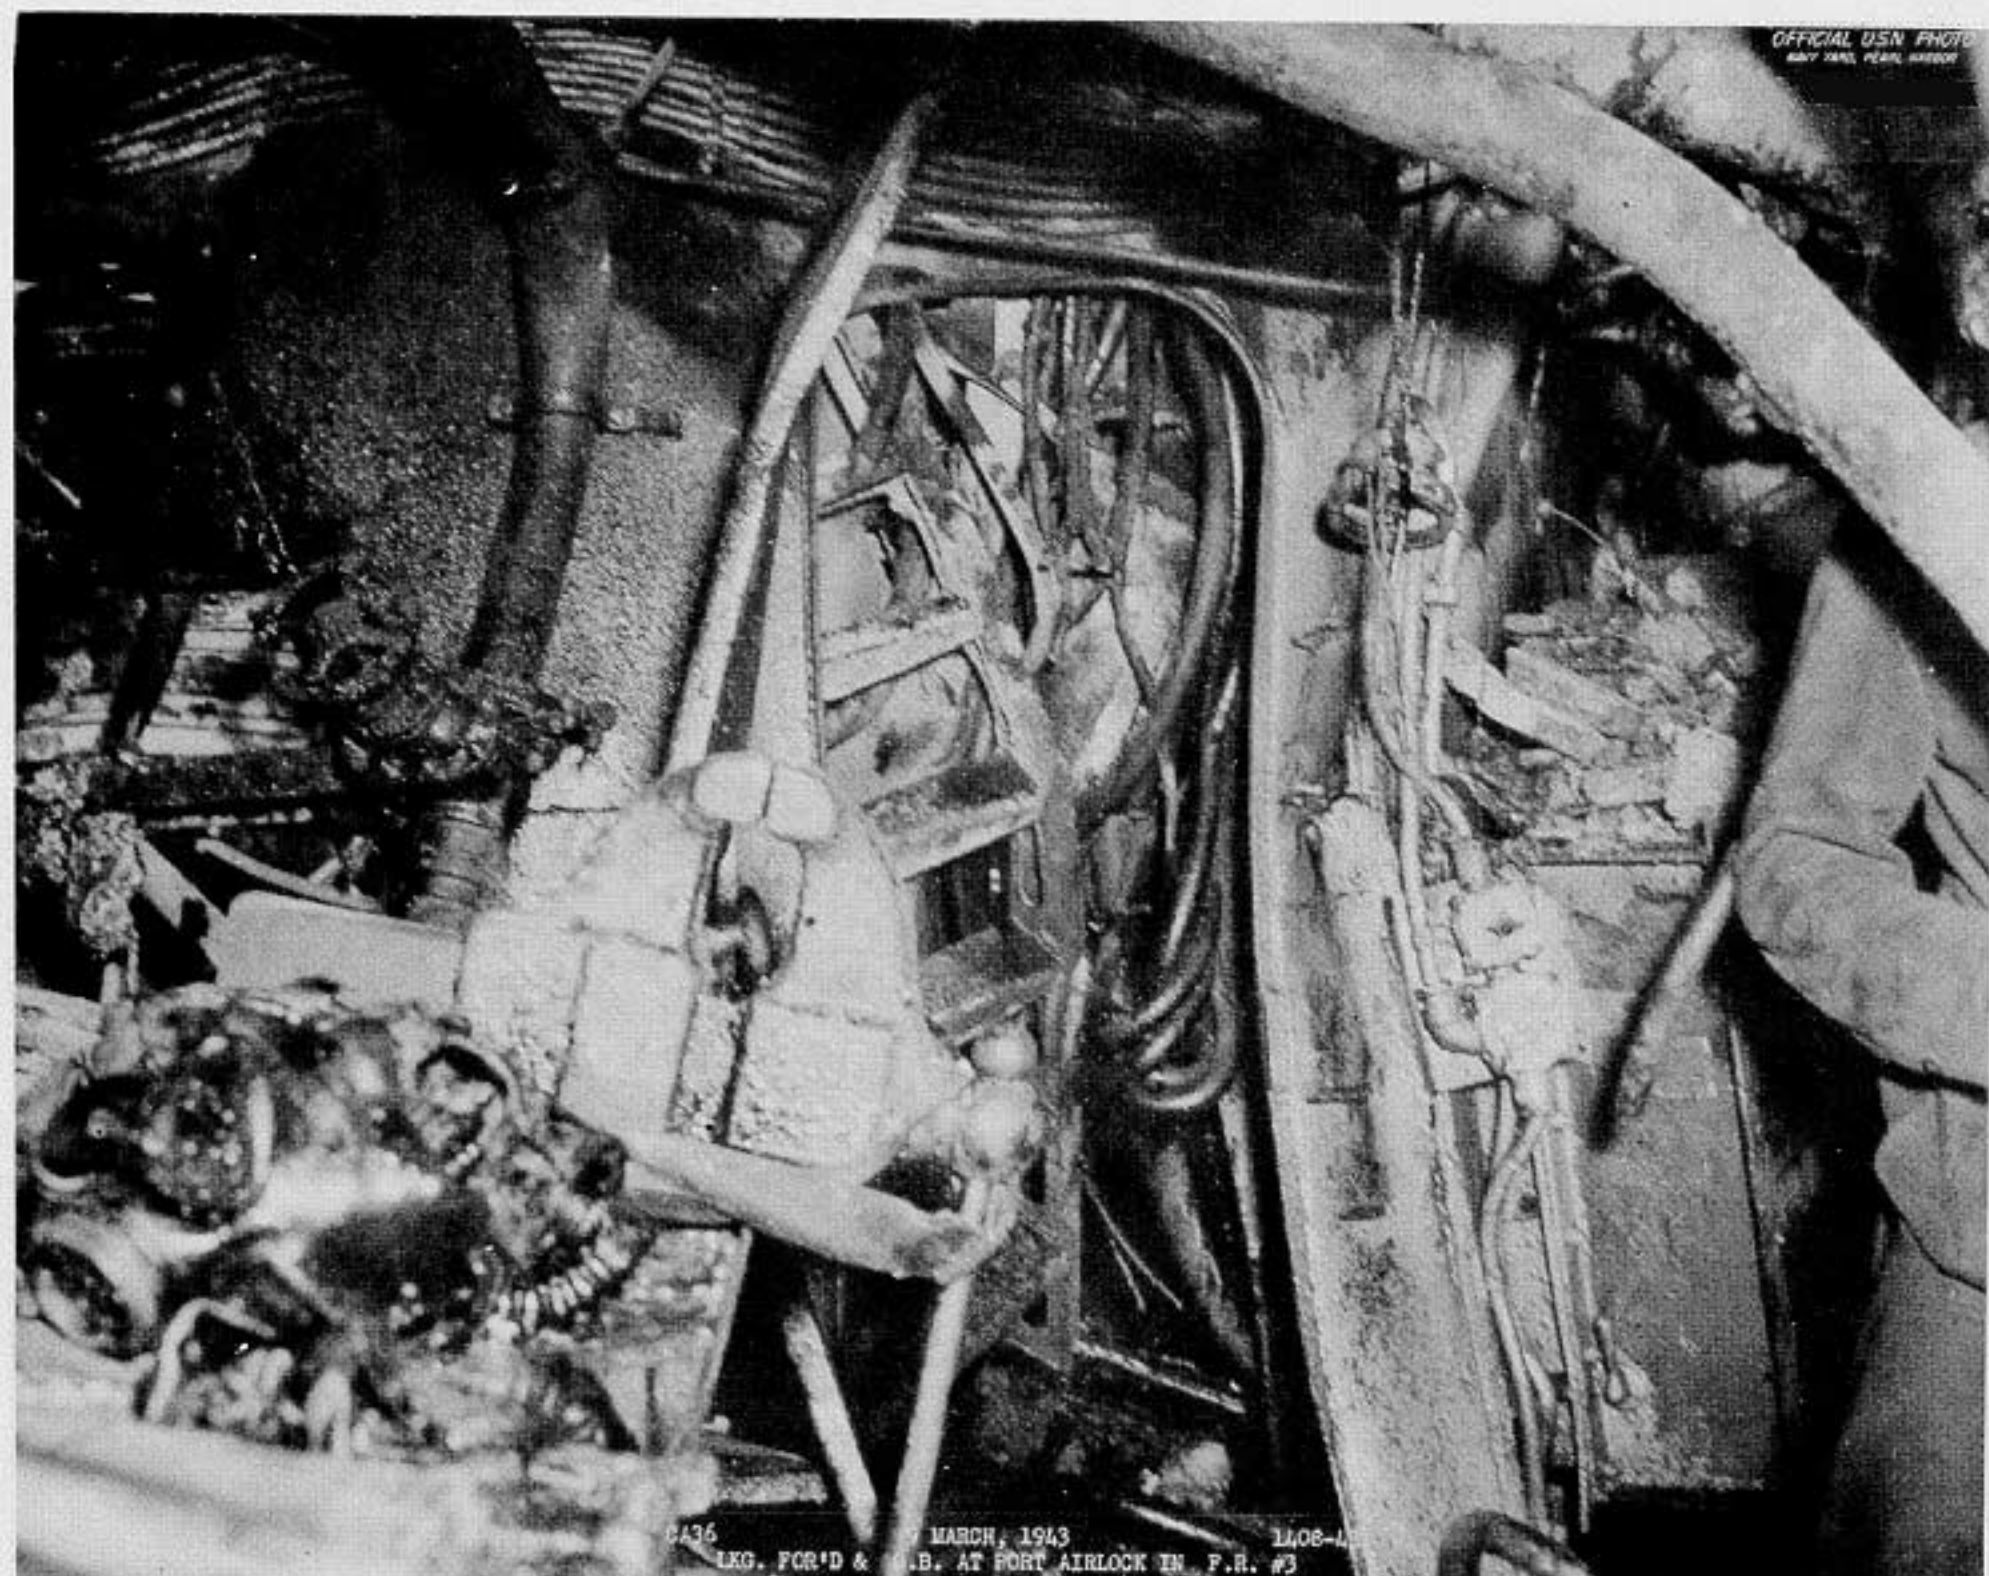
Photo No.24: USS MINNEAPOLIS - Port airlock in No. 3 fireroom looking forward and outboard.

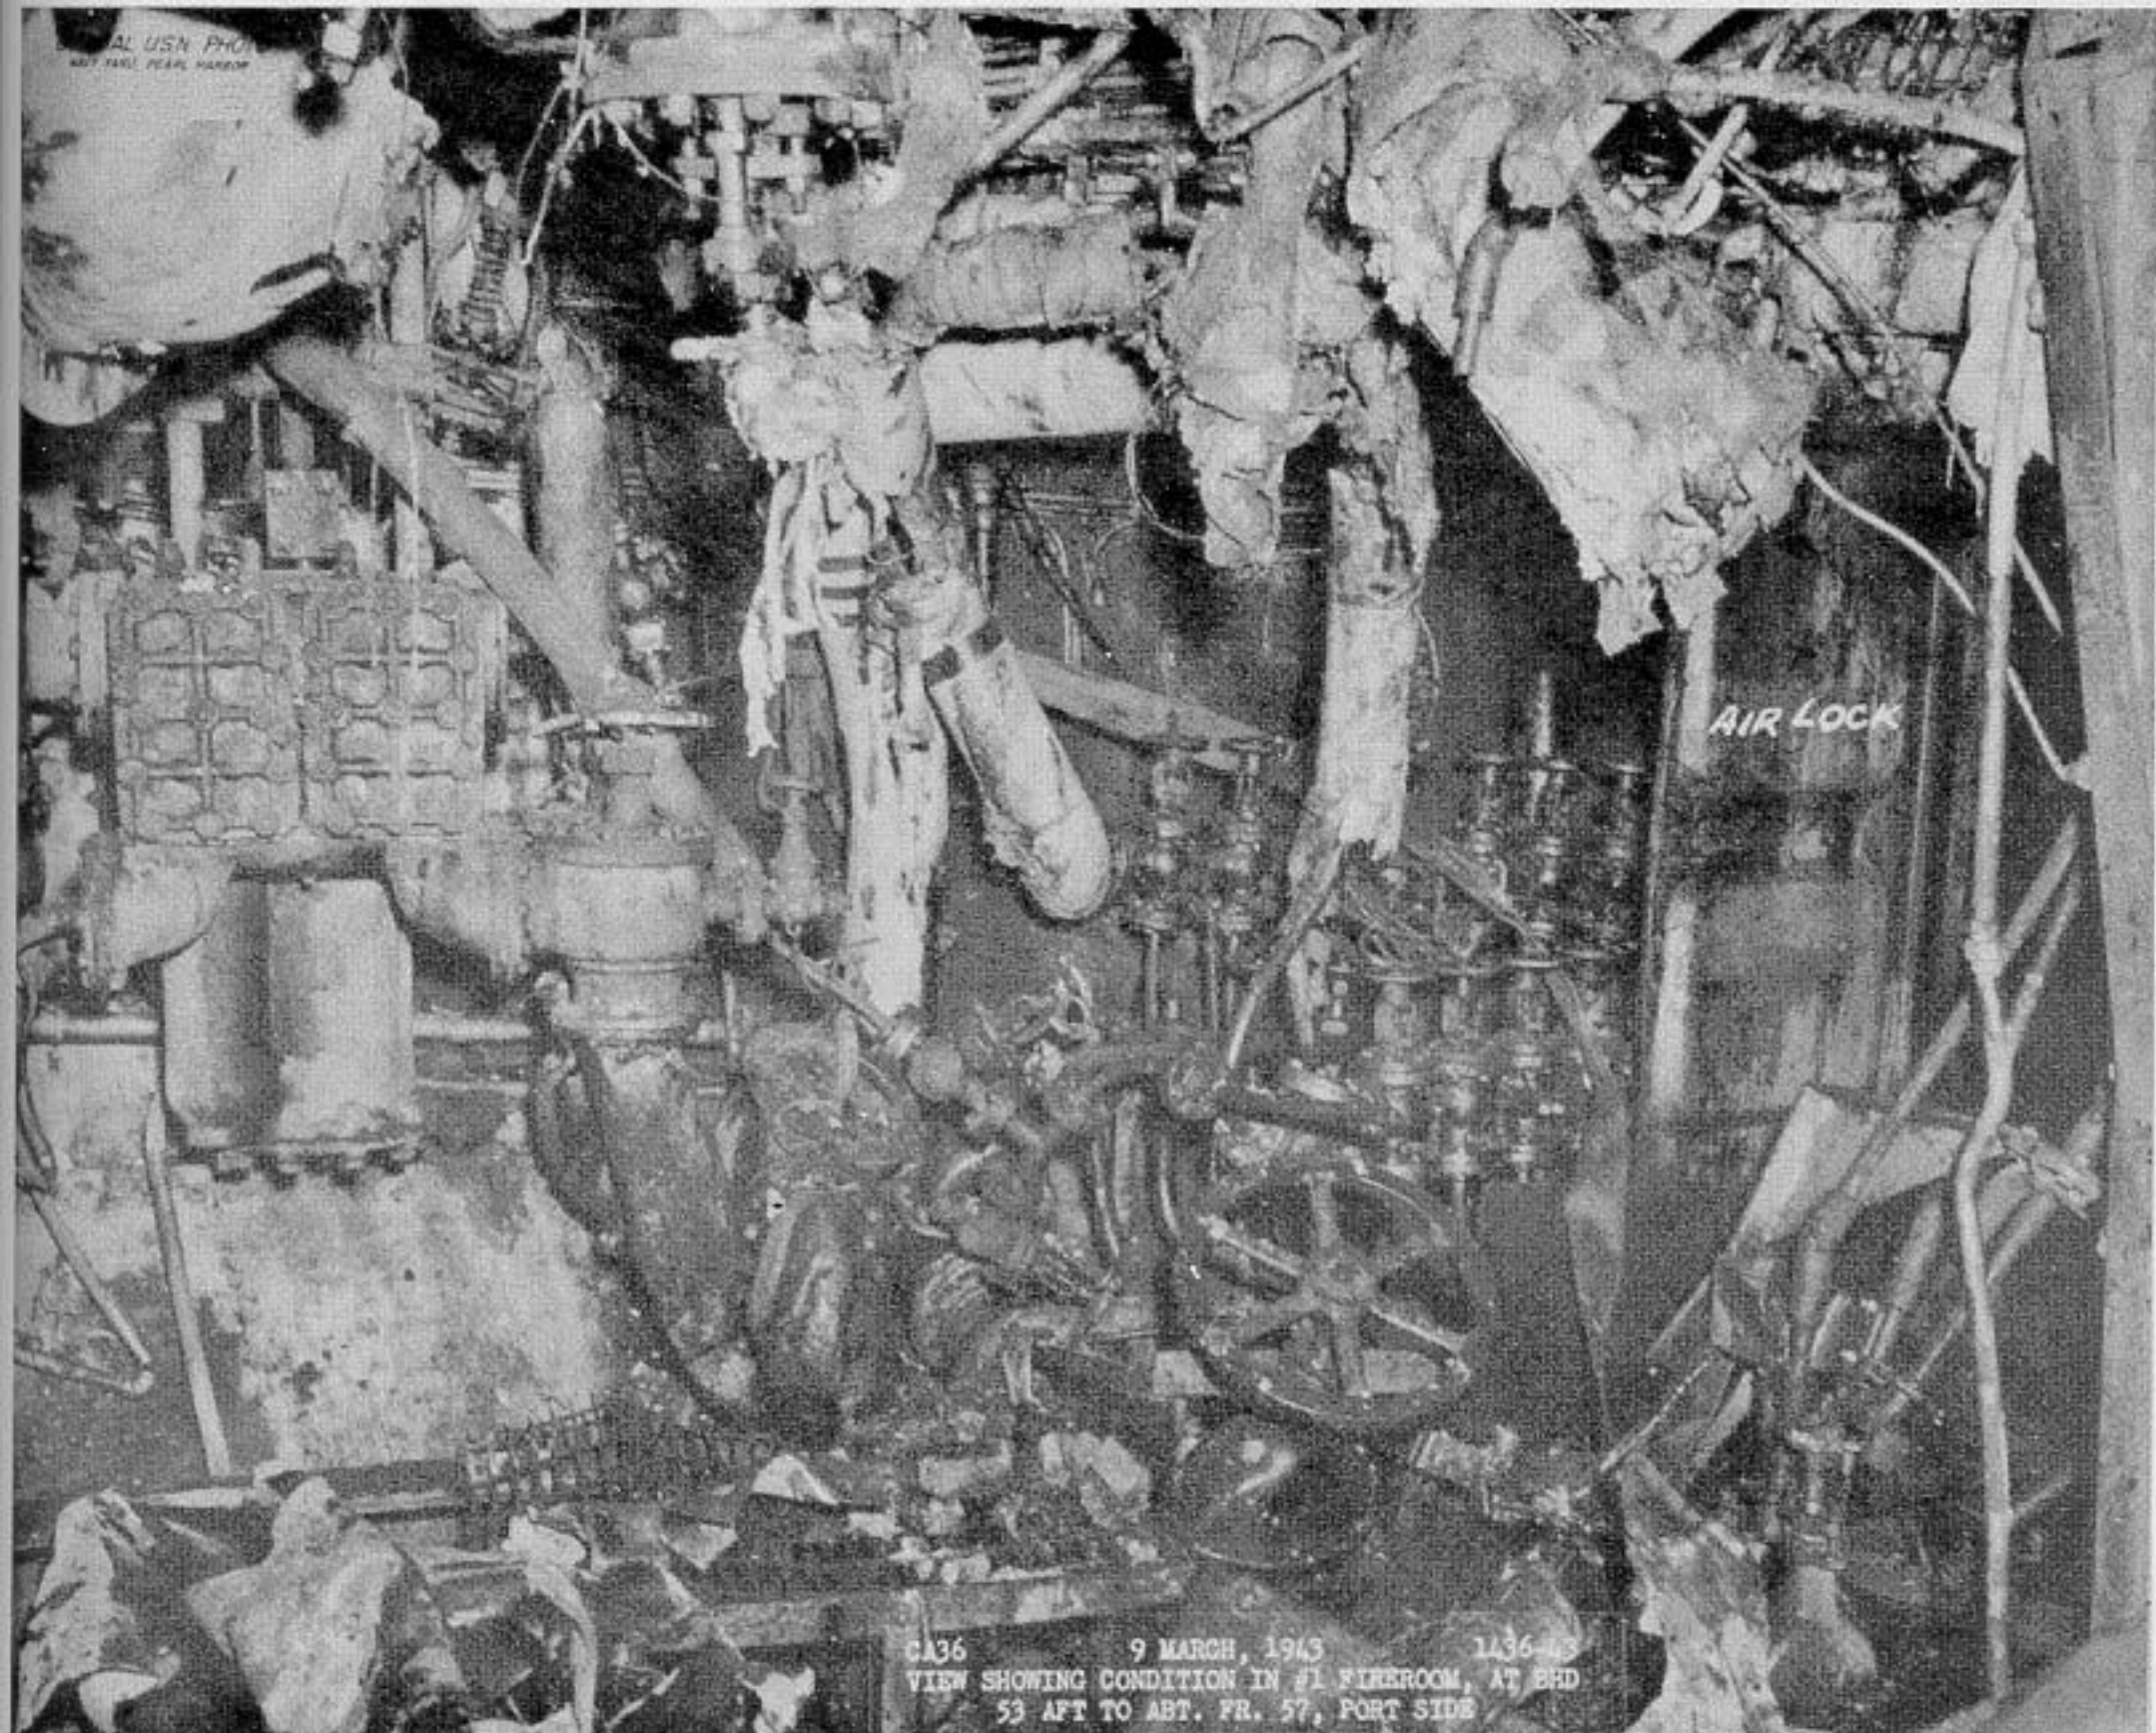
Photo No.25: USS MINNEAPOLIS - Port side No. 1 fireroom.

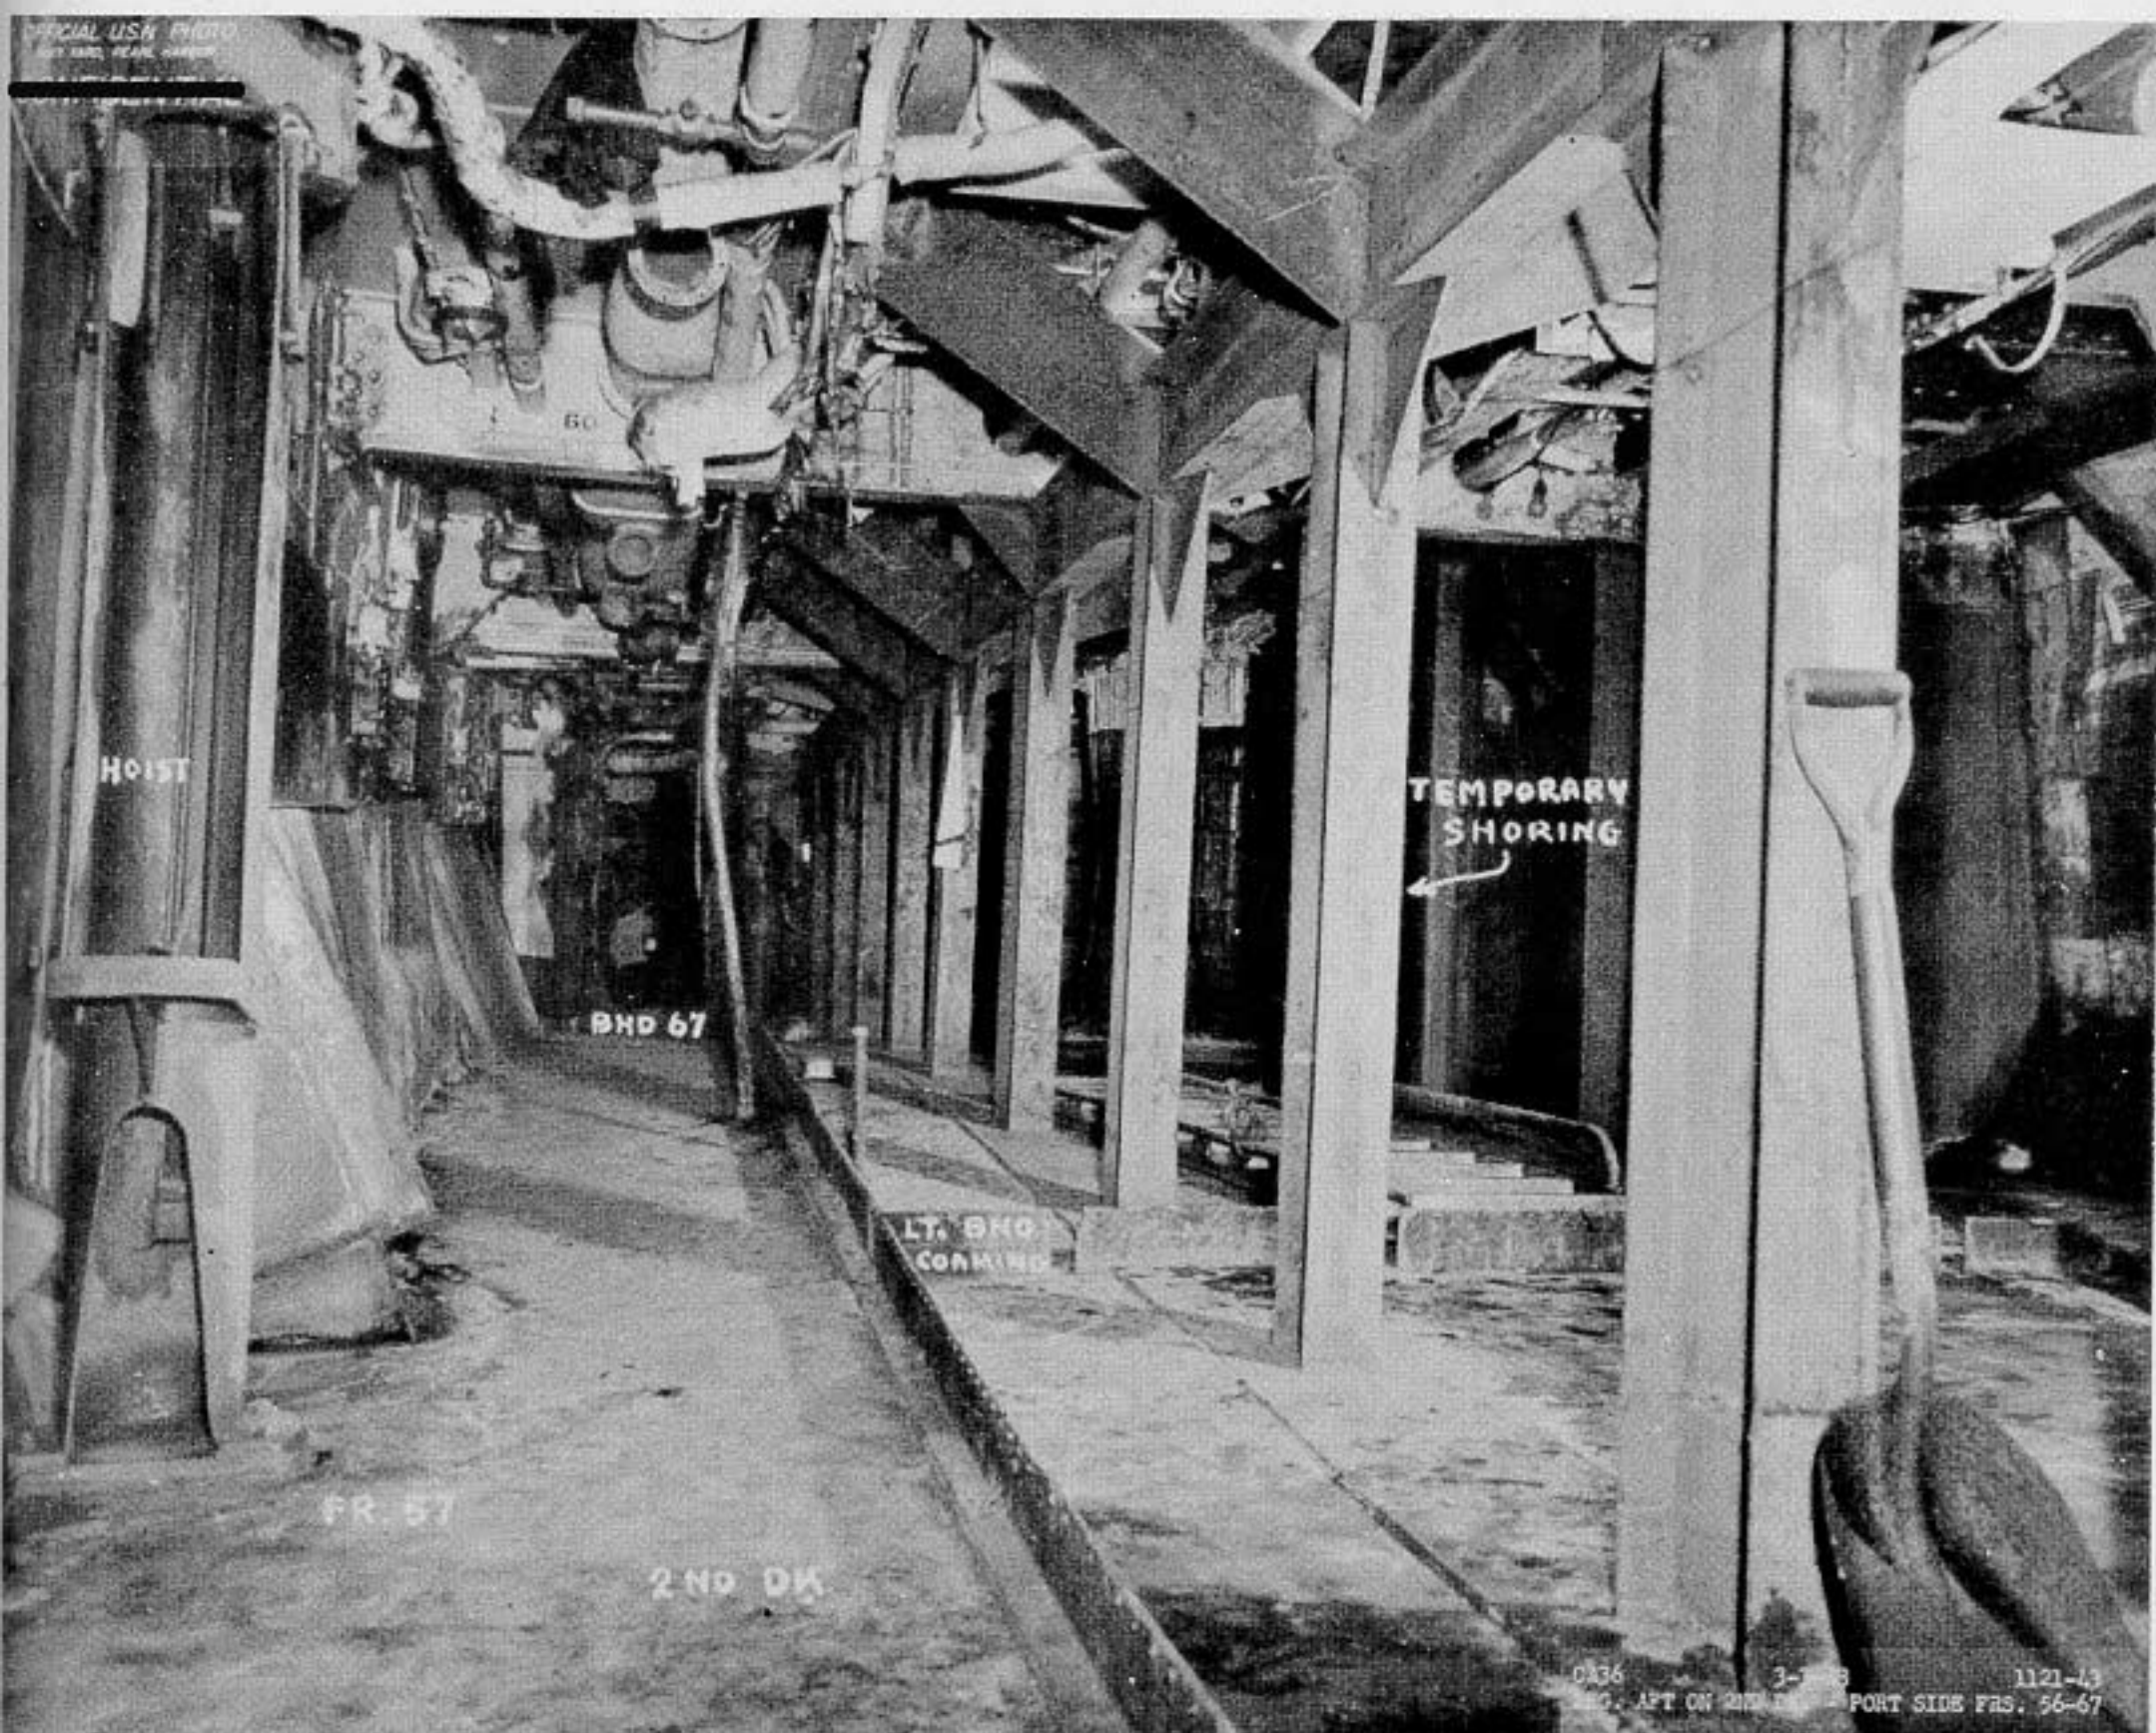
Photo No.26: USS MINNEAPOLIS - Port side second deck looking aft showing temporary shoring.
