JSC-08963

SKYLAB MISSION REPORT
THIRD VISIT

PREPARED BY
Mission Evaluation Team

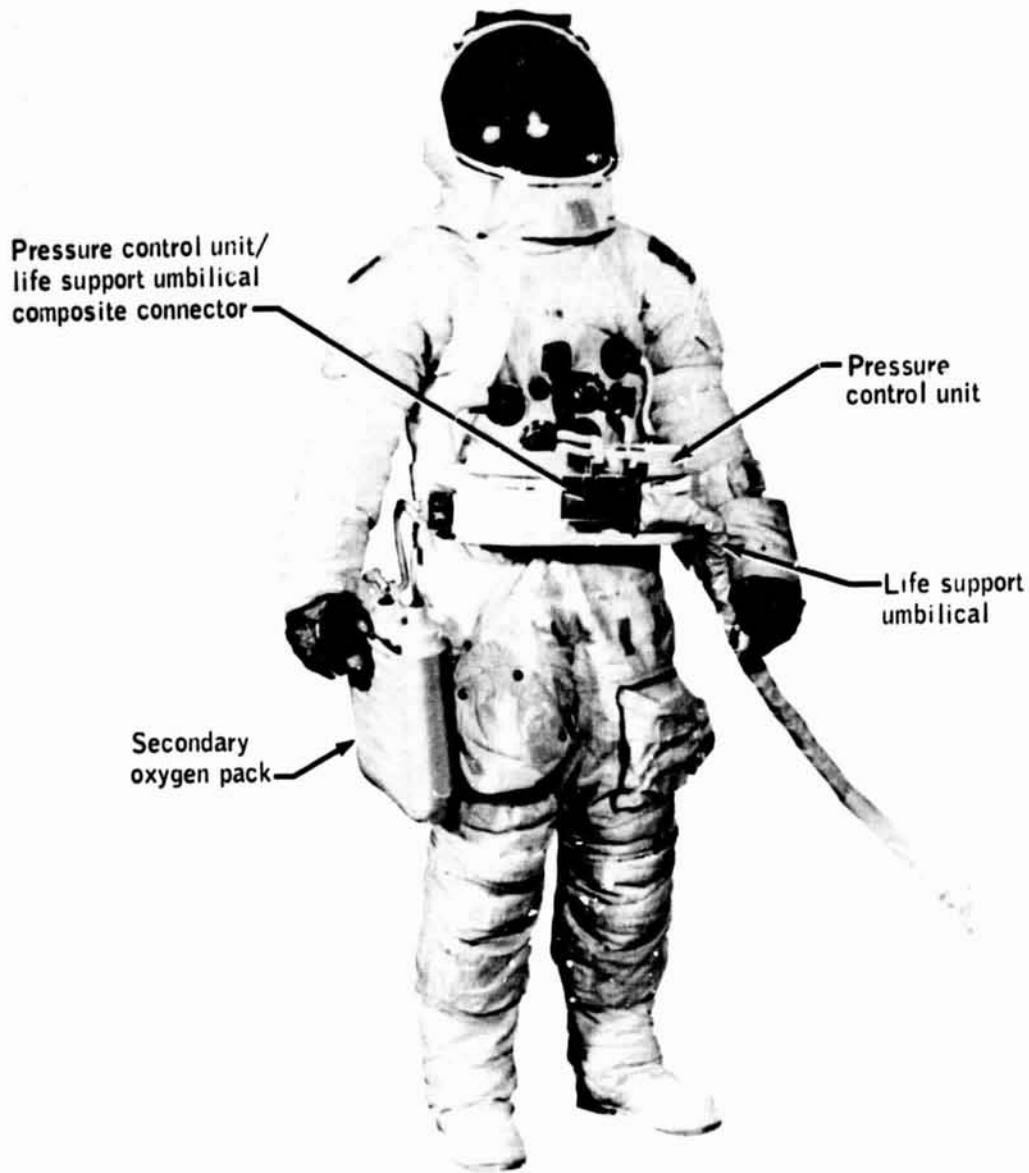
Figure 16-20.- Astronaut life support assembly.

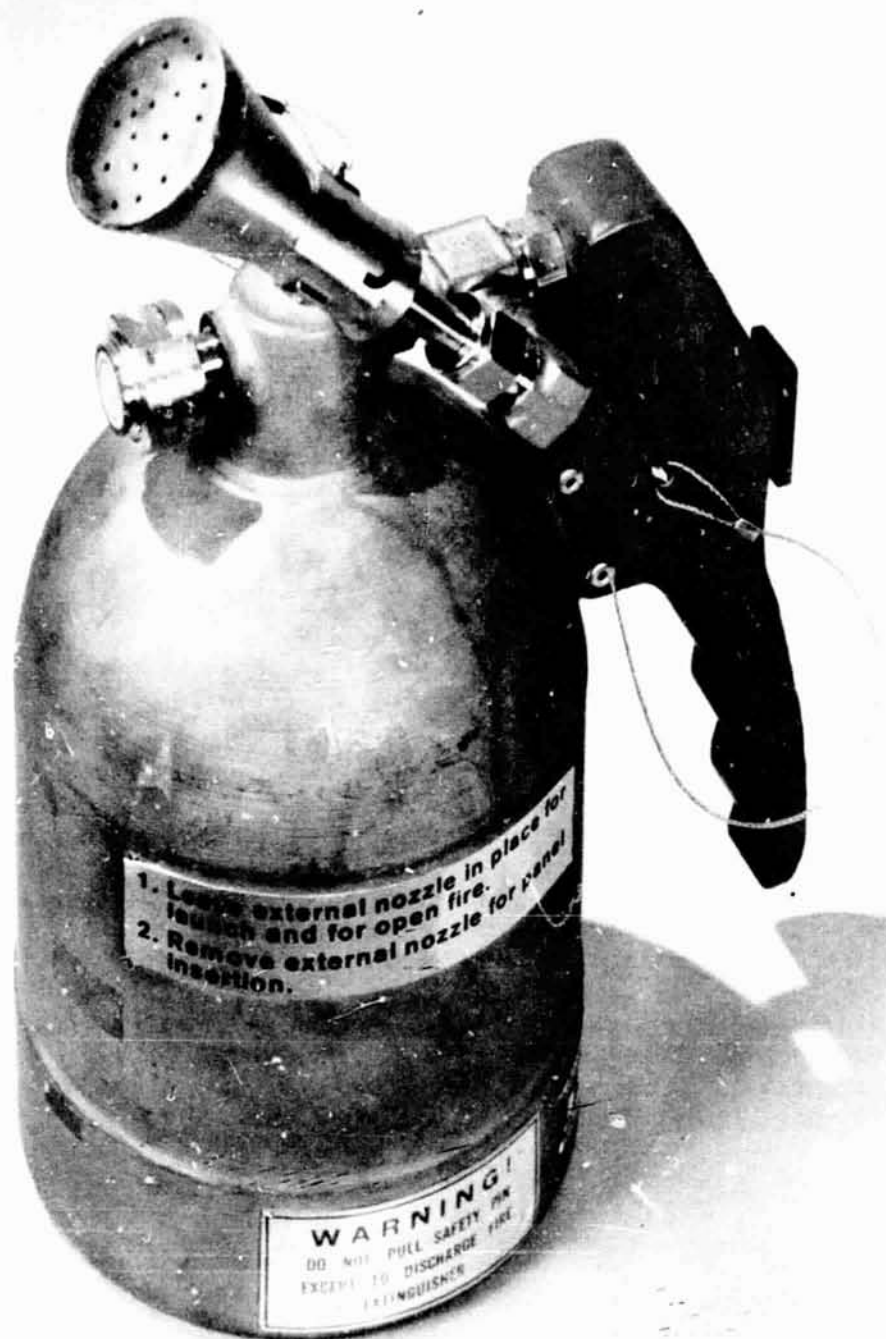
Figure A-1.- Skylab fire extinguisher.
