SATURN V LAUNCH VEHICLE FLIGHT EVALUATION REPORT-AS-510 APOLLO 15 MISSION

**SATURN V LAUNCH VEHICLE
FLIGHT EVALUATION REPORT - AS-510
APOLLO 15 MISSION**

**Saturn Flight Evaluation Working Group
George C. Marshall Space Flight Center**

All Mandatory and Desirable Objectives of this mission for the launch vehicle were accomplished except the precise determination of the lunar impact point. It is expected that this will be accomplished at a later date. No failures, anomalies, or deviations occurred that seriously affected the mission.

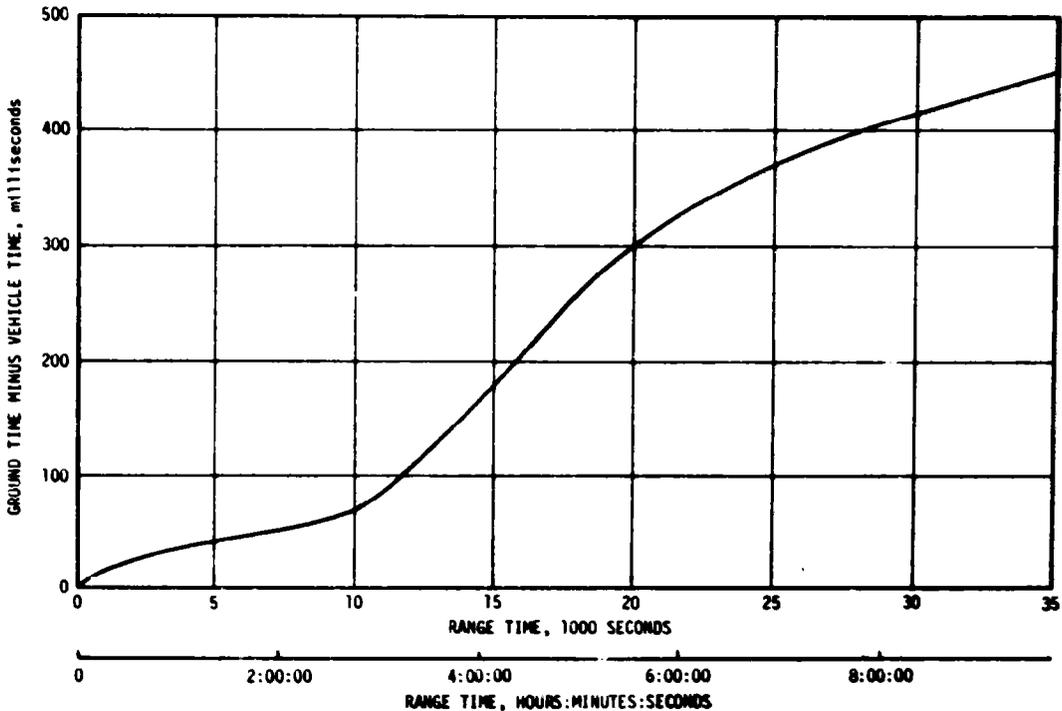
Figure 2-1. Ground Station Time to Vehicle Time Conversion

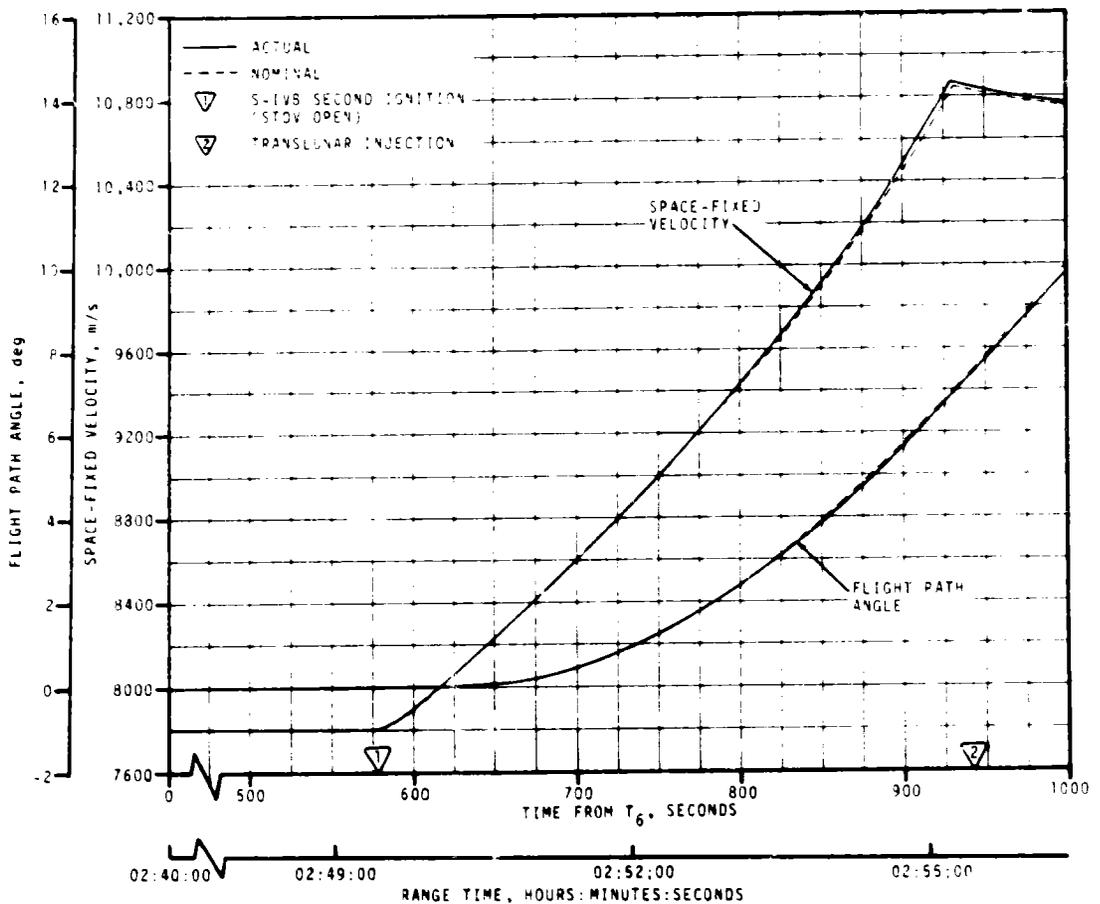
Figure 4-6. Injection Phase Space-Fixed Velocity and Flight Path Angle Comparisons

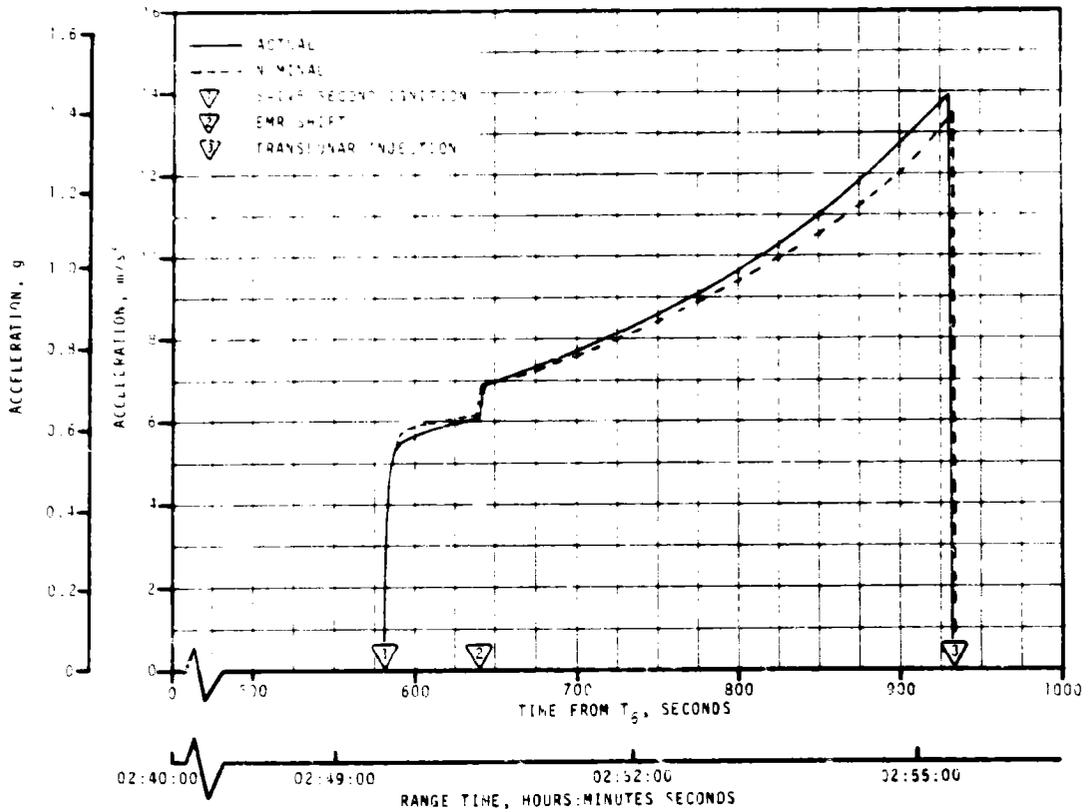
Figure 4-7. Injection Phase Acceleration Comparison

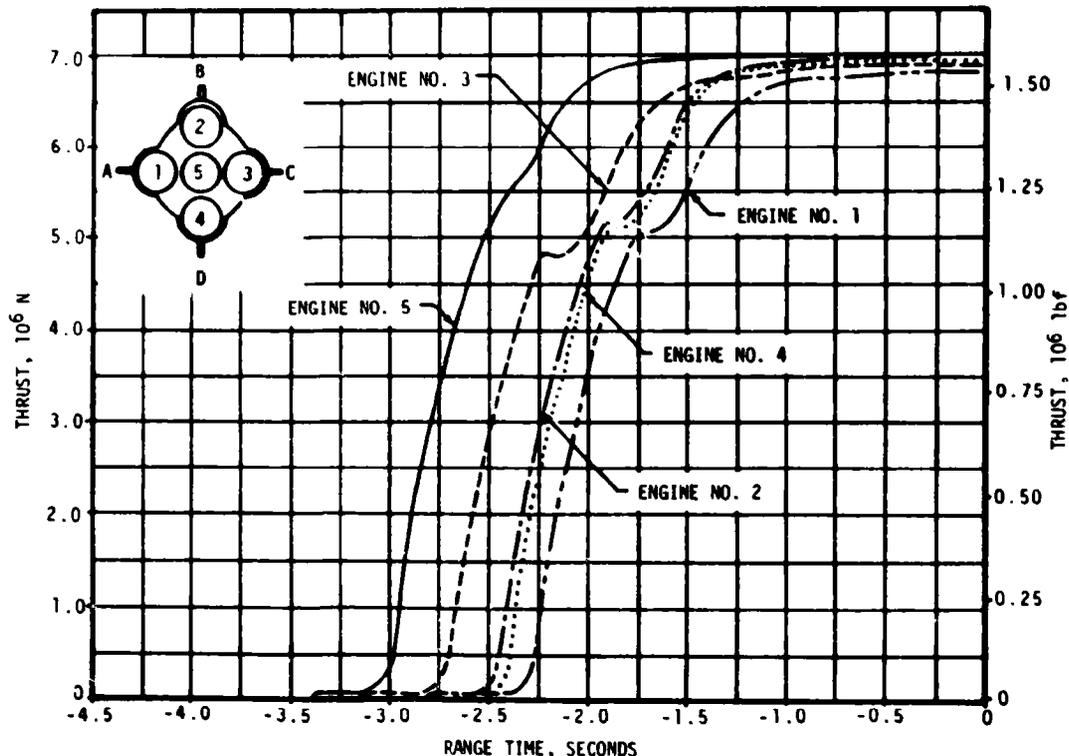
Figure 5-2. S-IC Engines Thrust Buildup

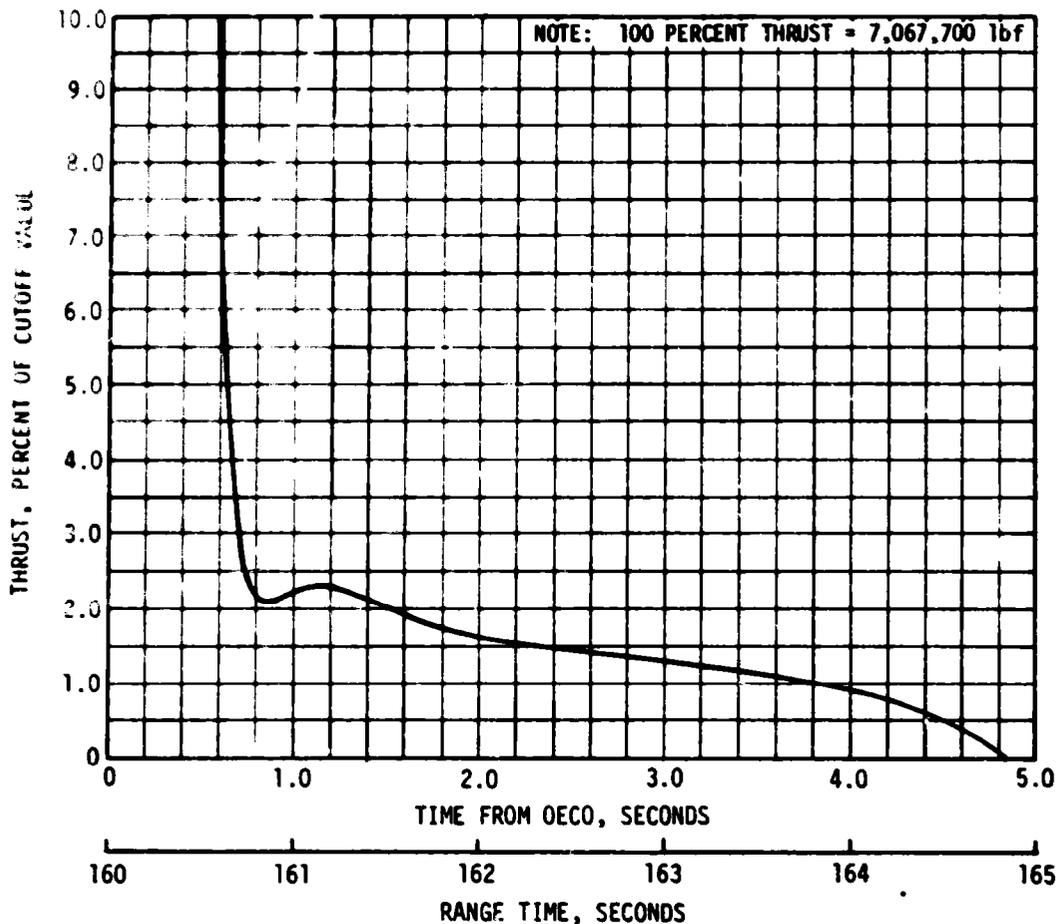
Figure 5-4. Normalized AS-510 Outboard Engine Thrust Decay Characteristic

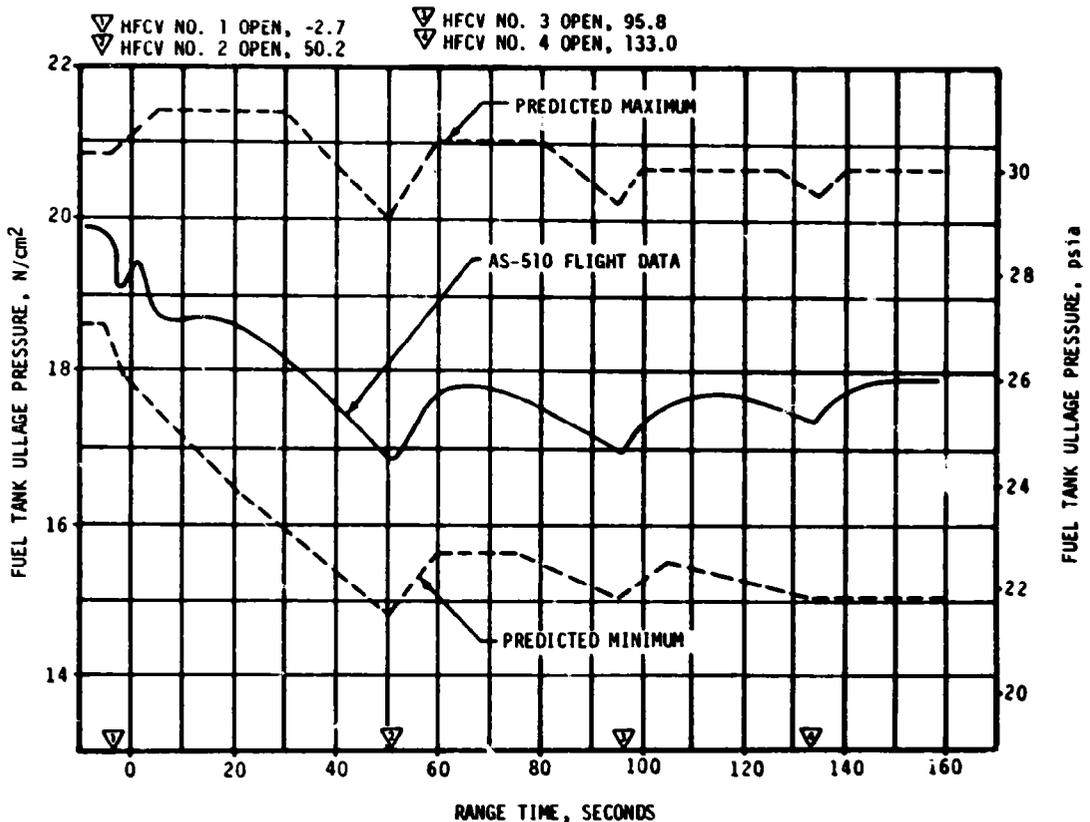
The prepressurization system was initiated at -71.96 seconds. Ullage pressure increased to the prepressurization switch band and flow was

Figure 5-5. S-IC Fuel Tank Ullage Pressure

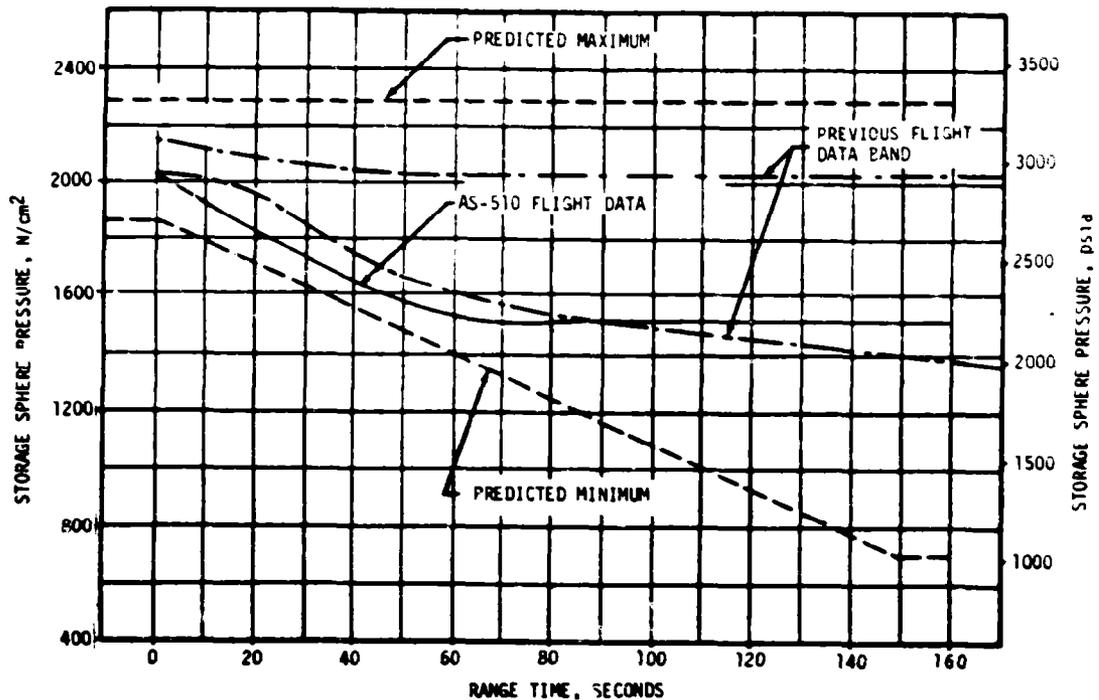
Higher than normal purge flows were experienced during the first 45 seconds of flight. This was observed at the storage sphere pressure, Figure 5-7, and the engine No. 1 customer connect point pressure, Figure 5-8. Based on the storage sphere pressure decay, the flowrate was between 0.14 and 0.22 lbm/s. The previous maximum flowrate for a similar configuration was observed on AS-509. For that flight the

Figure 5-7. S-IC Purge Systems Storage Sphere Pressure

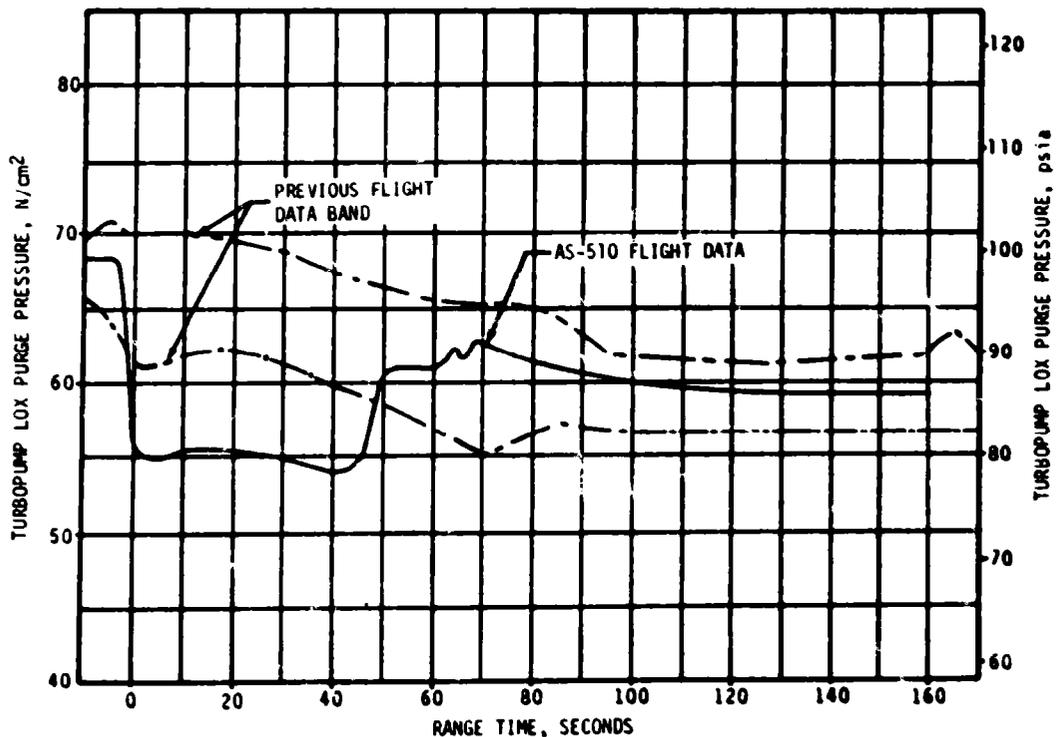
The turbopump intermediate seal is a dynamic seal with carbon segments spring loaded to ride the turbopump shaft. During transition to mainstage speed the carbon segments are unseated from the shaft due to shaft

Figure 5-8. F-1 Engine Turbopump LOX Purge Pressure at Station 109, Engine No. 1

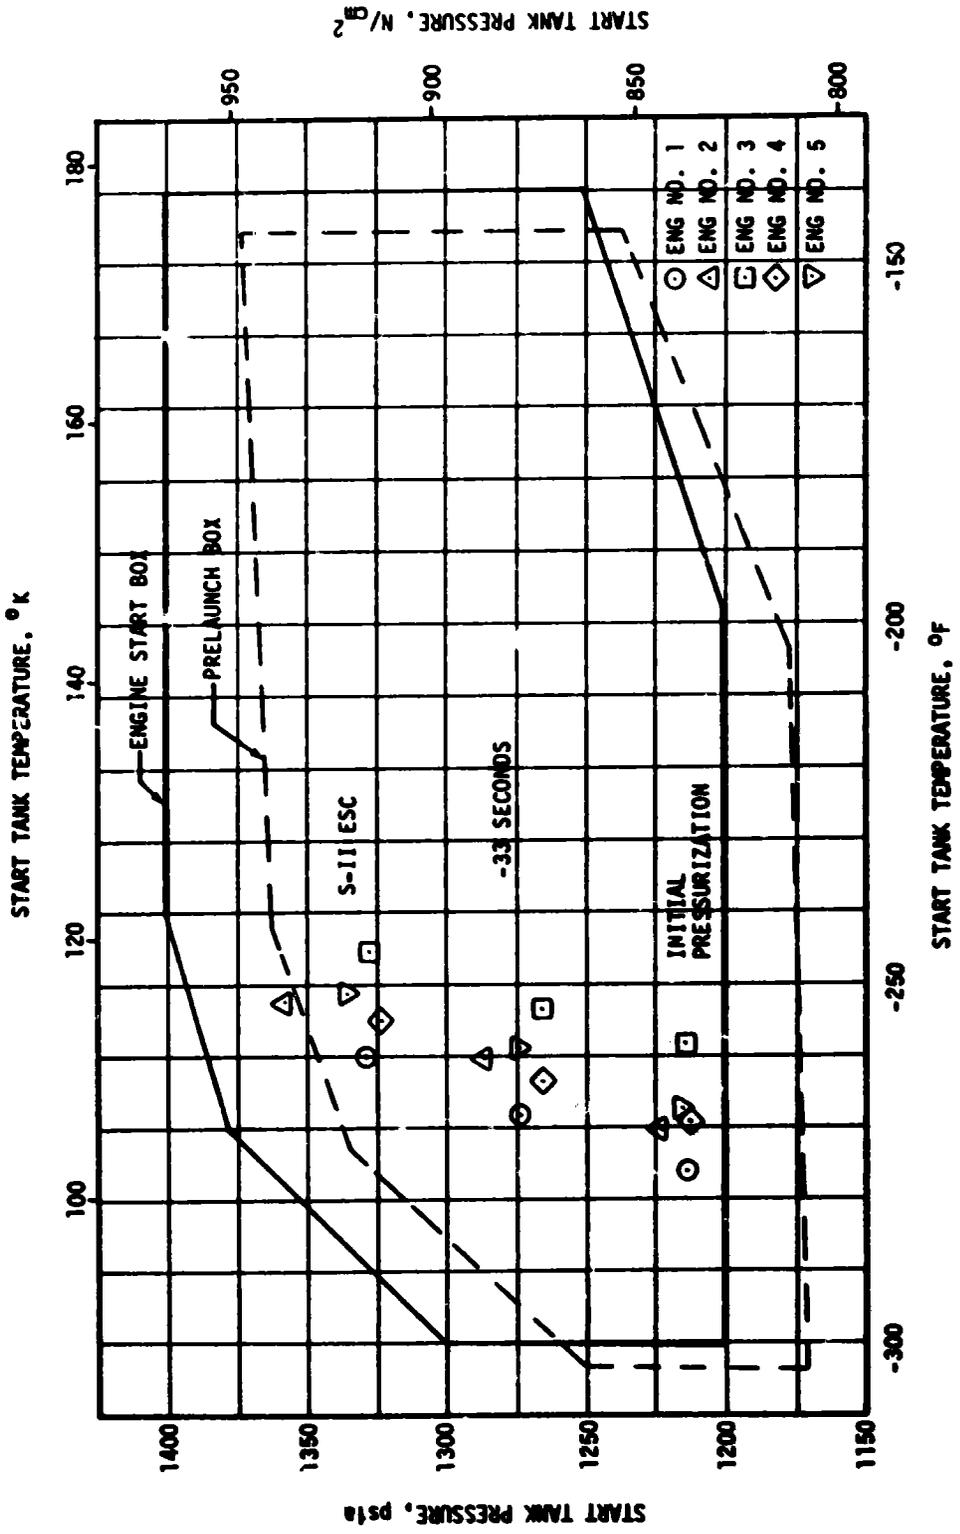
Figure 6-1. S-II Engine Start Tank Performance

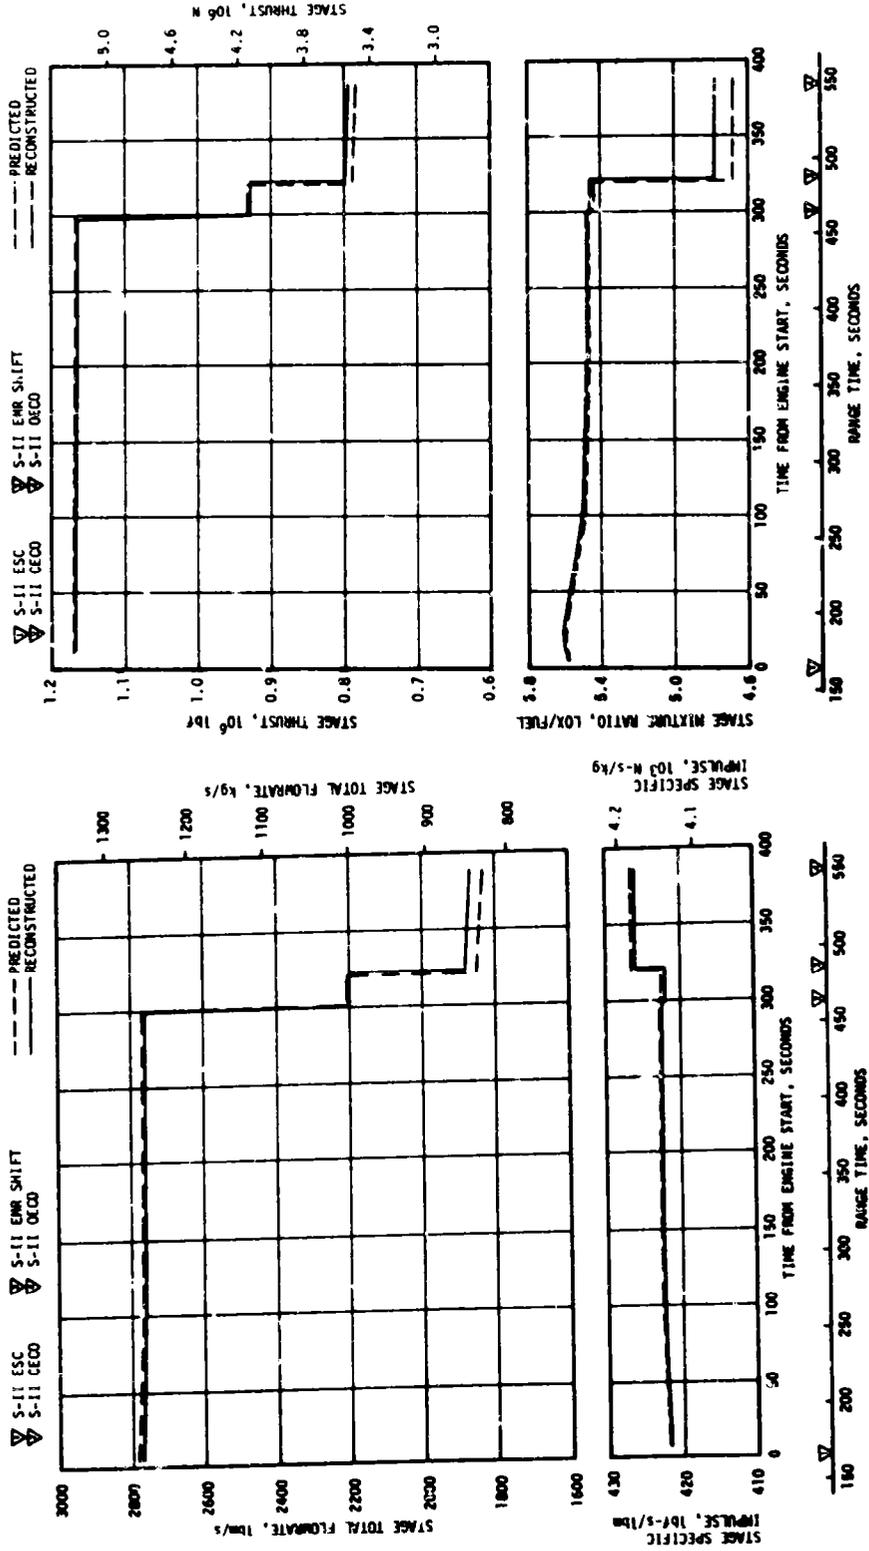
Figure 6-5. S-II Steady State Operation

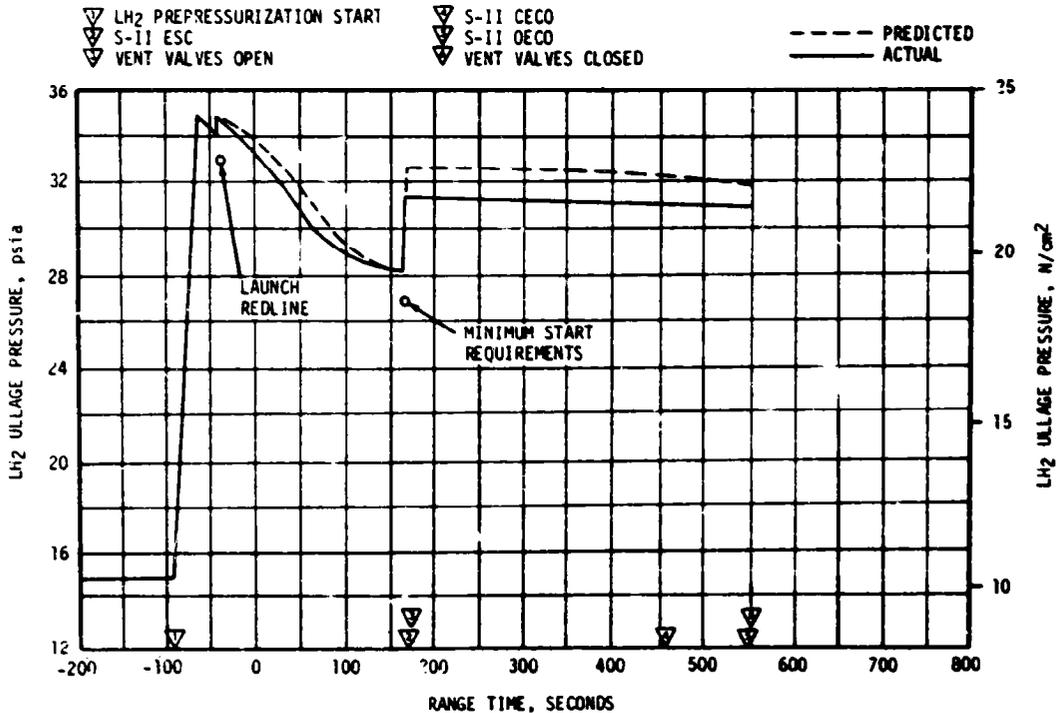
Figure 6-6. S-II Fuel Tank Ullage Pressure

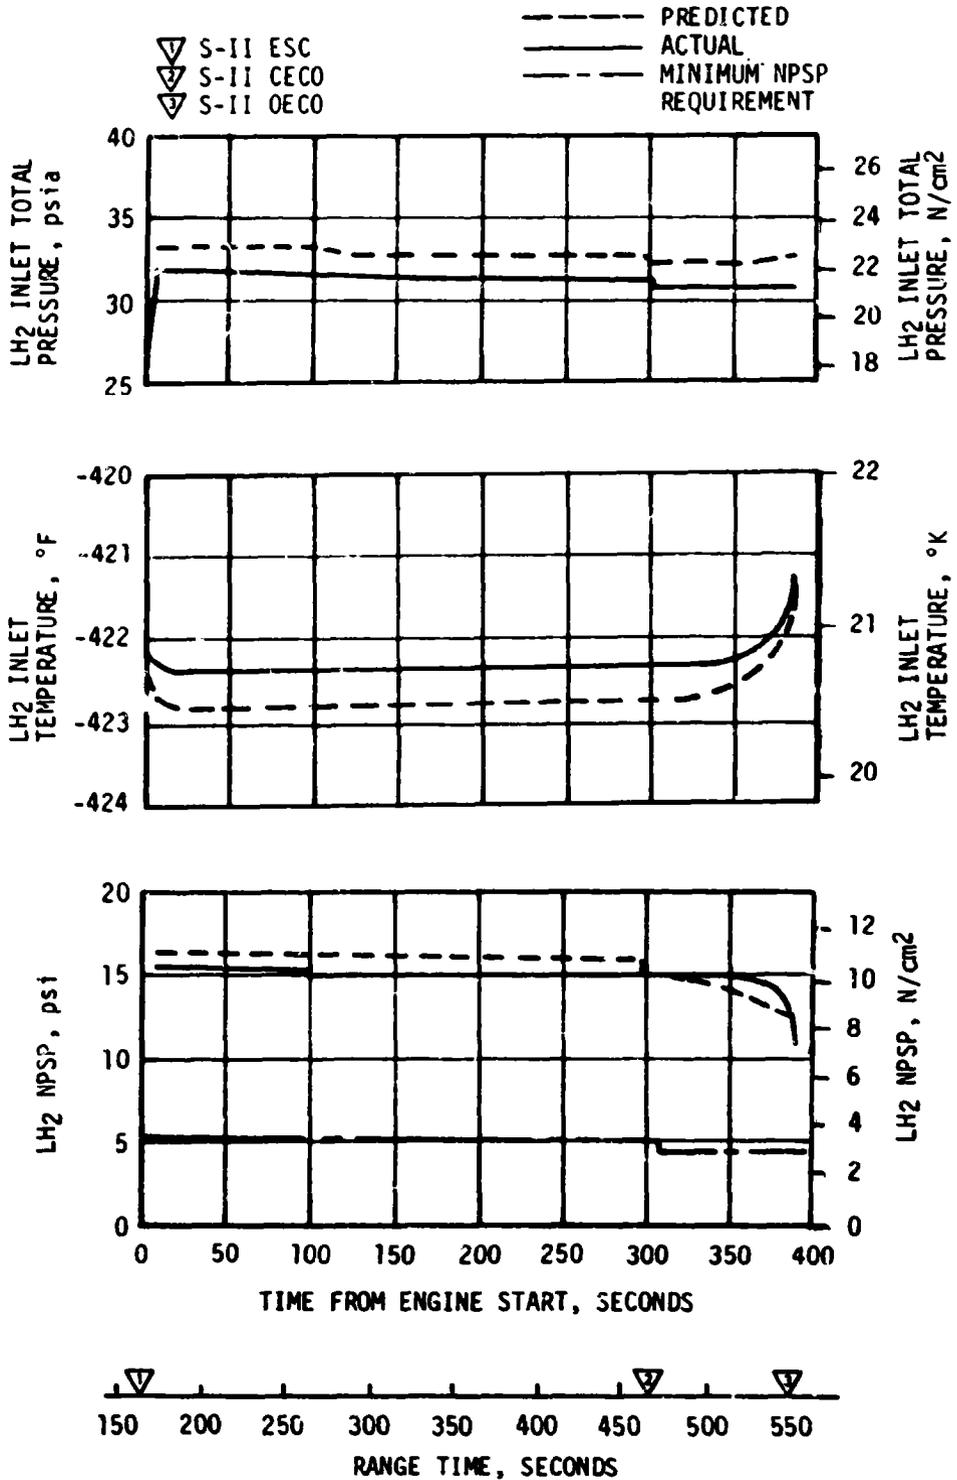
Figure 6-7. S-II Fuel Pump Inlet Conditions

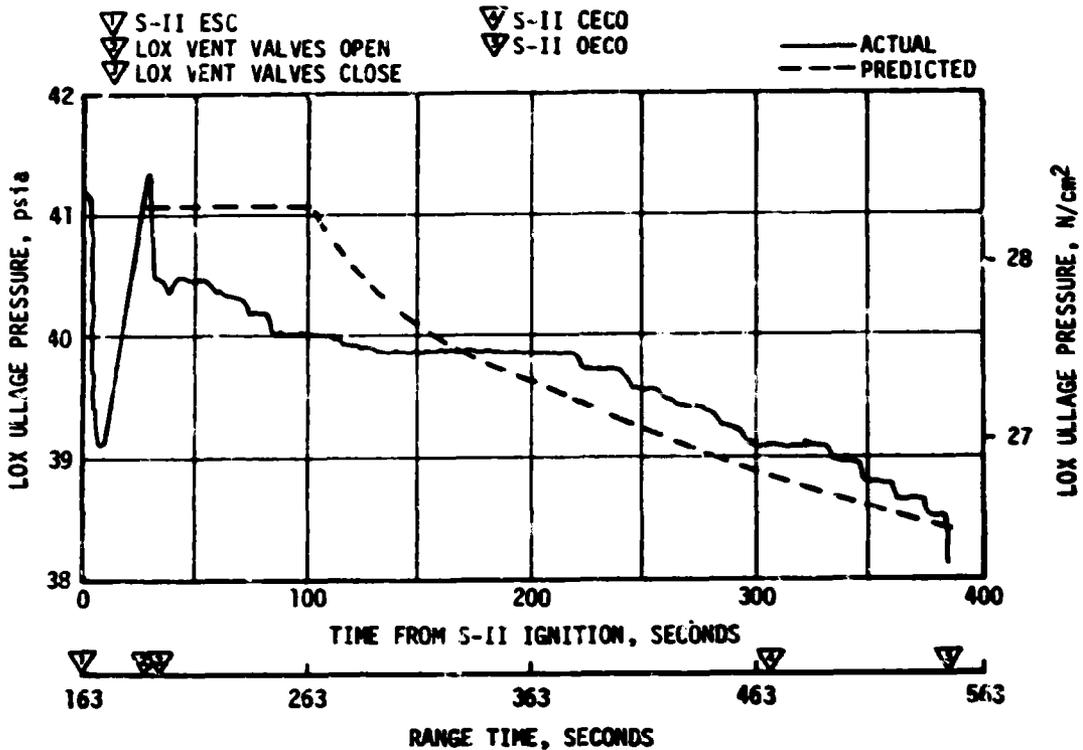
LOX tank ullage pressure, actual and predicted, is presented in Figure 6-8 for S-II burn. After a 2-minute cold helium chilldown flow through the LOX tank, the vent valves were closed at -184 seconds and the LOX tank was pressurized to the pressure switch setting of 38.7 psia in 34.8 seconds. The LOX tank ullage pressure increased to 40.0 psia because of common bulkhead flexure due to the LH₂ tank prepressurization. The LOX tank ullage pressure redline commit time was changed from -30 seconds to -19 seconds for this and subsequent flights because of the LOX vent valve problem that occurred during CDDT. This time change provides for a longer ullage pressure monitoring time before launch commit. The LOX vent valve No. 1 had an abnormally long closing time and did not fully close during the CDDT special accumulator test. Subsequent valve operations appeared to be normal including a special LOX ullage pressure decay test that was conducted during the CDDT. The LOX vent valve problem was attributed to frost accumulation on the poppet seat due to the valve being open during the 5 hours preceding the problem. The LOX vent valves were not replaced, but the countdown procedures incorporated a periodic cycling of the vent valves when operating at cryogenic temperatures.

Figure 6-8. S-II LOX Tank Ullage Pressure

The LOX tank ullage pressure was within approximately 1 psi of the pre-flight prediction. Vent valve No. 1 opened, and after one cycle, remained open from 189 seconds until 198.8 seconds. Vent valve No. 2 had one open-close cycle at 191.3 seconds but otherwise remained closed. Ullage pressure decreased at a relatively constant rate to 38.3 psia at S-II OECO. LOX pump total inlet pressure, temperature, and NPSP are presented in Figure 6-9.

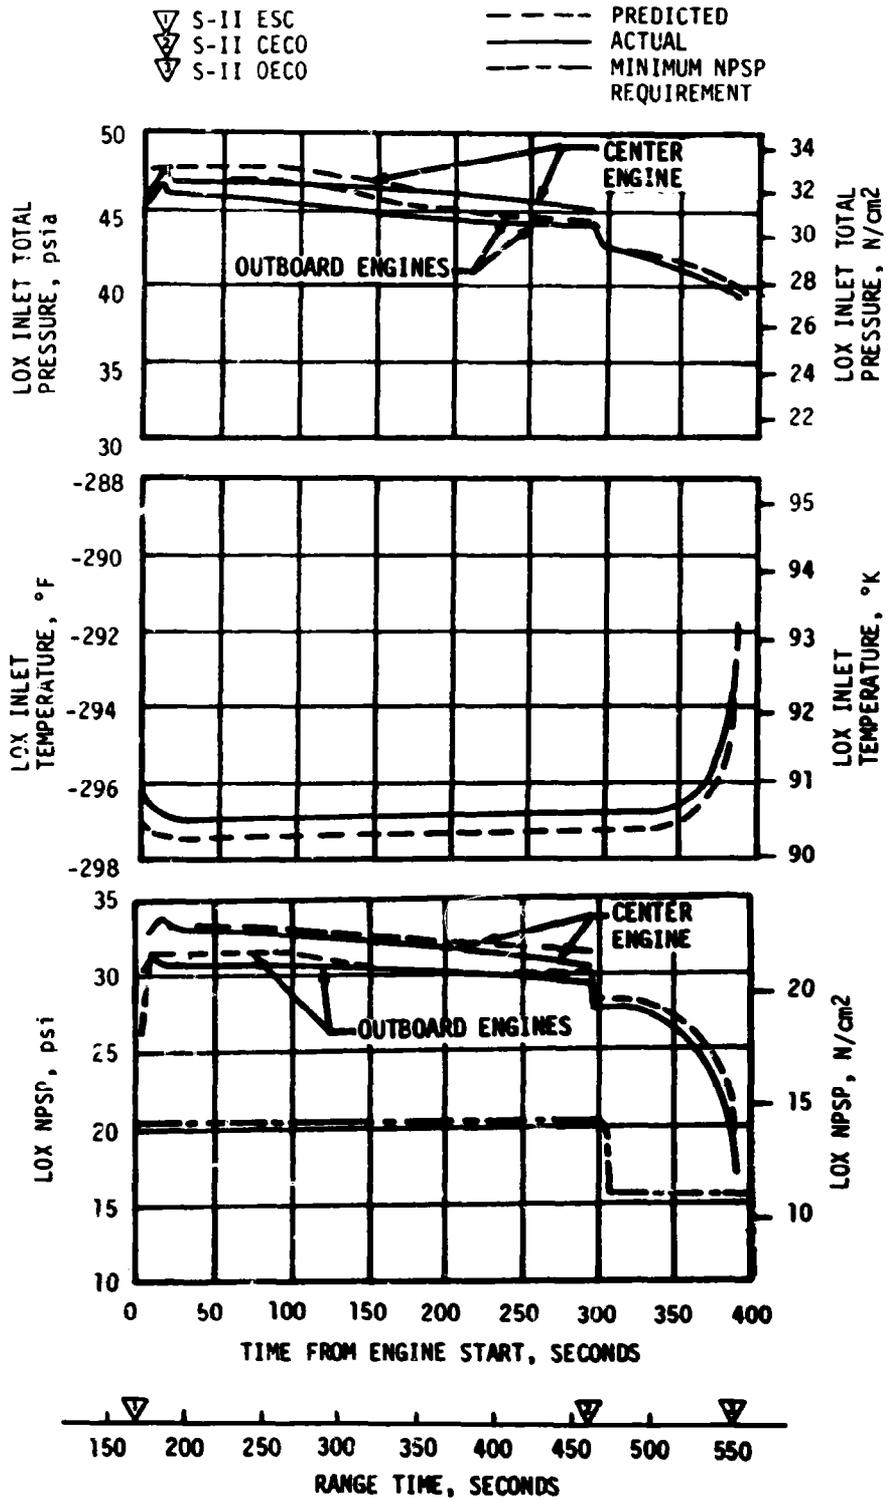
Figure 6-9. S-II LOX Pump Inlet Conditions

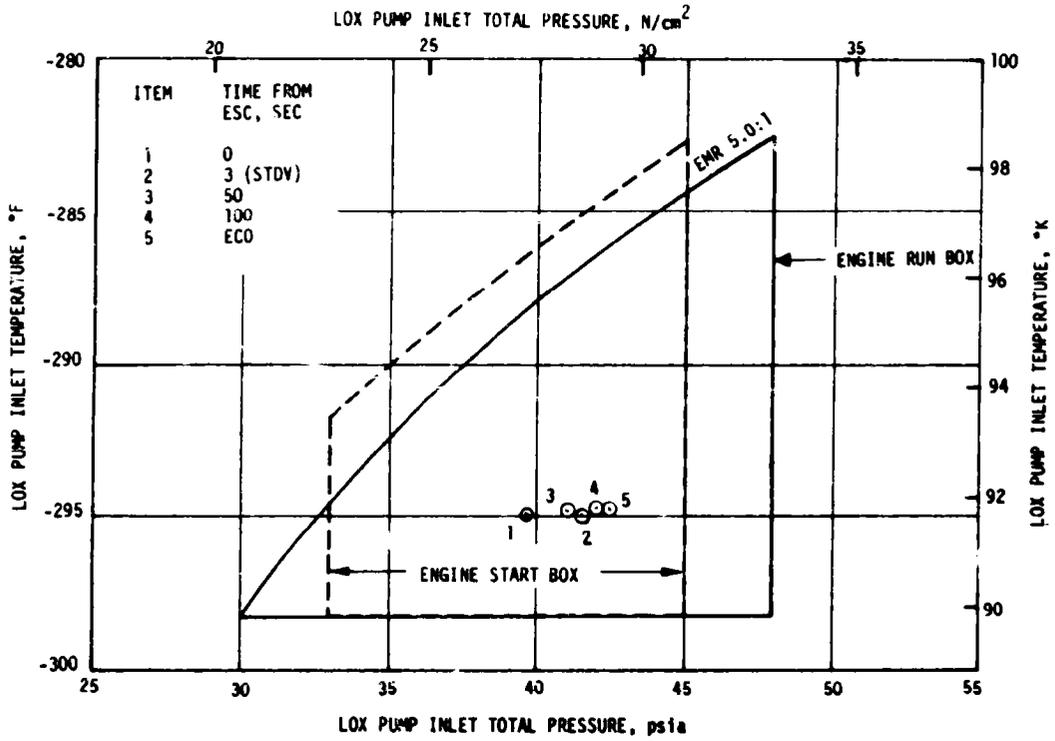
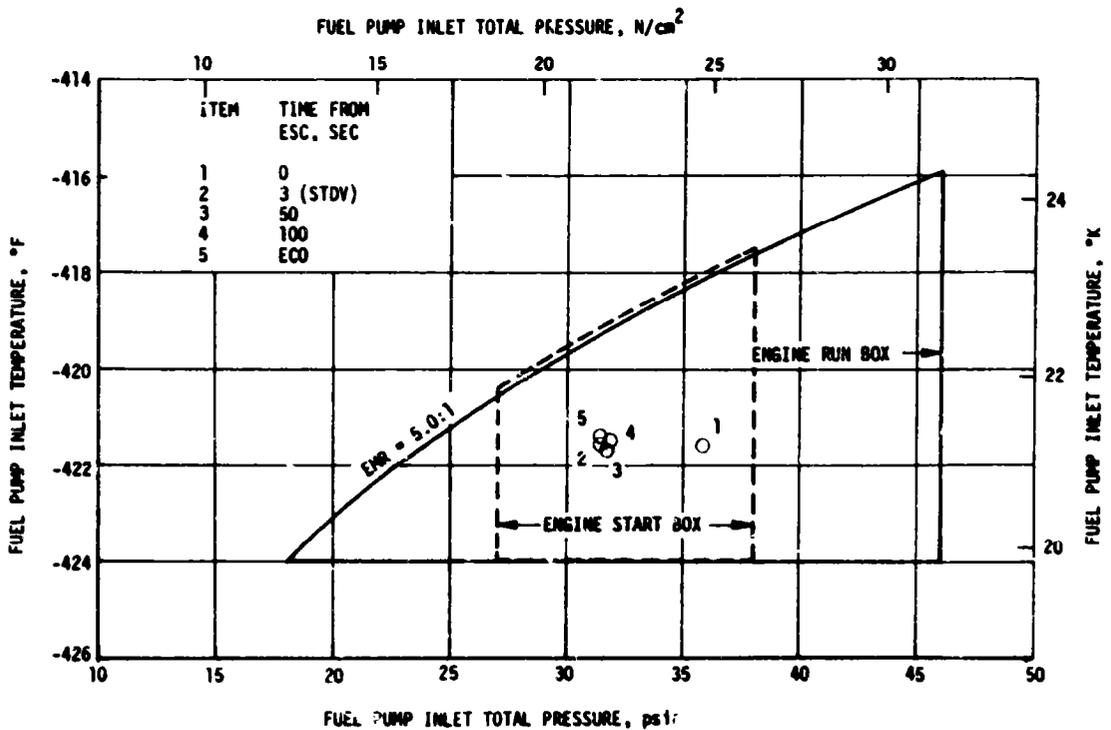
Figure 7-1. S-IVB Start Box and Run Requirements - First Burn

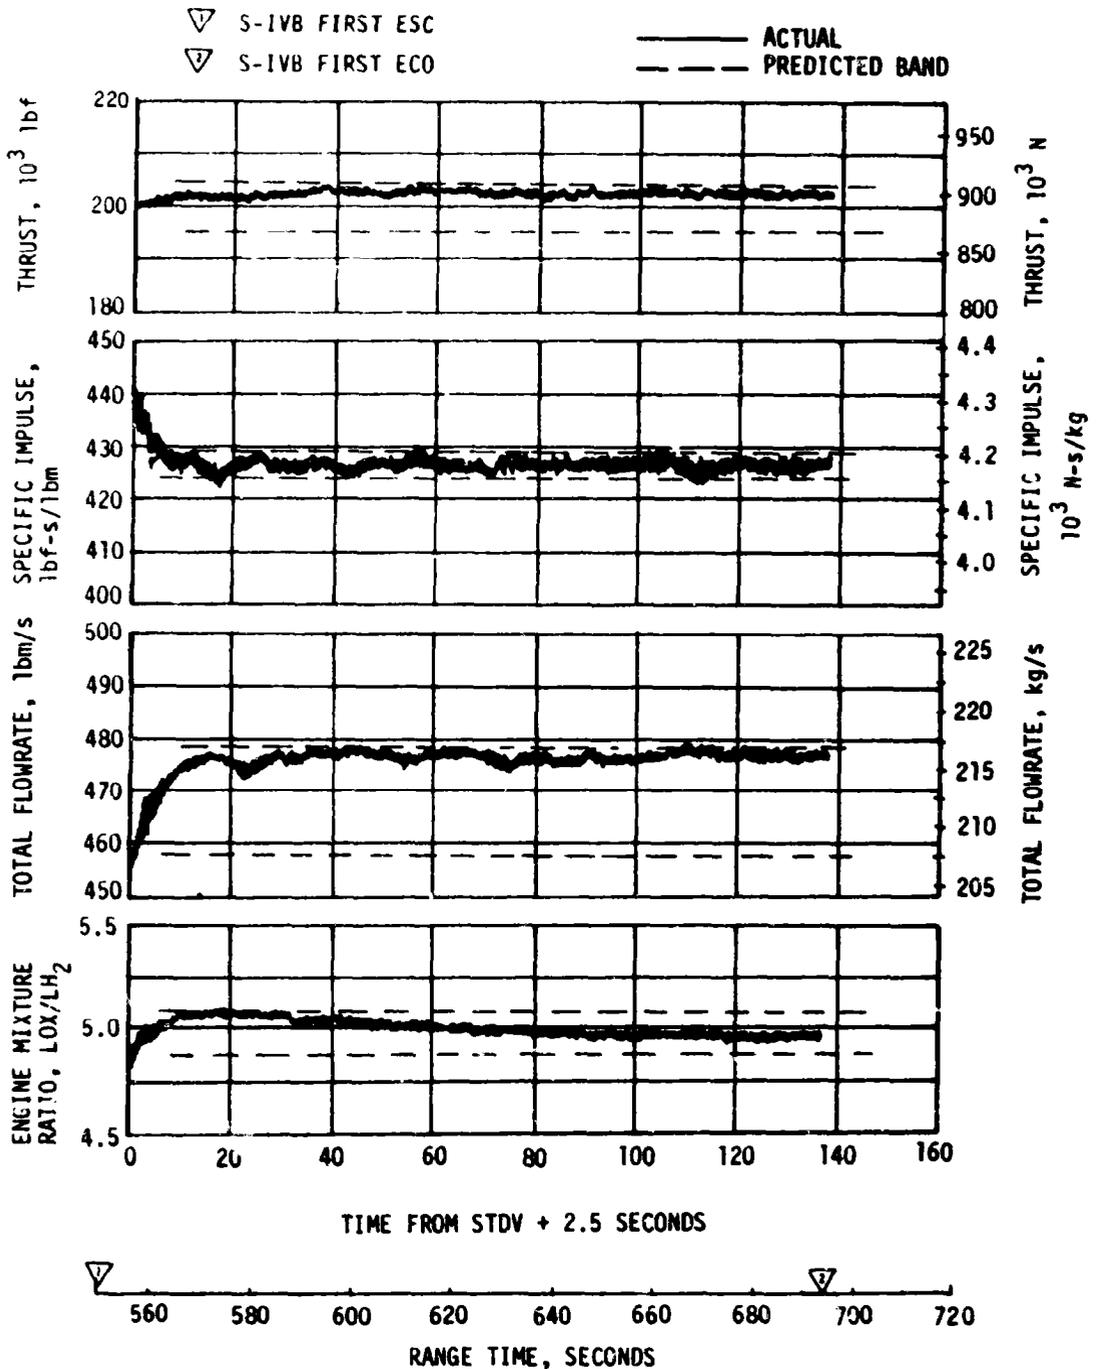
Figure 7-2. S-IVB Steady State Performance - First Burn

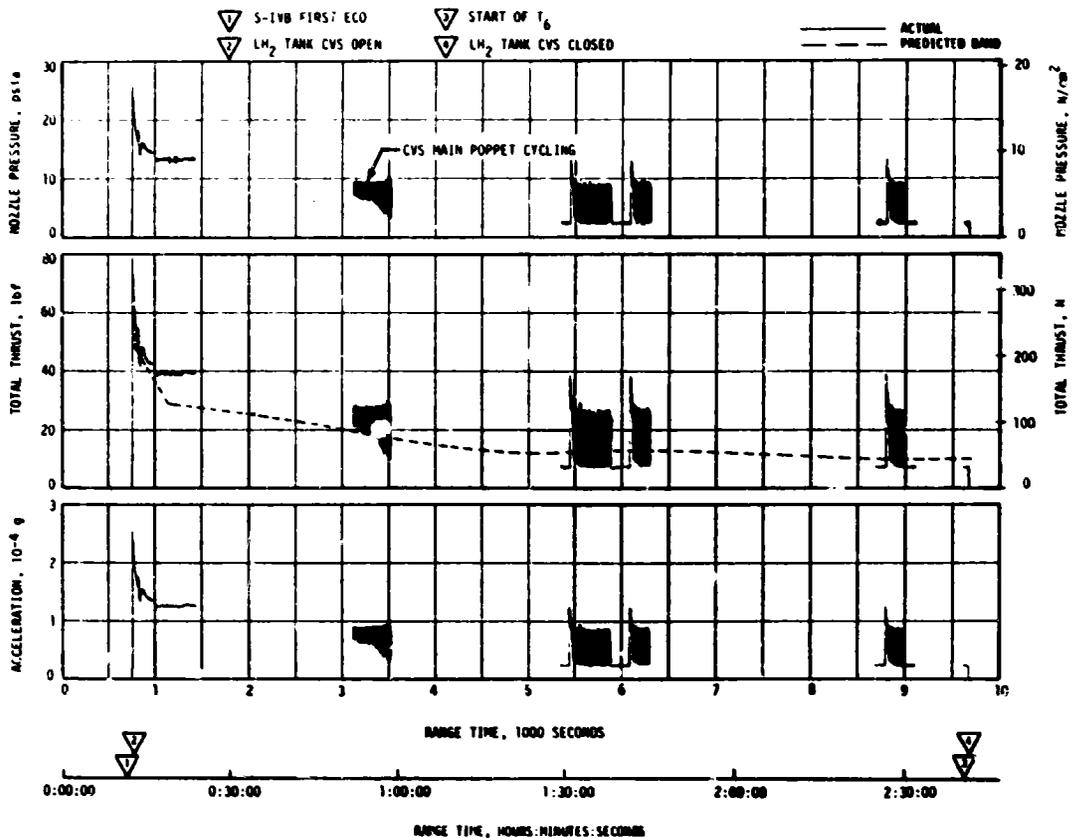
Calculations based on estimated temperatures indicate that the mass vented during parking orbit was 2293 lbm and that the boiloff mass was 2513 lbm.

Figure 7-3. S-IVB CVS Performance - Coast Phase

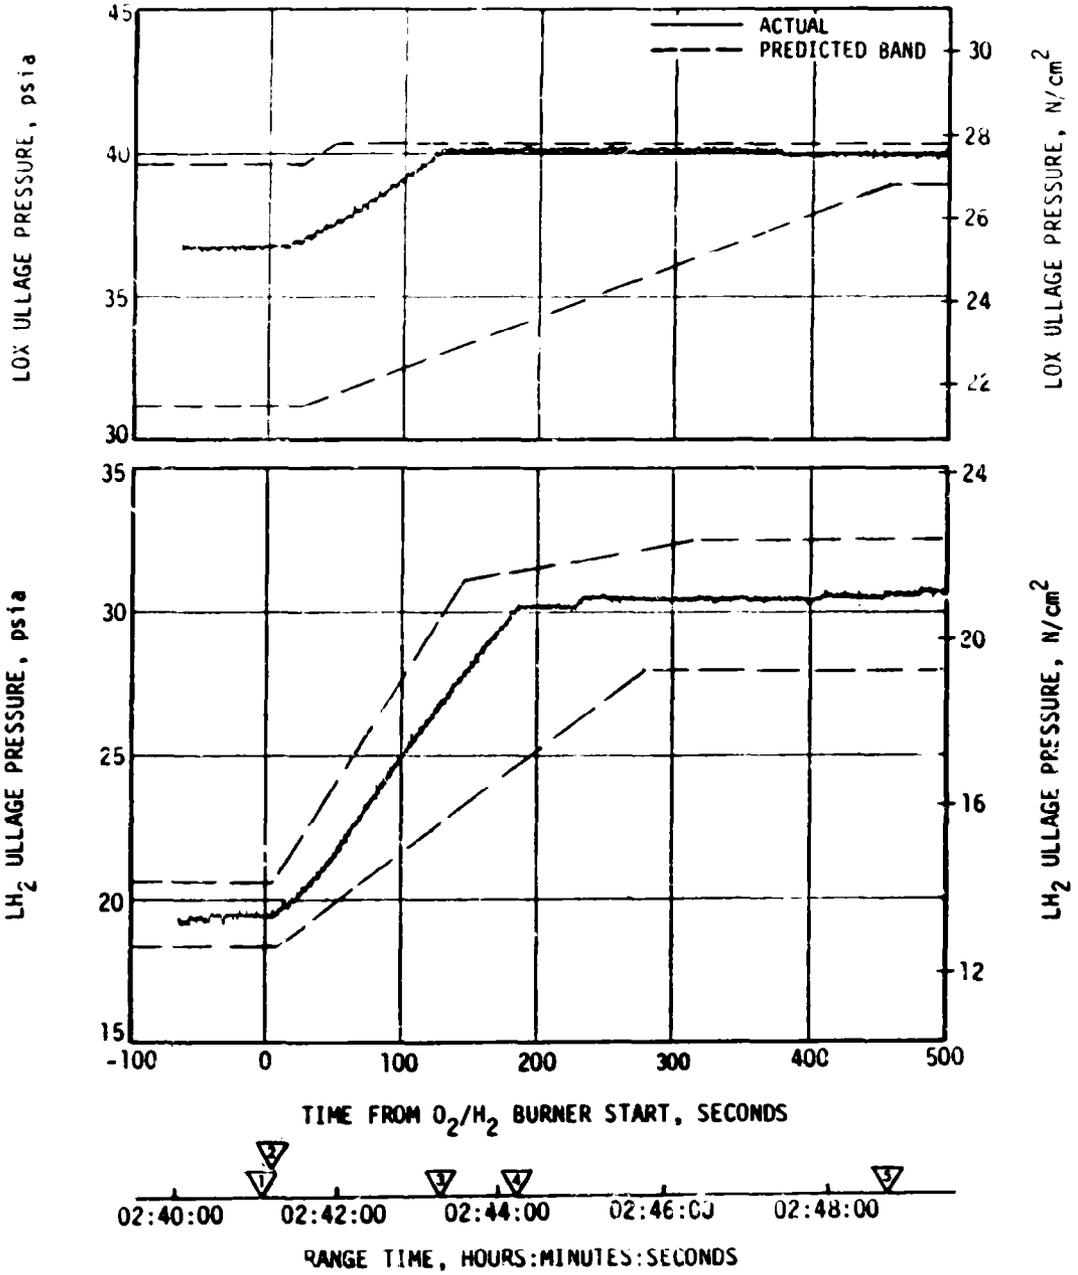
- 1 O_2/H_2 BURNER ON
- 2 LH_2 AND LOX CRYOGENIC REPRESS VALVES OPEN
- 3 TERMINATION OF LOX TANK REPRESS
- 4 TERMINATION OF LH_2 TANK REPRESS
- 5 O_2/H_2 BURNER OFF

Figure 7-4. S-IVB Ullage Condition During Repressurization Using O_2/H_2 Burner

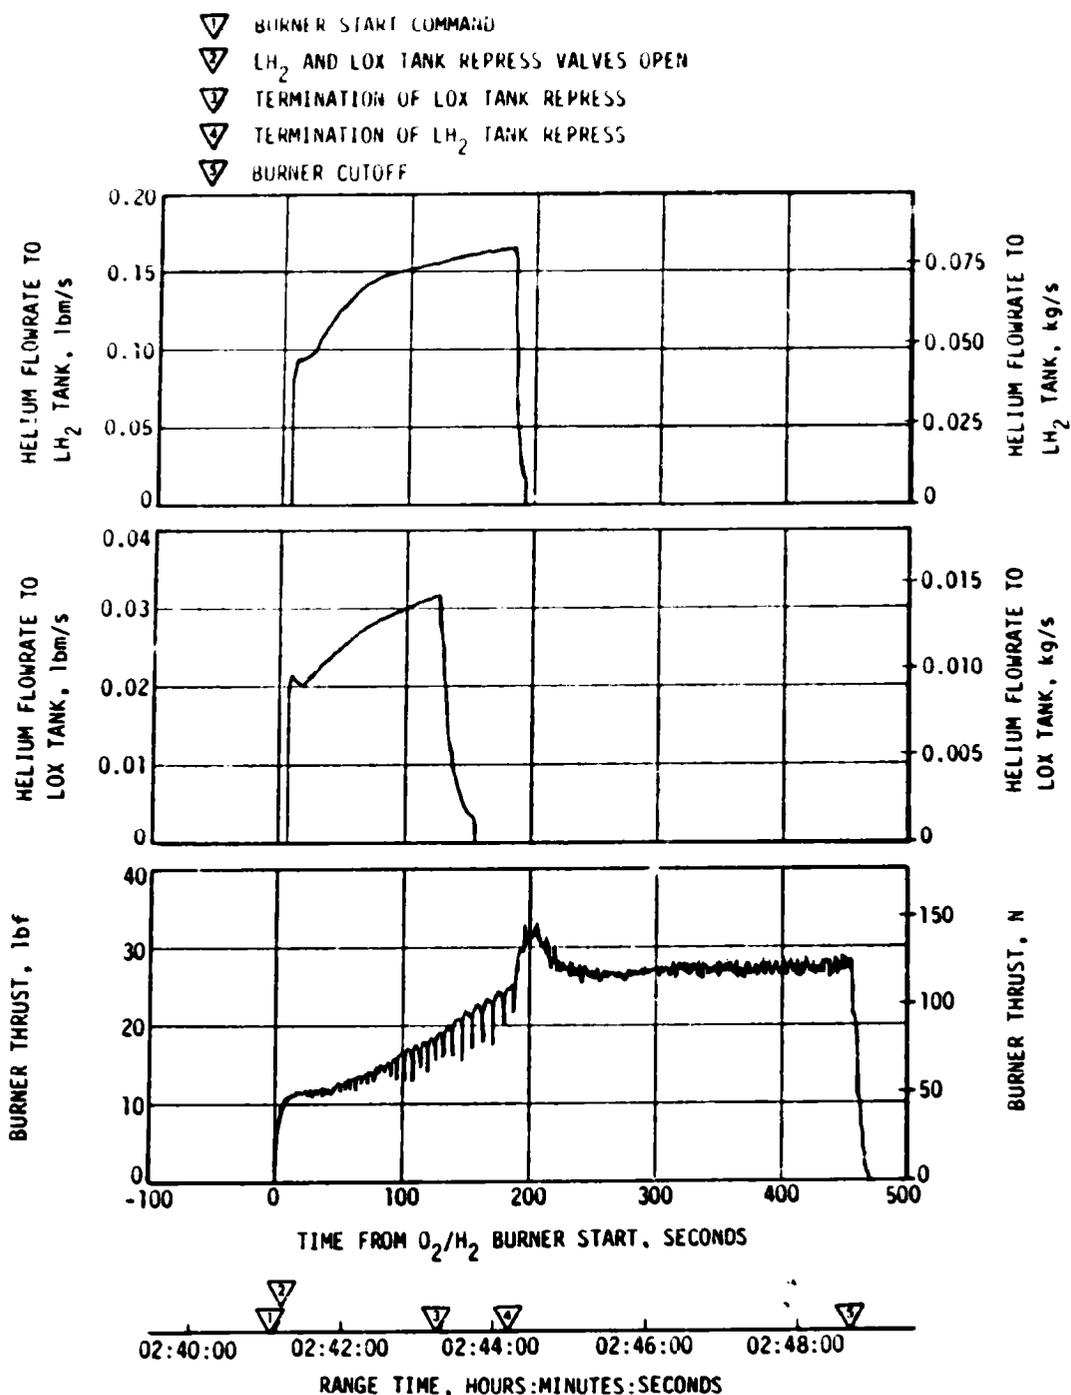
Figure 7-5. S-IVB O₂/H₂ Burner Thrust and Pressurant Flowrate
