SATURN V LAUNCH VEHICLE FLIGHT EVALUATION REPORT-AS-510 APOLLO 15 MISSION

**SATURN V LAUNCH VEHICLE
FLIGHT EVALUATION REPORT - AS-510
APOLLO 15 MISSION**

**Saturn Flight Evaluation Working Group
George C. Marshall Space Flight Center**

All Mandatory and Desirable Objectives of this mission for the launch vehicle were accomplished except the precise determination of the lunar impact point. It is expected that this will be accomplished at a later date. No failures, anomalies, or deviations occurred that seriously affected the mission.

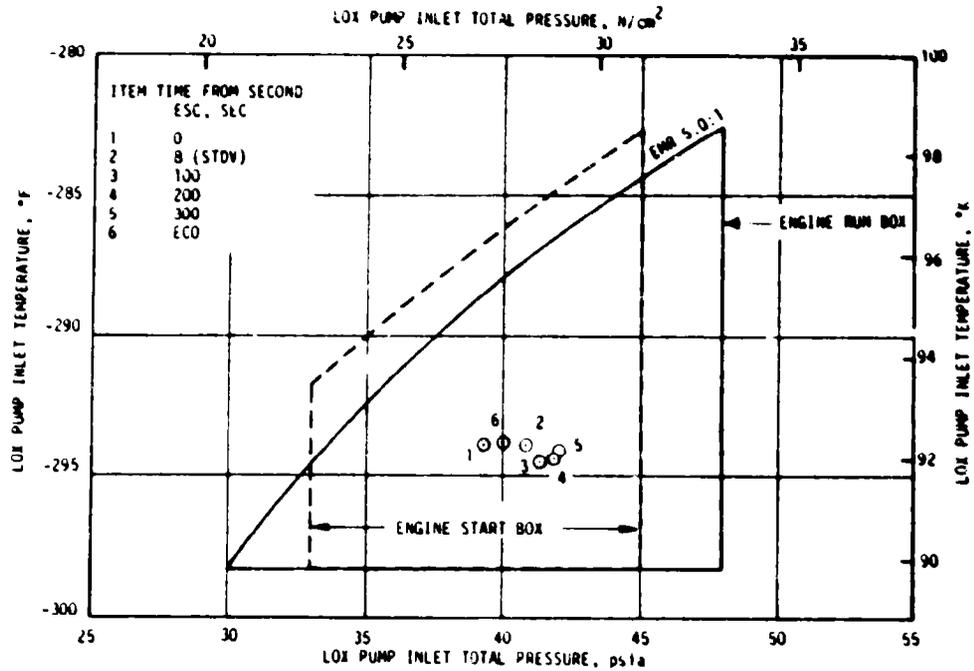
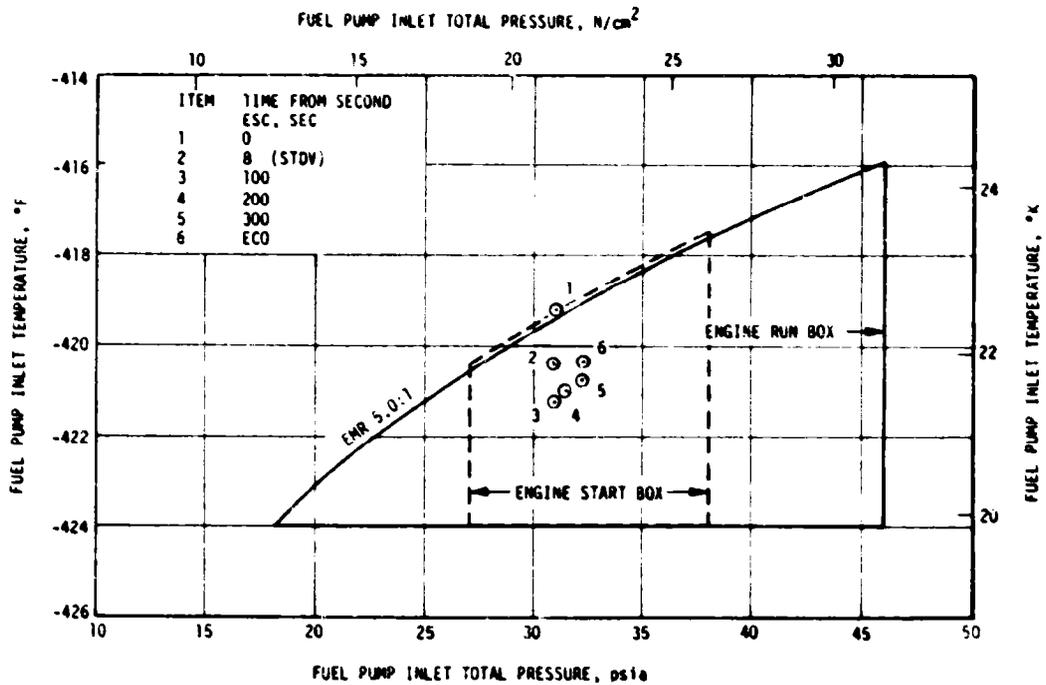
Figure 7-6. S-IVB Start Box and Run Requirements - Second Burn

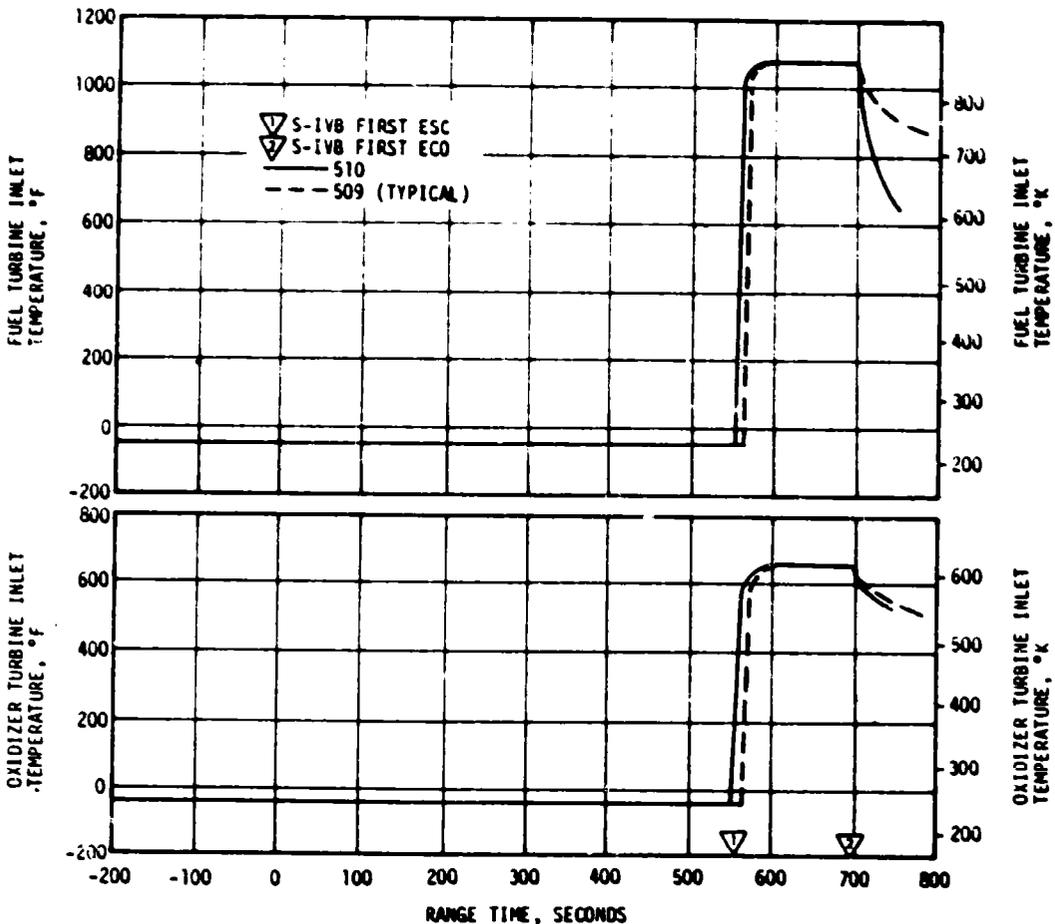
Figure 7-7. S-IVB Engine Turbine Inlet Temperatures Comparison - First Burn

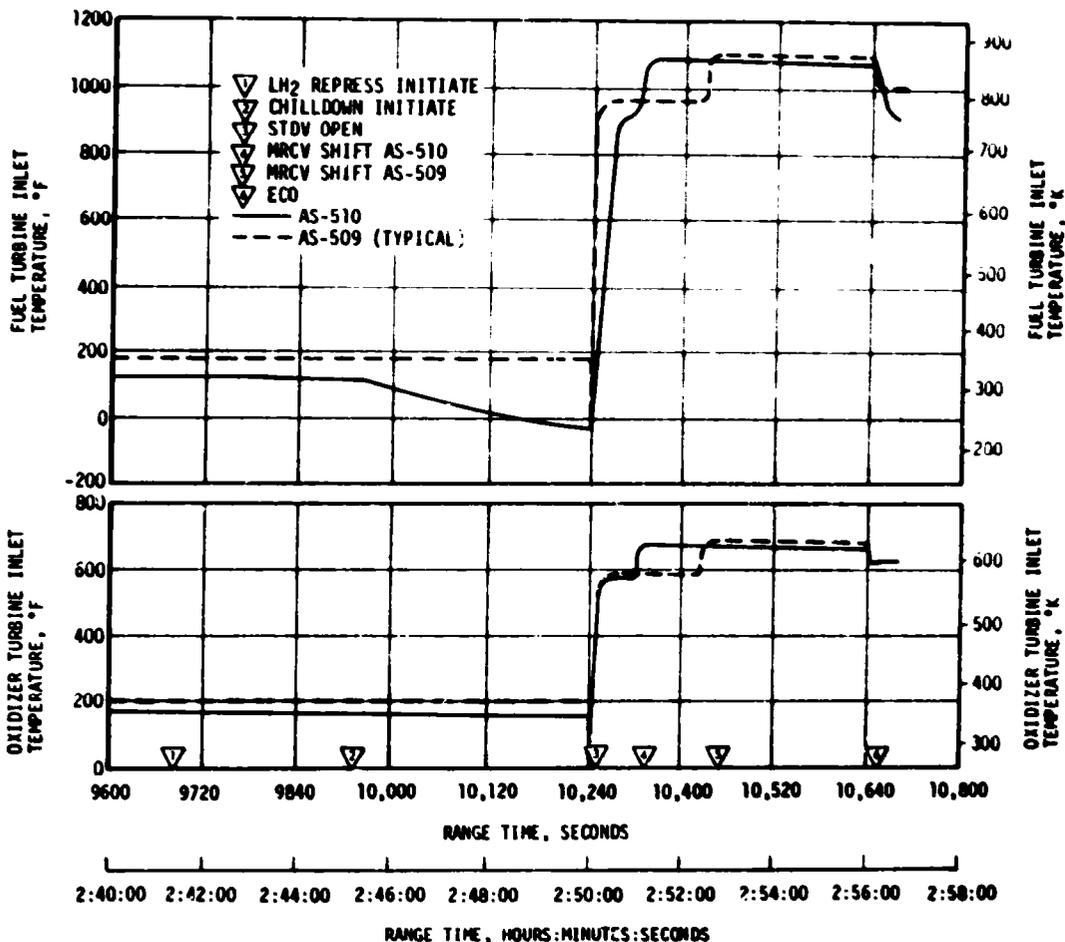
Figure 7-8. S-IVB Engine Turbine Inlet Temperatures Comparison - Second Burn

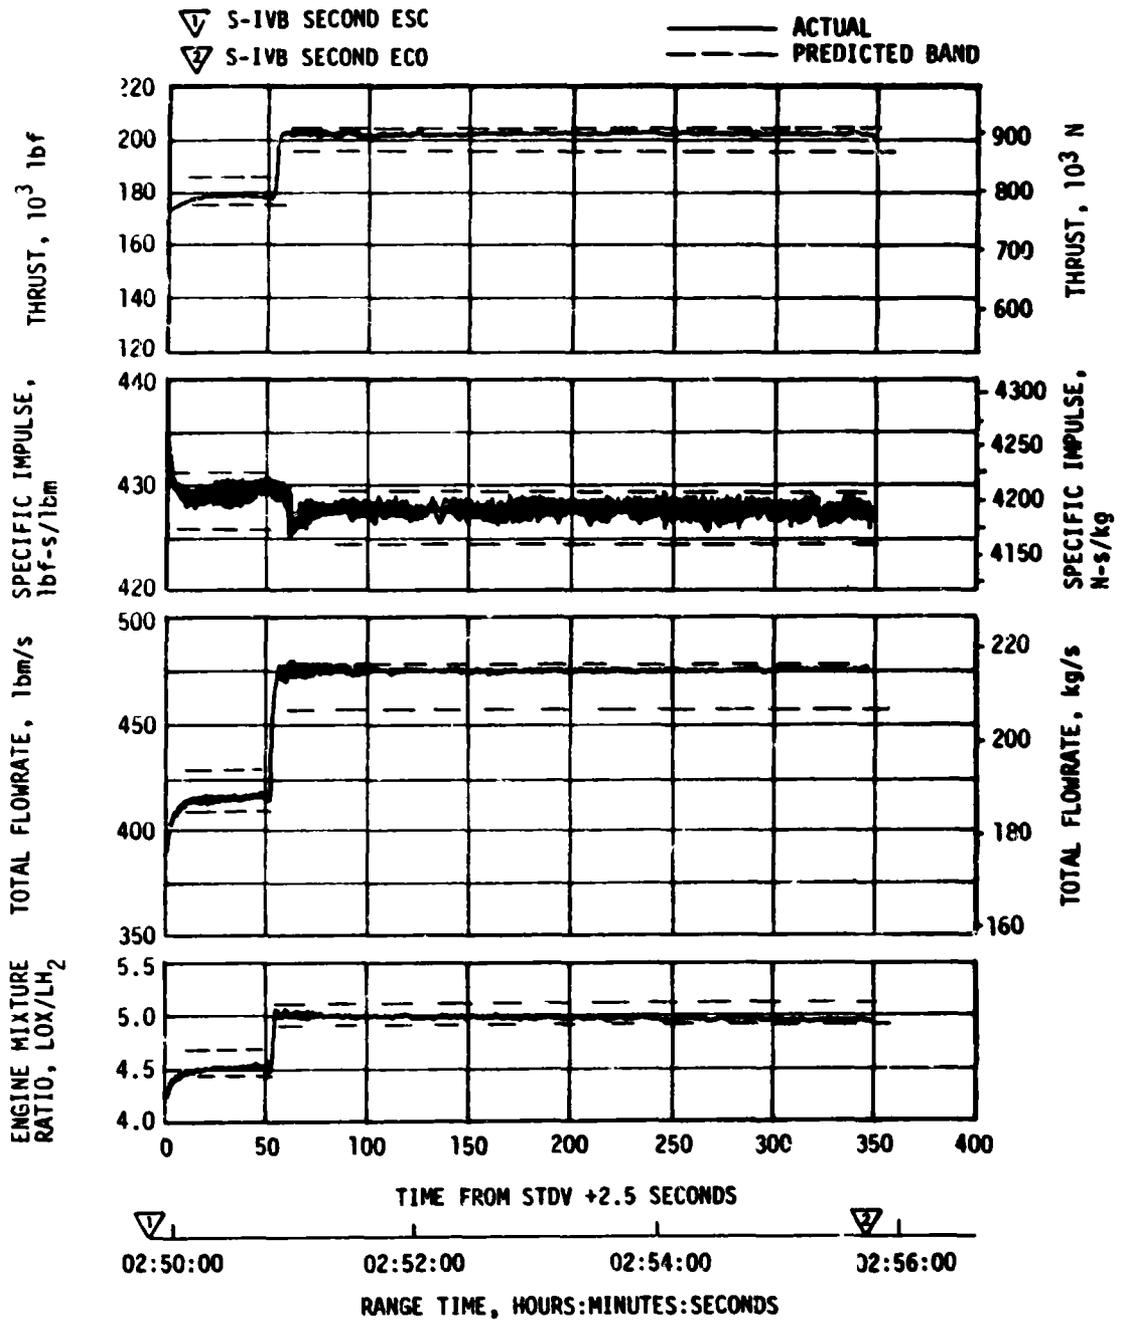
Figure 7-9. S-IVB Steady State Performance - Second Burn.

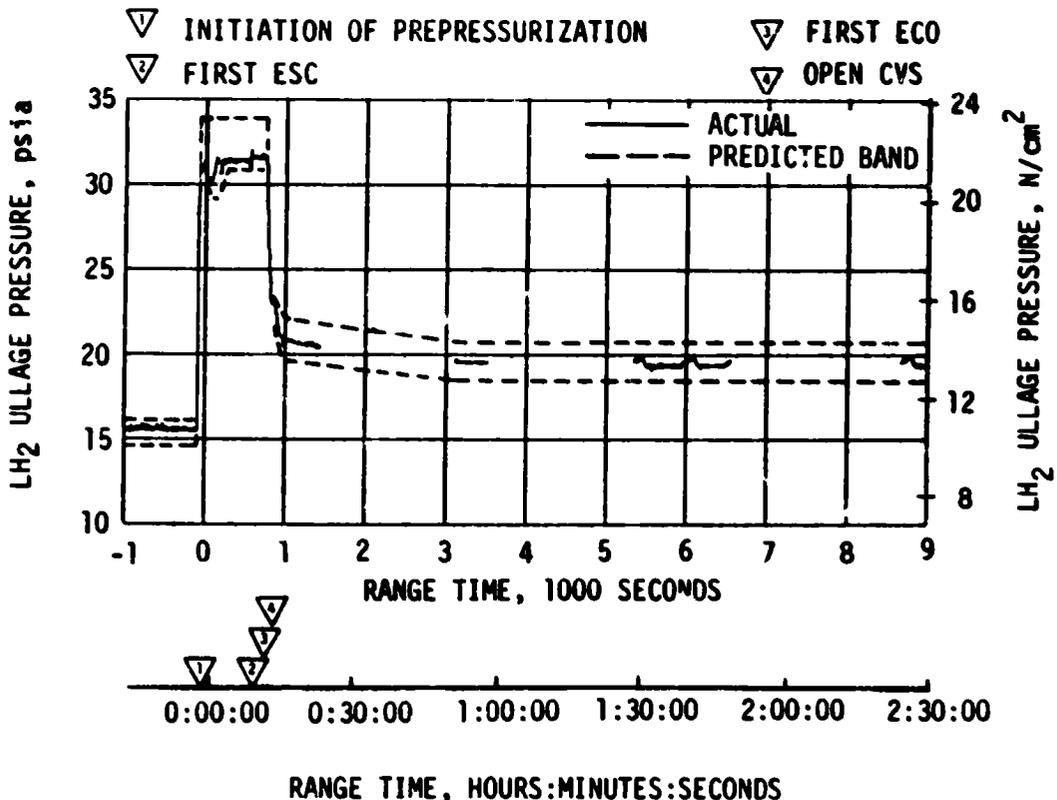
After the post insertion maneuver to the local horizontal, the No. 2 CVS Nozzle temperature dropped to the saturation point and remained there for 20 seconds. Sloshing LH₂ entered the CVS and some LH₂ (approximately 10 lbm) was vented through nozzle No. 2. Since it has been experienced on most of the previous flights (AS-501, AS-502, AS-503, AS-506, AS-507, and AS-508), the introduction of LH₂ into the CVS ducts is not a new occurrence and does not pose a problem. The effect was greater on AS-510 because the size of the post insertion maneuver was larger than those employed on previous flights. More detailed information is given in paragraph 10.4.2.

Figure 7-10. S-IVB LH₂ Ullage Pressure - First Burn and Parking Orbit

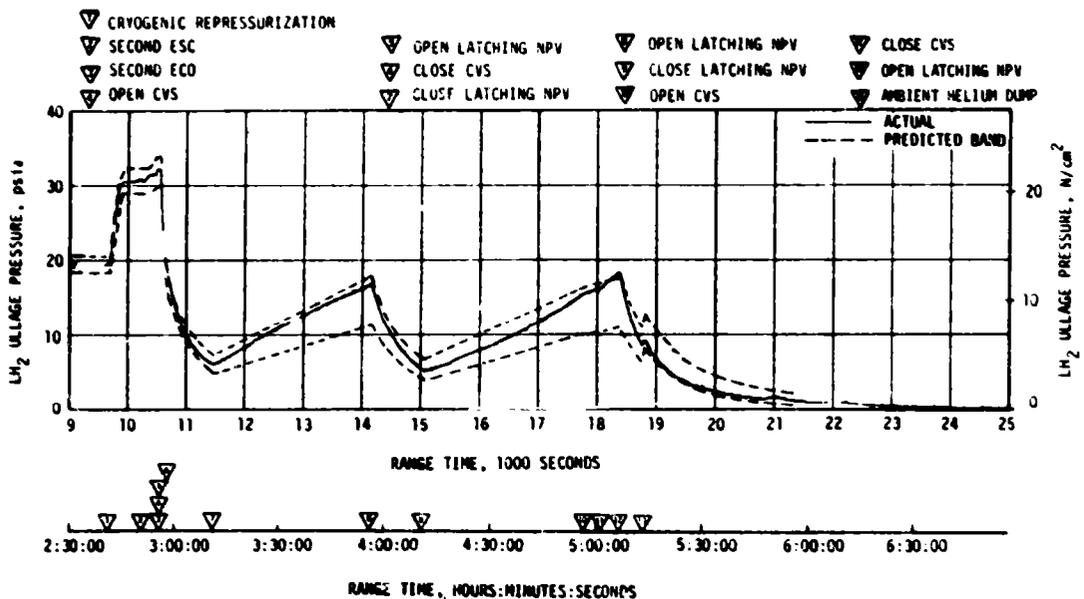
Figure 7-11. S-IVB LH₂ Ullage Pressure - Second Burn and Translunar Coast

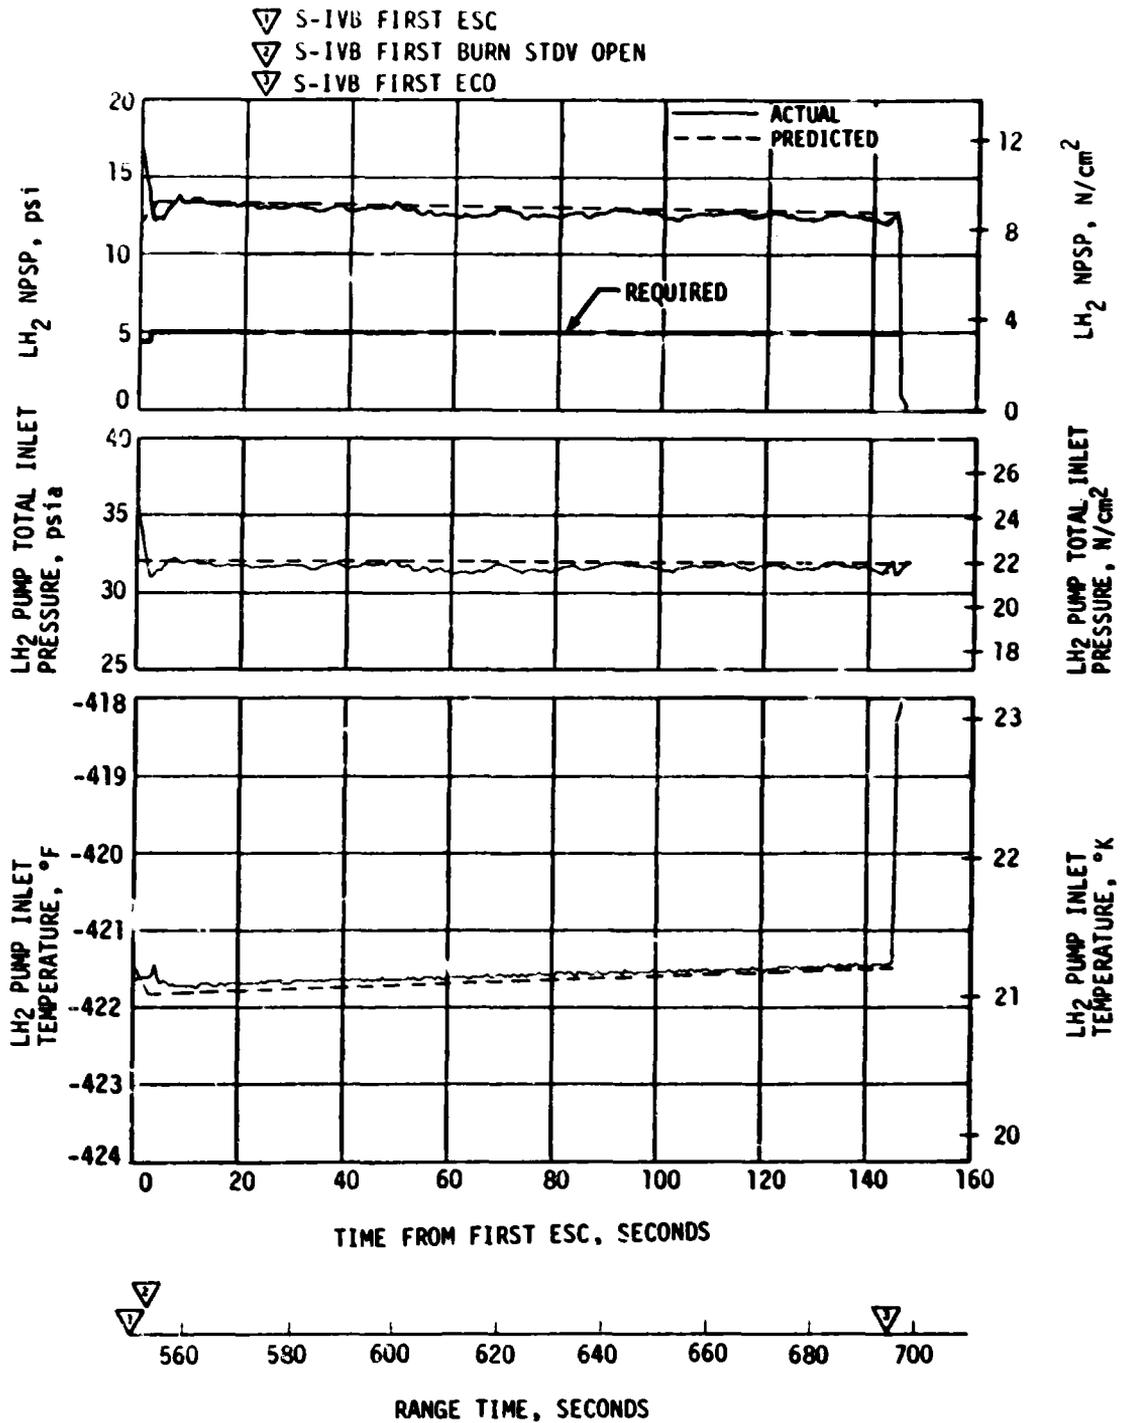
Figure 7-12. S-IVB Fuel Pump Inlet Conditions - First Burn

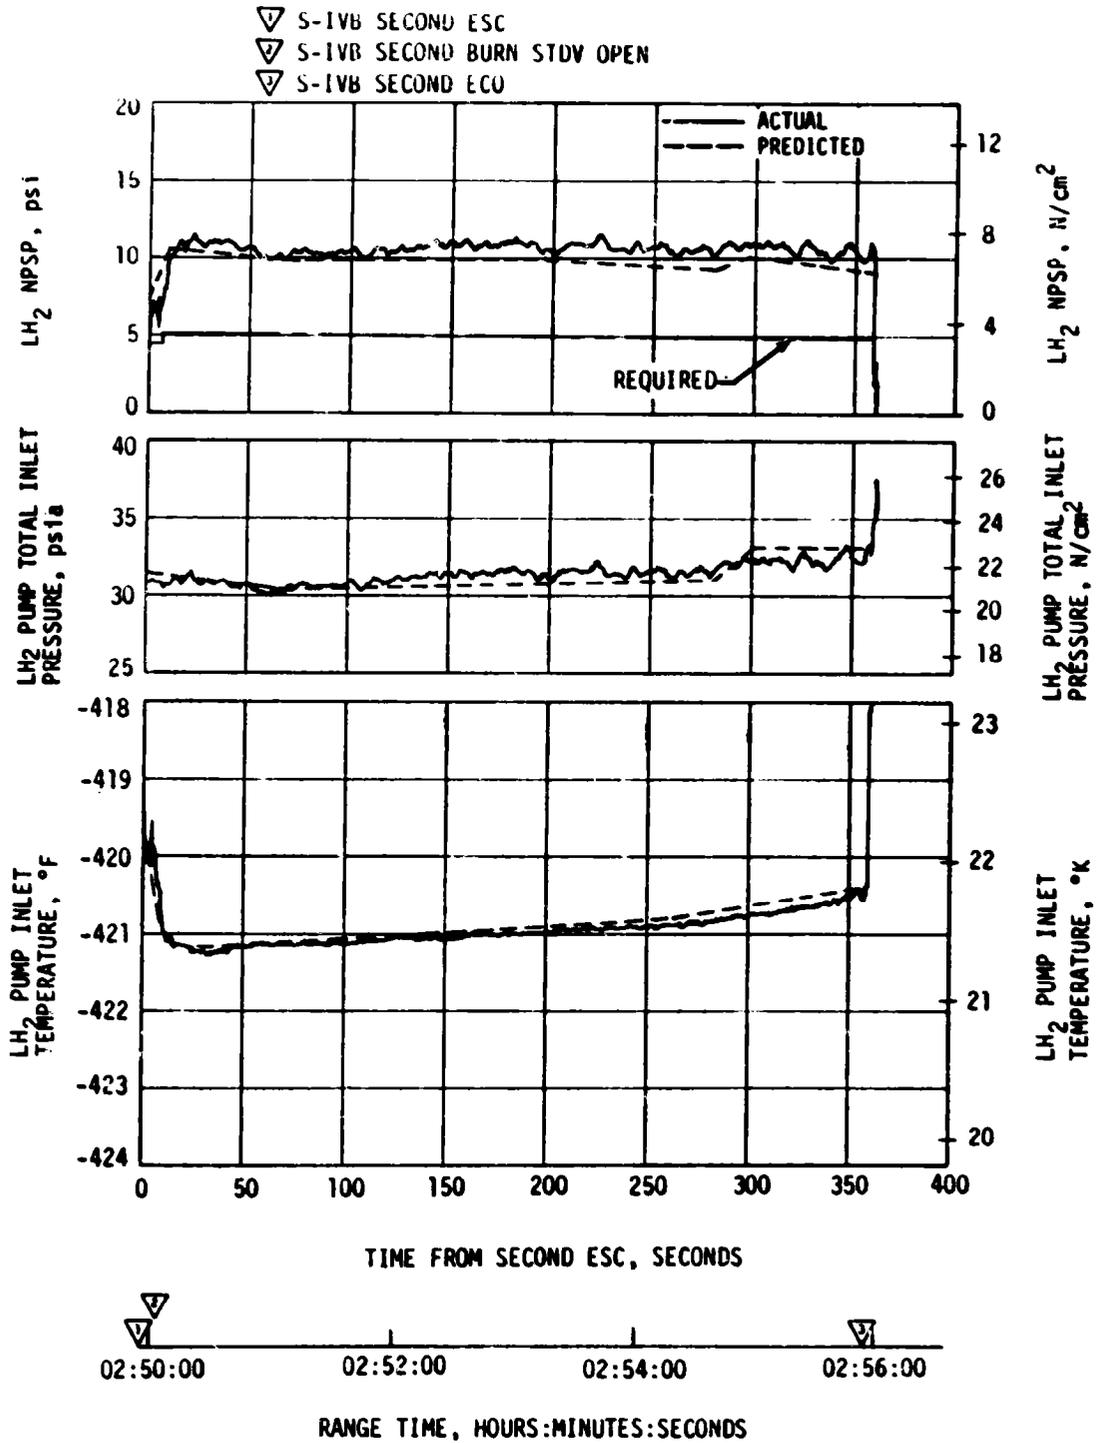
Figure 7-13. S-IVB Fuel Pump Inlet Conditions - Second Burn

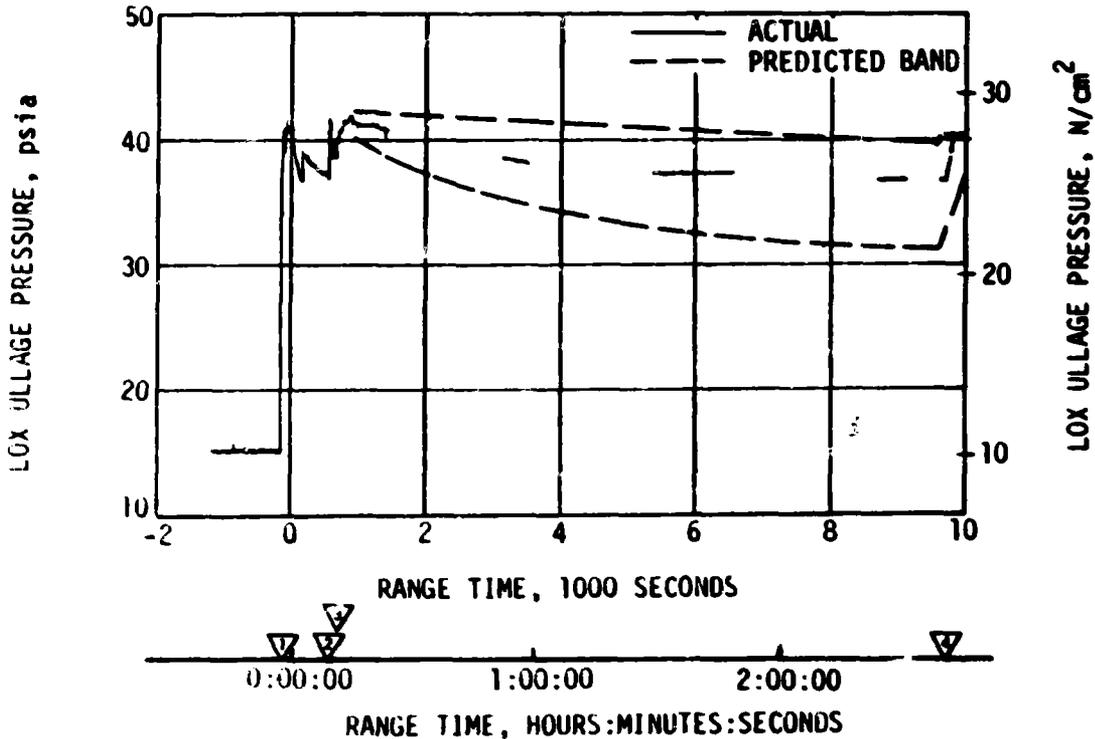
LOX tank prepressurization was initiated at -167 seconds and increased the LOX tank ullage pressure from ambient to 41.0 psia in 15.1 seconds, as shown in Figure 7-14. Five makeup cycles were required to maintain the LOX tank ullage pressure before the ullage temperature stabilized. At -56 seconds the LOX tank ullage pressure increased from 40.1 to 42.0 psia due to fuel tank prepressurization. The pressure then decreased to 40.6 psia at liftoff.

- ▽ LOX TANK PREPRESSURIZATION INITIATED
- ▽ S-IVB FIRST ENGINE START COMMAND
- ▽ S-IVB VELOCITY CUTOFF COMMAND
- ▽ CRYOGENIC REPRESSURIZATION INITIATED

Figure 7-14. S-IVB LOX Tank Ullage Pressure - First Burn and Earth Parking Orbit

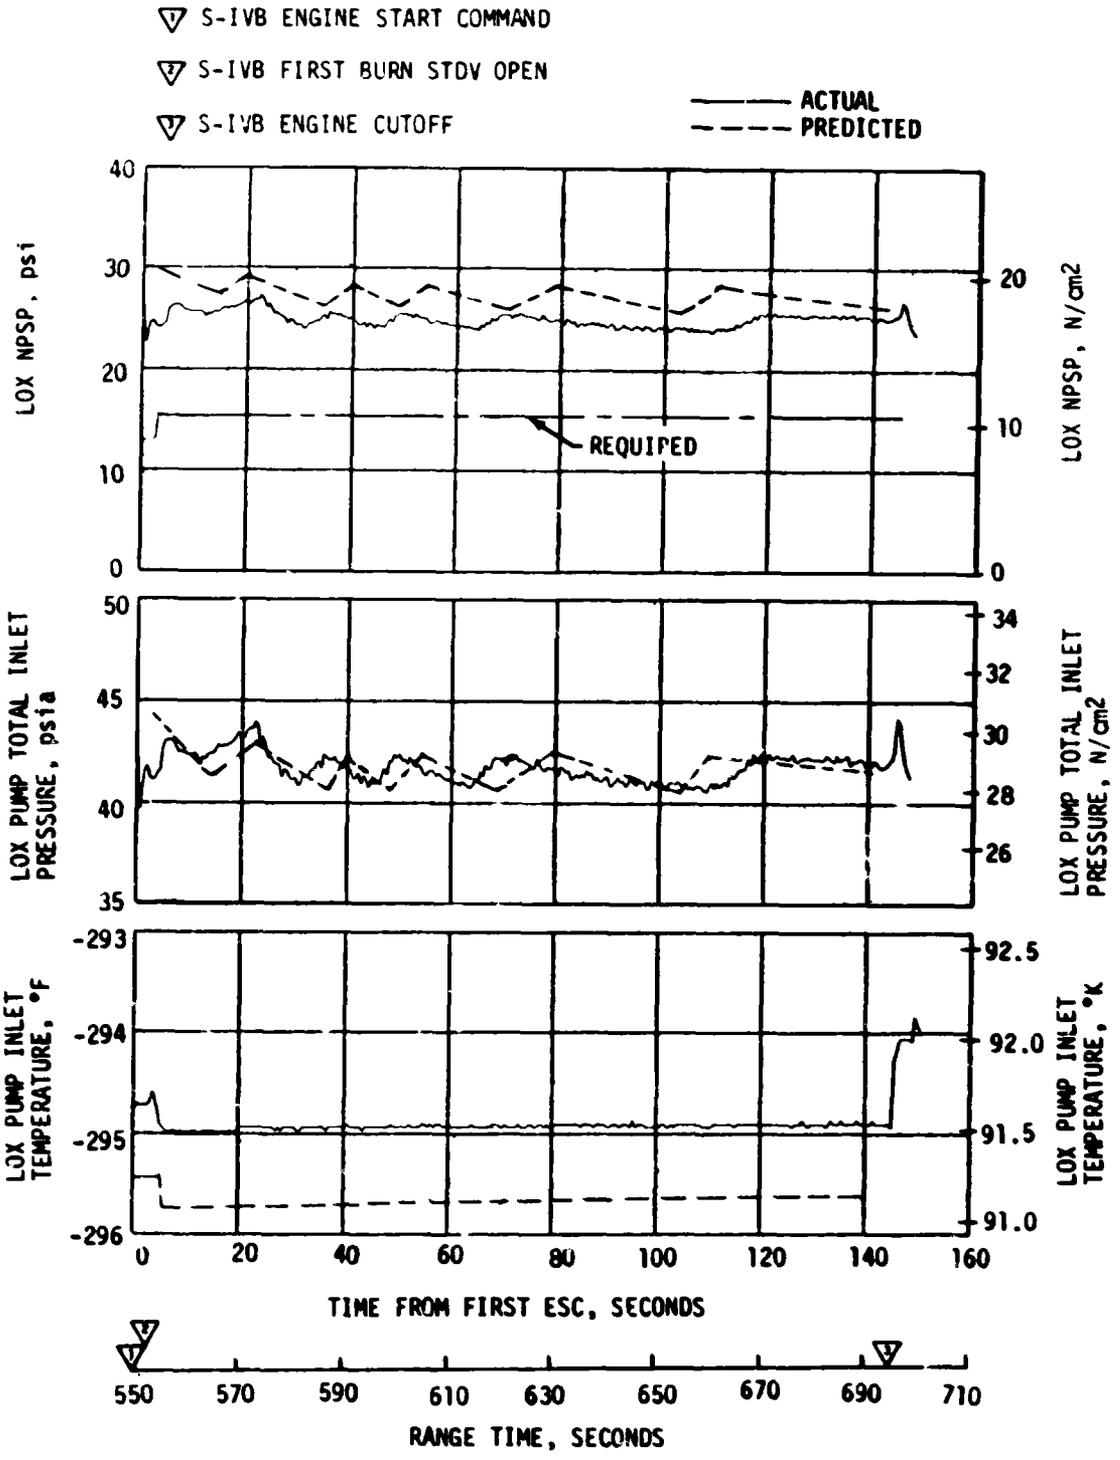
Figure 7-15. S-IVB LOX Pump Inlet Conditions - First Burn

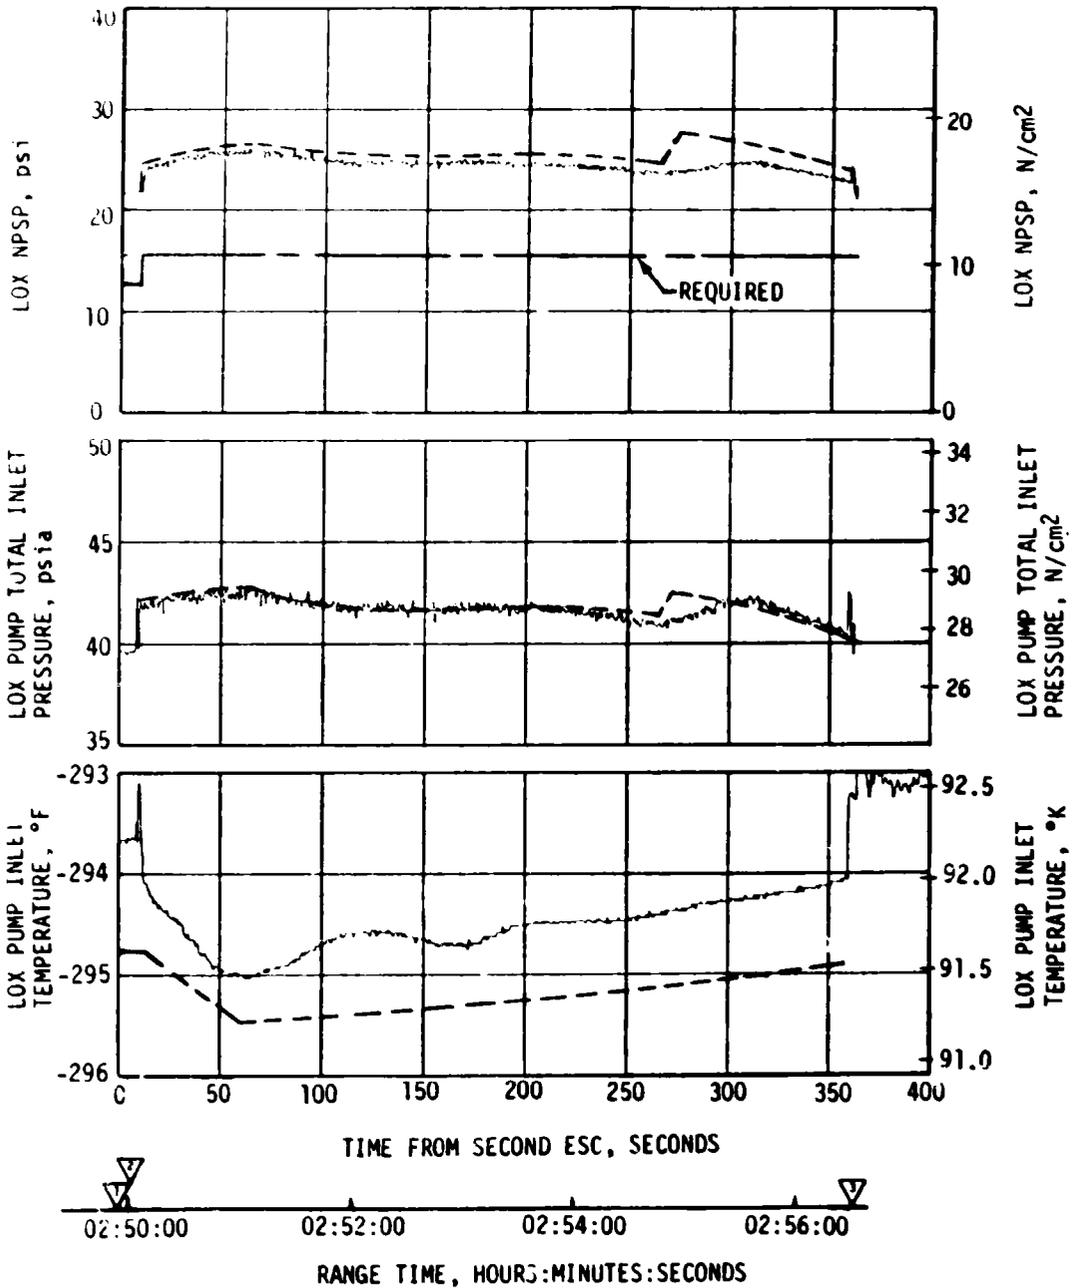
Figure 7-16. S-IVB LOX Pump Inlet Conditions - Second Burn

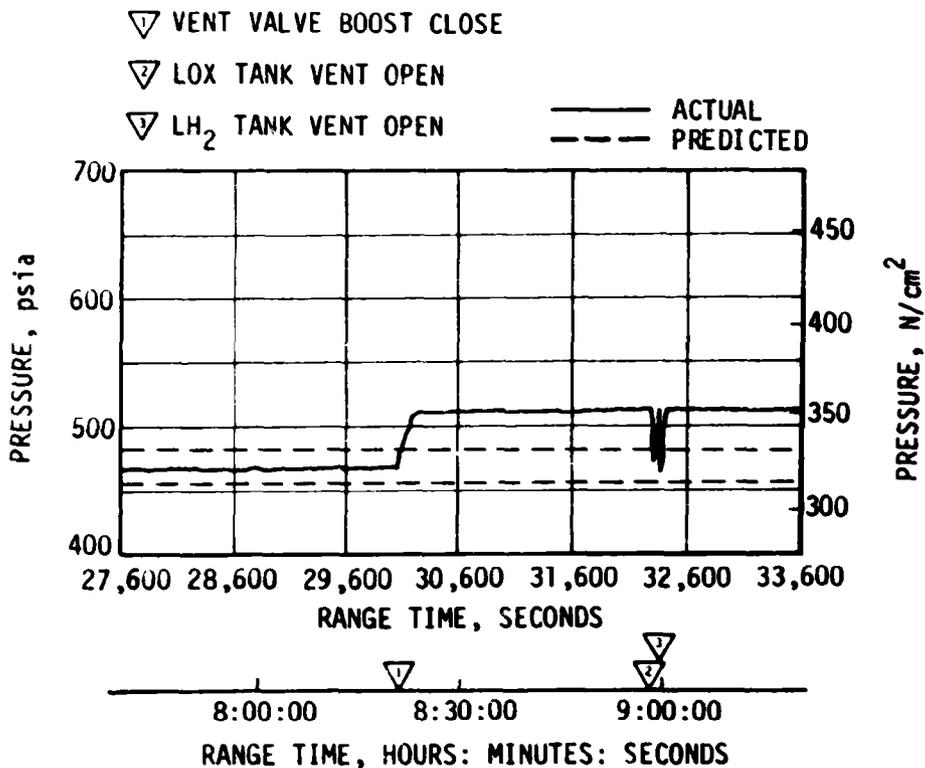
During qualification testing on the regulators, this type of operation was observed while flow testing the regulator below the specification temperature operating limit of -85°F .

Figure 7-18. Pneumatic Regulator Discharge Pressure

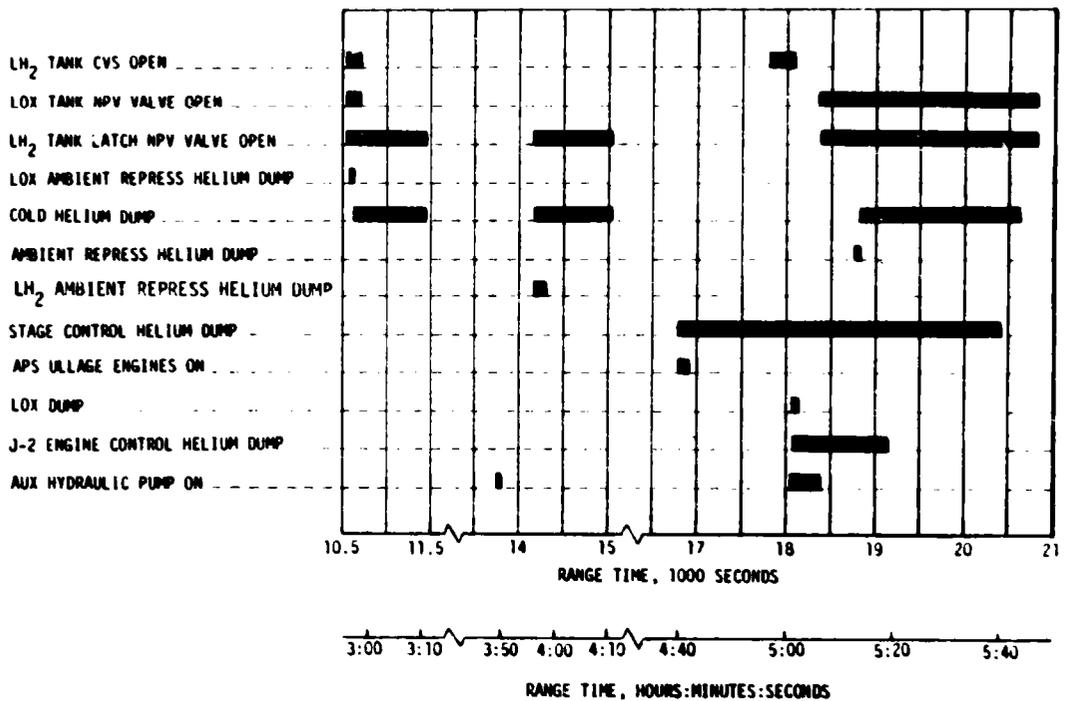
Figure 7-19. S-IVB LOX Dump and Orbital Safing Sequence

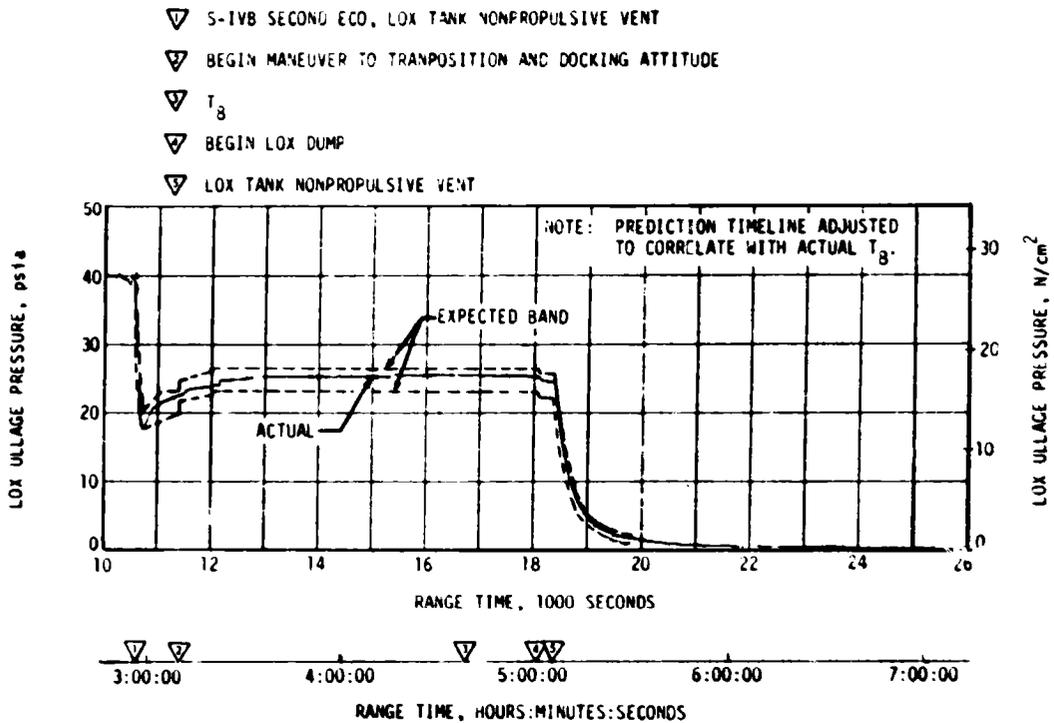
Figure 7-20. S-IVB LOX Tank Ullage Pressure - Second Burn and Translunar Coast

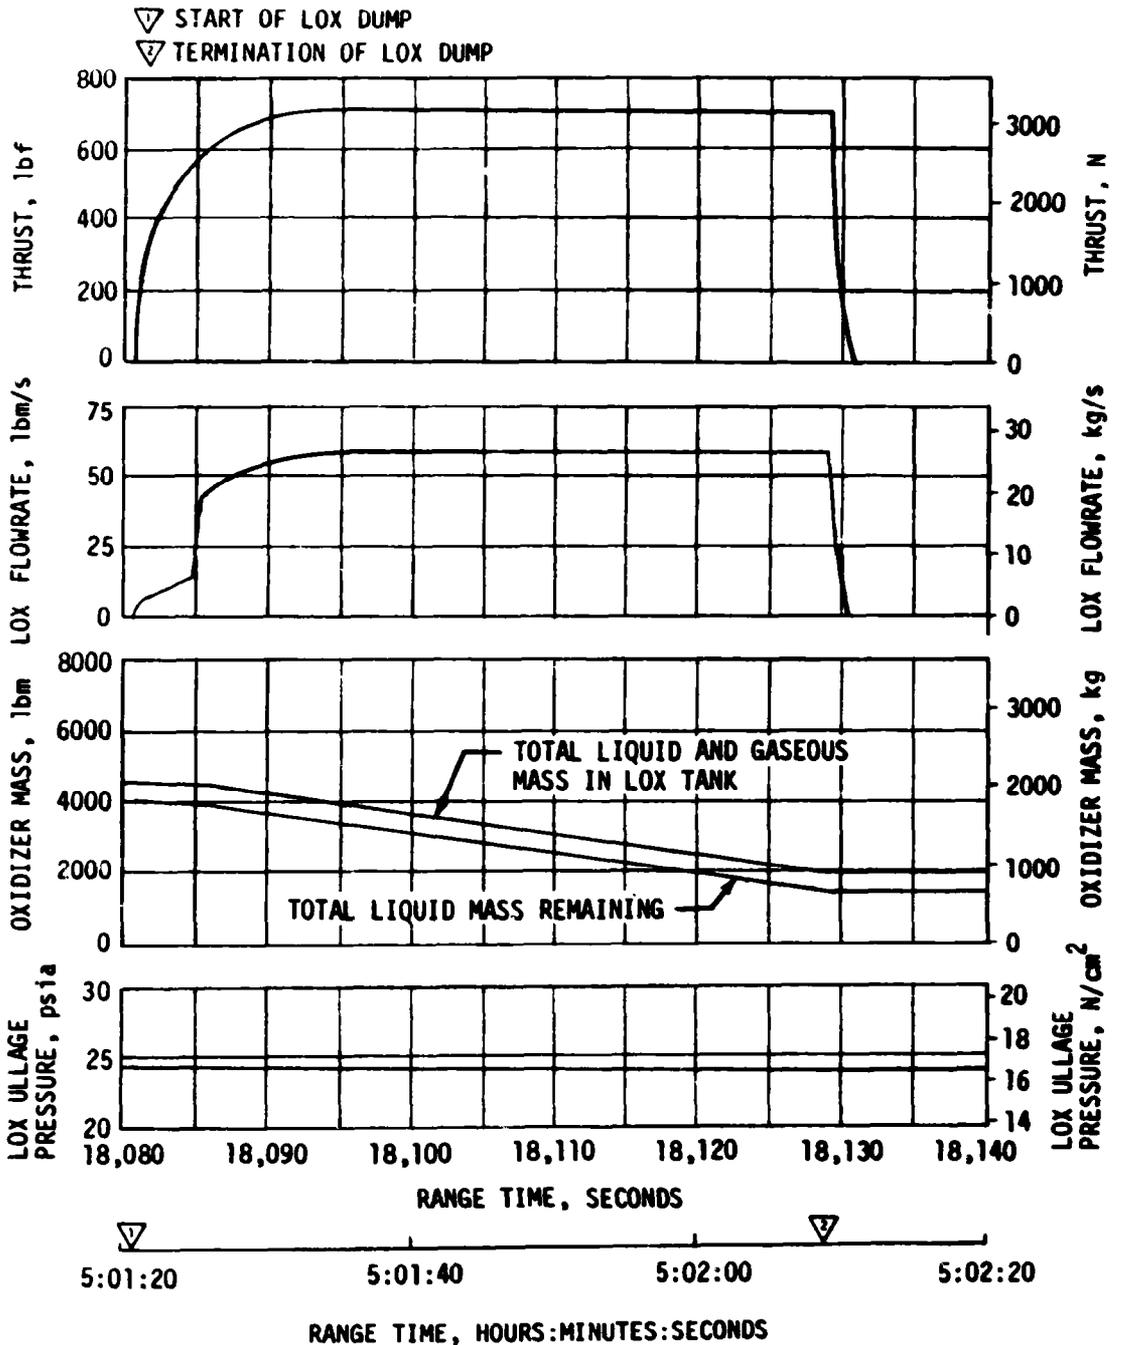
Figure 7-21. S-IVB LOX Dump Parameter Histories

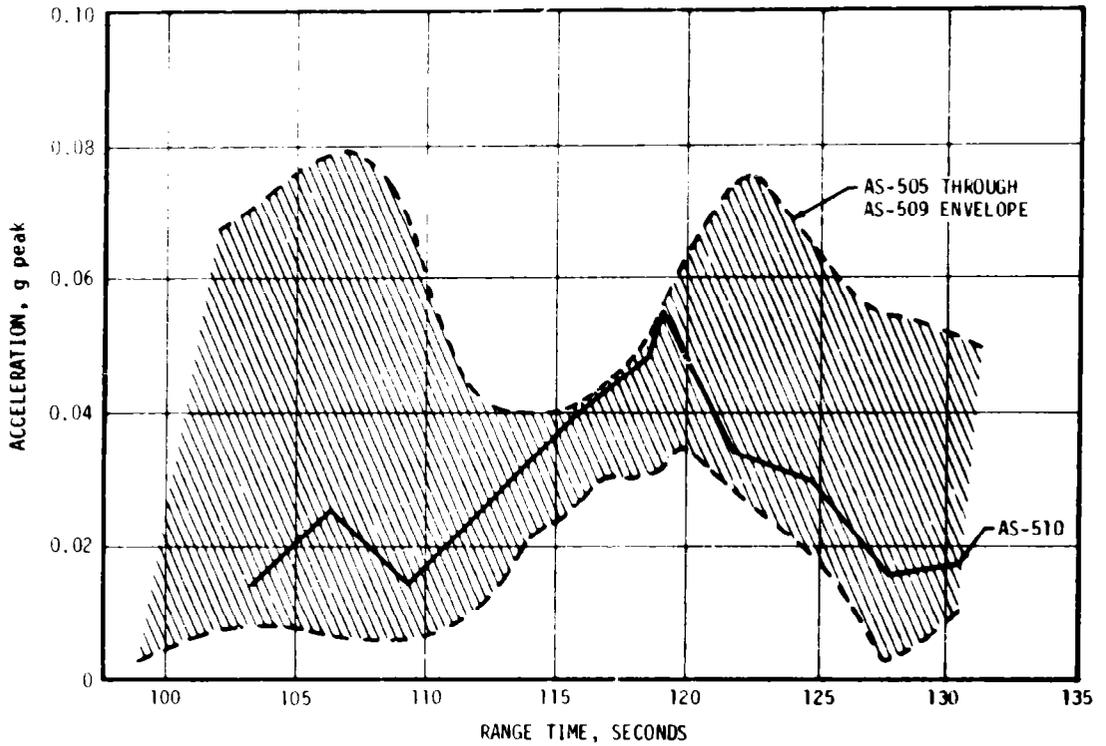
A transient response was experienced shortly after accumulator fill was initiated. The peak response of the LOX pump inlet pressure was approximately 45 psi peak-to-peak with a frequency of 68 hertz, Figure 8-8. The response of the center engine gimbal pad at the corresponding time

Figure 8-4. IU Accelerometer Response During Peak 4-5 Hertz Response (Longitudinal)

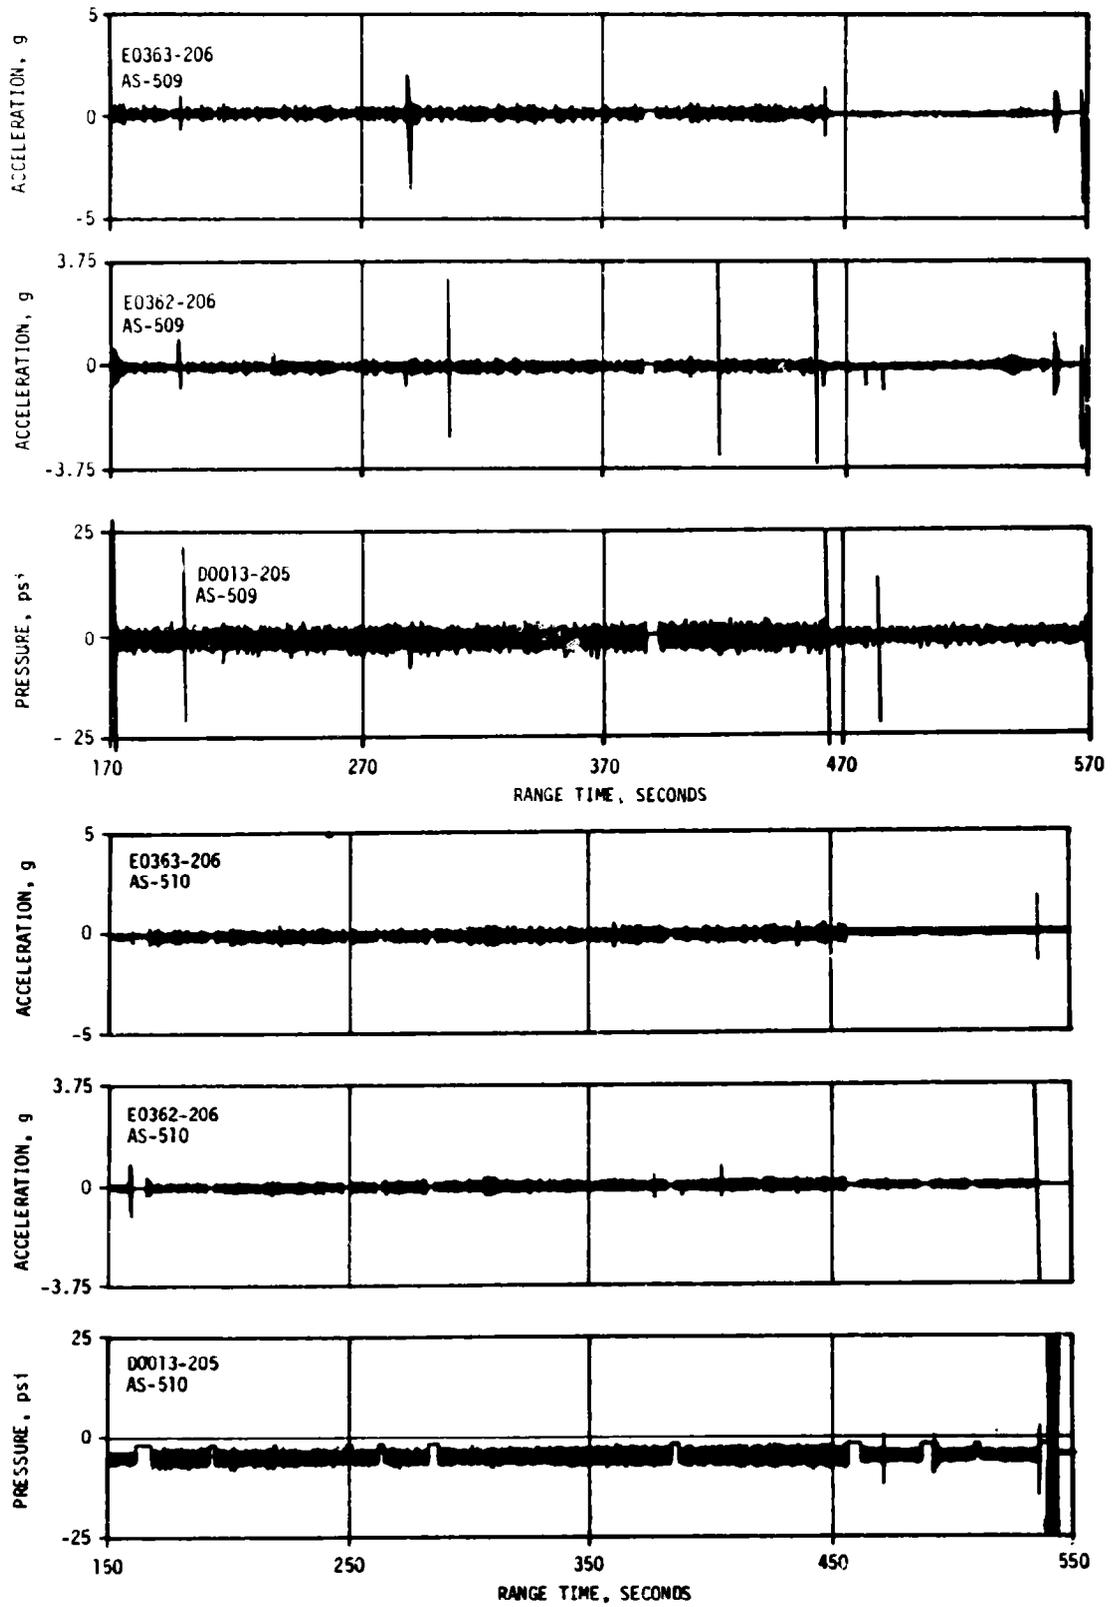
Figure 8-7. AS-510/AS-509 Acceleration and Pressure Oscillations During S-II Burn (8 to 20 Hz Filter)

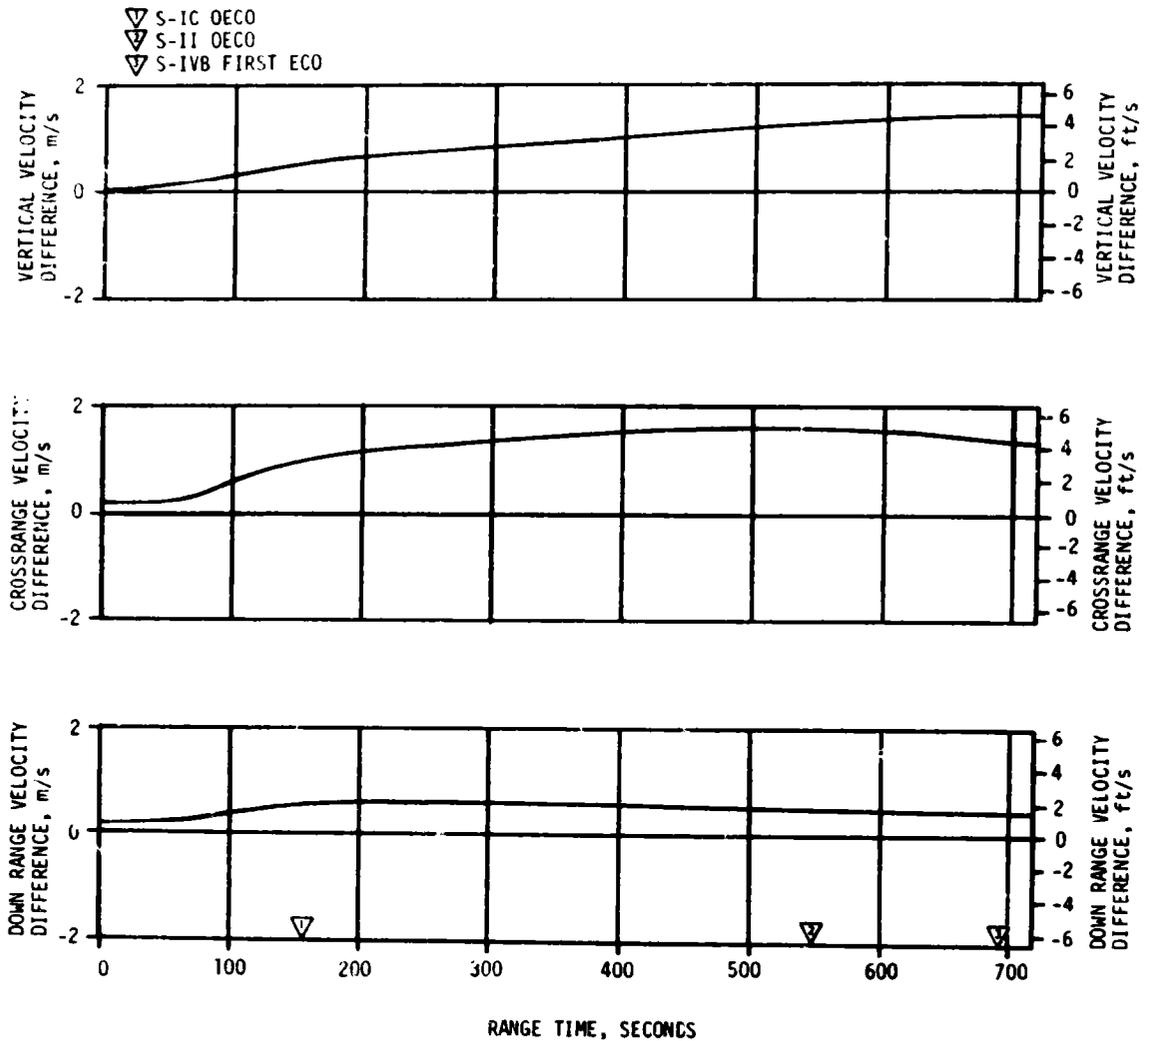
Figure 9-1. Trajectory and ST-124M-3 Platform Velocity Comparison, Boost-To-EPO (Trajectory Minus LVDC)

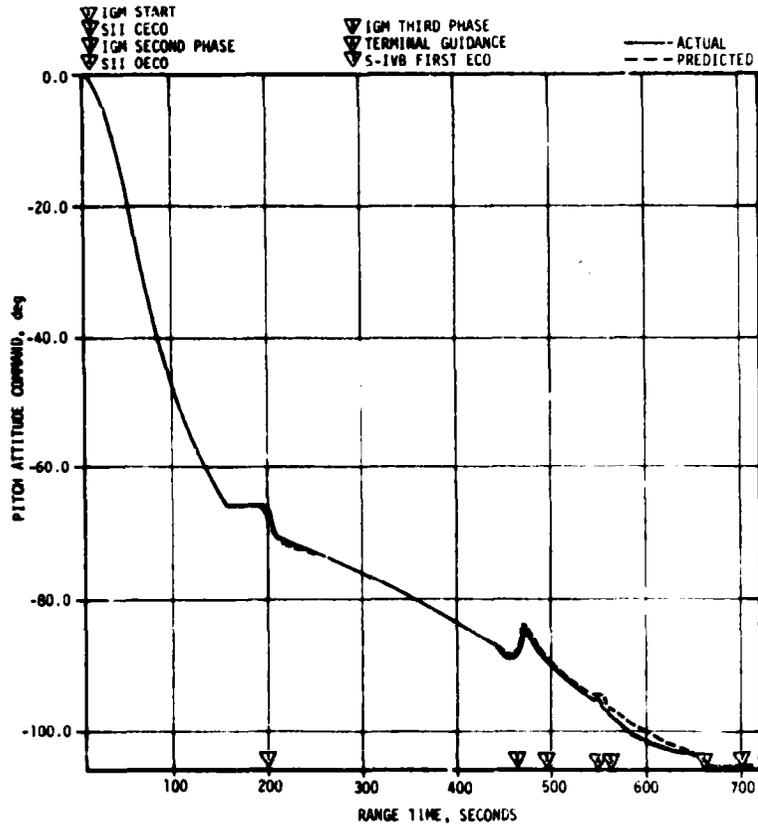
Figure 9-10. Rate-Limited Pitch Steering Command - AS-510 First Burn

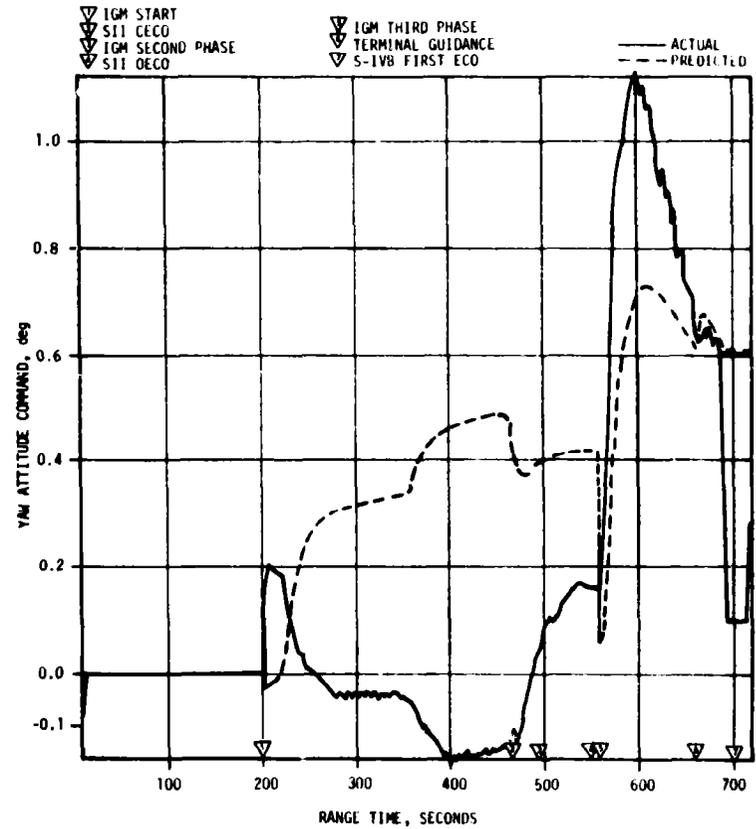
Figure 9-11. Rate-Limited Yaw Steering Command - AS-510 First Burn
