SATURN V LAUNCH VEHICLE FLIGHT EVALUATION REPORT-AS-510 APOLLO 15 MISSION

**SATURN V LAUNCH VEHICLE
FLIGHT EVALUATION REPORT - AS-510
APOLLO 15 MISSION**

**Saturn Flight Evaluation Working Group
George C. Marshall Space Flight Center**

All Mandatory and Desirable Objectives of this mission for the launch vehicle were accomplished except the precise determination of the lunar impact point. It is expected that this will be accomplished at a later date. No failures, anomalies, or deviations occurred that seriously affected the mission.

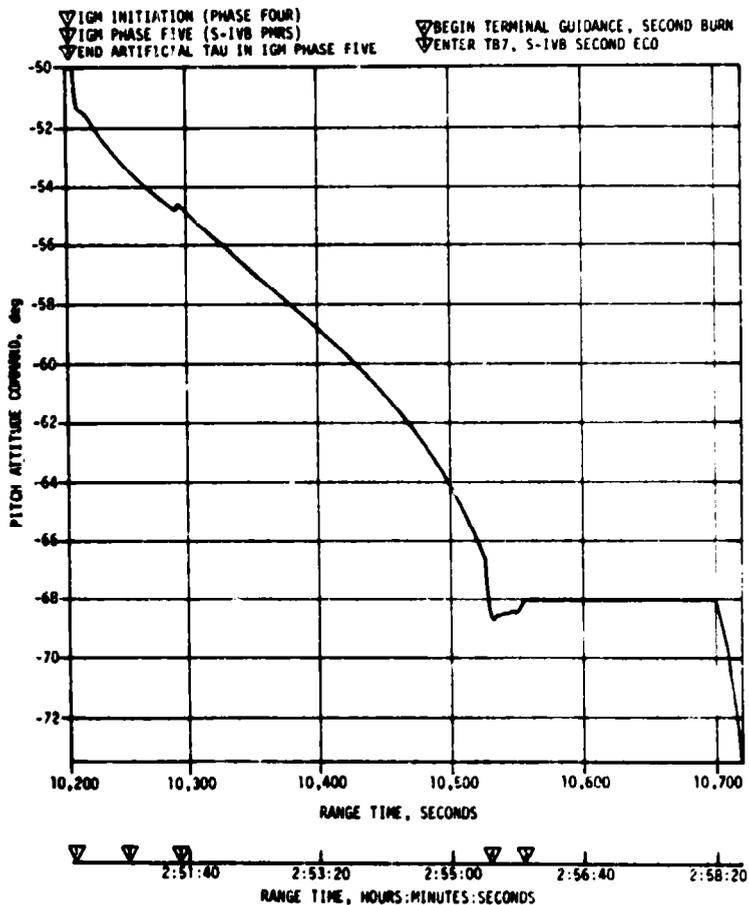
Figure 9-12. Rate-Limited Pitch Steering Command - AS-510 Second Burn

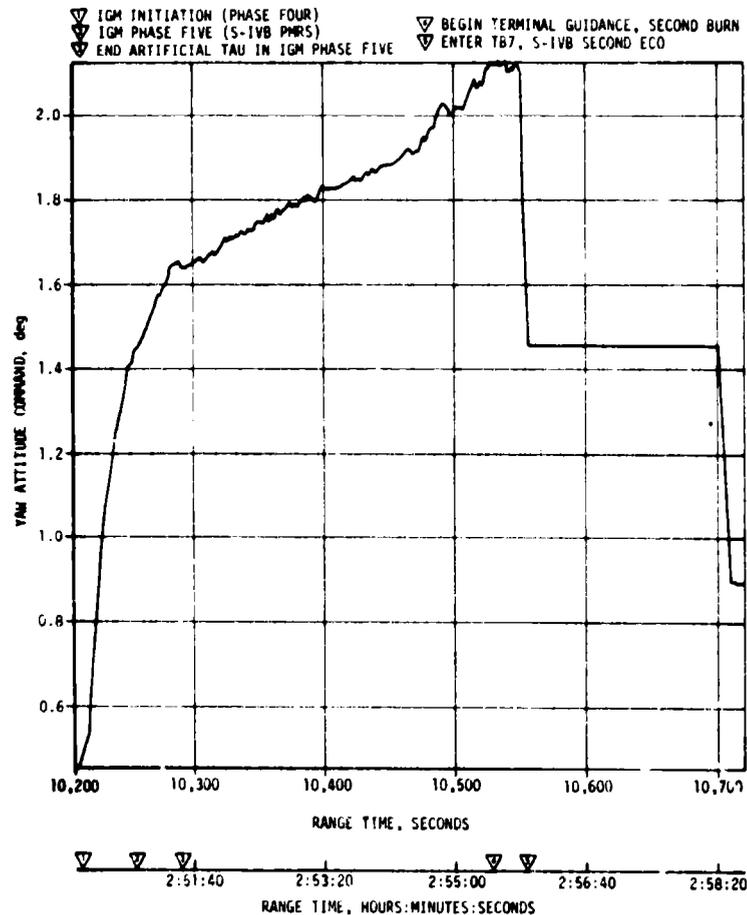
Figure 9-13. Rate-Limited Yaw Steering Command - AS-510 Second Burn

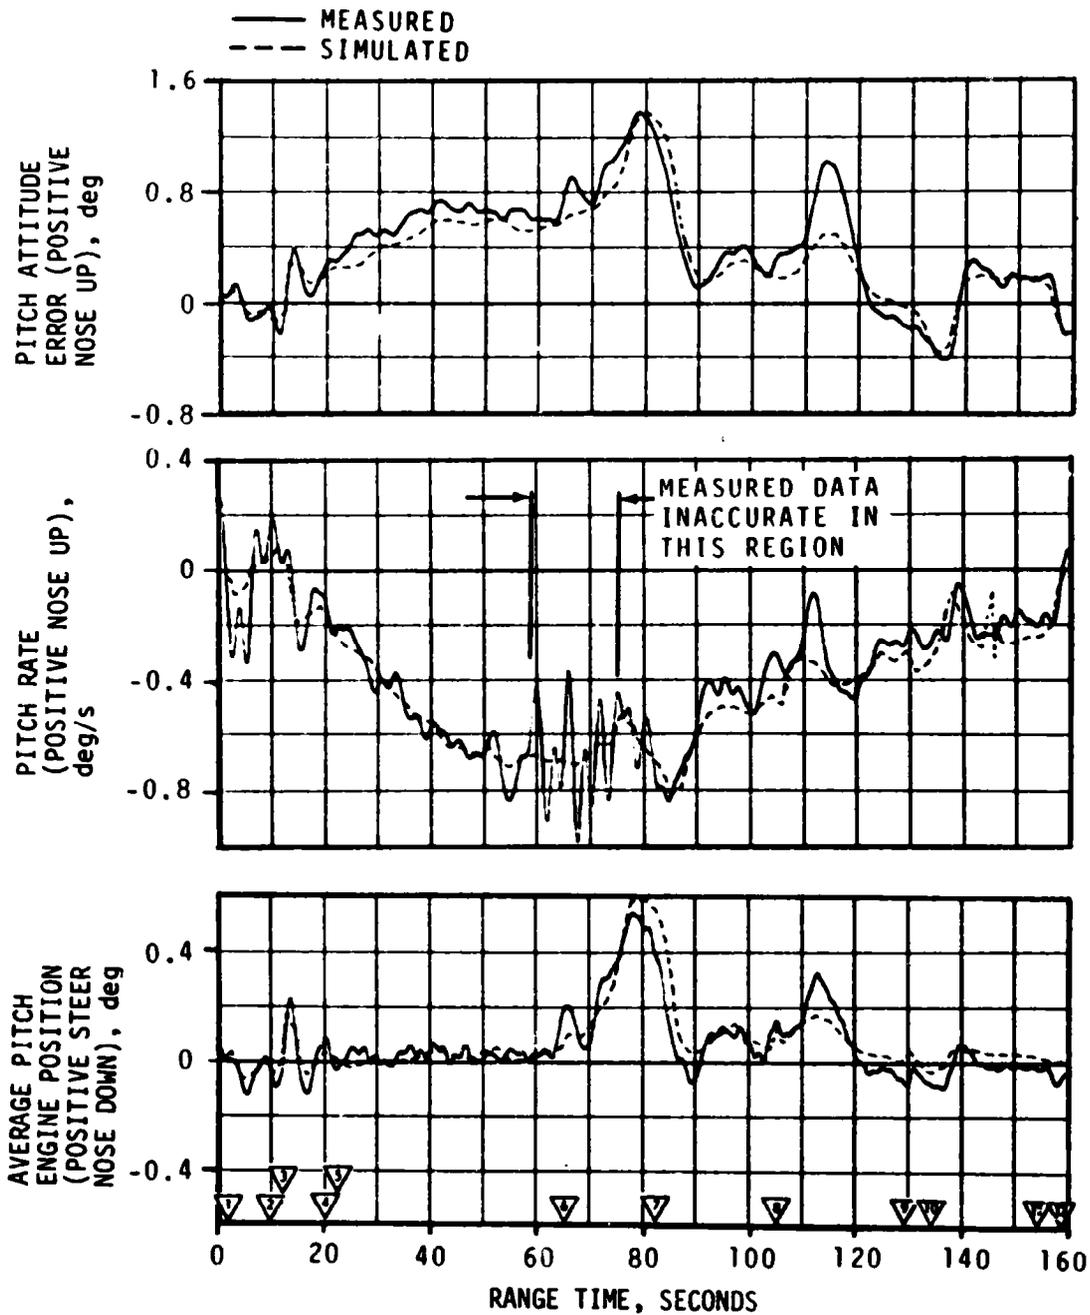
- ▽ MAX q
- ▽ 1ST GAIN SWITCH
- ▽ 2ND GAIN SWITCH
- ▽ S-IC CECO
- ▽ TILT ARREST
- ▽ S-IC OECC

Figure 10-1. Pitch Plane Dynamics During S-IC Burn

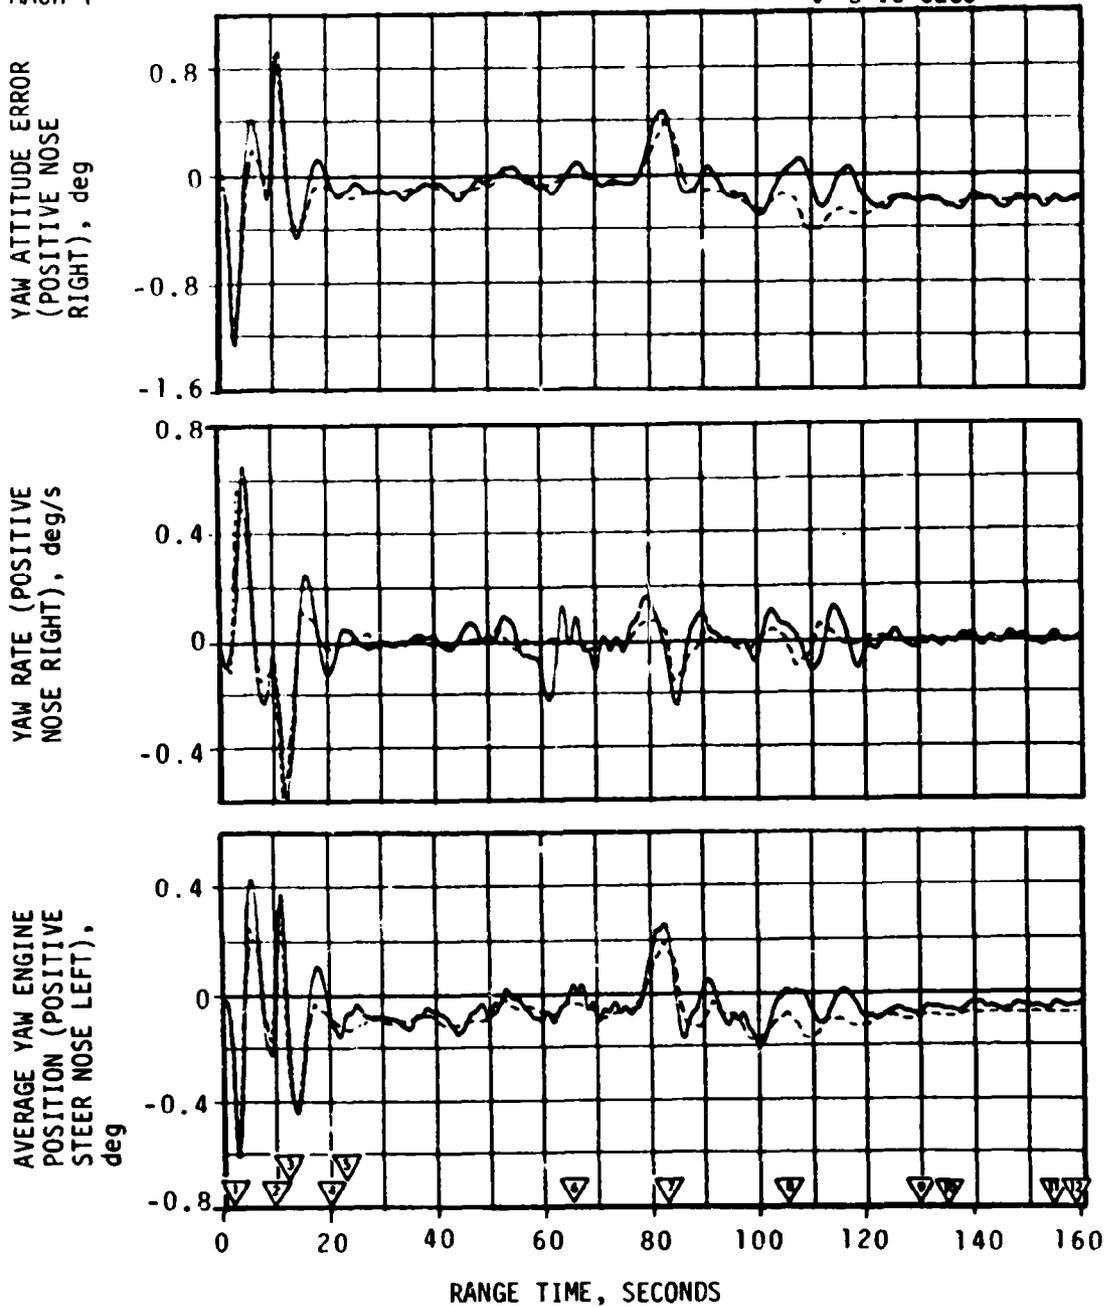
Figure 10-2. Yaw Plane Dynamics During S-IC Burn

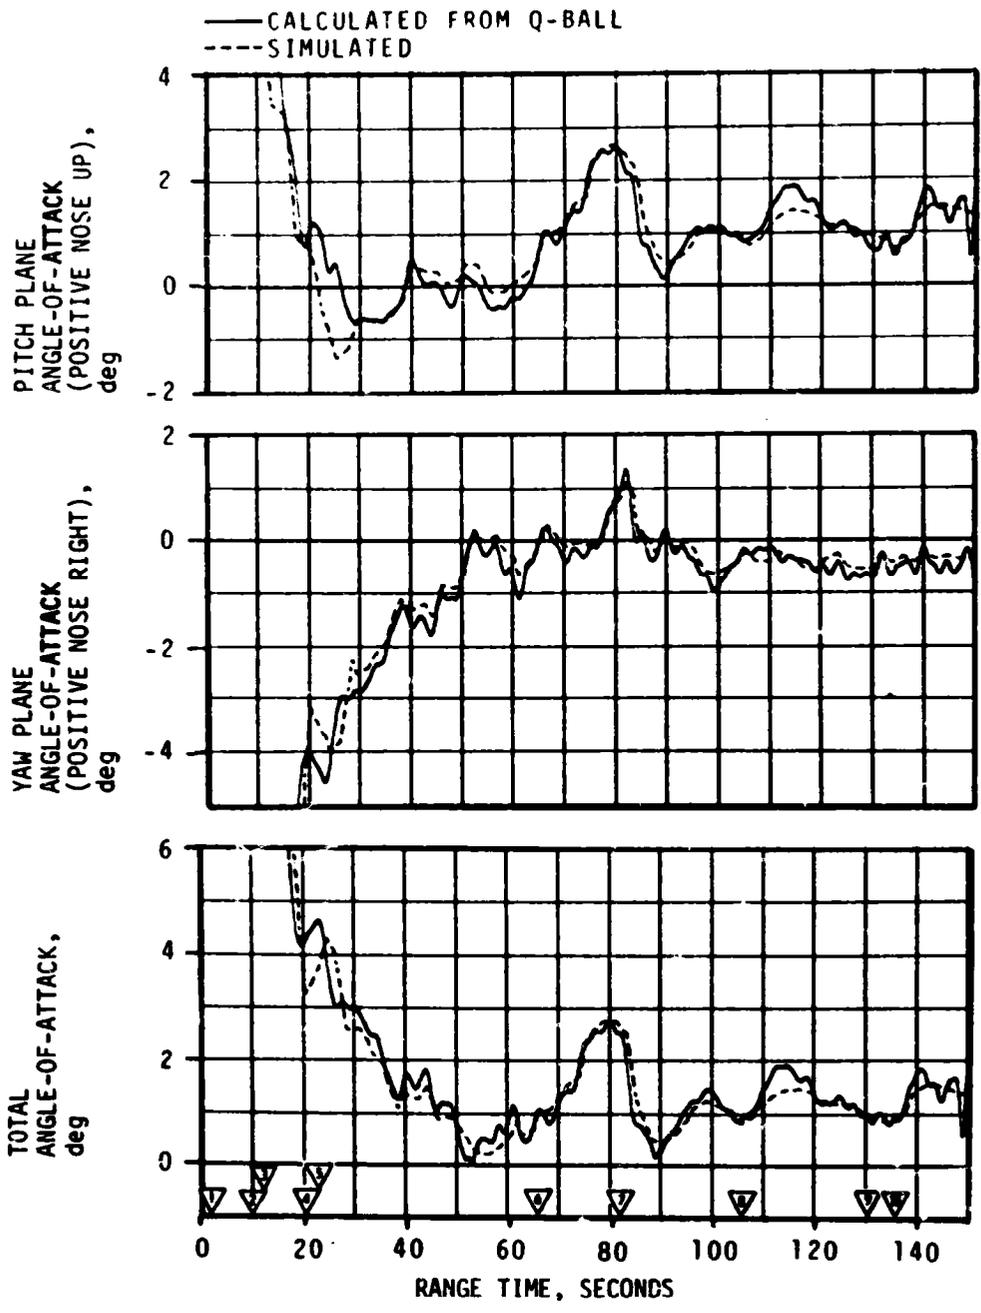
- ▽ MAX q
- ▽ 1ST GAIN SWITCH
- ▽ 2ND GAIN SWITCH
- ▽ S-IC LECO

Figure 10-3. Angle-Of-Attack During S-IC Burn

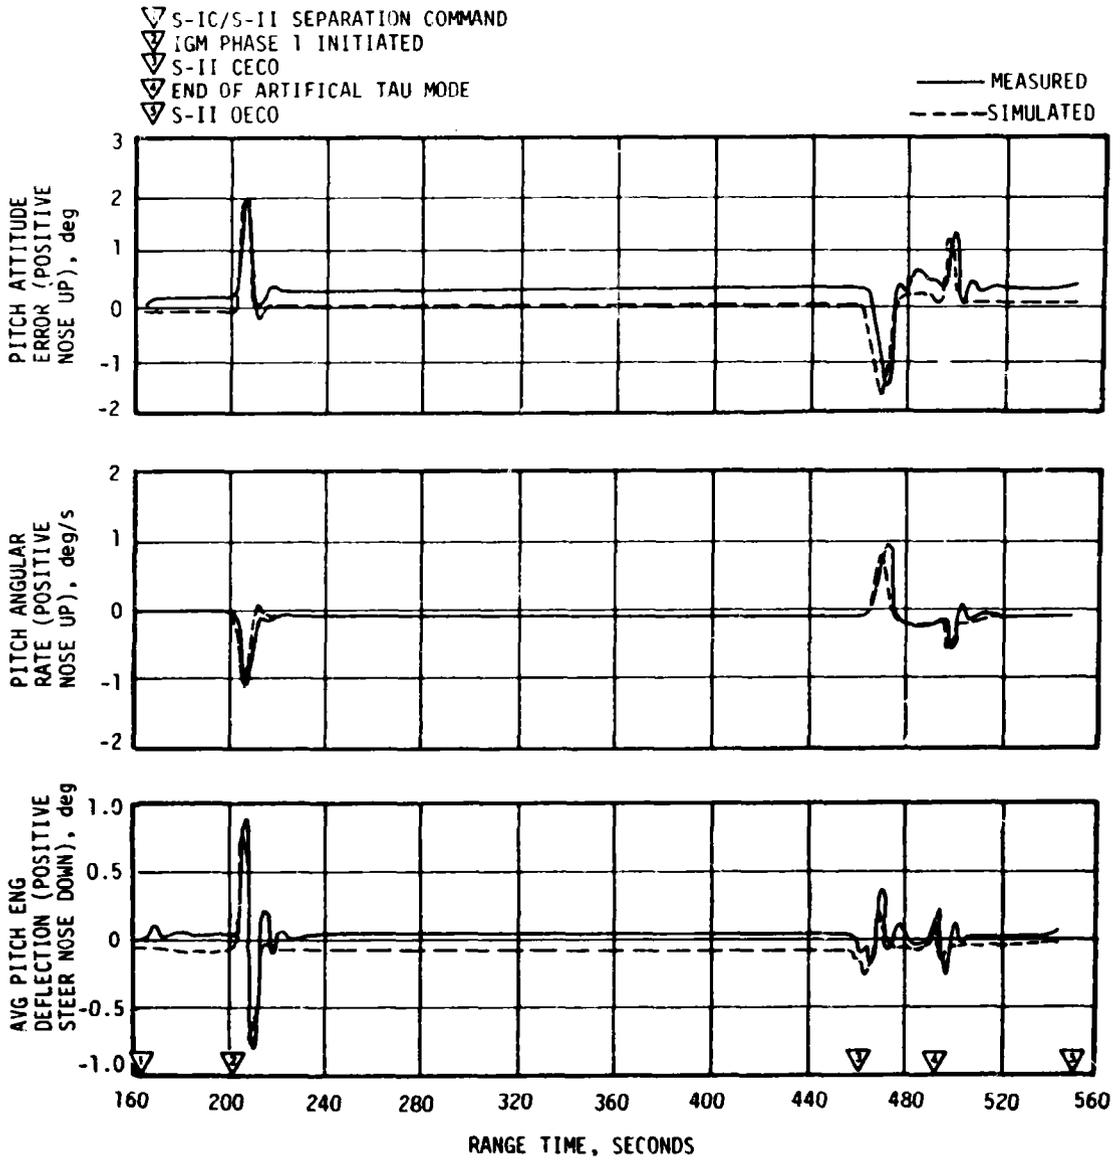
Figure 10-4. Pitch Plane Dynamics During S-II Burn

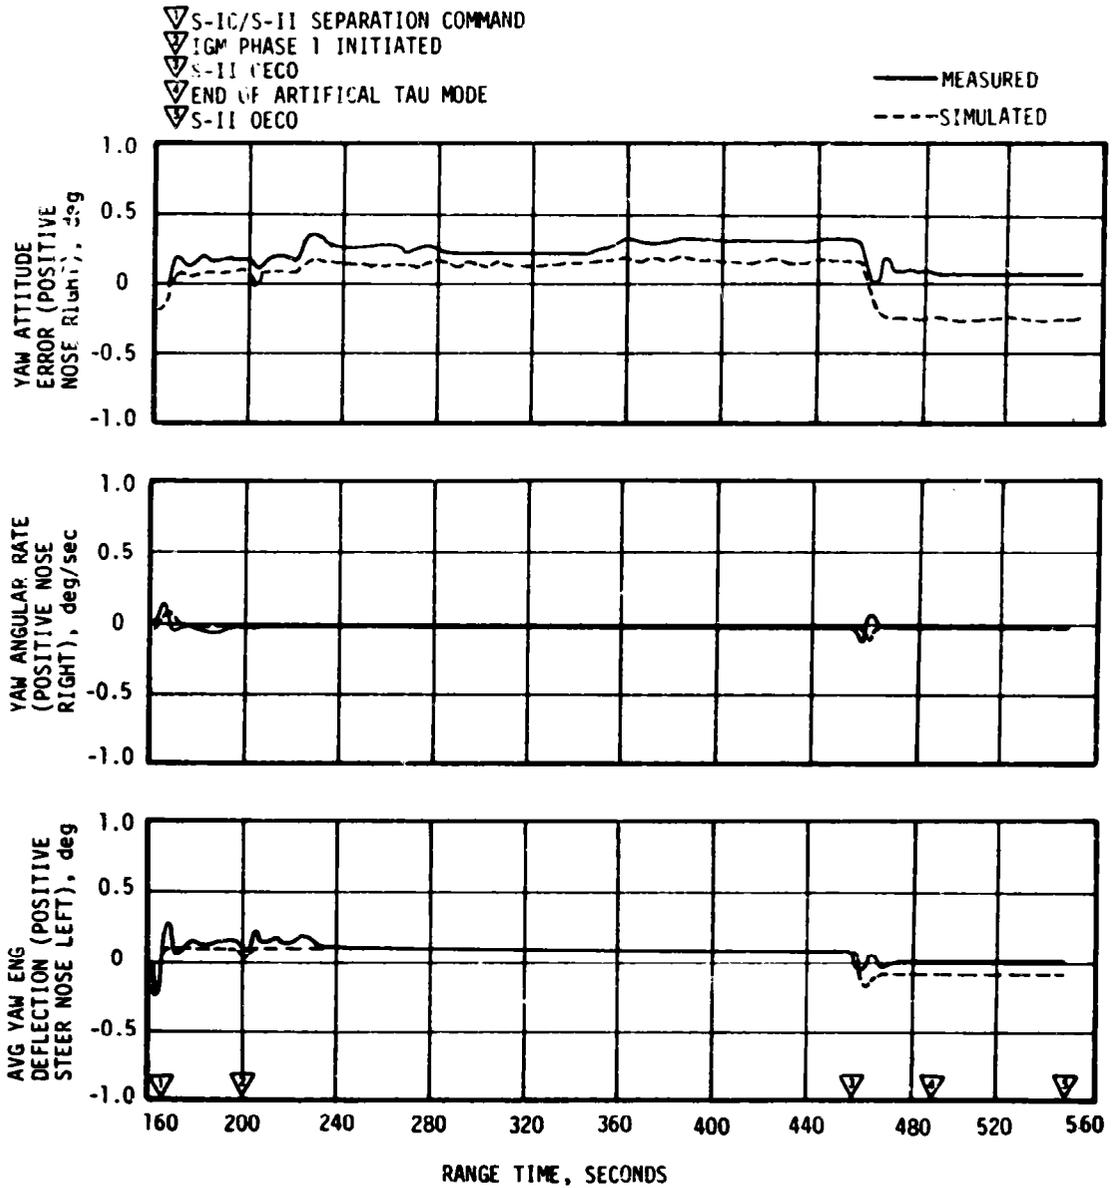
Figure 10-5. Yaw Plane Dynamics During S-II Burn

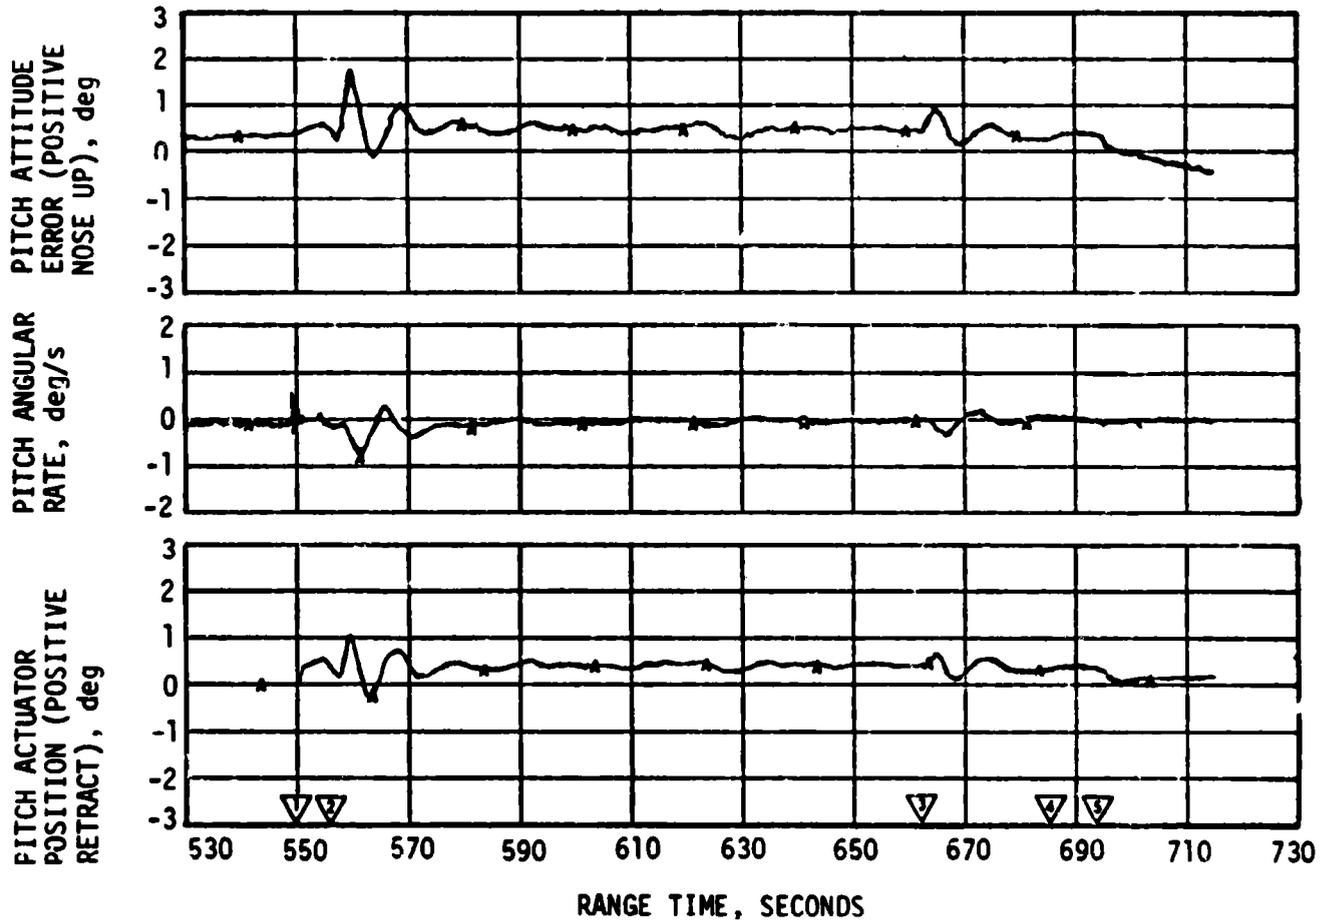
▽ BEGIN CHI FREEZE
▽ S-IVB FIRST ECO

Figure 10-6. Pitch Plane Dynamics During S-IVB First Burn

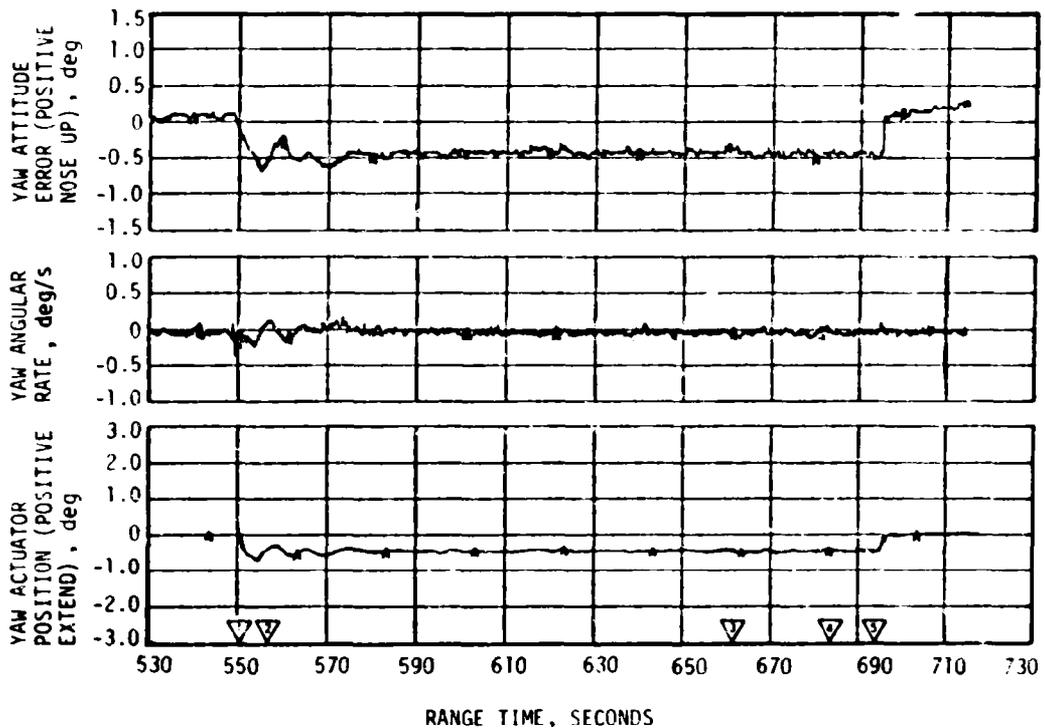
▽ BEGIN CHI FREEZE
 ▽ S-IVB FIRST BURN

Figure 10-7. Yaw Plane Dynamics During S-IVB First Burn

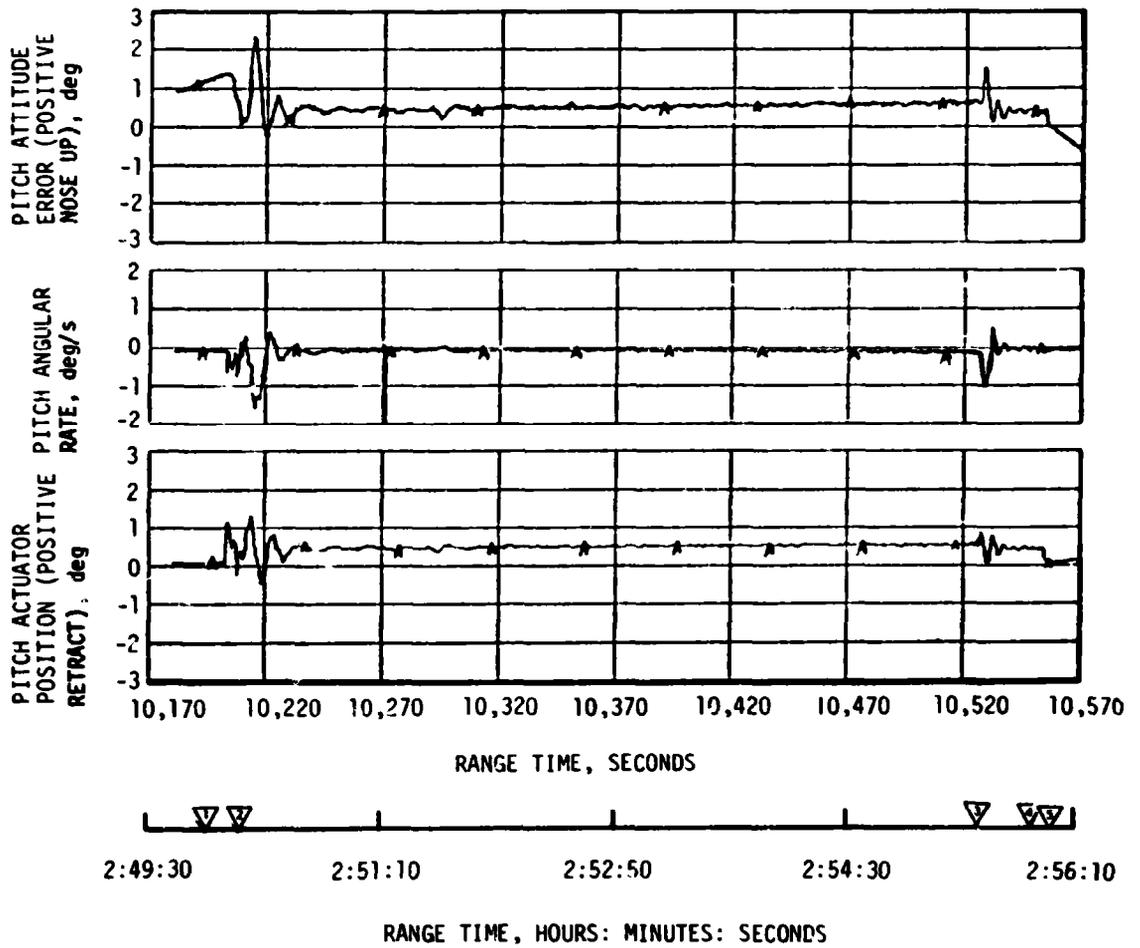
▽ BEGIN CHI FREEZE
 ▽ S-IVB SECOND ECO

Figure 10-9. Pitch Plane Dynamics During S-IVB Second Burn

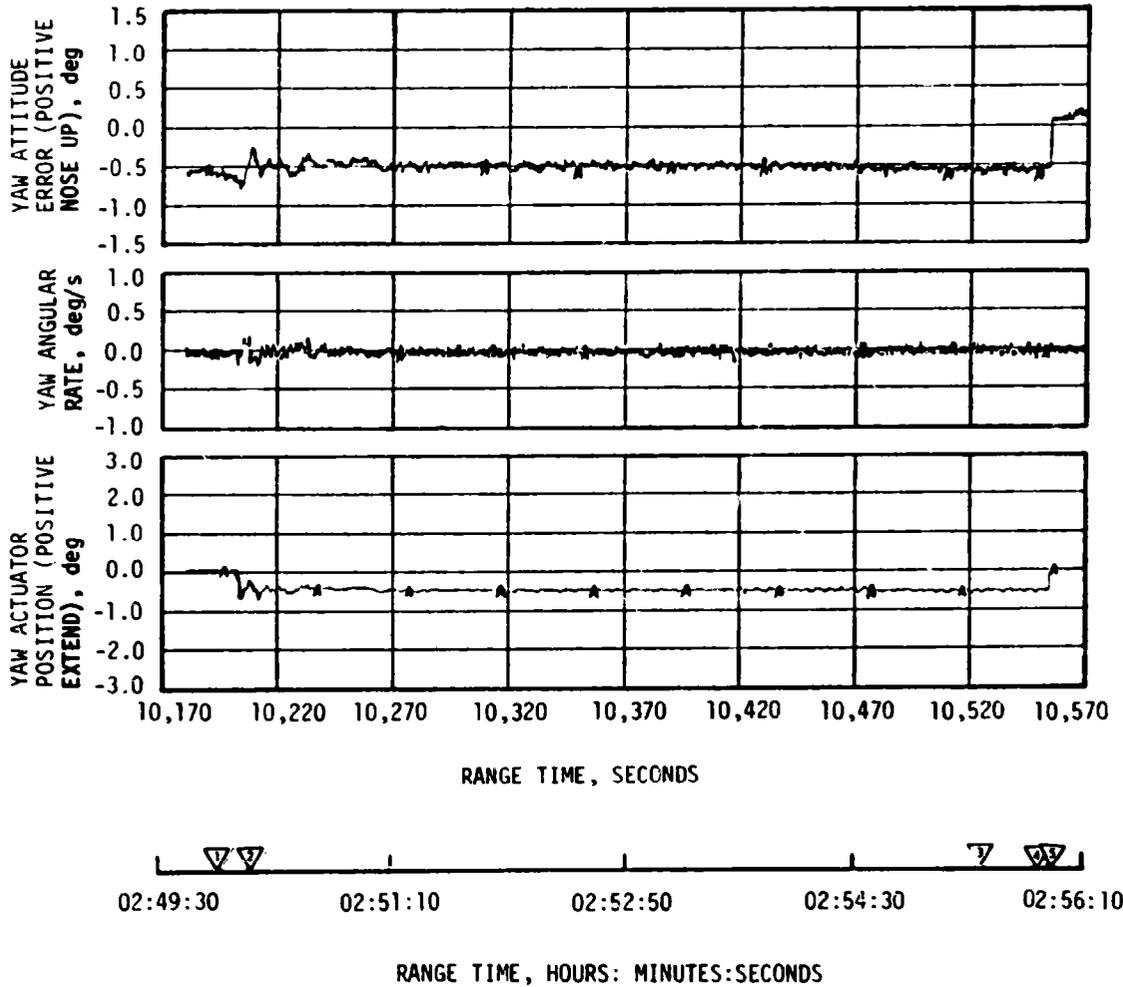
▽ BEGIN CHI FREEZE
 ▽ S-IVB SECOND ECO

Figure 10-10. Yaw Plane Dynamics During S-IVB Second Burn

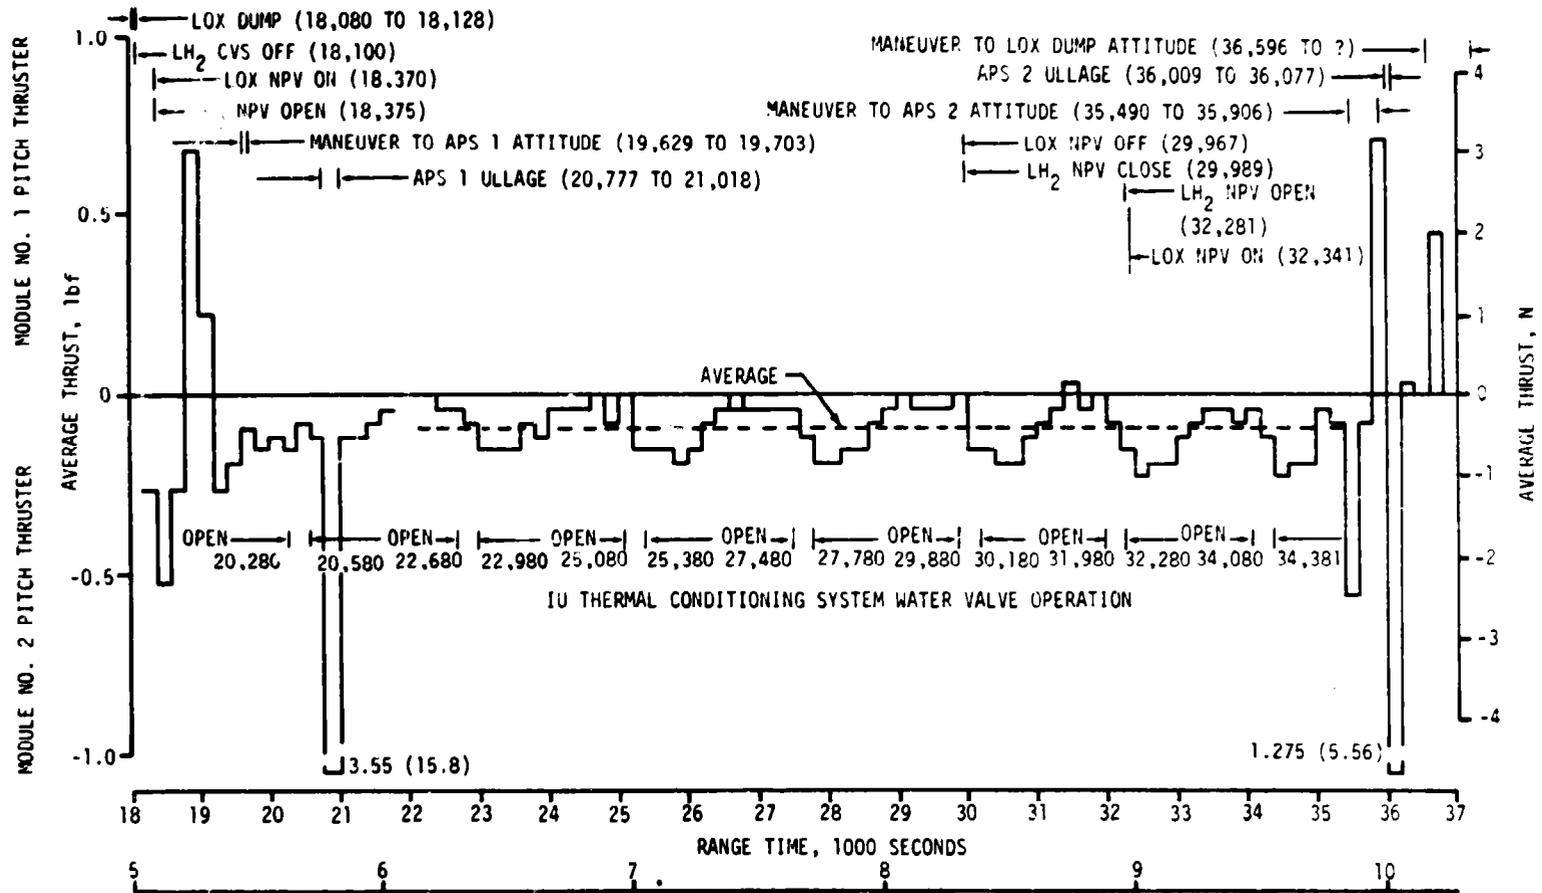
Figure 10-12. Average Pitch Control Thruster Thrust After LOX Dump

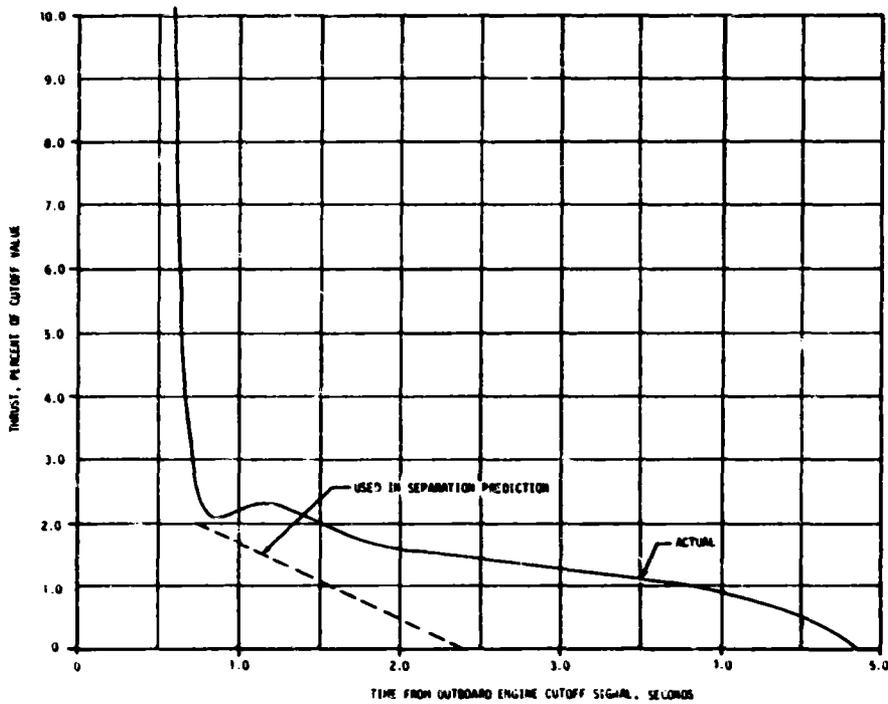
Figure 10-16. AS-510 Thrust Decay

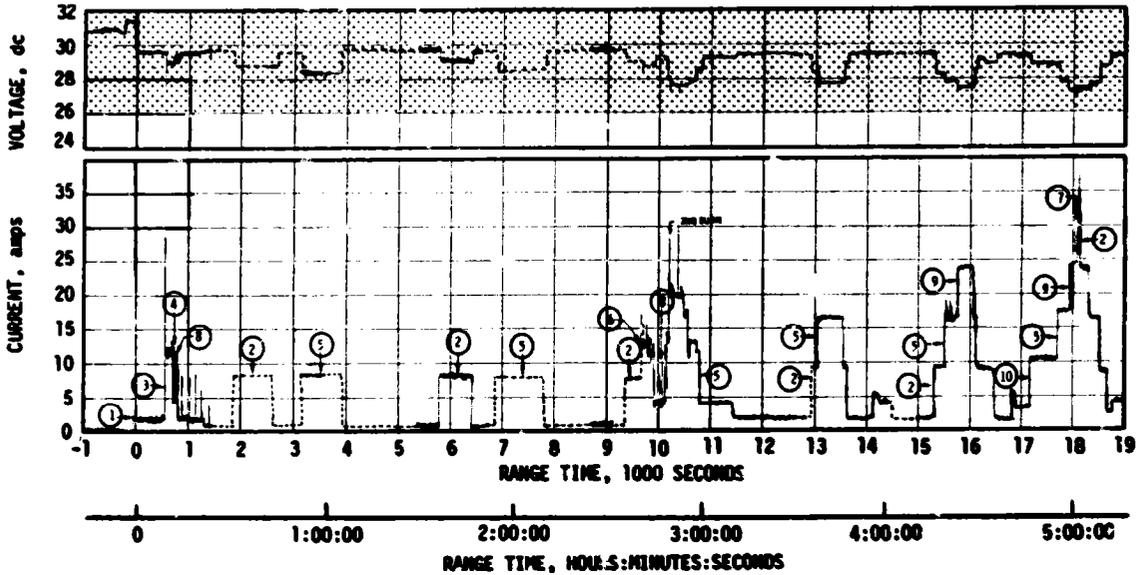
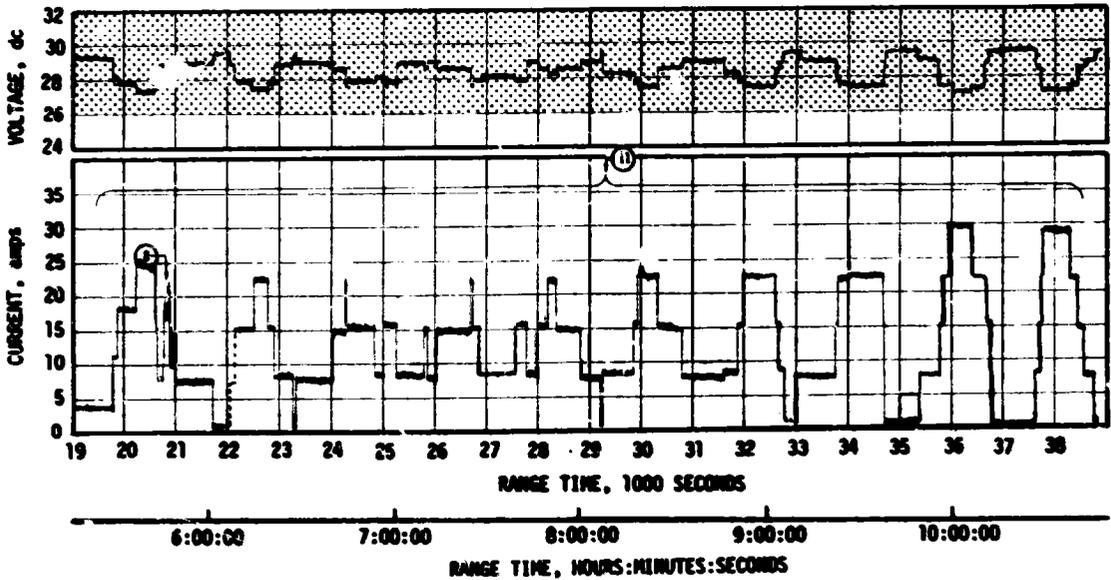
- ⑨ AFT NO. 2 BATTERY UNIT 2 HEATER CYCLE
- ⑩ AFT NO. 2 BATTERY HEATER CYCLE
- ⑪ TYPICAL
- A) AFT NO. 1 BATTERY HEATER CYCLE
- B) AFT NO. 1 BATTERY UNIT 2 HEATER CYCLE
- C) AFT NO. 2 BATTERY HEATER CYCLE
- D) AFT NO. 2 BATTERY UNIT 2 HEATER CYCLE

Figure 11-3. S-IVB Stage Aft No. 1 Battery Voltage and Current

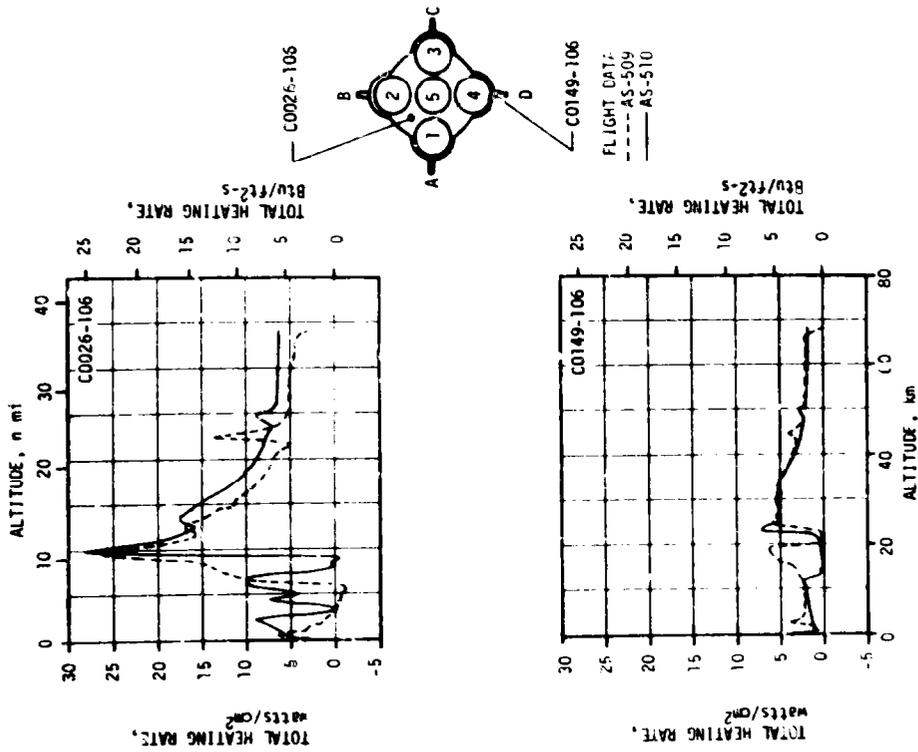
Figure 13-1. S-IC Base Region Total Heating Rate

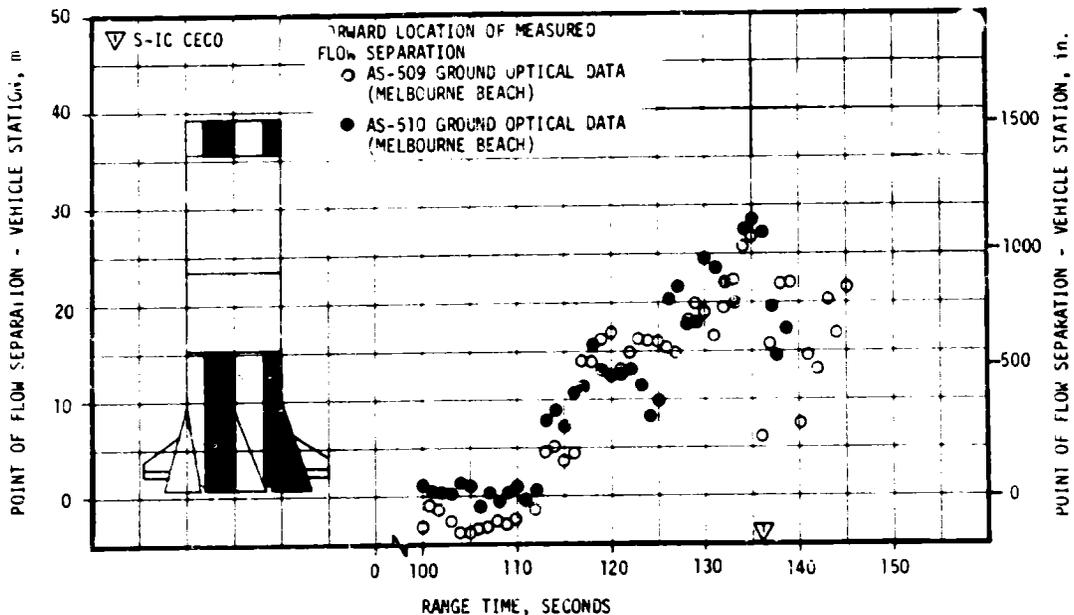
The AS-510 S-IC/S-II staging sequence was different from previous flights. The resulting forward skirt thermal environment was more severe than previously experienced. A detailed discussion of the staging conditions and thermal environment is found in Section 10-6.

Figure 13-7. Forward Location of Separated Flow on S-IC Stage

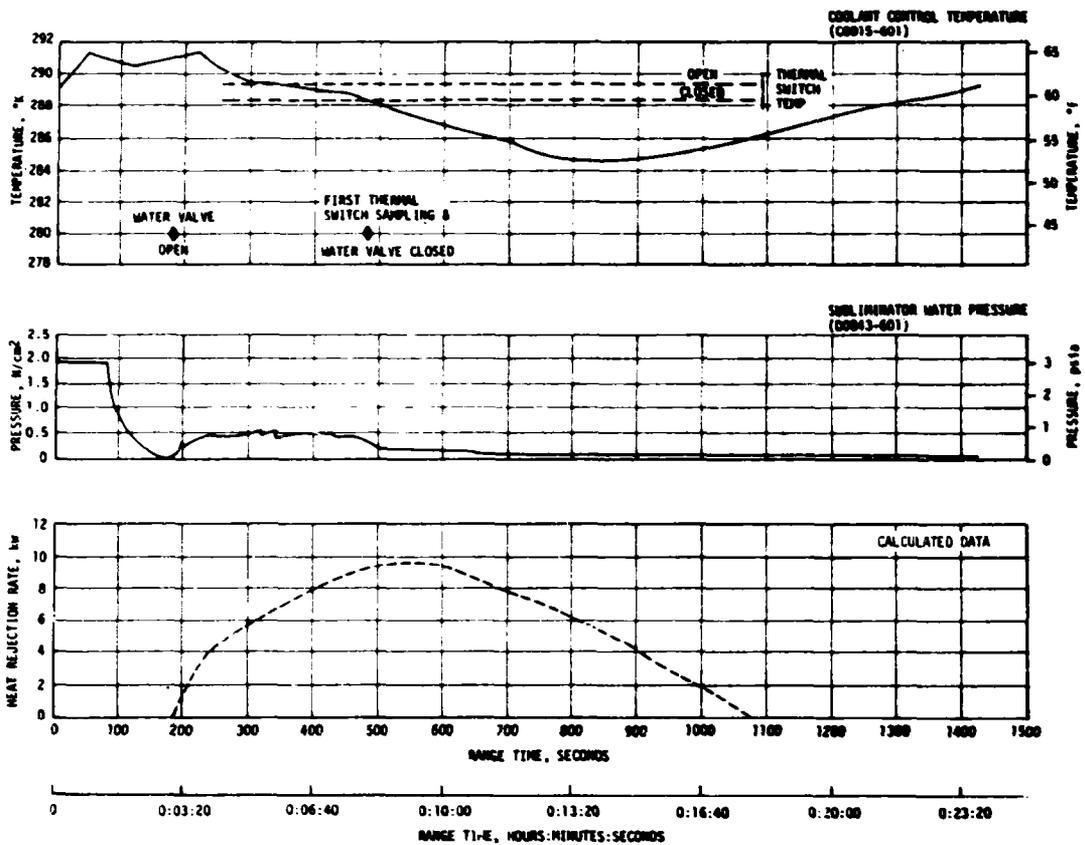
Figure 14-2. IU Sublimator Performance During Ascent

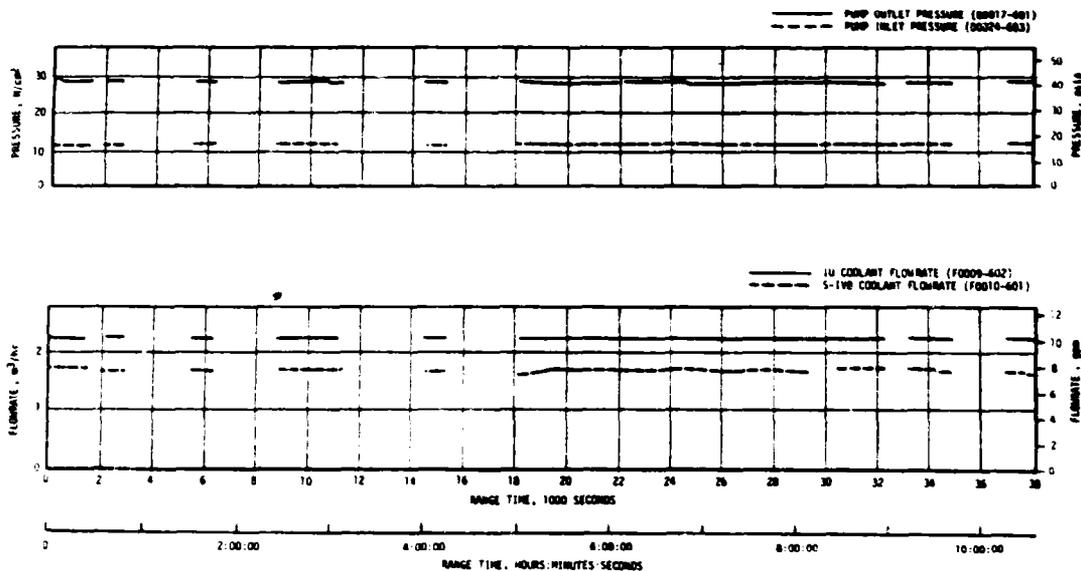
Figure 14-3. IU TCS Hydraulic Performance

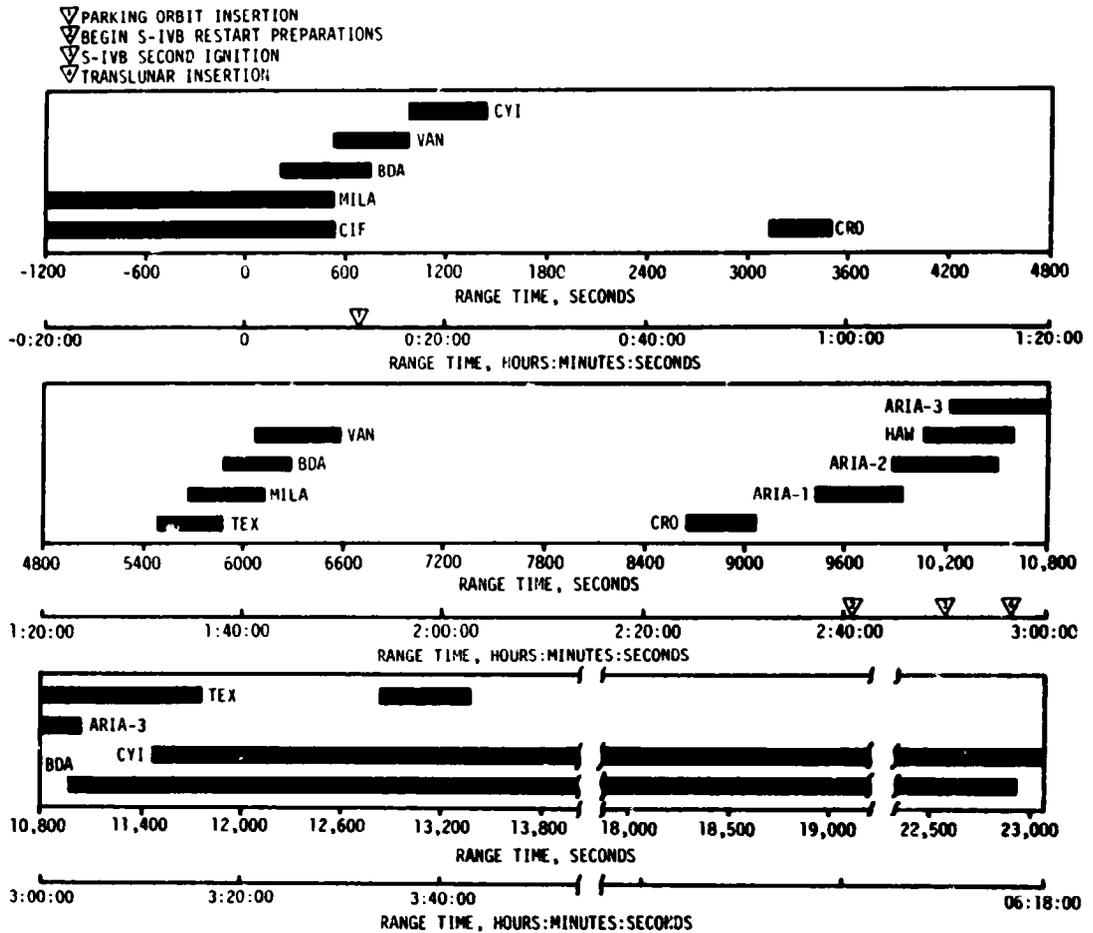
The performance of S-IVB and IU VHF telemetry systems was normal during earth orbit, S-IVB second burn, and final coast. Usable VHF telemetry data were received to 20,680 seconds (6:18:00) for the IU VHF and to 23,225 seconds (6:27:05) for the S-IVB VHF telemetry system. A summary of available VHF telemetry coverage showing Acquisition of Signal (AOS) and LOS for each station is shown in Figure 15-1.

Figure 15-1. VHF Telemetry Coverage Summary

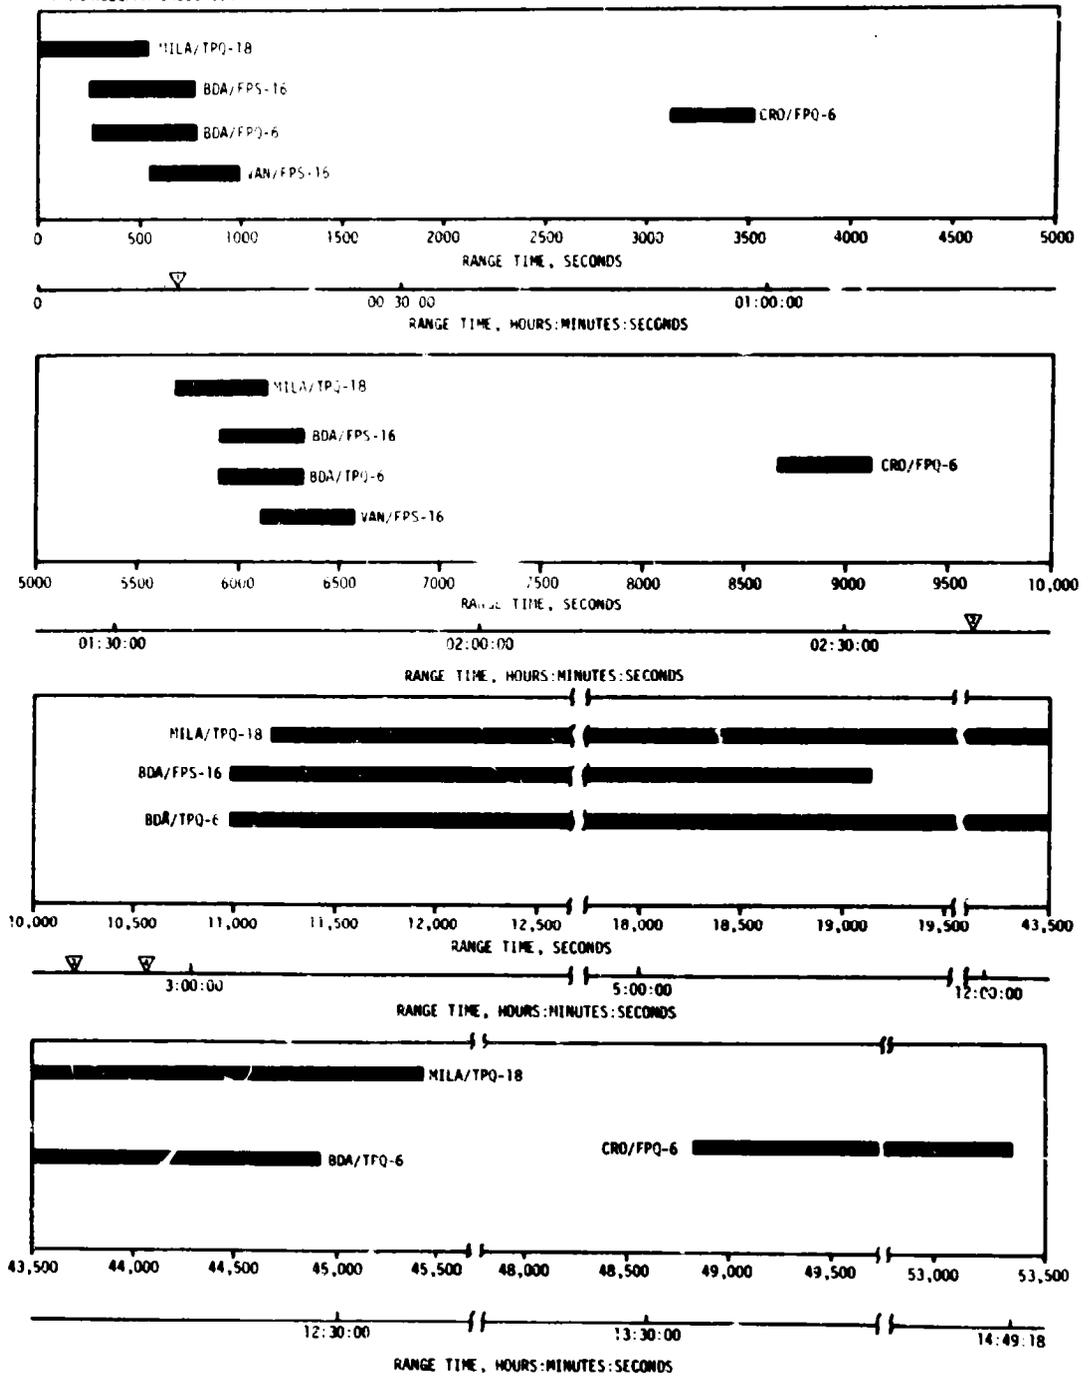
- ▽ PARKING ORBIT INSERTION
- ▽ BEGIN RESTART PREPARATIONS
- ▽ S-1VB SECOND IGNITION
- ▽ TRANS-LUNAR INJECTION

Figure 15-2. C-Band Radar Coverage Summary
