SATURN V LAUNCH VEHICLE FLIGHT EVALUATION REPORT-AS-510 APOLLO 15 MISSION

**SATURN V LAUNCH VEHICLE
FLIGHT EVALUATION REPORT - AS-510
APOLLO 15 MISSION**

**Saturn Flight Evaluation Working Group
George C. Marshall Space Flight Center**

All Mandatory and Desirable Objectives of this mission for the launch vehicle were accomplished except the precise determination of the lunar impact point. It is expected that this will be accomplished at a later date. No failures, anomalies, or deviations occurred that seriously affected the mission.

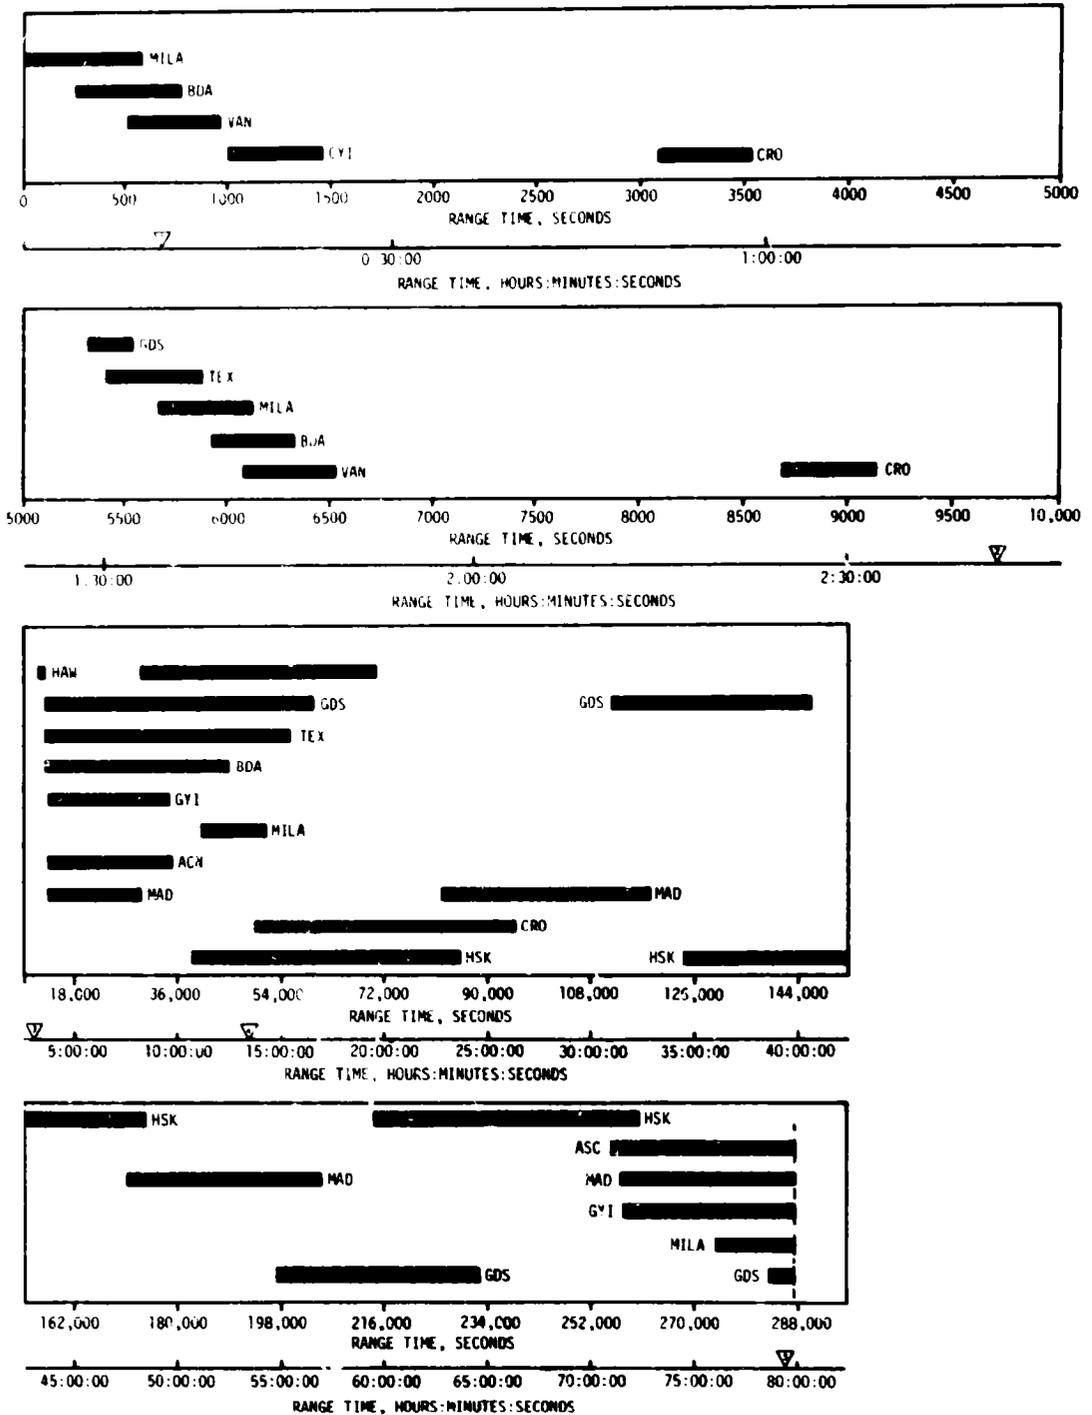
Figure 15-3. CCS Coverage Summary

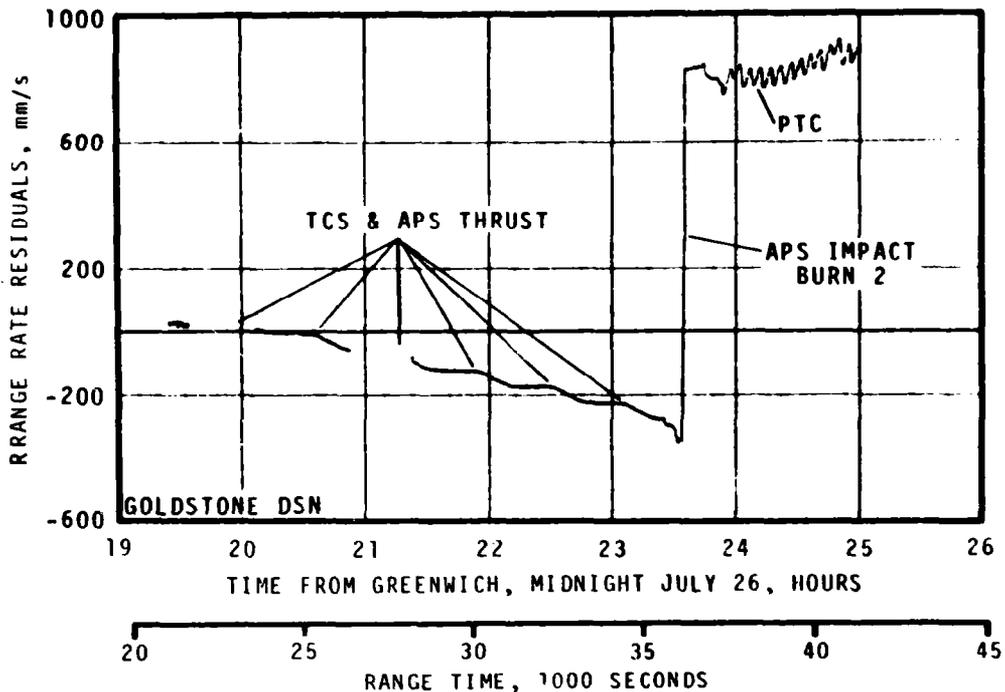
Figure 17-6. TCS and APS Thrust Perturbations

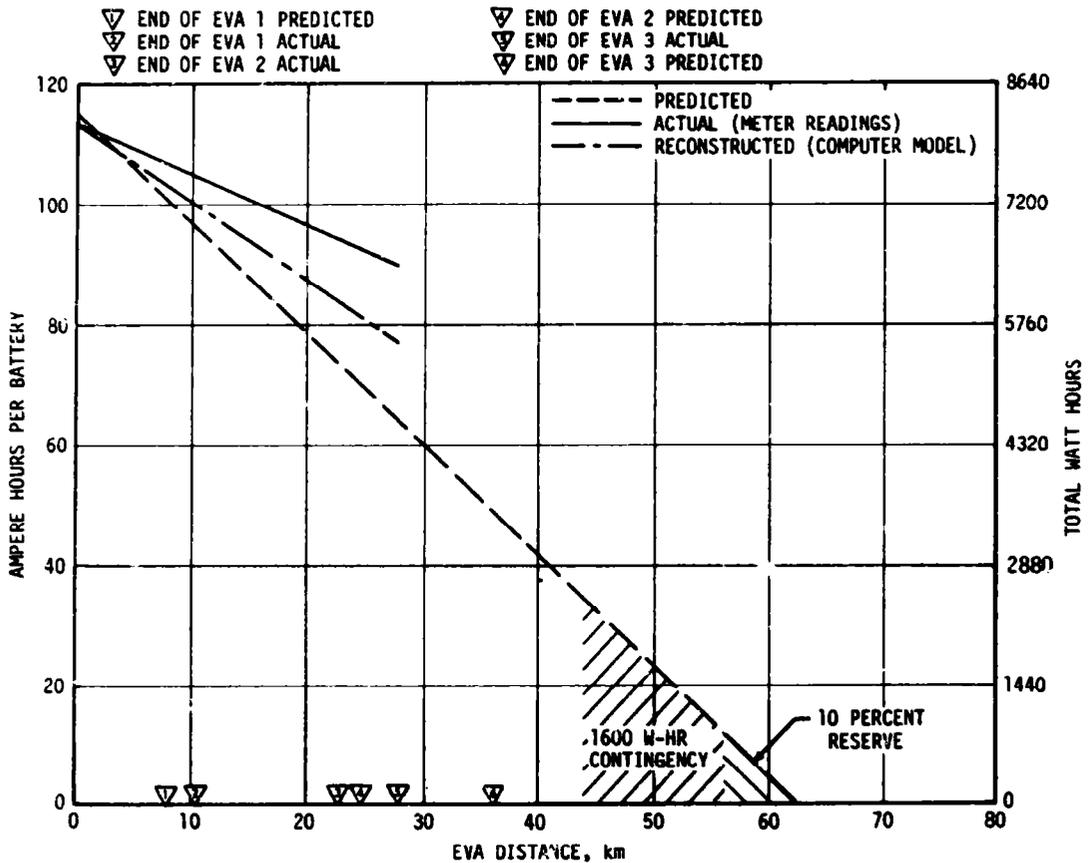
Figure 20-7. LRV Energy Consumed

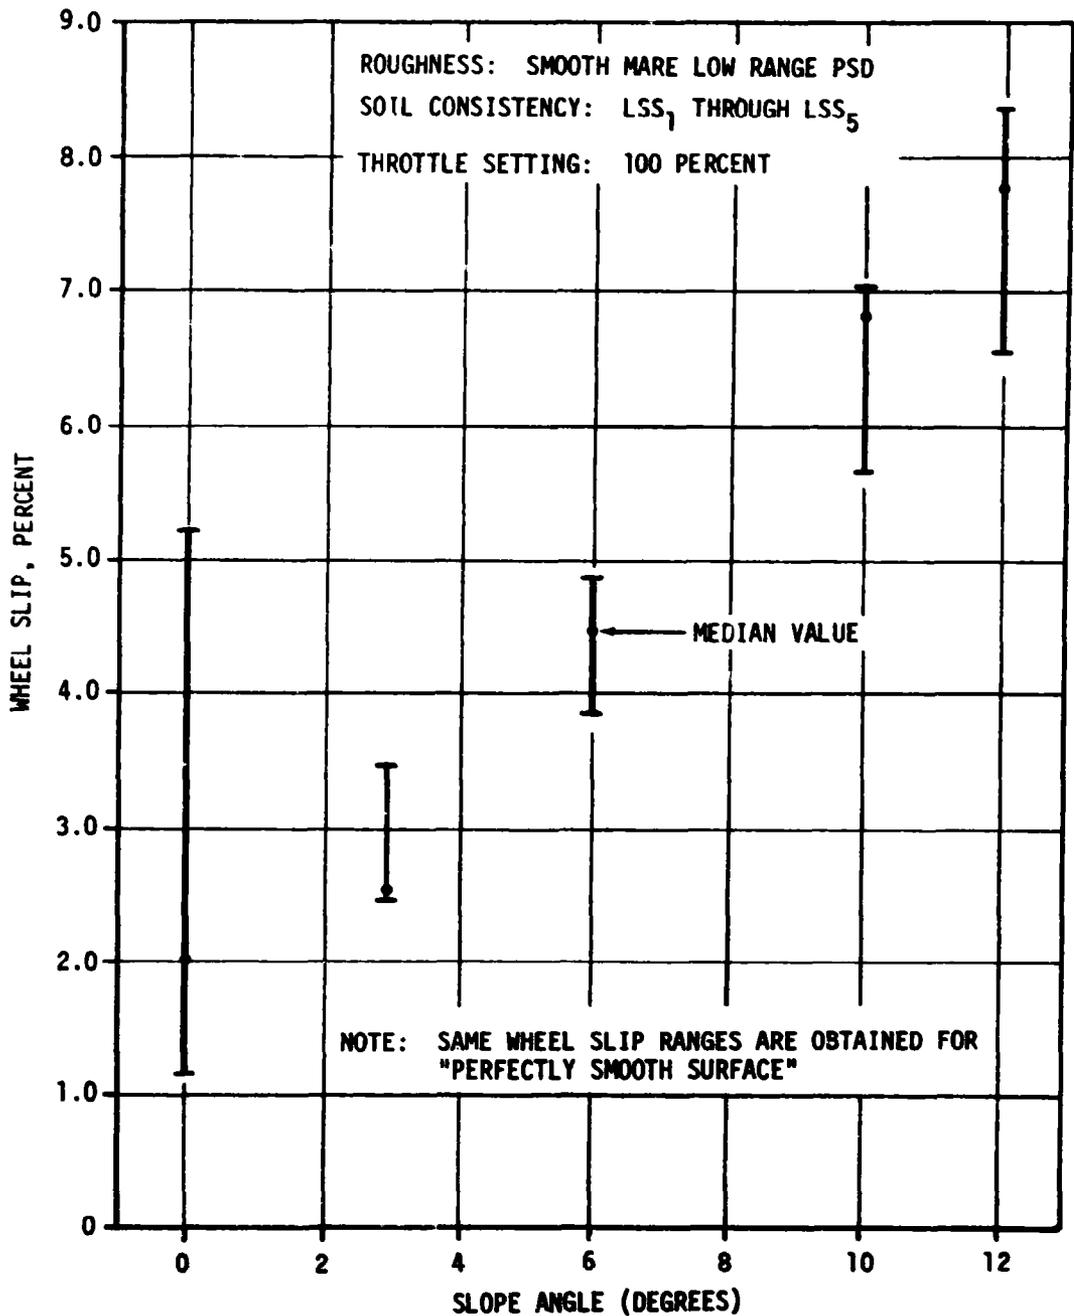
Figure 20-11. MSFC Computer Program Estimates on LRV Wheel Slip Versus Slope Angle Under Full Throttle (Maximum Velocity) Conditions

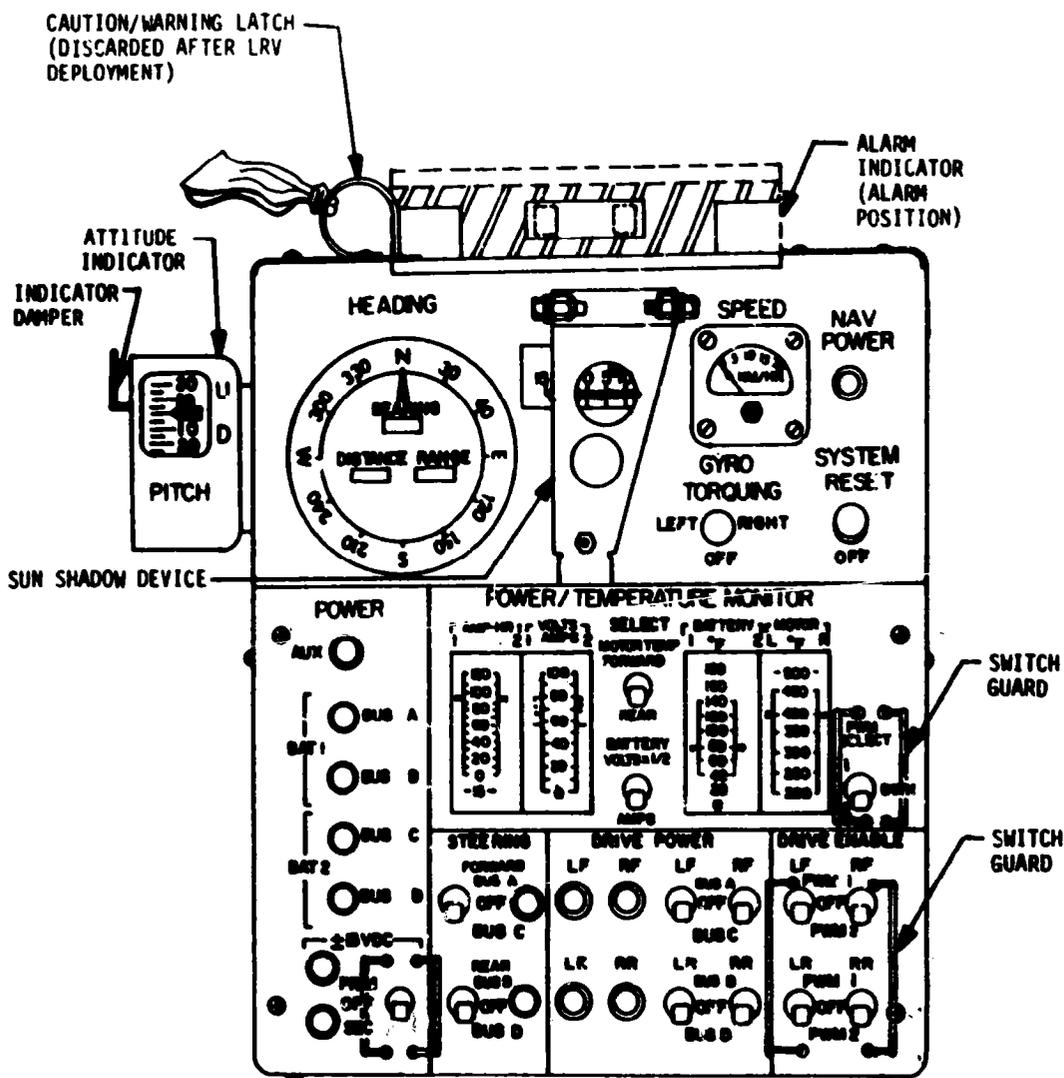
Figure 20-18. Control and Display Console
