Recovery of the Space Shuttle *Columbia* Avionics

Investigation, Analysis, and Lessons Learned

NASA - Lyndon B. Johnson Space Center

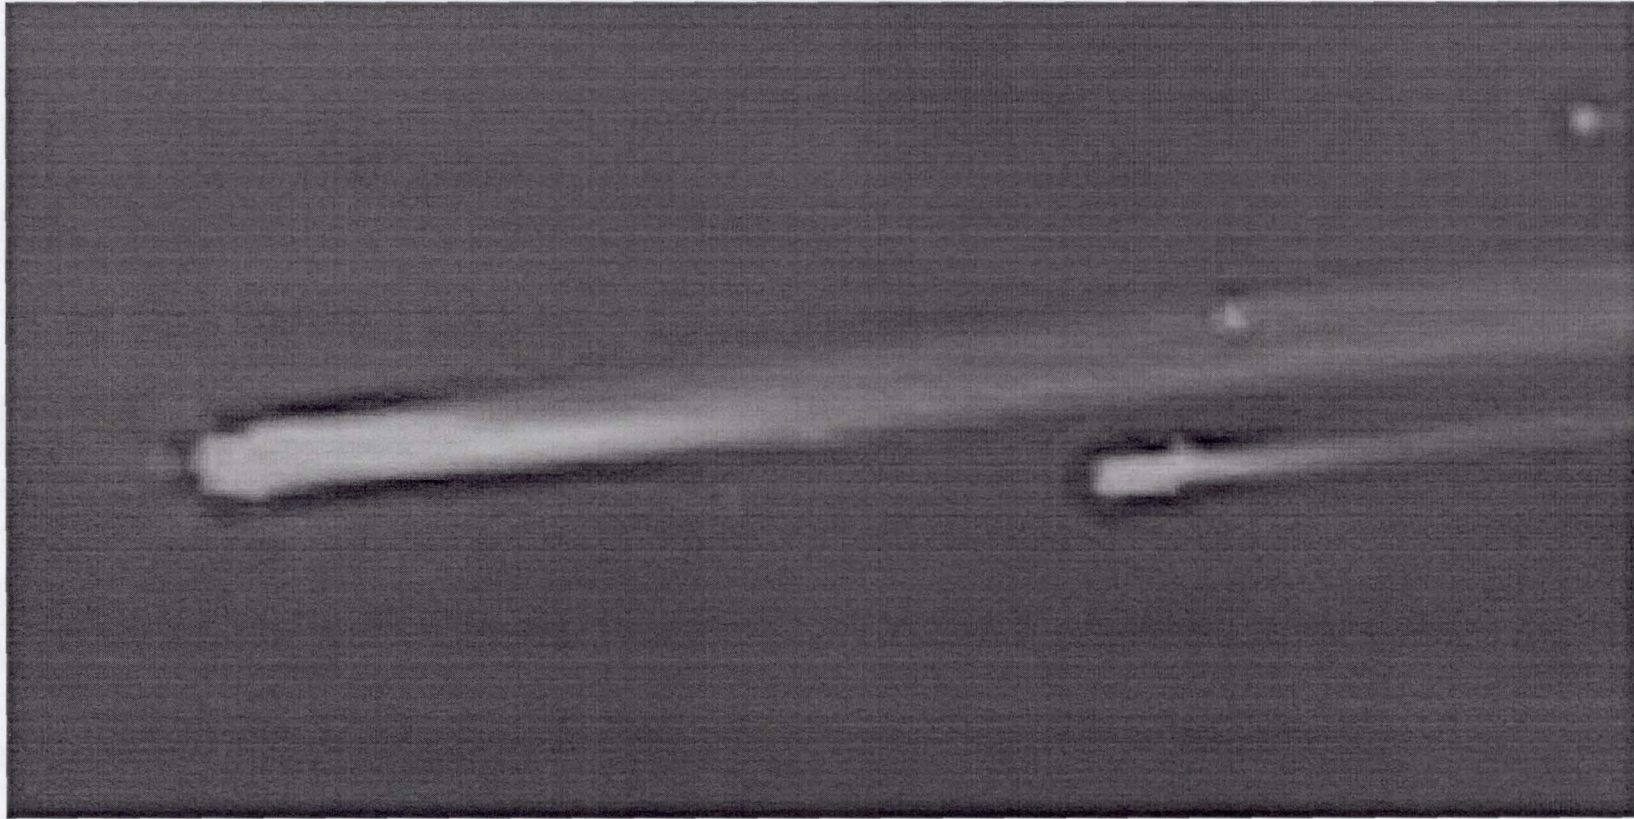
Loss of the Space Shuttle *Columbia*

- On February 1st, 2003, the Space Shuttle *Columbia* was tragically lost with its crew during reentry, 16 minutes before the planned landing at the Kennedy Space Center (NASA-KSC) in Florida.
- Telemetry received from *Columbia* was inconclusive in determining the cause of the accident.
- Telemetry did indicate that anomalous conditions existed in the left wing of *Columbia* prior to its loss.

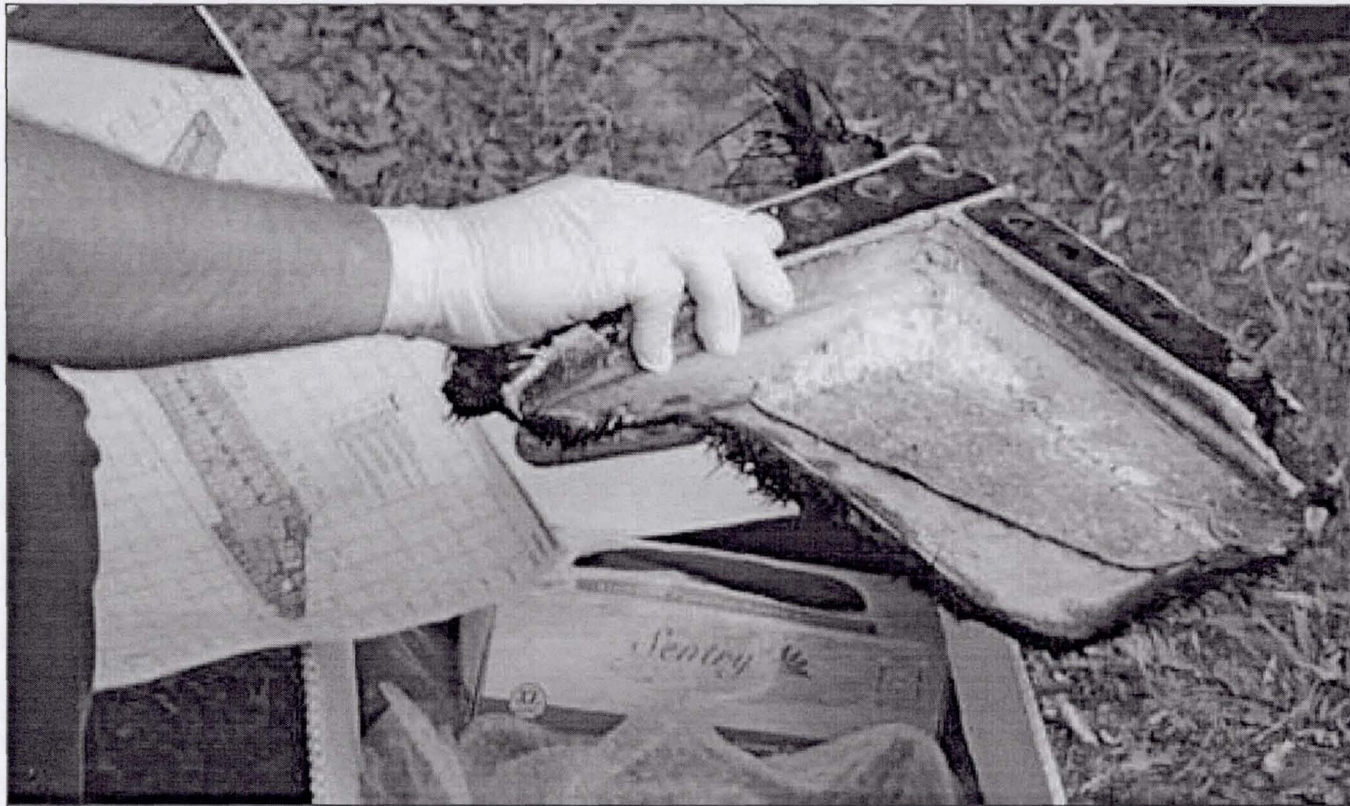
Debris Recovery

- Debris recovery from Columbia took months. Most of the debris was recovered in an area 10 miles wide and 220 miles long.
- Searchers recovered approximately 70,000 items; 37% of *Columbia* by weight.
- Approximately 25,000 people took part in the recovery operation, including more than 130 government agencies, 270 business and volunteer organizations, and numerous private individuals.

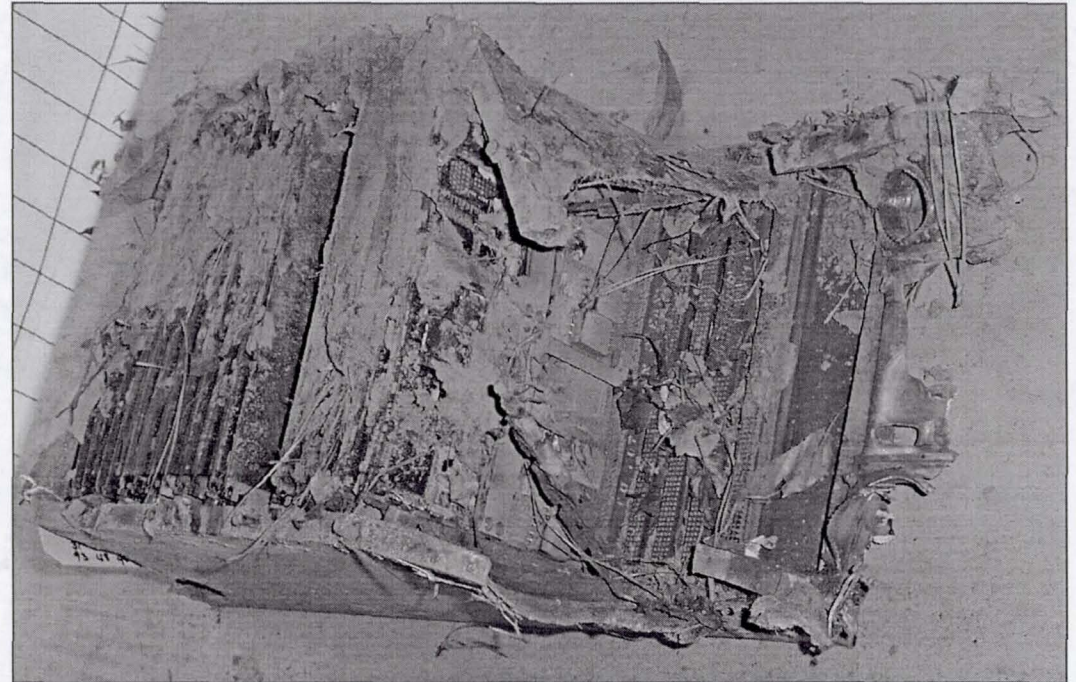
Recovery of *Columbia's* Avionics

- *Columbia's* avionics were subjected to extreme levels of temperature, shock, and vibration during breakup of the Orbiter.
- Unknown factors contributed to the survival of any particular avionics unit; some units survived relatively intact (e.g. MAGR, OEX Tape Recorder), while others were destroyed (e.g. GPC, MEDS ADC).
- Two important units that survived will be examined in detail:
 - Military Airborne GPS Receiver (MAGR)
 - Orbiter Experiments (OEX) Tape Recorder

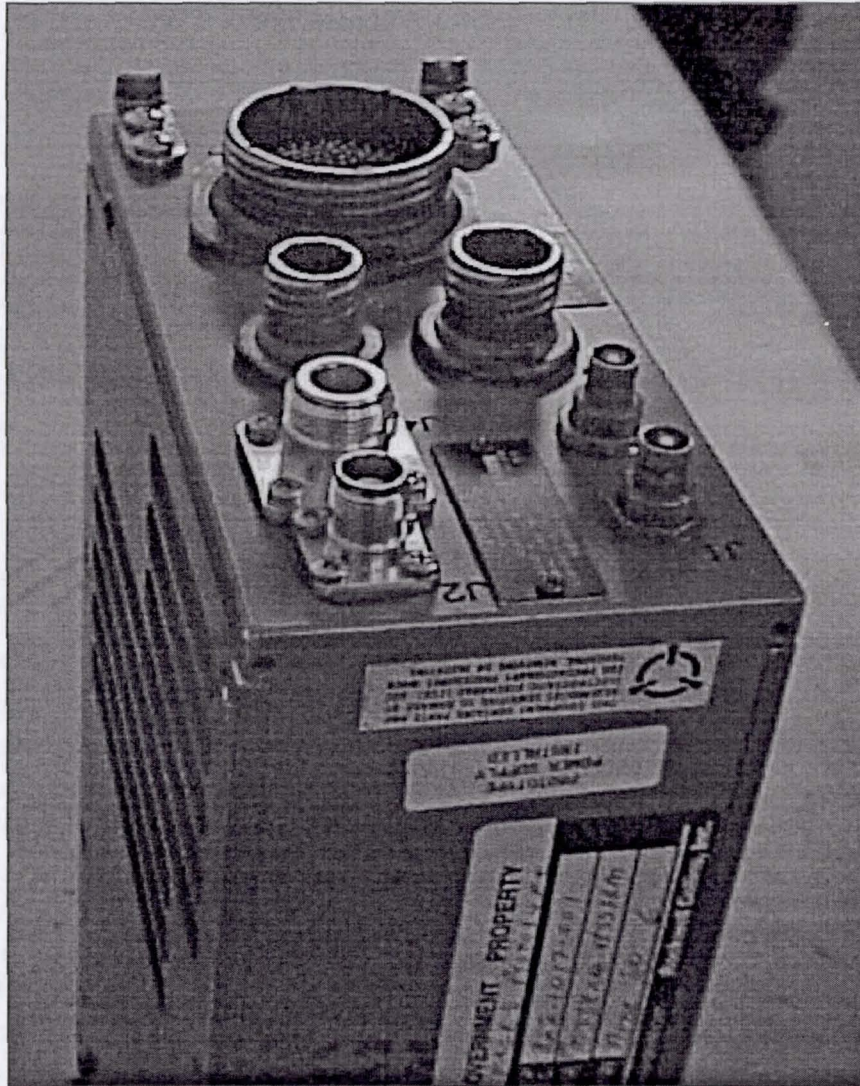
Military Airborne GPS Receiver (MAGR)

- The MAGR is a modified GPS receiver, built by Rockwell Collins, that is also used on a number of U.S. military aircraft.
- The MAGR provides position information to the Orbiter's General Purpose Computers that is used for navigation.
- MAGR's have flown 28 flights since 1996 before becoming certified for full operational use in September 2002.
- Each Orbiter (including *Columbia*) has one MAGR.

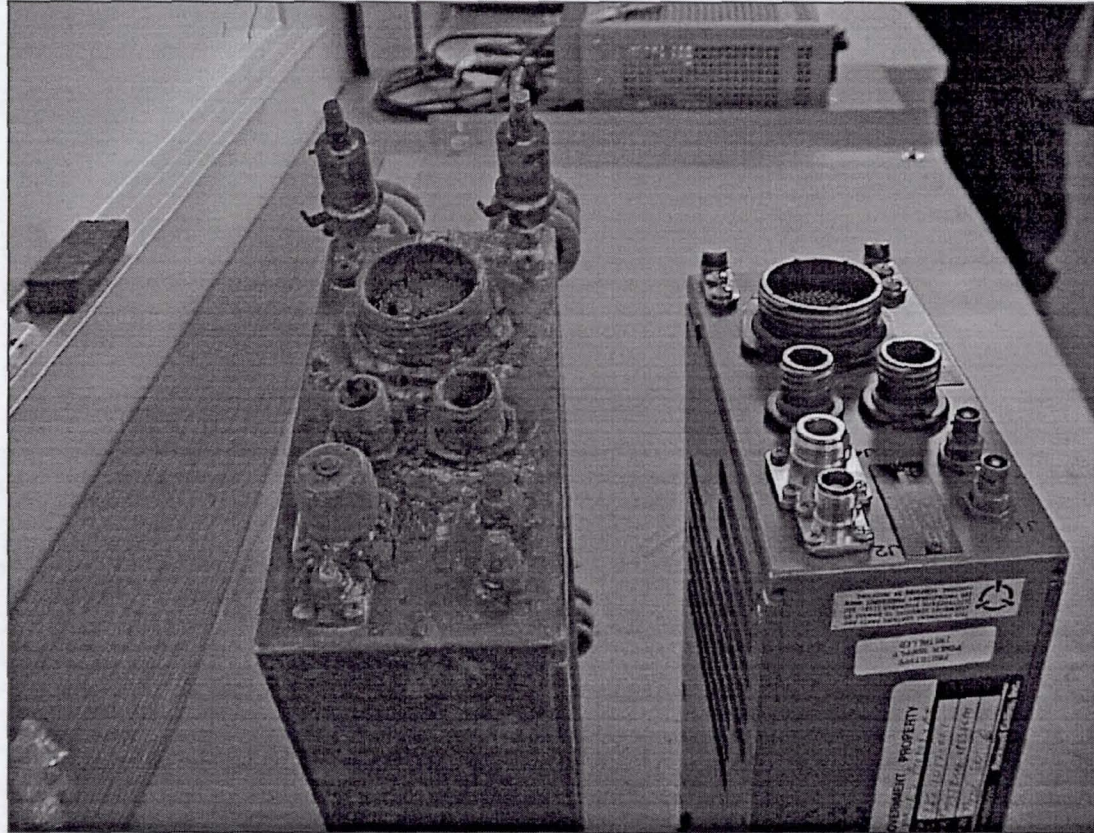
Recovery of the MAGR S/N 11

- S/N 11 was found about 350 yards from the Texas shore of the Toledo Bend Reservoir on February 28, 2003.
- It was sent to its manufacturer, Rockwell Collins, to determine if data could be retrieved from its battery-backed RAM.
- Data from the MAGR's memory could confirm the time when the MAGR lost power.

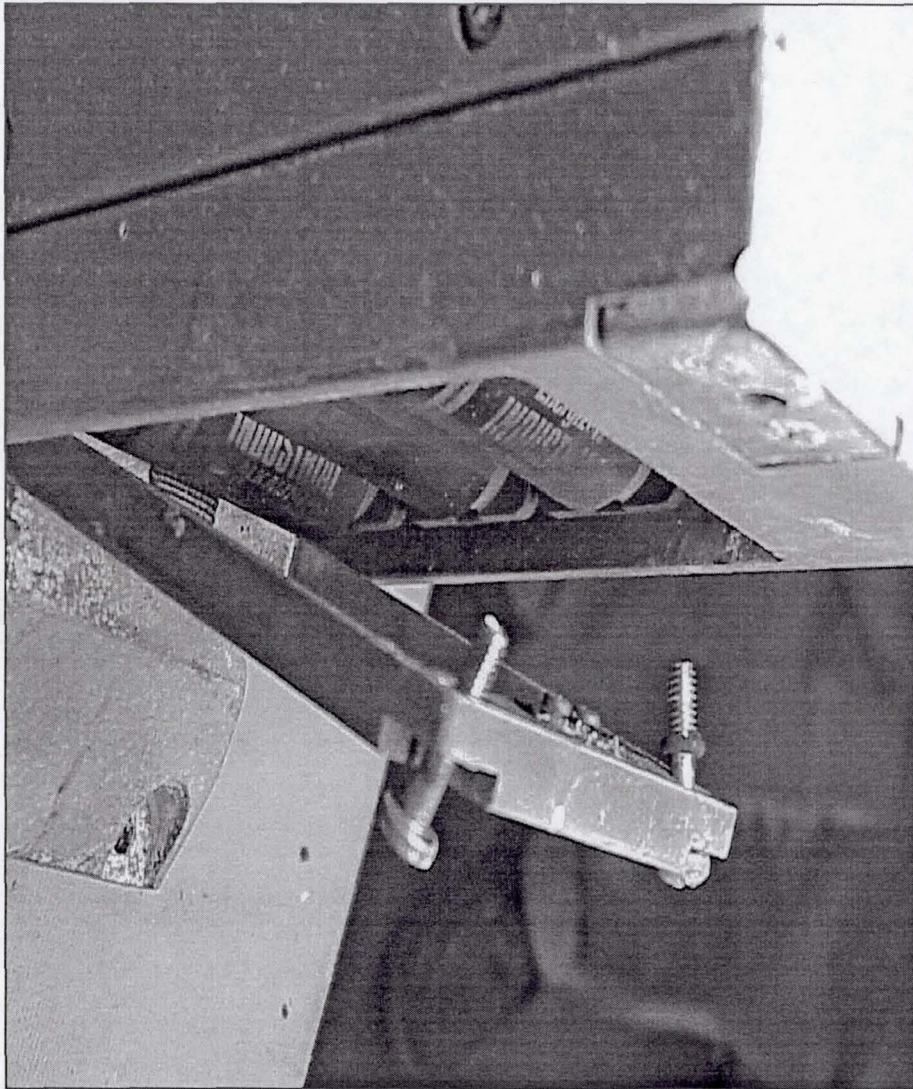
Recovery of the Data from the MAGR

- Evidence of thermal damage and solder re-flow was present on some of S/N 11's circuit cards.
- The card containing the battery-backed RAM was mounted in the innermost portion of the MAGR chassis and did not show any evidence of heat damage.
- It was quickly determined that the batteries (three C-cells) were still good and that the RAM had sufficient voltage to retain data.
- The MAGR was left on internal battery power; connecting an external power source before memory contents could be extracted was deemed too risky.

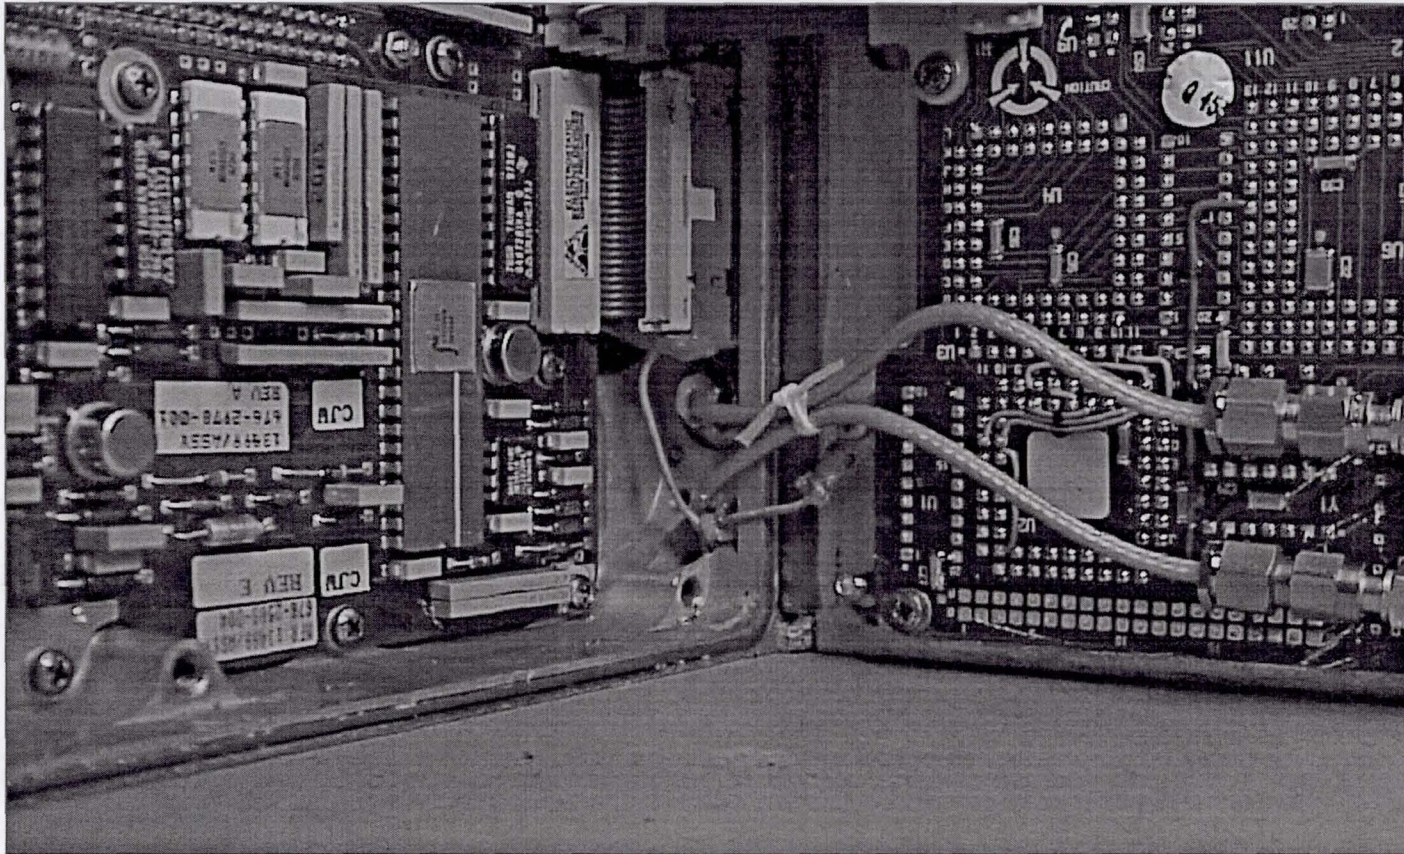
Recovery of the Data from the MAGR (continued)

- Damaged MAGR circuit cards were replaced with good cards from another MAGR.
- Internal processors were halted to prevent inadvertent overwrite of the memory.
- Data was extracted directly from memory via a bus monitor.

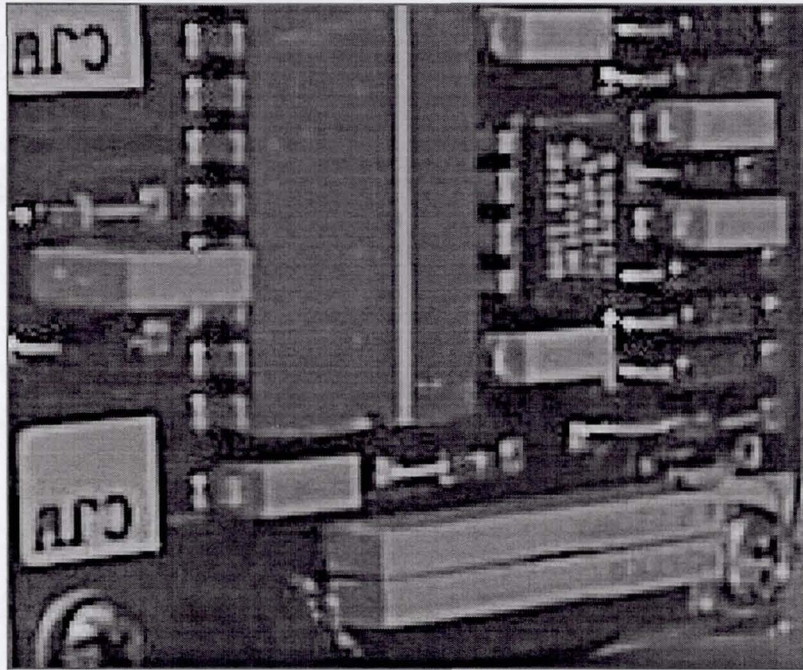
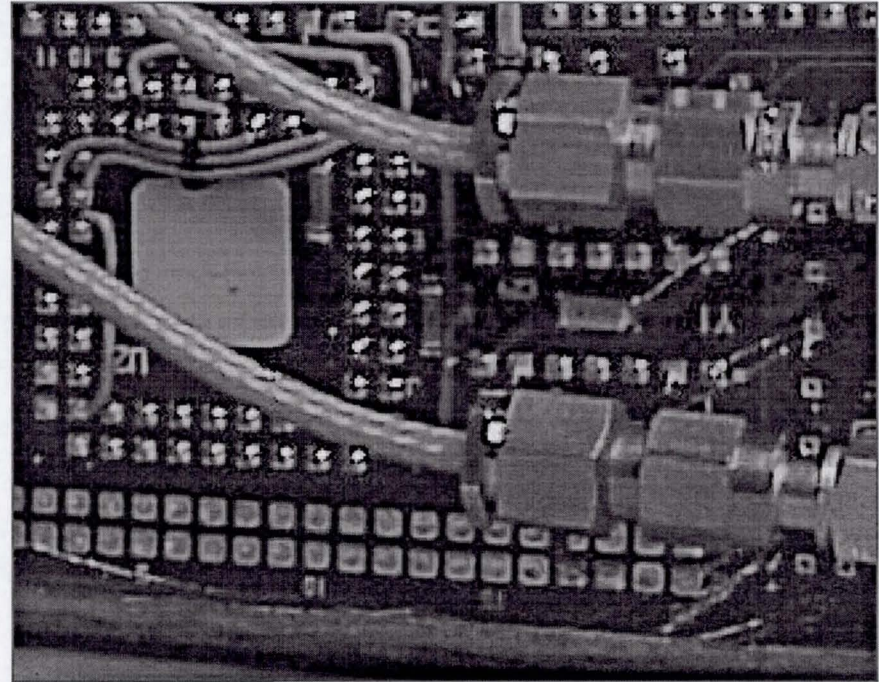
Processing of MAGR Data

- Data from the MAGR was checked against expected data values; although overall quality was good, some time and position values, though of valid format, were considered suspect.
- Further examination of the data at the binary level revealed that flipping some bits would change the data to a value that was more in line with expected values.
- In order to determine exactly which bits should be flipped, comparisons were made with reliable ground data.

- By comparing, bit by bit, almanac and ephemeris data recorded at ground stations with data stored in the MAGR's memory, engineers were able to determine that two data lines were the source of all suspect bits, and that these lines were most likely shorted together.

- Examining the MAGR's memory card more closely, a short circuit, caused by solder splash, was discovered between these lines.
 - Previous examinations of the MAGR's memory card were limited by the potential for inadvertently affecting the MAGR's memory contents as a result of the examination.

- Removal of the short circuit and re-reading the memory showed immediate correction of all of suspect bits.

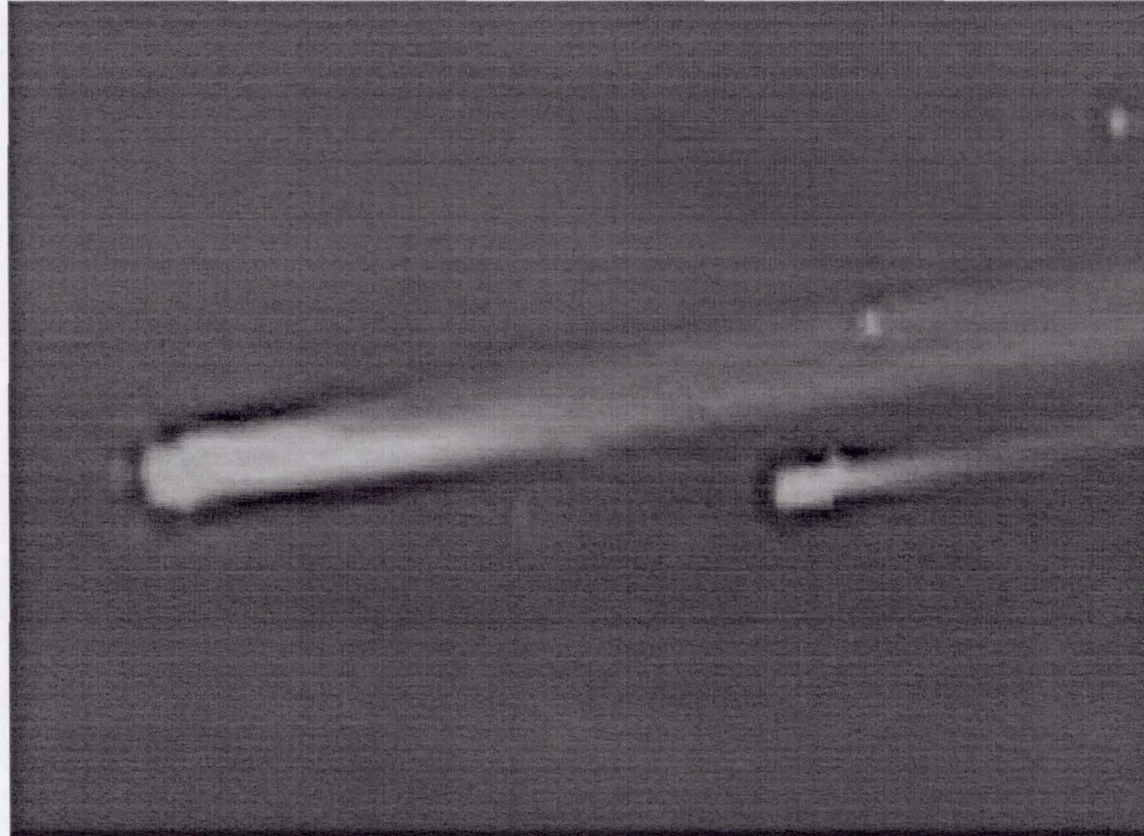
Use of Recovered MAGR Data

- High-resolution time code data from the MAGR was used to determine when the receiver lost power, which in turn gave investigators insight on the degradation of *Columbia's* physical condition.

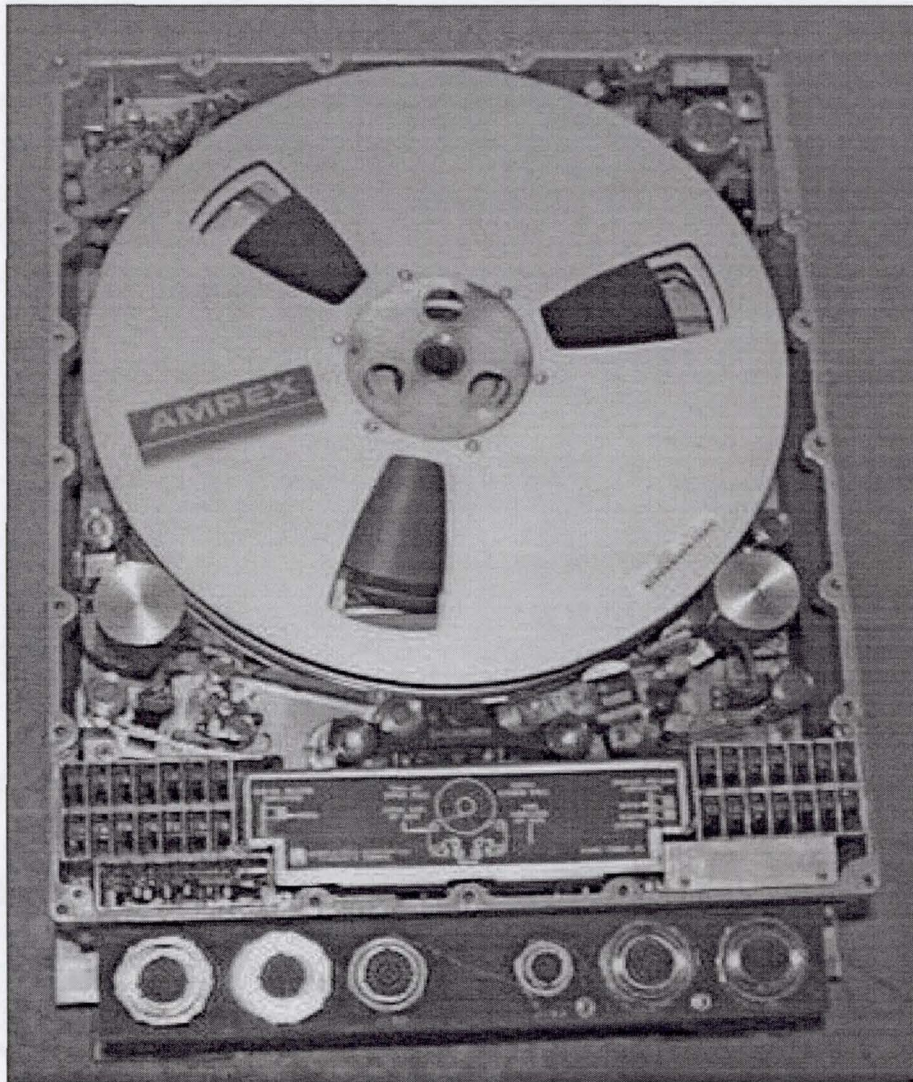
Orbiter Experiments (OEX) Tape Recorder

- Modified Bell & Howell MARS instrumentation recorder, introduced in 1966.
 - *Columbia's* unit, S/N 1001, was purchased in 1978.
- Records a variety of sensor data (temperature, strain gauge, accelerometer, etc.) from different Orbiter systems, predominantly main engines and structures.
- OEX is a remnant of flight test instrumentation that was flown on *Columbia's* first six missions.
- Comparable instrumentation is flown on all Orbiters, but *Columbia* had the greatest number of sensors.
- OEX data is not telemetered; it can only be retrieved post-landing.

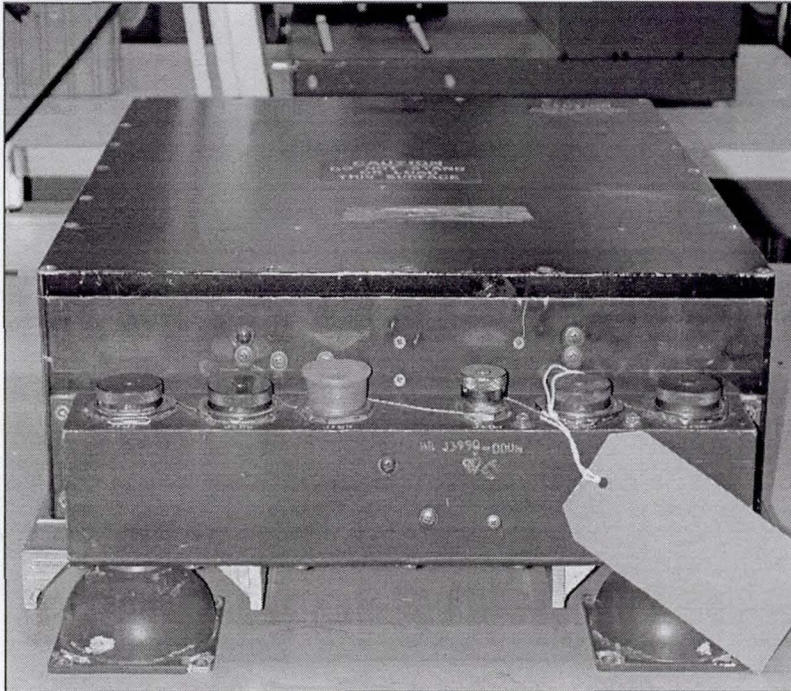
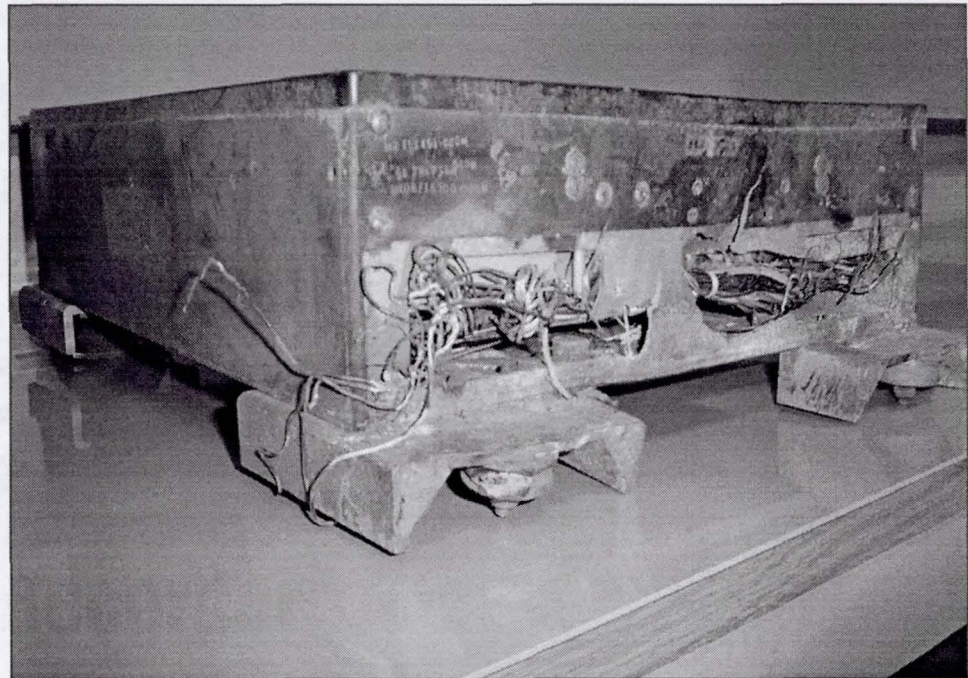
Recovery of S/N 1001 OEX Recorder

- S/N 1001 was found near Hemphill, TX on March 14, 2003.
- It was immediately shipped to the Johnson Space Center (NASA-JSC) in Houston, TX for preliminary evaluation.
- Other than the loss of the front connector panel and some exposure to rain, the recorder appeared to be in good shape.
- It was then sent to Imation, Inc. in St. Paul, MN for removal and processing of the magnetic tape.

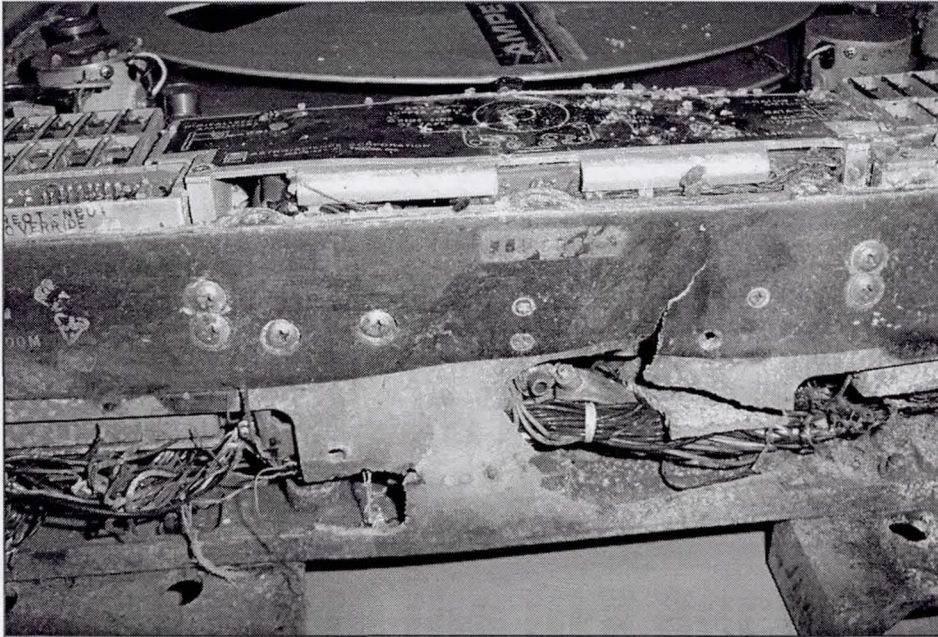
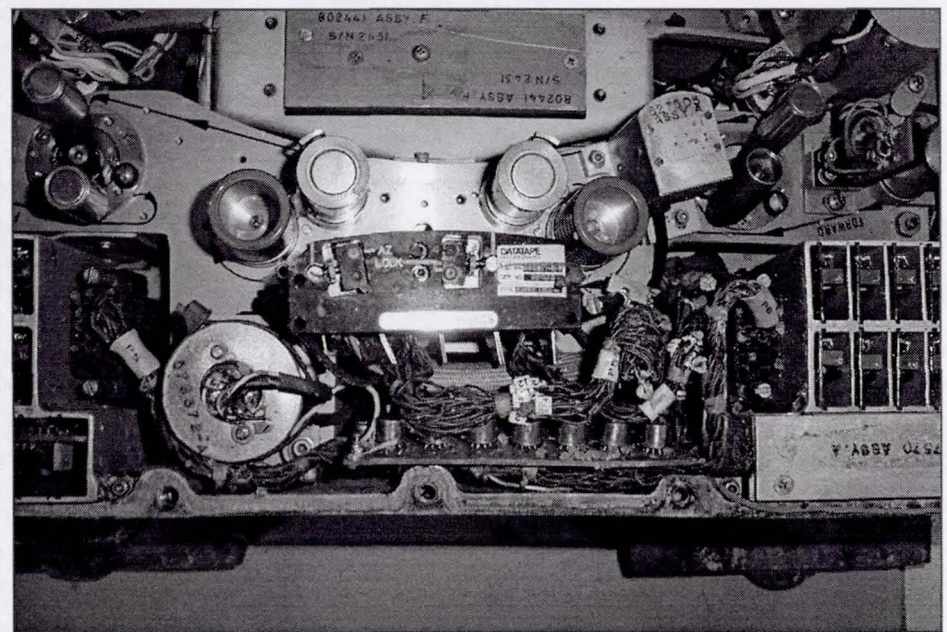
Damage to the OEX Recorder

- After removal of the lid, the apparent lack of damage to the recorder was proven optimistic; many internal recorder components had been severely damaged.
- Separation of the front connector panel (which presumably stayed with the connected cables) allowed hot gases and debris to enter the chassis.
- The hot gases re-flowed solder off of circuit cards and wires, and melted some of the Kapton drive belts.
- Mechanical forces on both the top and the bottom of the recorder deformed portions of the chassis and many internal components, including the tape reels.

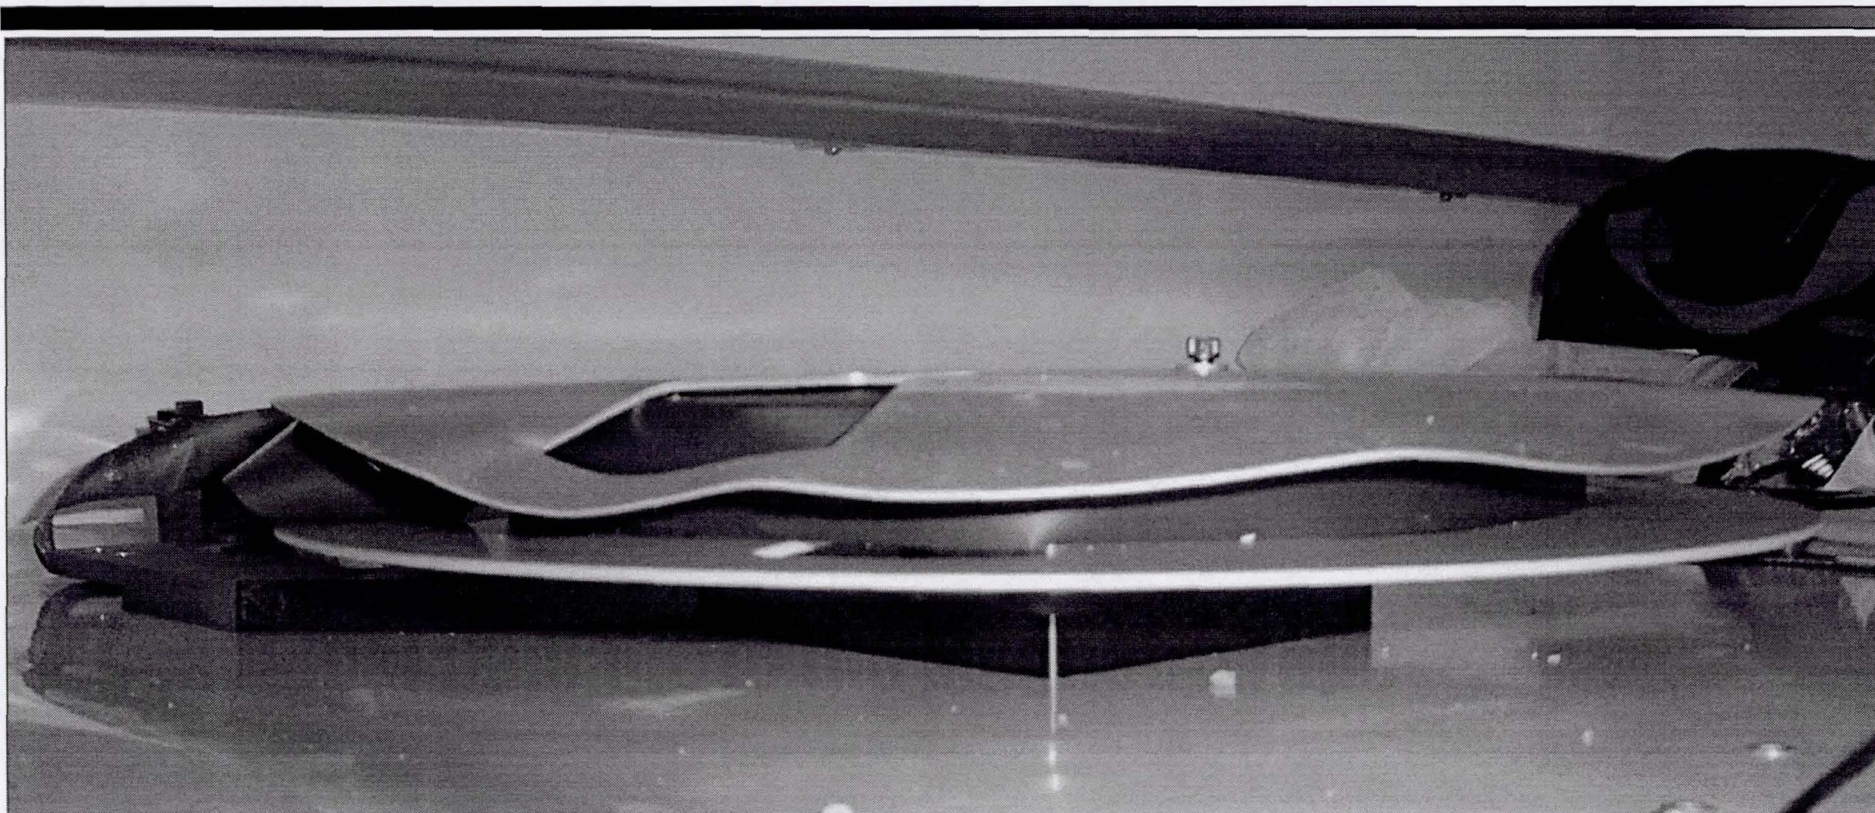
Mechanical Damage to the Magnetic Tape

- Pressure on the top of the recorder drove the chassis down to the limit of the shock mounts, and beyond.
- The recorder's lid deformed inward wherever there was free space in the chassis, which bent the tape reel over the tape itself.
- Pressure from the bottom drove components upward, sandwiching the tape reels between the two forces and severely damaging the reels and tape.

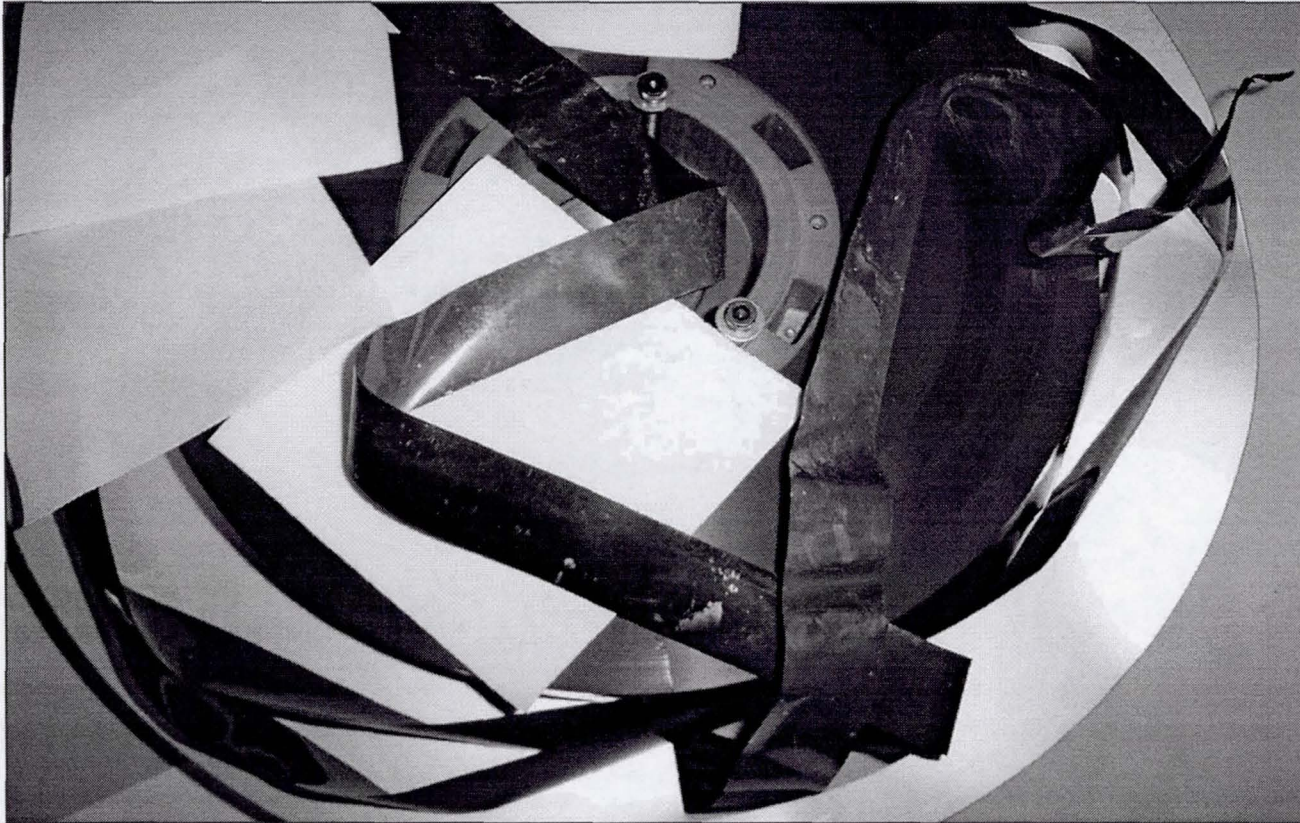
Temperature Damage To The Magnetic Tape

- Hot gases entering the chassis damaged and discolored the tape near the front of the recorder, eventually melting through the tape.
- The now-loose tape ends fluttered within the reel and folded back upon themselves multiple times.
- Tight packing on the rest of the tape reel spared it from much of the damage. Of the 4650 ft. of recorded tape (total length 9300 ft.), 241 ft exhibited heat and water damage.

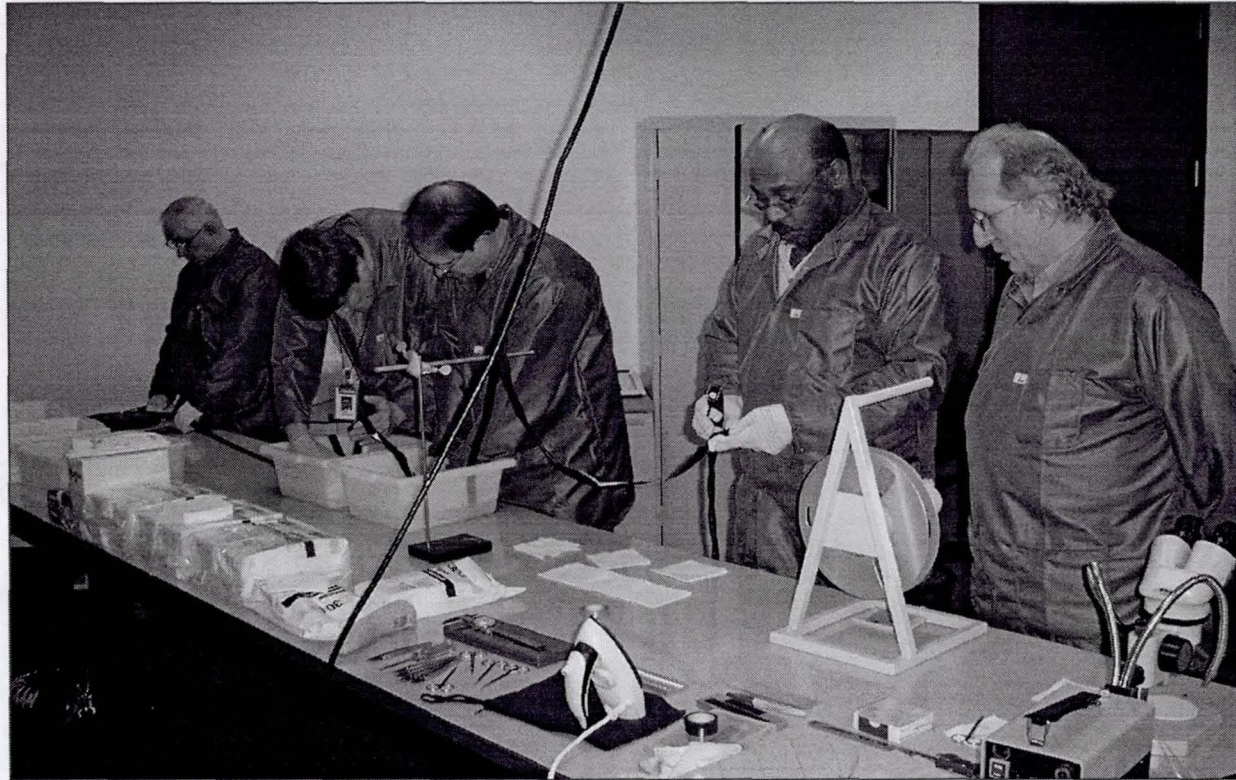
Processing The Magnetic Tape

- Small portions of the tape were coated in Fe_3O_4 colloid to visually reveal the magnetic data structure.
- The tape was then examined under a microscope to determine where recorded data ended. The tape cut past the end of recorded data.
- The tape was washed in two baths of de-ionized H_2O to remove debris.
- The tape was dried, repacked by hand on a reel, and spliced to a new tape.
- The tape was then shipped to NASA-KSC for playback.
- All flight data was successfully recovered from the tape

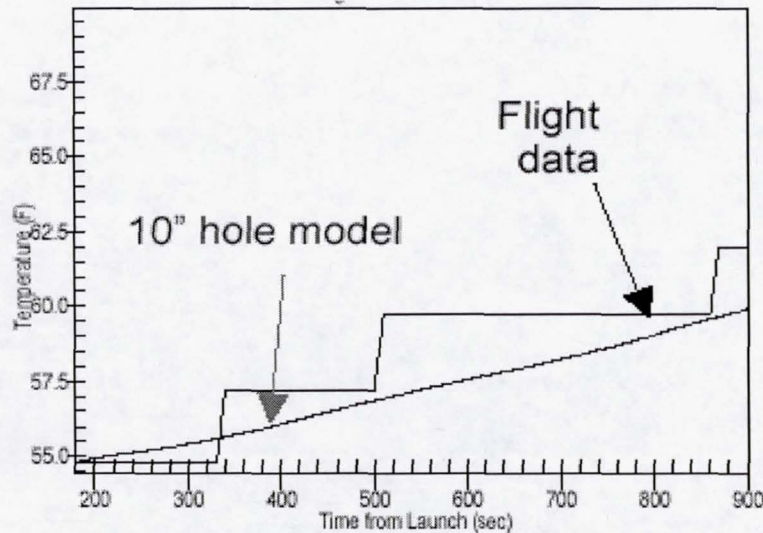
Spar Temperature
Ascent Heating

(CAIB/NAIT Working Scenario, 8 July 2003)

- Telemetry for the left wing comprises 11 different sensors.
- OEX data for the left wing comprises 143 different sensors.
- OEX launch accelerometer data detected an event in proximity to the RCC panel, close to the observed location of the foam impact.
- OEX landing data helped determine internal temperature increases in the wing, which were then correlated with foam impact test data and math modeling.

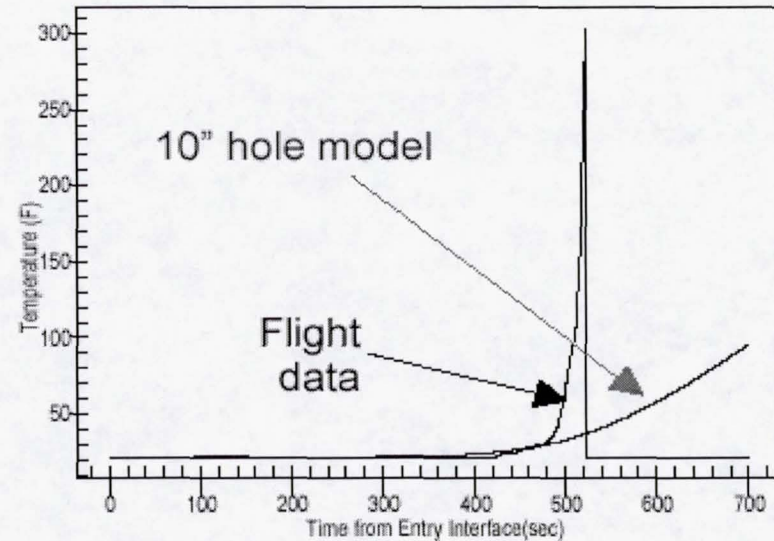
Spar Temperature
Entry Heating
Model includes 10% Sneak Flow

(CAIB/NAIT Working Scenario, 8 July 2003)
