# STS-135 SSP Flight Readiness Review

**MS/Terri Murphy**  
**June 21, 2011**

# STS-135 Debris Risk Summary

## IIFA STS-134-I-002 Cylindrical Object Observed Near +Y Thrust Panel During SRB Separation

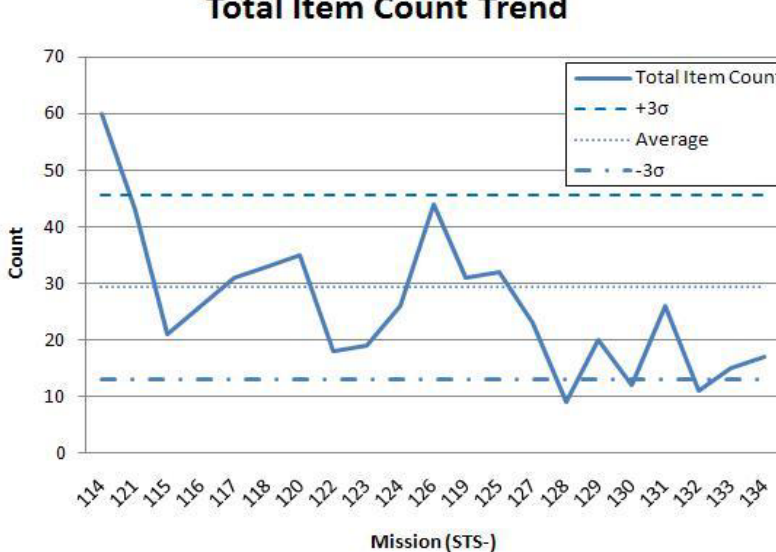
**Total Item Count Trend**

Total
+3σ	45.65
μ	29.38
-3σ	13.12
STS-134	14

Baseline established with data from STS-114 through STS-127.

**STS-133 debris count is below the baseline average and within family of the last several flights.**

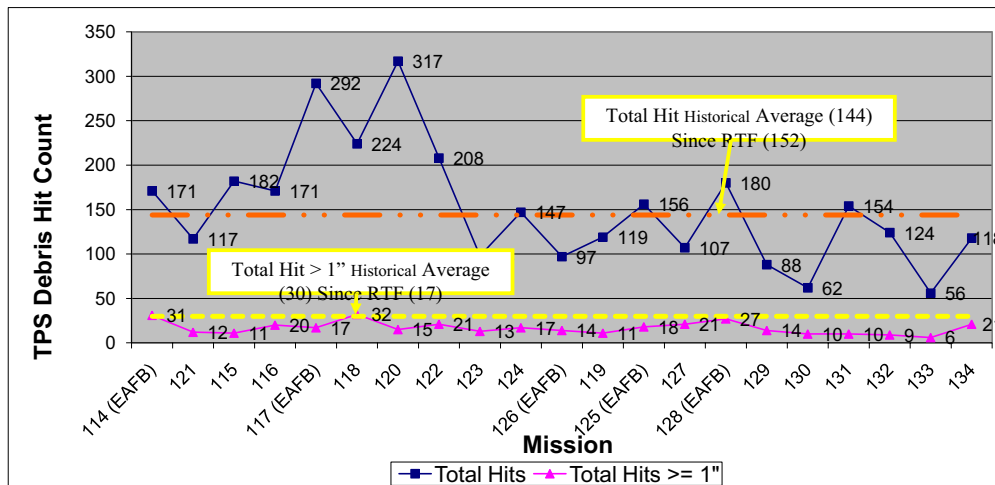
**Orbiter Debris Impact summary  
 RTF Summary thru STS-134, OV-105**

- Total # of TPS Hits = 118 / TPS Hits w/damage > 1" = 21
- Prior to RTF Average for >1" = 30.5 per flight / Average Since RTF = 17 per flight

- STS-134 elliptical volume Hits>1" = 9.421 in<sup>3</sup> / RTF Average = 2.536 in<sup>3</sup>
- STS-134 Total elliptical volume ALL Hits = 10.065 in<sup>3</sup> / RTF Average = 3.515 in<sup>3</sup>

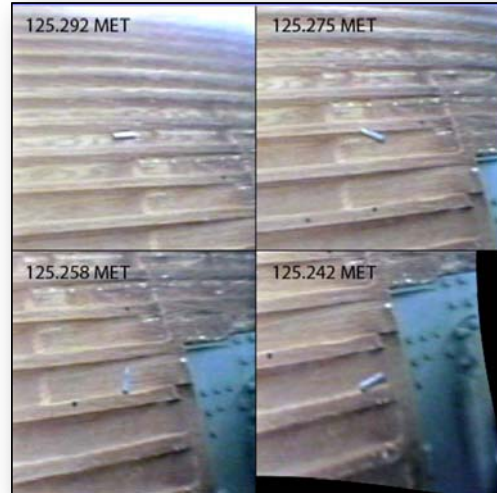
**Cylindrical Object Observed Near +Y Thrust Panel  
 During SRB Separation**

- Right SRB ET Observation Camera (SRF110) recorded imagery of cylindrical object downstream of ET/SRB forward attach point.
  - Object not observed in any other camera view

- Point of origin outside field of view
  - Observed in 7 frames approximately 0.4 sec after SRB separation (~125 sec MET)
  - Appears to be metallic with range of size from 0.25 to 2.78 in length with length to diameter aspect ratio between 2 – 5+. Maximum initial velocity ~ 33 ft/sec.

- Object is tumbling end over end at approx. 900 rpm
- Large uncertainty on size, velocity, and direction due to large depth of field of camera and due to fact that both object and reference points on tank are moving relative to camera and each other.

- Potential correlation with debris radar
  - Object with Ballistic number (BN) of 3.9 psf is observed at ~125 sec in forward third of vehicle.
- Potential correlation to WLEIDS on panel 12R at approx 126.6 sec (2 Grms trigger)

- No damage observed from postflight inspections

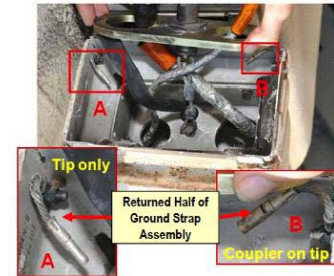
BI145 RH Fairing Assembly at Postflight

**Ground Strap Coupler**

- RSRB Ground strap coupler used in RSS crossover assembly
  - Connects pins on grounding straps at RSRB and ET sides of separation plane
  - Coupler symmetric – can be retained with either pin at separation
    - Is retrieved approx ½ time
    - Remaining times most likely with ET, but could be lost during retrieval, or liberated
- Liberation unexpected but cannot rule out possibility

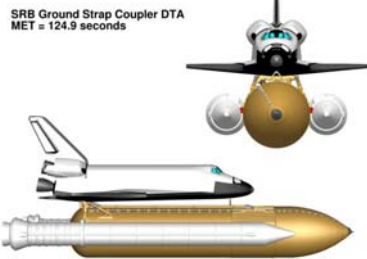
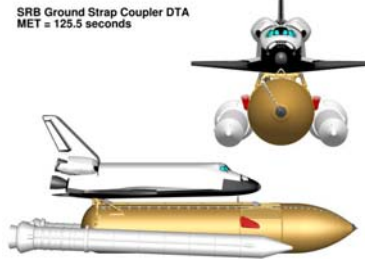
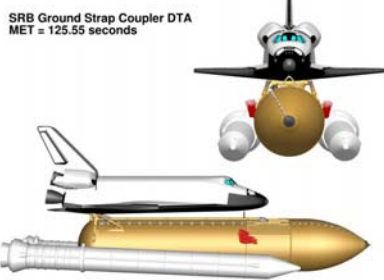
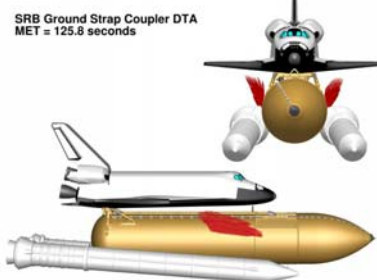
<b>DTA Timeline from ET/SRB Interface</b>		Presenter	Doug Drewry/MS
		Date	6/21/11

**SRB Separation + 0.1 second debris traces**

**SRB Separation + 0.7 seconds**

**SRB Separation + 0.75 seconds**

**SRB Separation + 1 second**

**SRB Separation + 1.5 seconds**

- Assessment insufficient to classify either object as most likely or to rule out other possibilities.
- However SRB Ground Strap Coupler debris transport shows potential impacts and damage to RCC, tile and special tile regions.
  - RCC Front side coating damage expected due to the hard/strong nature of the impactor (10 times denser and about 100 times stronger than ice)
  - RCC Punch through failure is possible given Modeling uncertainties
  - Tile damage would require assessment during mission

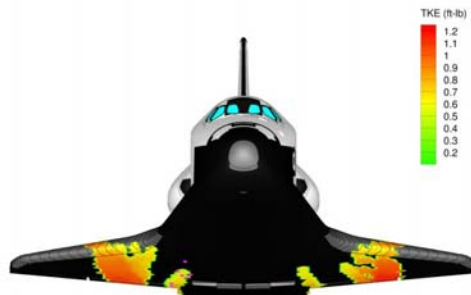
<b>Ground Strap Coupler Impacts on Orbiter</b>		Presenter	Doug Drewry/MS
		Date	6/21/11

**Maximum Impact TKE = 1.23 ft-lbs**

The following table lists worst case impact conditions for some key Orbiter components.

Component	Mass <i>lb<sub>m</sub></i>	Maximum TKE			Max. velocity		Max. angle	
		Velocity <i>ft/sec</i>	Angle <i>deg.</i>	TKE <i>ft-lb</i>	Velocity <i>ft/sec</i>	Angle <i>deg.</i>	Velocity <i>ft/sec</i>	Angle <i>deg.</i>
Wing RCC	0.0022	169	1.6	1.0	169	1.6	150	39.9
Orbiter Tile	0.0022	190	0.9	1.2	190	0.9	151	22.8
Body Flap	0.0022	154	1.2	0.8	154	1.2	151	5.1
Elevons	0.0022	187	1.4	1.2	187	1.4	66	8.8
Carrier Panels	0.0022	168	1.0	1.0	168	1.0	136	14.9
Main Gear/Special Tile	0.0022	136	13.7	0.6	136	13.7	136	13.7

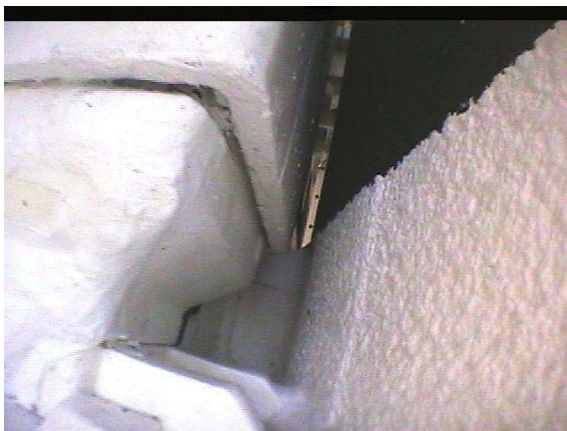
Borescope Dry-run at Pad A

- Enhanced inspections performed in VAB to clear the vehicle for rollout which included borescope inspections behind RSS crossover cavity
- PAD A planned inspections
  - Borecope the crossover areas during final SRB inspections at L-3 or in the event of an off-nominal high wind event

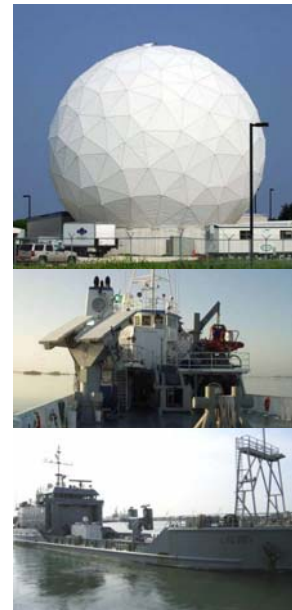
## **Debris Radar Configuration for STS-135:**

- **STS-135 NDR Configuration:**
  - 1 MCR C-band radar
  - 2 NASA X-band radars
    - NASA #1 on SRB vessel *Liberty Star*
    - NASA #2 on *Runnymede-Class* ARMY LCU
  - Operational SRB tracking, following ASTT, by both X-bd radars
  - NDR Readiness has been completed
