ROER RIVER CROSSING

FEBRUARY 1945 • JULICH-GERMANY

GENERAL REPORT

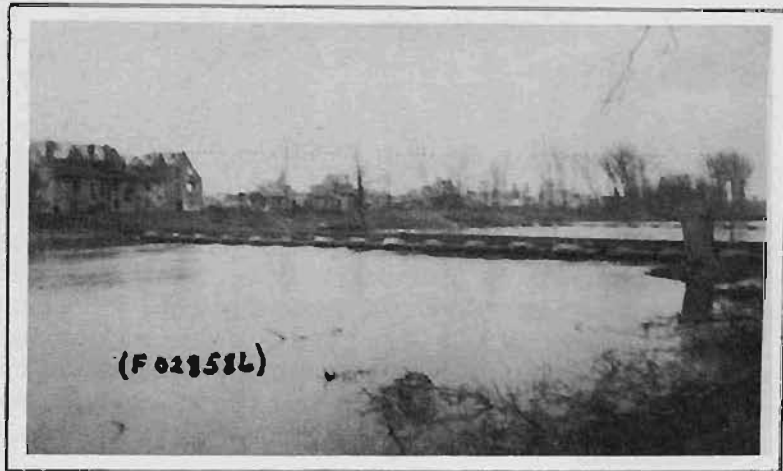
(F02958L)

Completed bridge near Julich after
flood subsided. Constructed by 247
Engr C Bn and 992nd Engr Tw Br Co.

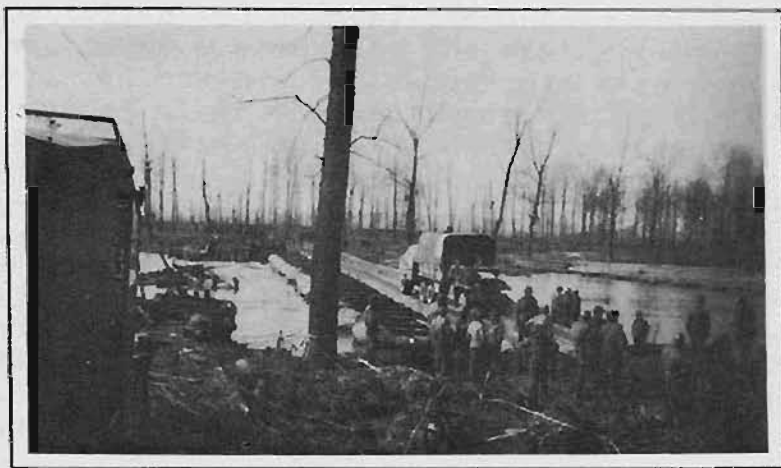
Completed bridge built by 246th
Engr C Bn and 992 Engr Tw Br Co.

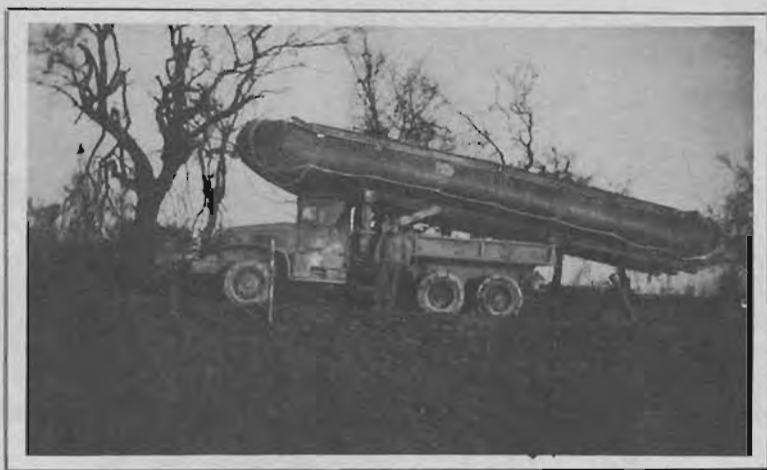
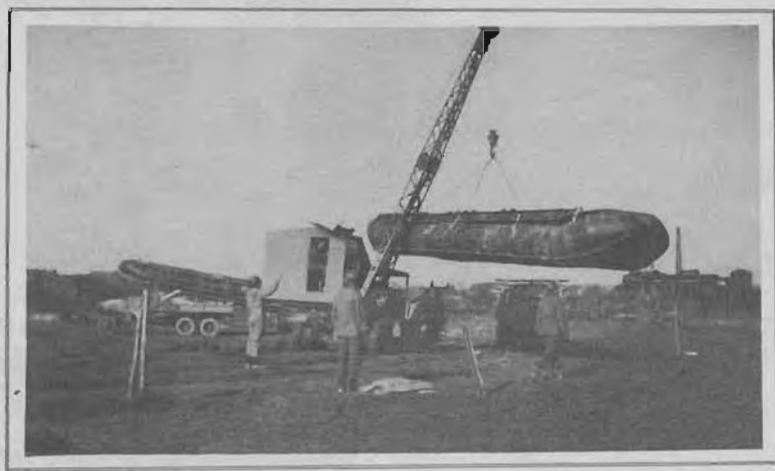
Incl No 5

Method of pre-inflating pontoons
and loading on dump trucks used
in Roer Crossing.

- a. Two and one-half ton dump trucks, with ramps to carry inflated floats, served a two-fold purpose, and they are recommended for use on crossings of a similar nature. Since no construction sites were available on the river bank, inflation and construction of floats was possible at a site quite a distance to the rear of the bridge site. Ramp trucks made it possible to quickly get the floats into the water by simply backing the trucks to the water's edge, raising the bed of the dump truck, and sliding the float into the water. Construction
