REPORT ON THE ENGINEERING ANALYSIS OF THE CSM 109 APOLLO 13 MISSION

July, 1970

Flight Test Requirements and Evaluation Unit 093-201

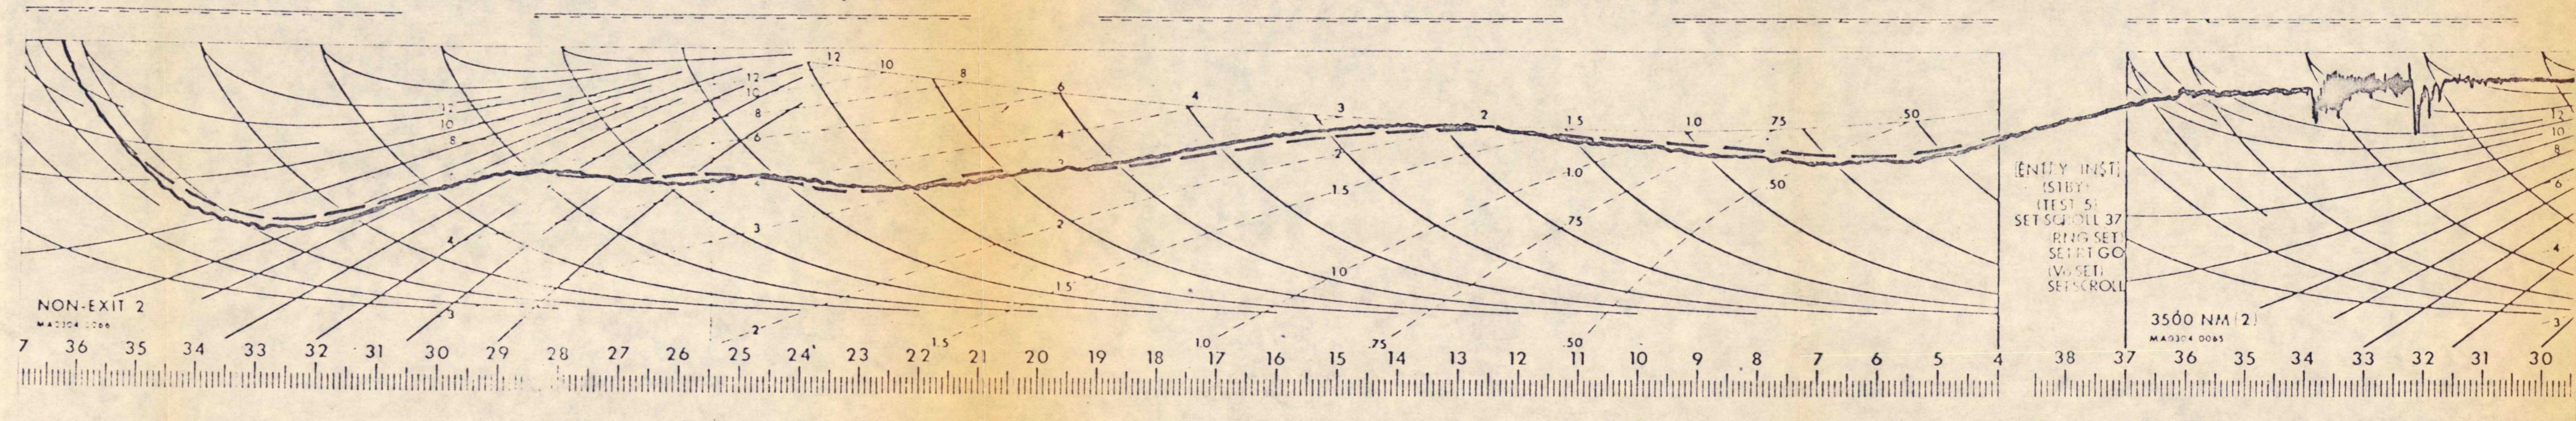
Figure 4.2-4 Apollo 13 EMS Entry Scroll

The performance of the G&N system and the entry monitor system (EMS) during entry was excellent. A copy of the EMS scroll is presented in Figure 4.2-4.

The maximum load factor read from the scroll was 5.6g. No PCM entry data are available for comparison because the DSE was left deenergized to conserve battery power. The 0.05g light did not illuminate and the crew started the EMS manually. The EMS must have been started very close to 0.05g because the expected jump from a zero load factor to the load factor at the time of manual start is not visible on the G-V trace. No G&N incompatibility (i.e., no tangency) is apparent in the up phase. The trace predicted by the operational trajectory is superimposed on a copy of the actual scroll trace in Figure 4.2-4. The close agreement between the traces shows that the entry trajectory was as planned.

Because of the conditions to which the crew were subjected during the mission, and because of the many last minute changes to the entry procedures, it is possible that the mode switch was actuated prematurely.

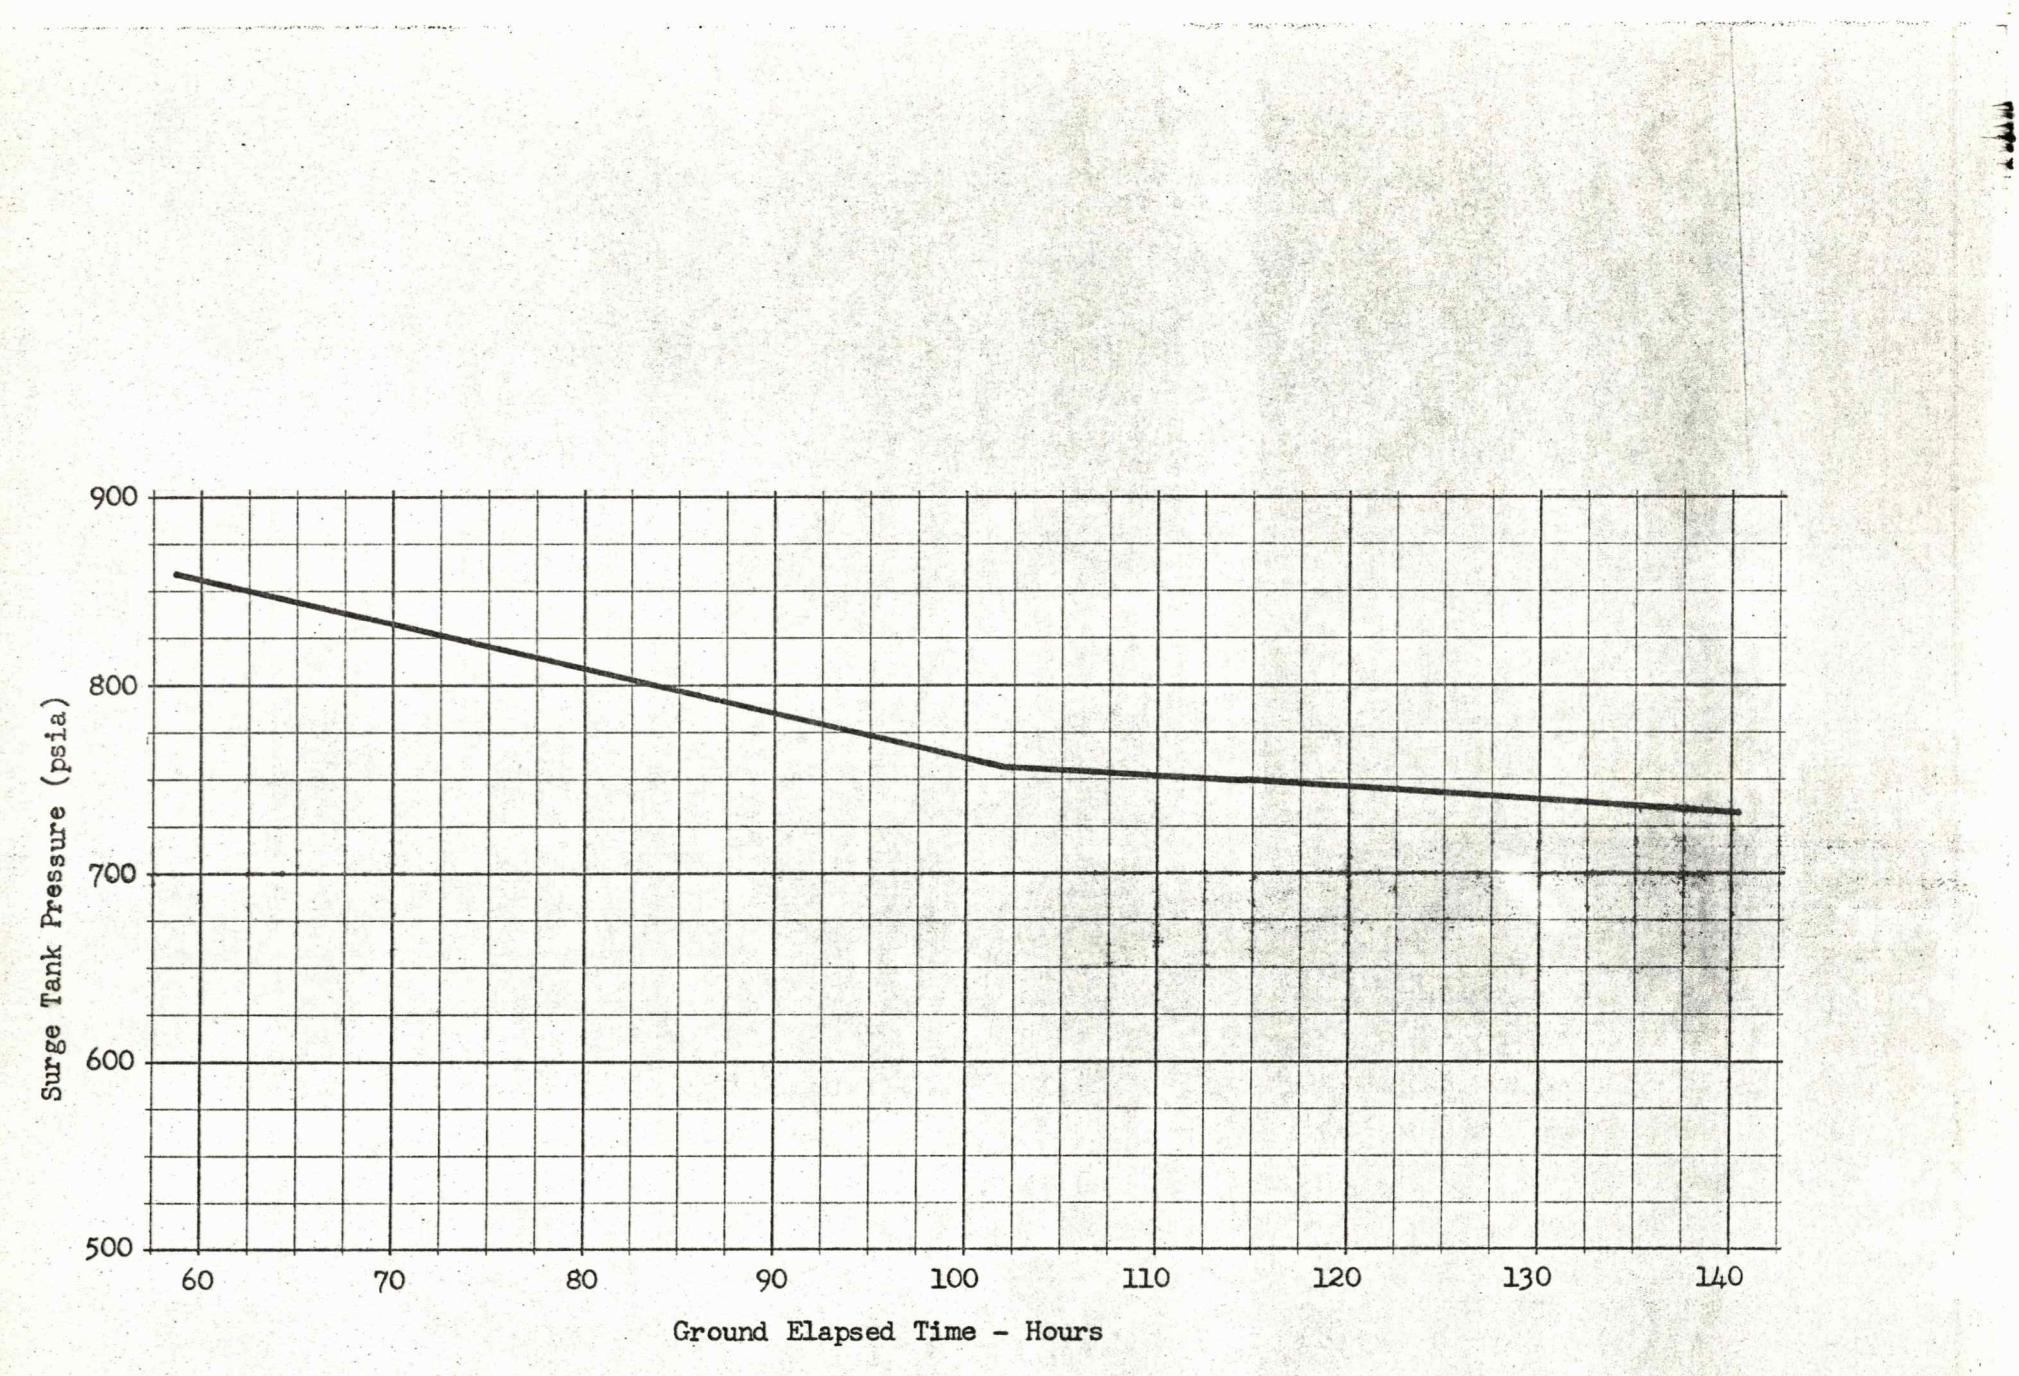
Figure 4.8-3 Apollo 13 Oxygen Surge Tank Pressure Decay During Isolation

The drop in surge-tank pressure during isolation is of particular interest, since the drop could be indicative of leakage if no withdrawals were made. Tank pressure dropped at the rate of 55 psi per day for the first 44 hours of isolation, and 15.6 psi per day for the next 38 hours. The difference in the rates is attributed to (1) the higher tank pressure during the first interval and (2) oxygen withdrawal during water tank pressurization. A plot of surge-tank pressure during the isolation period is presented in Figure 4.8-3. The pressure decay was converted to leakage and/or consumption for the last 38.5-hour time period, and was found to be 2.88 x 10^{-3} lbs/hour. The checkout at Downey showed a leakage of 0.464 sccm nitrogen at 902 psia and 74F, which, converted to the flight conditions, yields an oxygen leakage of 6.54 x 10^{-6} lbs/hour. The difference between flight and checkout data probably represents water withdrawal attempts and amounts to 0.11 lb. during the 38.5-hour time span.

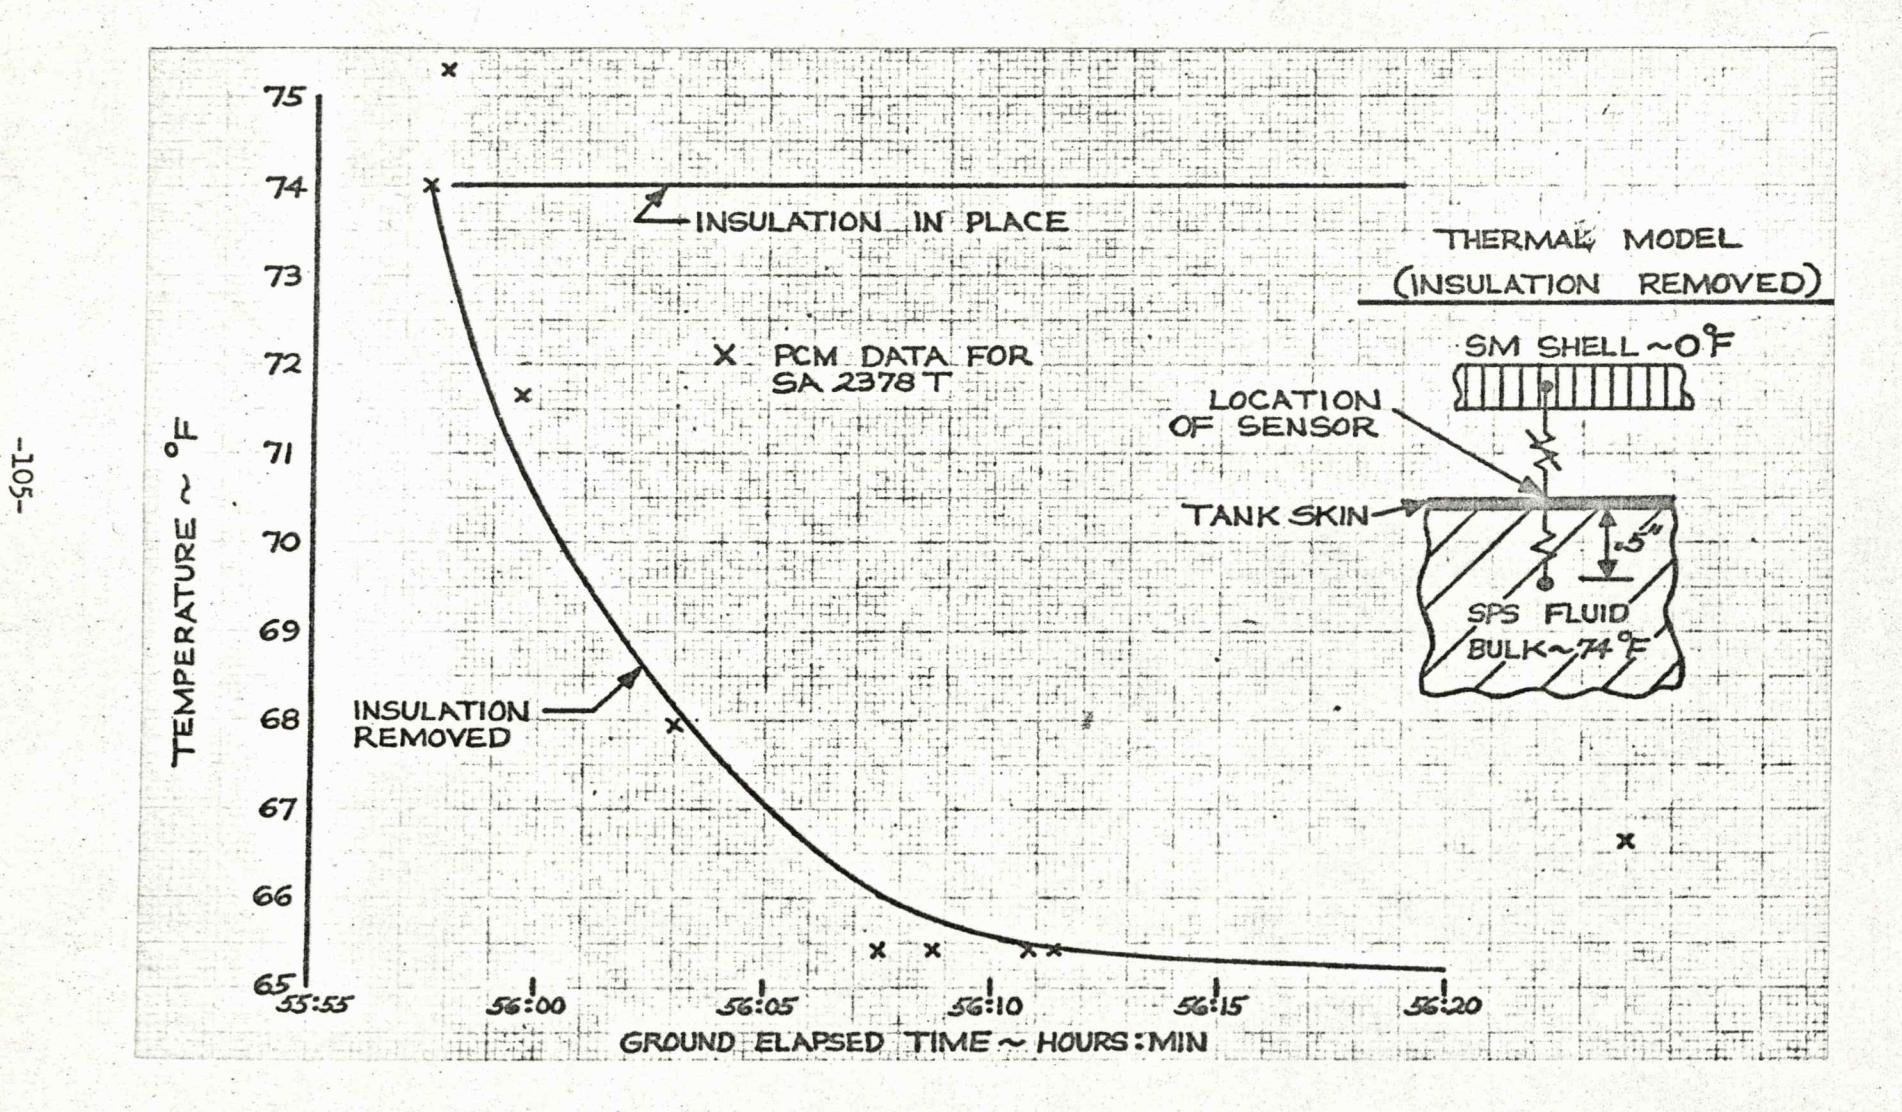
Figure 4.13-6 Location of SA2378T and SPS Tank Insulation

The SPS oxidizer storage-tank skin-temperature sensor (SA2378T) exhibited a rapid and unprecedented rate of change of temperature immediately following the O_2 tank incident. The remaining SPS tank skin temperature sensors responded normally. It is concluded that the pressure wave which tore the outer panel from bay 4 dislodged the aluminized mylar insulation blanket from the SPS storage tank to the extent that the SA2378 sensor became exposed to the ambient conditions of bay 3. Figure 4.13-6 illustrates the SPS tank insulation placement and the location of the sensor under the blanket.
