MSC-07230

APOLLO 16 MISSION REPORT

MANNED SPACECRAFT CENTER  
HOUSTON, TEXAS  
AUGUST 1972

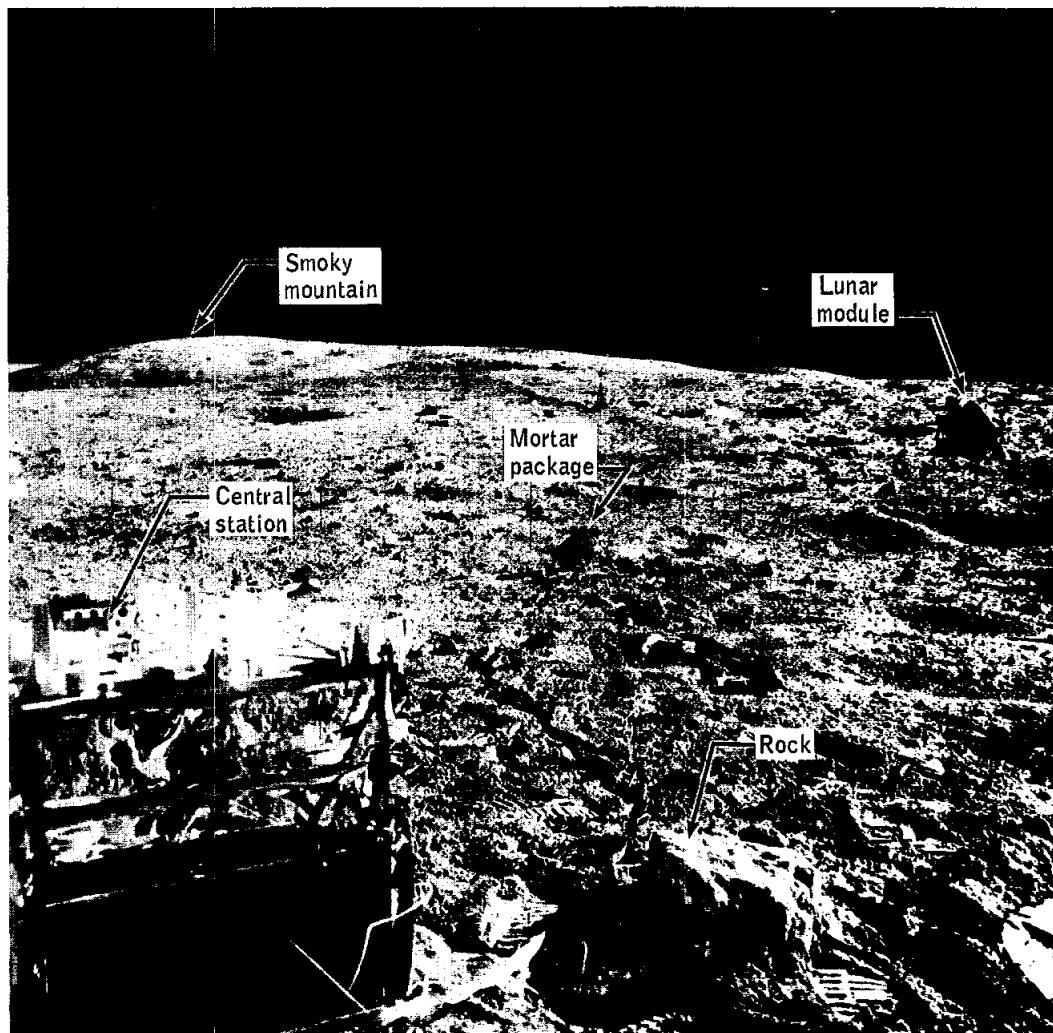
Figure 4-4.- Apollo lunar surface experiments  
package central station

The site selected for emplacement of the Apollo lunar surface experiments package was approximately 95 meters southwest of the lunar module. As shown in figure 4-4, the deployment site is highly cratered and rock strewn but this was unavoidable because this is the general character of the terrain. While the Lunar Module Pilot was carrying the experiments package to the deployment site, subpackage 2 fell off the carry bar. The subpackage became detached because the latch pin had not locked. Lunar dirt in the subpackage socket had prevented the flanged end of the carry

bar from sliding all the way into place so that the pin could lock. As a result, the package was free to rotate and vertical oscillations caused the detachment. The Lunar Module Pilot knocked the dirt out of the socket and re-attached the package. Dropping of the package caused no operational degradation.

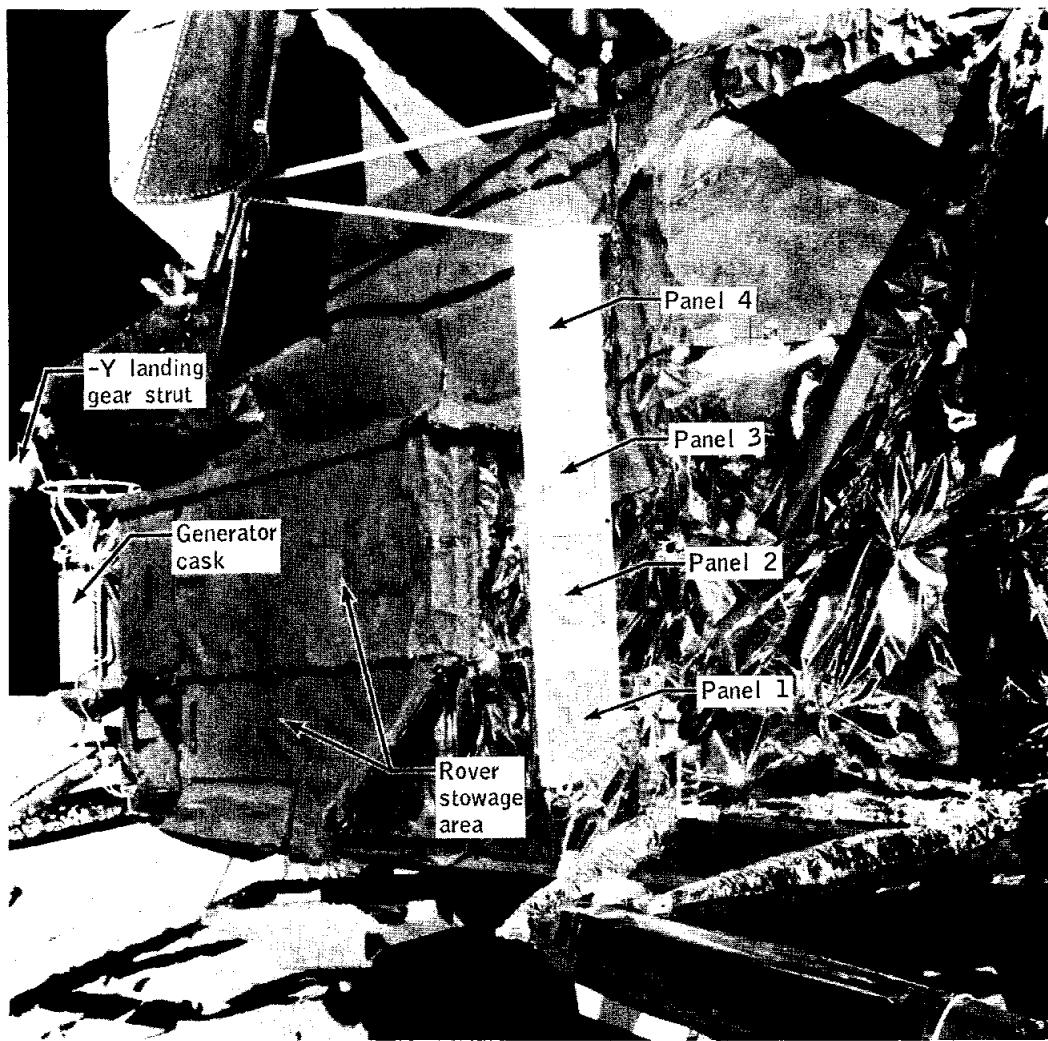
Figure 4-11.- Cosmic ray detector experiment.

The panel array of the cosmic ray detector experiment (S-152) was exposed in its initial configuration upon jettisoning of the spacecraft-launch vehicle adapter panels. The hidden surface of panel 4 was partly exposed by the Commander early in the first extravehicular activity (fig. 4-11). The planned area of exposure for detecting particles at the lunar surface could not be obtained because the experiment mechanism jammed as described in section 14.4.4. The detector panel array was retrieved at

the end of the third extravehicular activity, folded in the proper configuration for transearth coast data collection, and returned for analysis. It was difficult to separate the panel assembly from the main frame at the end of the third extravehicular activity because of thermal expansion of the Teflon slides.

The plastic in all panels of the experiment was degraded by heating above the design limit of  $54^{\circ}\text{ C}$ , at which temperature degradation begins. The high temperature was most likely caused by a film accumulating on the thermal control surface, in addition to lunar dust. Analysis of the film has not been completed.

As a result of the incomplete exposure of panel 4, the portion of the experiment designed to measure neutron flux was degraded, as were those designed to measure solar wind gas, and search for radon ( $Rn^{222}$ ) and argon ( $Ar^{40}$ ).

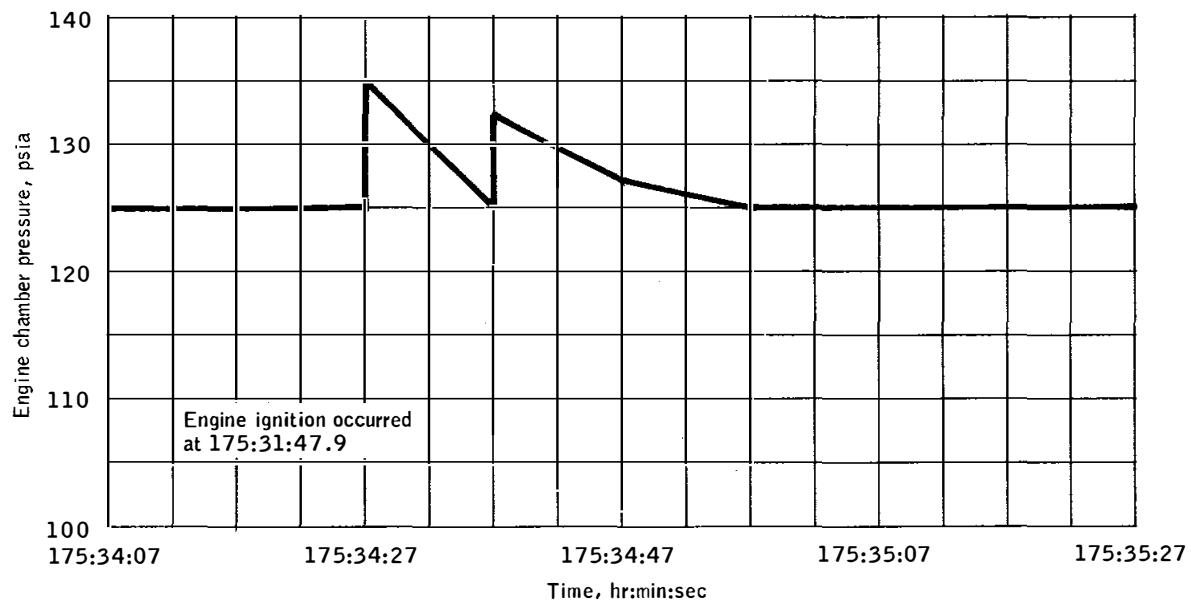
Figure 7-3.- Ascent propulsion system pressure fluctuations.

Two upward shifts in the engine chamber pressure were recorded during the ascent maneuver, as shown in figure 7-3. A review of all other available engine and acceleration data failed to substantiate the increased chamber pressure indication. The crew did not recall feeling additional acceleration or surges during the maneuver. This anomaly is discussed further in section 14.2.8.

Approximately 157 seconds into the lunar orbit insertion firing, the telemetry indication of the ascent propulsion engine chamber pressure reflected an abrupt 10-psi rise followed by a slow decay to its initial value in 10 seconds (fig. 7-3). The phenomenon was repeated 11 seconds after the initial pressure rise.

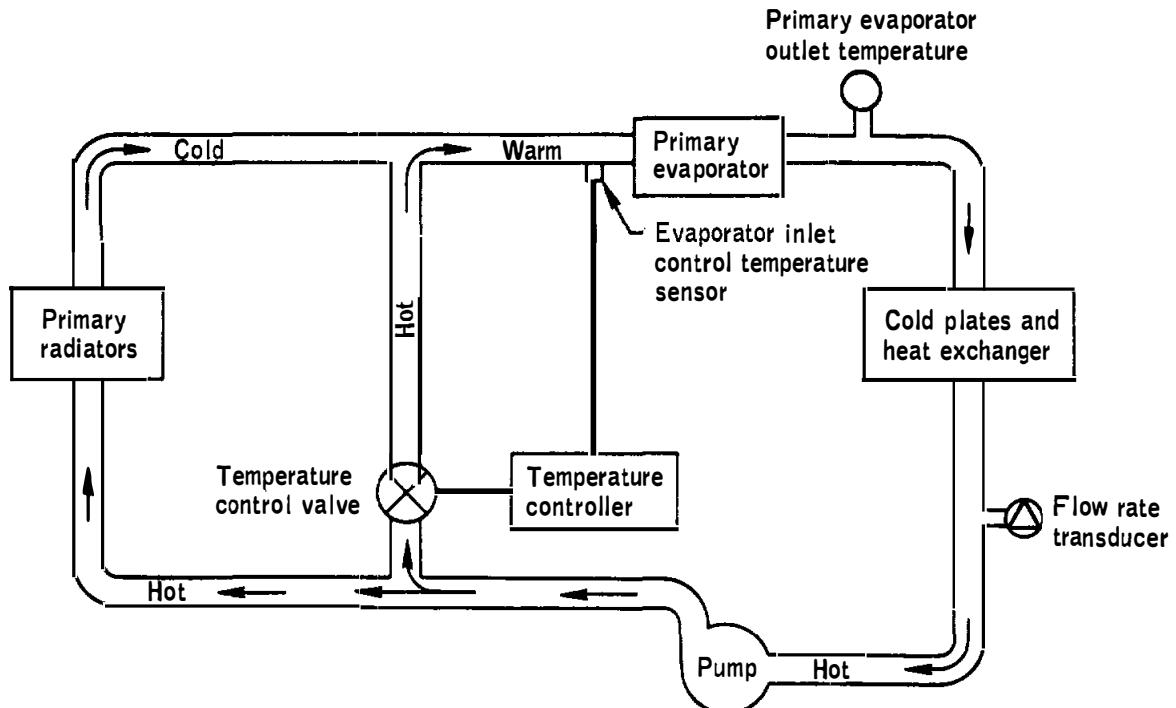
Figure 14-1.- Primary water/glycol coolant loop.

About 3 hours into the mission, the water/glycol temperature control circuit (fig. 14-1) malfunctioned in the automatic mode. The malfunction allowed an excessive amount of hot water/glycol to bypass the radiator causing the mixed water/glycol temperature to exceed the upper control

limit of 48° F. After remaining in this maximum bypass position for 5 minutes, the temperature control valve cycled regularly between maximum and minimum flow to the radiators for about 14 minutes before stopping again at maximum bypass. The control was changed to manual and back to automatic to restart the valve operation and, finally, left in manual at the desired valve position. Variations in the evaporator outlet temperature and total system flow rate for the period are shown in figure 14-2. Control valve operation is evident from the variation of system flow rate. Total flow rate increases as the flow control valve opens since the total system pressure drop decreases.

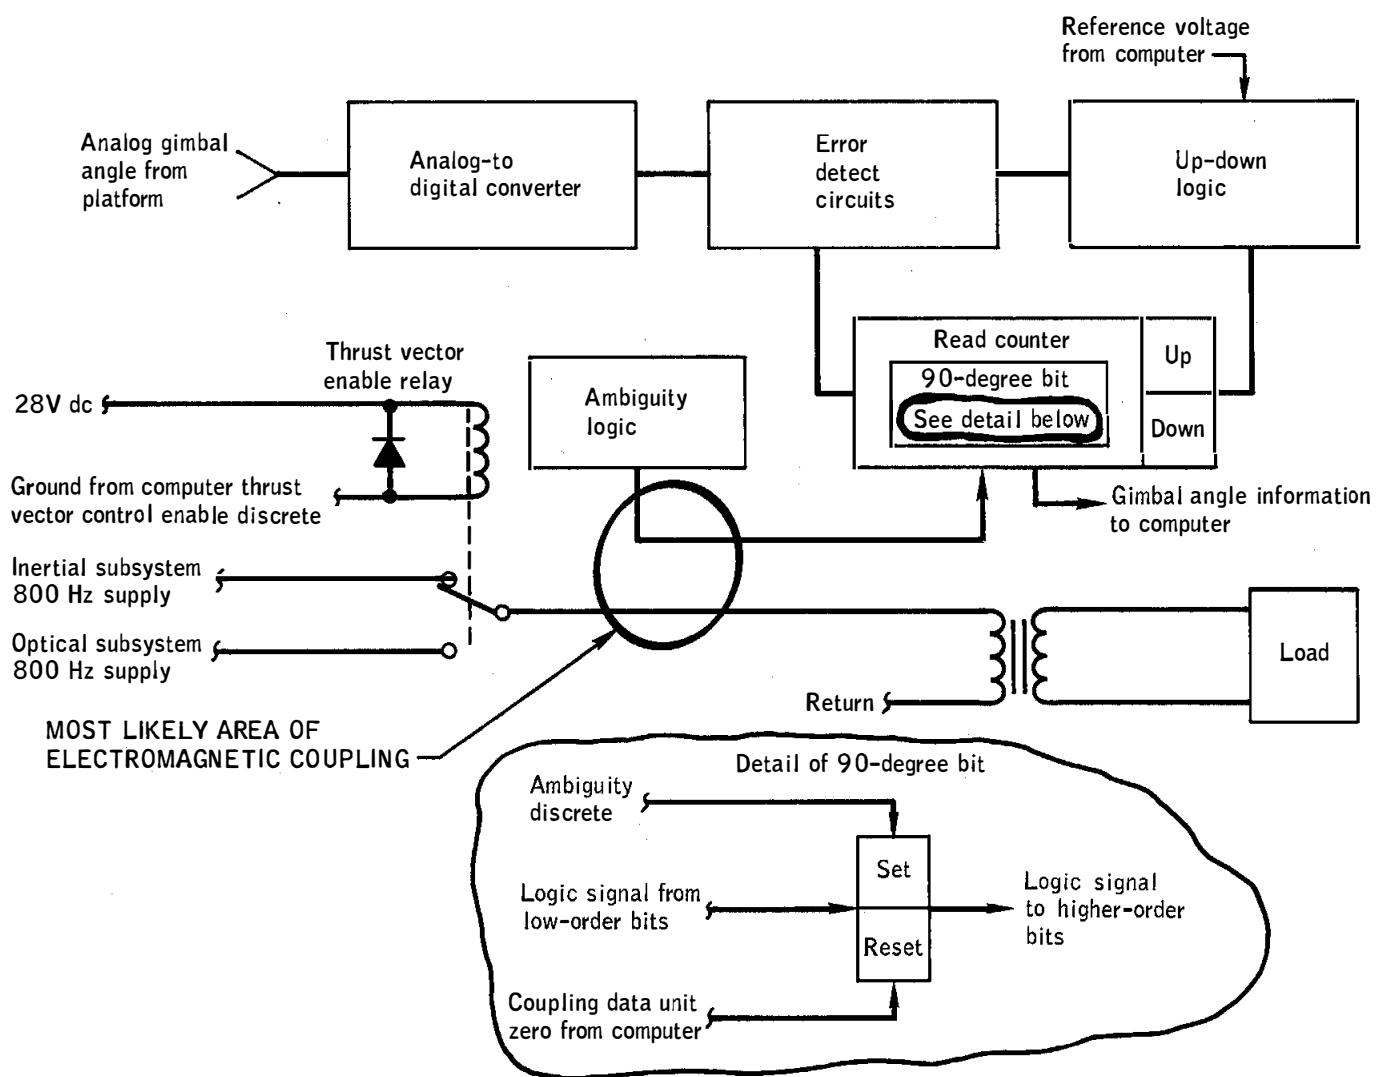
Figure 14-4.- Coupling data unit functional diagram.

Figure 14-4 is a simplified representation of the pertinent circuits in the middle gimbal angle coupling data unit. The purpose of the read counter is to store, in digital form, the platform gimbal angle. If the gimbal angle changes, the analog signal is no longer the same as the digital signal from the read counter and the resulting error signal causes a pulse train to be generated. The pulse train increments or decrements the read counter until it matches the analog gimbal angle. The read counter is a series of flip-flop logic circuits whose only inputs are a pulse train and timing pulses. The 90-degree bit is unique, however, because it can also be set by an ambiguity discrete. The purpose of the ambiguity discrete is to prevent the platform from going to an ambiguous position when the inertial measurement unit is turned on.

The cause of the problem is contact bounce in the thrust vector enable relay (fig. 14-4). The relay switches between two 800-hertz excitation-voltage power sources which are applied to a transformer in the digital-to-analog converter portion of the coupling data unit. A relay without a coil spike suppression diode will transfer between contacts in about 0.5 millisecond with the transients caused by the power interruption and collapsing field of the transformer inconsequential. The addition of the suppression diode across the relay increases the dropout contact transfer time to about 6 milliseconds.

In either condition if the relay contact initially closes the circuit to the transformer (fig. 14-4) at the beginning of either half cycle of the 800-hertz wave form, the current taken by the transformer during the first 3/4 cycle of the 800-hertz excitation voltage will reach 4 to 5 times the steady-state level. If this higher-than-normal current is interrupted by the relay contact reopening, the transformer will feed back a voltage transient as high as 250 volts on the line to the relay. Both of these problems result in circuit-interruption (bounce) durations that would cause high voltage spikes; however, the bounce must occur, as stated previously, at the right time in the 800-hertz waveform.

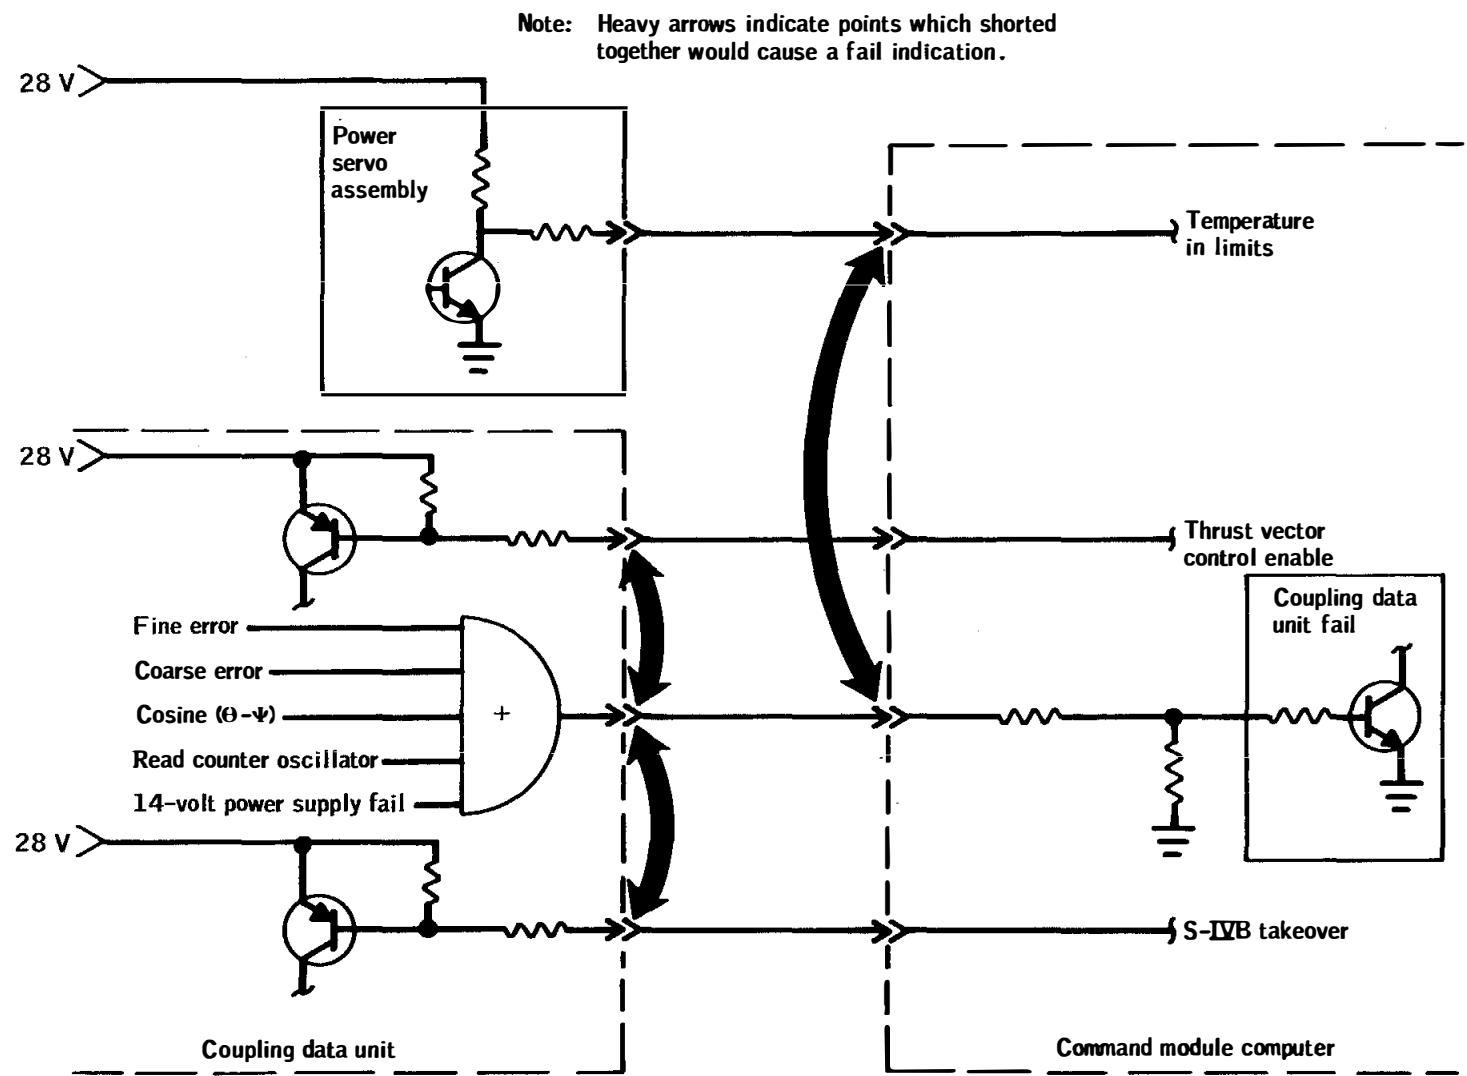
Figure 14-5.-- Coupling data unit fail indication.

Data during each occurrence has been reviewed and no abnormalities were observed. If a real failure of the coupling data unit had occurred and lasted as long as 894 seconds, then some data indication should have been observed. For this reason, an intermittent short in the wiring harness or associated connectors shown in figure 14-5 is indicated. However, other possible causes may be an intermittent in the failure detection logic circuits or the input logic to the computer.

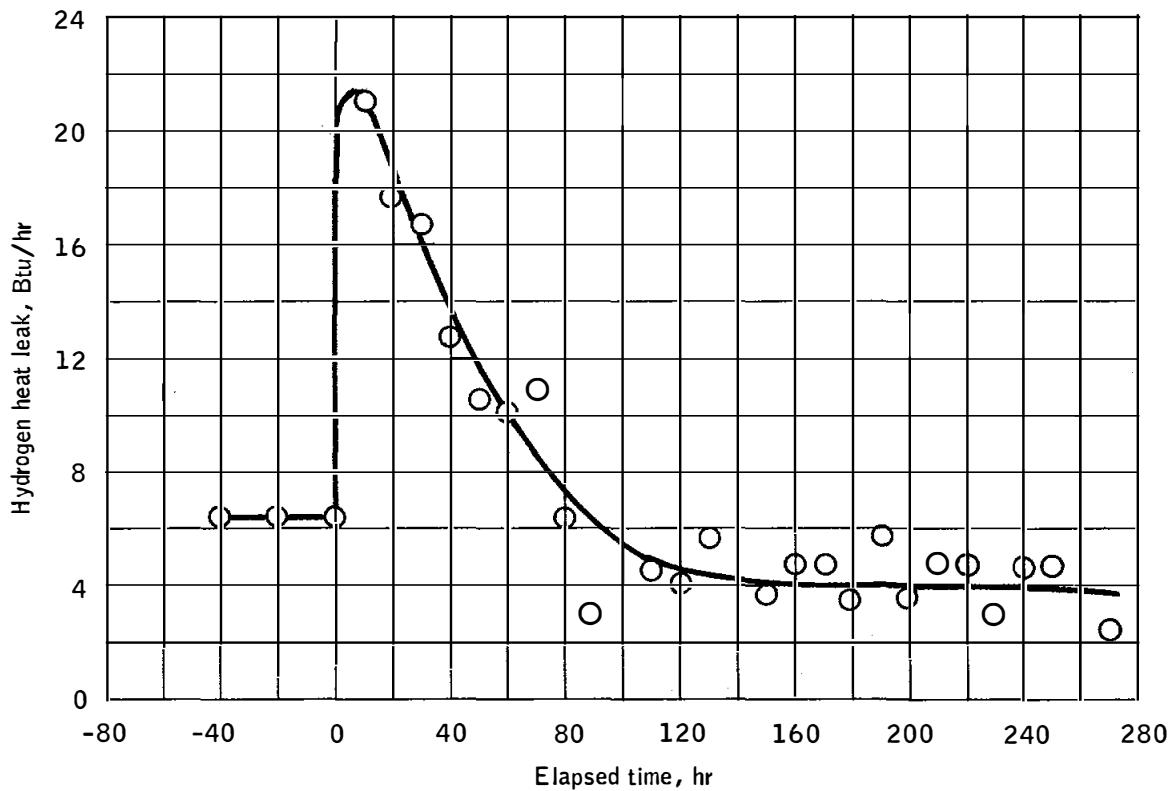
Figure 14-6.- Hydrogen tank heat leak data.

The heat leak into cryogenic hydrogen tank 3 was abnormal during the early hours of the mission. Analysis of the Kennedy Space Center data has shown that the heat leak of this tank was normal prior to lift-off. As shown in figure 14-6, the leak decreased from a high value of 15 to 20 Btu/hour to a normal 2 to 6 Btu/hour by 70 hours and remained normal thereafter. All other parameters were normal.

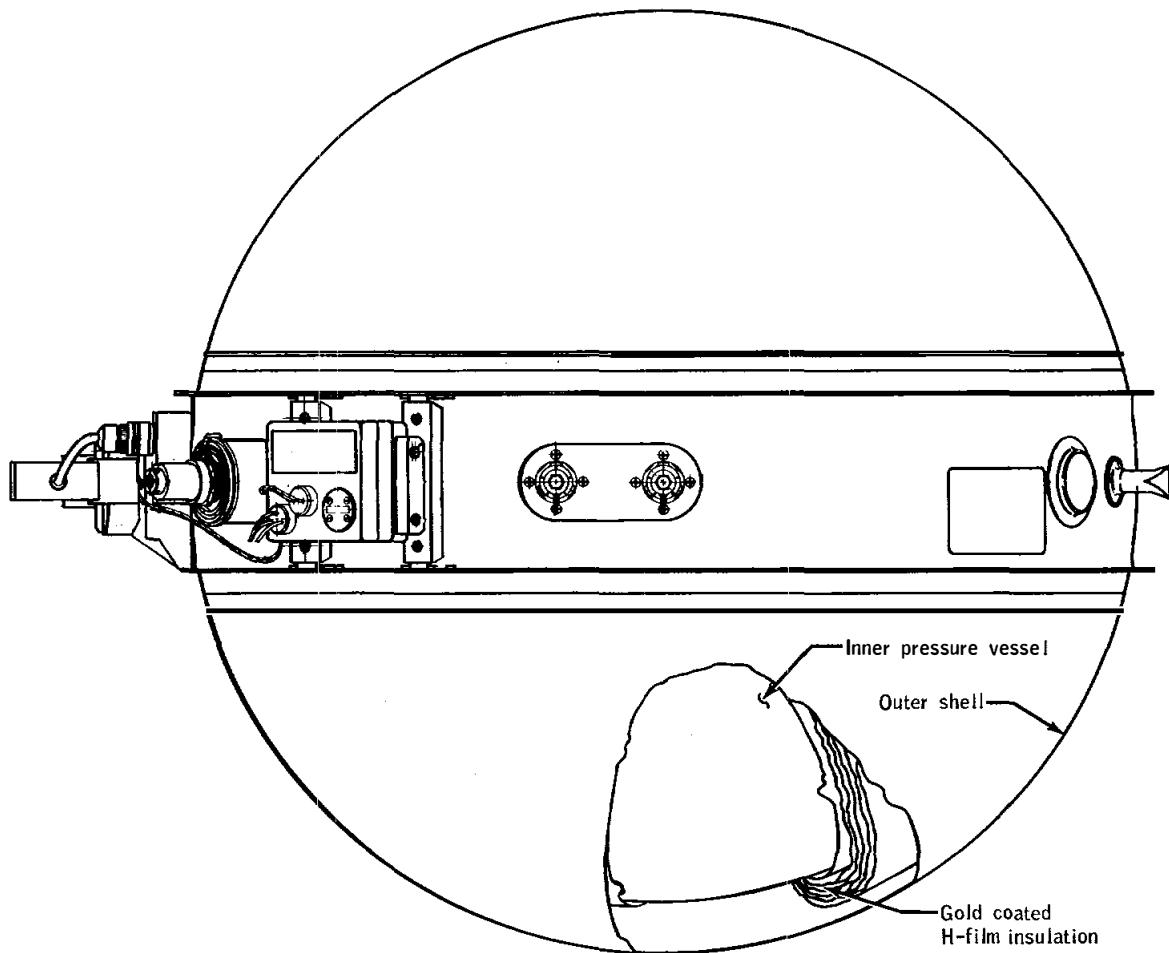
Figure 14-7.- Hydrogen tank.

The insulation for this tank consists of several layers of gold-coated H-film in a vacuum annulus that is formed between the inner pressure vessel and the outer shell (fig. 14-7). The primary insulation system is, however, the vacuum annulus. Degradation of this insulating vacuum will cause a significant increase in the heat leak into the tank as shown in figure 14-8. The analysis indicates that the high initial heat leak resulted from a degradation of this vacuum by approximately one decade (approximately  $10^{-6}$  to  $10^{-5}$  torr). This degradation could have been caused by any of three conditions.

- a. If thermal insulation layers rubbed together during the launch phase vibration, the condition could have caused the release of previously entrapped or absorbed gas molecules into the annulus (hereafter referred to as "insulation scrubbing").
- b. A hydrogen leak from the pressure vessel into the annulus.
- c. An ambient air leak into the annulus during launch.

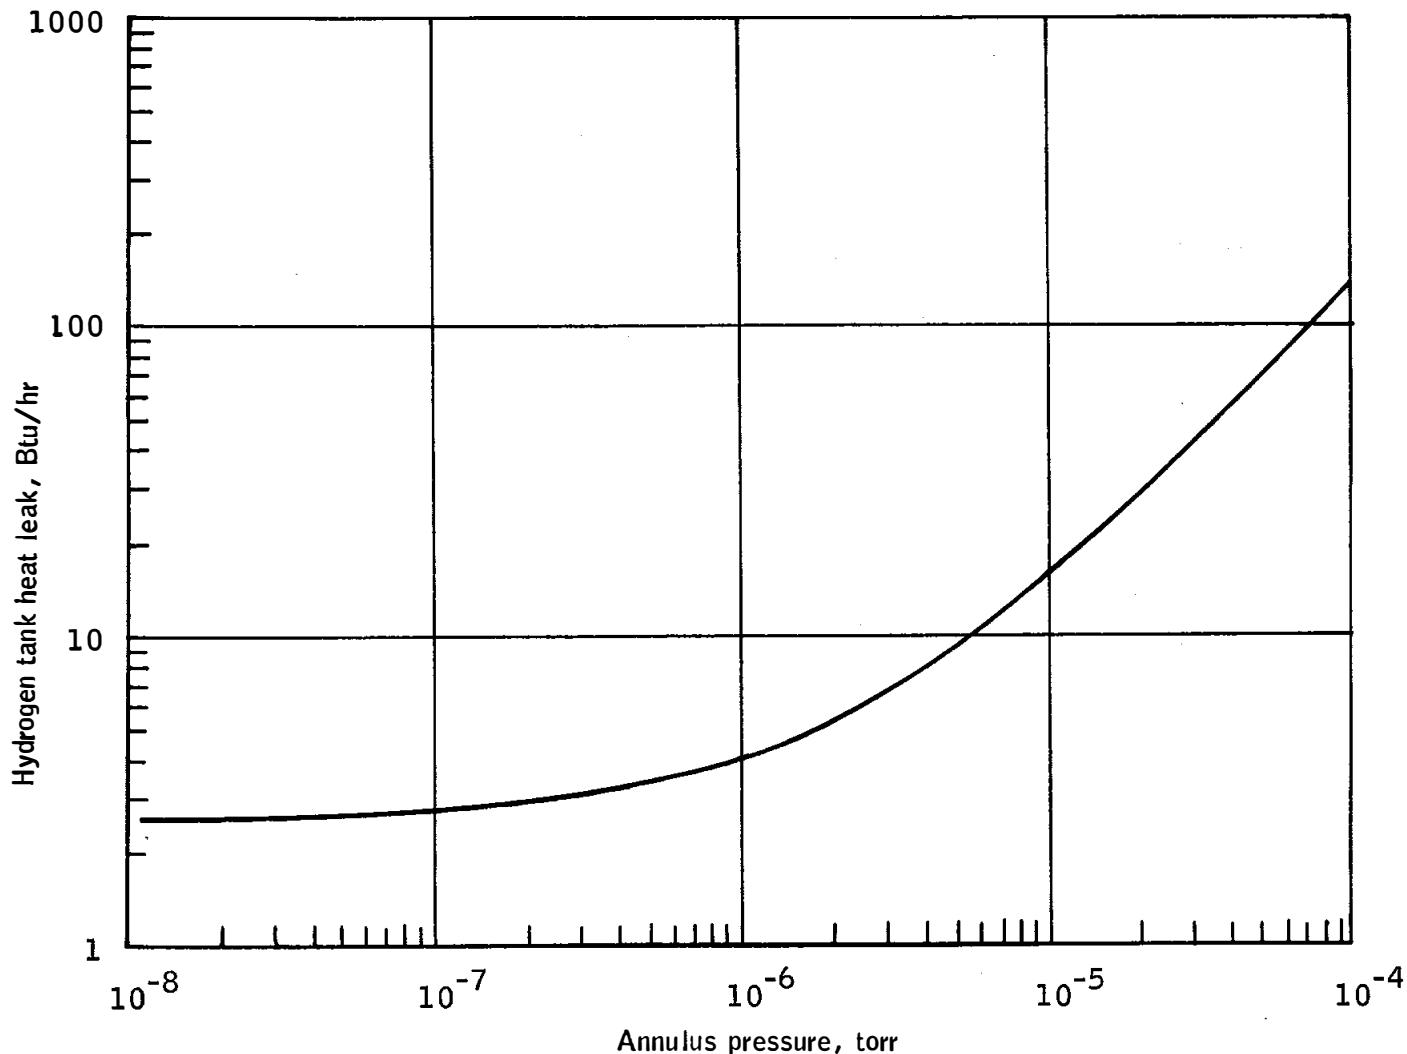
Figure 14-8.- Hydrogen tank heat leak as a function of annulus pressure.

Condition c.- An ambient air leak is the most probable cause of the high heat leak. Figure 14-8 shows that a pressure of  $5 \times 10^{-5}$  torr in the annulus would produce a heat leak of 21 Btu/hr, which is the average observed for the first 10 hours of the flight. The heat leak returned to a normal value of 6 Btu/hr by 80 hours, which corresponds to approximately  $2 \times 10^{-6}$  torr. Assuming that a small hole opened in the outer shell during the launch phase, the annulus pressure would quickly build up to that required to produce the observed heat leak. As the bay pressure continued to decrease and fall below that in the annulus, the annulus pressure would follow the decrease slowly and drop to a final value sufficient to provide the normal heat leak observed by 80 hours. Analysis shows that the area of the opening was at least  $2.2 \times 10^{-3}$  sq cm. For an opening of this size, iterative analysis places the formation of the crack or hole at approximately 2 1/2 minutes into the flight to produce the observed conditions.

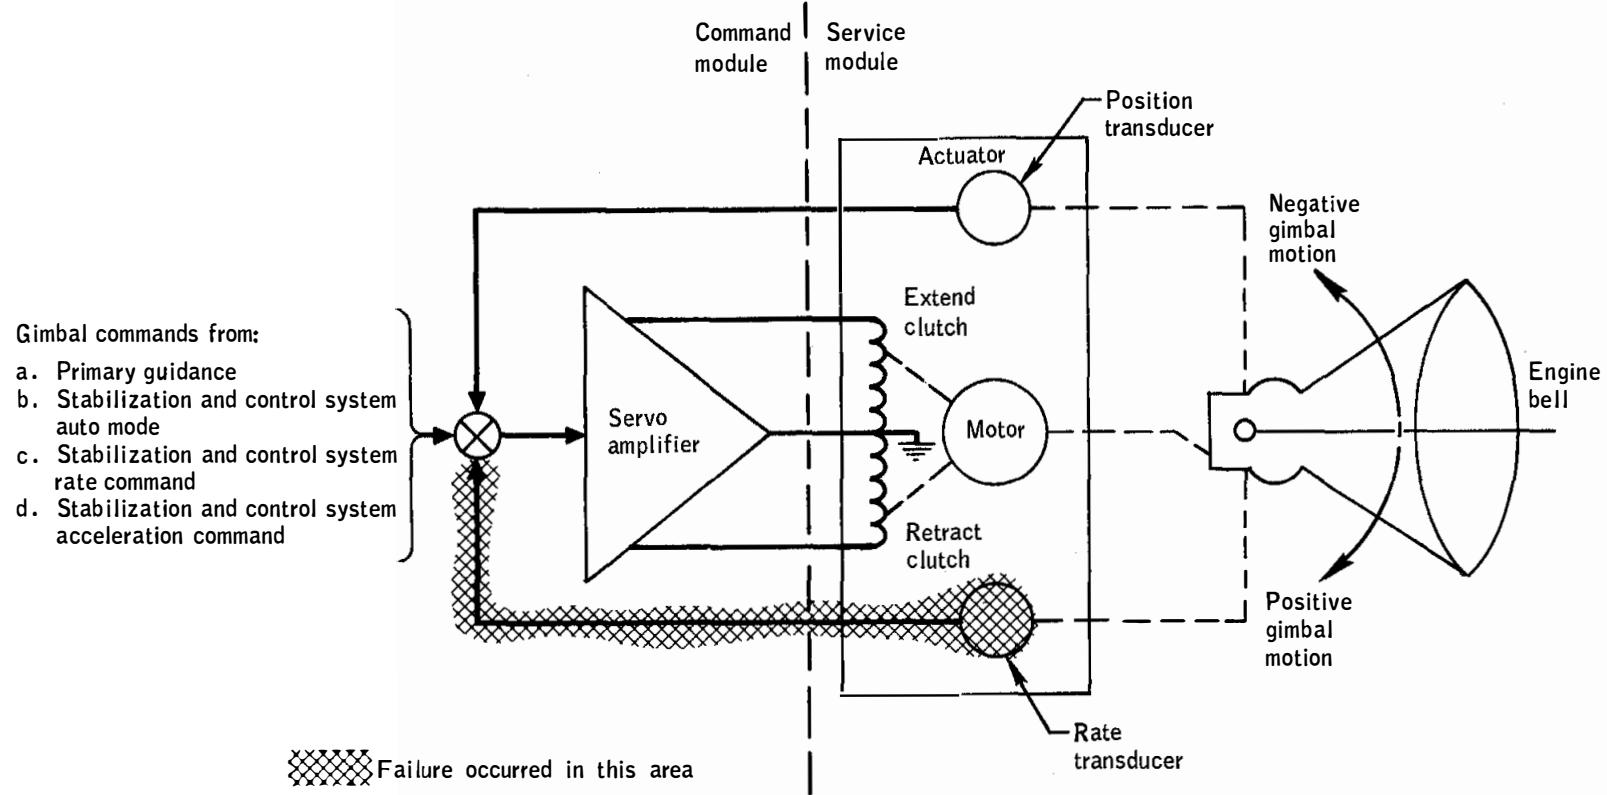
Figure 14-10.- Service propulsion system gimbal servo diagram.

During the pre-ignition checklist for the lunar orbit circularization maneuver, an oscillation was detected in the yaw axis of the secondary servo system for the service propulsion engine gimbal actuator. Figure 14-10 is a functional diagram of the servo loop. The oscillation was present in all modes of operation, but only when the secondary yaw servo loop was used. The oscillation was limited at  $\pm 1.0$  degree and at 2.4 hertz with the gimbal correctly following commands to different positions. Figure 14-11 shows one occasion that the oscillation did not occur when repositioning the engine which implies that the failure is electrical in nature.

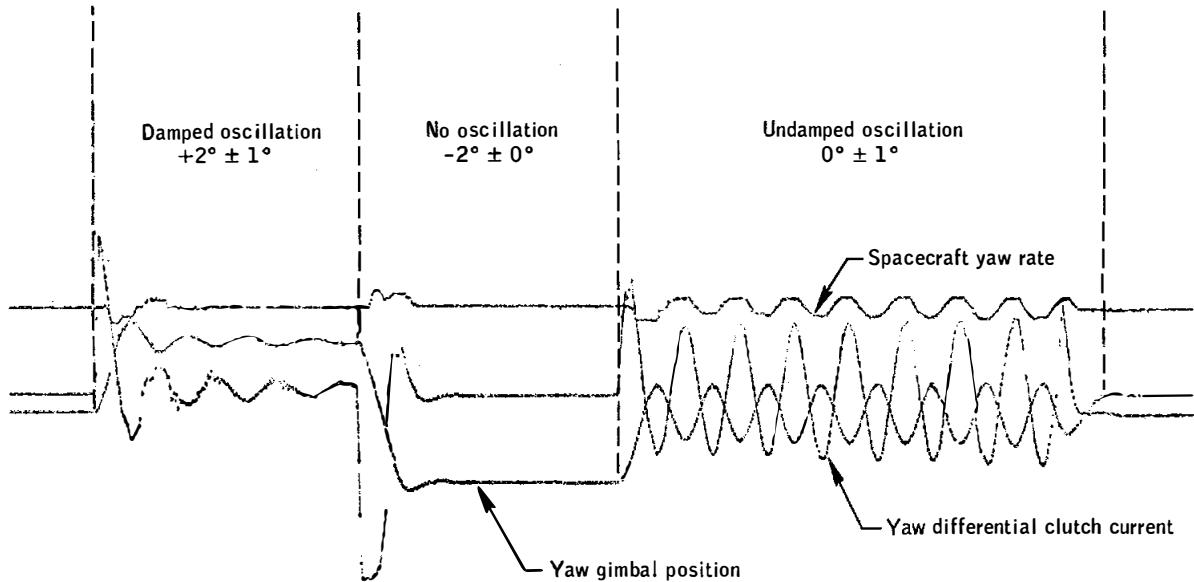
Figure 14-11.- Secondary yaw gimbal drive test  
(primary guidance control).

Inflight results were matched by simulations of system performance with an open in the rate feedback loop of the yaw servo system. It was also demonstrated that the oscillations would have damped after ignition because of the side load forces exerted on the engine bell while thrusting. Therefore, the secondary yaw servo system was considered safe to use if the primary servo system were to fail and it became necessary to switch over to the secondary system.

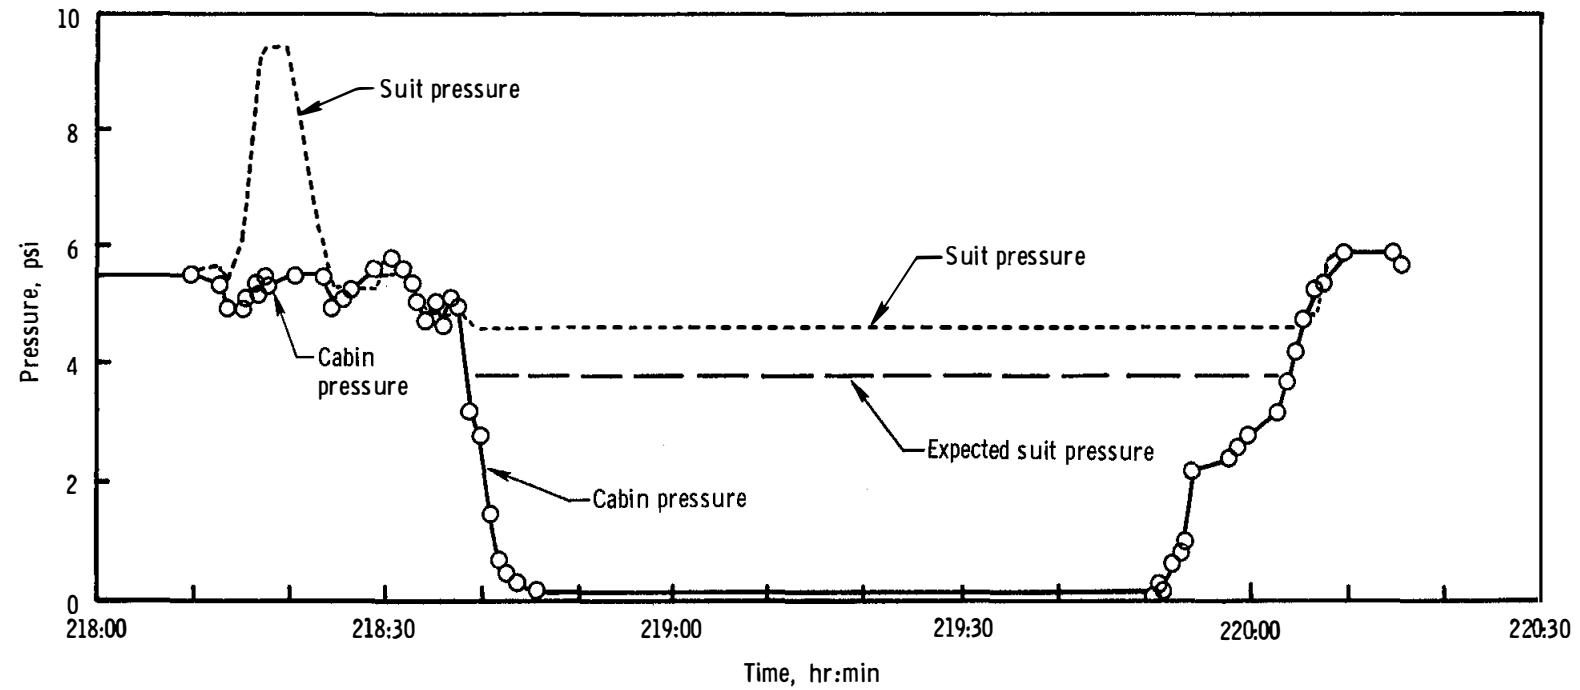
Figure 14-13.- Suit loop pressure data.

While the cabin was depressurized during the transearth extravehicular activity, the indicated environmental control system suit loop pressure transducer reading was 4.6 psia (fig. 14-13). Specification values for this regulated pressure are 3.5 to 4.0 psia and the control point determined from Kennedy Space Center altitude chamber testing was 3.8 psia. The Commander's and Lunar Module Pilot's suit cuff gage readings of 3.5 and 3.8 psia indicated that pressure regulation was satisfactory and that the transducer reading was erroneous.

Prior to the reduced cabin pressure operations, the suit transducer performed acceptably and read within 0.1 psi of the cabin pressure transducer with the suit loop open to cabin. After cabin repressurization, the suit transducer again appeared to read correctly above 4.6 psia.

were conducted. The results were within tolerance. Teardown analysis revealed three particles of calcium aluminum silicate (lunar origin) ranging from 500 to 2000 microns in size in the sense cavity. If one of the lunar particles had been caught in the air gap (see fig. 14-14) of the variable reluctance element, the armature would transmit an incorrect signal. Normal readings were obtained when the cabin was repressurized and a suit pressure in excess of 4.6 psia was obtained. This could have freed any particle that might have been lodged in the air gap.

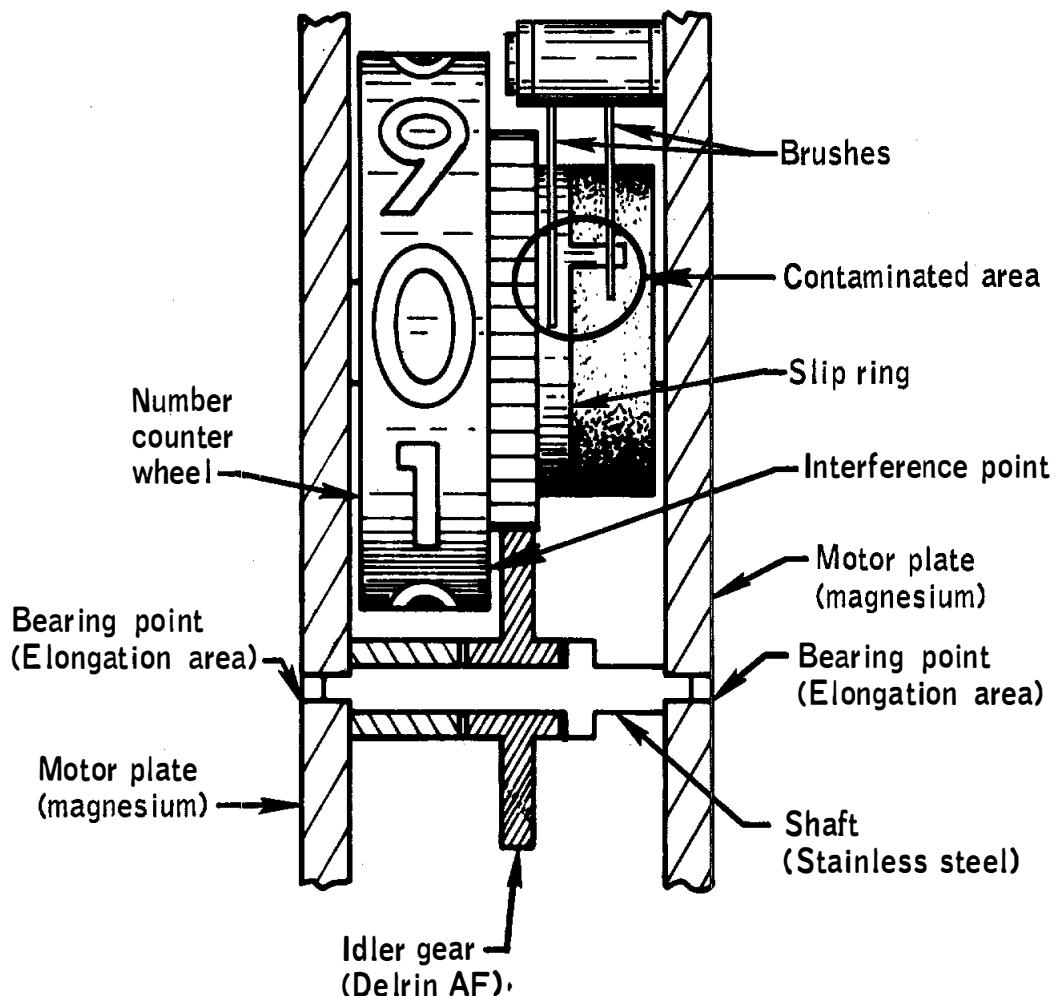
Figure 14-15.- Digital event timer seconds counter.

Inspection of the digital event timer showed that the bearing points in the magnesium motor plates had been elongated. The idler gear is free to rotate on the shaft (fig. 14-15); however, the design permits the stainless steel shaft to also rotate which would account for the wear in the motor plates. The elongated bearing points permitted the idler gear to rub against the number wheel. This interference rubbed paint off the number wheel and the paint particles prevented the slip rings and brushes from making good contact which affected proper counting of the seconds wheel.

The bearing points also elongated on the Apollo 15 digital event timer. The idler gear shaft can be prevented from rotating by staking at the bearing point in the motor plates. For Skylab, corrective action will be to secure the shafts of digital event timers, that require opening of the case for other rework. For Apollo 17, the units will be visually inspected for signs of wear.

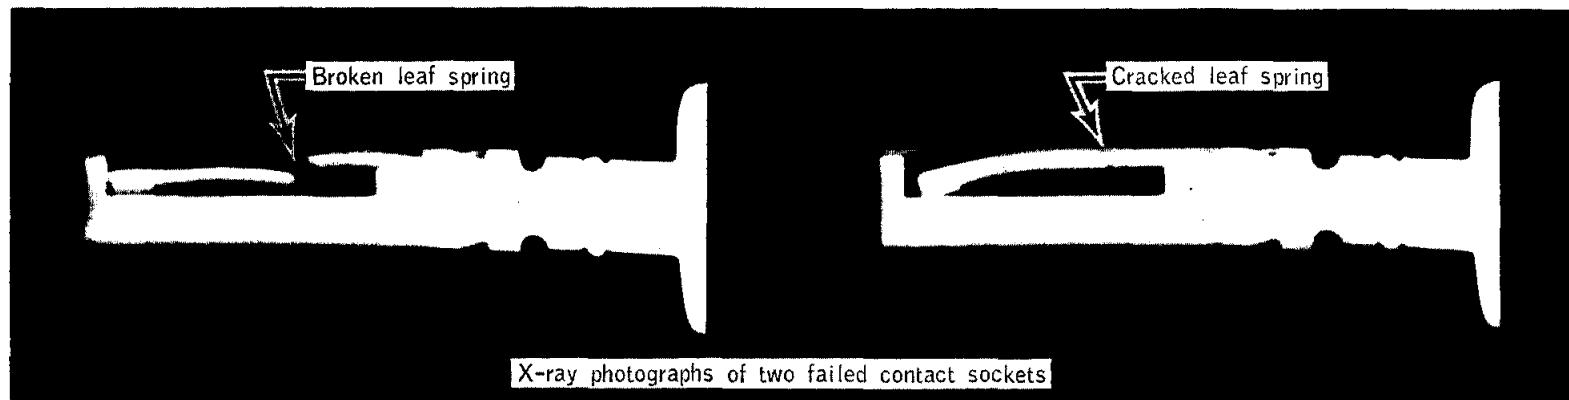
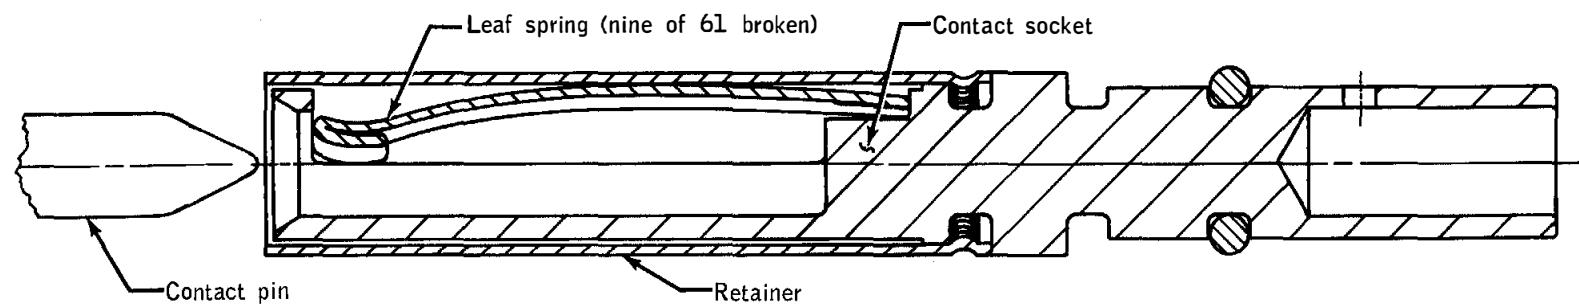
Figure 14-16.- Contact and leaf spring arrangement of optical unit connector.

The optical unit assembly was thoroughly soaked during recovery by salt water which caused extensive corrosion. The unit was cleaned, however, and tested. The intermittent flight condition was reproduced by wiggling the scanning telescope wiring harness in the optical unit assembly. An examination of the female connector on this harness revealed 9 of 61 contact springs (fig. 14-16) were cracked or broken. Also, several contact springs were found broken in a 91-pin connector in the optical unit assembly. The cause of the broken springs is being investigated.

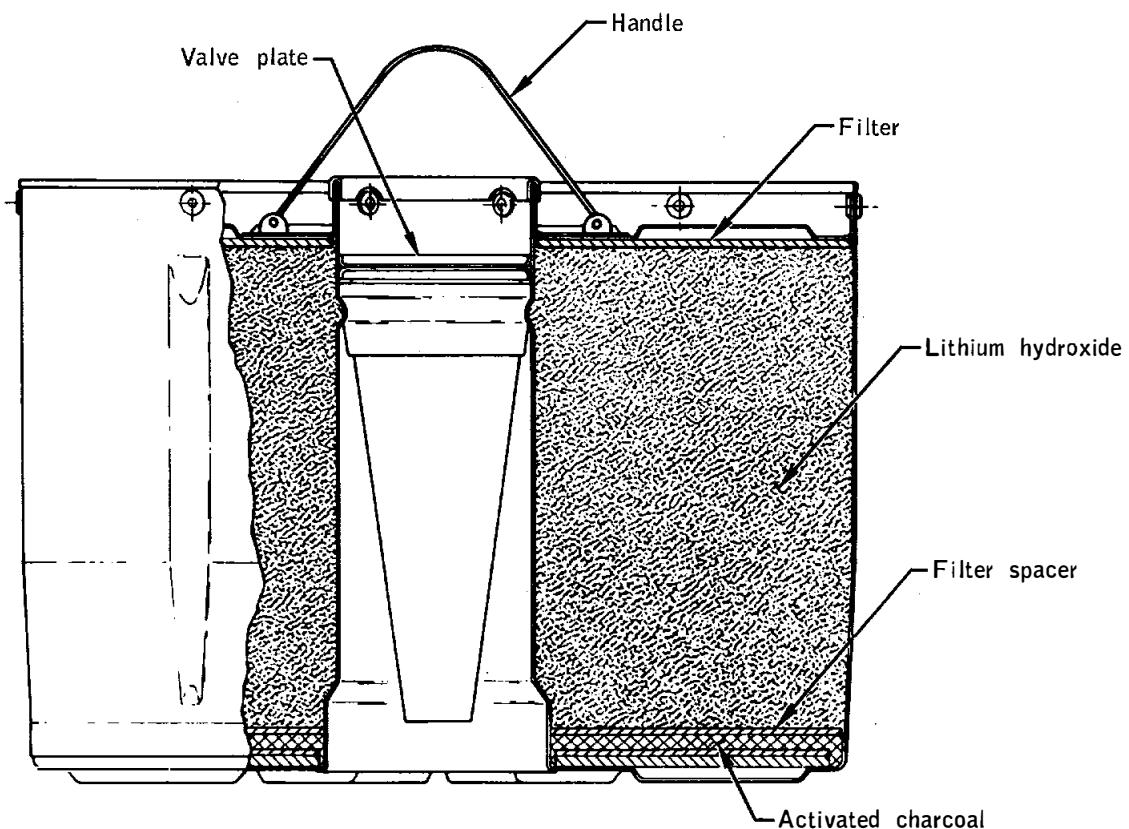
Figure 14-17.- Lithium hydroxide canister.

Although canister 10 was jettisoned with the lunar module, canister 12 was returned for inspection and analysis. Figure 14-17 shows a cross-section of the lithium hydroxide canister. The lithium hydroxide swells while it is being used, and to account for this swelling, the units are fit checked in the spacecraft with 0.030-inch shims on all sides. Additionally, the pull force required to remove the canister is checked with the shims in place. An analysis performed on five separate layers of the chemical bed indicated that approximately 32 percent of the lithium hydroxide had been used. In addition, the analysis showed the moisture content to be approximately 21 percent compared to a range of 5 to 10 percent found in canisters used during the solo period on previous flights.

A dimensional analysis showed both sides of the environmental control unit canister receptacle to be within specification, although postflight removal forces using the canisters indicated a tighter fit in side B (53-lb pull) than side A (22-lb pull). The preflight pull force for this canister was 18 pounds. Normally, pull forces for these canisters are 10 pounds or less.

The combination of the adverse environment and the initially tighter-fitting canister apparently accounted for the removal difficulty.

To prevent recurrence of this problem during the Apollo 17 mission, the prelaunch insertion and removal force specification during fit checks at the Kennedy Space Center will be changed from 30 pounds to 8 pounds for the canisters to be used during the solo activities. The maximum allowable force on the remaining canisters will be reduced to 15 pounds. In addition, flight procedures will be changed to insure that the suit flow control valves are positioned to cabin flow for solo operation.

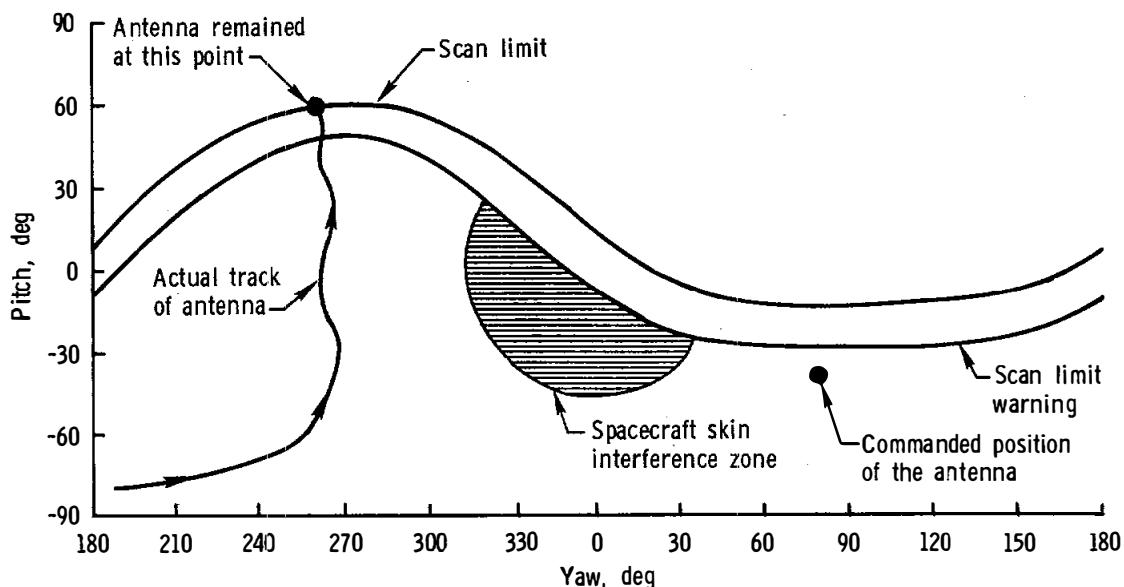
Figure 14-18.- High gain antenna scan limit.

the spacecraft were being maintained by ground-commanded switching between the high-gain antenna and omnidirectional antenna D. The initial indication of a problem occurred at about 234:04 when the high-gain antenna reached the scan limit and failed to drive to the position set on the manual controls. Figure 14-18 shows the path taken by the antenna prior to the anomaly, where it stopped, and the position to which it should have driven. The antenna remained at the position indicated until the crew awakened about 1 1/2 hours later and cycled the high gain antenna track mode switch from "reacquisition" to "manual" and then back to "reacquisition".
