MSC-07230

APOLLO 16 MISSION REPORT

MANNED SPACECRAFT CENTER  
HOUSTON, TEXAS  
AUGUST 1972

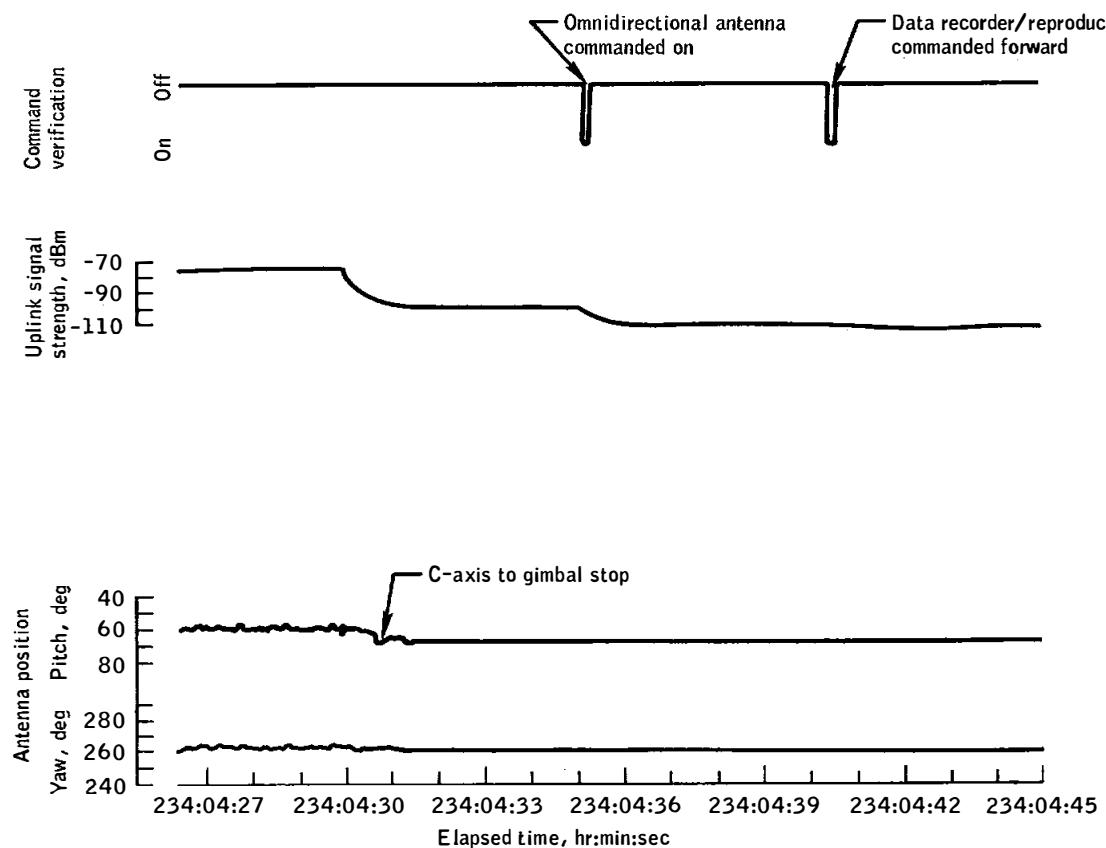
Figure 14-19.- High-gain antenna data at beginning of anomalous period.

Figure 14-19 shows the pitch and yaw positions and signal strengths in the time frame of the problem. This figure indicates normal high gain antenna operation up to and immediately following entry into the scan-limit region. The step decrease in both uplink and downlink signal strength was due to switching from narrow to wide beam. Such a beam switch results when the logic latchup circuit 2 latches (fig. 14-20). Logic latchup circuit 2 latches when logic latchup circuit 1 latches and logic latchup 1 latches when the antenna with the "reacquisition" track mode selected, tracks from the clear track area to the scan limit. Latching of logic latchup 1 also internally switches the antenna to manual track. For the

antenna position (pitch = 60 degrees and yaw = 258 degrees at the scan limit) and the commanded position (pitch = -44 degrees and yaw = 84 degrees), the C-axis error signal is large and it should drive the C-axis to the gimbal stop upon switching to "manual". The A-axis should also start rotating, but its response is very slow because it is essentially 180 degrees away from the commanded position. The A-axis manual error signal also has a false unstable null 180 degrees away from the true null. The rapid change in pitch shortly after the beam switching, shown in figure 14-19 (from approximately 59 deg to 71 deg) is verification that the C-axis drove to the stop as expected. Normally, the C-axis would remain against the gimbal stop until the A-axis rotated approximately 90 degrees and then would drive away from the stop to the commanded position.

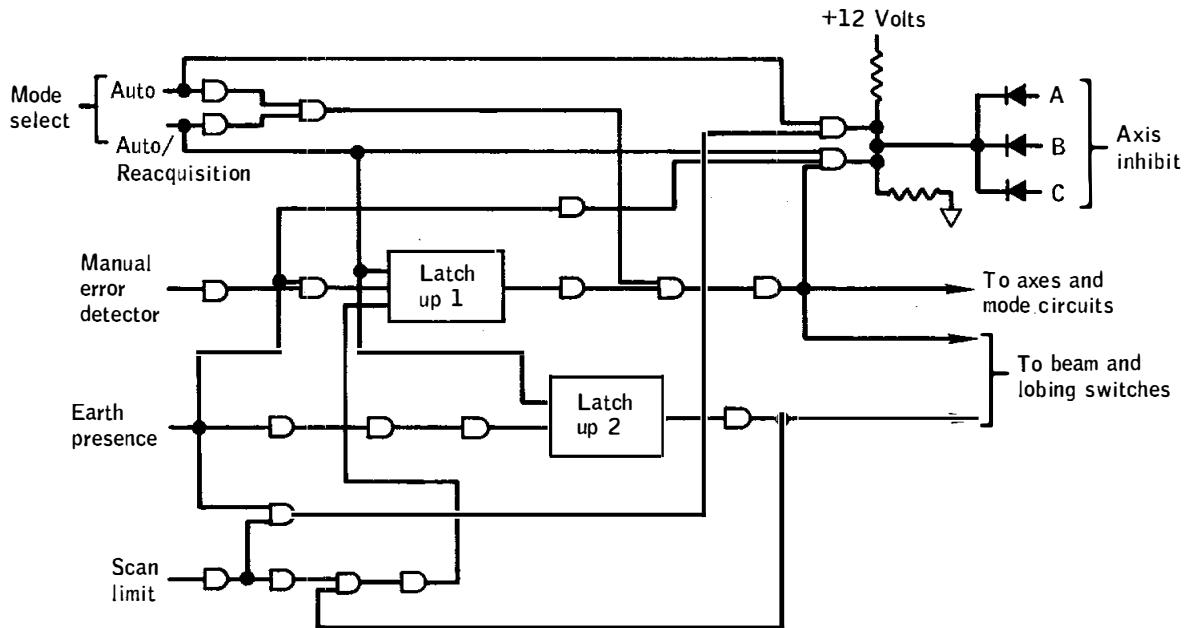
Figure 14-20.- High-gain antenna logic diagram.

no noise has been associated with the "inhibit" mode. Figure 14-20 shows that selecting the "automatic" mode and reaching the scan limit triggers an "inhibit" circuit.

Tests did indicate, however, that the anomaly could be the result of simultaneous selection of both the "reacquisition" and "automatic" track modes. In this case, an inhibit would result if the antenna entered, and remained inside the scan limit (fig. 14-20). Simultaneous selection of both "reacquisition" and "automatic" track would require a fault, or malfunction in the mode select switch, associated space-craft wiring, or internally in the high-gain antenna electronics. Although the telemetry data indicate no voltage on the "automatic" select line, such a condition could occur and not be detected. The mode select switch and the associated wiring, however, were thoroughly checked, including disassembly and inspection of the switch, and no discrepancies were noted.

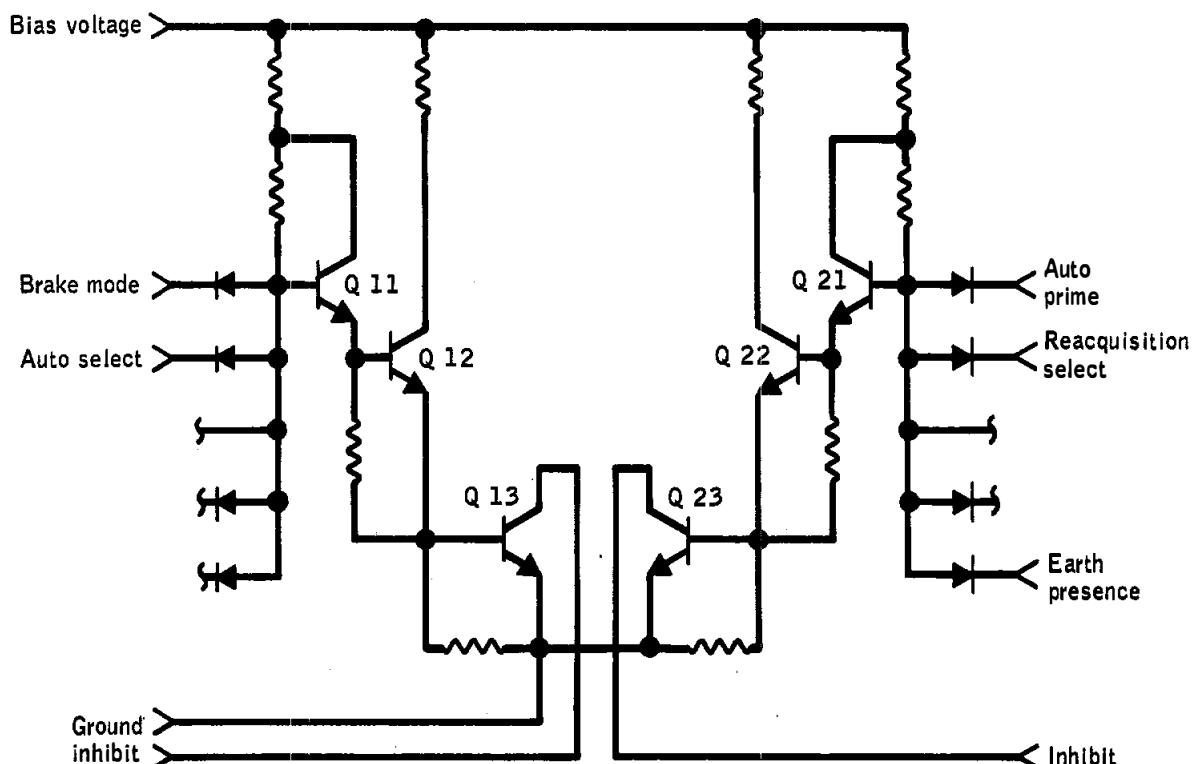
Figure 14-21.- Schematic of integrated circuit within uplink package.

The integrated circuit generating the inhibit is shown in figure 14-21. These types of devices have been found susceptible to contamination from internal floating particles. A particle can move as a result of acceleration or electric fields, and create an internal short which changes the state. Additional acceleration or changes in the electric fields can result in the particle moving again and either clearing the problem, or showing itself as an intermittent problem.

A particle resulting in any one of the following shorts (fig. 14-21) would result in an unscheduled inhibit.

No corrective action is planned because experience shows contamination in the electronics box has a low probability of occurring. Further, if the problem became permanent in one electronics box, the secondary unit can be selected.

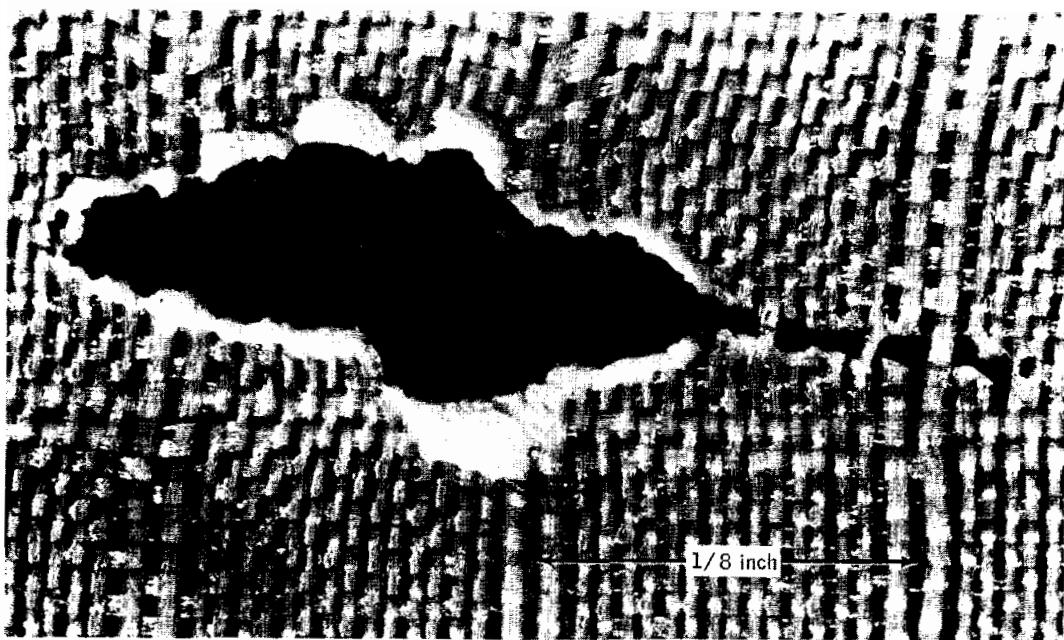
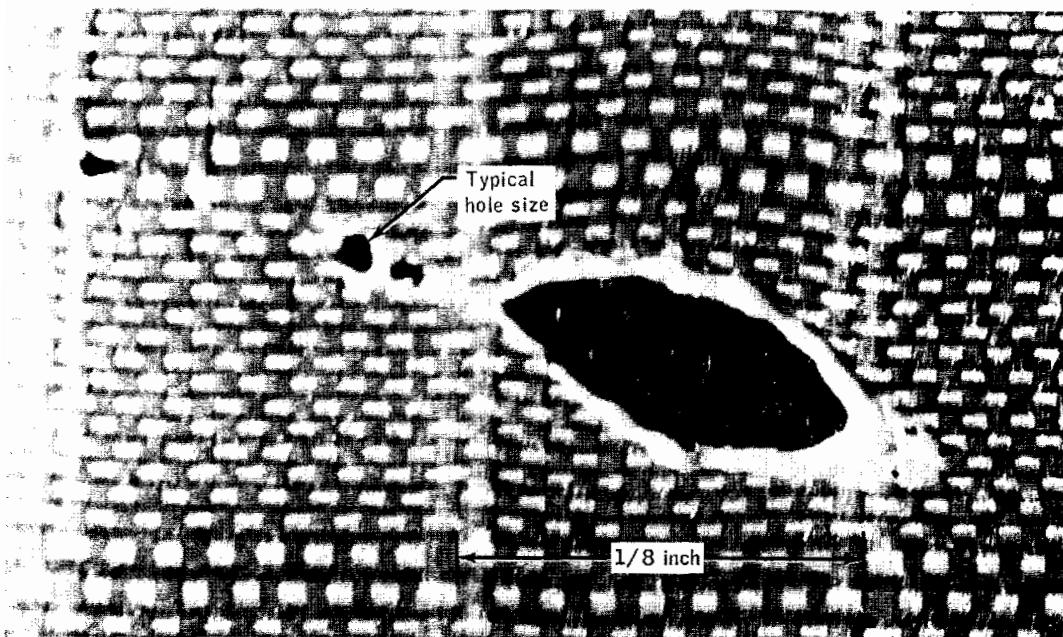
Figure 14-23.- Typical burn holes found in recovered parachutes.

Inspection of the canopy of one of the recovered main parachutes indicated numerous small burn holes which are similar to the burn holes observed on parachutes from previous missions (fig. 14-23). The cause of the earlier holes had been attributed to the reaction control system oxidizer.

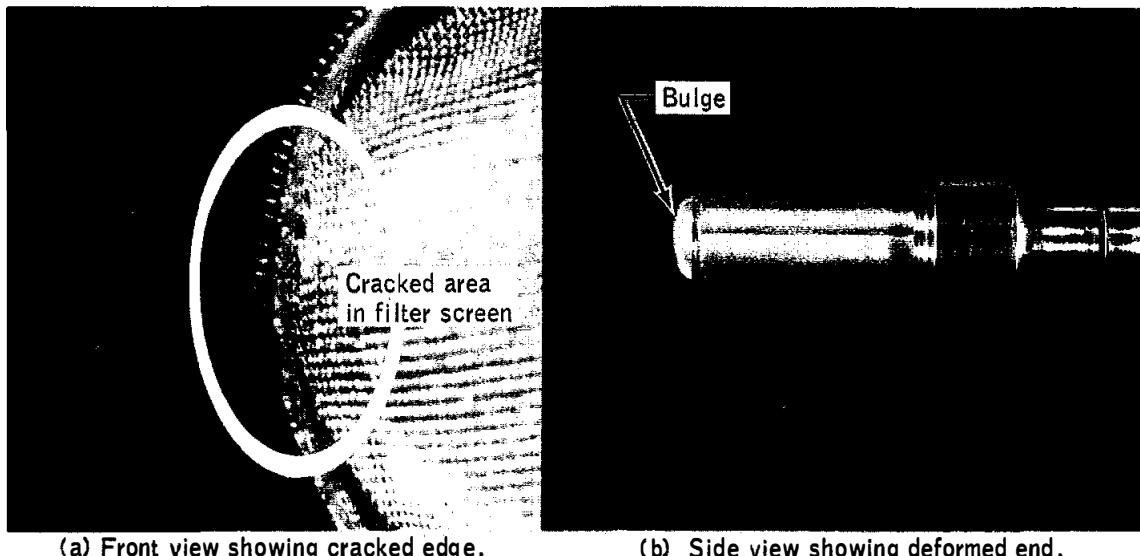
Figure 14-25.- Reaction control system regulator filter.

The deformed filters are being evaluated. This evaluation includes retesting the filters for bubble point and performing a microscopic examination and a metallurgical examination in the areas of the wire separation. The objective of this investigation is to establish if the deformation is a normal condition resulting from system activation or if a unique condition occurred on Apollo 16.

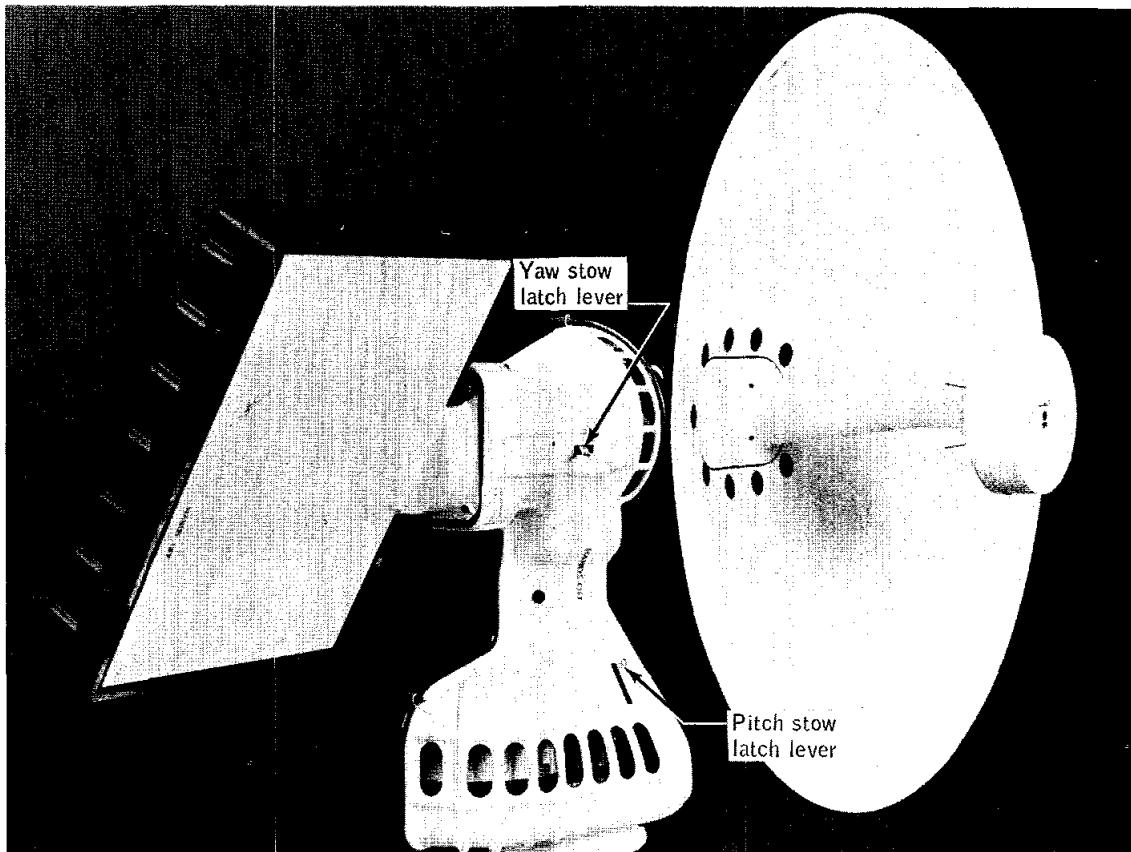
Figure 14-29.- Lunar module S-band steerable antenna.

The S-band steerable antenna (fig. 14-29) would not move in the yaw axis during initial activation. Several unsuccessful attempts were made to operate the unit using both the manual slew and auto track modes. Photographs and inflight test data show that the problem was caused by failure of the mechanical stow latch to release.

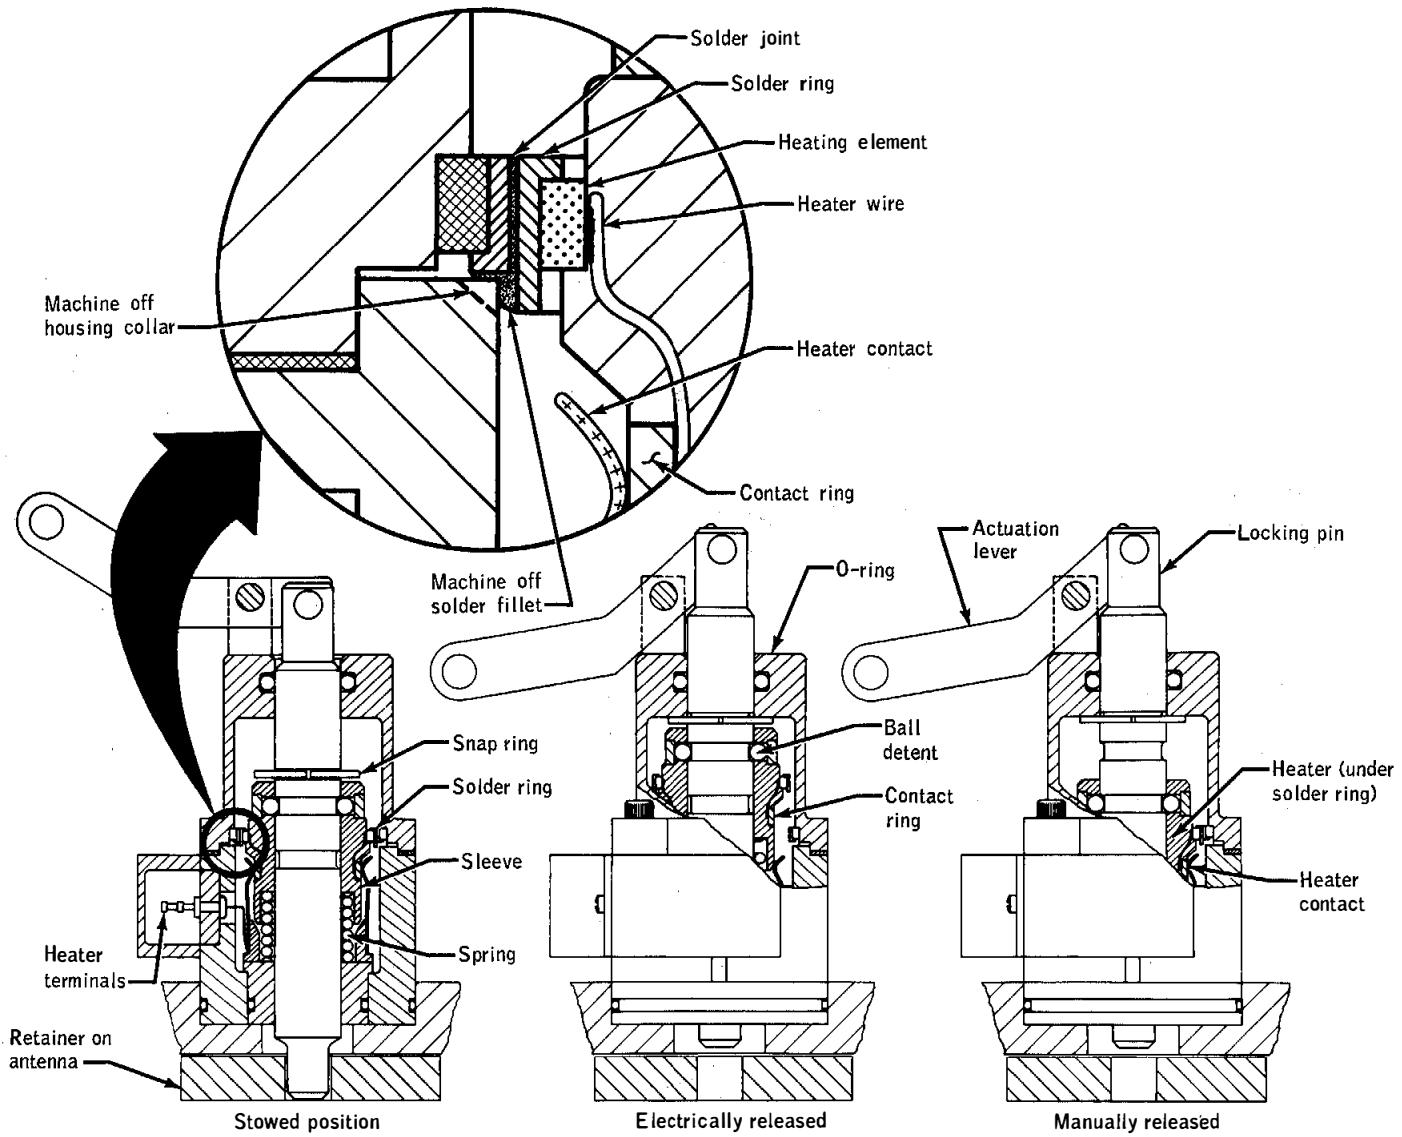
Figure 14-30.- Antenna stow latch mechanism.

Functionally, the stow latch restrains the antenna during launch. Figure 14-30 shows the functional operation of the latch. The lock pin, when extended, holds the antenna in the stowed position. A spring is held under compression by a sleeve which is constrained to the latch housing by a shoulder soldered to the sleeve. Melting the solder allows the spring to push the sleeve which, in turn, raises the lock pin out of the retainer. A manual mode is provided for checkout purposes. The lever (fig. 14-30)

Antenna photographs taken on the lunar surface and in lunar orbit prior to docking indicate that the lever for the yaw axis latch was still in the locked position. The crew noted a 2- to 3-degree movement of the yaw indicator during activation attempts. Ground tests have shown that the tolerances in the antenna retainer/locking mechanism will allow a slight movement of the antenna dish even though the pin is locked.

There are several areas in the electrical circuitry which could have caused the problem. One is that one contact in the safe/arm switch (figure 14-31) did not make. The second is that an open may have existed downstream of the safe/arm switch, either in the solder-melting element or in the wiring back through ground. A resistance measurement is made across the two parallel solder-melting elements prior to flight. About a 3-ohm increase in resistance was found at the last check. This change is equivalent to a possible 10-ohm increase in one of the elements which could have reduced the power dissipation below that required to melt the solder. Allowable tolerances on mechanical drawings and tests on sample latches have shown that it is possible for a solder fillet extending below the ring to make physical contact with the housing (fig. 14-30). The

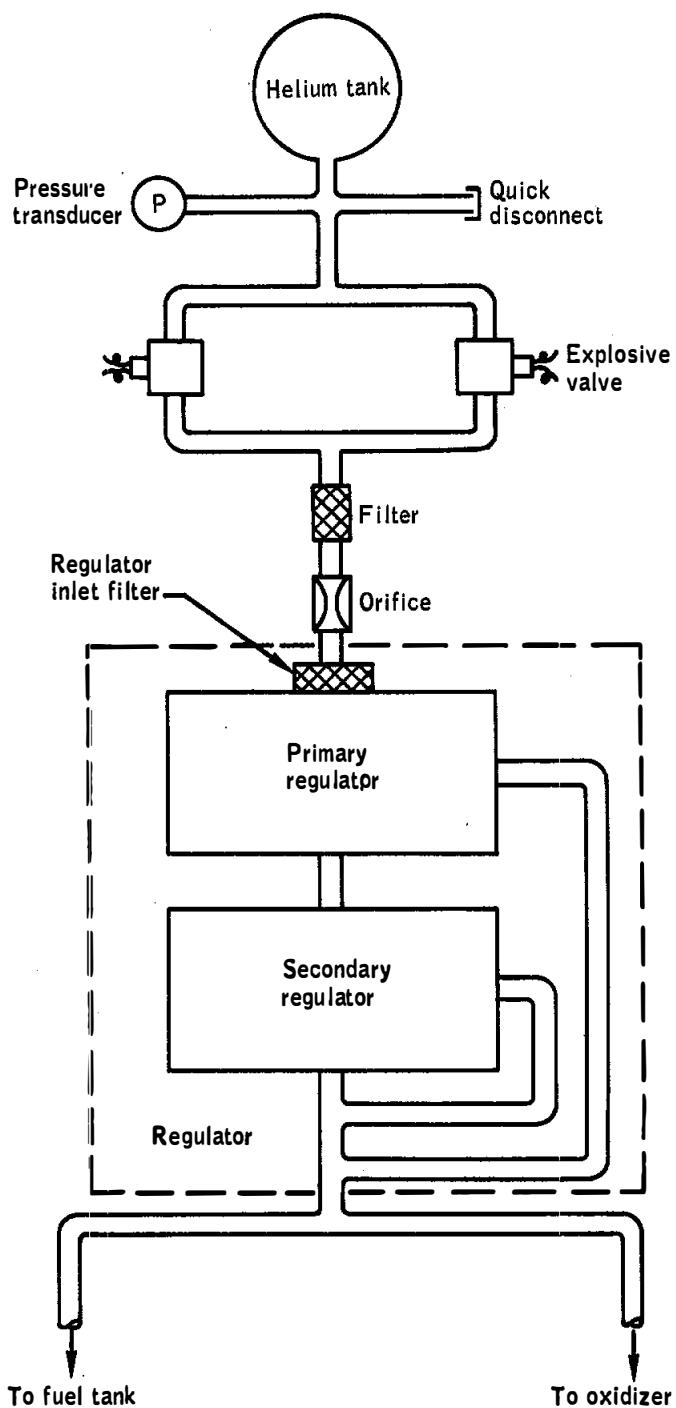
Figure 14-32.- Reaction control system pressurization system.

During pressurization of the system at about 95 hours, the regulator outlet pressure in system A (fig. 14-32) increased above regulator lockup pressure. The normal pressurization is characterized by a sharp increase from the nominal pad pressure, in the interval of 1 to 2 seconds, to the normal regulator outlet pressure. The outlet pressure of system A, after reaching the normal value of 184 psia, continued to rise at approximately 10 psi/minute, a condition which clearly indicated the existence of internal leakage in the regulator assembly.

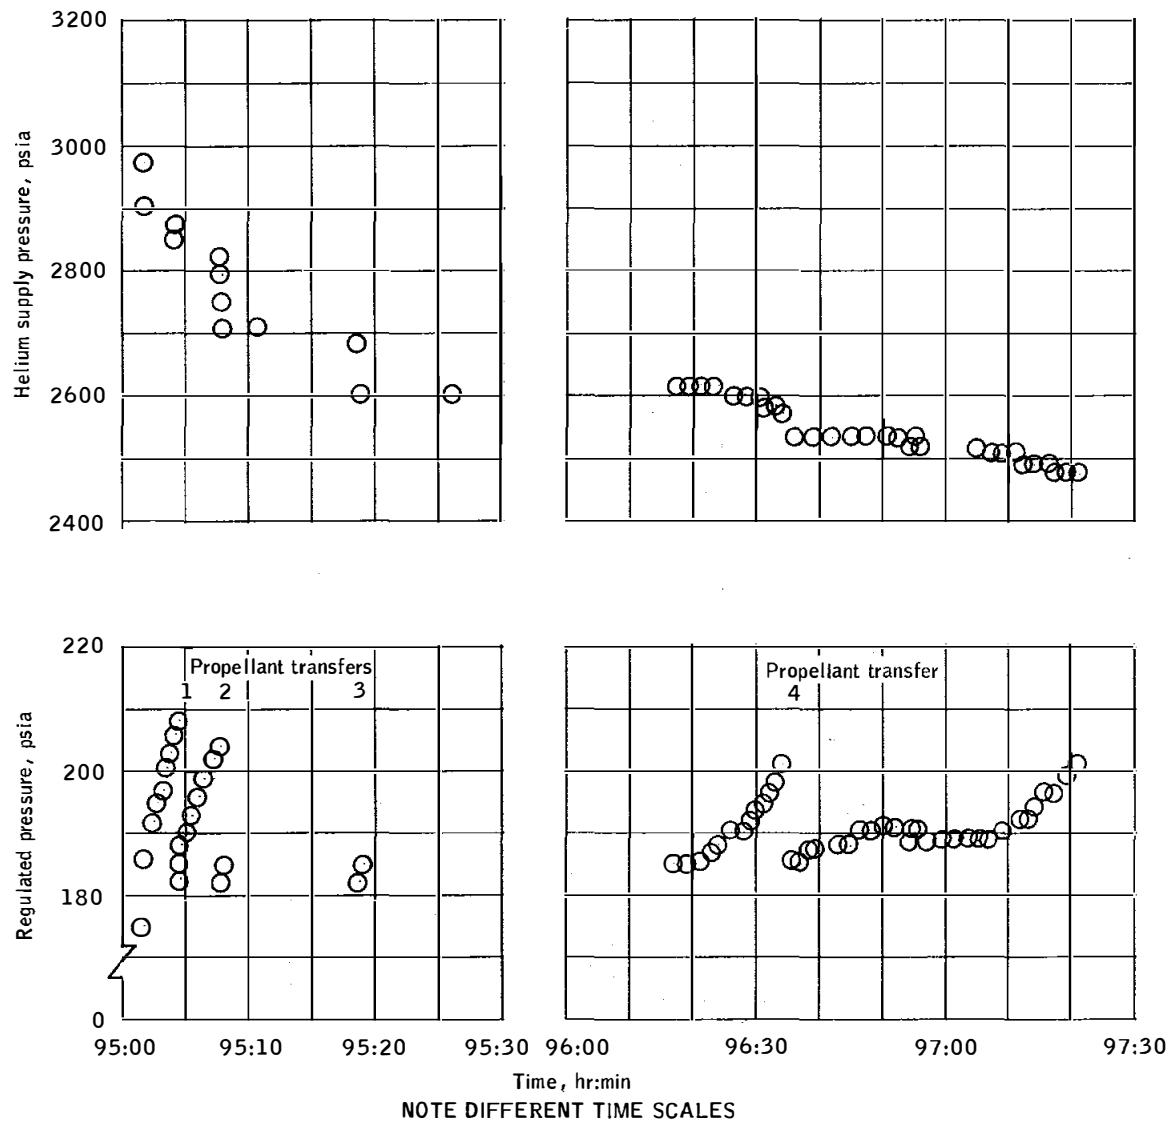
Figure 14-33.— Comparison of helium supply pressure and regulator outlet pressure following reaction control system pressurization.

Approximately 3 minutes after pressurization, the first of four propellant transfer operations was performed (fig. 14-33) to lower the ullage pressure and to create a larger pressurant volume in the propellant tanks, thereby obtaining a blowdown capability for expulsion of the remaining propellant in case of total loss of system A pressurization gas through the relief valves. The helium leakage continued throughout the mission, although the leakage rate varied from essentially zero to a maximum of about 1100 scc/min (figs. 14-34 and 14-35). The regulator outlet pressure eventually increased to about 237 psia at which time the relief valves of system A started to periodically relieve the pressure to about 232 psia.

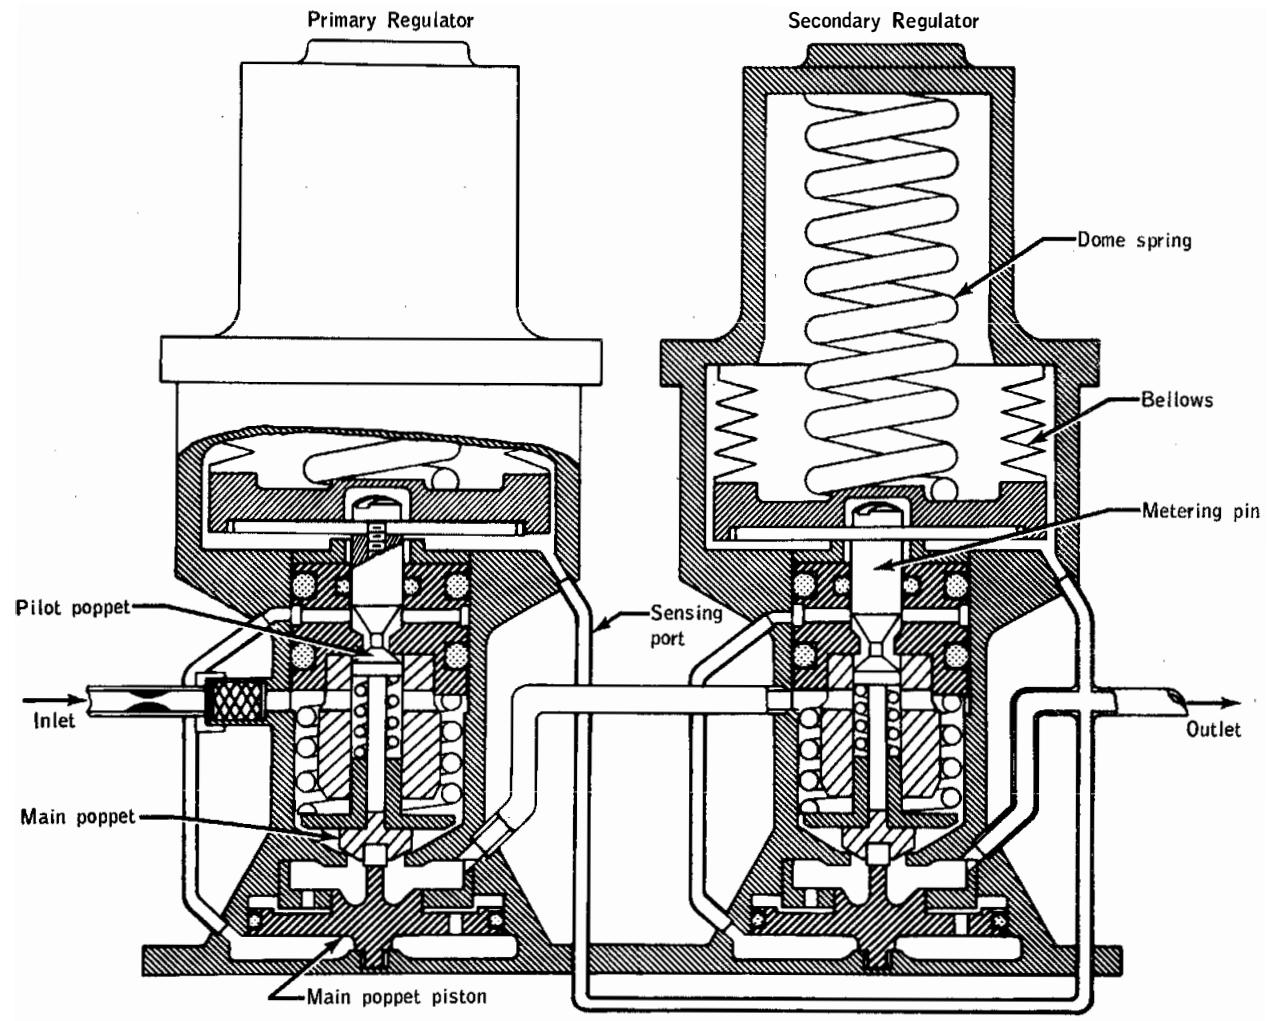
Figure 14-36.- Cross-section of reaction control regulator.

The helium regulator assembly consists of two series regulators (figure 14-36). The unit immediately exposed to the high pressure source is designated as the primary regulator and the downstream unit as the secondary regulator. Both units are identical in configuration with the exception of shims which are used to determine their pressure settings. The primary unit is set to regulate at  $181 \pm 3$  psia; the secondary, at  $185 \pm 3$  psia.

During buildup of the Apollo 16 reaction control system module, a quick disconnect (fig. 14-37) located directly downstream of the regulator outlet was replaced three times. During one change a five-legged fitting (fig. 14-37) required replacement. The repairs required seven brazing operations in an area which is directly above the regulator outlet when installed in the vehicle. Any contaminants introduced during these operations would be trapped in the volume downstream of the regulator by various filters (fig. 14-37). These contaminants could have been moved around during reaction control system module installation or when the lunar module ascent stage was rotated during the cleaning process. During these operations, any contaminants present could have been transported to the area directly downstream of the secondary regulator primary poppet. This volume has many areas where contaminants can be trapped (fig. 14-36).

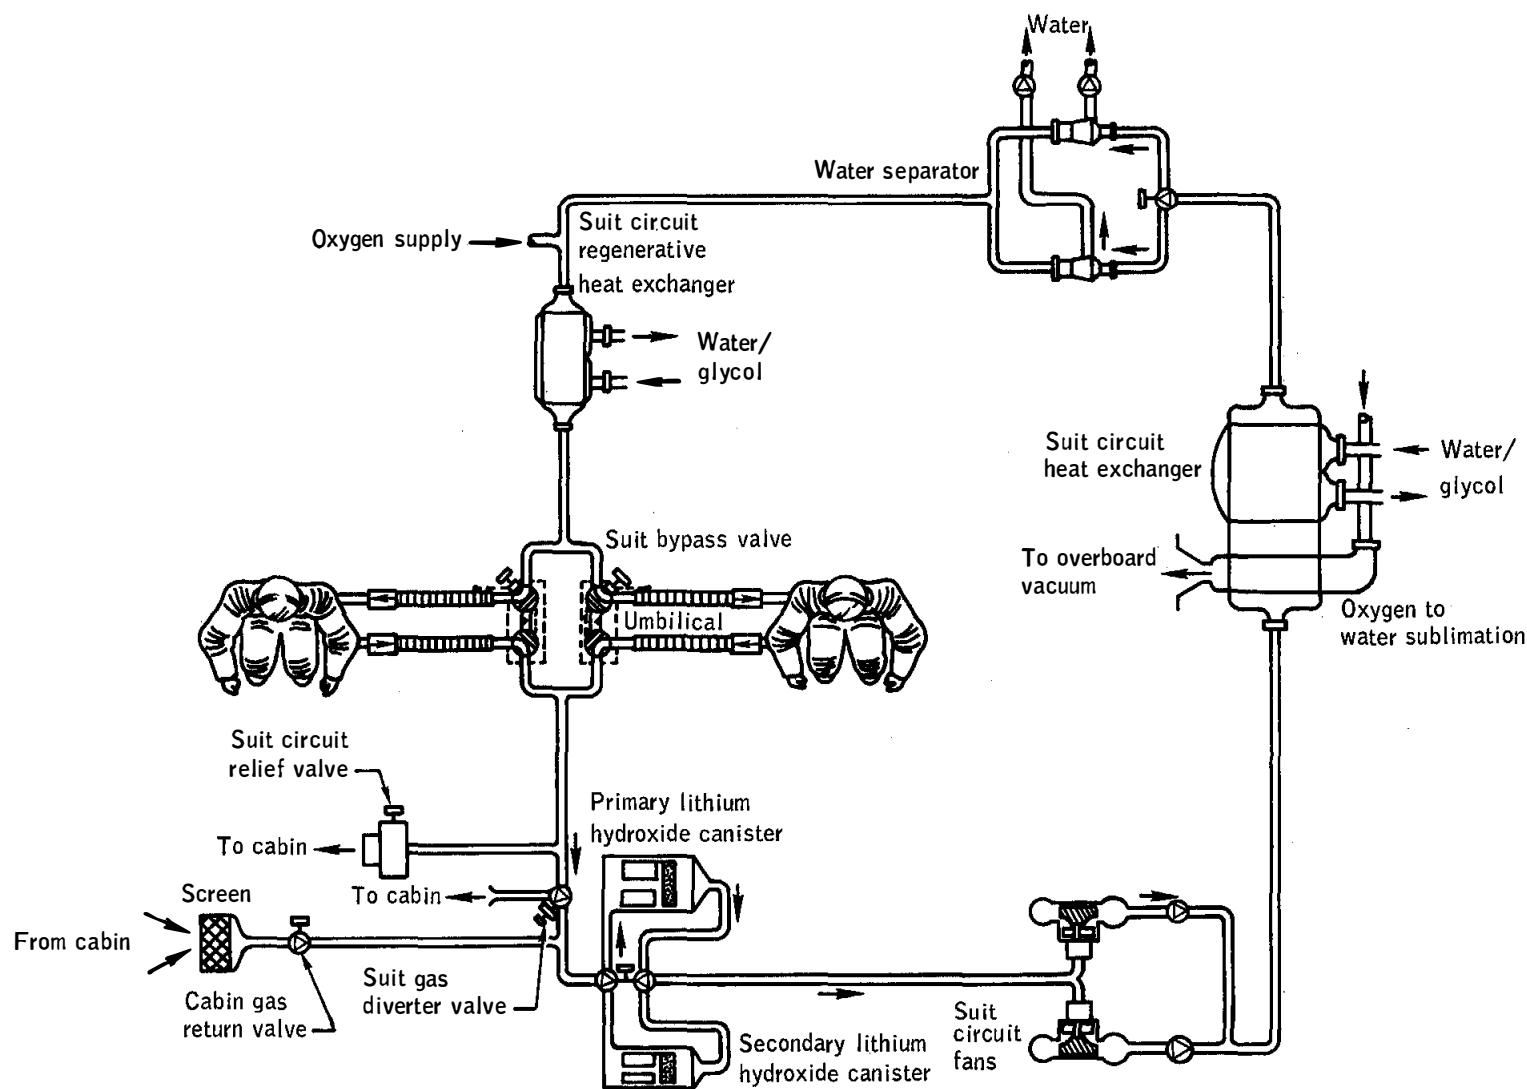
Figure 14-38.- Atmosphere revitalization section.

The crew reported hearing a chattering noise and experiencing a pulsating, insufficient flow in the suit circuit at 95:47 while configured to the cabin mode of operation (fig. 14-38). Data indicate that the cabin mode flow was normal at system activation (93:41), and this was confirmed by the crew after the mission. The pulsing and chattering occurred again after the demand regulator check (95:55) and after lunar landing (105:57).

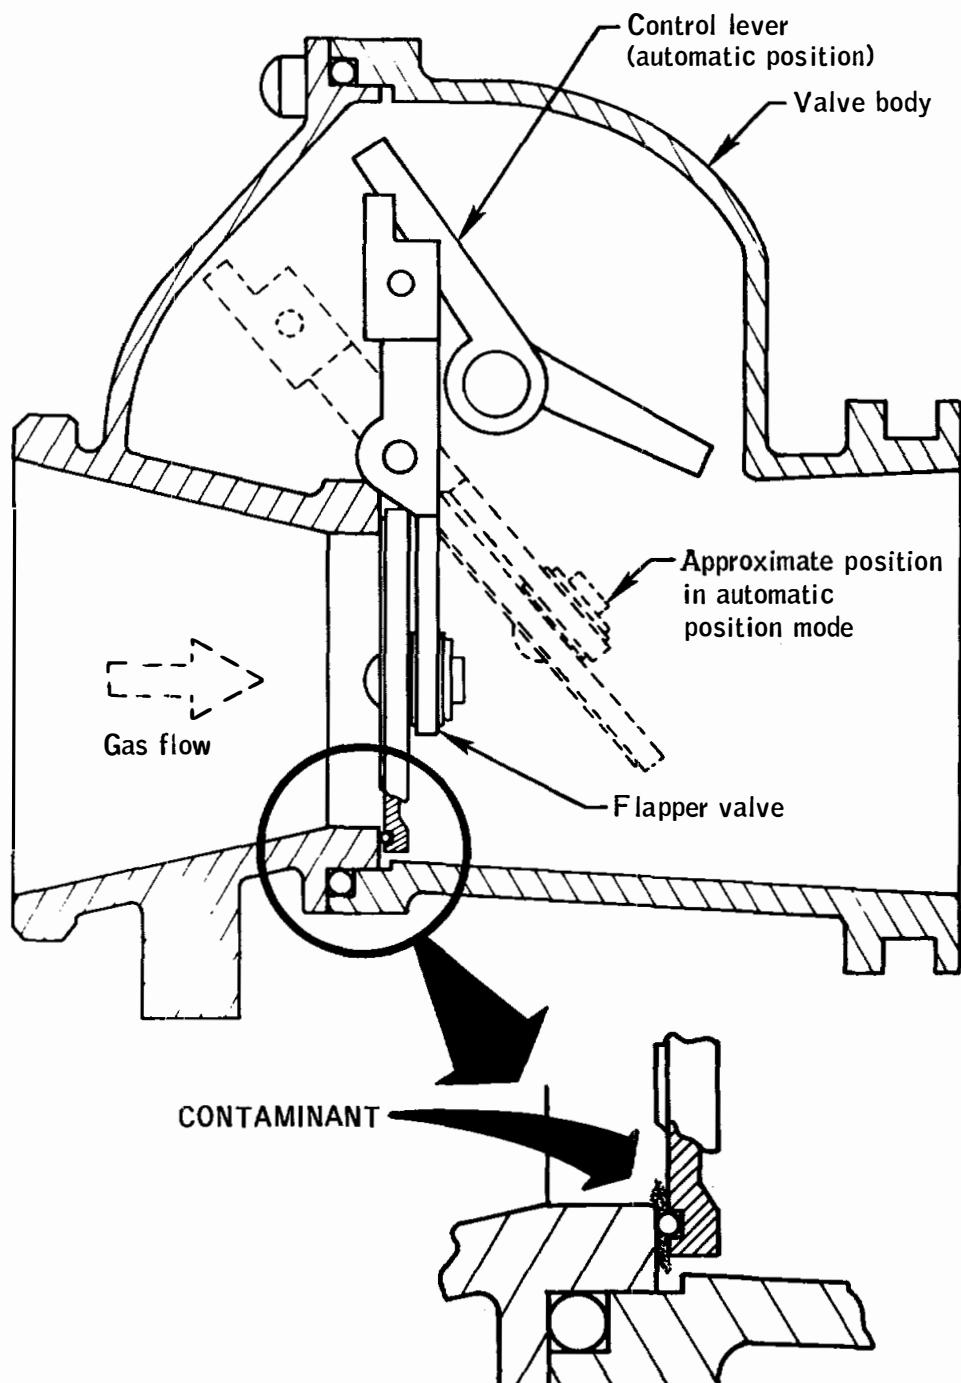
Figure 14-39.- Cabin gas return valve.

Since the valve functioned properly upon activation and again late in the lunar stay, the apparent cause of the problem was contamination. There are two possible areas of contamination: material on the inlet screen or residue on the flapper seal (fig. 14-39). A suspected source of residue is the orange juice that leaked from the drink bags.

A test will be performed on the Apollo 17 lunar module to check the force needed to open the cabin gas return valve flapper in the "automatic" position, thus increasing confidence in the ground checkout of the valve.

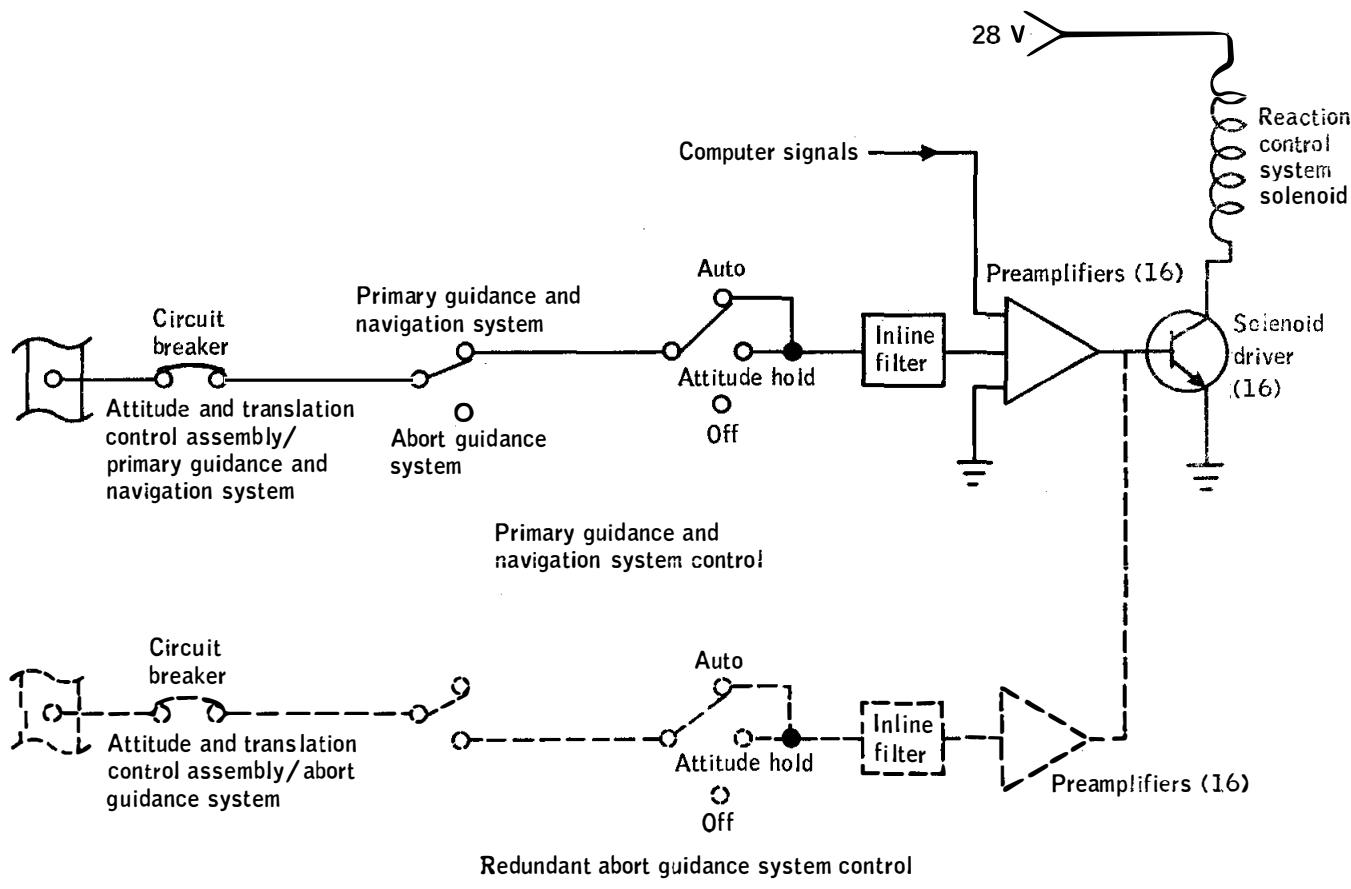
Figure 14-40.— Reaction control system control schematic.

Any of the following conditions could have caused the problem (refer to fig. 14-40):

Extensive changes to the flight plan and attendant procedural changes were communicated to the crew. The procedural changes were correct and were copied correctly. If the procedures for an engine hot-fire test had been required by the ground before the crew left the lunar module, an open circuit breaker or a system malfunction would have been detected. If a system malfunction had occurred, however, the deorbit maneuver could not have been executed. The deorbit maneuver can only be executed with the primary guidance system. If a system malfunction had occurred during the manned portion of the flight, adequate system redundancy is available for attitude control (fig. 14-40).

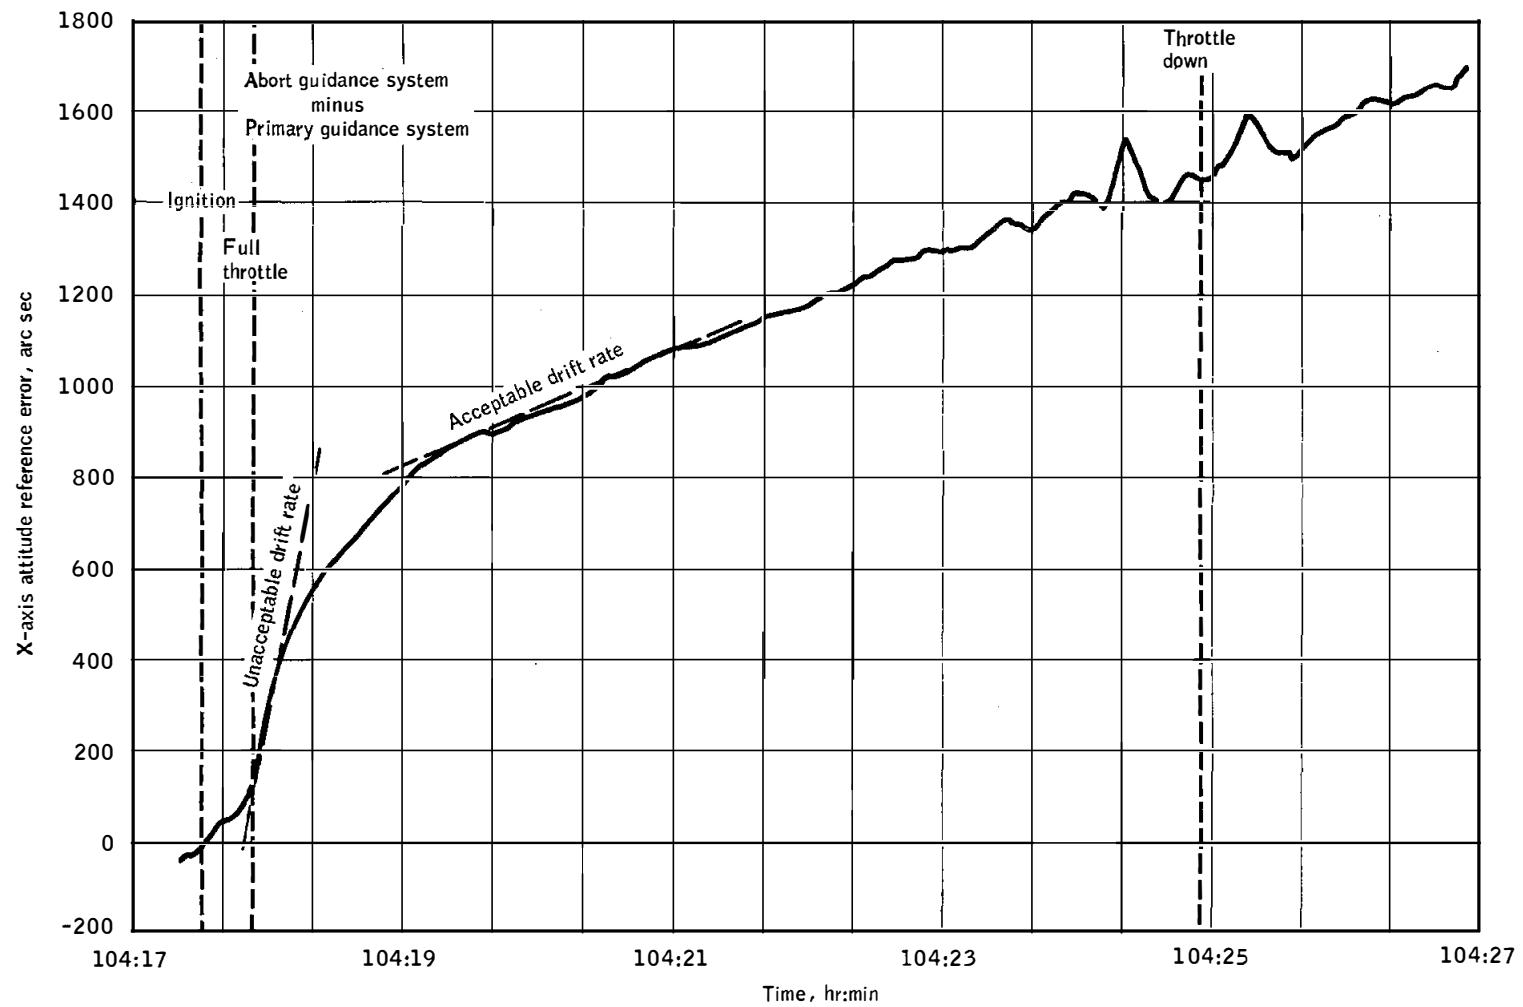
Figure 14-41.- Attitude reference error during descent.

Figure 14-41 is a time history of the difference between the abort guidance system and the primary guidance system X-axis attitude reference during descent. The rapid error buildup during the first 2 minutes indicates drift rates of up to 19 degrees per hour. No reason can be given for these high drift rates; however, a change in the X-axis gyro performance characteristics obviously took place. The steady drift rate of 2 degrees per hour during the last 8 minutes is believed to have been caused by a shift in a mass unbalance along the X gyro spin reference axis. Drift caused by this mass unbalance was also apparent in the data for the lunar surface calibration (due to gravity) and during ascent (due to the ascent engine thrust).

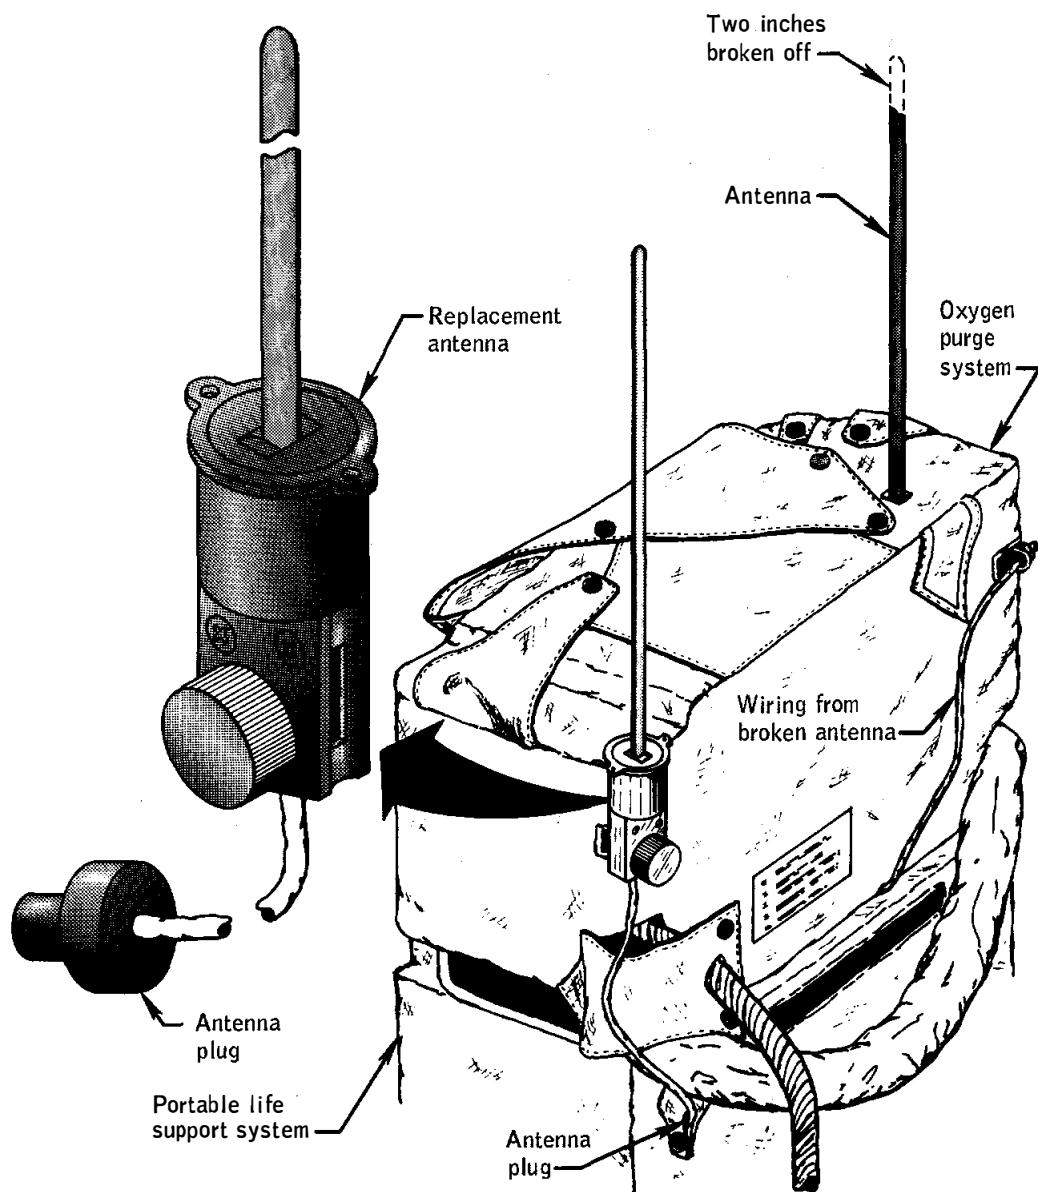
Figure 14-43.- Oxygen purge system antenna.

Following ingress after the second extravehicular activity, the crew reported that approximately 2 inches had been broken off the tip of the antenna on the Commander's oxygen purge system (fig. 14-43). The antenna had inadvertently been left unstowed while ingressing and it is believed that the antenna was broken when it struck the ascent propulsion system engine cover as the Commander was entering through the hatch.

One spare oxygen purge system antenna will be carried on Apollo 17 and will be stowed in the buddy secondary life support system bag on the lunar roving vehicle.

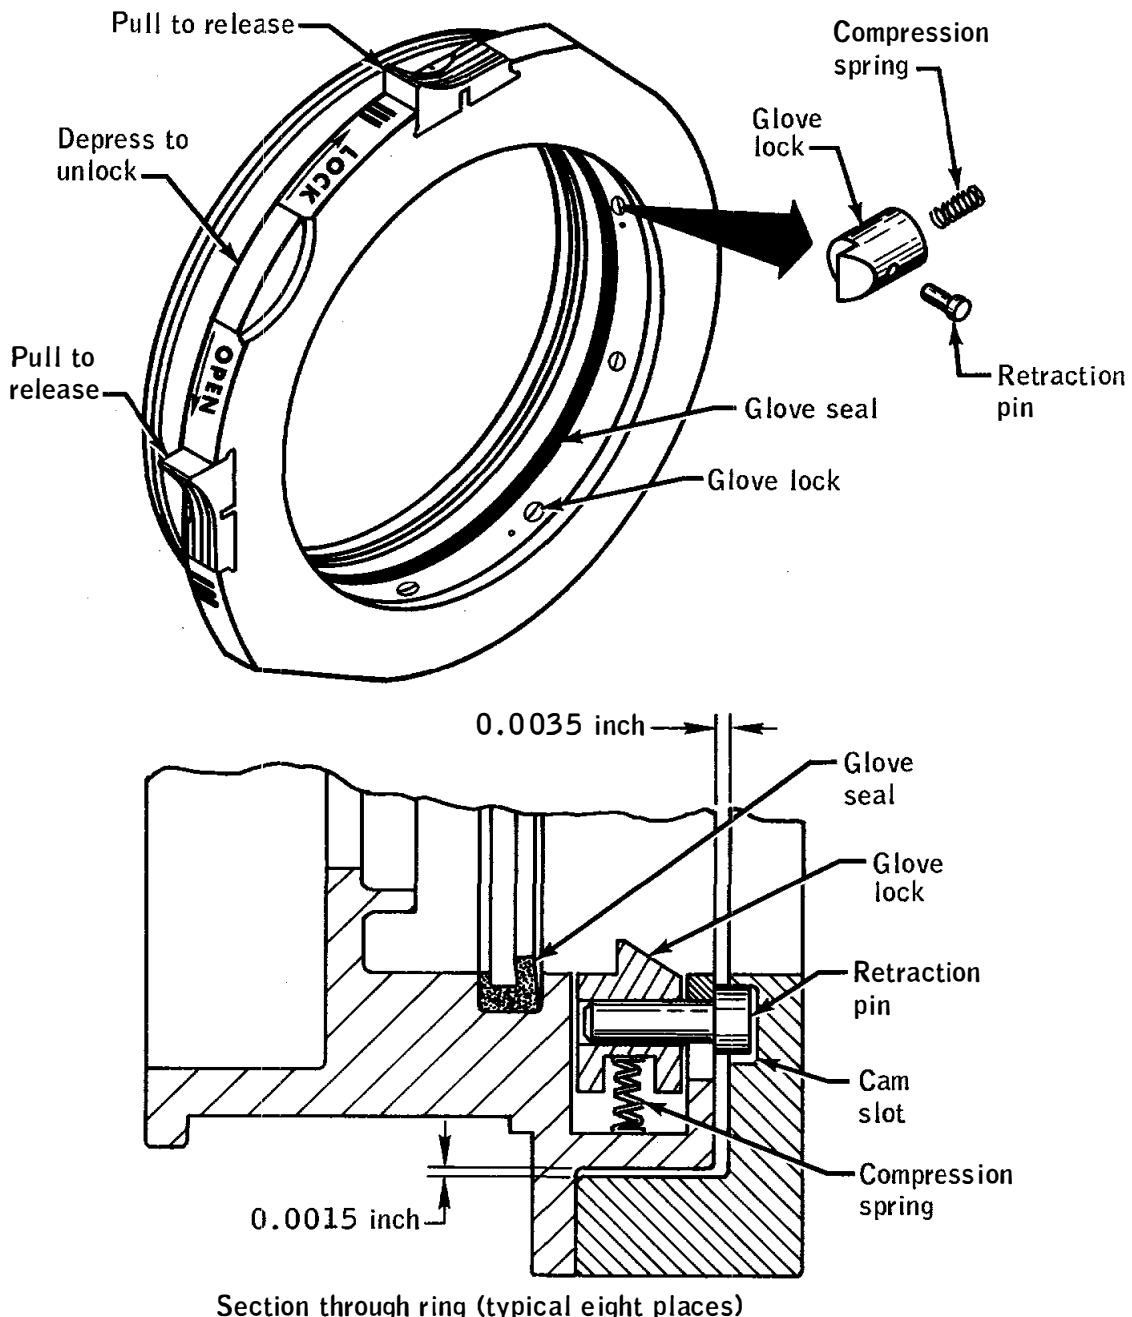
Figure 14-45.- Wrist disconnect.

The wrist disconnect attaches the glove to the suit sleeve (fig. 14-45) and is covered by a gauntlet on the glove. The gauntlet is loose fitting around the suit sleeve and dirt can get to the wrist disconnect. Small tolerances between the sliding surfaces are inherent in the design to make it impossible to accidentally unlock the wrist disconnects.

Postflight inspection of the wrist disconnects showed that lunar dust in the clearance areas caused the problem. Rubber dust covers for the ring disconnects which will afford better protection from contamination will be added for Apollo 17.
