MSC-07230

APOLLO 16 MISSION REPORT

MANNED SPACECRAFT CENTER  
HOUSTON, TEXAS  
AUGUST 1972

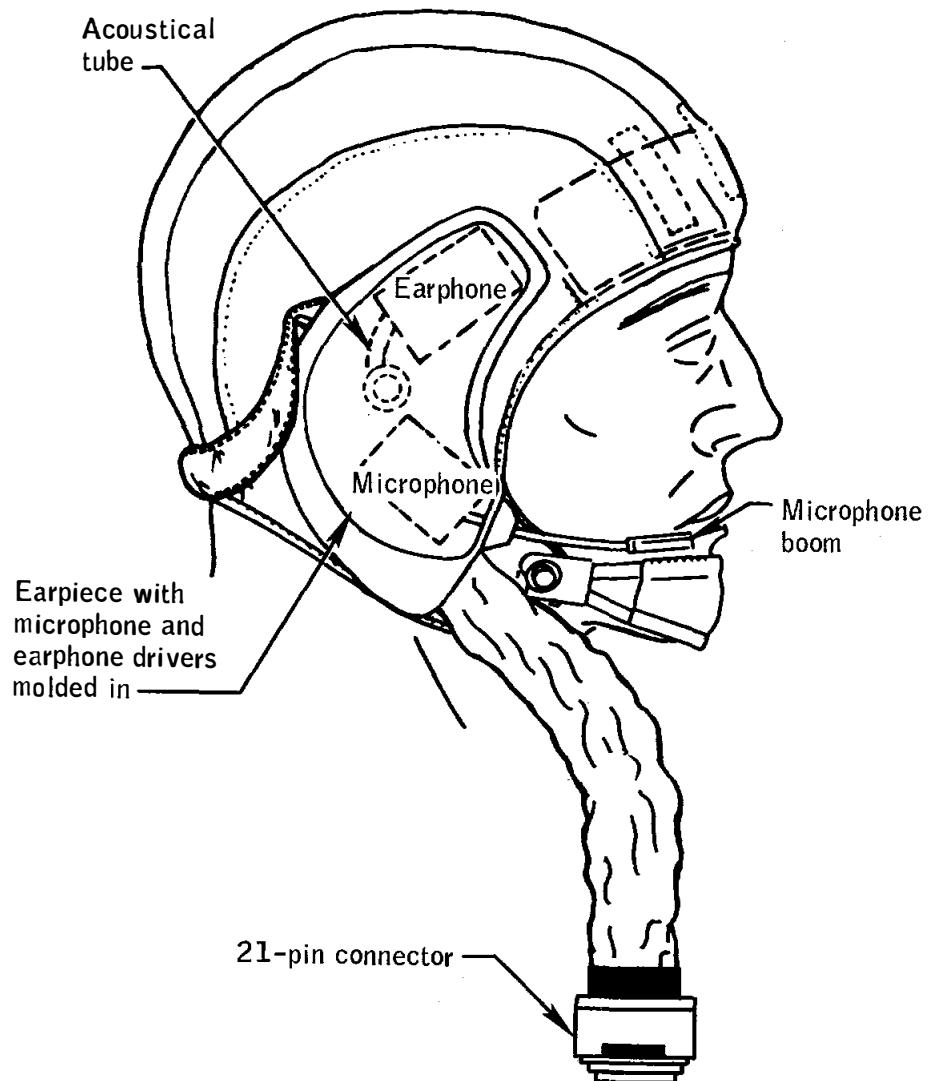
Figure 14-47.- Communications carrier.

During the transearth coast phase, the Lunar Module Pilot experienced intermittent operation of his communications carrier headset earphone circuit. This condition was cleared by flexing the constant wear garment harness near the 21-pin connector (fig. 14-47).

Indications are the problem was caused because the connector was not fully seated and the flexing of the harness seated the connector.

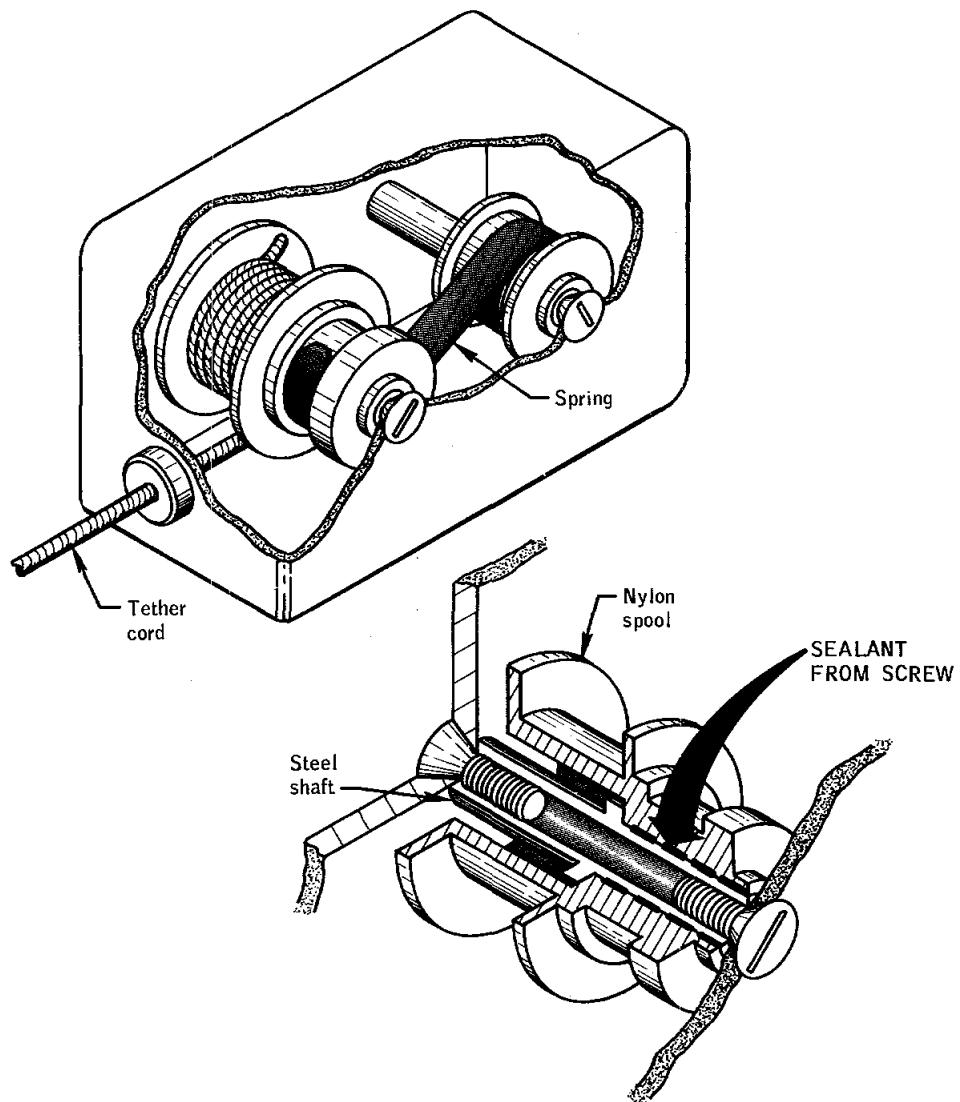
Figure 14-48.- Retractable tether.

Postflight inspection indicates that the tether is now operating; however, there is a noticeable increase in friction (fig. 14-48) during the retraction cycle. A thread sealant (loctite) was found on the spool shaft, which increased the friction.

Future units will be tested for friction buildup prior to flight.

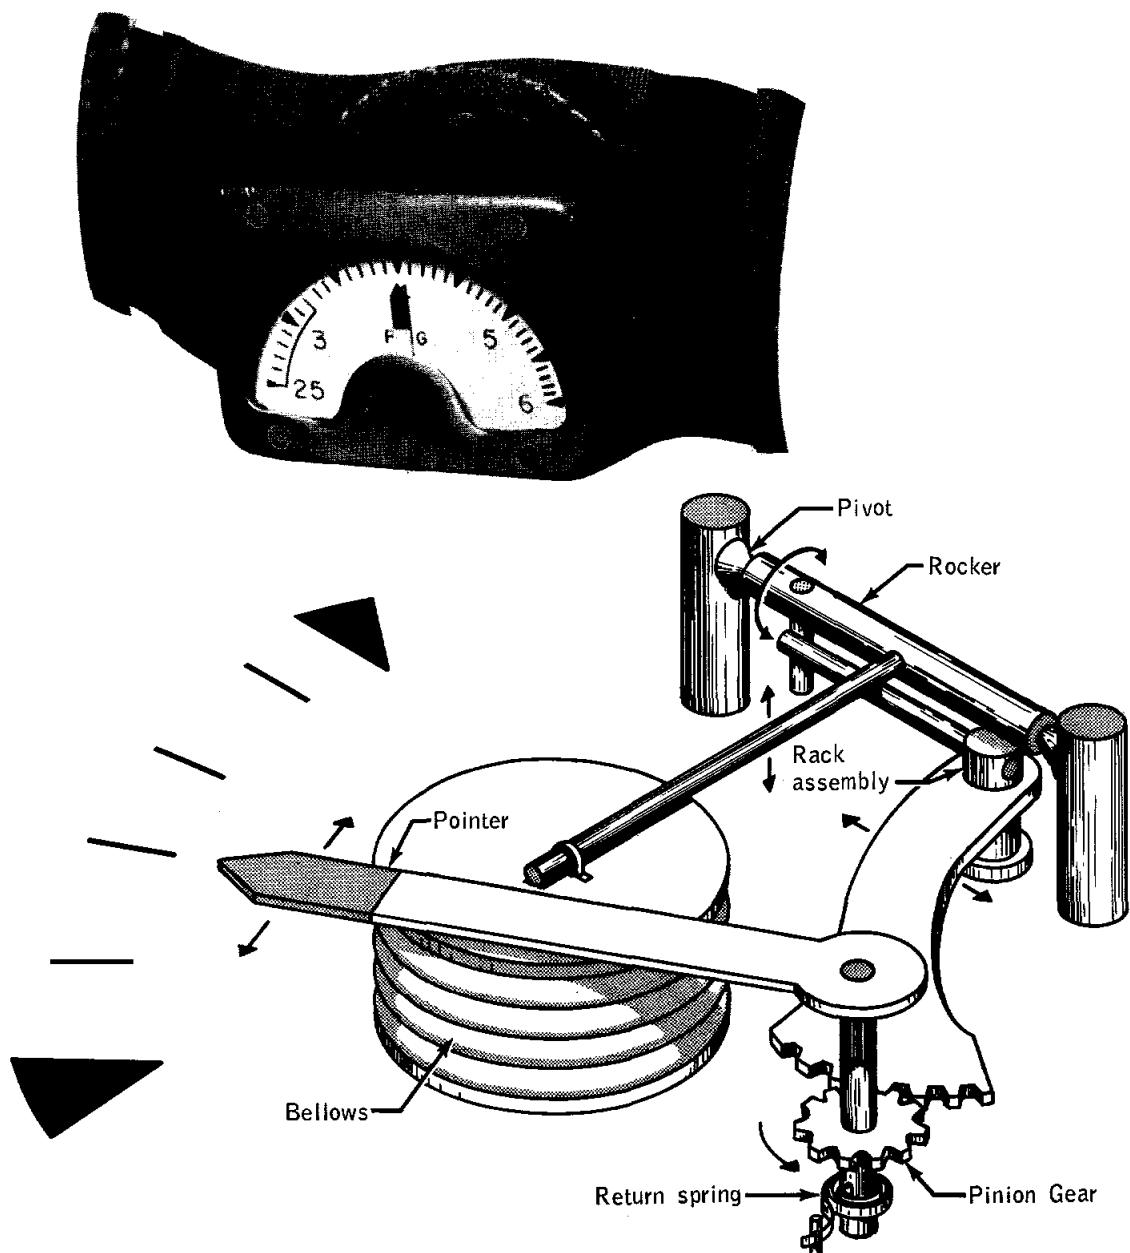
Figure 14-49.- Cuff gage mechanism.

The cuff gage (fig. 14-49) is a bellows-actuated aneroid-type mechanical gage which indicates differential pressure and has an accuracy of  $\pm 0.1$  psia. The gage opening to the outside of the gage is protected by a centered plug. When the bellows is pressurized, it lifts the rocker arm, rotating the rocker in its pivots. The other arm on the rocker then rotates the rack assembly, causing the pinion gear and pointer to rotate.

Both gages were disassembled and inspected. No discrepancies were found. Minor contamination was found, some particles as large as 0.001 to 0.002 inch, but none were large enough to interfere with the operation of the gage mechanism. Leak tests on the bellows were also performed and the results were well within specification.

Before final assembly, the gage is completely cleaned with freon and dried. Since the cleanliness procedure is satisfactory and no anomaly could be found in the flight gage, no corrective action is required.

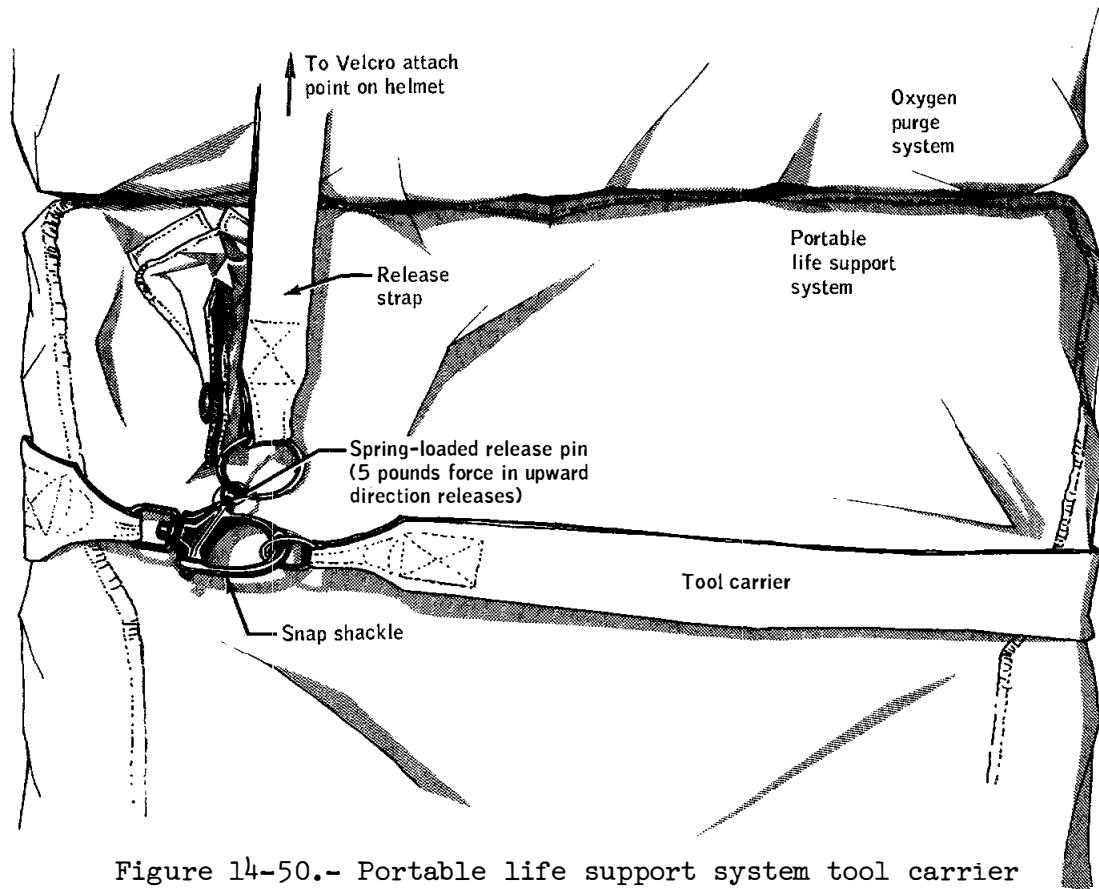
Figure 14-50.- Portable life support system tool carrier spring-pin shackle connection.

The harness is held together by a quick-disconnect snap buckle which has a spring-loaded release pin (fig. 14-50). Only a small force (5 lb) on the release strap is required to move the pin. The pin was inadvertently pulled during the cabin activity.

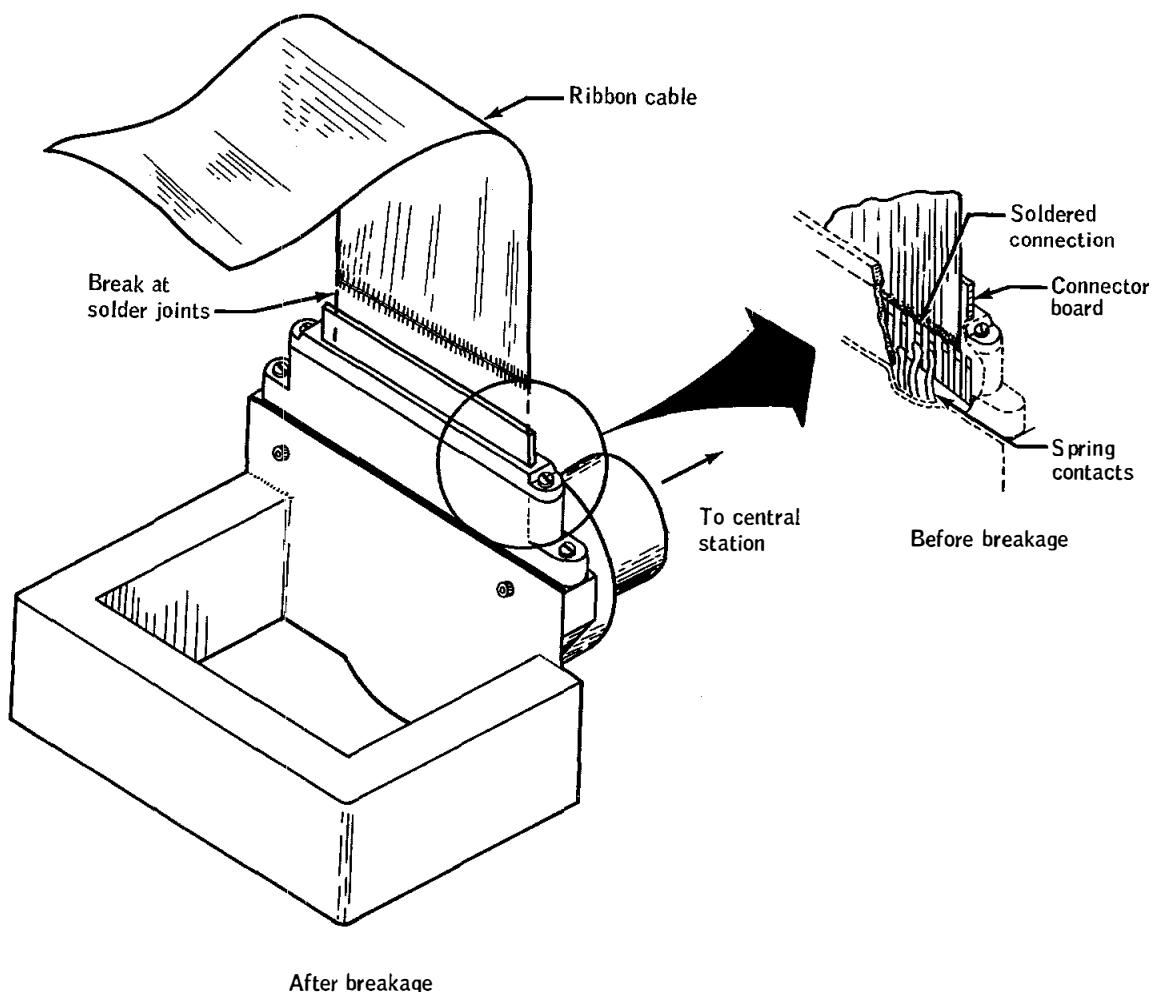
Figure 14-51.- Heat flow experiment connector.

The heat flow experiment is stowed on subpackage 2. Upon arrival at the Apollo lunar surface experiments package deployment site, the experiment is removed from the subpackage and the electrical ribbon cable is connected to the central station by an Astromate connector (fig. 14-51). The cable is bonded and soldered to a printed circuit board which is clamped in a connector. The cable-to-board joint is reinforced by two to four thicknesses of 0.5-mil Kapton tape.

Pull tests performed on the cable/Astromate connector configuration indicate the strength at the cable/board interface was 31 pounds. A modified joint assembly (fig. 14-52) which provides for strain relief and has a pull strength of over 100 pounds will be used for the heat flow experiment connector and similar connectors on Apollo 17.

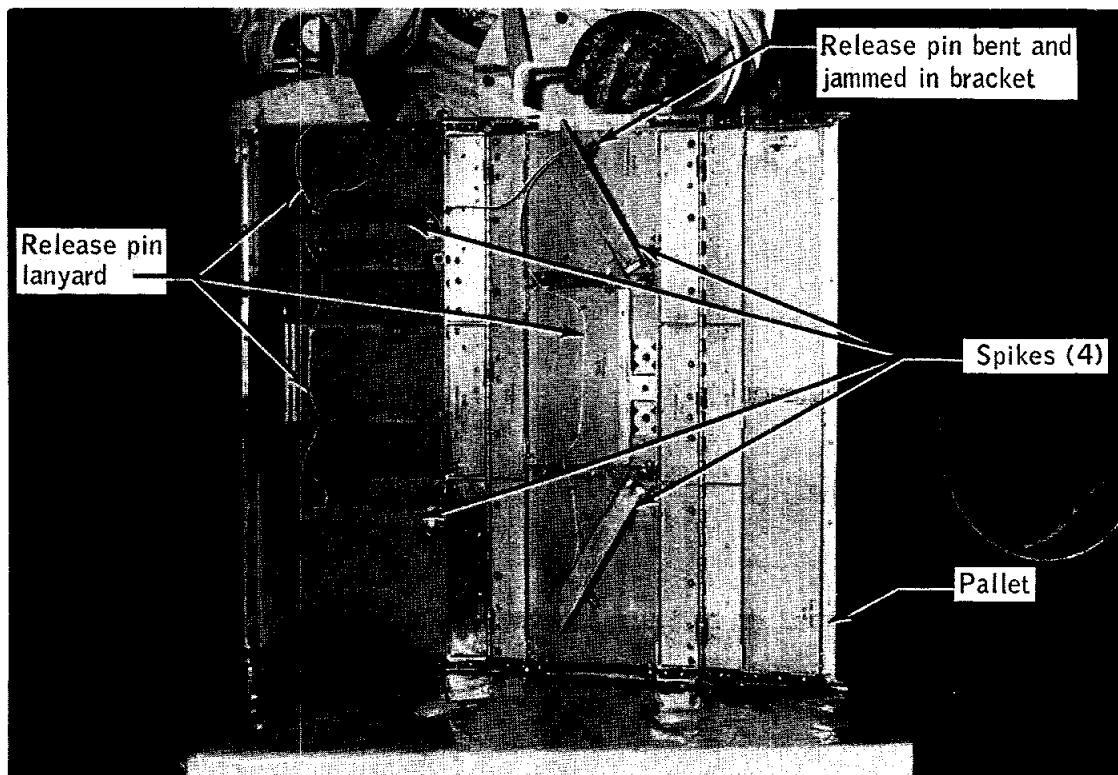
Figure 14-53.- Bottom view of active seismic experiment mortar package pallet.

The mortar package pallet assembly includes four 7-inch long stakes (fig. 14-53) which deploy normal to the pallet when the release pins are removed. When the pallet is properly positioned, the stakes are pressed into the lunar surface to provide additional stability to the platform.

Tests performed during the development of the pallet assembly showed three deployed stakes are adequate to provide stability.

No corrective action is required as the experiment is not scheduled for another mission.

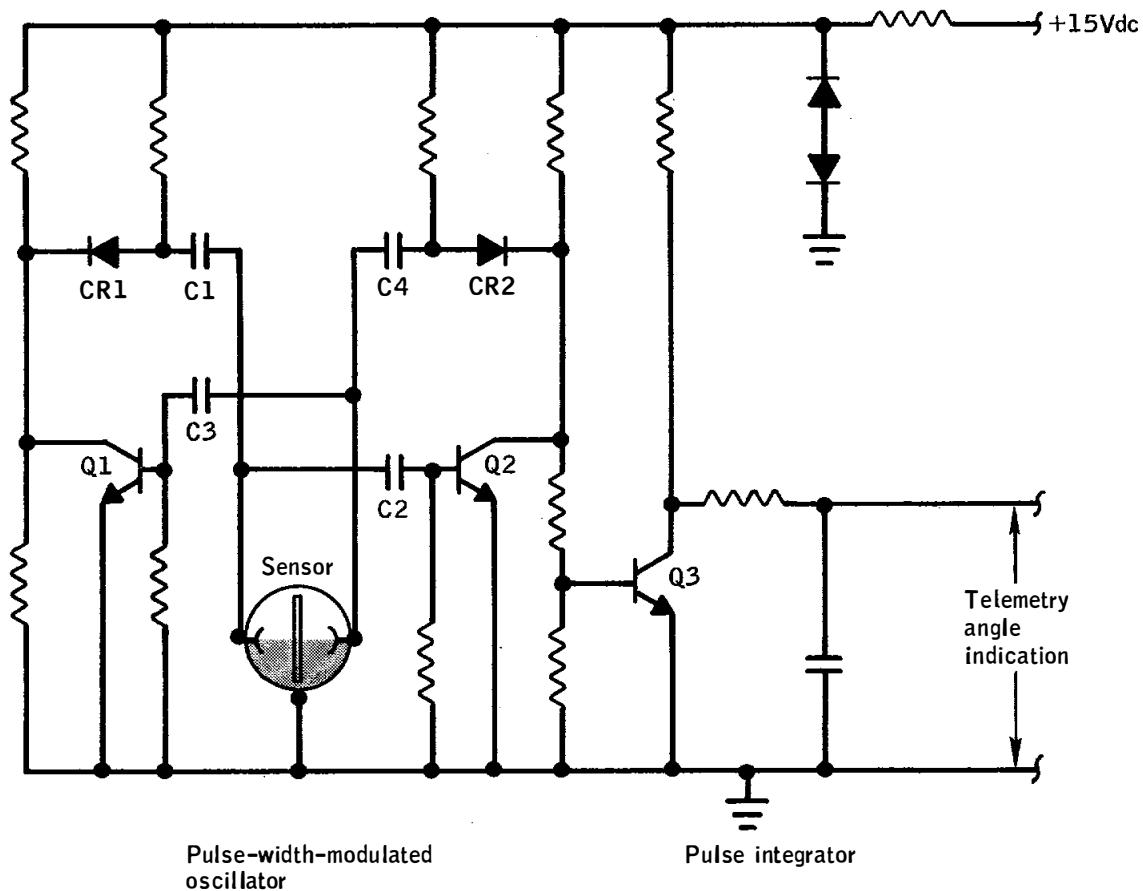
Figure 14-54.- Roll or pitch angle sensor electronics.

The sensor circuitry includes a free-running multivibrator, with the pulse-width ratio controlled by the sensor which functions as a potentiometer (fig. 14-54). Numerous failure possibilities in the circuit, such as open transistors, shorted capacitors, and open solder joints could have caused failure of the multivibrator and the off-scale high reading.

Note: An open in any component in the pulse-width-modulated oscillator (CR1, CR2, C1, C2, C3, C4, Q1 and Q2) is a single-point failure, or an open in the pulse integrator (Q3) is a single-point failure.

No corrective action is required as the experiment is not scheduled for another mission.

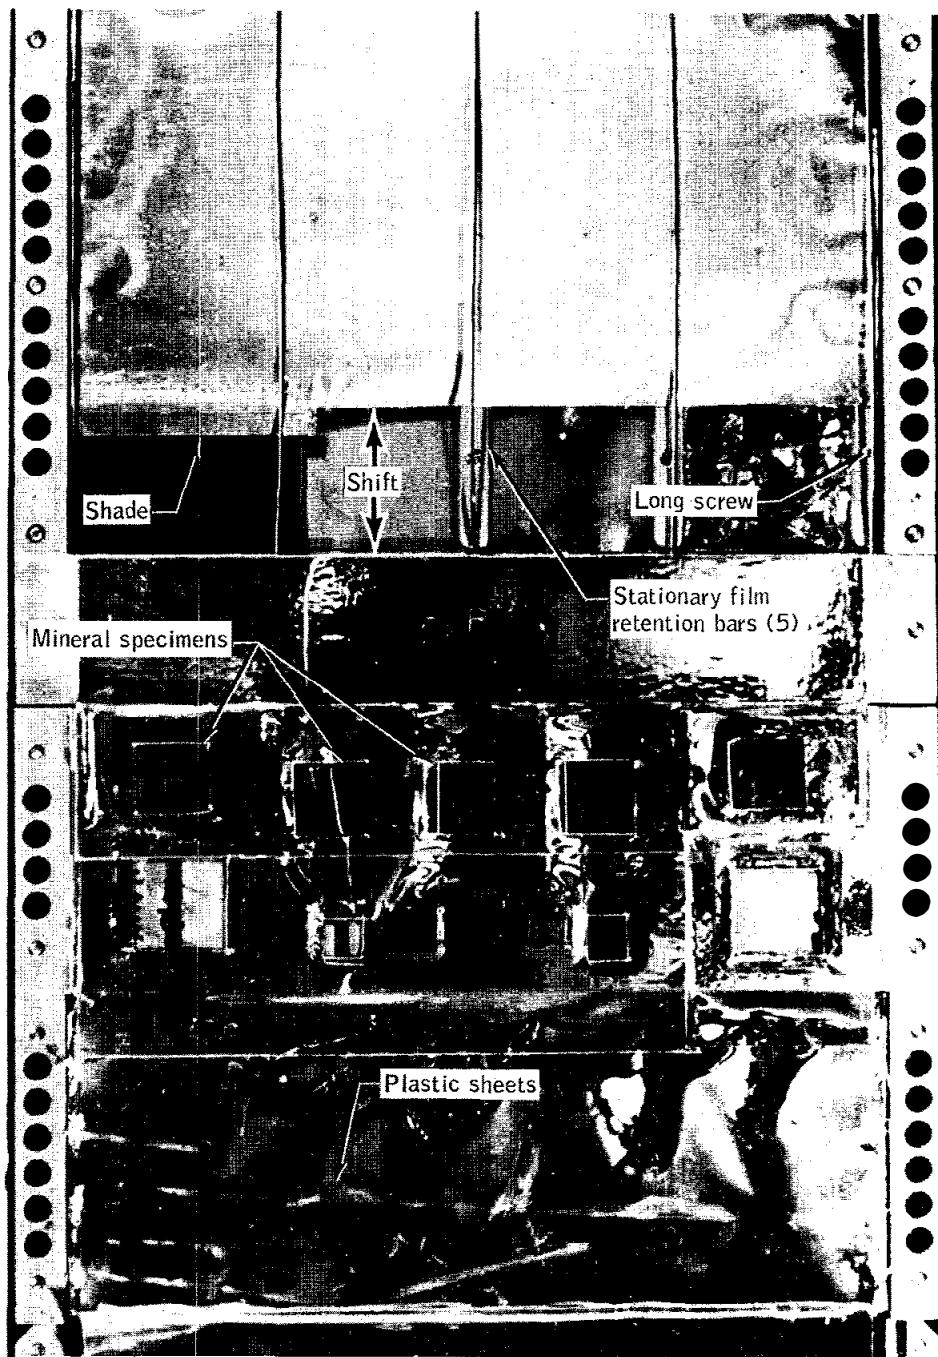
Figure 14-55.- Panel 4 with partially deployed shade.

The Commander pulled the red-ring lanyard to shift the shade in panel 4. The shade moved only 1 inch instead of about 3.5 inches and the lanyard broke.

A movable platinum shade (fig. 14-55) covers the top half of panel 4 during translunar flight and until after the radioisotope thermoelectric generator is removed from the area during lunar surface operations. The

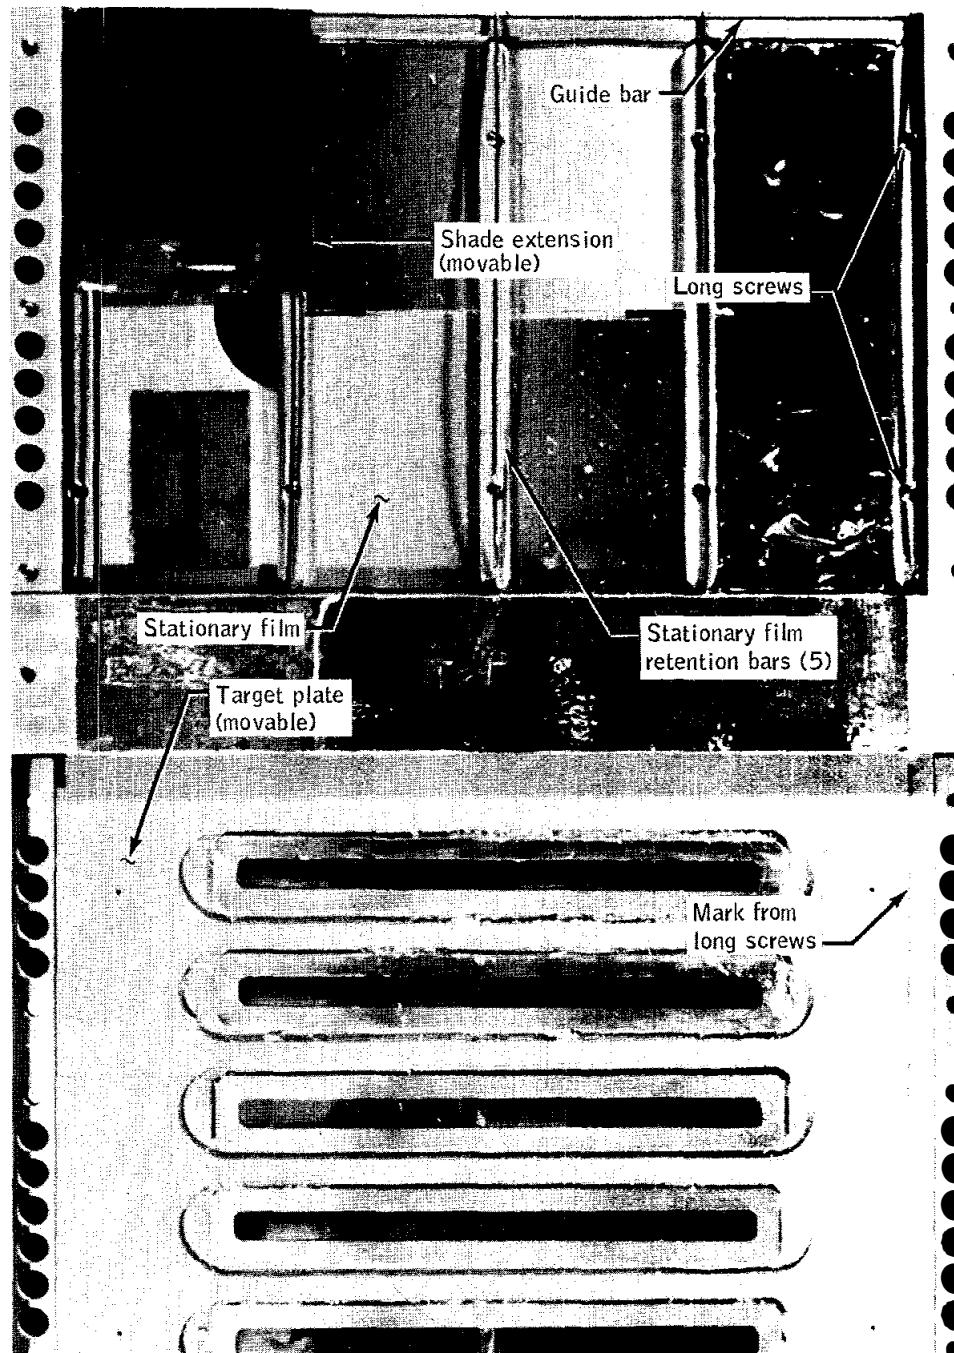
Figure 14-56.- Panel 4 target plate and fully deployed shade.

Examination of the panel assembly has shown that the failure of the shifting mechanism was caused by a clamping of the target plate by two retention bar screws which projected past the backplate into the target plate, and effectively locked it in place (fig. 14-57).

Figure 14-56 shows the panel 4 assembly with the target plate and shade fully deployed after having backed off the two projecting screws. Note the rub mark from the screws on the target plate.

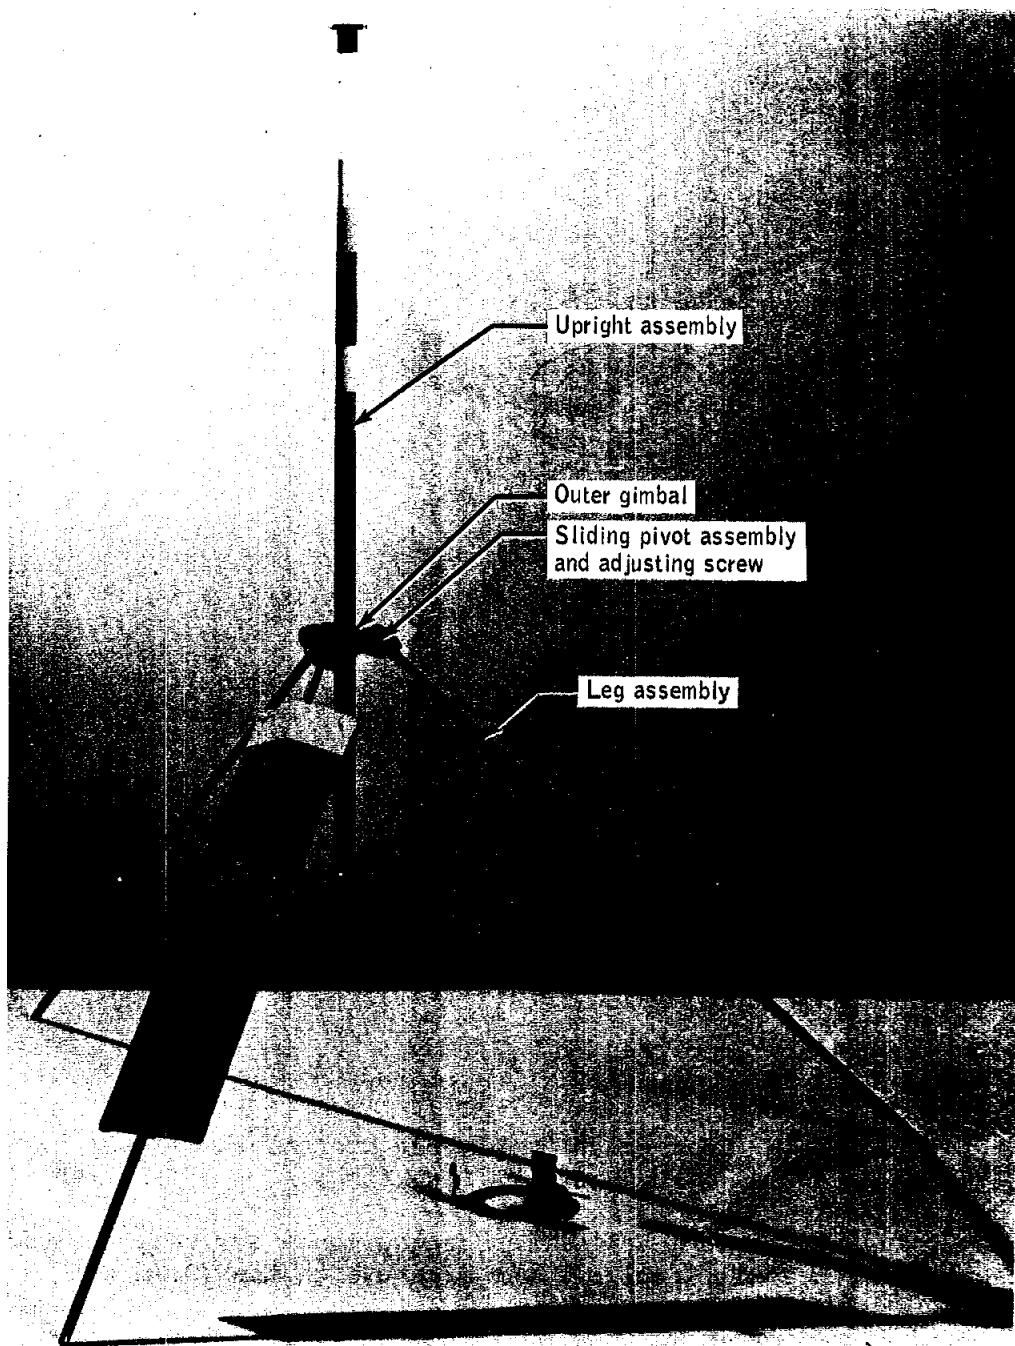
Figure 14-58.- Gnomon assembly.

When the gnomon (fig. 14-58) was being unstowed from its stowage bag during the second extravehicular activity, the leg assembly remained in the bag, and the vertical staff came out separately. The leg assembly, because of its color scale, was used during the rest of the lunar surface photographic operations. The primary function of the complete gnomon is to indicate the local vertical in lunar surface geology photographs.

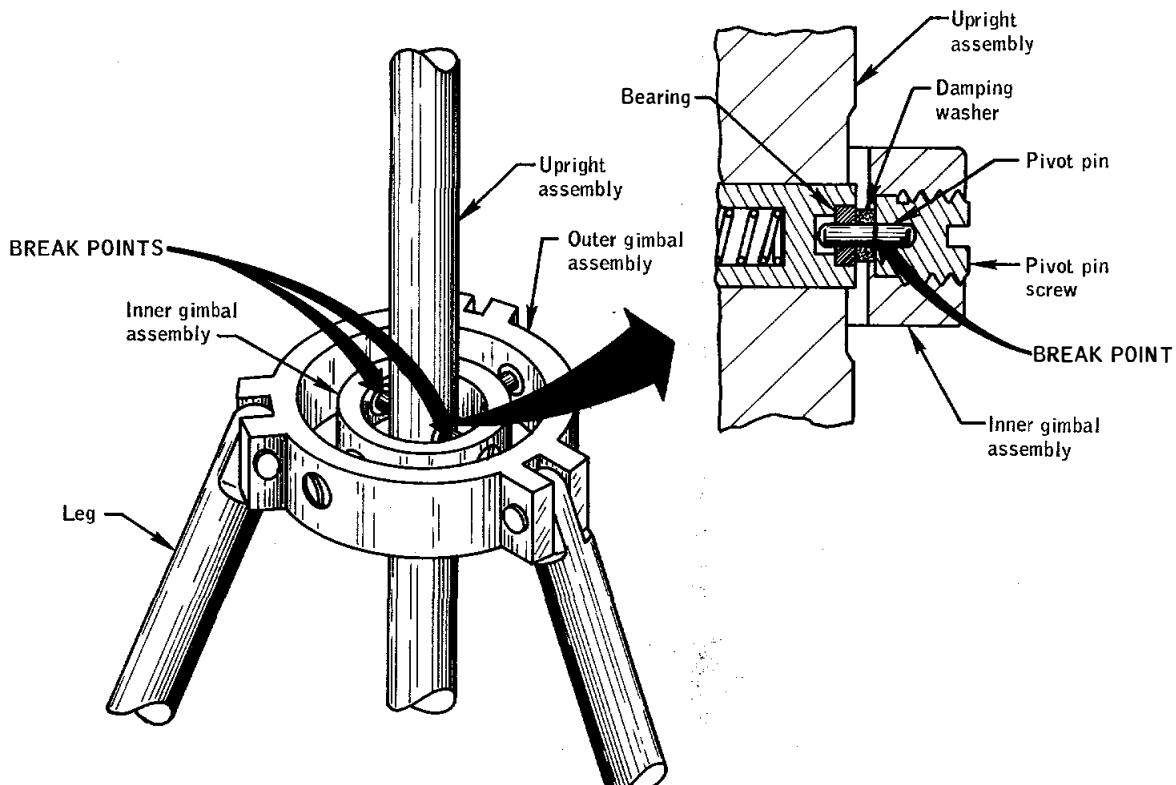
Figure 14-59.- Gnomon gimbal assembly

The staff can be separated from the leg assembly by backing out the gimbal pivot screws. However, all four screws must be backed out (fig. 14-59). There was no indication in the photographs of any screws backing out. During ground operations, a staff separated from the leg assembly by breaking the inner gimbal pivot pins. The break occurred where the 0.040-inch-diameter pivot pin is pressed into the pivot screw.

but has a tendency to be brittle without additional tempering. In addition, the combination with stainless steel can be conducive to stress corrosion. Either, or a combination, of the two conditions is considered as the most likely cause of the anomaly.

Pivot pins for the Apollo 17 gnomon will be given the additional tempering required for greater toughness, and a thin film of oil will be applied for protection against corrosion. Ground tests have shown the

damping will be unaffected. Assembly of the pin in the screw will be delayed until as late as possible before launch so as to reduce the time for possible stress corrosion to occur.

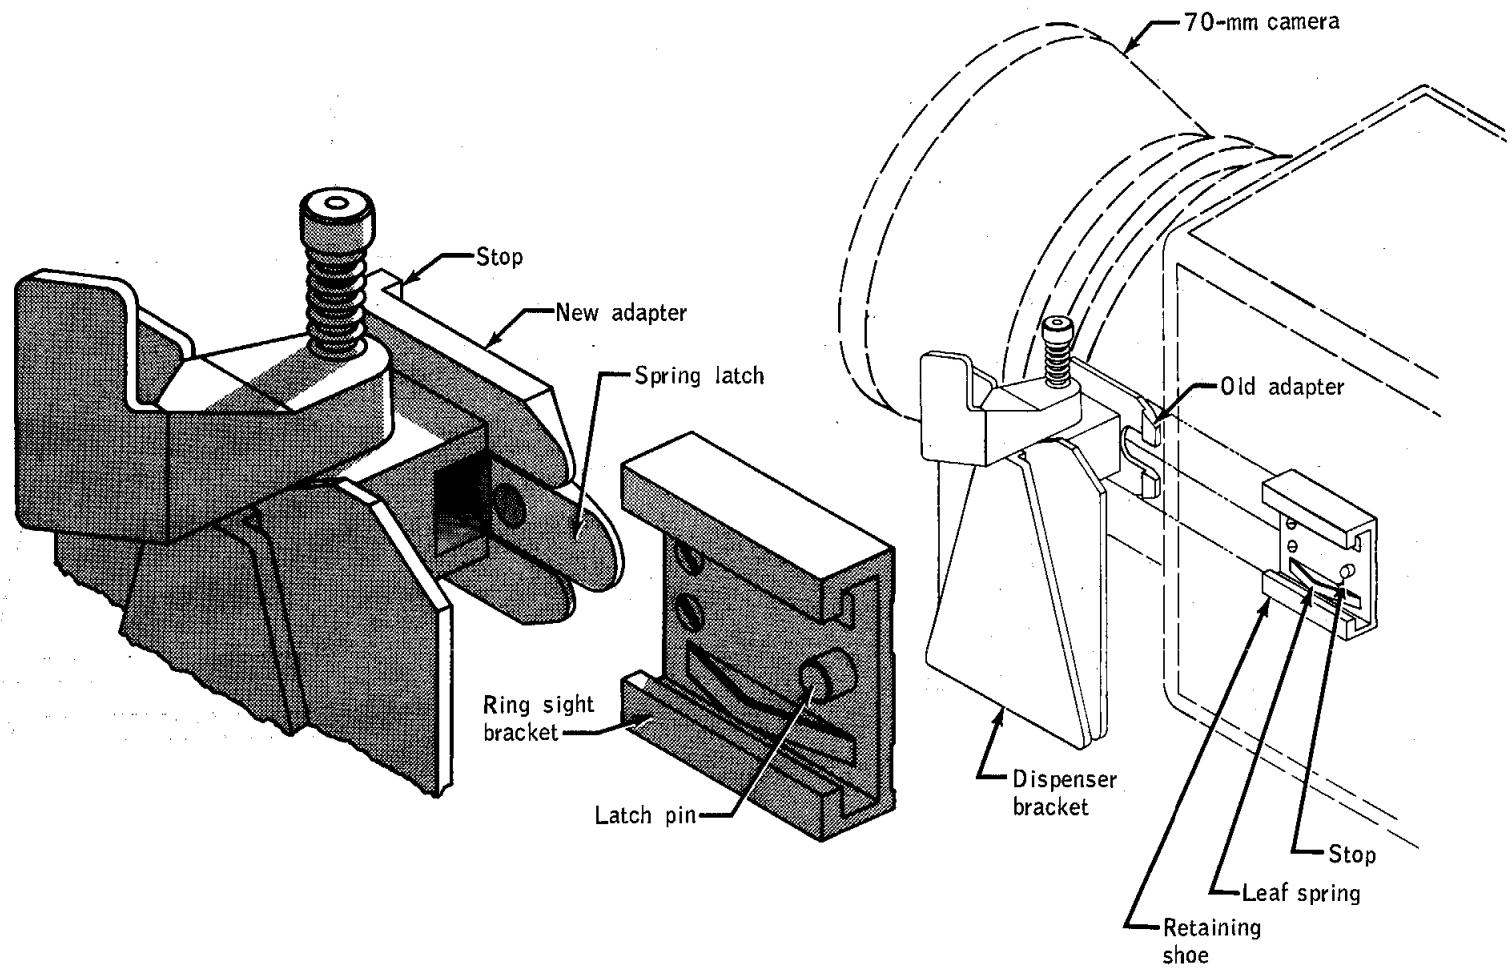
Figure 14-60.-- Sample bag dispenser retention.

The dispenser is mounted on an adapter (fig. 14-60) which is inserted in the ring-sight tee-slot bracket on the camera. The adapter-to-tee slot interface is horizontal and depends on springs in the tee slot to hold the adapter in the latched position. This latching method is inadequate.

The adapter has been redesigned so as to provide a positive lock in the installed position as shown in figure 14-60.

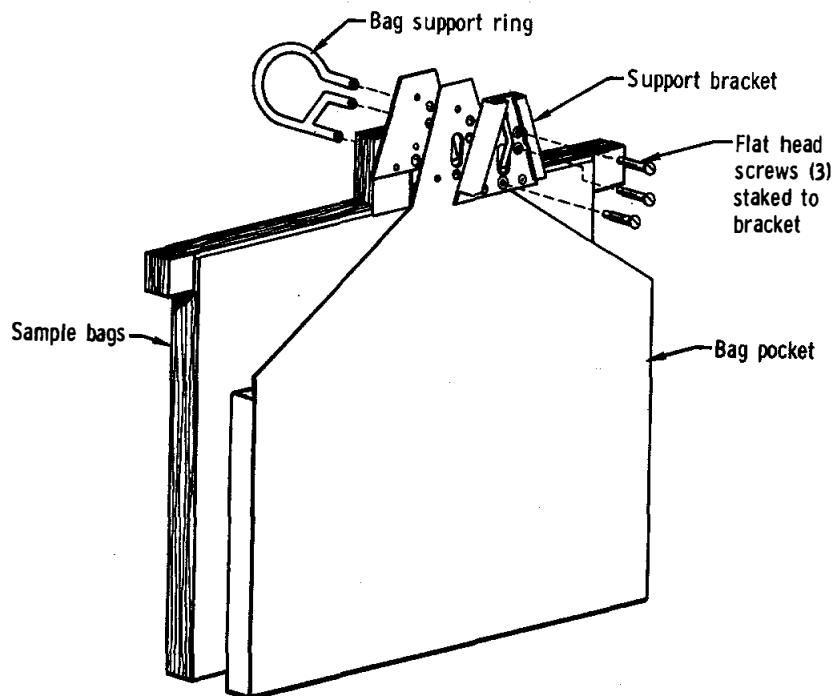
Figure 14-61.- Documented sample bag dispenser assembly.

The three flat-headed stainless steel screws mate with threads in the aluminum ring (fig. 14-61). The heads are staked to the aluminum bracket plate. Thread sealant materials are not permitted because of the possibility of lunar sample contamination.

The Apollo 17 dispensers will be re-inspected to assure proper staking of the screws and tightness of the threads in the aluminum ring.

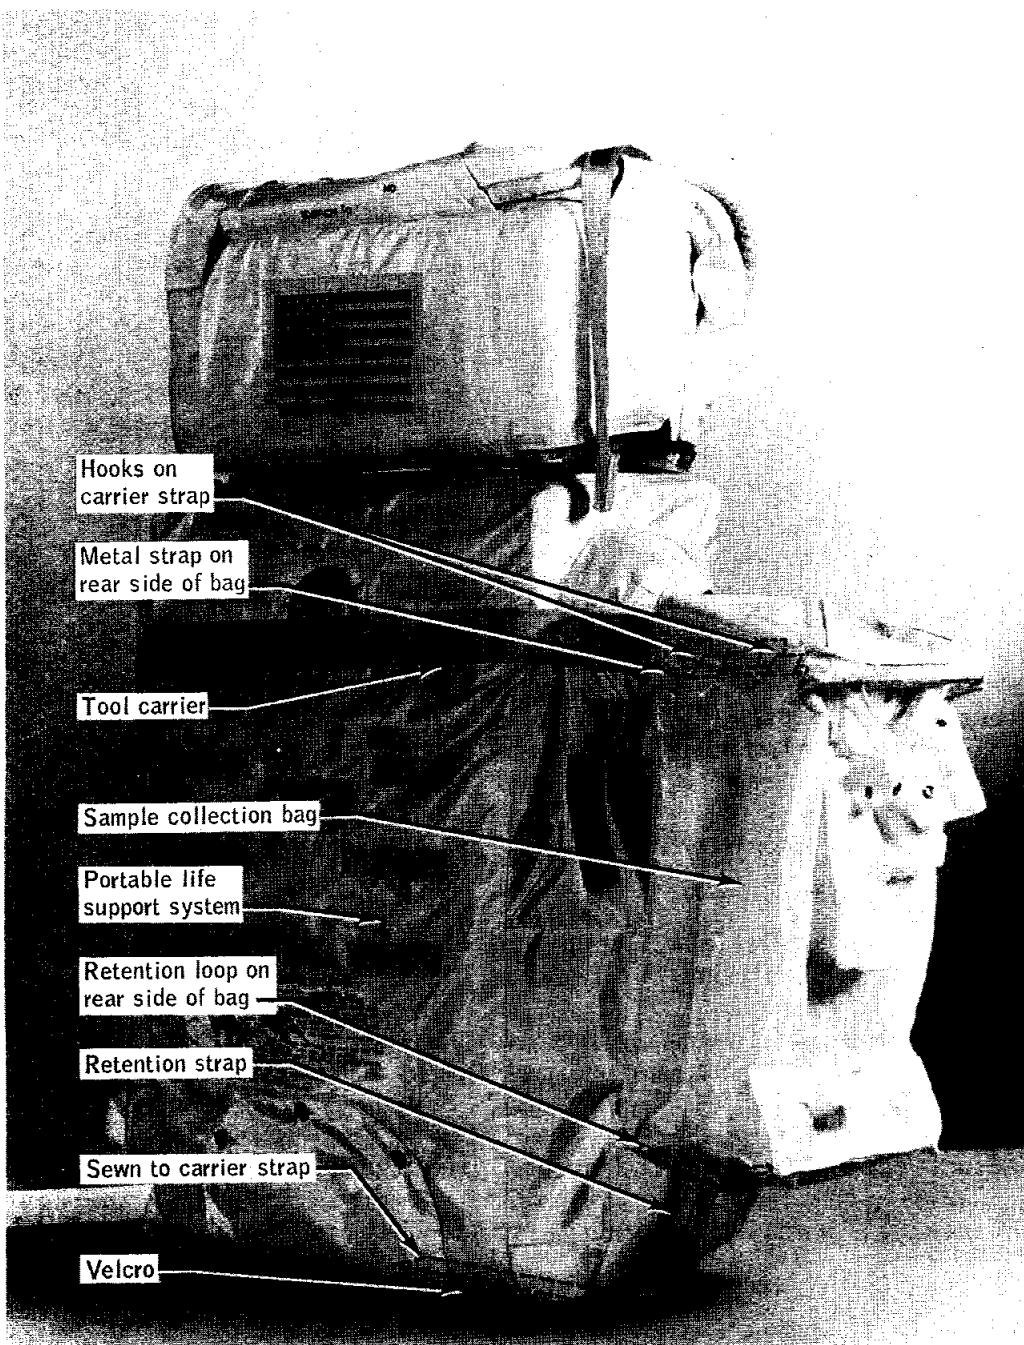
Figure 14-62.- Sample collection bag on portable life support system tool carrier.

During lunar surface operations, the Commander's sample collection bag came loose from the portable life support system tool carrier several times and fell off once.

The sample collection bag essentially consists of a Teflon bag on a metal frame (fig. 14-62). The bag opening is covered by a Teflon lid on a hinged metal frame. Attached to the metal frame on one side of the bag, about 2 inches below the lid, is a 3/8-inch-wide stainless steel strap with offsets to accomodate the two hooks on the tool carrier. About 1 inch from the bottom of the same side is a 1-inch-wide Teflon band, sewn to the bag, with an offset loop approximately 1 inch by 5 inches to accomodate the Velcro strap from the bottom of the tool carrier. The Velcro strap, when tightened down, keeps the bag from floating or bouncing off the hooks. During the lunar roving vehicle operations, the Velcro strap sometimes loosened because of the entrapped lunar dust so that the bag could come off.

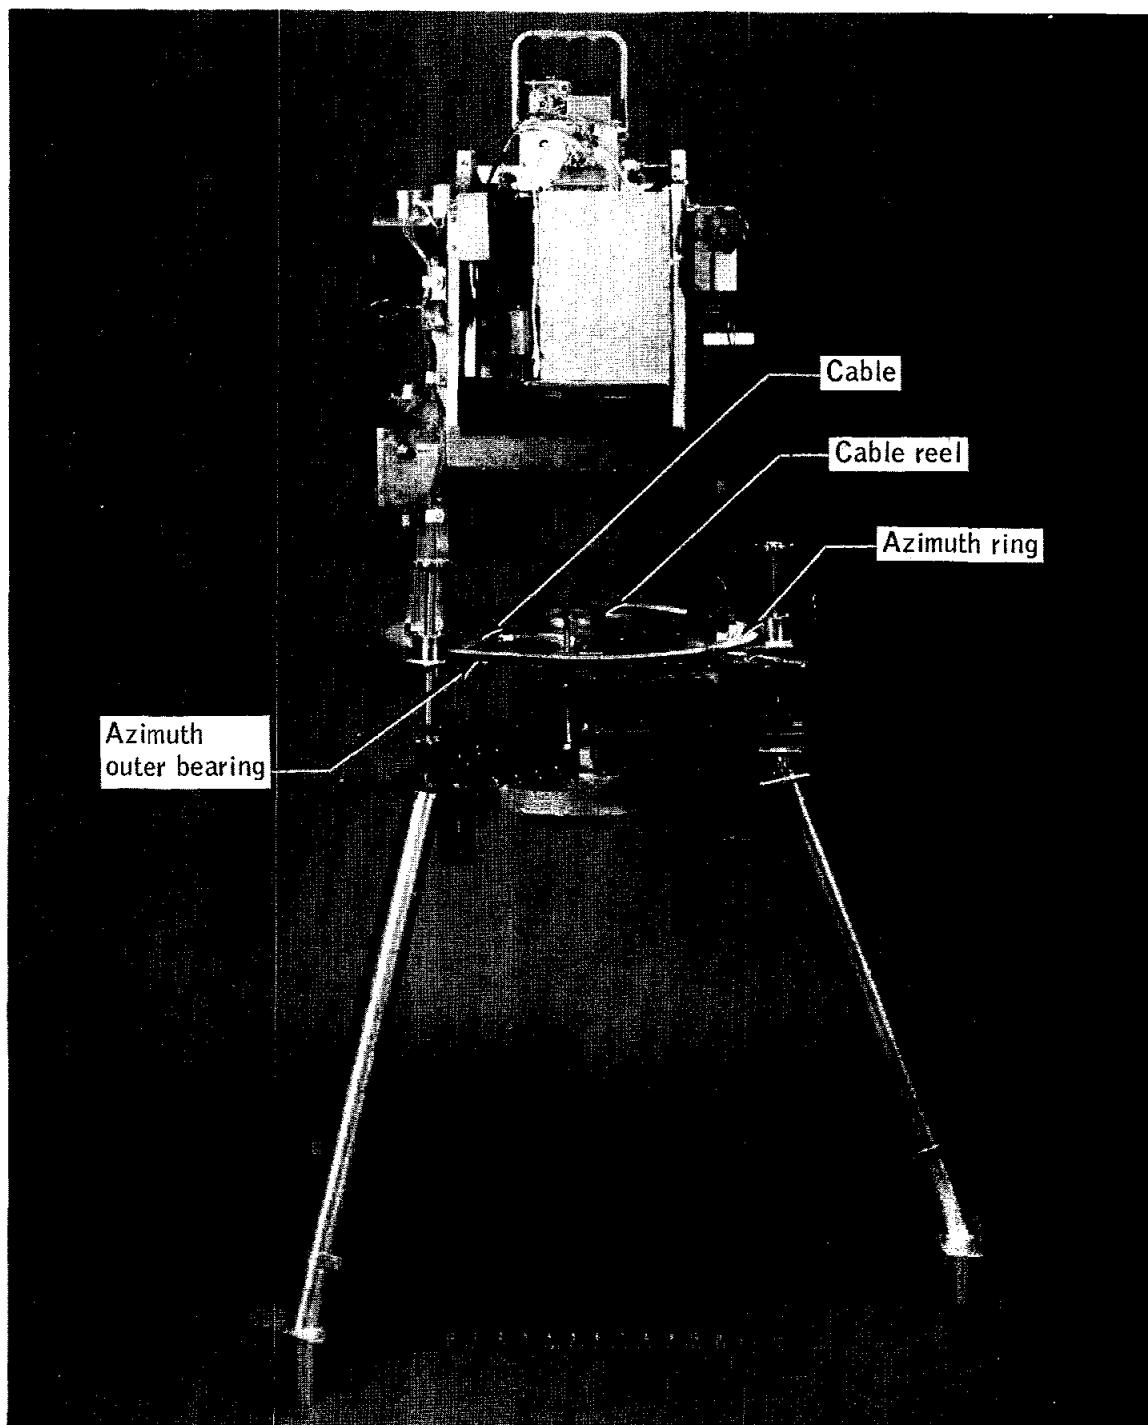
Figure 14-63.- Far ultraviolet camera.

To adjust the azimuth to the proper dial reading, the camera is rotated on a 12.5-inch diameter ball-bearing ring (fig. 14-63). The bearing is not sealed; however, the crew did not observe any lunar dust on the bearing.

The azimuth ring bearing was packed with a waxy, low-outgassing grease which stiffens appreciably at temperature below 50° F. This grease is normally used as a sealant rather than a lubricant. The camera was intentionally kept in the shade to protect the film from high temperatures. As a result, the grease stiffened. The manual azimuth adjustment operation was not included in cold chamber tests with other operations of the camera.

The difficulty was caused by the use of the wrong type of grease in the azimuth ring bearing.

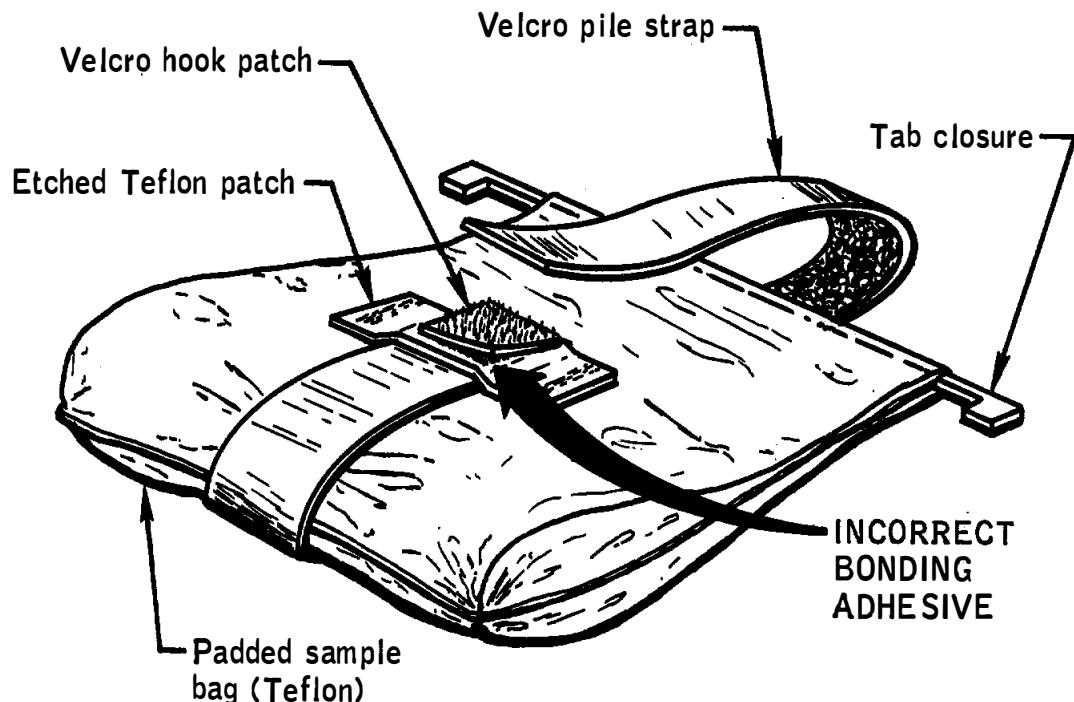
Figure 14-64.- Padded sample bag.

When the crew wrapped the Velcro strap around each of the padded sample bags to further secure them, the Velcro attachment patches came off the bags and the straps were ineffective.

A 20-inch-long wrap-around Velcro pile strap is provided to hold the bag closed in addition to the usual tab closure (fig. 14-64). One end of the strap is bonded with a fluorel adhesive to an etched Teflon patch which

is heat-sealed to the Teflon bag. A Velcro hook patch is bonded to the etched Teflon patch with a pressure-sensitive adhesive and provides the attach point for the other end of the strap. The peel strength of the pressure-sensitive bond was less than that of the Velcro pile-to-hook connections. Consequently, when the Velcro strap was adjusted to the proper tension, the hook patch came off the bag.

The problem resulted from using the improper bond material for the Velcro hook patch.

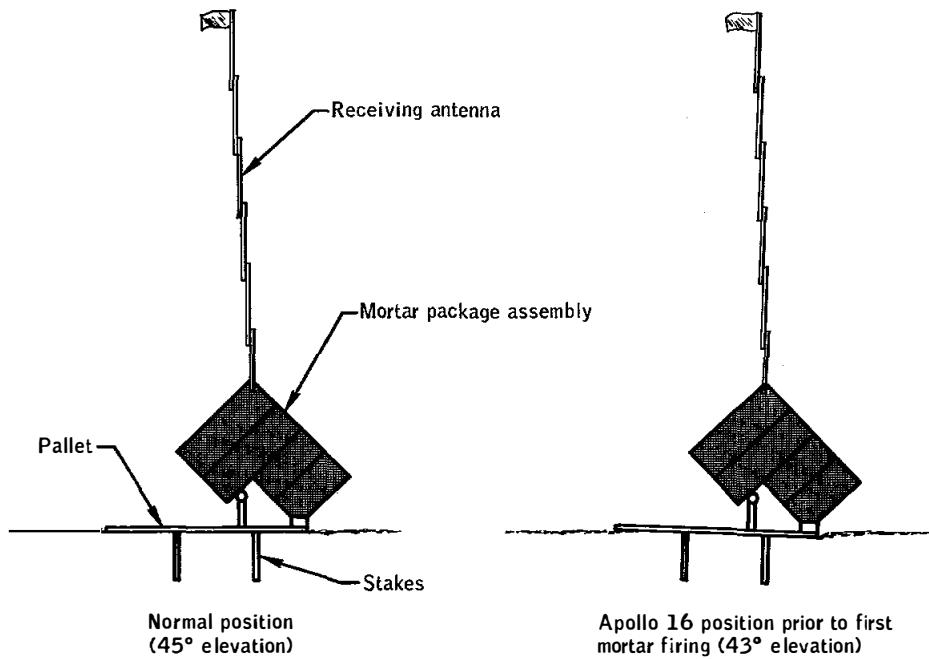
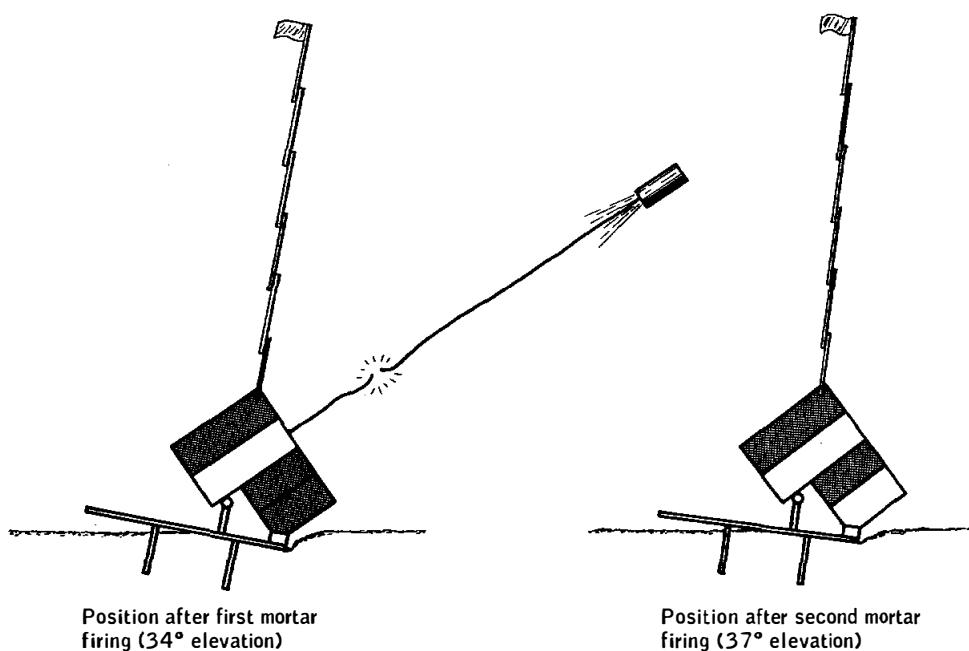
Figure 14-65.- Pitch movement of mortar package assembly.

Immediately prior to launching the third grenade, the pitch sensor indicated that the mortar package assembly was pitched down about 8° from the nominal plus 45° elevation (fig. 14-65). Within 2 seconds after firing the mortar, the sensor indication was off-scale-high and has remained off-scale-high.

Based on ground tests during which the assembly was rotated through  $360^\circ$ , an off-scale-high indication means either that the mortar package assembly is pitched up between  $25^\circ$  and  $155^\circ$  above the normal plus  $45^\circ$  elevation, or that the sensor has failed. There are two stable positions of the mortar package and pallet assembly between these two points: (1) pitched up  $30^\circ$  above normal ( $75^\circ$  elevation), and (2) pitched up  $135^\circ$  above normal ( $180^\circ$  elevation). The temperature profiles for the two temperature sensors on the mortar package assembly, when compared with the calculated temperature profiles for elevations of  $45^\circ$  and  $75^\circ$ , indicated that the mortar package assembly was not in the  $75^\circ$  elevation position. In the  $180^\circ$  elevation position, the receiving antenna would have been broken off or badly bent and lying on the ground. In this case, complete real-time event data would not have been received during the flight of the third grenade. However, complete real-time event data were received during the entire 19-second flight, indicating that the mortar package assembly was not in the  $180^\circ$  elevation position.

It is most likely that there is a failure in the pitch sensor circuit, and the orientation of the mortar package is unknown.
