MSC-07230

APOLLO 16 MISSION REPORT

MANNED SPACECRAFT CENTER  
HOUSTON, TEXAS  
AUGUST 1972

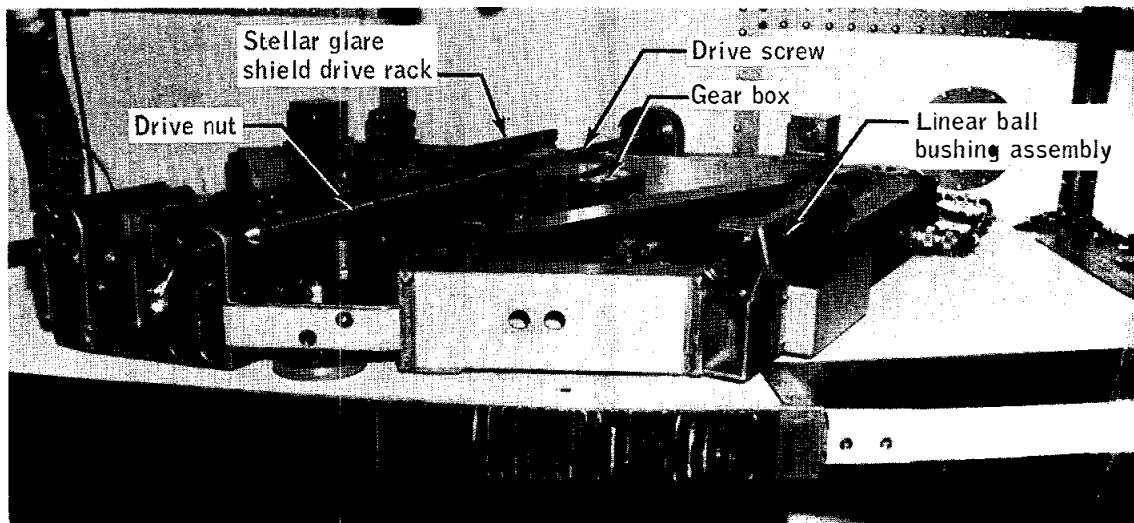
Figure 14-66.- Mapping camera deployment mechanism.

Deployment rails attached to the bottom of the camera slide through ball-bushings that are part of the deployment mechanism (fig. 14-66). Deployment of the camera is accomplished by the drive screw turning within the drive nut, which is bolted to the camera. Friction in this screw-nut drive is minimized through the use of recirculating streams of ball bearings riding between the threads of the nut and screw.

Preflight deployment operations had disclosed a chattering noise in the mechanism when the retraction was aided by the pull of the cable harness to the camera. An analysis of the drive train indicates that a state of dynamic instability may exist in a zero-g environment because of the resultant loss of the damping provided by the deployment rail friction. Simulated zero-g tests are being conducted by suspending the camera with a long cable in order to remove the weight from the rails while maintaining the inertial properties of the camera during the deployment.

A separate anomaly report will be published upon completion of analysis and testing.

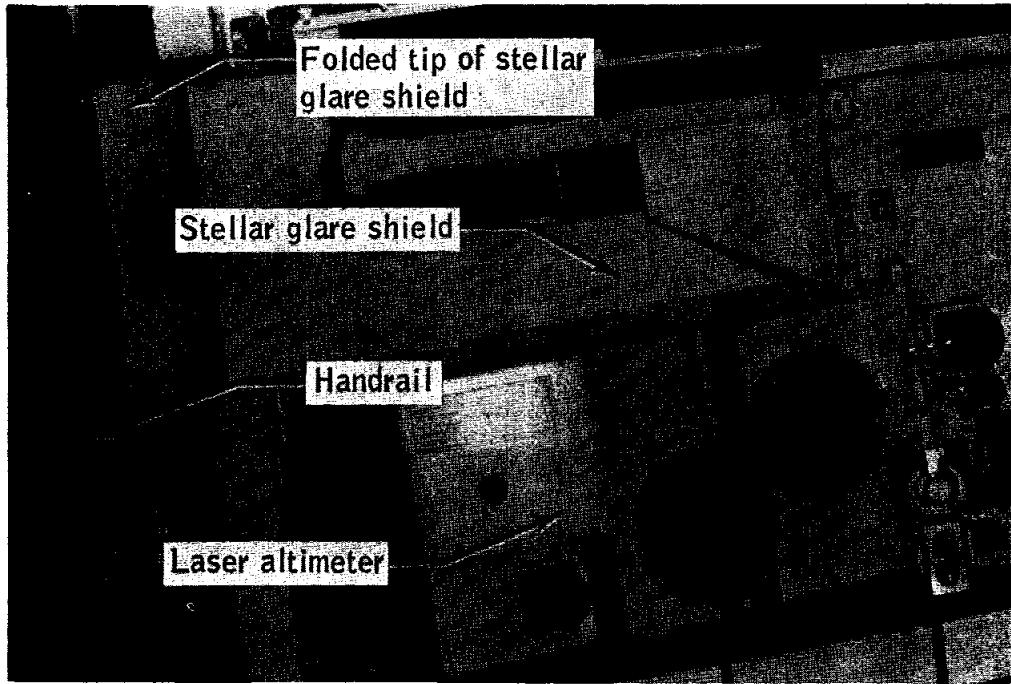
Figure 14-67.- Mockup photograph of glare shield handrail.

The Command Module Pilot observed that the glare shield for the stellar camera was jammed against the handrail paralleling the scientific instrument module bay (fig. 14-67) during the transearth extravehicular activity. In the 16-mm photography of the extravehicular activity, the outermost edge of the folding tip of the glare shield is visible above the handrail, in the fully-extended position as shown in figure 14-64.

Scientific instrument module bay photographs taken from the lunar module indicate that the glare shield was properly retracted at rendezvous; therefore, the failure to retract occurred at the third, fourth, or fifth (last) camera retraction. A review of the stellar film indicates that this anomaly did not affect the stellar photography.

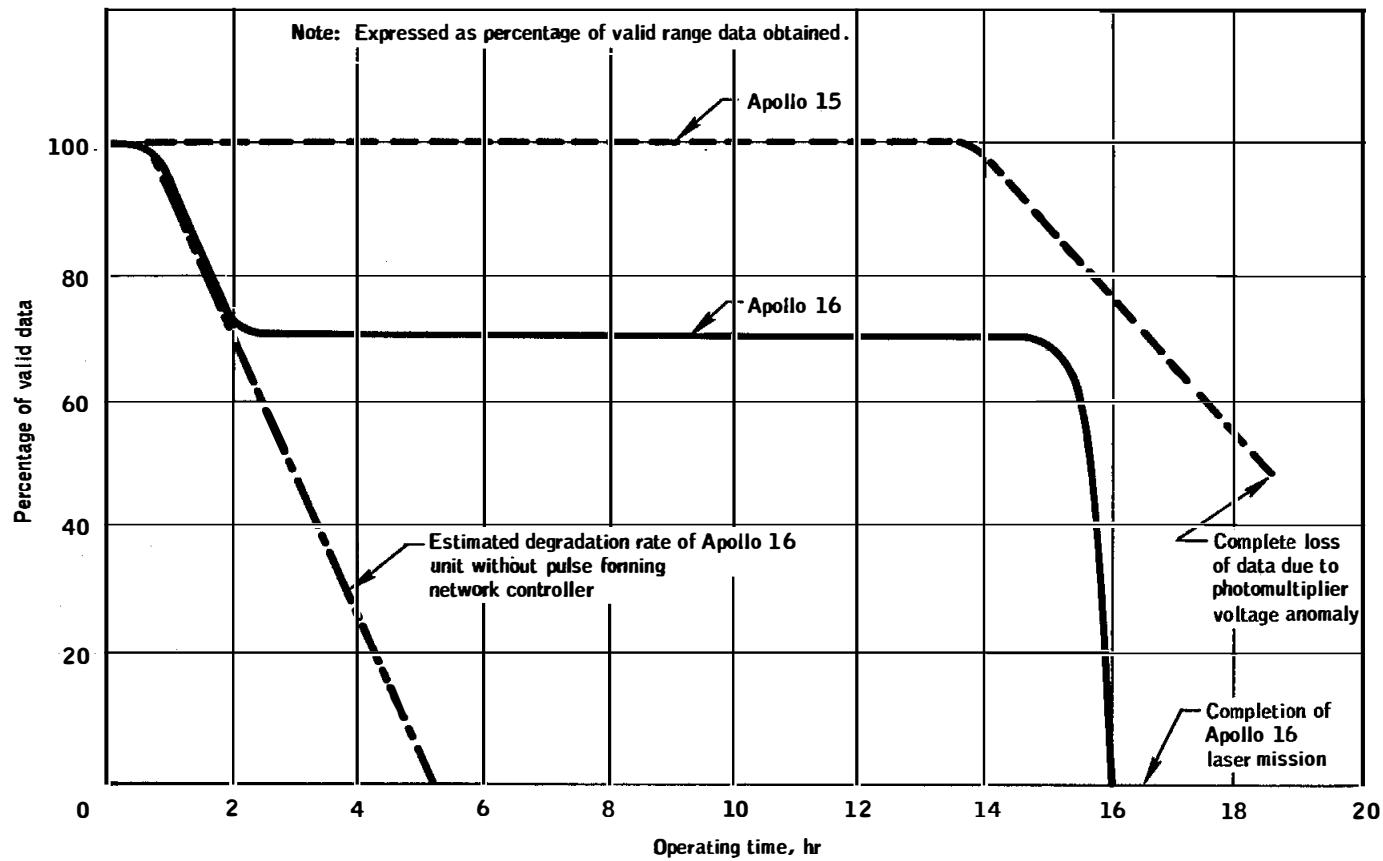
Figure 14-68.- Laser degradation versus operating time.

There were approximately 2400 laser operations (firings) during the mission. The laser output appeared to degrade more rapidly than during the Apollo 15 mission (fig. 14-68) but was compensated by the action of the pulse forming network voltage controller added for this purpose as a result of the Apollo 15 anomaly. The voltage controller consists of a laser power status sensor (photodiode) located inside the laser module and associated circuitry to increase the output of the pulse forming network power supply if the sensed laser power is lower than a pre-established threshold.

Compensation was sufficient until the last 40 minutes of the final scheduled operating period. After this time, laser output was apparently too low for ranging against the sunlit lunar surface. One consequence of the pulse forming network controller operation was some loss of altitude data on alternate laser firings; therefore, data validity was only about 70 percent during most of this mission. Had the controller not been added to this unit, the amount of valid data obtained would have been significantly less. An estimate of the data that would have been obtained is shown in figure 14-68. The controller operates to increase input power to the laser if the laser output on the preceding operation was low, and to decrease input if the output was high. It appears that the threshold may have been low, or the voltage steps too large, so that inadequate output was obtained on the lower step, resulting in loss of altitude data. This was particularly true on illuminated portions of the lunar surface where background radiance decreases receiver sensitivity.

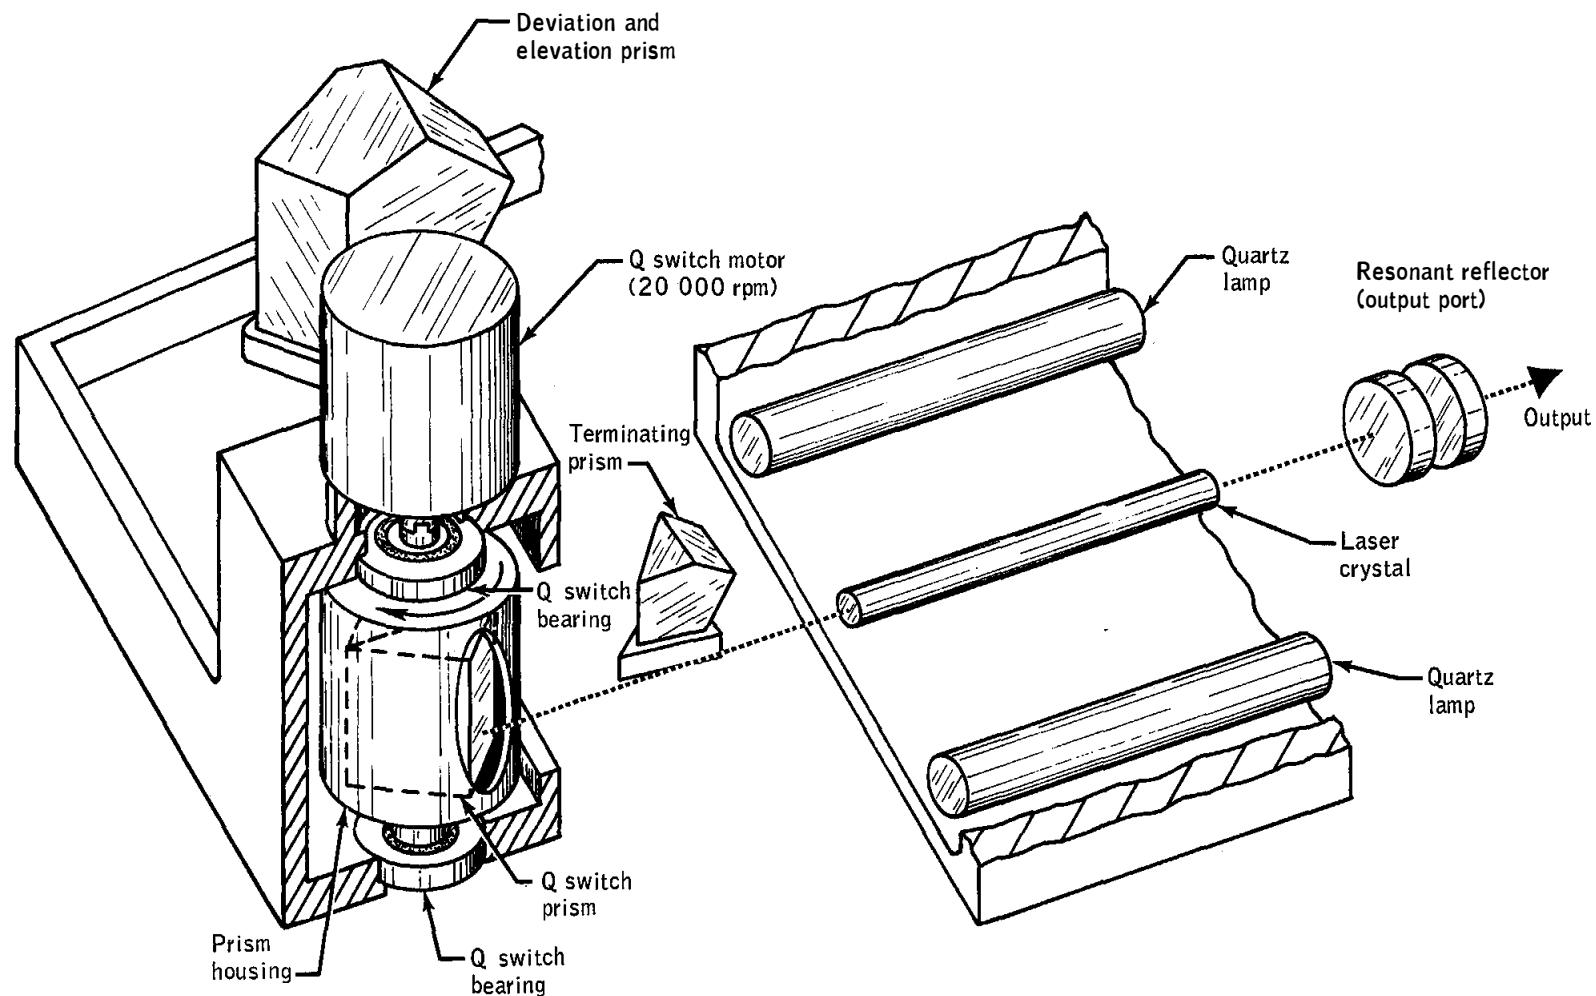
Figure 14-69.- Laser altimeter module light reflection components.

Analysis of the Apollo 15 failure indicated that the most probable cause was contamination of the internal optical surfaces by oil from the Q-switch bearings (fig. 14-69). Consequently, a delta qualification test was performed on a laser module, using new bearings incorporating oil-retainer shields. The qualification test consisted of a 220-hour thermal vacuum test which included a 50.5-hour mission operation timeline. Over 9000 laser firings were performed and the voltage controller had only reached step 4 by the end of the test.

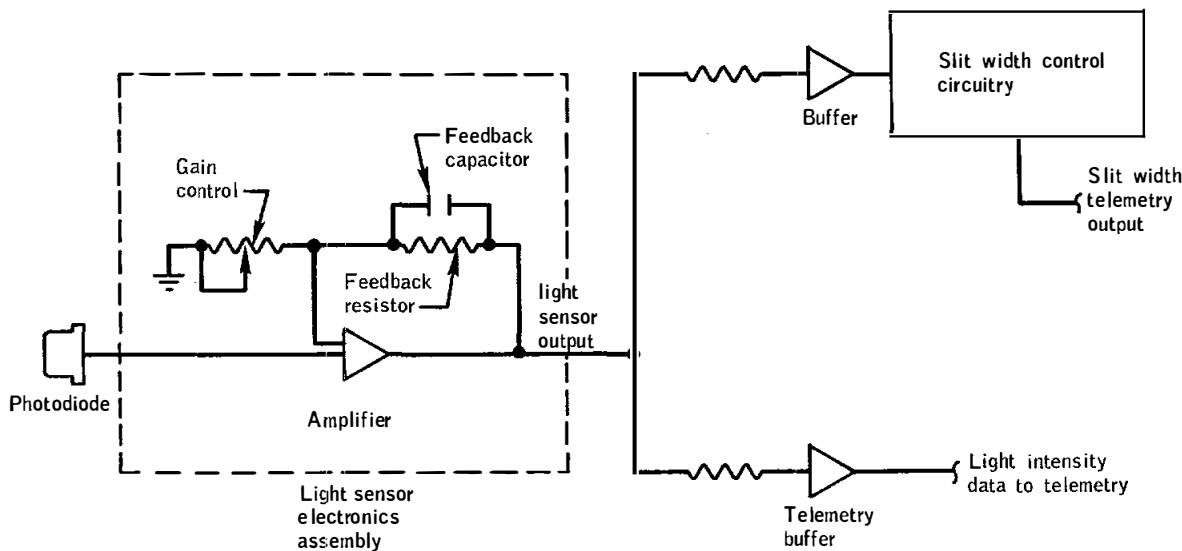
Figure 14-70.- Block diagram of panoramic camera automatic exposure control.

The panoramic camera contains a light sensor and associated circuitry that determines the film exposure. As the scene luminance decreases, the output from the sensor decreases; the resulting signal delivered to the slit width servo causes the exposure slit to widen, thereby automatically increasing the film exposure. The slit width and the light sensor output are both telemetered (fig. 14-70).

Throughout the mission, telemetry indicated that the sensor output was too low, resulting in a slit width that was too wide. Consequently, an overexposure of the film occurred. Based upon preflight brightness calculations and real-time mapping camera exposure data, the degree of overexposure was estimated to be approximately 1-1/2 to 2 f-stops. As a consequence, the film processing was modified to compensate for this degree of overexposure.

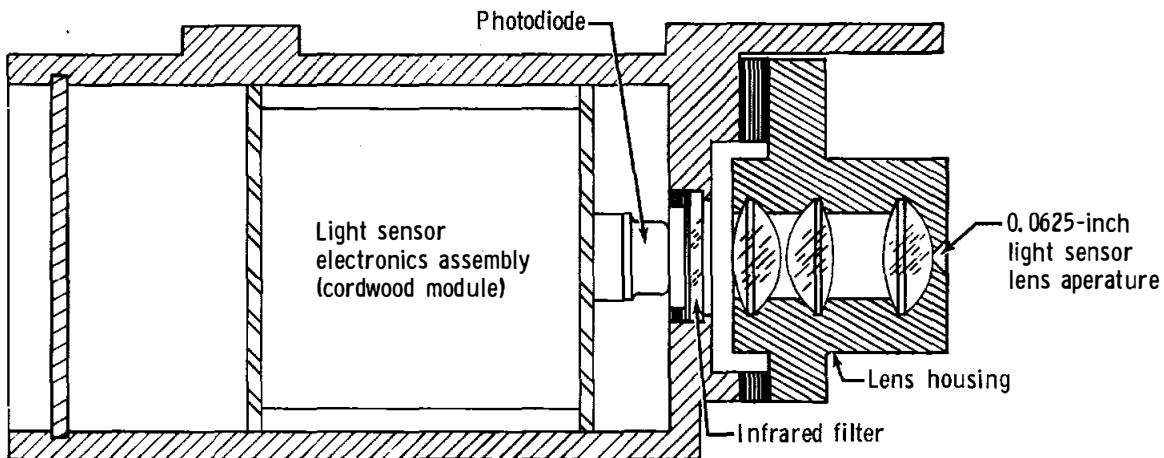
Figure 14-71.- Panoramic camera light sensor assembly.

The problem could have been the result of contamination on the sensor optics or a failure in the light sensor or its associated circuitry (fig. 14-71). Analyses and tests have shown that component open or short circuit failures could not have caused the problem since the amount of overexposure could not be duplicated. Feedback capacitor leakage (equivalent to about 6 megohms leakage resistance), or a decrease in the gain of the photodiode input amplifier (an integrated circuit), or a decrease in photodiode sensitivity, shown in figure 14-70, could have caused the problem. These components, however, have no previous history of these types of failures; therefore, no corrective action will be taken.

A review of data indicates that the problem occurred preflight, at some time between January 5, 1972, and February 25, 1972. The failure was not detected because the test merely ascertained that the light sensor responded to stimulation (a light source placed in front of the sensor). Although sensor output voltage was recorded, no voltage tolerances had been established for the test.

To preclude a similar problem not being detected in ground testing, sensor output voltage limits have been added to the test procedure.

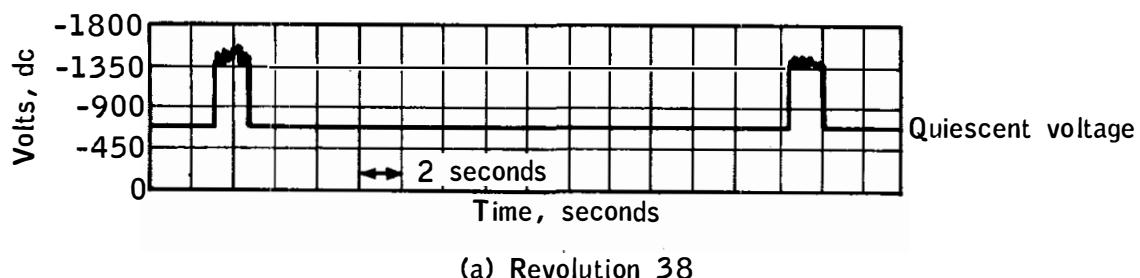
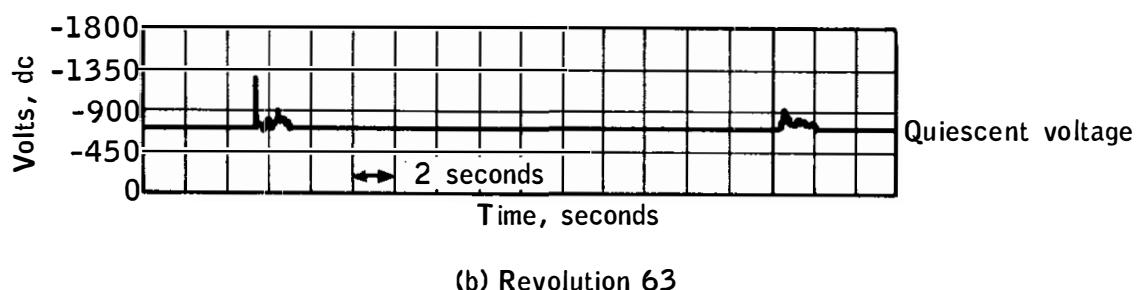
Figure 14-72.-- Laser altimeter photomultiplier voltages.

During the revolution-60 operation of the laser altimeter, the high voltage supply for the photomultiplier tube was occasionally erratic. During the next operating period (revolution 63) the erratic behavior became more pronounced (fig. 14-72), and there were several instances when the voltage failed to rise from the quiescent (idling) level.

The photomultiplier tube power supply idles at approximately minus 700 volts during the periods between laser firings. About three-fourths of a second before the laser fires, the power supply is commanded to increase its voltage to the value required for proper photomultiplier tube operation. This value is determined by automatic gain control circuitry (fig. 14-73) that senses the background illumination from the lunar surface. As a result of the automatic gain control action, the photomultiplier tube voltage varies during the mission and appears somewhat noisy, as evidenced by the normal trace (revolution 38) shown in figure 14-72. The revolution-63 trace is unusually erratic, however, and failure to rise from the quiescent level is indicative of anomalous operation.

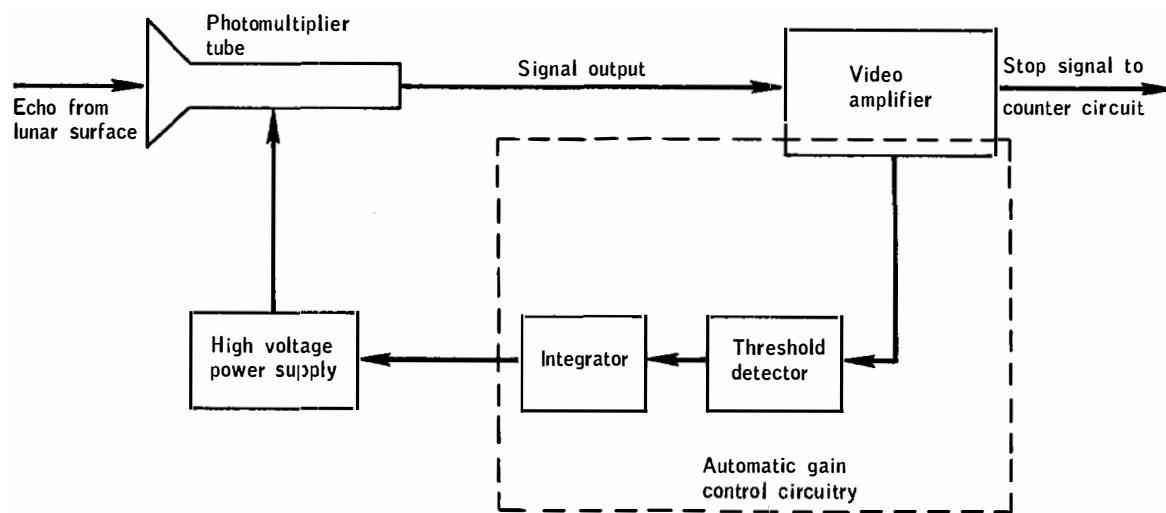
Figure 14-73.-- Laser receiver circuitry.

Some of the anomalous voltages which occurred during revolution 60 were probably caused by sunlight reflecting off the deployed spectrometers. Although the spectrometers were not in the field of view of the altimeter receiver optics, reflections from the spectrometers may have been reflecting from the altimeter's gold-plated lens barrel and, thence, into the photomultiplier tube, thereby unduly affecting the automatic gain control action. This does not, however, explain the revolution-63 performance, because the mass spectrometer had been jettisoned and the gamma-ray spectrometer was not deployed.

A number of intermittent conditions are possible that could either increase the gain of the photomultiplier amplifier or couple electrical noise into the amplifier's input. Either of these occurrences could cause the effects observed in the data. An intermittent condition could have been caused by the cyclic thermal environment that occurs as a result of lunar orbit operation. Since qualification test results and acceptance tests are considered to be adequate for this equipment, no corrective action will be taken.

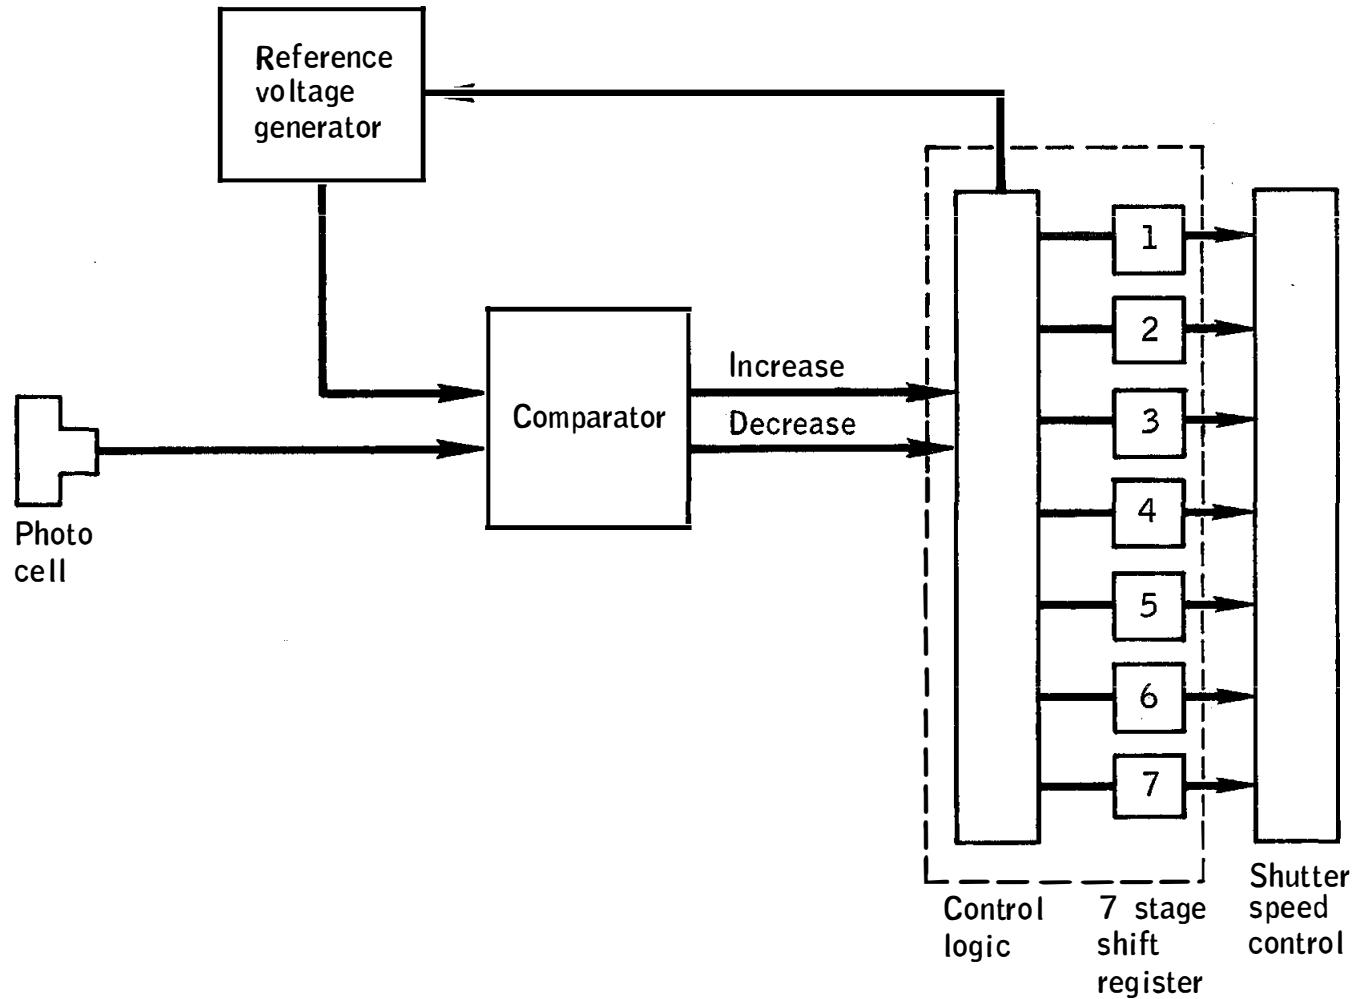
Figure 14-74.- Photocell servosystem.

Shutter speed is controlled by a photo cell which senses the light level in the camera's field of view. The photocell operates in a servo system which controls shutter speed. The photocell servo system consists of the photocell, a comparator, a voltage reference, and a seven-stage shift register, as shown in figure 14-74.

Noise voltage pulses can set or reset (turn on or off) any stage in the register regardless of the condition of any other stage. Thus, more than one stage could be on at the same time, and, in this condition, when the first clocking pulse occurs, the logic would turn stage five on and all other stages off. The remaining five clocking pulses then could still shift to the on stage required by the light level seen by the photocell and no anomalous operation would result. Should the noise pulse occur during the clocking cycle, however, there may not be enough clocking pulses left to shift the on condition back to the required stage. Since the effect of the noise pulse is to shift the on condition to stage five, slow shutter speed and overexposure can be expected to occur more often than fast shutter speed and underexposure.

Noise voltage on the power supplied to the register or generated by some intermittent condition in the camera must have switched one or more stages in the shift register on or off. The camera qualification test results and acceptance tests are adequate. No corrective action is necessary.

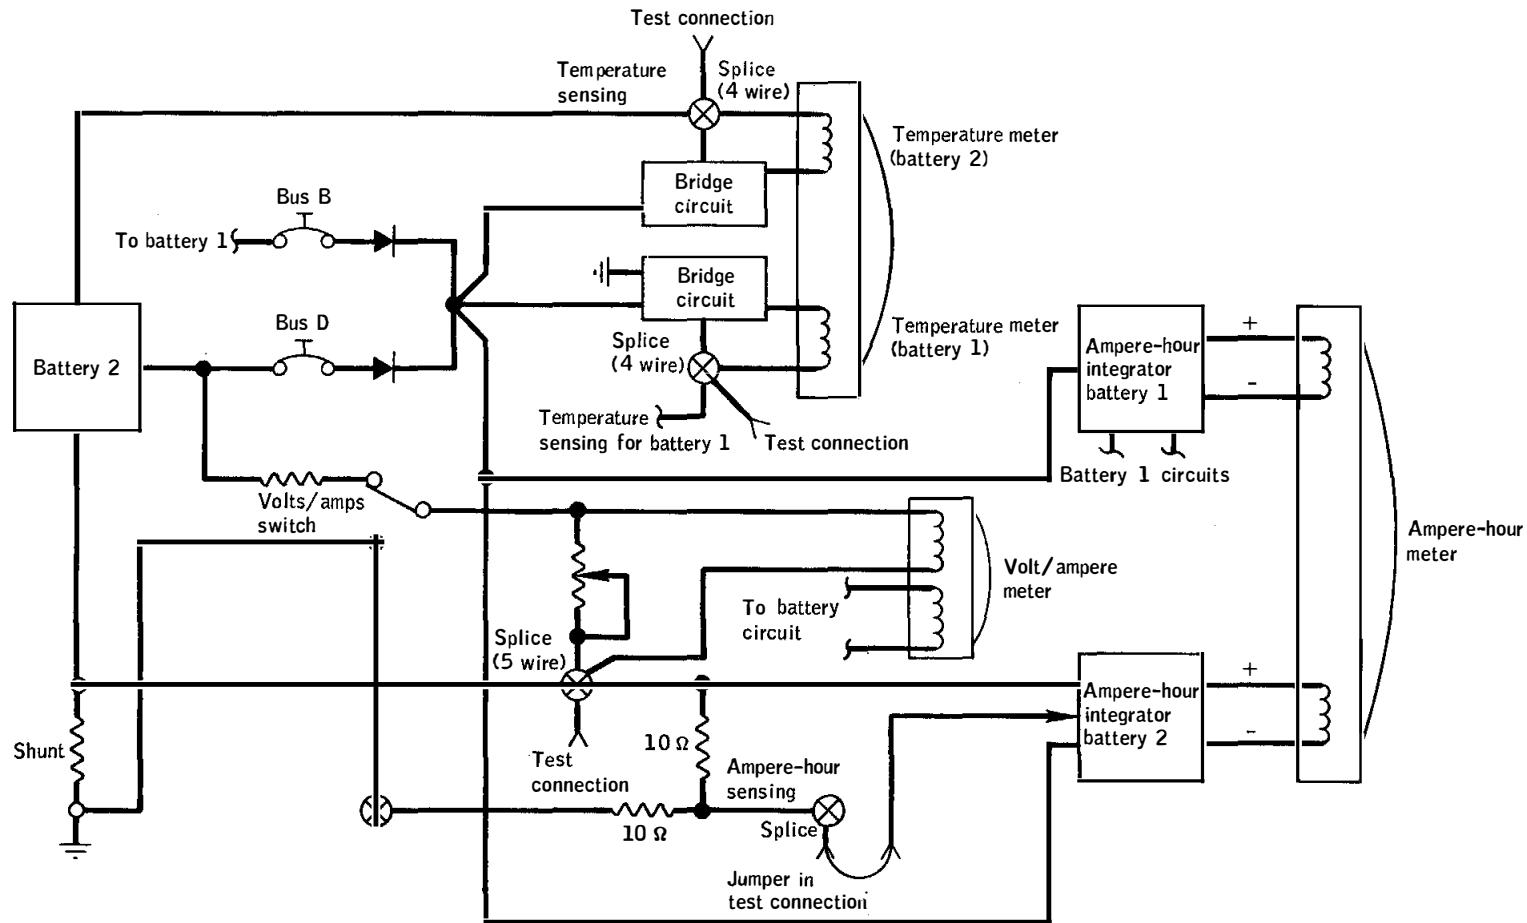
Figure 14-76.—Lunar roving vehicle electrical meter circuitry.

The circuitry associated with the electrical system meters is shown in figure 14-76. Note the multiple wire-crimp splices in the system. The return for the volt/ampere meter is connected to the battery return with a five-wire crimp splice containing one 12-gage wire, one 20-gage wire, and three 22-gage wires. This splice was associated with the electrical modification made on the Apollo 16 lunar roving vehicle at the launch site. An intermittent connection at this splice would explain the volt meter reading off-scale low and then later reading properly. An open connection at this splice would reverse the polarity on the ampere-hour integrator sense line and give a false indication of battery 2 charging as observed during the second and third extravehicular activities (see fig. 14-77). Also, the battery 1 ampere-hour meter indicated a 20-ampere-hour decrease rate which was greater than predicted. However, a review of the data shows that the current readings taken during this period of time were correct and a 20-ampere load was present. Therefore, the ampere-hour integrator for battery 1 was working properly.

Both battery temperatures reading off-scale low and then reading properly could be caused by an intermittent connection at the four-wire splice (fig. 14-76). However, this would require a simultaneous open circuit at two splices initially, which later corrected themselves, and finally, failure of a single splice in the battery 1 temperature circuit.

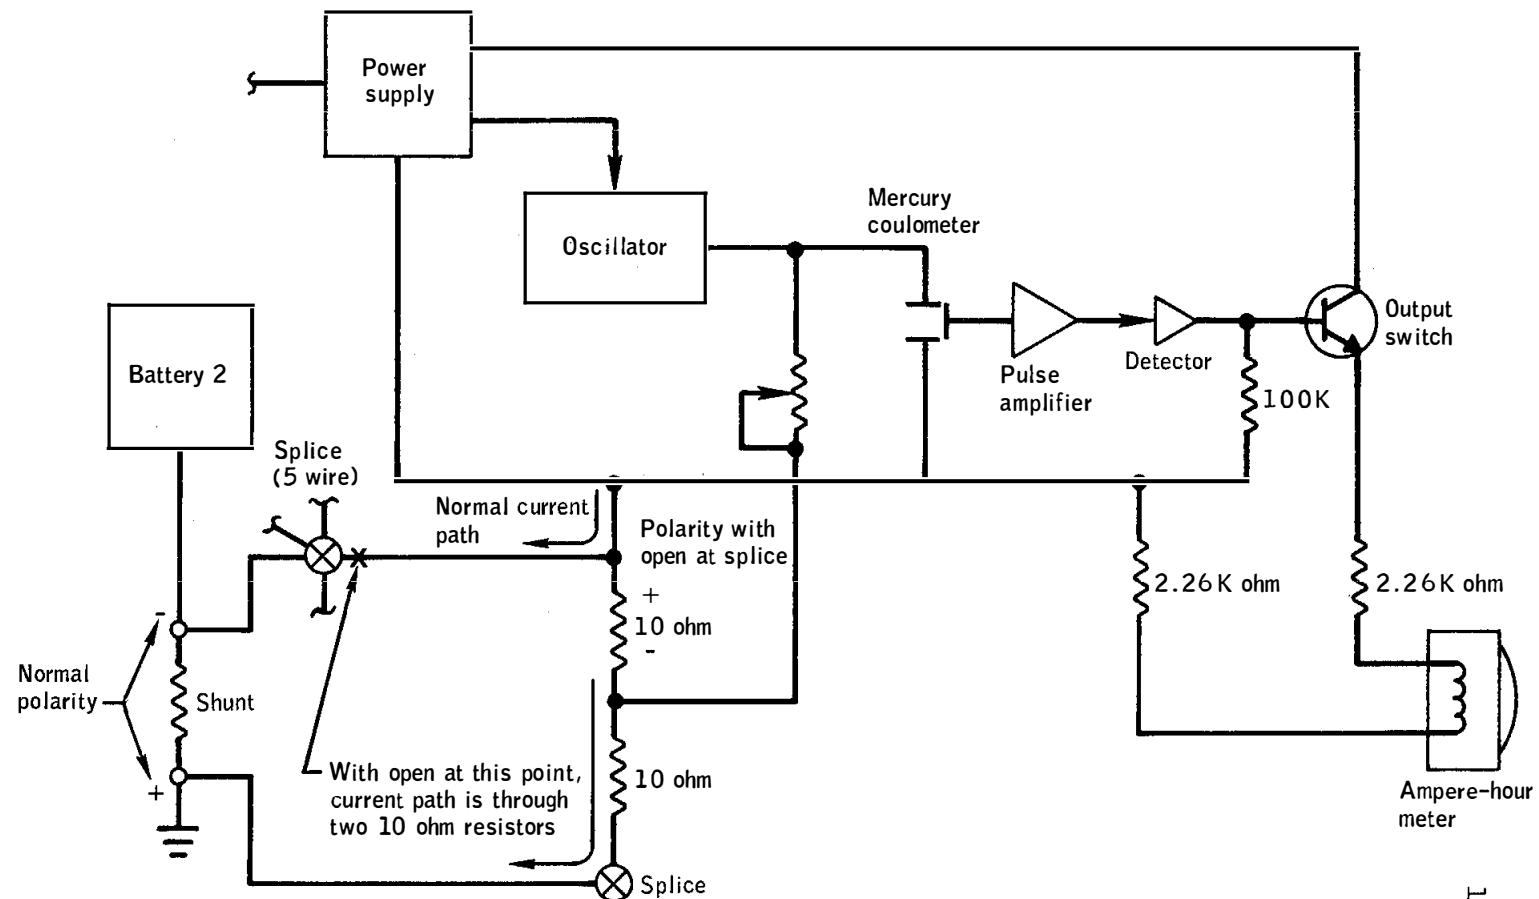
Figure 14-77.- Battery 2 ampere-hour integrator circuit.

ampere-hour integrator reading full-scale, unless a sneak circuit existed. This sneak circuit must result from an open circuit at the five-wire splice in the battery 2 volt and ampere-hour meter circuit.

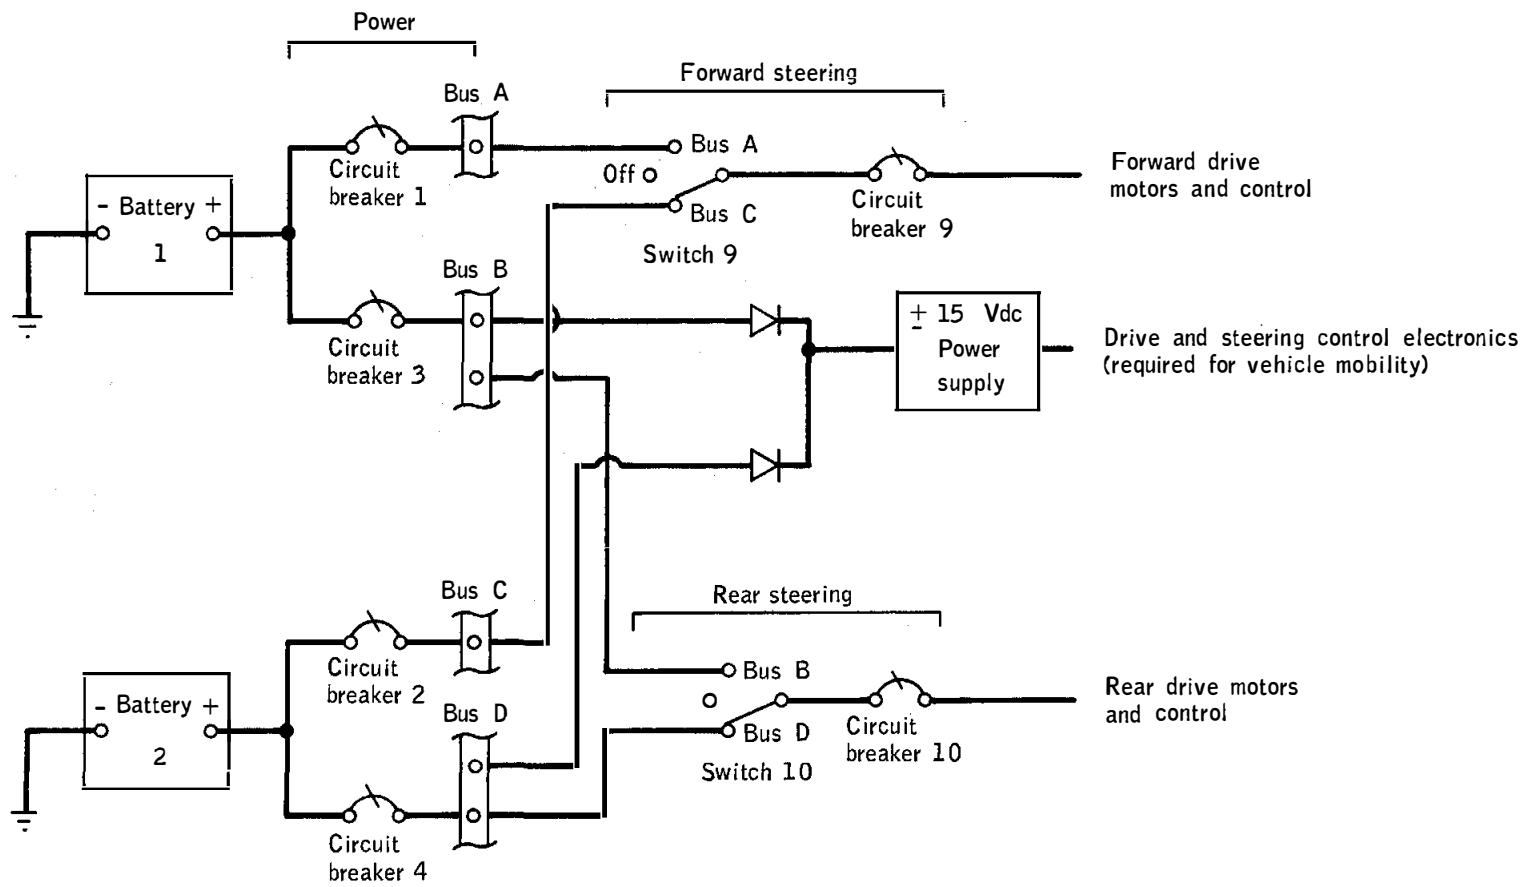
Figure 14-78.- Lunar roving vehicle steering power schematic.

Figure 14-78 shows that switch 10, circuit breaker 10, and circuit breakers 3 or 4 must be closed to provide power to the rear steering system. In addition, circuit breakers 3 or 4 must be closed to provide  $\pm 15$  Vdc for the drive as well as steering control electronics. Since the vehicle had both mobility and forward steering, at least one of these breakers made contact. Switch 10 was cycled after vehicle motion; however, the rear steering remained inoperative. Circuit breaker 10 could possibly have been open due to some contaminant existing in the breaker.

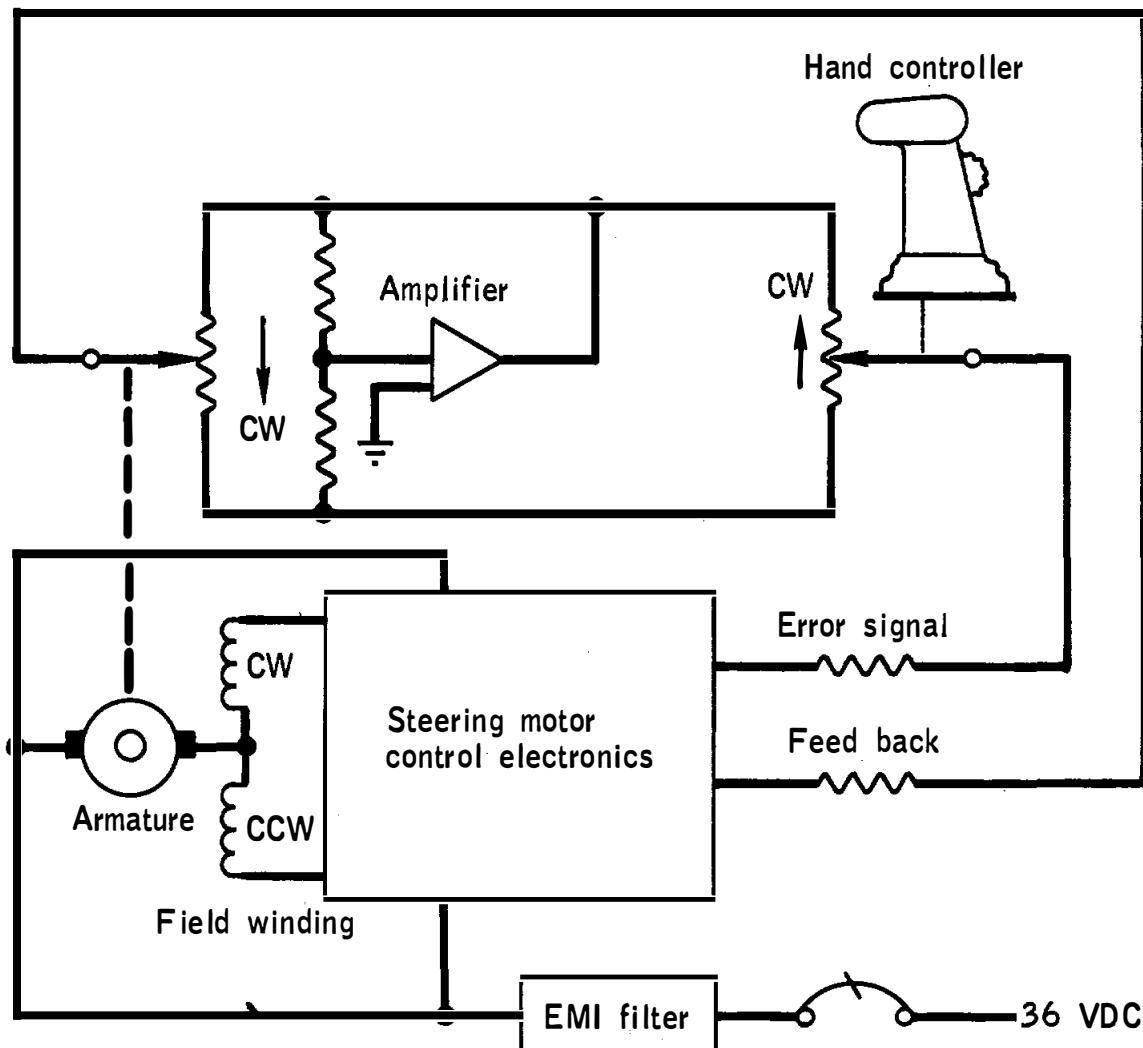
Figure 14-79.- Steering system electrical.

Another possible cause of the anomalous condition is in the steering servo system (fig. 14-79). A signal generated by the hand controller is coupled to the input servo amplifier as an error signal across a bridge. This signal is amplified and applied to the steering motor field coils in a direction determined by the polarity of the input signal which depends upon the direction of the hand controller deflection. The feedback potentiometer is driven by the steering motor in a direction to balance the bridge, thus cancelling the original error signal. A non-conductive lubricant (DC 40), is applied to the wiper and resistive element of the potentiometers to produce smooth operation and reduce noise. At low temperatures, this lubricant could become more viscous and insulate the wiper

from the resistive element. No error signal would then be present at the input to the servo amplifier, although the hand controller was deflected. As the steering electronics heat up, the lubricant becomes less viscous. Exercising the hand controller then cleans the lubricant from the wiper and resistive element, allowing contact to be made. This would account for the anomalous condition. Tests will be conducted to determine the effect of the lubricant on the potentiometers at low temperatures.

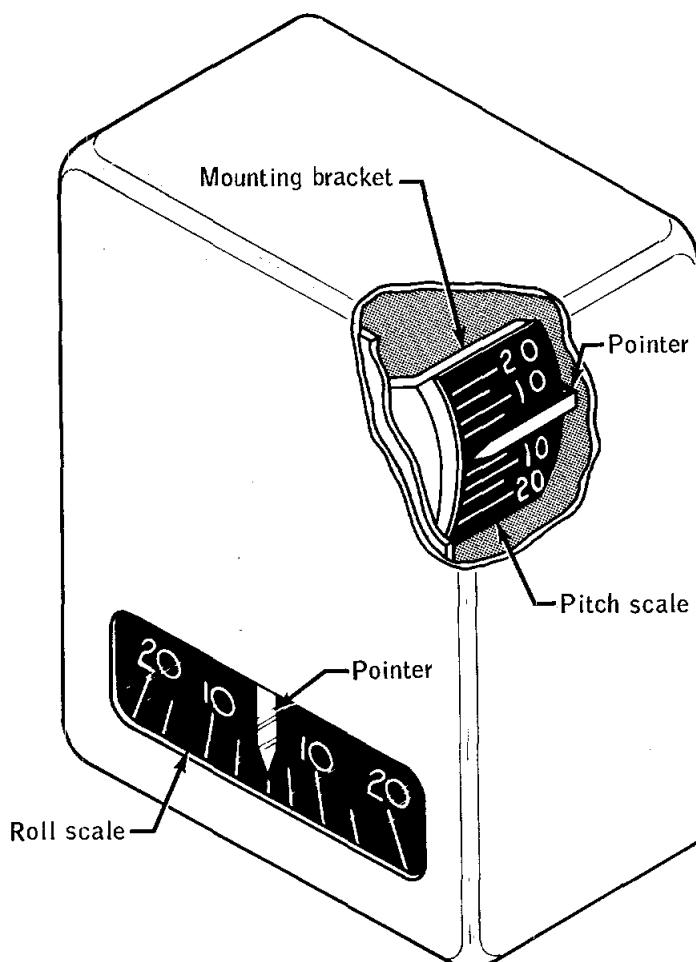
Figure 14-81.- Pitch attitude indicator.

During the second extravehicular activity, the crew reported that the lunar roving vehicle pitch attitude indicator scale had fallen off. The indicator provides a vehicle pitch reference between plus and minus 20 degrees. The loose pitch scale did not impact the mission because the pointer for the indicator continued to work properly and the crew could adequately estimate the vehicle pitch from the pointer position.

The pitch attitude indicator scale is bonded to a bracket (fig. 14-81) which is attached to the indicator case. The scale is constructed of 2024T3

aluminum and the bracket is 6/6 nylon. A comparison of the coefficients of thermal expansion of the materials indicate approximately a 4-to-1 ratio for nylon-to-aluminum. With this expansion ratio, stress factors of safety for an ideal bond are 3 and 4 at temperatures of minus 100° F and plus 250° F, respectively. Although a review of the bonding procedures did not reveal any problems, a flaw most probably existed in the bond and this allowed stress buildup which caused the scale to become unbonded. The crew experienced no difficulty in estimating the pitch angle after the scale became unbonded. The back of the meter case must be machined off to gain access to the scale, and special handling permits must be obtained before working on the meter because of the radioactive materials within the case. For these reasons, no hardware changes will be made for Apollo 17.
