STS-4 GNC Postflight Report

The enclosed STS-4 GNC postflight report is limited in scope to analysis of systems anomalies and discussion of topics which we believe need attention.

TABLE OF CONTENTS

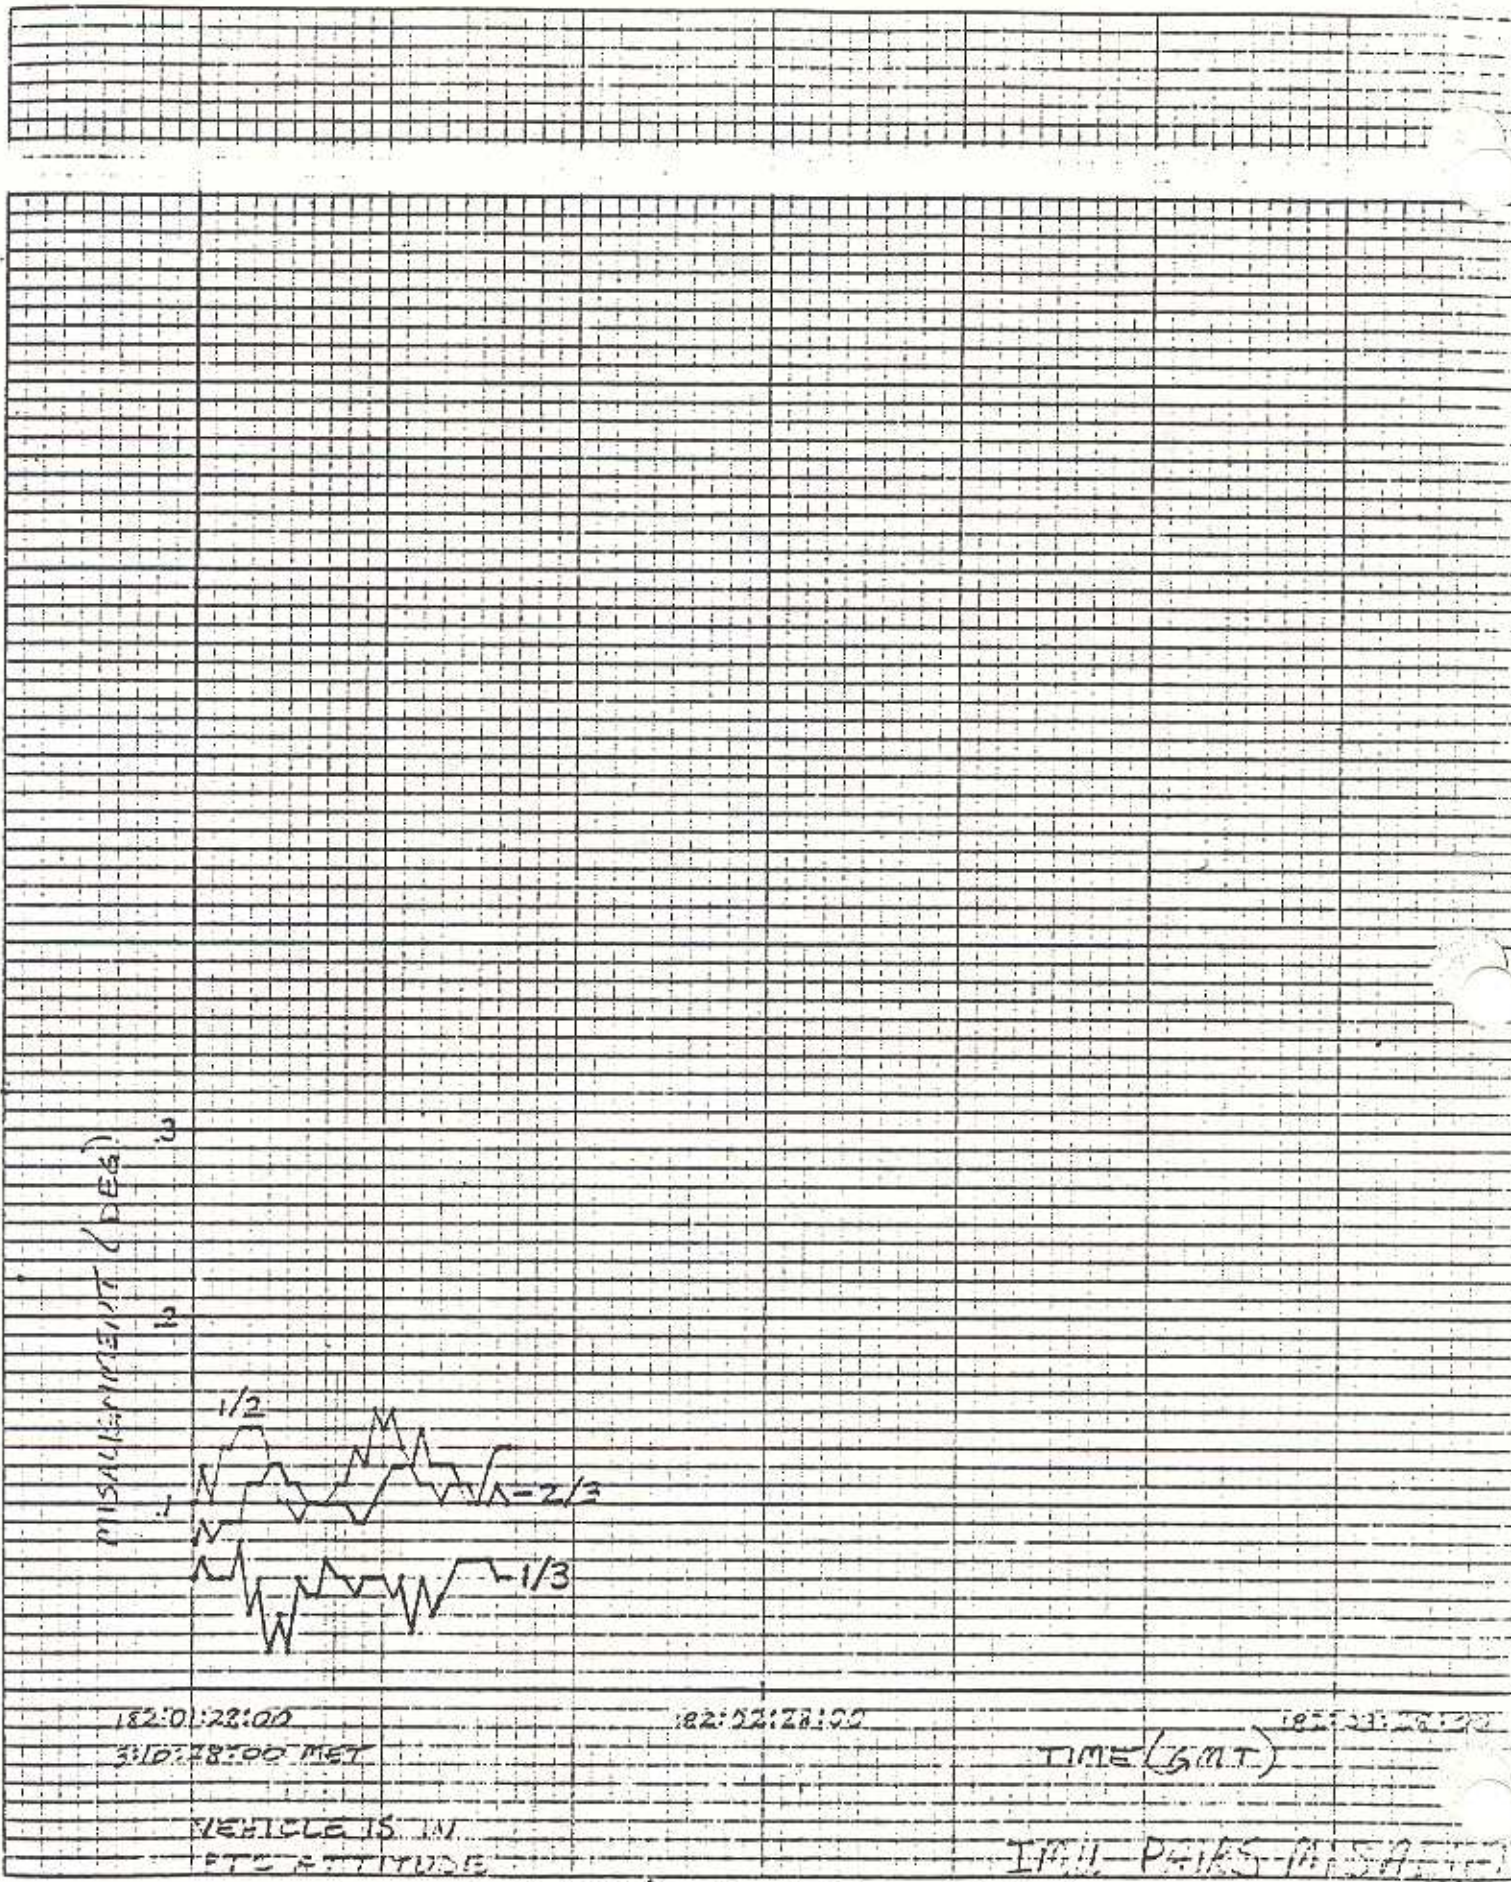
FIG 2.1.3

Conclusion and Recommendations - Although there is a wide disparity of opinion concerning the variations in torquing angles. We believe that they are caused by errors in the IMU resolver reads of the gimbals angles. This is substantiated by the enclosed plots which show a sinusoidal behavior of the IMU attitude differences (figures 2.1.1, 2.1.2, 2.1.3) during a period on STS-2 where the vehicle was flying a -ZLV attitude. The period of the oscillations match the orbital period (90 min), which says that as the gimbals rotate with the vehicle, a non-linear attitude is output by the IMUs. This type of behavior will cause the variations we see in the torquing angles. Also enclosed is 30 minutes of data (figure 2.1.4) during a PTC period of STS-4. Although there is not enough data to be conclusive, the same sinusoidal behavior is suggested. Because of these variations in torquing angles and the sinusoidal nature of the attitude outputs, we are considering a recommendation to E&D that the IMUs on OV-102 be tested in the JSC ISL lab. Since OV-102 will be down for mods, this will be an excellent opportunity to try to correlate ground testing with the type of behavior observed during the five flights.

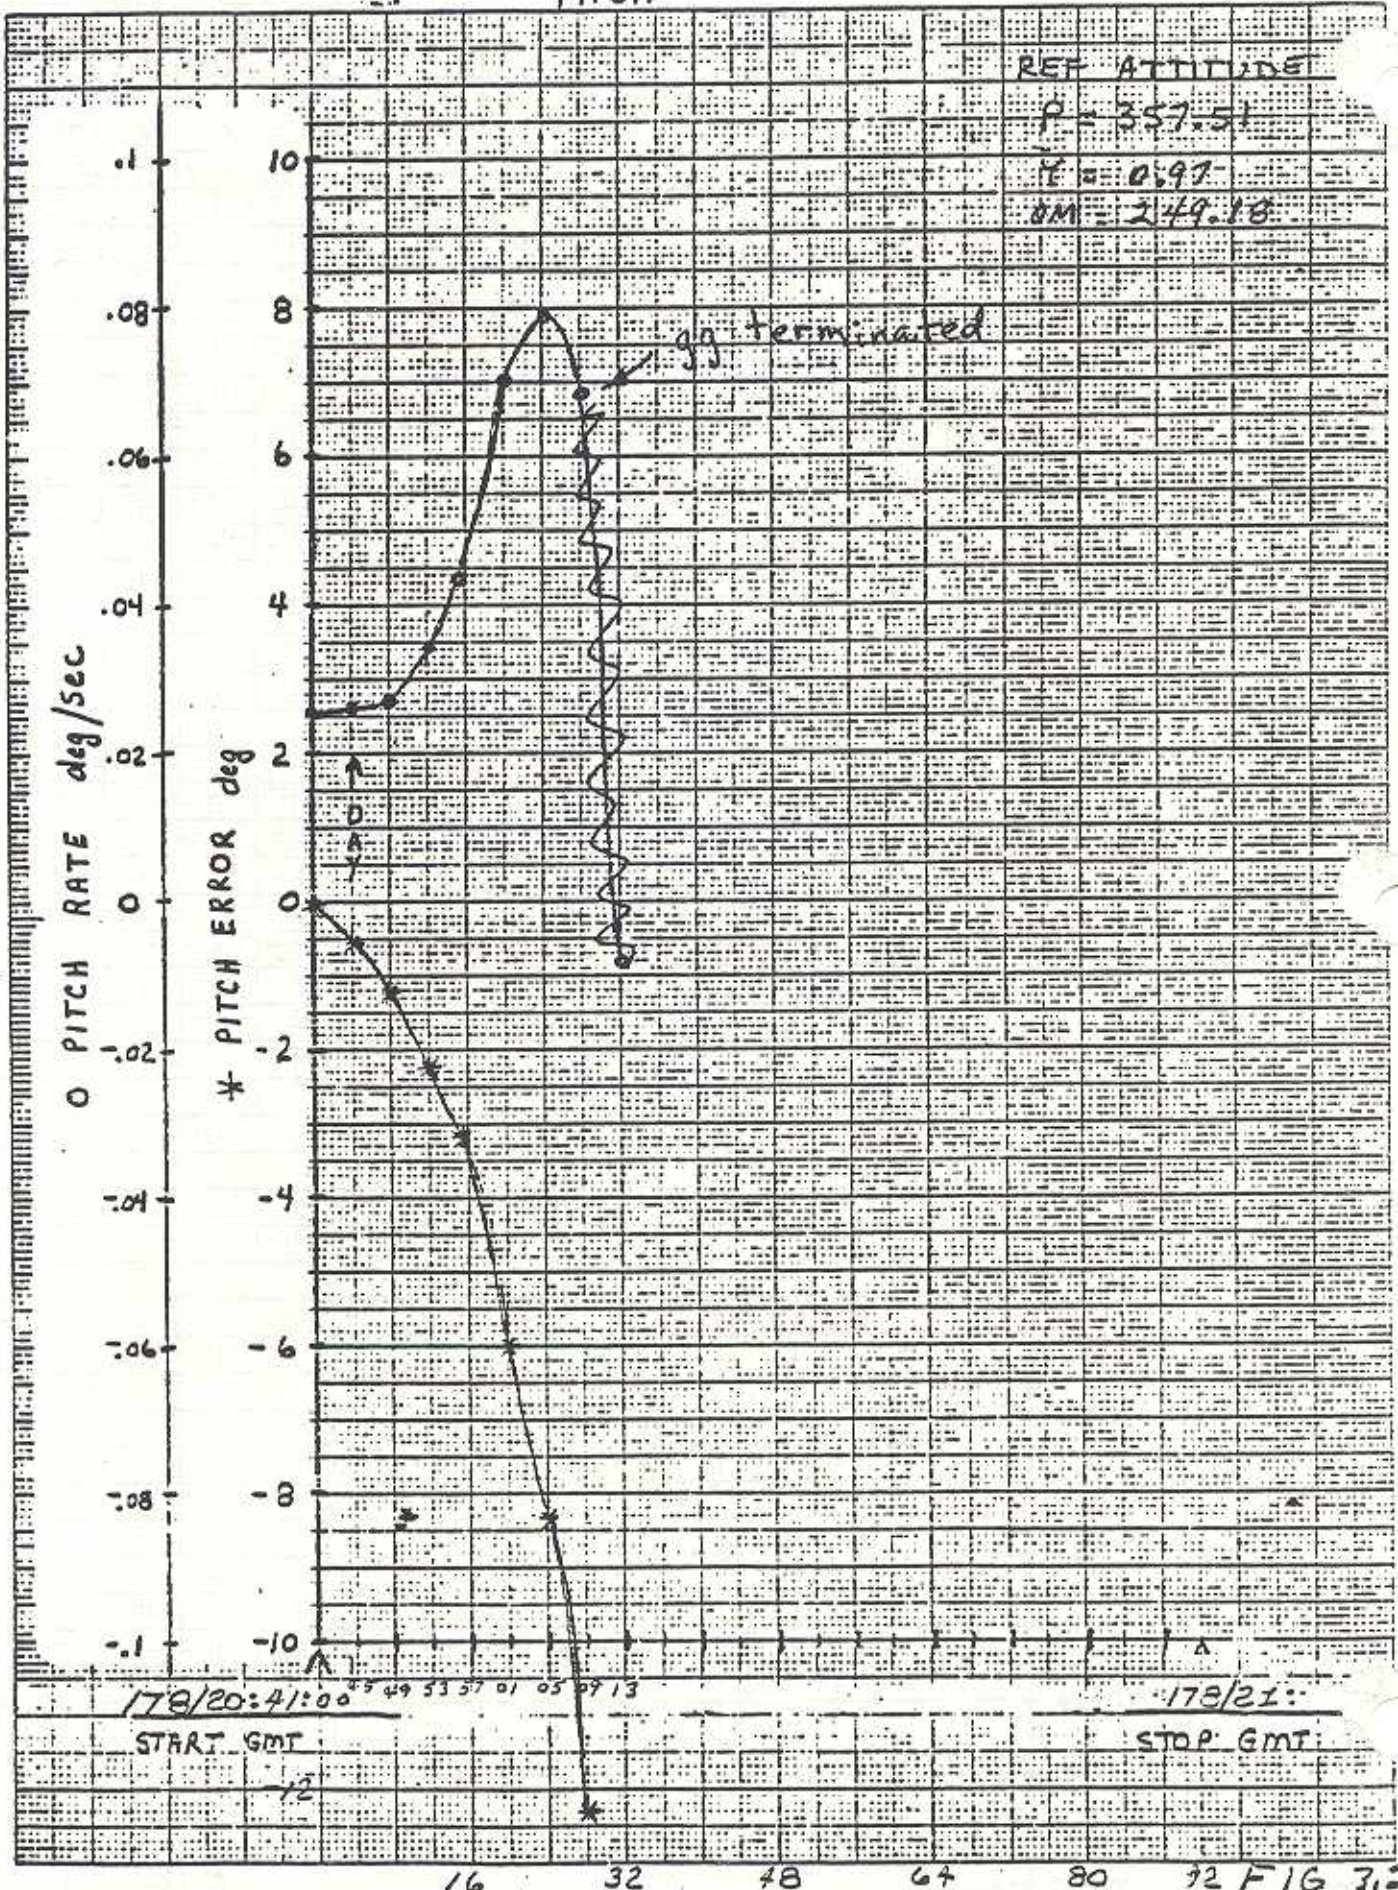
FIG 3.1

3.1.1 Day One - The day one gravity gradient (gg) test was started at 178:20:41:00 at a pitch, yaw, omicron of 357.51, 0.97, and 249.18 degrees respectively. This test was unsuccessful. There were unknown forces much greater than gravity gradient forces acting on the vehicle and all three axes were divergent. The initial attempt was terminated at 178:21:10:00 with maximum attitude errors in roll, pitch, yaw of 117 degrees, -13.6 degrees, and 18.9 degrees respectively. The maximum rate errors seen in roll, pitch, yaw were -0.196 degree/sec., 0.055 degree/sec., and 0.085 degree/sec respectively. (See figures 3.1, 3.2, 3.3).

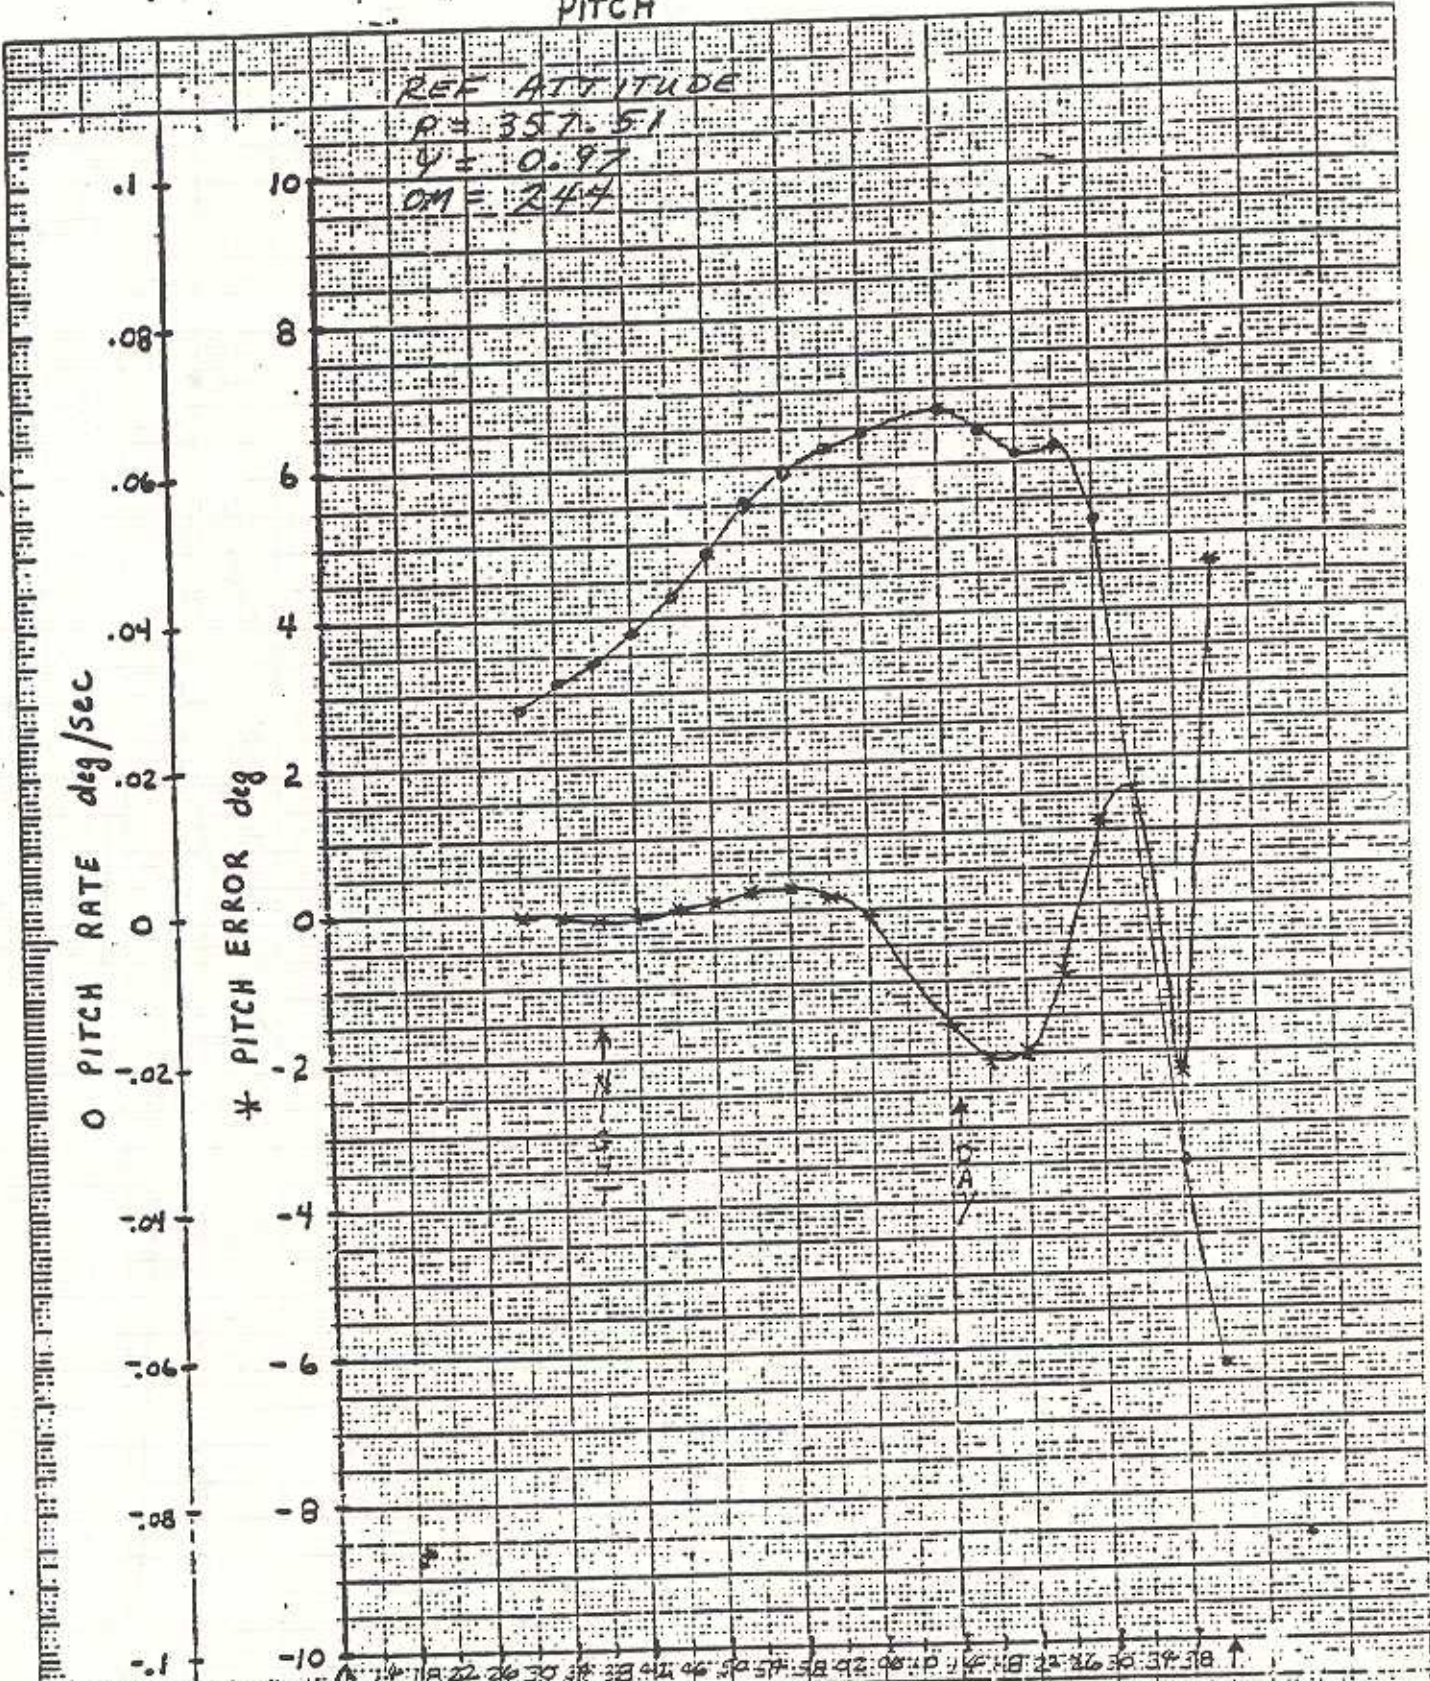
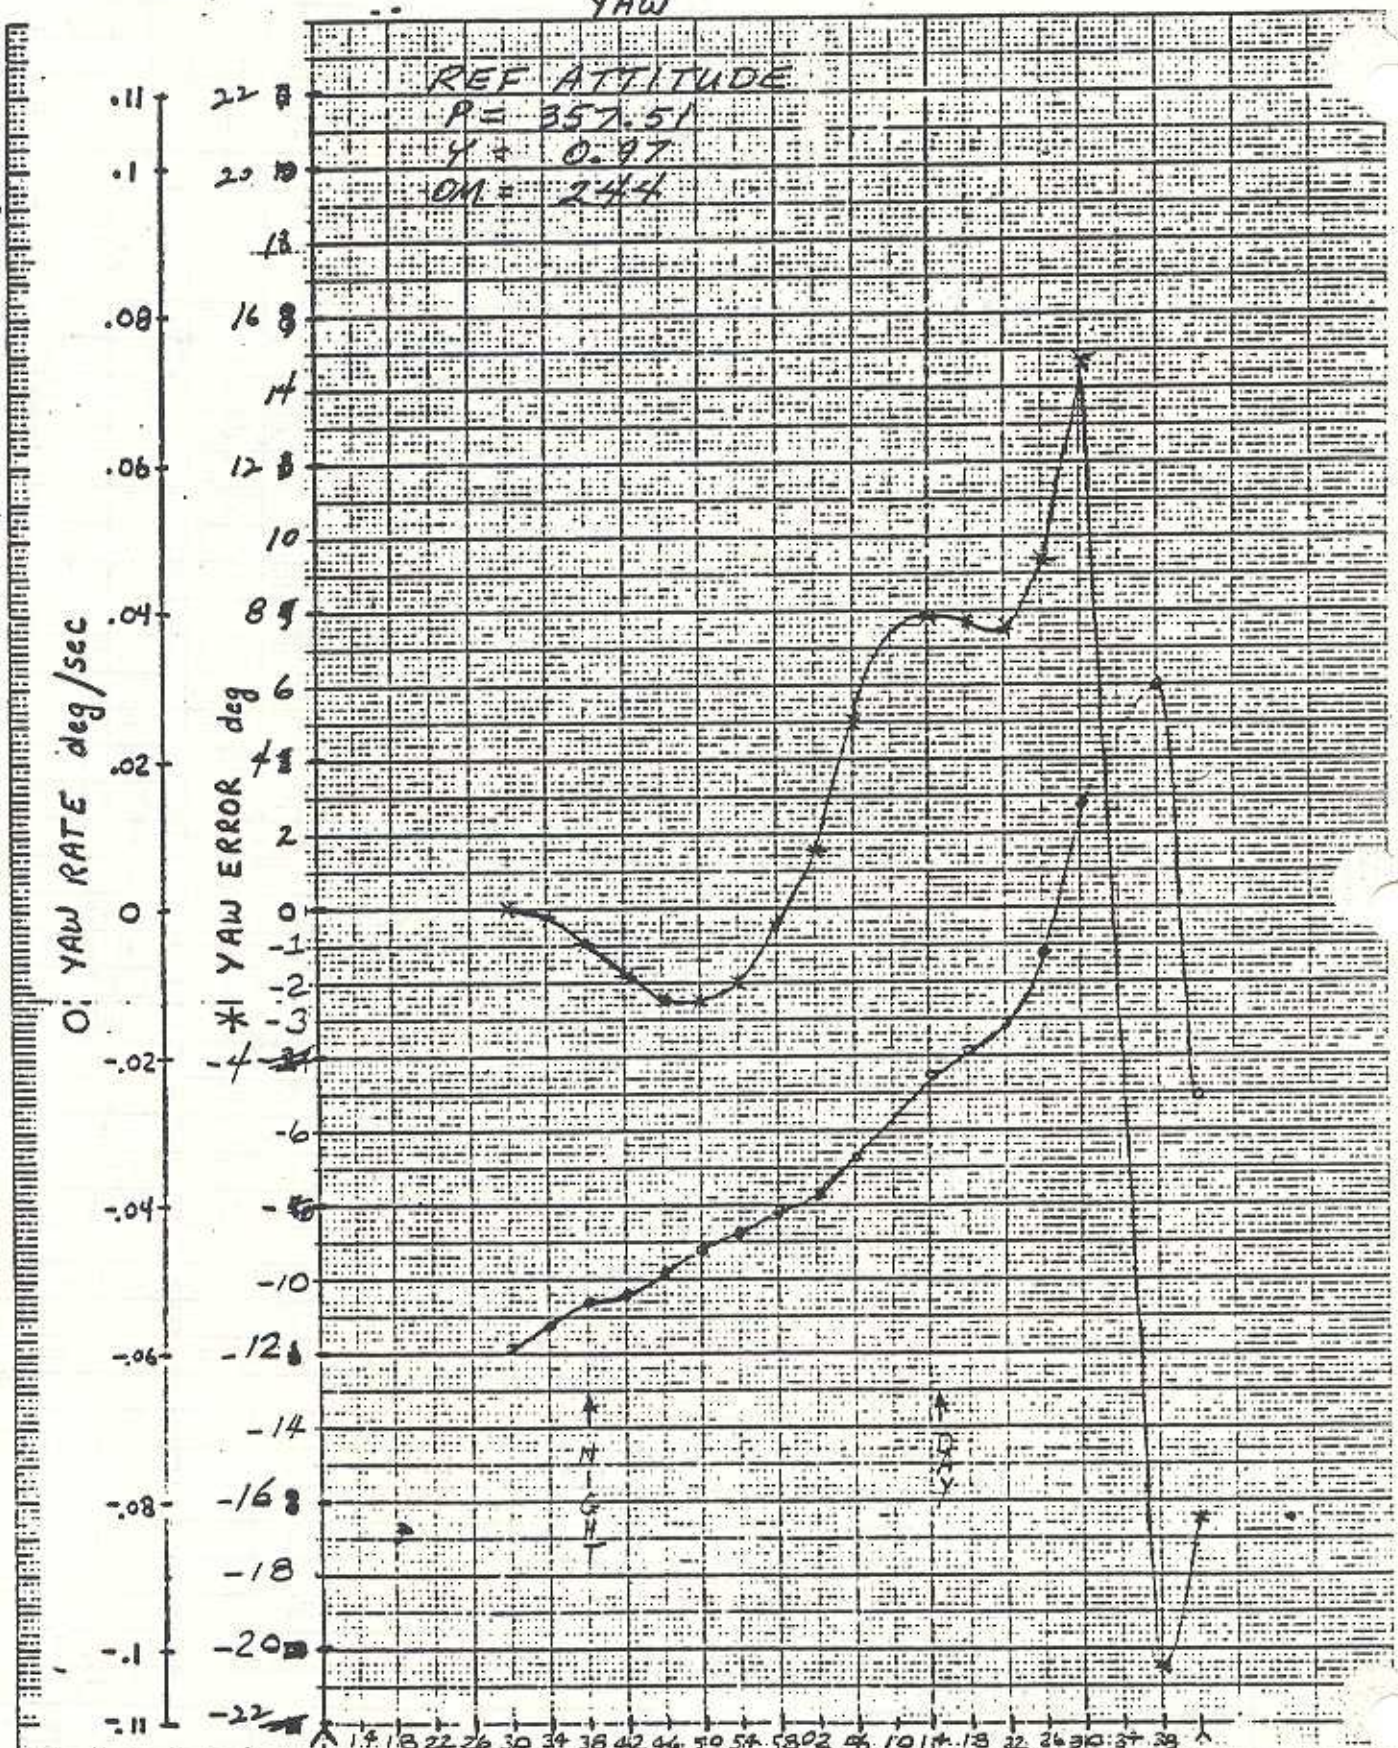
A restart of gg was performed at 178:21:29:00 with a change in omicron to 244 degrees and leaving pitch and yaw the same at 357.51 and 0.97 respectively. The omicron change was based on the orbit being 161 n miles versus 165 n miles. This attempt was somewhat more stable in pitch and yaw for the first 50 minutes before the same magnitude of force caused a divergent condition. Roll on this second attempt still was not acting stable as it had drifted off 40 degrees in the first 50 minutes before the divergent condition was apparent. This second attempt was terminated at 178:22:42:00 with maximum attitude errors in roll, pitch, yaw of 262 degrees, 4.6 degrees, and -20.7 degrees respectively. The maximum rate error seen in roll, pitch, yaw were -0.279 degrees/sec., -0.087 degrees/sec., and 0.099 degrees/sec., (see figures 3.4, 3.5, 3.6).
