STS-4 GNC Postflight Report

The enclosed STS-4 GNC postflight report is limited in scope to analysis of systems anomalies and discussion of topics which we believe need attention.

TABLE OF CONTENTS

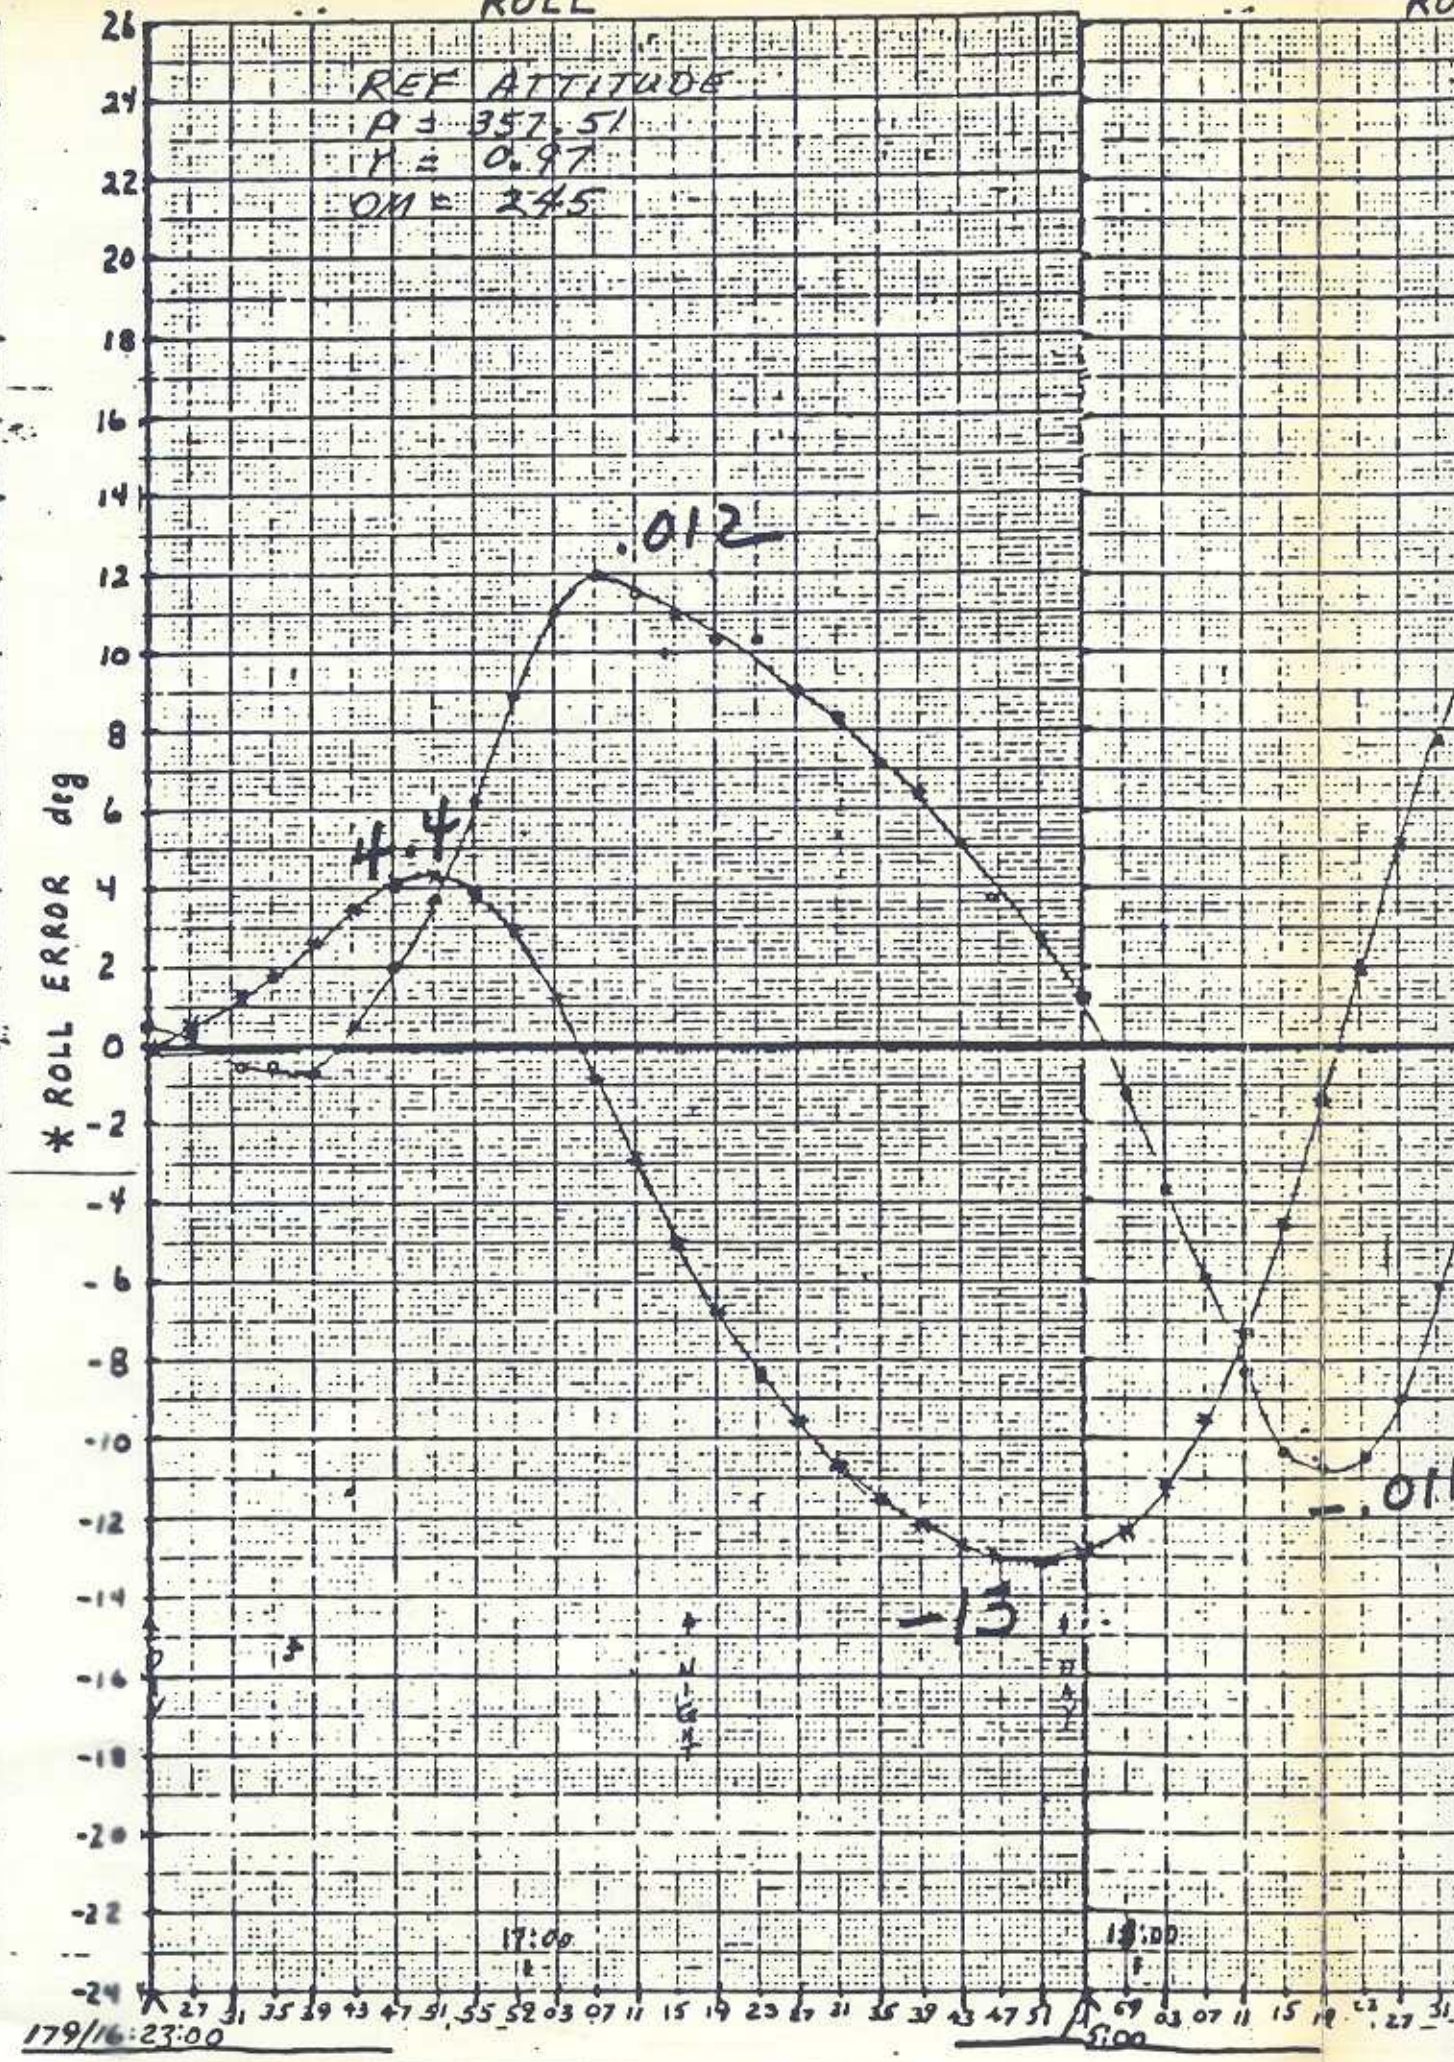
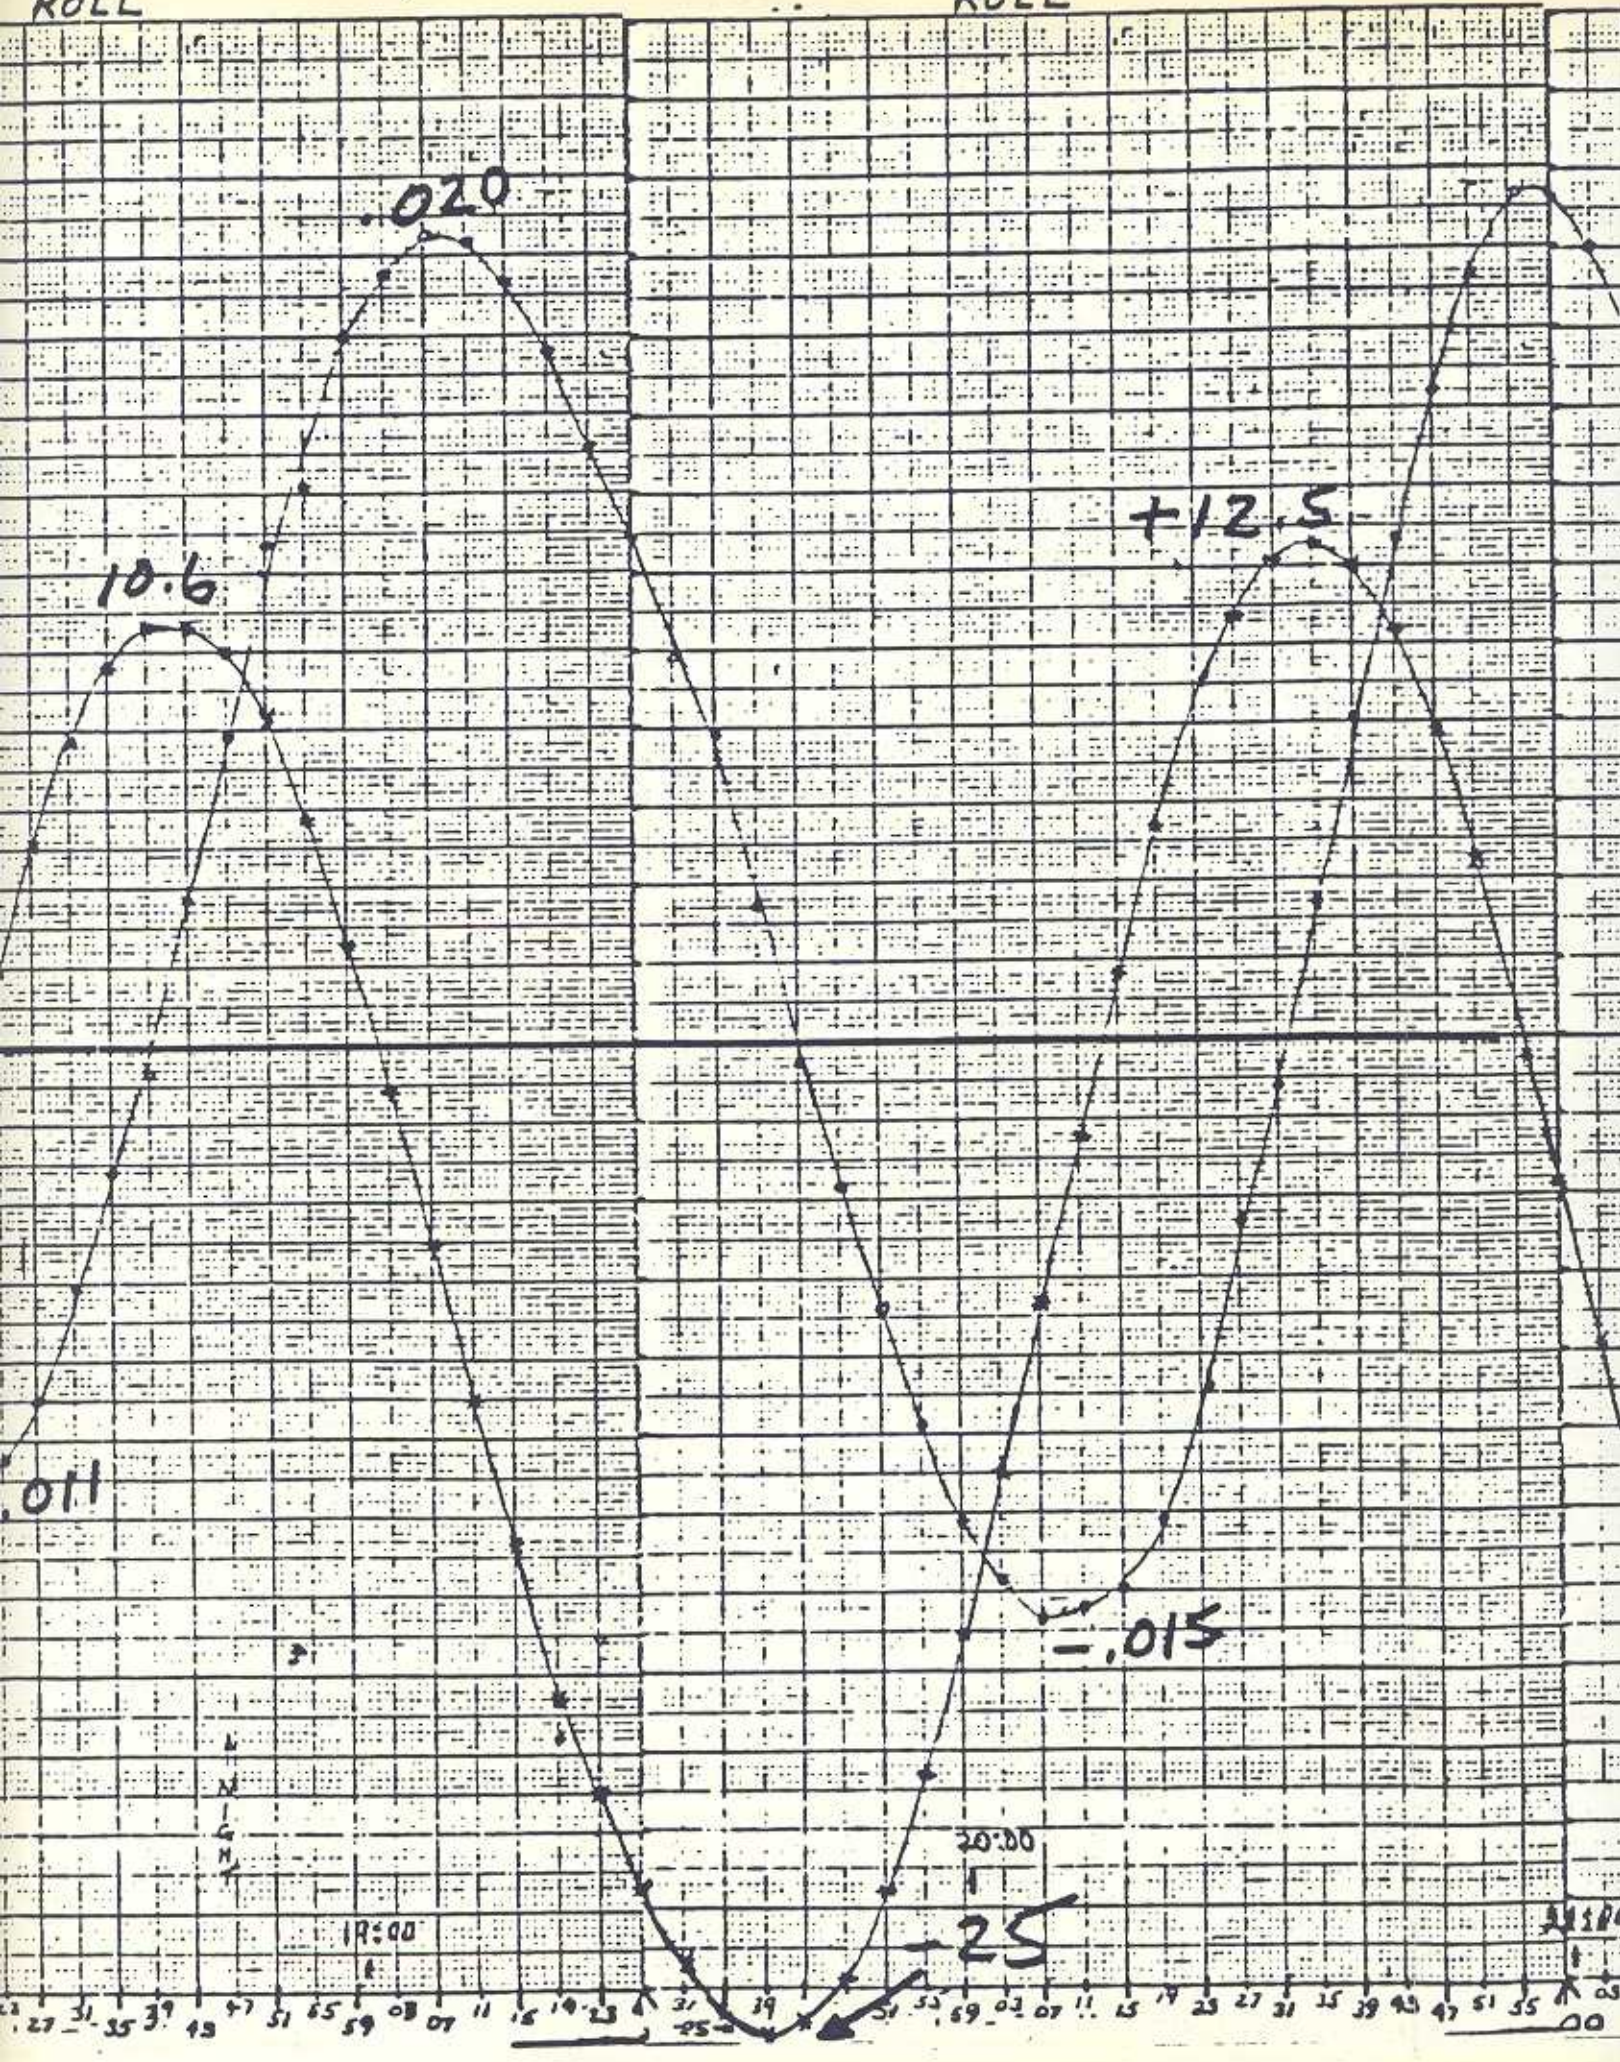
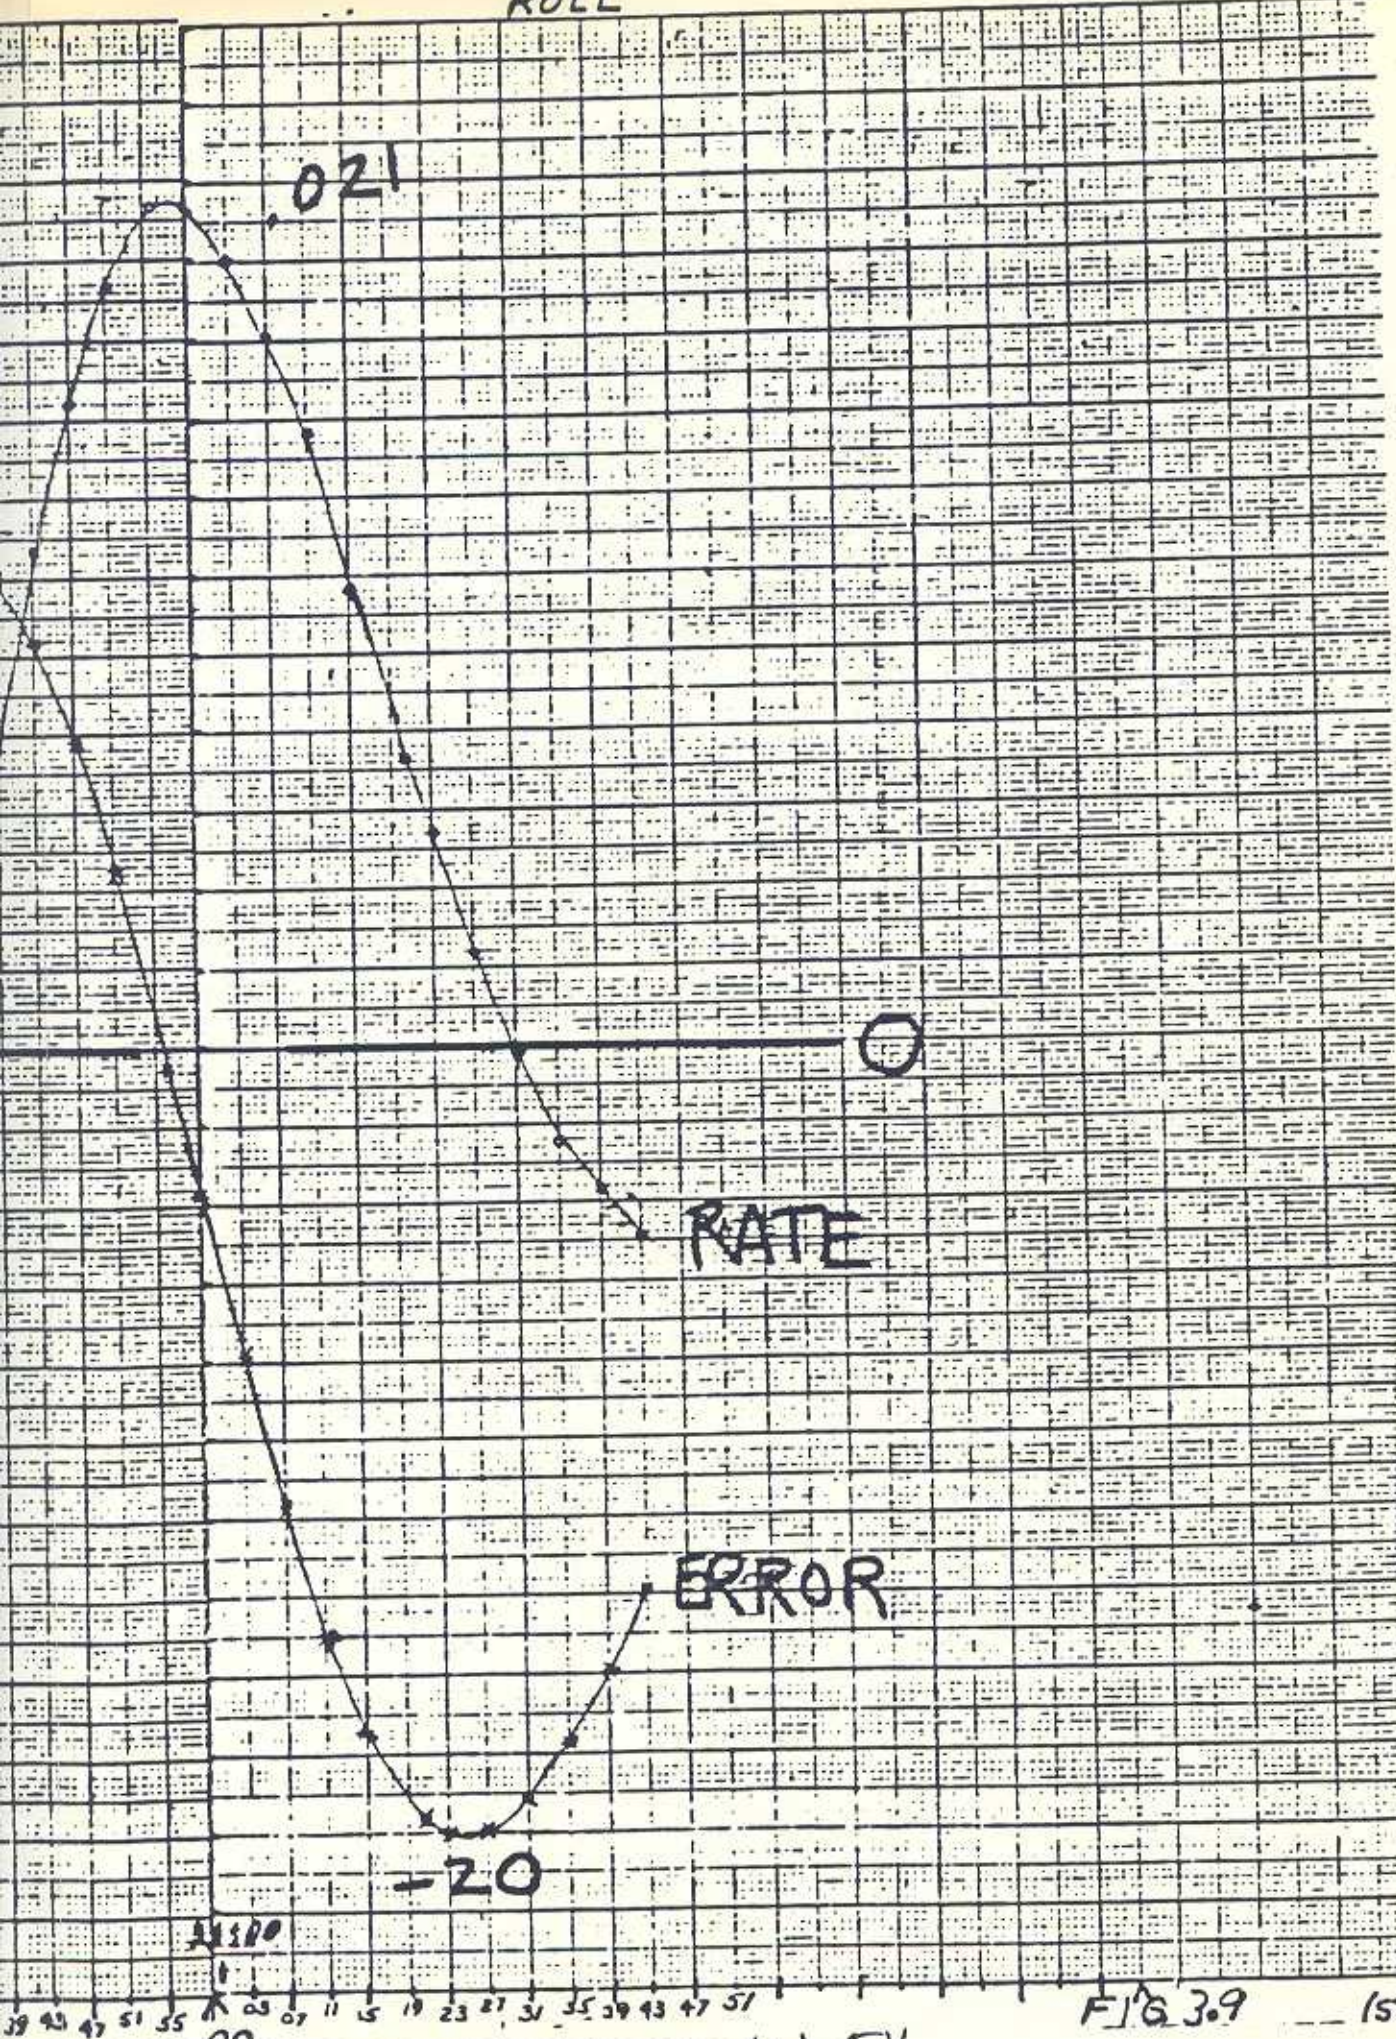
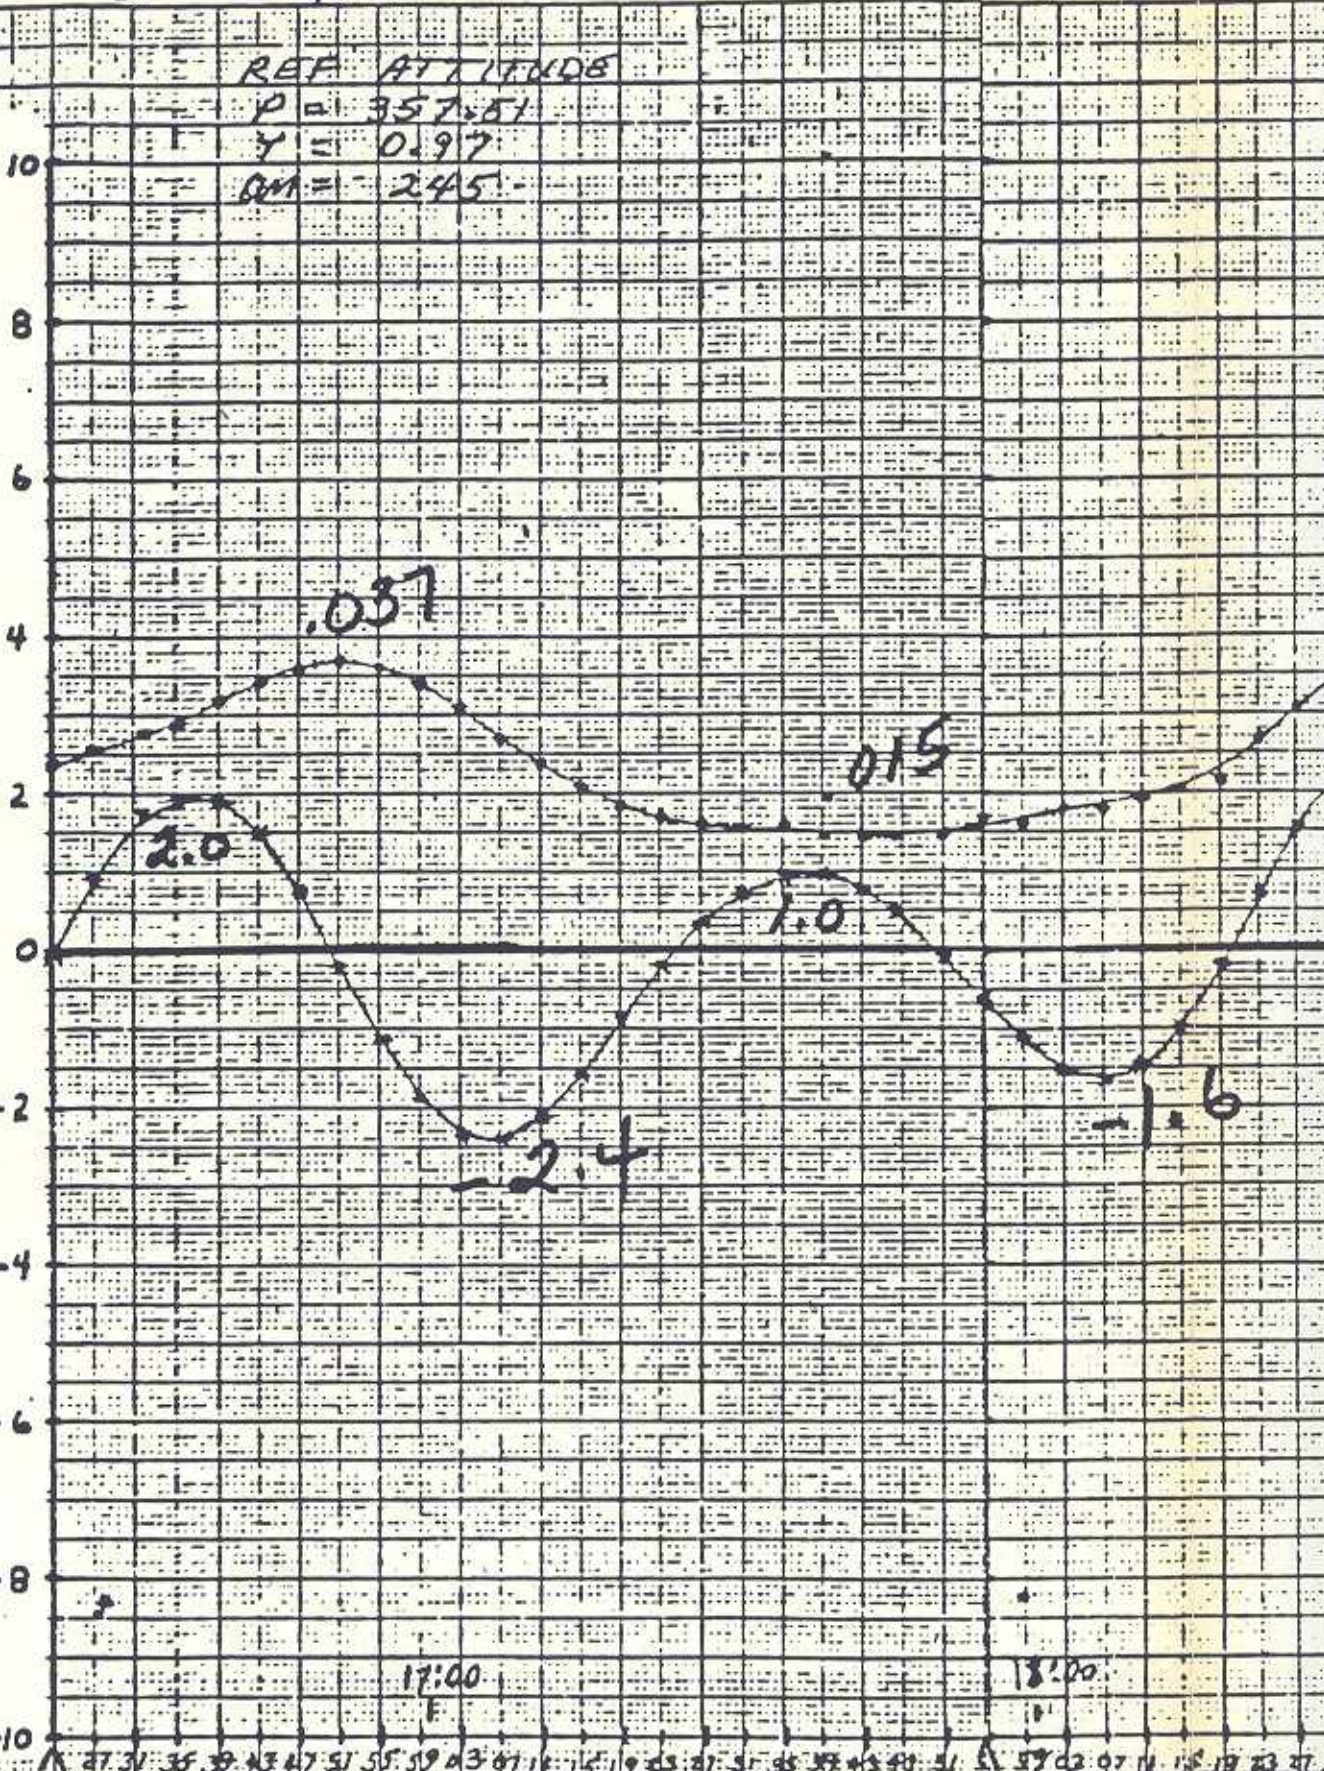
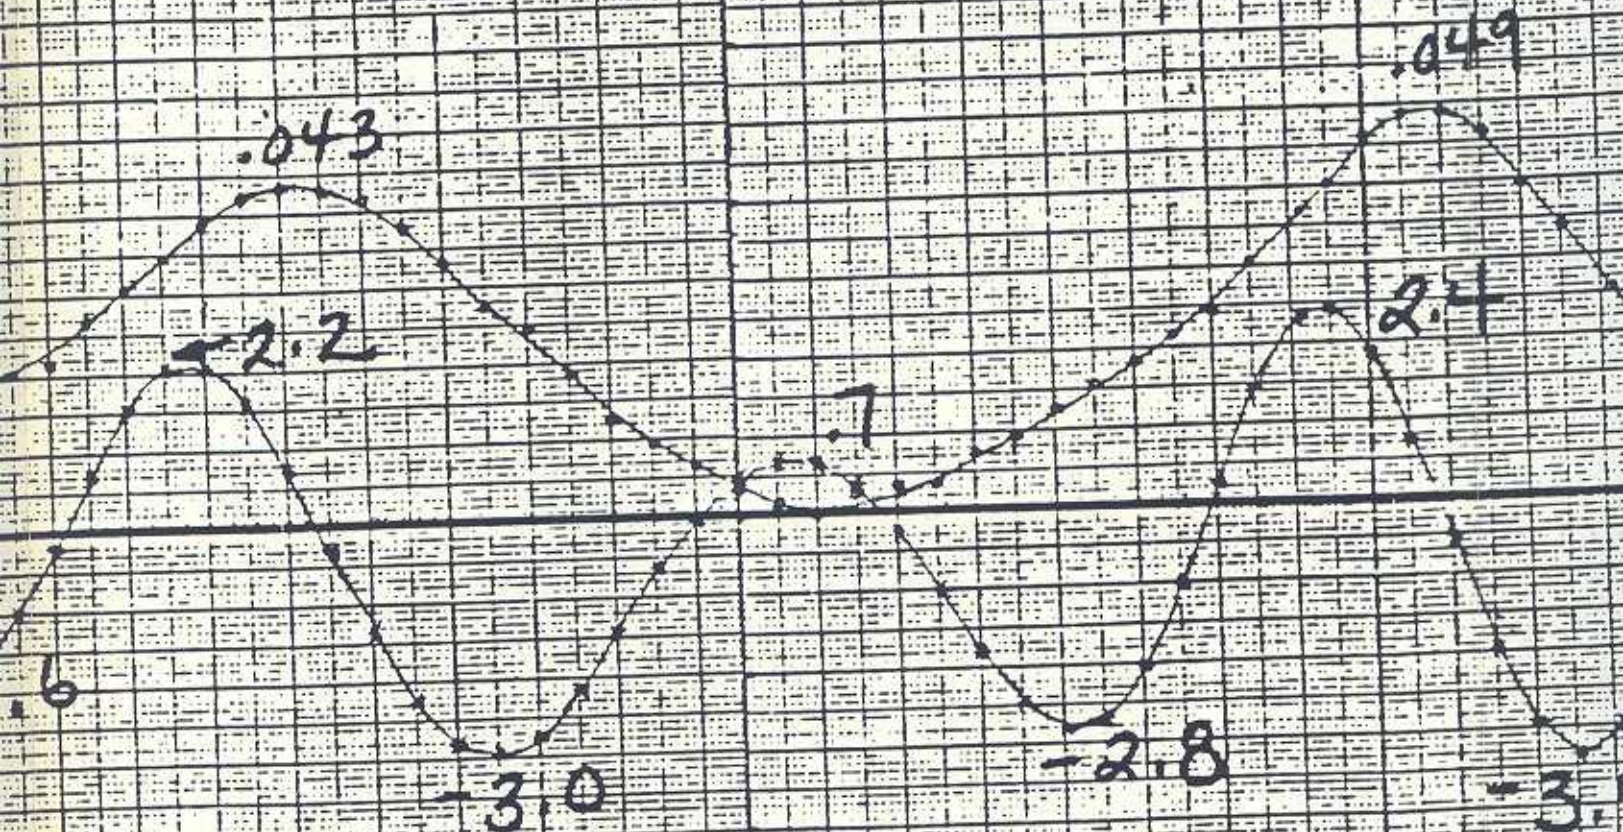
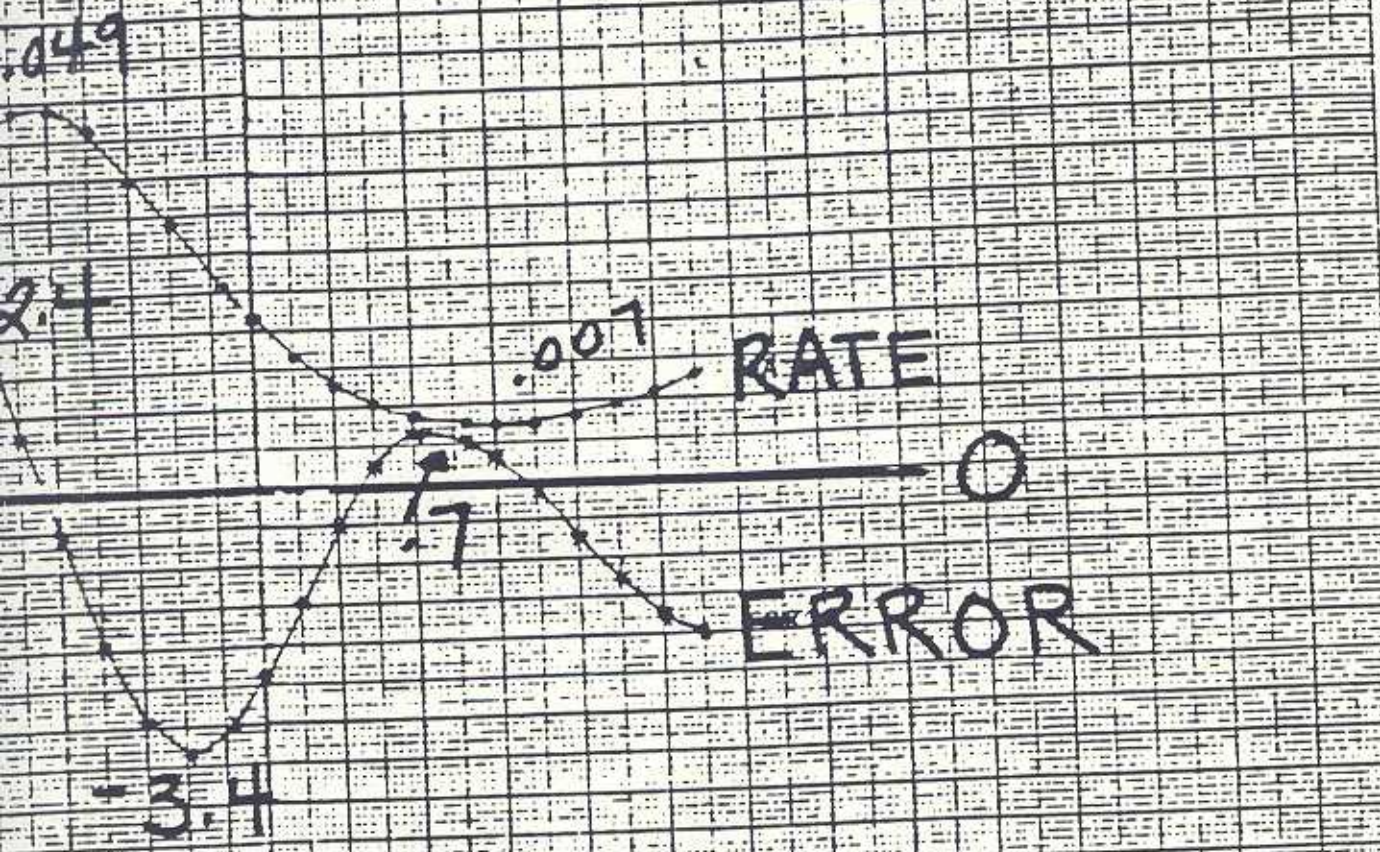
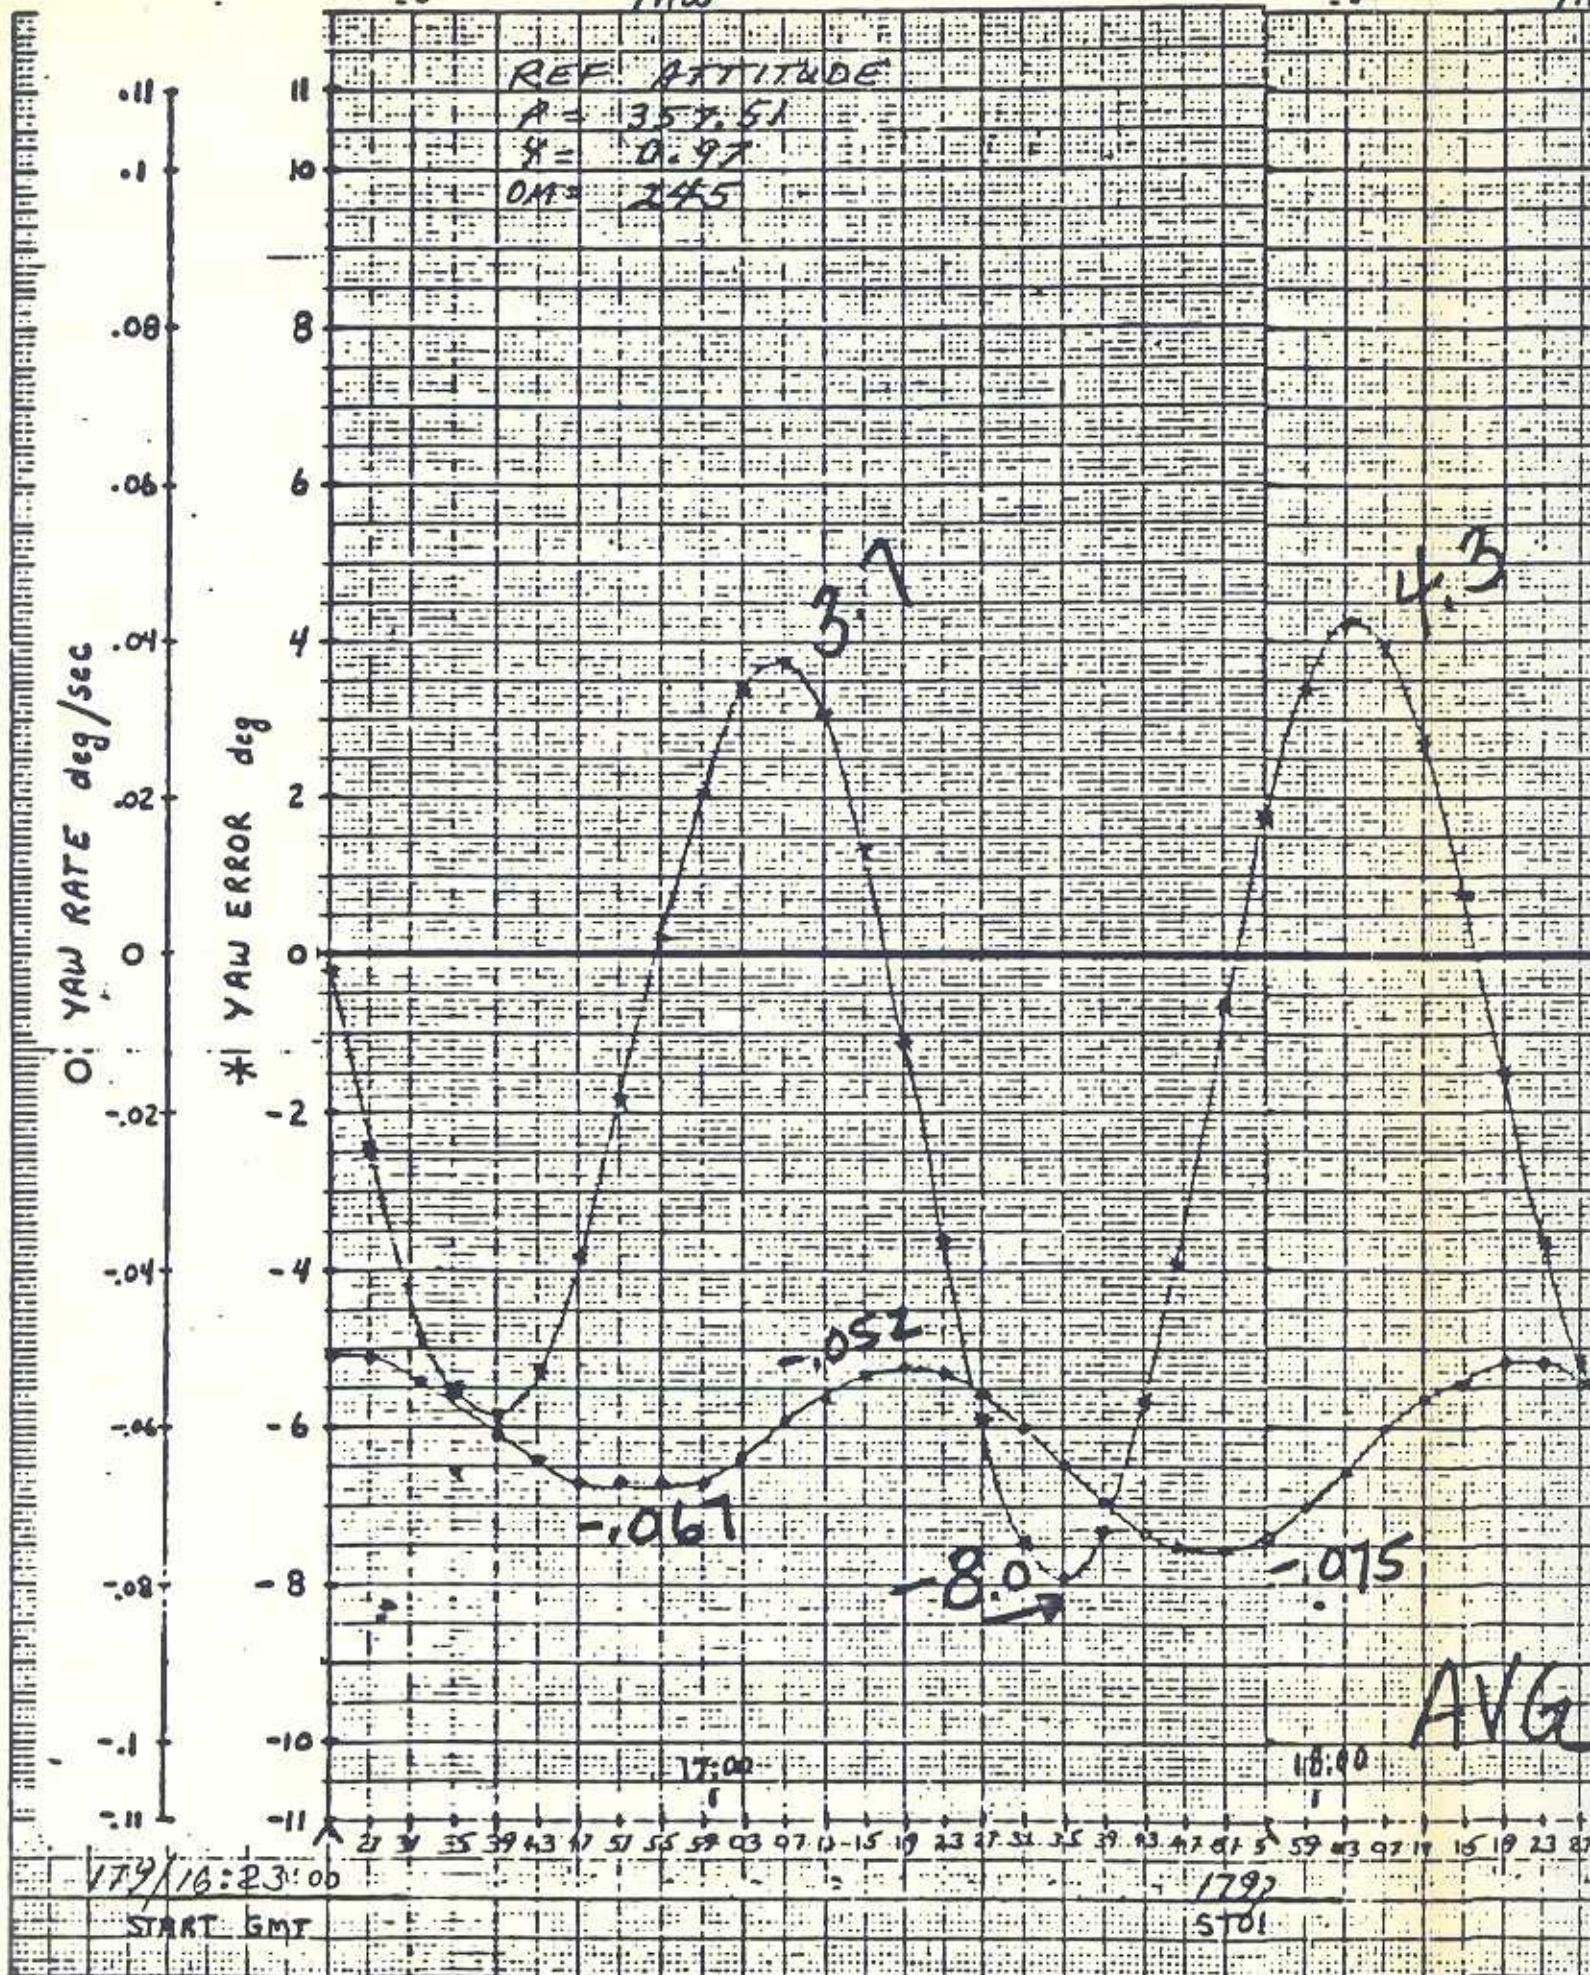
There was an apparent correlation between the force acting upon the Orbiter and the sunlight striking the vehicle. The first attempt to establish gravity gradient was started at sunrise and was immediately divergent. The second attempt was started at sunset with less divergence noted through the night pass. However, at sunrise the Orbiter diverge immediately (see figure 3.7, 3.8). At this point there was a suspected vent occurring on the vehicle which became more active as the vehicle entered sunlight. Venting of any sort violates the general guidelines for establishing gravity gradient equilibrium. The DAP errors were monitored throughout the sleep period with the same correlation noted between a venting force and sunlight. Attempts to isolate the location of the venting force were undertaken. It seems that the venting force provided a roll torque of approximately 1.76 ft/lbs, and was located in a plane through the center of gravity containing a body vector pitch of 13 ± 10 degrees and a yaw of 76 ± 10 degrees. The approximate location of the venting force would be located near the center of gravity in the
