# STS-1 Orbiter Final Mission Report

August 1981

STS-1 ORBITER  
FINAL  
MISSION REPORT

PREPARED BY  
Mission Evaluation Team

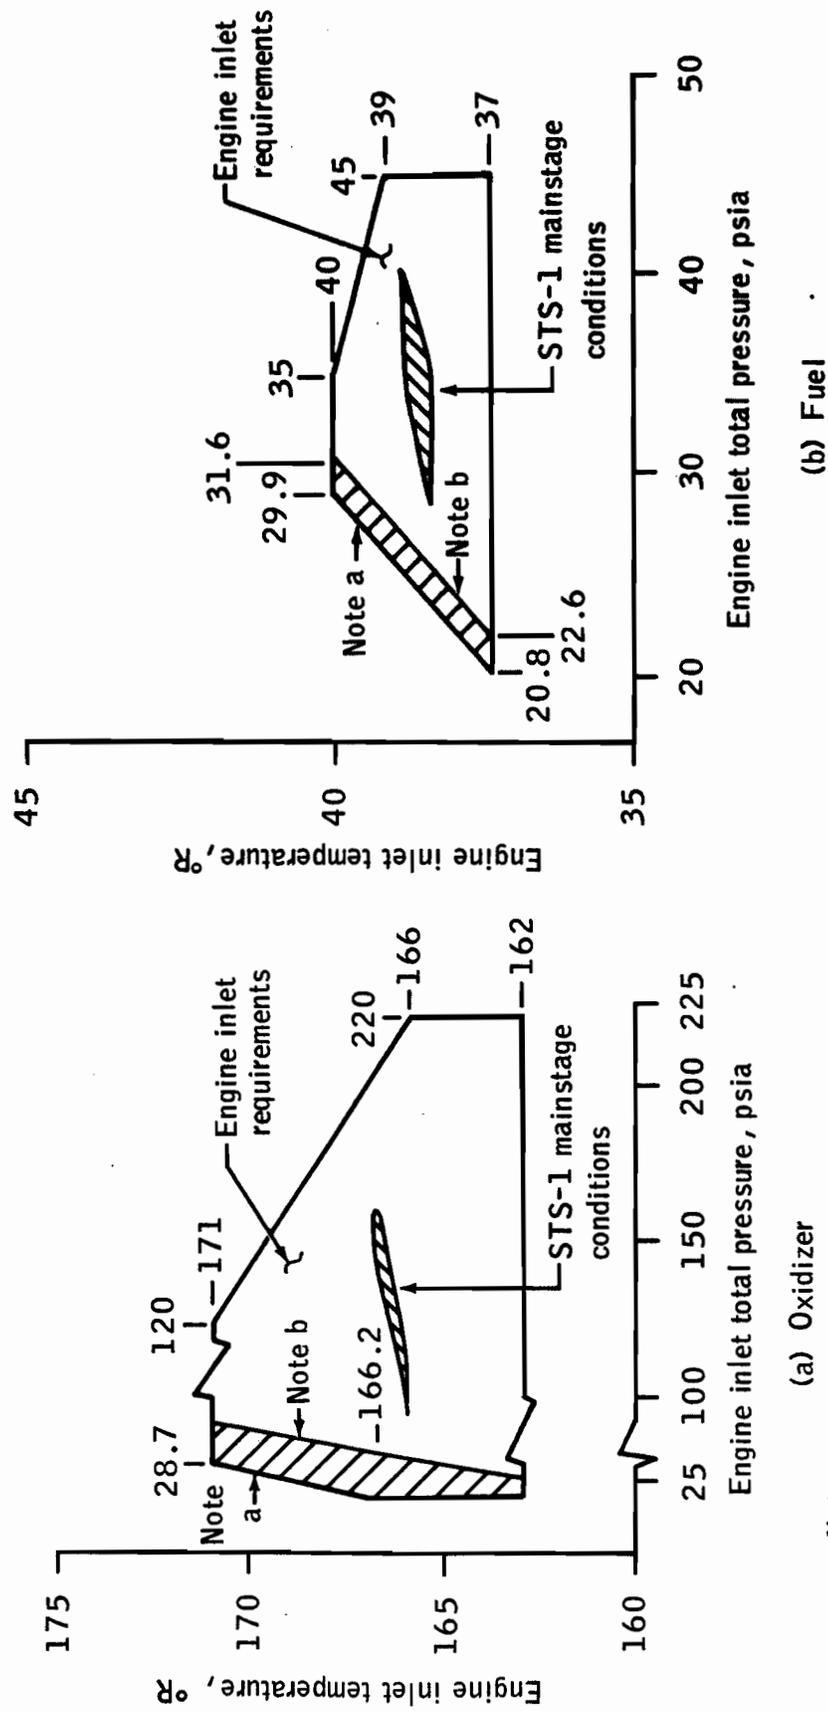
Figure 2-1.- Engine propellant inlet conditions (mainstage operation).

The operation of the Orbiter propellant feedlines was satisfactory during ascent. The operating band for feedline temperatures and pressures was within the requirements as shown in figure 2-1. A tabulation of pre-STs-1 predicted conditions and actual STS-1 propellant conditions for engine 1, which is typical of all three engines, is presented in table 2-II.

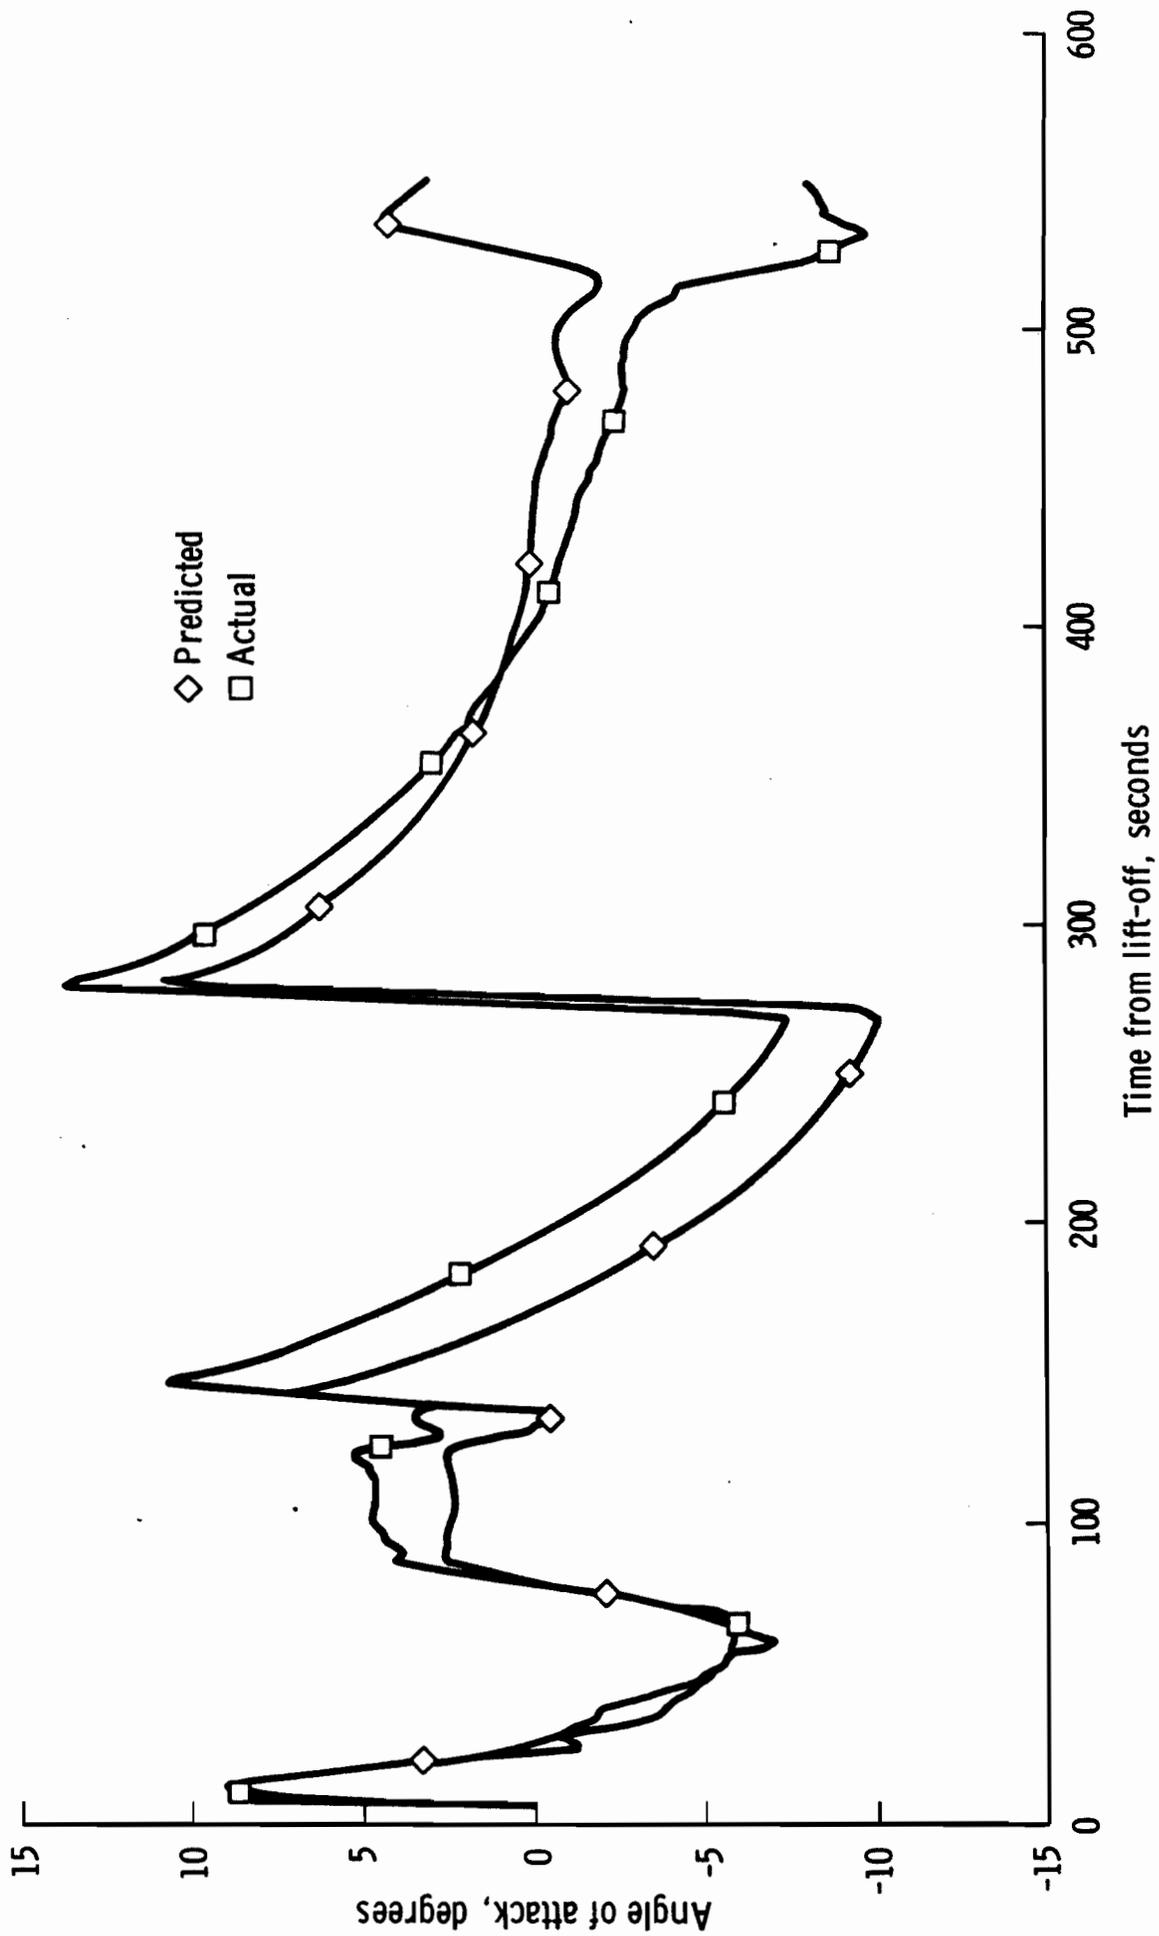
Figure 2-11. - Comparison of predicted and actual angle of attack for STS-1 launch phase.

Figure 2-11 presents a comparison of the navigation derived angle of attack for both the primary avionics software system (PASS) and the backup flight system (BFS) for STS-1 along with the preflight prediction. The fact that both PASS and BFS obtained identical solutions for this parameter provides excellent evidence that their navigated states were synchronized, and since the software requirements were implemented independently, this also provides evidence that the navigation subsystem was performing normally. The difference between the preflight predicted and actual flight angle of attack is attributable to the trajectory lofting that occurred during the first stage. The fuel optimal powered explicit guidance (PEG) allowed the altitude rate error to be nulled by gravity, while thrust acceleration was being used more efficiently to accumulate downrange velocity.

The flight data show that the ascent guidance, navigation, and control performed in a normal manner. One minor area of concern is the lofting problem (Section 8.0, integrated problem I-1). Another minor area of concern is the fact that the initial attitude error and rate in the pitch axis was not as small at lift-off as expected. The initial attitude error and rate were due to the swaying motion that occurs between main engine ignition and lift-off. A study is in progress to determine if this transient requires any corrective action.

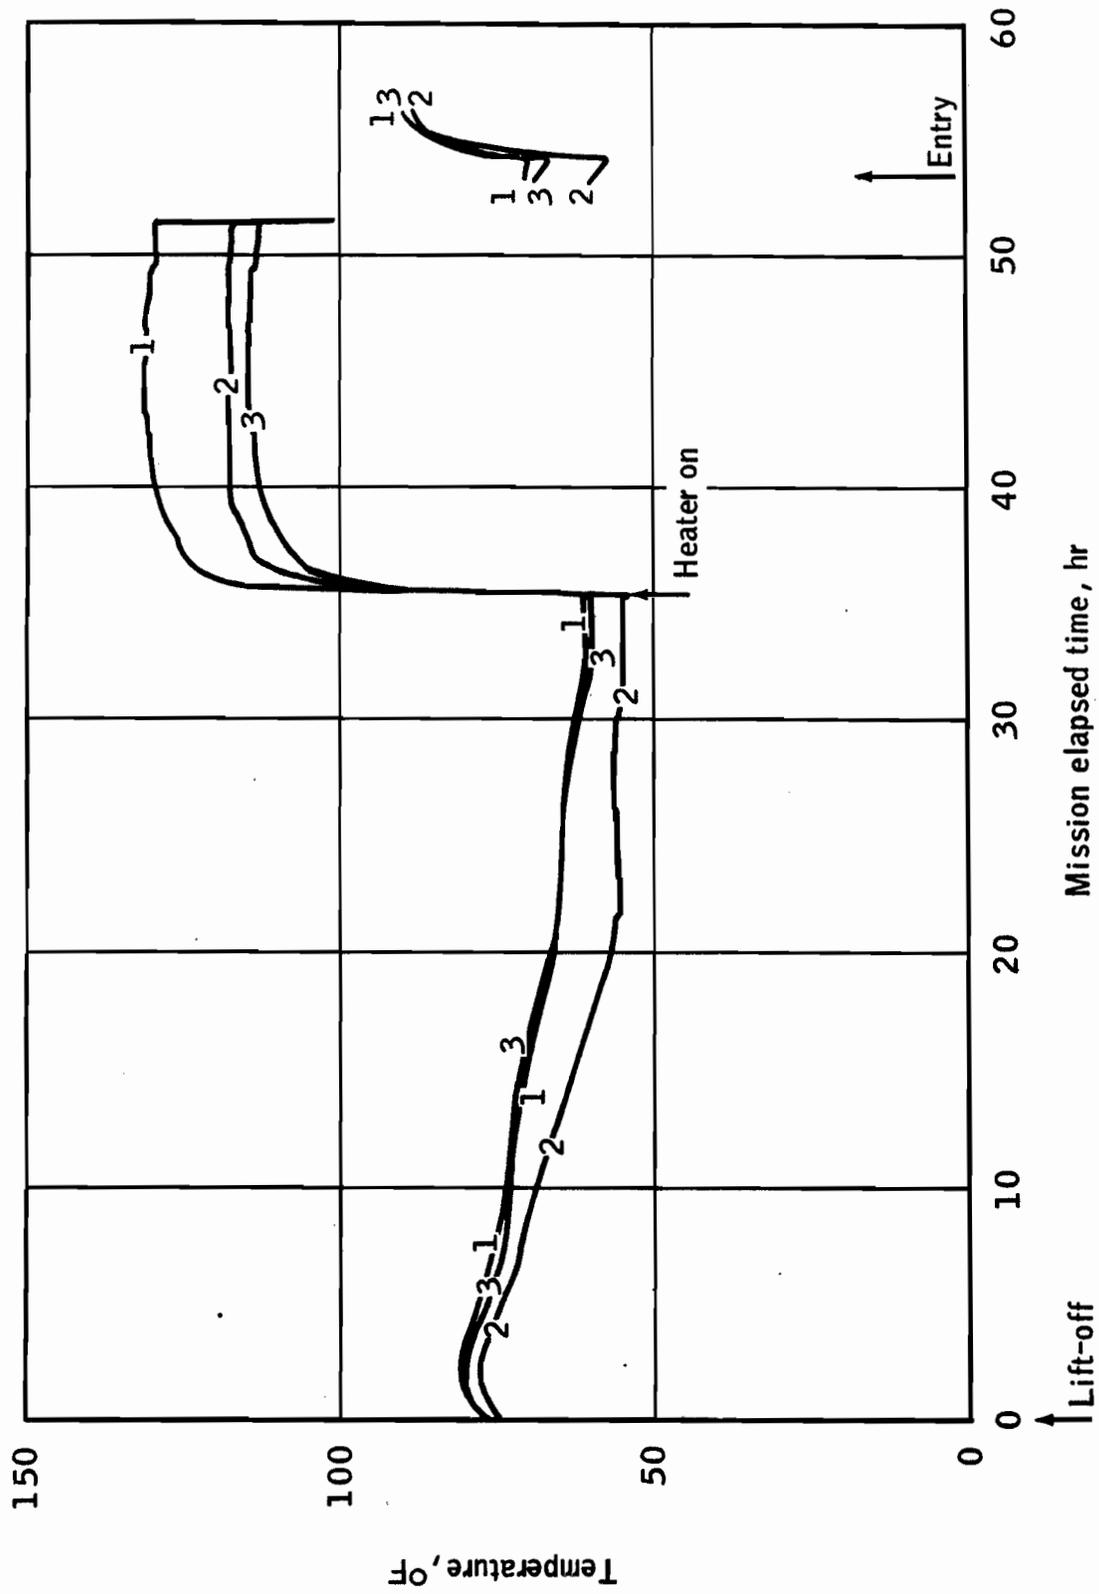
Figure 2-16.- Typical temperature response in RCS forward compartment.

Of particular interest is the performance of the forward RCS compartment heaters. The port heater came on for the first time at 35:20:00 mission elapsed time (MET) as compared with an expected time of 16 hours MET, and this would indicate that the loss from the compartment was much less than expected (see section 8.0, flight test problem report 1e). However, the heater remained on (100-percent duty cycle) until it was disabled, as planned, for entry. A typical temperature response of the port panel heaters is shown in figure 2-16. The expected duty cycle was approximately 25 percent. In addition, the temperatures of the heater panels ranged from 115° to 130° F maximum as compared with an expected range of 132° to 153° F (see section 8.0, flight test problem report 1f). This would indicate either a larger than expected compartment or a heat leak or lower than expected voltage. Evaluation is underway to identify potential causes. No problems are anticipated for STS-2 since the planned major attitude, payload bay to earth, is the same as that of STS-1.

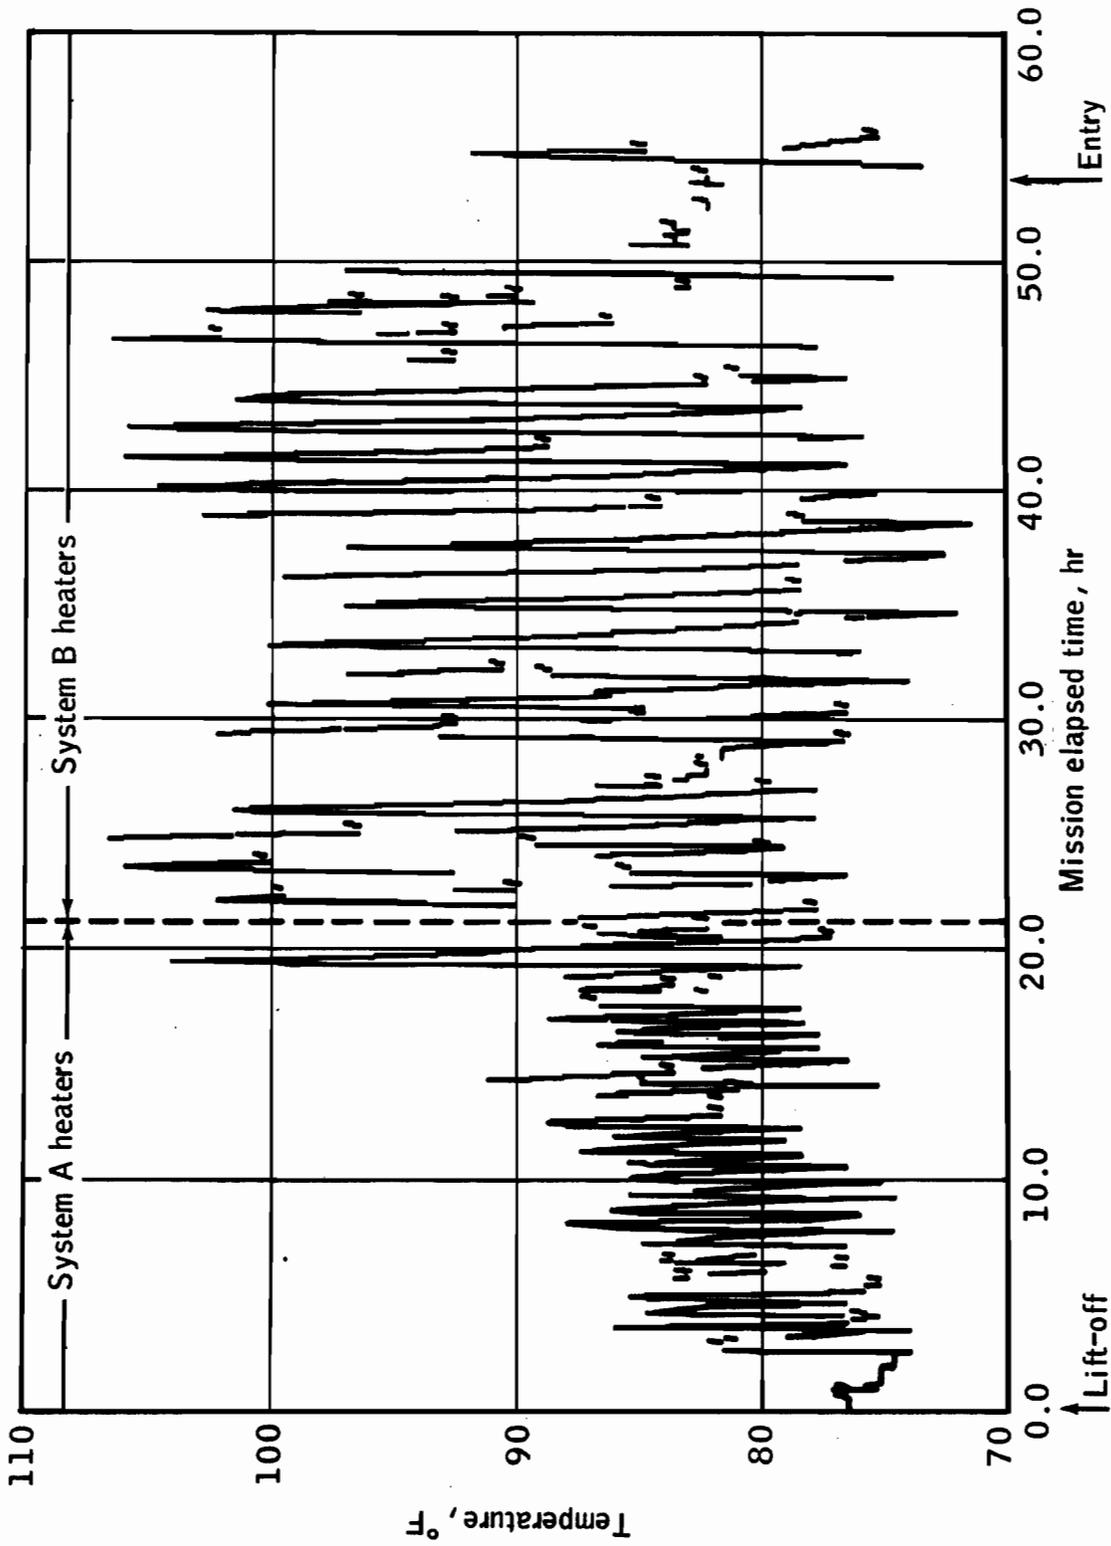
Figure 2-17. - Flash evaporator feed line temperature amplitude change.

At 103:09:30 G.m.t., the FES feed water line heaters on the port side were switched from system A heaters to system B heaters, the switch resulting in a temperature amplitude change (figure 2-17). Mislocation of the temperature transducer is suspected.

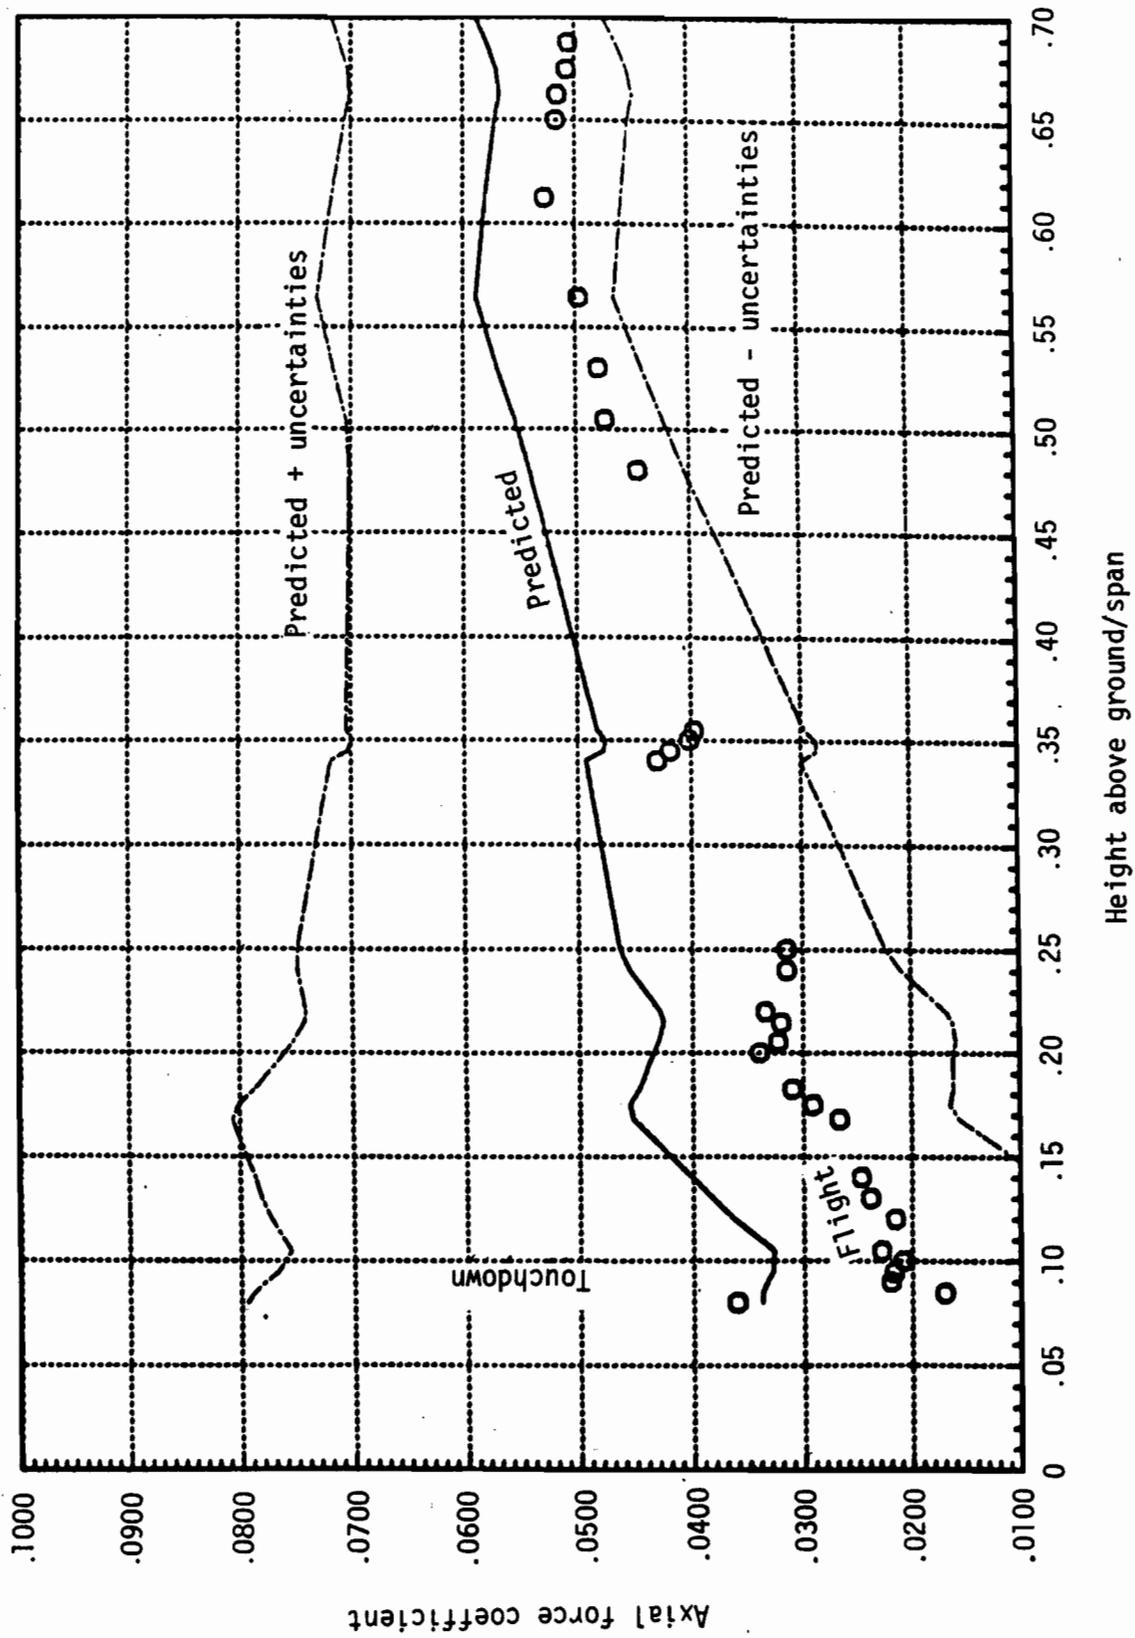
Figure 2-31.- Lower than predicted axial force coefficient during landing.

2.9.2.1 Performance and Trim. - Comparisons of the predicted lift-to-drag (L/D) ratio and the predicted  $\pm$  uncertainties data with the calculated STS-1 L/D ratio are shown in figure 2-30. There was no discernable difference between the predicted and actual calculated values down the last 100 ft before touchdown. At that point, ground effects occurred which caused the L/D to be higher than predicted. This difference was traced to the axial force coefficient that was lower than predicted (fig. 2-31).

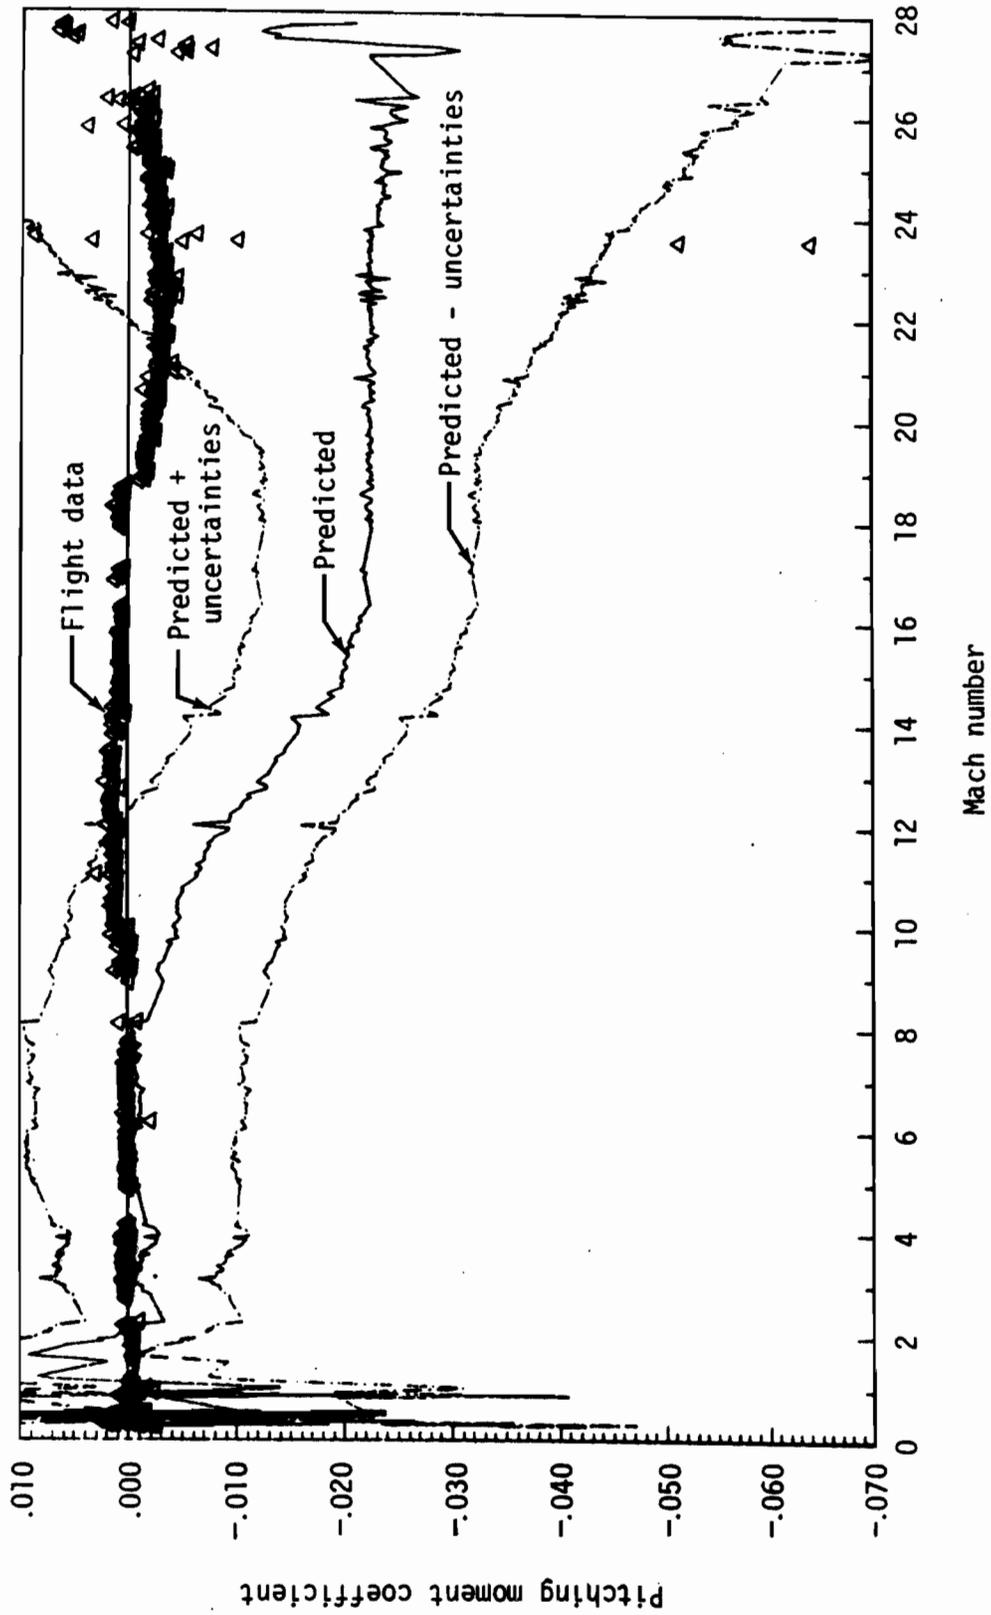
Figure 2-32.- Pitching moment coefficient during entry phase.

The body flap functioned as predicted except at the higher Mach numbers (28 to 8) where the body flap was down 7 degrees further than predicted. Between Mach 21 and 12, the pitching moment coefficient flight values fall outside the predicted and uncertainties bank (fig. 2-32) (Section 8.0, flight test problem report 39). Below Mach 8, the pitching moment coefficient followed the predicted value.

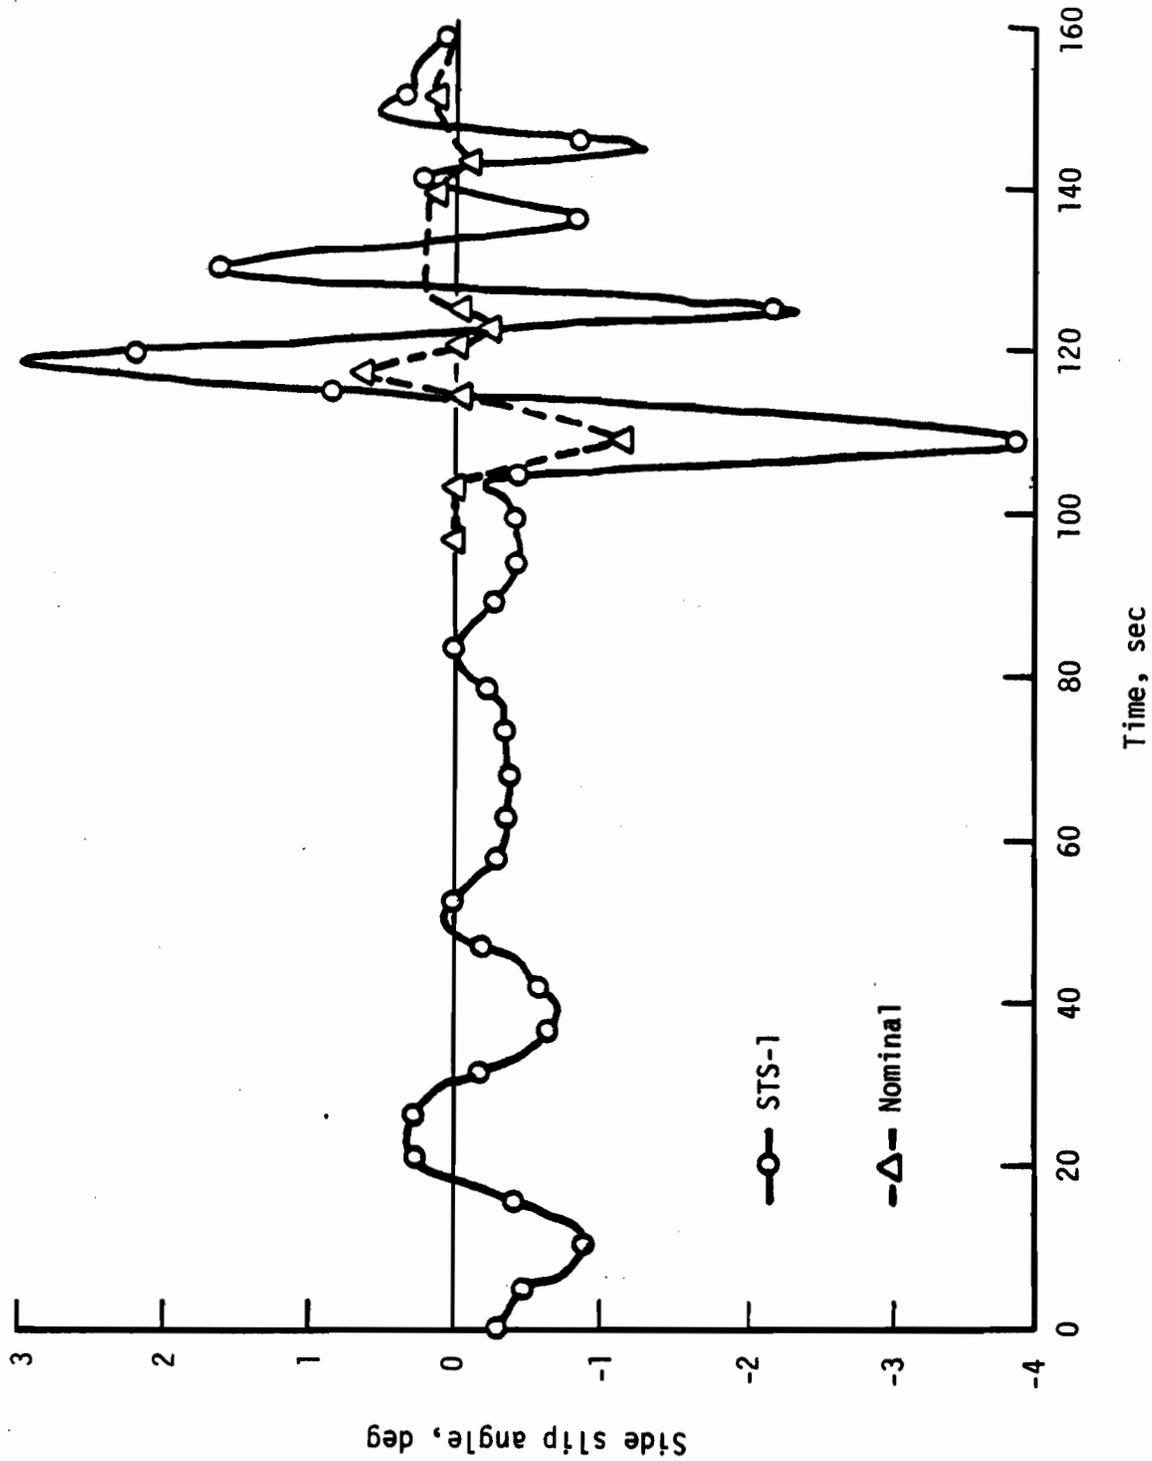
Figure 2-33.- Oscillations from first bank reversal.

2.9.2.2 Bank Reversals. - The initial bank reversal was performed at a dynamic pressure of 14 lb/ft. This reversal created several cycles of lightly damped motion that resulted in peak beta values of 4 degrees (fig. 2-33). Analysis and motion matching studies have shown that this discrepancy resulted from the rolling moment from the yaw thrusters. The predictions had this roll moment included, but at a higher level (fig. 2-34).

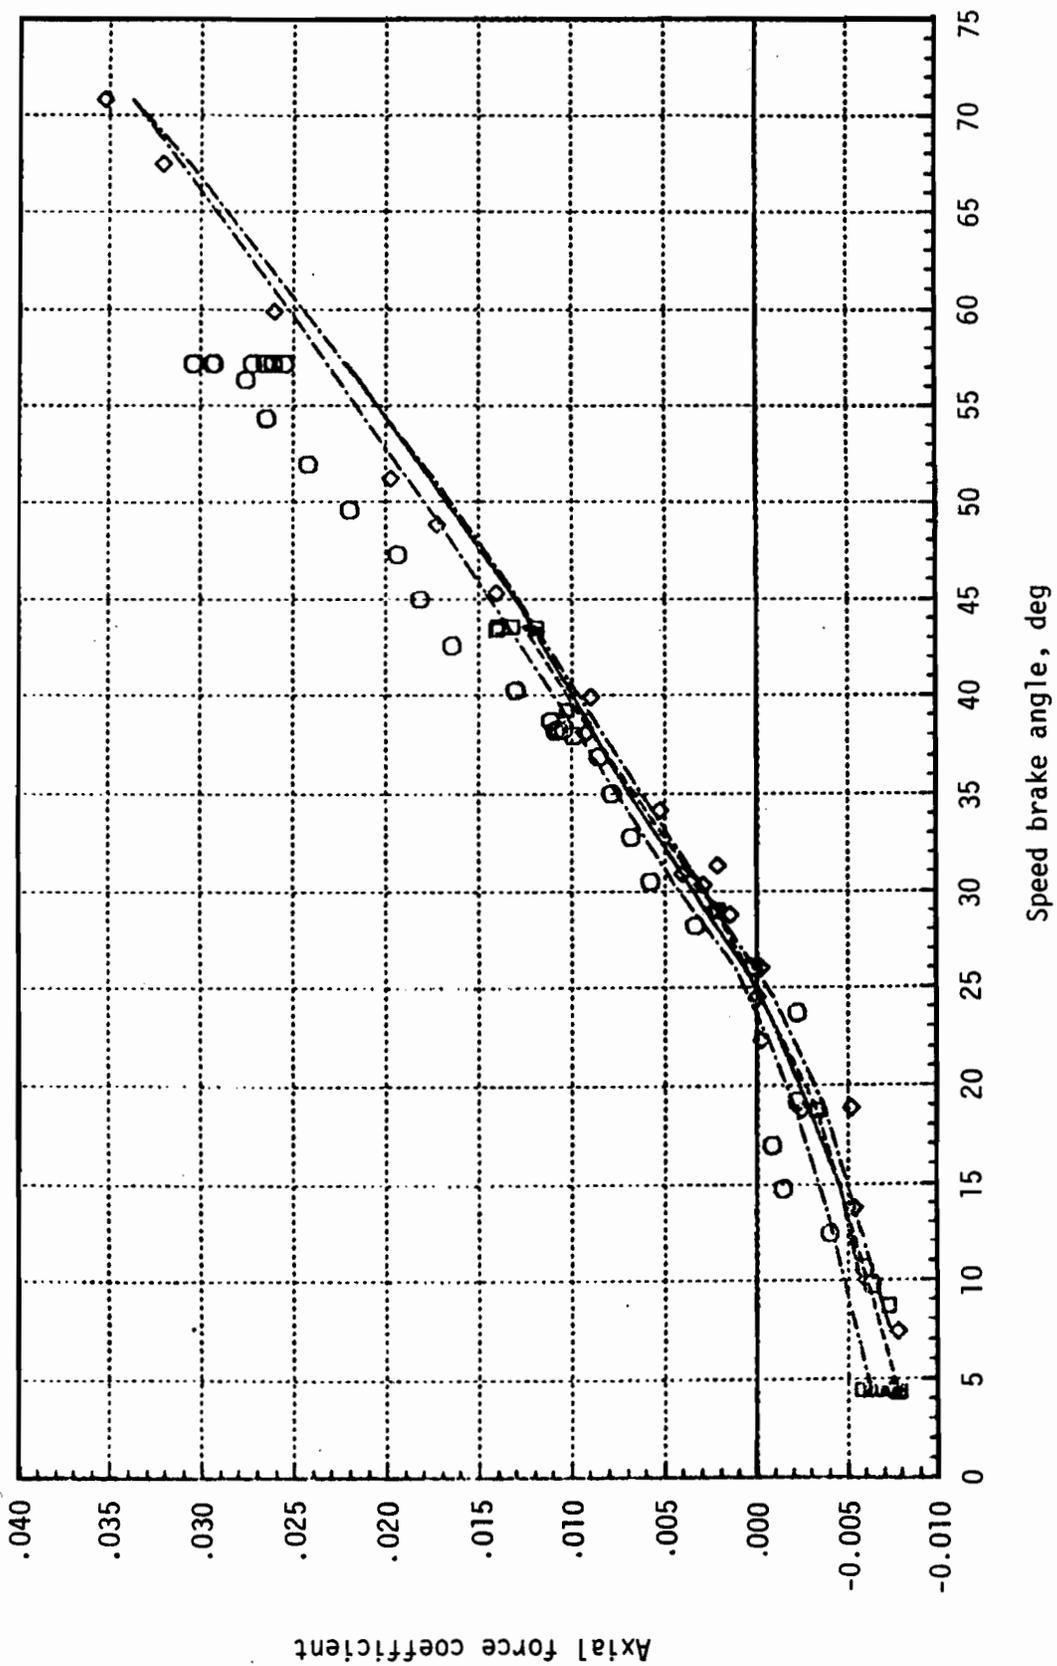
Figure 2-38.- Drag force coefficient and lift-to-drag ratio.

2.9.2.4 Approach and Landing. - An evaluation of the aerodynamics during the approach and landing phase showed differences from the preflight predictions in both the drag force coefficient (fig. 2-38) and the speedbrake drag (fig. 2-39). The difference along with the increased L/D discussed previously, contributed approximately 1000 ft of the 3200 ft landing point overshoot.

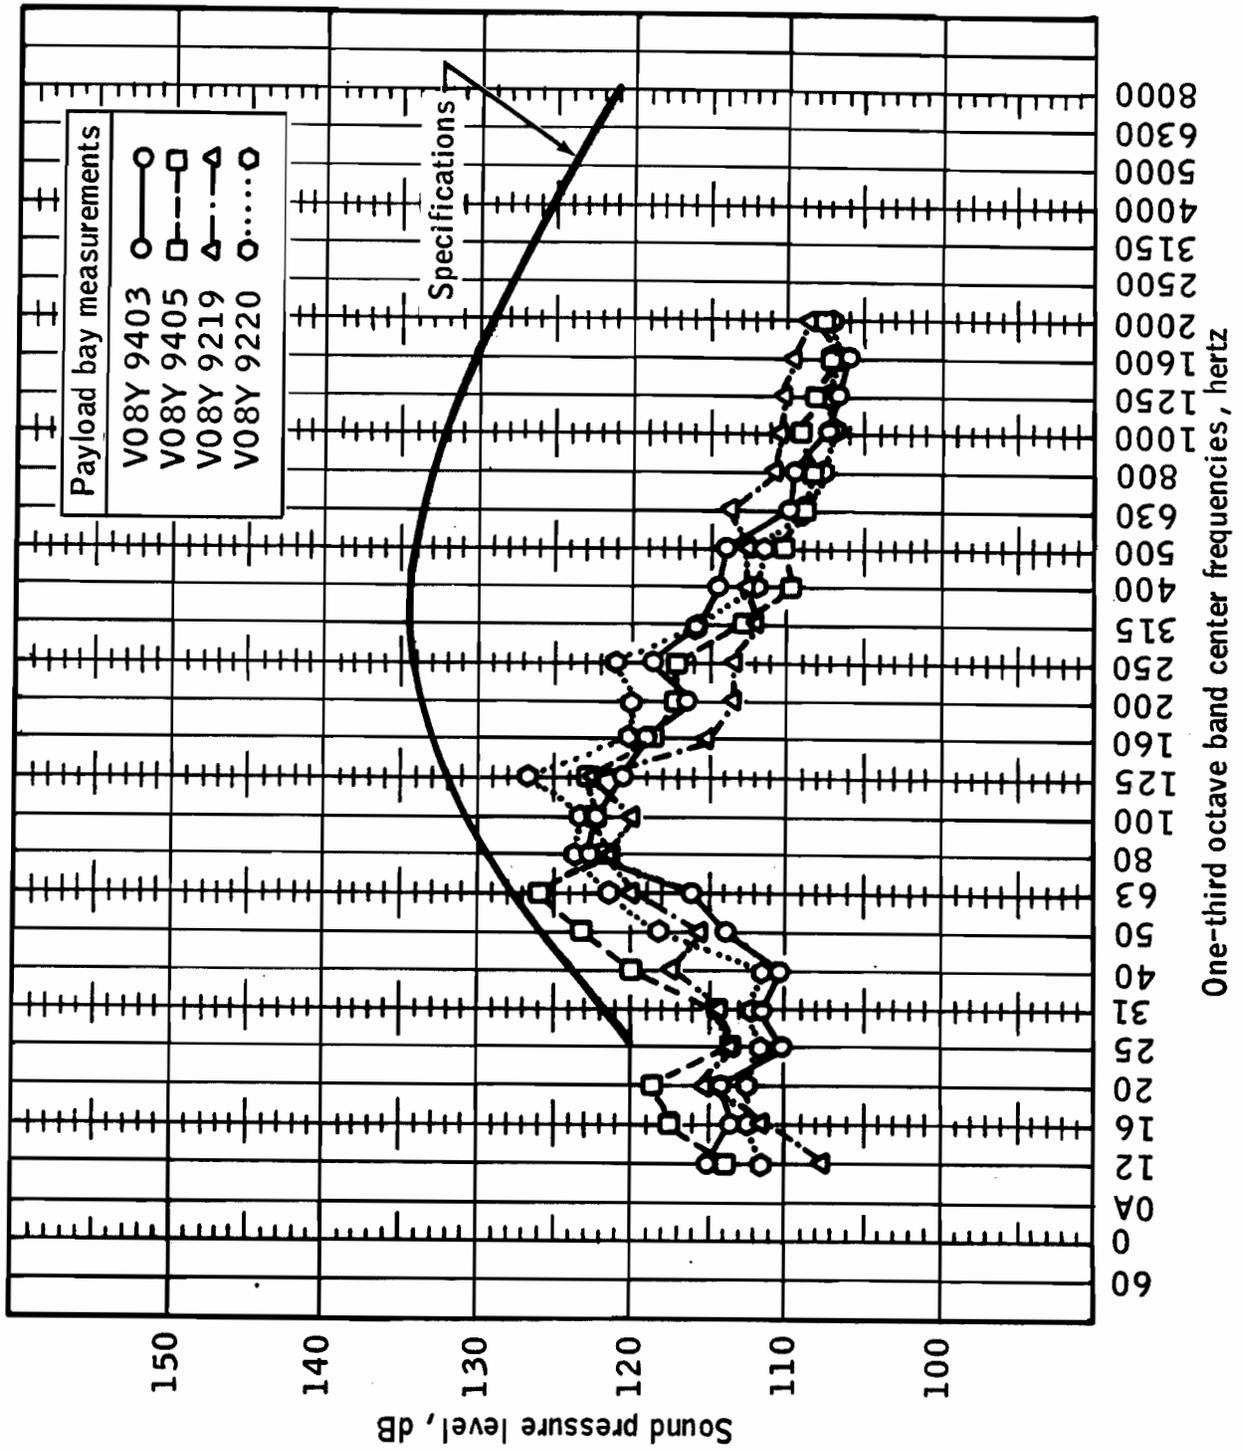
The plots in figures 3-3, 3-4, and 3-5 are one-third octave bands representing the frequencies of 12.5 to 2000 Hz for analyzing averaging time of 1.0 second. In the frequency range from 12.5 to 80 Hz, the measured noise level is in agreement with the specification curve. From the 80 Hz to 2000 Hz the attenuation of the noise level was greater than predicted. The variance from the specification is around 5-8 dB at the midfrequency and reaches as much as 15-19 dB at the extreme upper frequency. The overall dB level for the four internal microphones ranged from 130 to 133.5 as compared to the 145 dB for the specification criteria overall. Figure 3-6 is a space average plot of the four internal microphones for the SSME ignition and SRB ignition/lift-off event times. The space averaging takes into consideration the influence of any microphone that may be reading high or low relative to the other microphones. The overall dB levels of 133 and 130 for each time event are still below the specification criteria.

Figure 3-3.- Internal acoustic measurements from payload bay at main engine start.

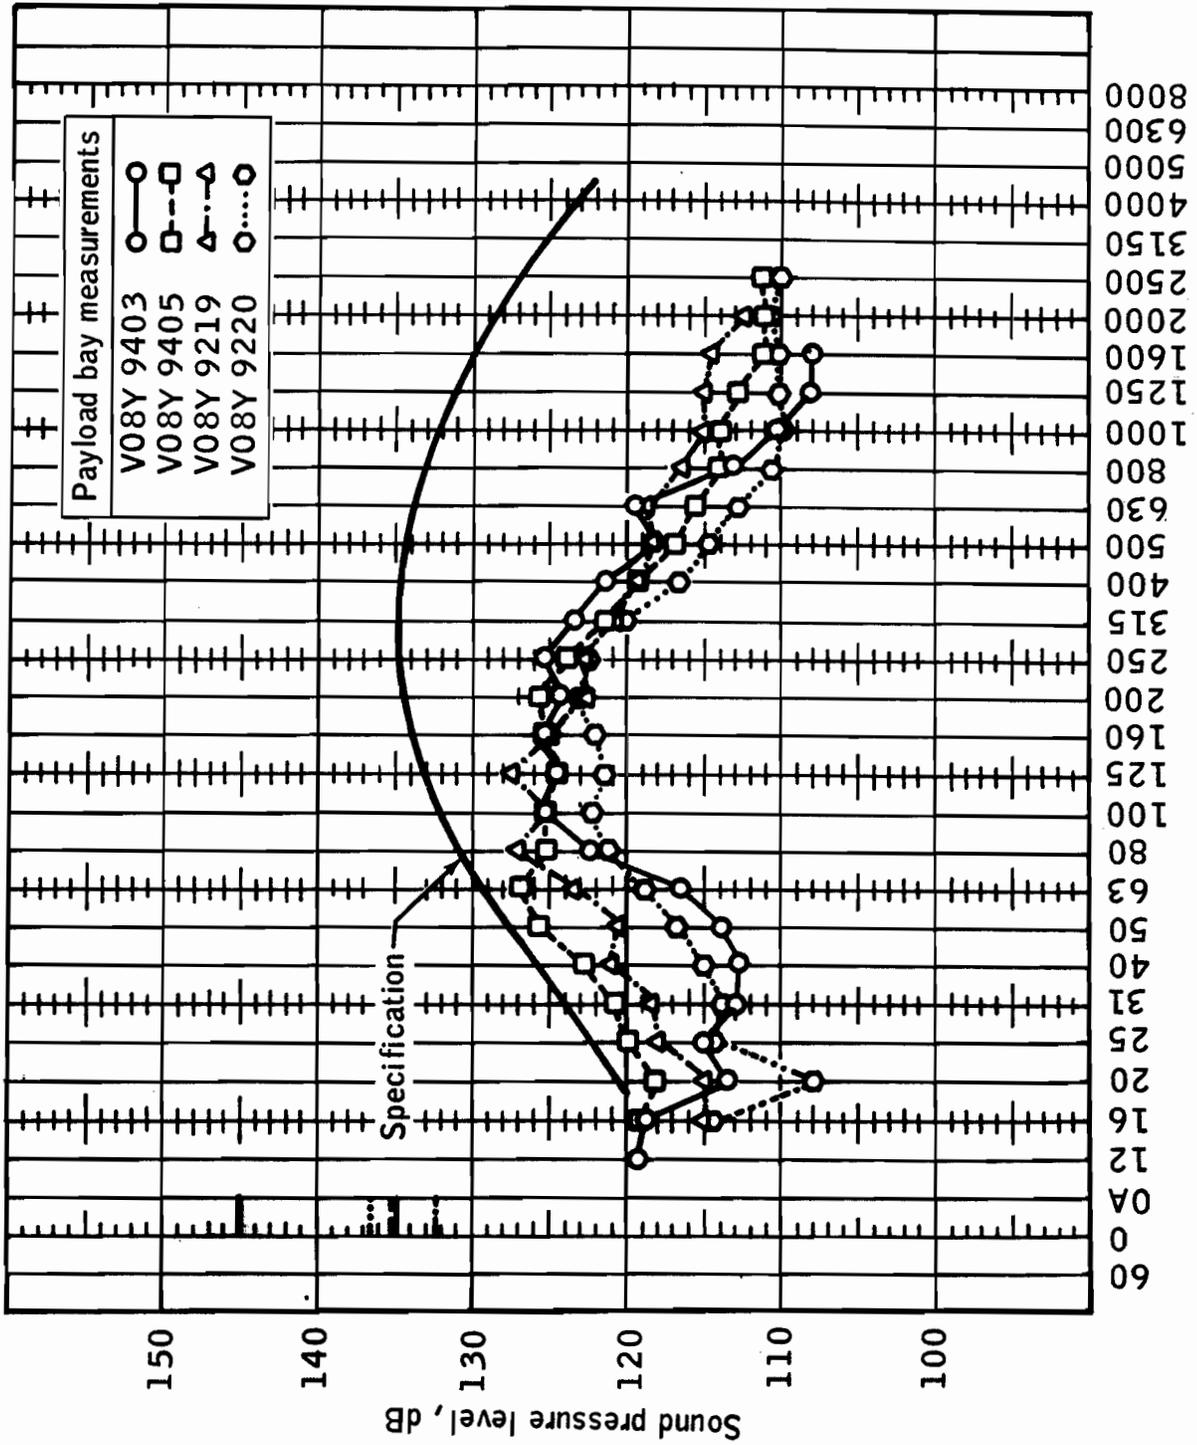
One-third octave band center frequencies, hertz  
 Figure 3-4. - Internal acoustic measurements from payload bay at lift-off.

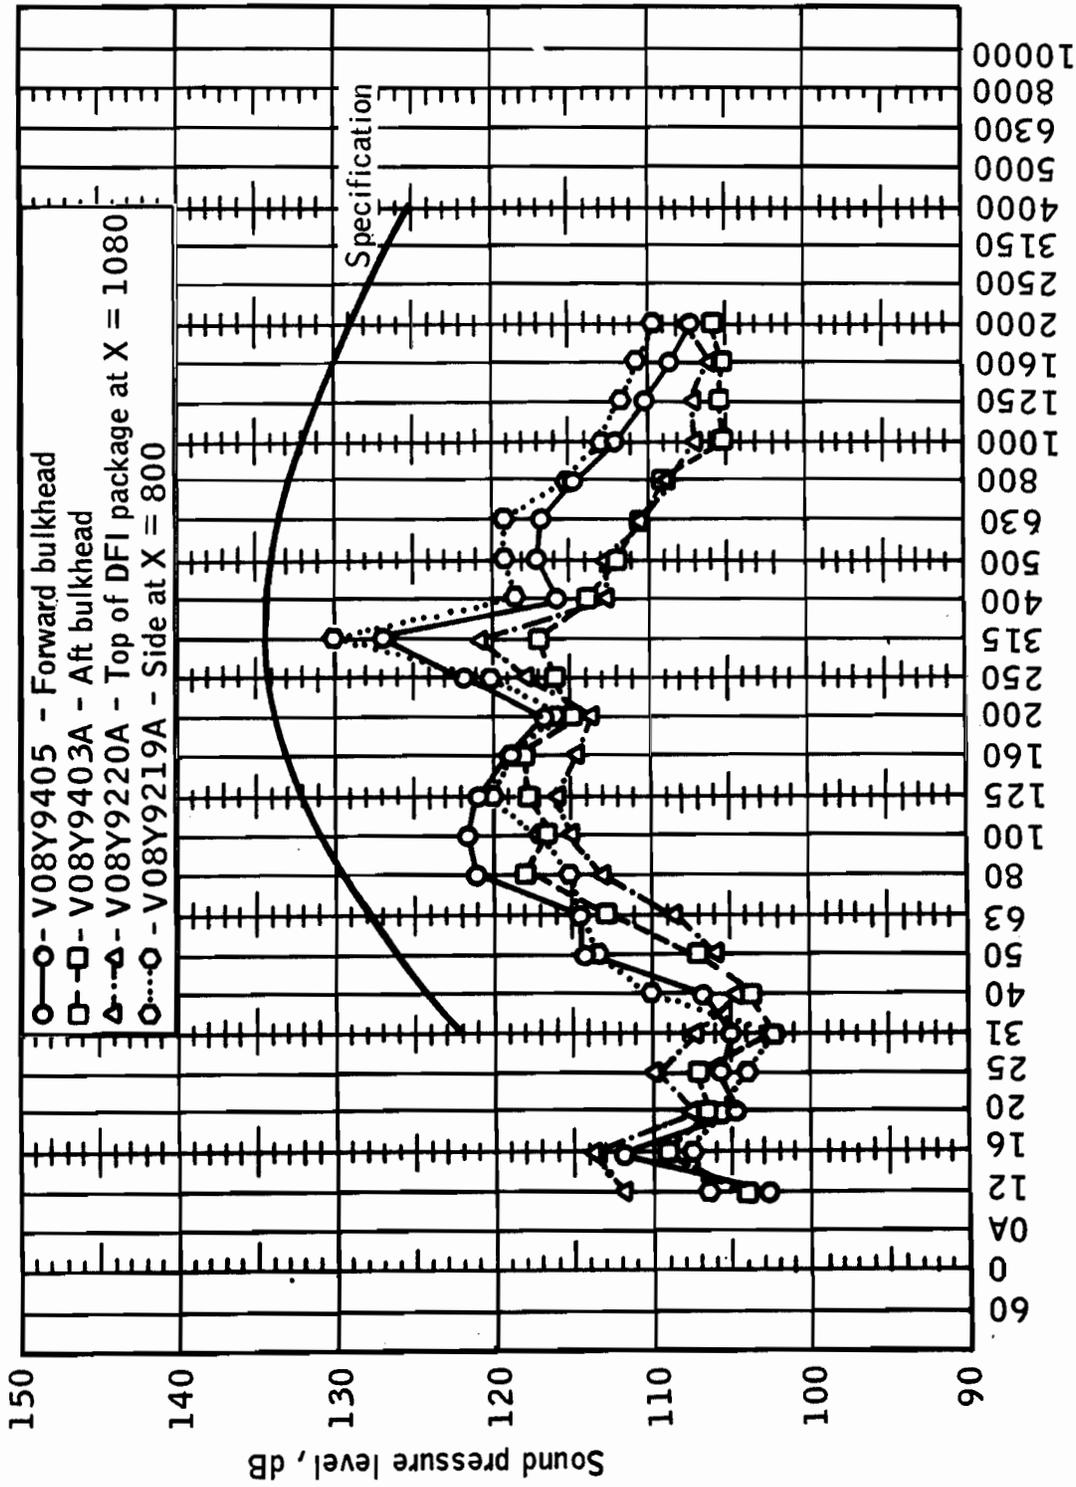
Figure 3-5.- Payload bay acoustic data during transonic region .
