STS-2 Orbiter Mission Report

February 1982

National Aeronautics and
Space Administration

Lyndon B. Johnson Space Center
Houston, Texas

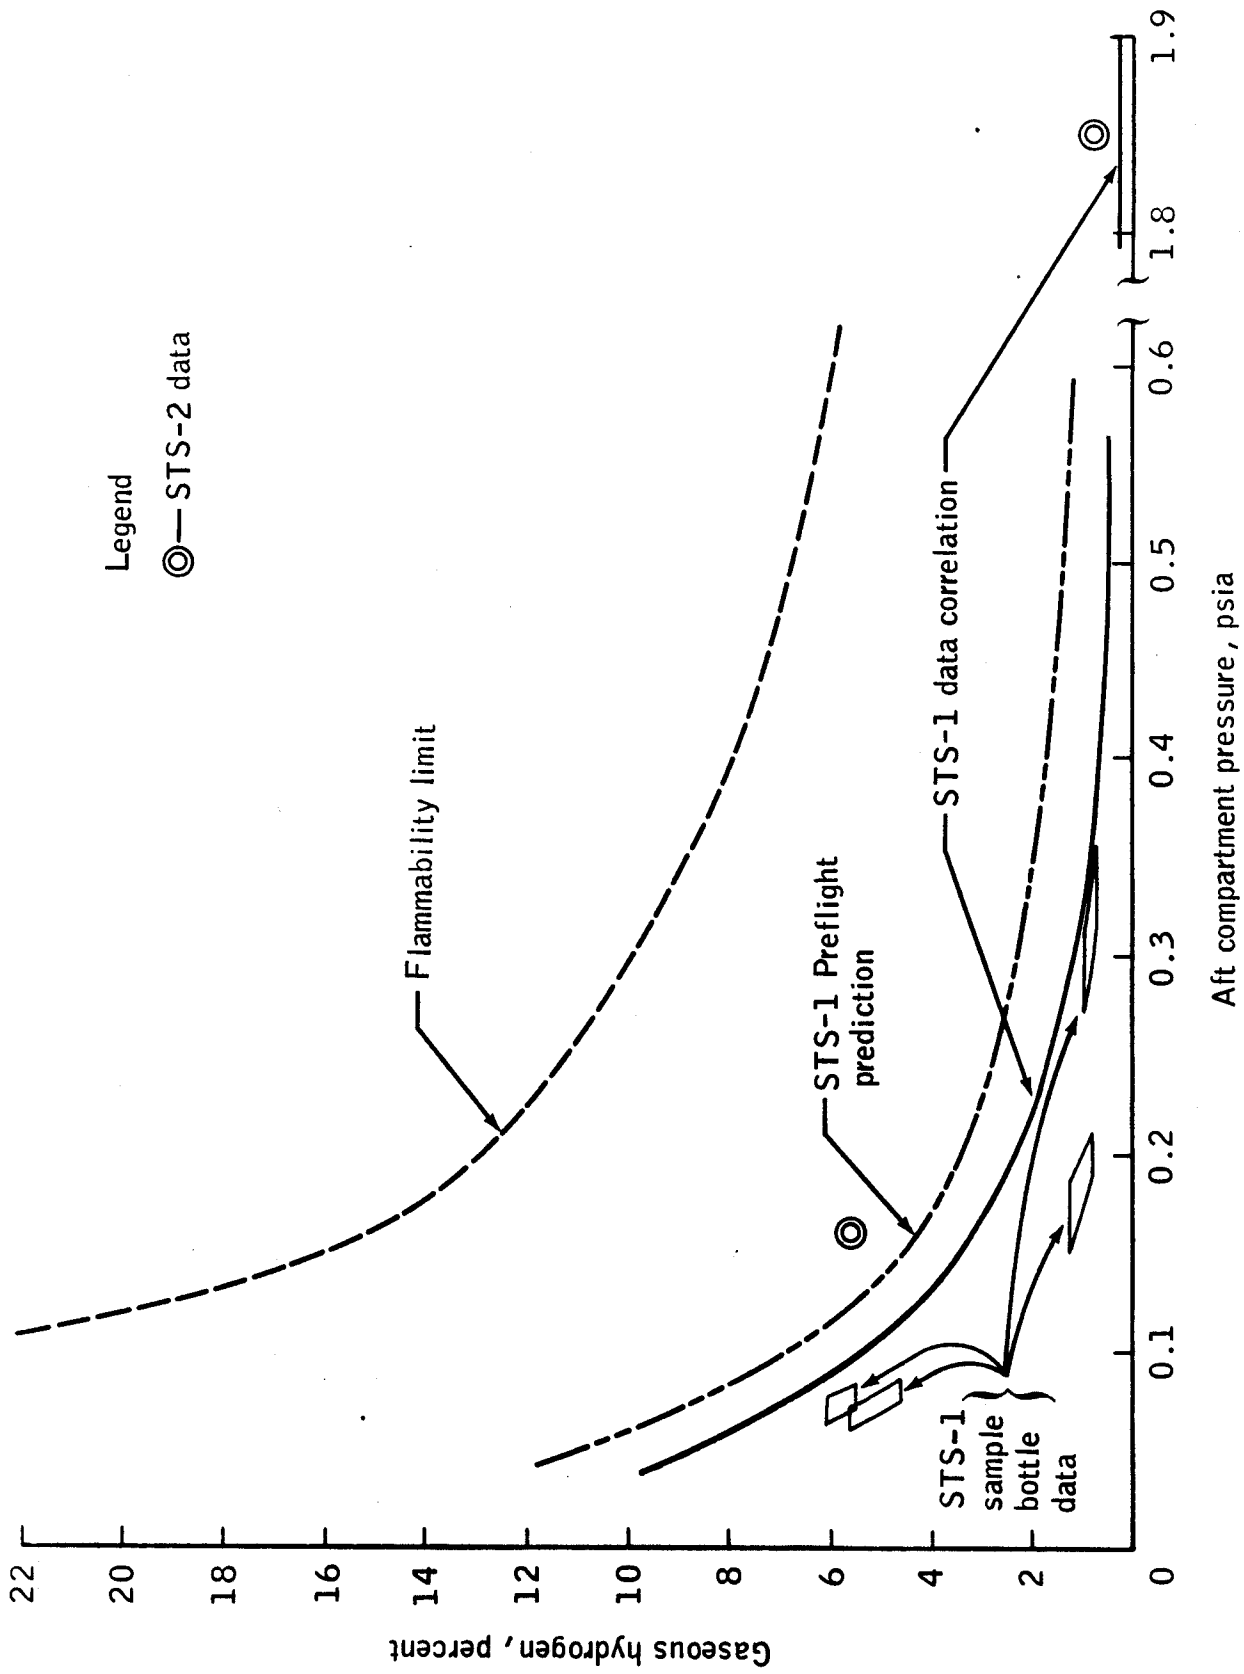
Figure 2-2.- Aft compartment hydrogen concentration.

The gaseous hydrogen concentrations during ascent are found on figure 2-2 together with the results from STS-1. The gas sampling device failed on one bank of three bottles; therefore, no samples were collected in those three bottles. (Section 7.0, flight test problem report 42.) Of the remaining three bottles, one leaked and contained air. The concentrations in the two good sample bottles are shown on figure 2-2. The STS-2 data were significantly above the STS-1 concentrations, but well below the flammability limit, indicating a hazardous concentration did not exist.

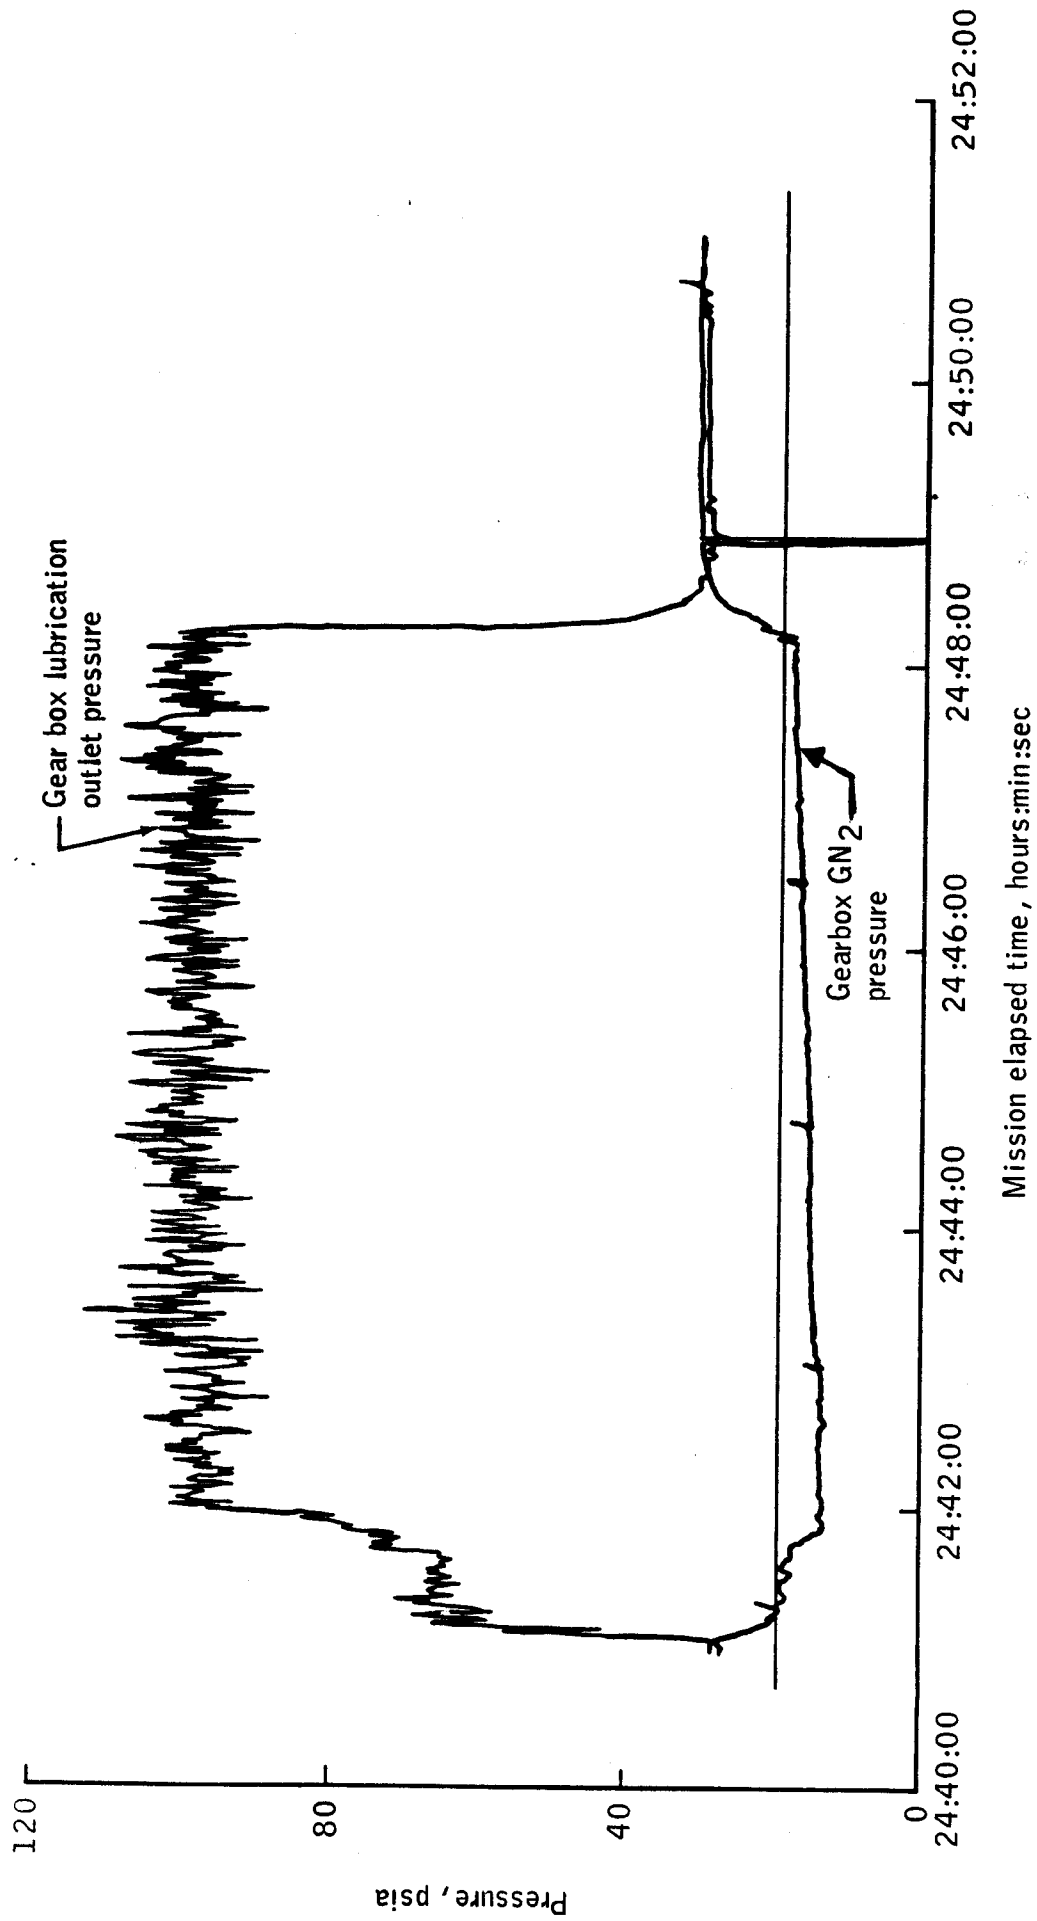
Figure 2-5.- APU I lubrication oil outlet pressure.

During the first launch attempt, APUs 1 and 3 lubrication oil outlet pressures increased to over 100 psia, indicating that the filter was plugged, as shown in figures 2-5 and 2-6. (Section 7.0, flight test problem report 1.) The lubrication oil was drained, the filters examined, and a contaminant isolated. The contaminant was pentaerythritol, a crystal formed when hydrazine penetrates the gearbox. The gearboxes were flushed and reserviced. No plugging was indicated during ascent, but the APU 1 filter plugged again briefly during descent.

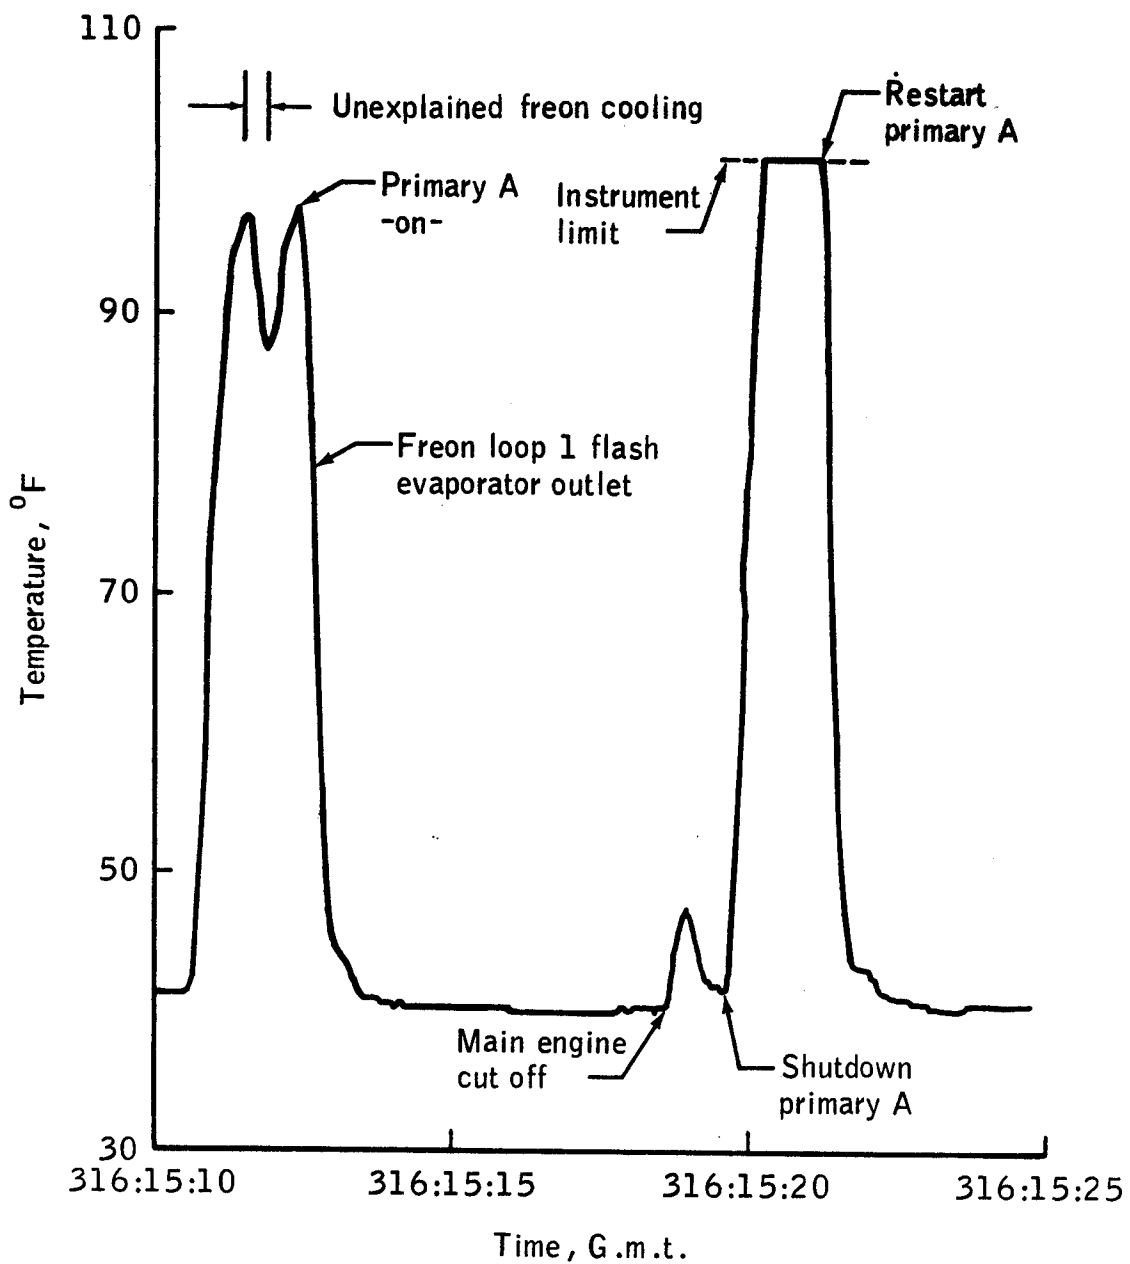
Figure 2-12.- Flash evaporator transients during ascent.

During the flash evaporator freon outlet temperature transient after MECO, the flash-evaporator primary A controller shut down. Figure 2-12 shows this shutdown and the subsequent successful restart. A description of this shutdown and subsequent flash evaporator anomalies is given in section 7.0, flight test problem report 11.

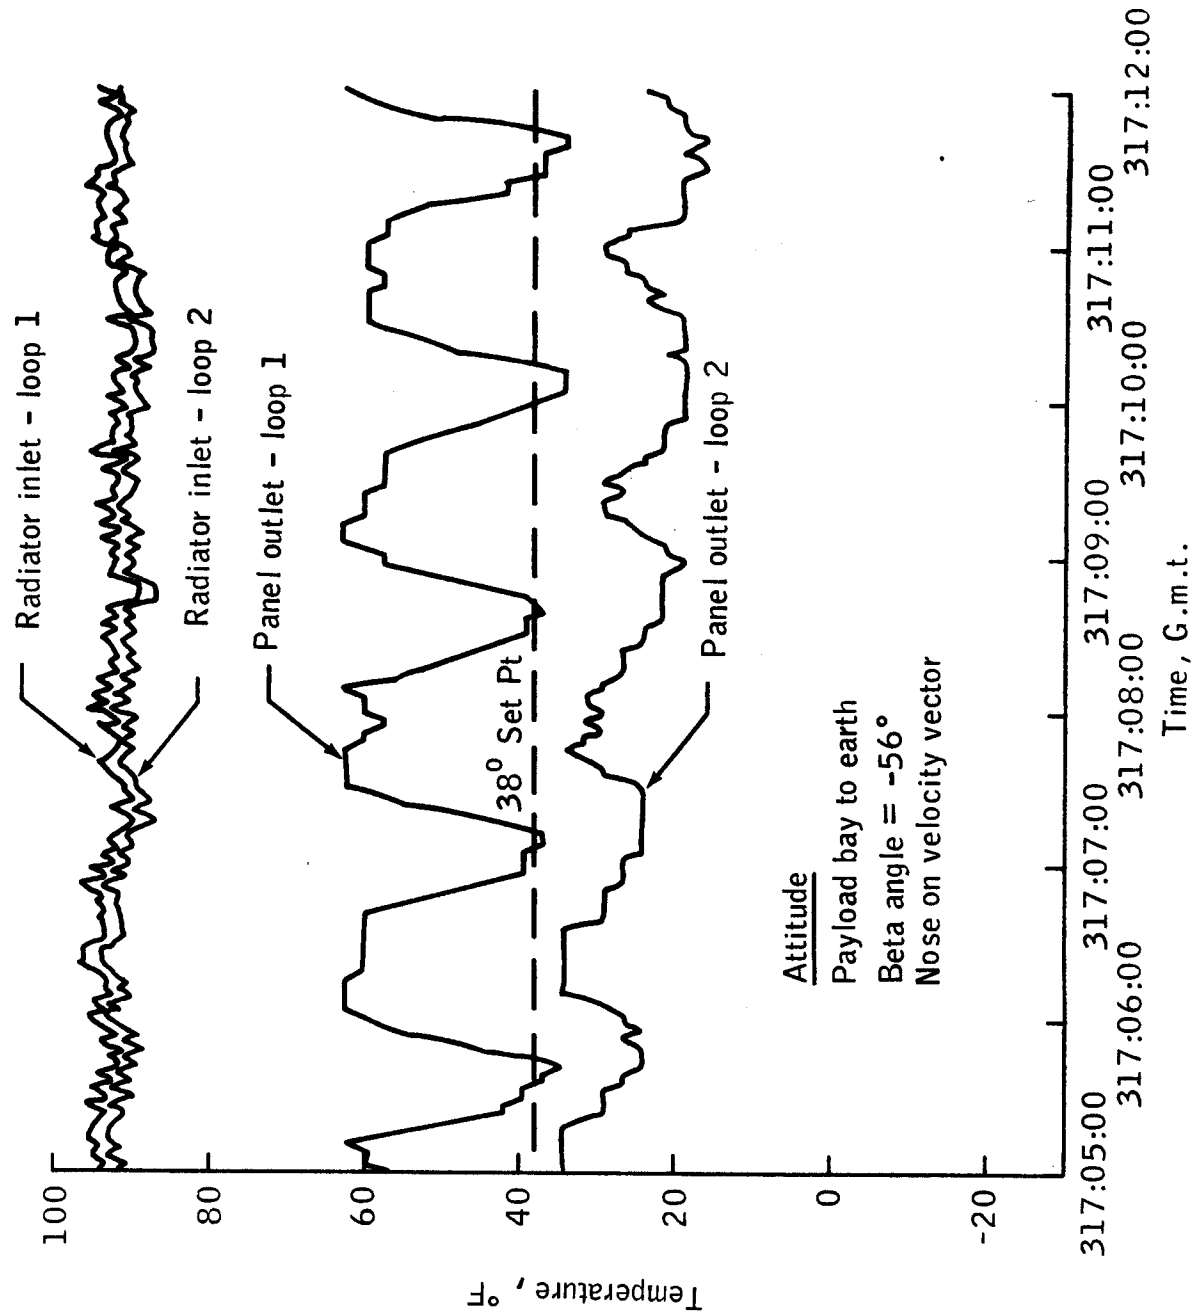
Figure 2-14.- STS-2 radiator performance.

About 2.5 hours after launch, upon positioning the flow proportioning modules to the "payload" position, fault messages were triggered during the normal momentary drop in interchanger freon flowrates as the valves moved. The port radiator heat rejection during the STS-2 mission was significantly less than the starboard heat rejection during the top-to-earth, nose-on velocity-vector attitude. This behavior is due to the high beta angle flown, causing a higher amount of solar radiation to enter the forward radiator cavity on the port side than on the starboard side, as shown in figure 2-13. The radiator inlet and outlet temperatures are shown in figure 2-14 where FCL (freon coolant loop 1) (port side) was not controlled to the 38° F set point while FCL 2 (starboard side) was controlled to the 38° F set point. (Section 7.0, flight test problem report 11.)

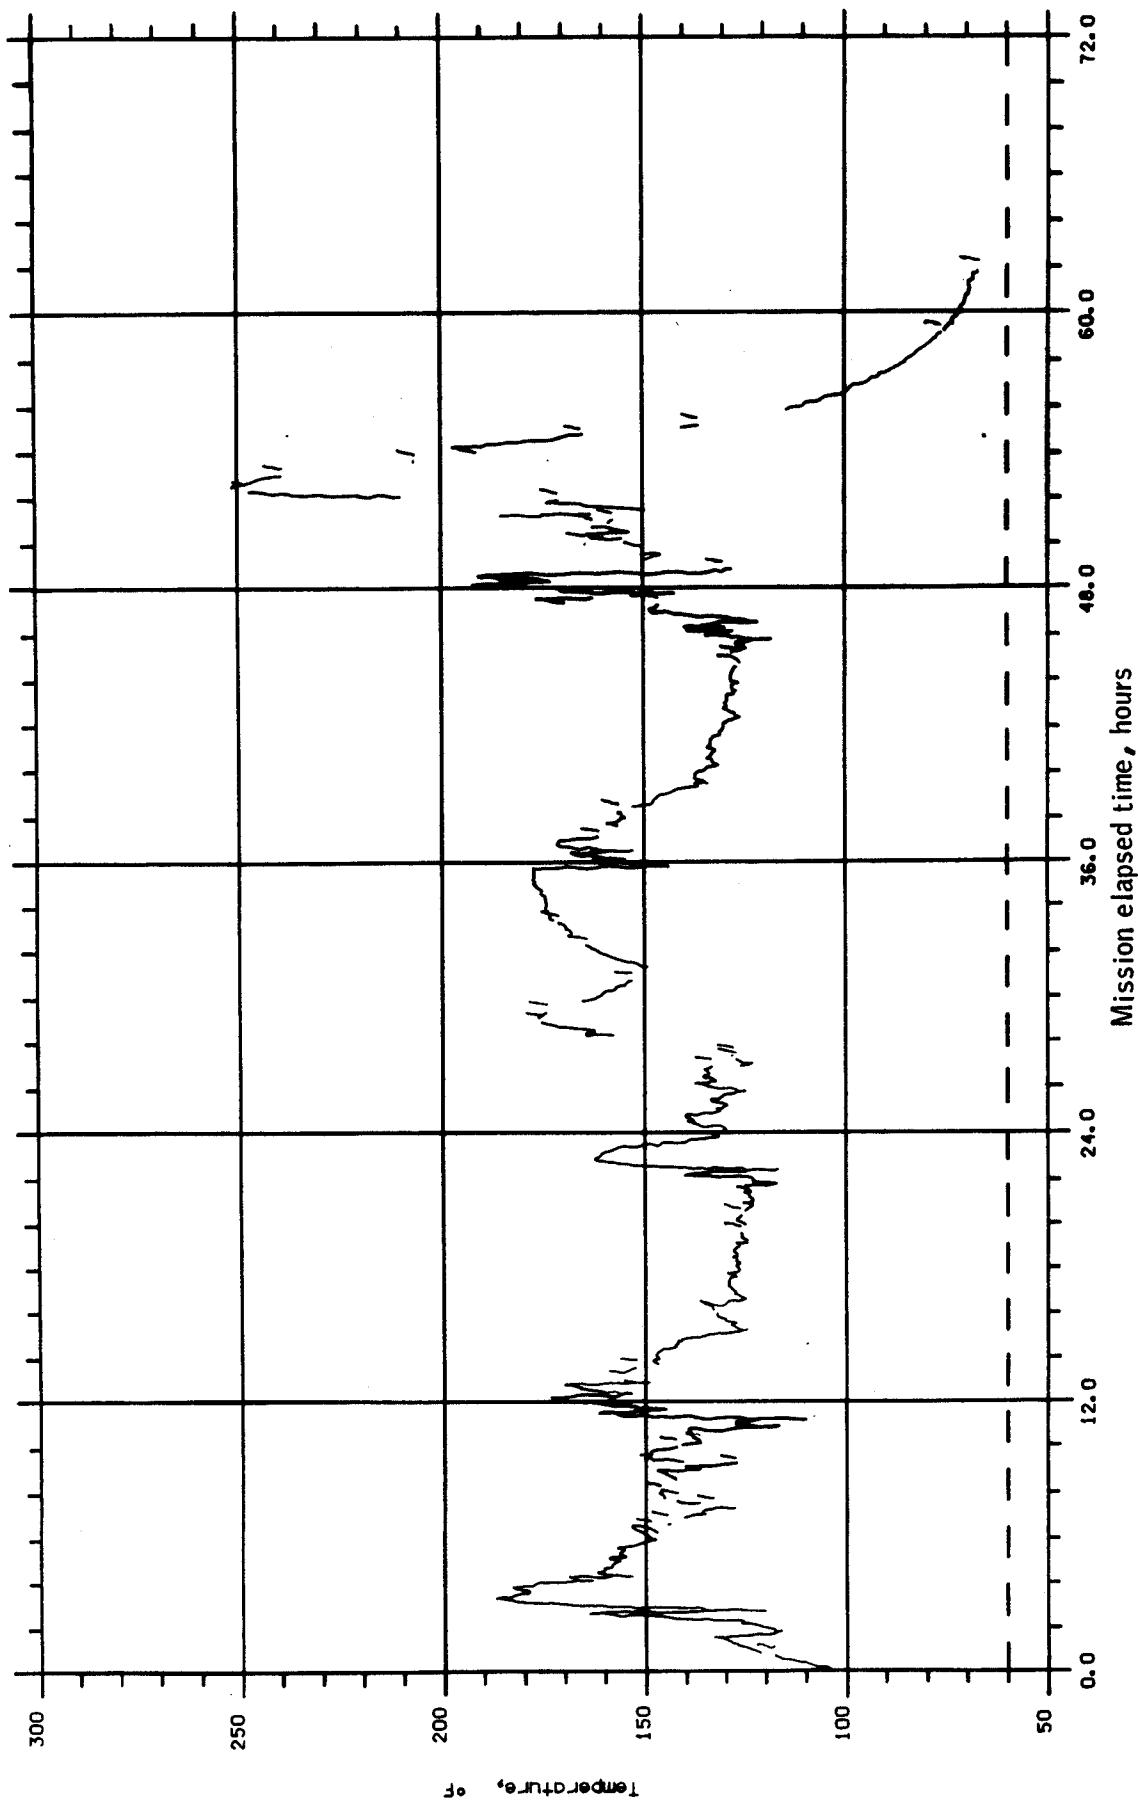
Figure 2-27.- Fuel valve temperature on engine F5L.

At approximately 318:17 G.m.t. to 318:18 G.m.t., heavy VRCS firing activity occurred, causing the F5L engine fuel valve temperature (V42T9111) to reach 250° F while the oxidizer injector temperature (V42T1529) had exceeded its upper transducer range of 250° F, (figure 2-27). (Section 7.0, flight test problem report 46.)

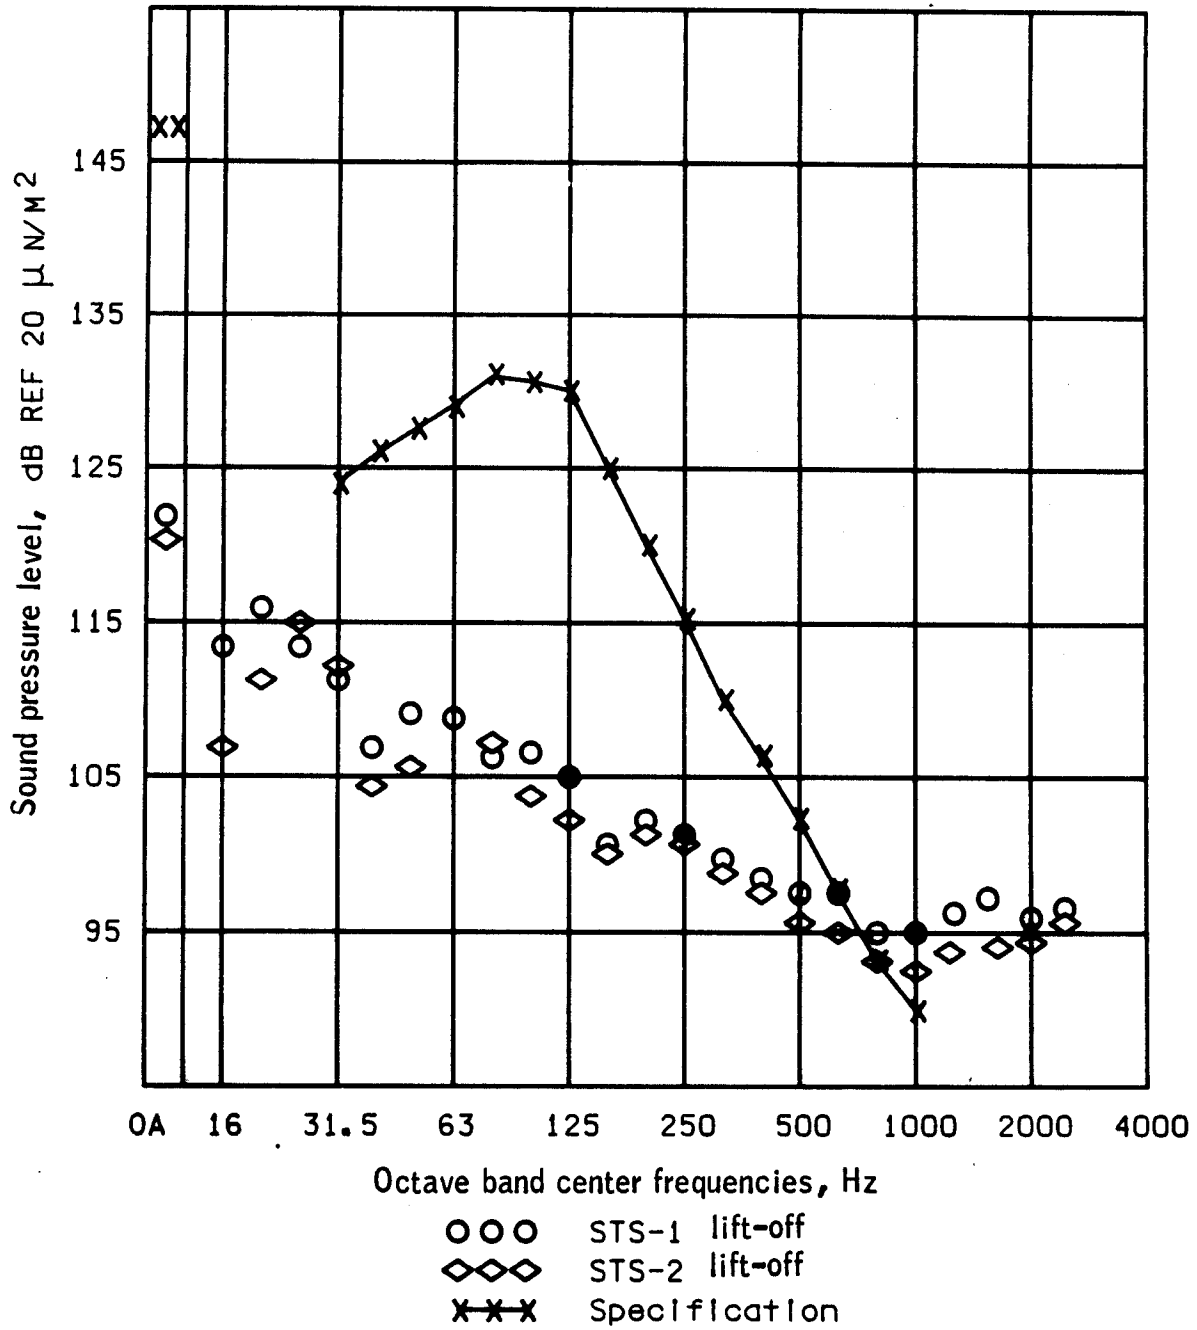
The measured noise level at the pilot's seat in the crew compartment cabin area (figure 3-3) is 2 dB lower than the overall levels that were measured on STS-1 for the same ascent event (SRB ignition/lift-off), and are well below specification level. A cursory review was made of the data during the OMS and RCS firings and the levels were in the noise threshold of the transducers.

Figure 3-3.- Acoustic measurements at the pilot seat in cabin area.
