STS-3 Orbiter Mission Report

June 1982

Lyndon B. Johnson Space Center
Houston, Texas

STS-3 ORBITER
MISSION REPORT

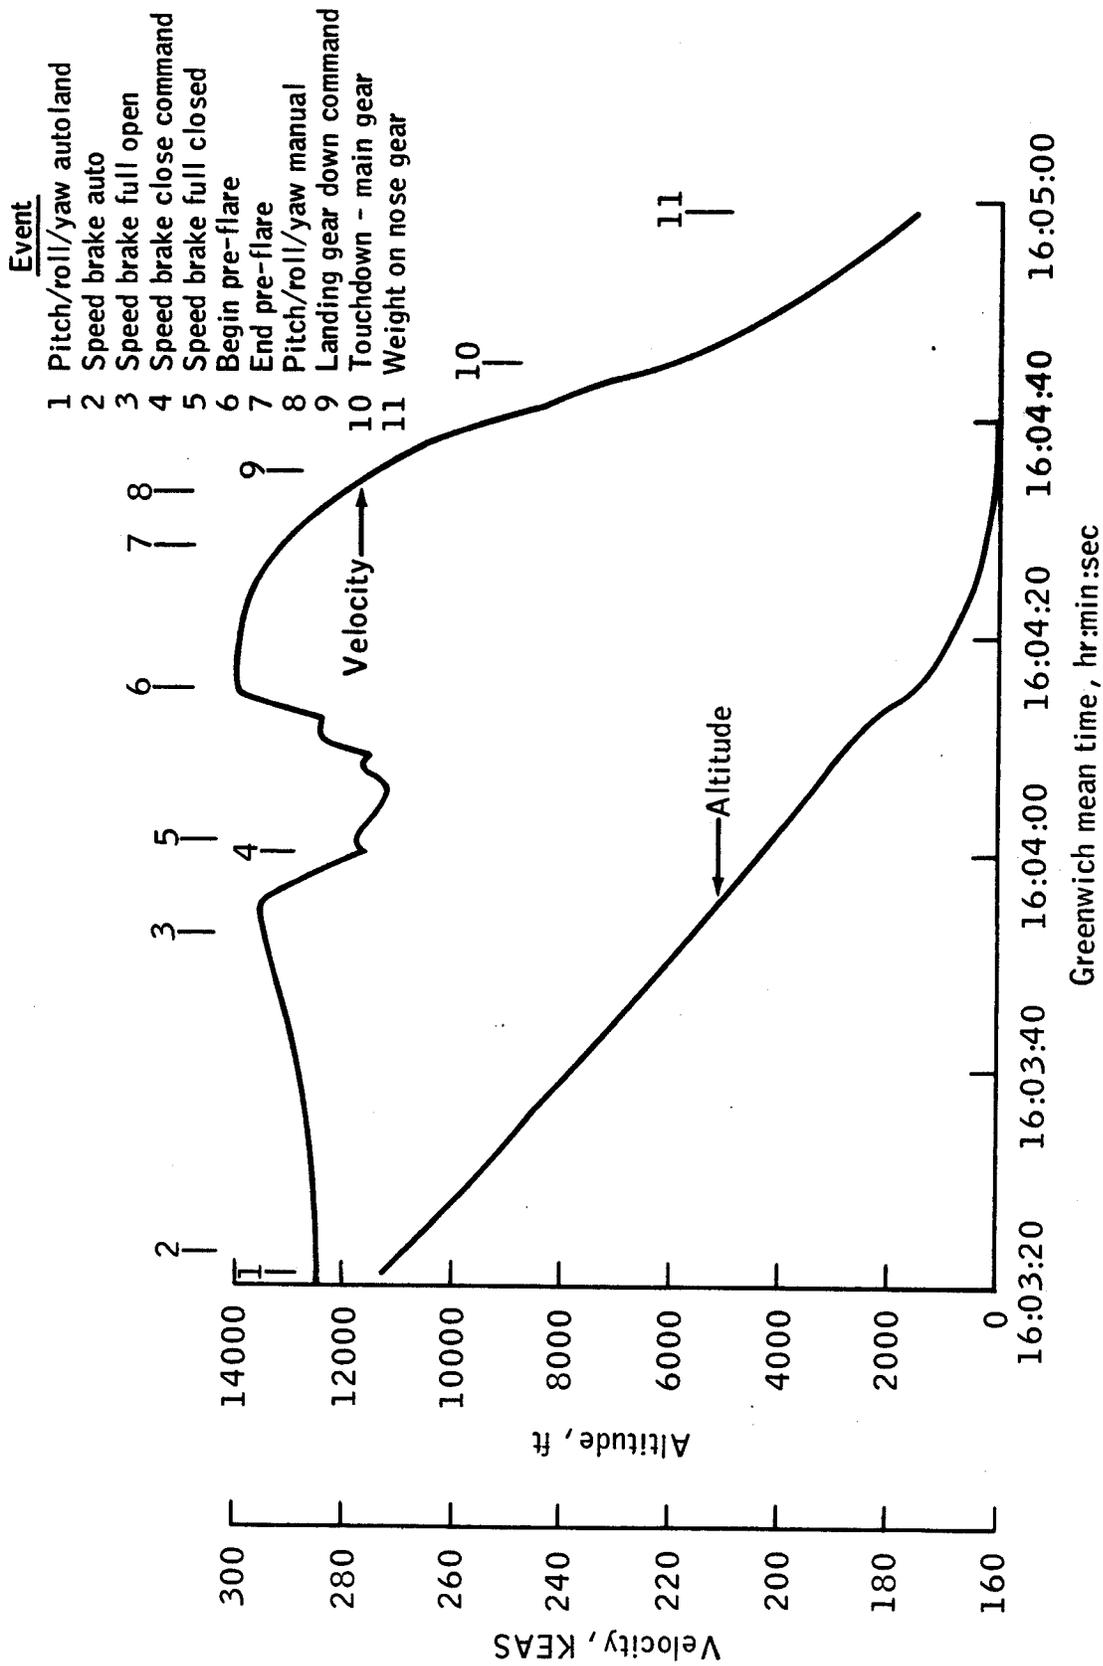
Figure 2-3.- Trajectory and velocity data during final portions of entry.

Figure 2-3 shows the EAS (estimated air speed) and descent trajectory during the final 10,000 ft of descent. Figure 2-4 shows wind speed with respect to runway position, speed brake position, and flightpath angle during the final 10,000 ft of descent. At 8000 ft altitude, the wind began shearing from 2 knots tailwind to a 3 knots headwind at 7000 ft. Then there was drastic shearing of the wind up to 22 knots at 6000 ft. This wind change caused the EAS to increase which in turn caused the speed brake to be driven out to a maximum value of 98.6 degrees at 5000 ft. The wind level started decreasing at 6000 ft, and the EAS reversed its trend at 5500 ft. This resulted in an overshoot of the 285 knot target-value down to 273 knots at 3500 ft and because the speed brake setting at 4000 ft (38 degrees) was less than the software criteria of 55 degrees, the system retracted the speed brake to the closed position.

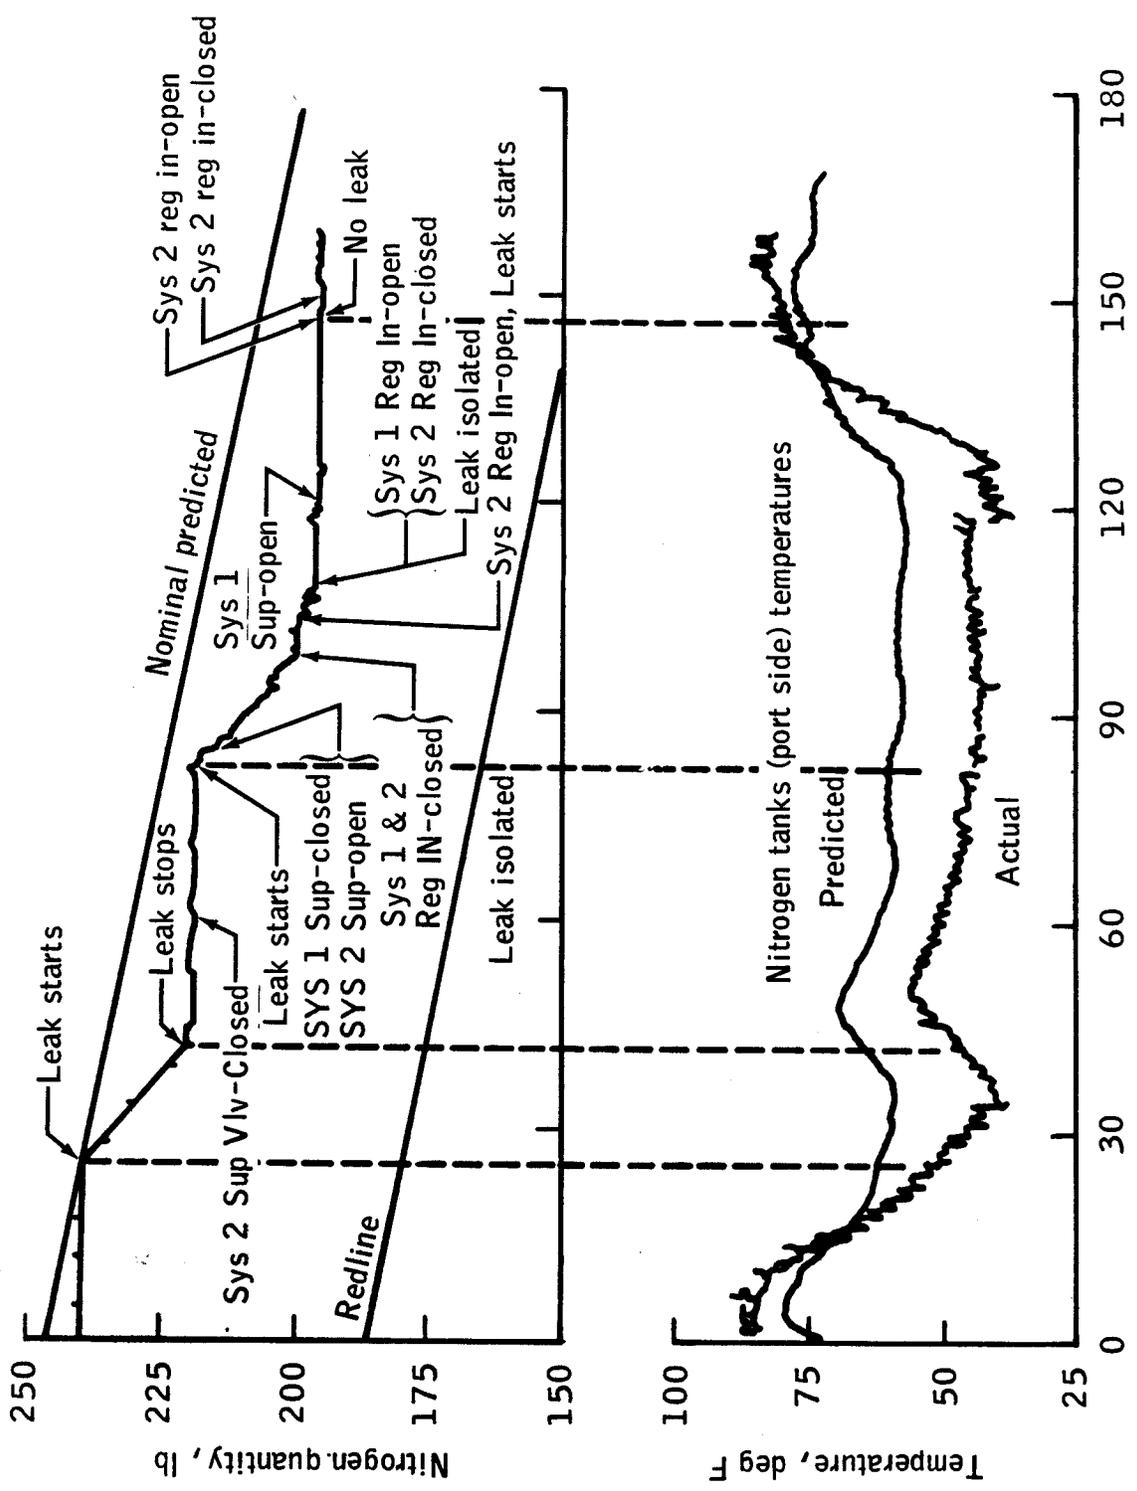
Figure 2-7.- Nitrogen leak data.

During the cold tail-to-Sun and nose-to-Sun attitudes, a GN₂ leak of approximately 1.2 lb/hr was noted. This GN₂ leak disappeared during vehicle orientation to warm attitudes. Figure 2-7 reflects leak start and stop times, valve configuration and N₂ tank temperatures for the entire mission. A detailed description of this GN₂ leak is given in section 7.0, flight test problem report 17).

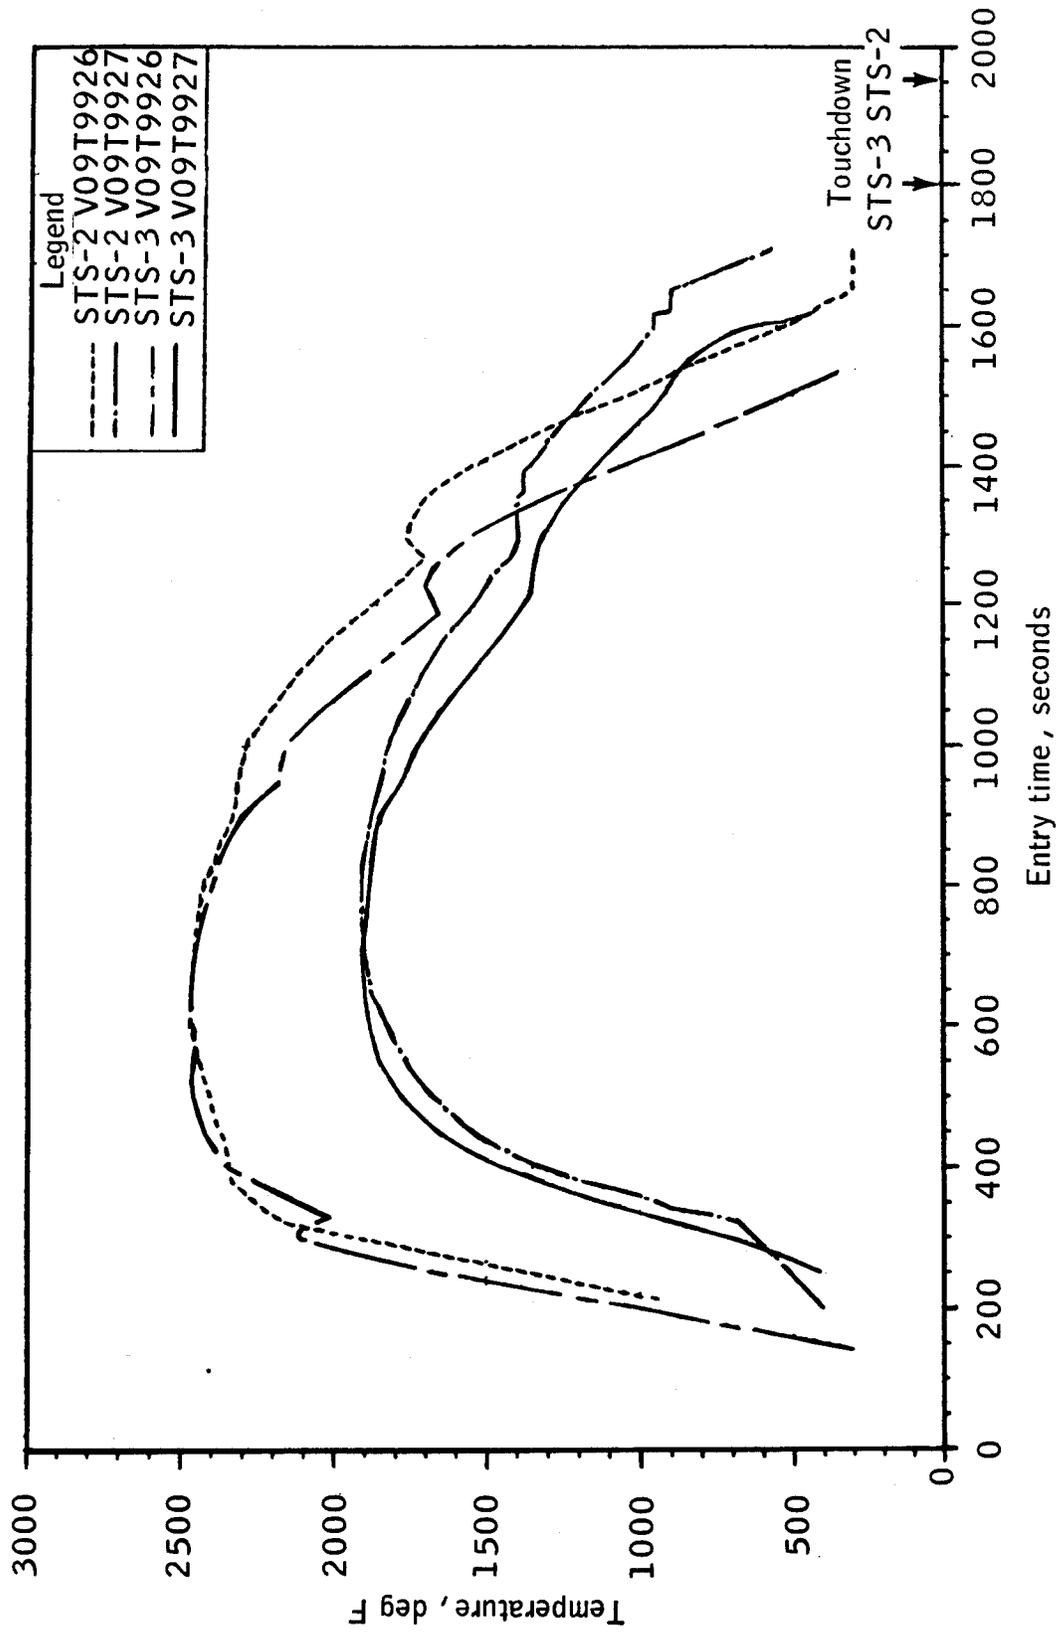
Figure 2-12.- STS-2 and STS-3 Comparison of LESS and RCC panel 9 temperatures.

2.8.2.2 Wing Leading Edge.- Figures 2-12 and 2-13 present time histories of the RCC IML (inner moldline) temperatures for the STS-2 and 3 flights from the 55- and 80-percent semi-span leading-edge radiometers. Shock interaction effects in the 55-percent area produced higher localized heating as shown in these figures. Figure 2-14 compares the measured flight temperature response of lower panel 16 (80 percent) Inconel clevis. As can be seen from these figures, no degradation in the thermal performance has occurred from the STS-1, 2, and 3 flights. Table 2-XIV presents a summary of the wing leading edge DFI temperature measurements for the STS-3 flight. The wing leading panels were all examined externally for evidence of anomalies, chips, cracks, etc., from the STS-3 mission. Three small coating chips on panels 3 left-hand, 11 right-hand, and 18 right-hand were repaired with the launch site coating repair. Areas of discoloration as a result of gas flow-through at the RCC/HRSI interface panels were significantly reduced from the STS-2 flight results.

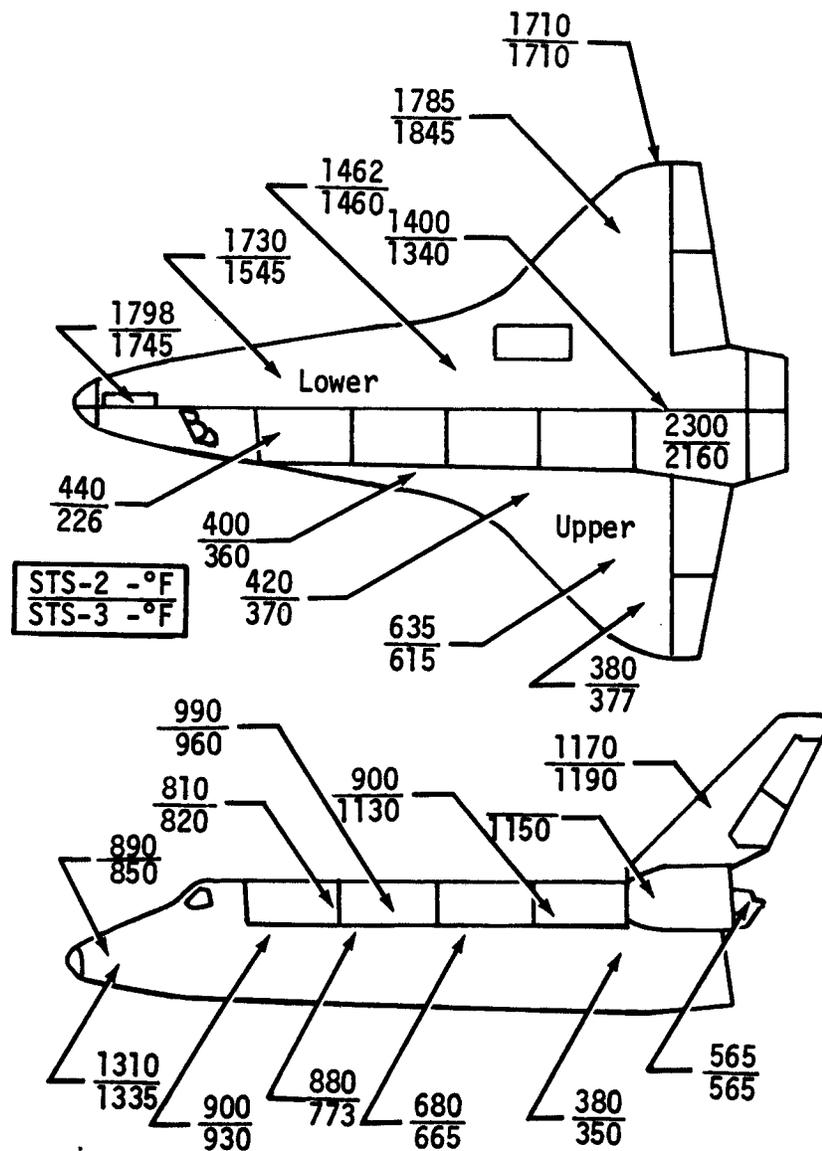
Figure 2-15.- STS-2 and STS-3 peak entry surface temperature comparison.

2.8.2.6 Thermal Protection Reusable Surface Insulation: Good DFI data were obtained during entry and these data showed in general that STS-3 was slightly cooler than STS-2. Figures 2-15 and 2-16 compare the STS-2 and STS-3 peak measured surface and structural temperatures, respectively, during entry. Figures 2-17, 2-18, and 2-19 show some typical comparisons of flight data with the heating predictions at three locations on the lower fuselage.
