STS-4 Orbiter Mission Report

September 1982

STS-4 ORBITER

MISSION REPORT

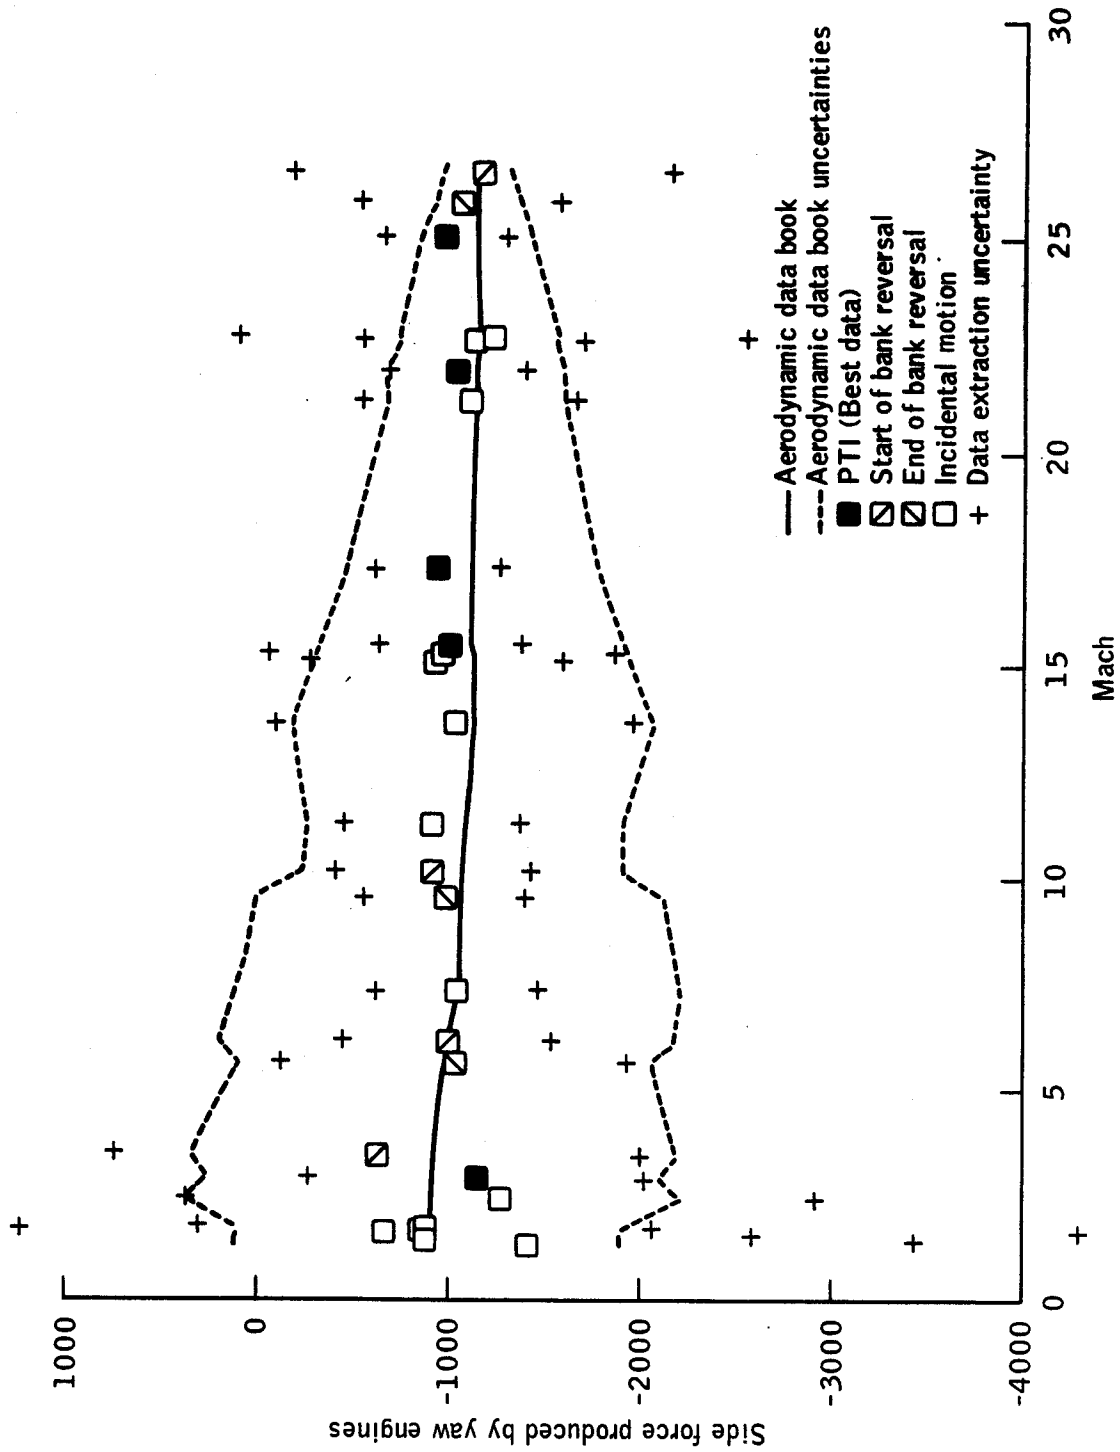
Figure 2-7.- Side force produced by RCS engines versus Mach number.

Figure 2-7 shows the side force (Y) produced by the RCS engines versus Mach number. The values determined are close to the data book values, indicating reliable data book values for the side force due to RCS (reaction control system) engines.

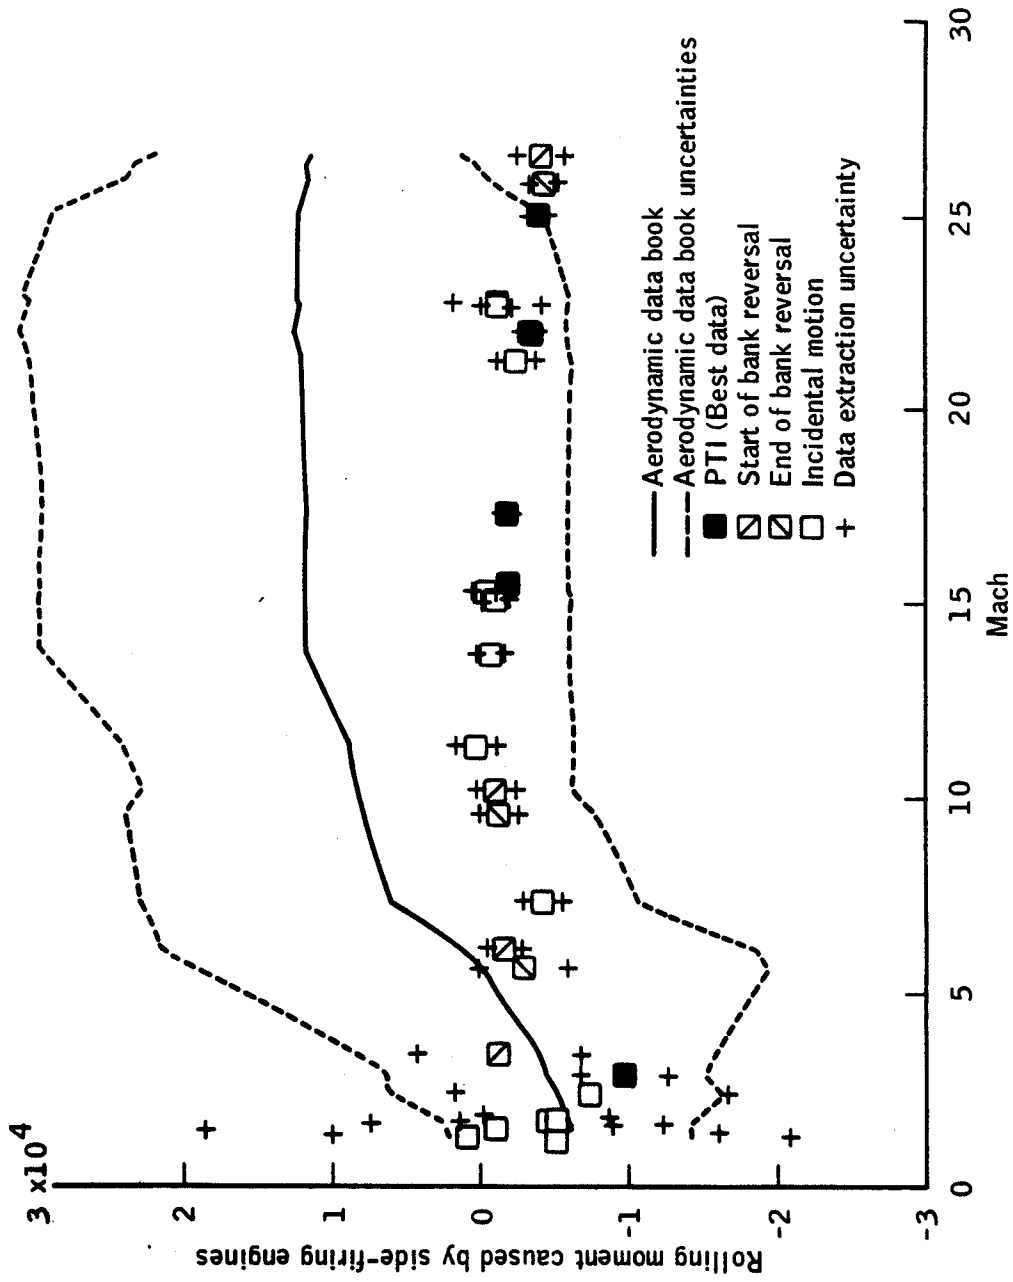
Figure 2-8.- Rolling moment caused by side-firing engines versus Mach number.

Figure 2-8 presents the corresponding rolling moment from the side-firing engines. As on STS 1 through 3, the flight results are consistent, reliable and different from the predictions. This difference has been identified as a wind tunnel scaling problem and the aerodynamic data base has been changed accordingly.

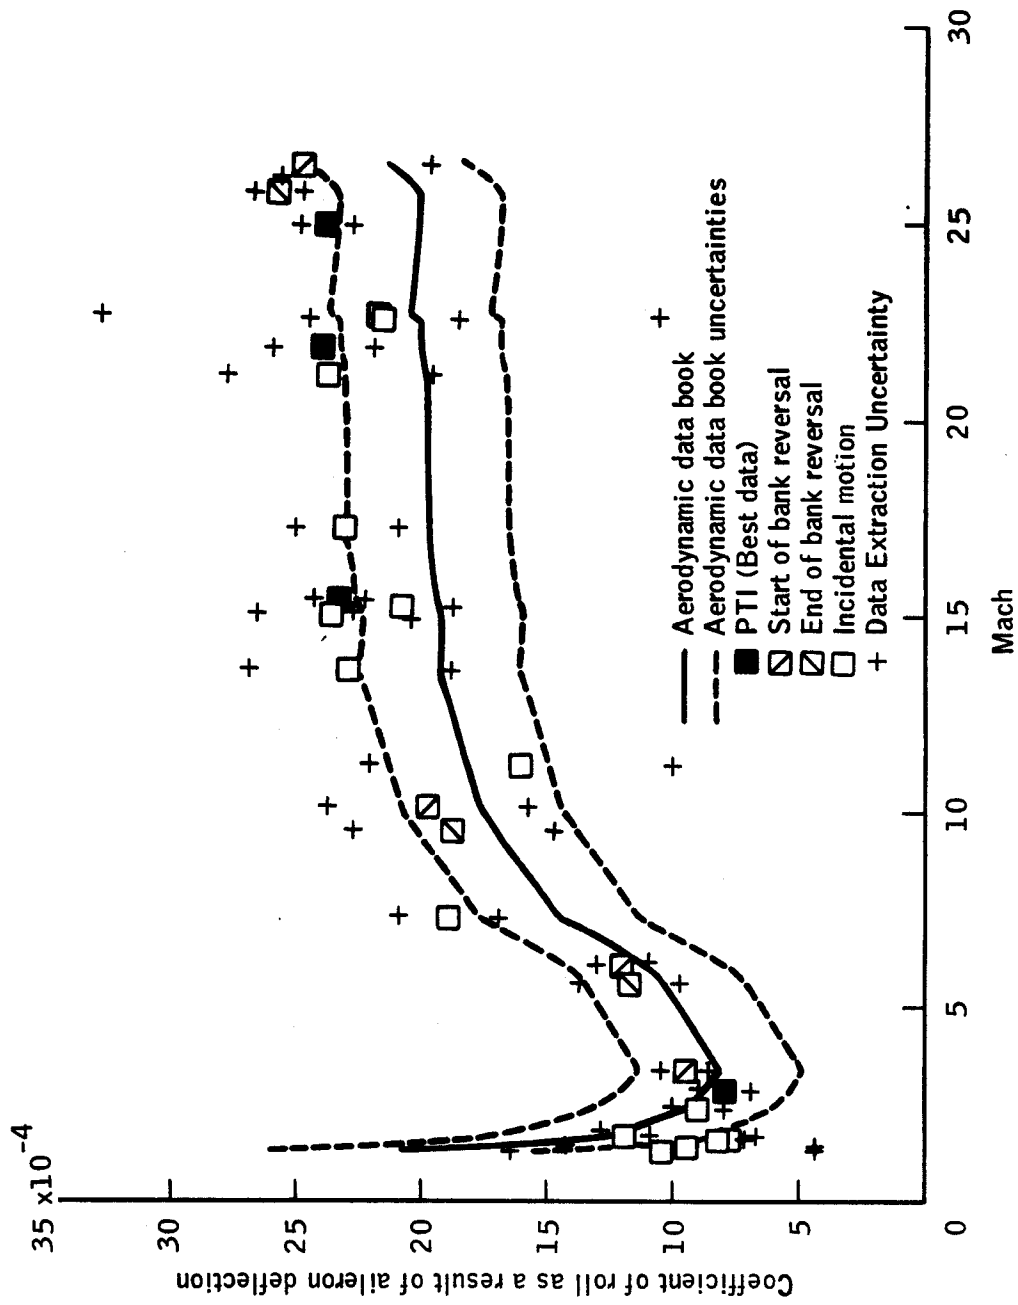
Figure 2-9.- Coefficient of roll due to aileron deflection versus Mach number for STS-4.

Figure 2-9 shows the coefficient of roll due to aileron deflection versus Mach number. Above Mach 10, the derived data are more positive than the data book values, indicating a greater amount of aileron effectiveness for roll above Mach 10. However, below Mach 5, the derived data are less positive than the data book values, indicating less control effectiveness. These results do not concur with STS-3 results (see figure 2-10). This is apparently due to an elevon setting of 5° on STS-4 compared to 3° on STS-3. Figure 2-11 shows the coefficient of yaw due to aileron deflection versus Mach. The flight data are more negative than data book values.

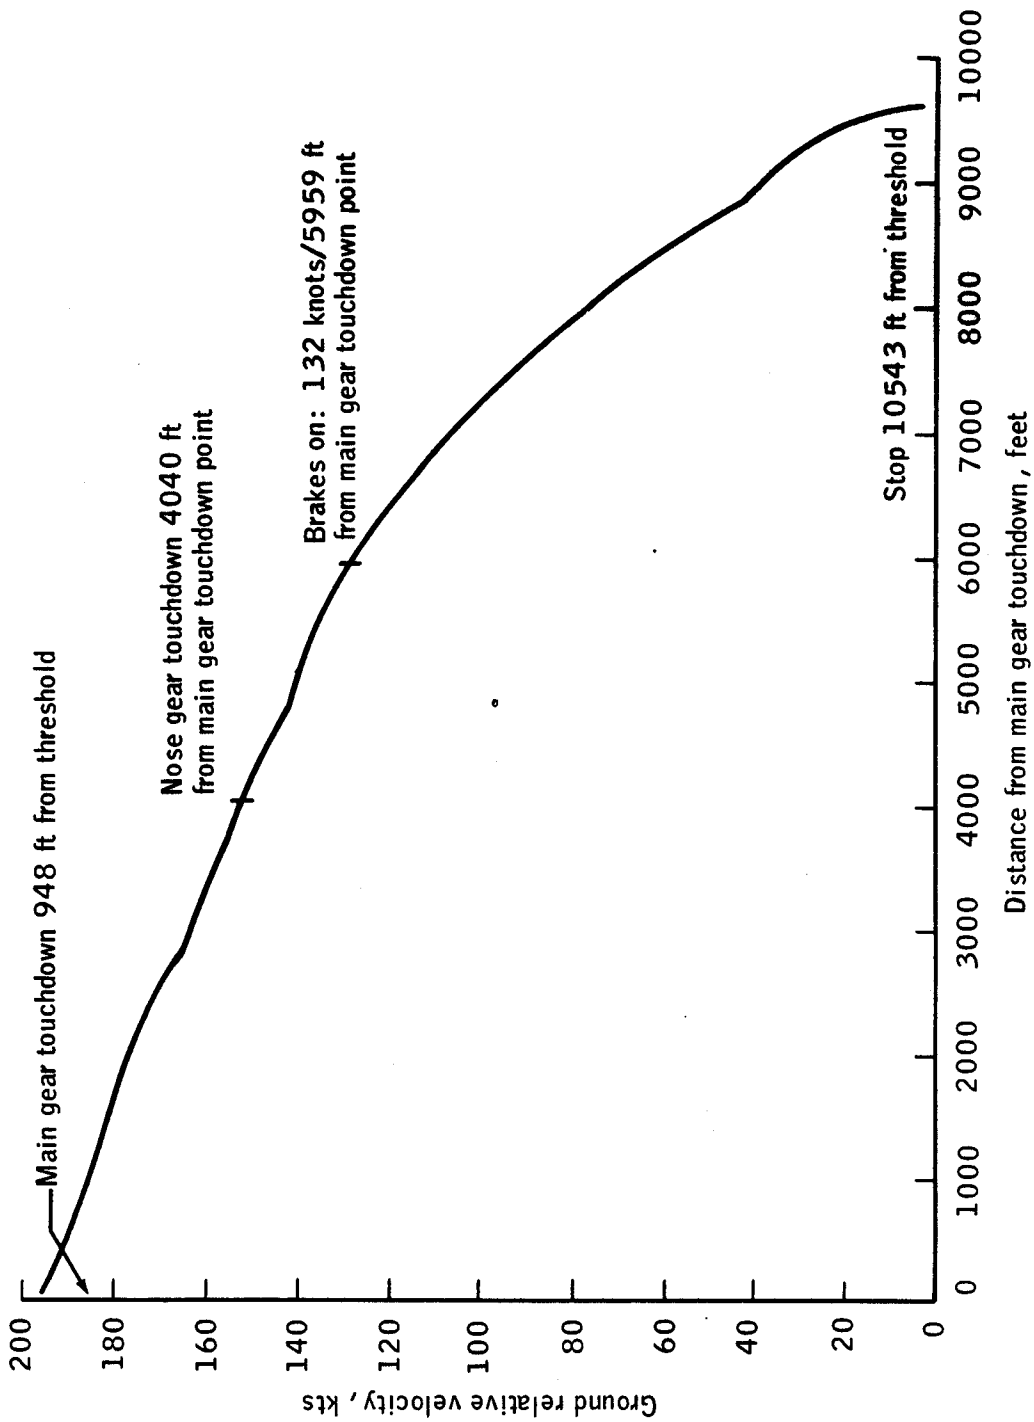
Figure 2-19. - STS-4 rollout time history.

2.9.7.2 Landing and Rollout.- Touchdown occurred at 185:16:09:39.9 G.m.t., at a sink rate of less than 1 ft/sec and 948 feet beyond the threshold. Nose-wheel touchdown took place 12.7 seconds later and 4988 feet from the threshold. Table 2-IV provides detailed performance values regarding speed during landing. Figure 2-19 shows the time history of the ground speed during landing. Nose-wheel steering was not engaged during the rollout.

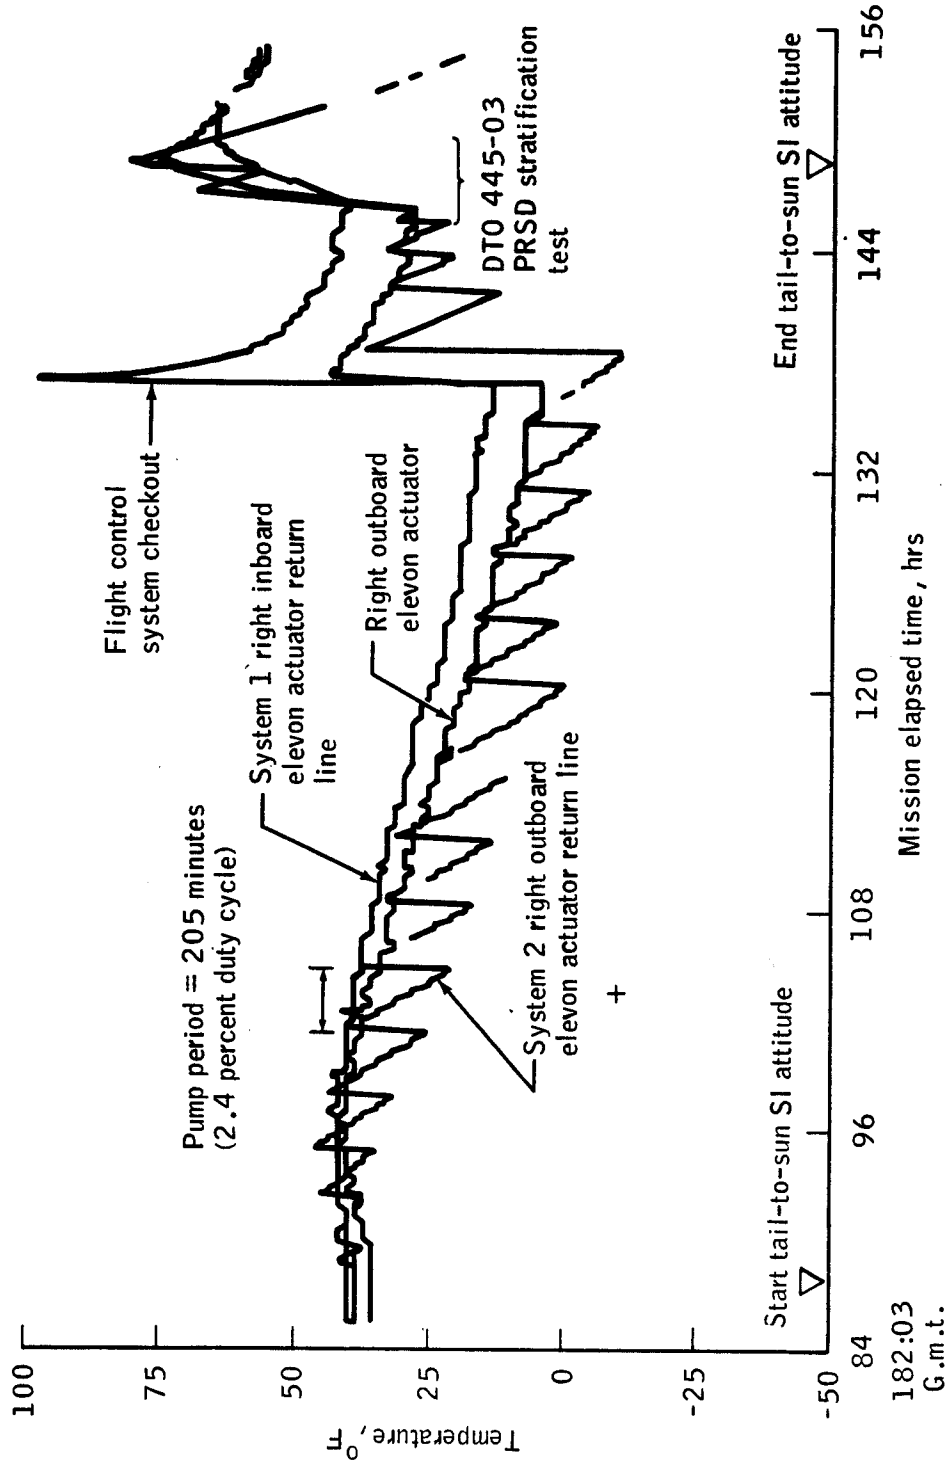
Figure 2-23.- Right wing hydraulics.

Figure 2-23 shows the timer mode thermal response for the ROEL (right outboard elevon) actuator and the system 2 ROEL actuator return line. The response of the system 1 REIL (right inboard elevon) actuator return line, which is located under the actuator insulation, is also shown. It can be seen that the 2.4-percent duty cycle was not adequate to maintain line temperatures above the desired 0° F. This points out the delicate balance which must be achieved to meet minimum temperatures while minimizing circulation pump run time.

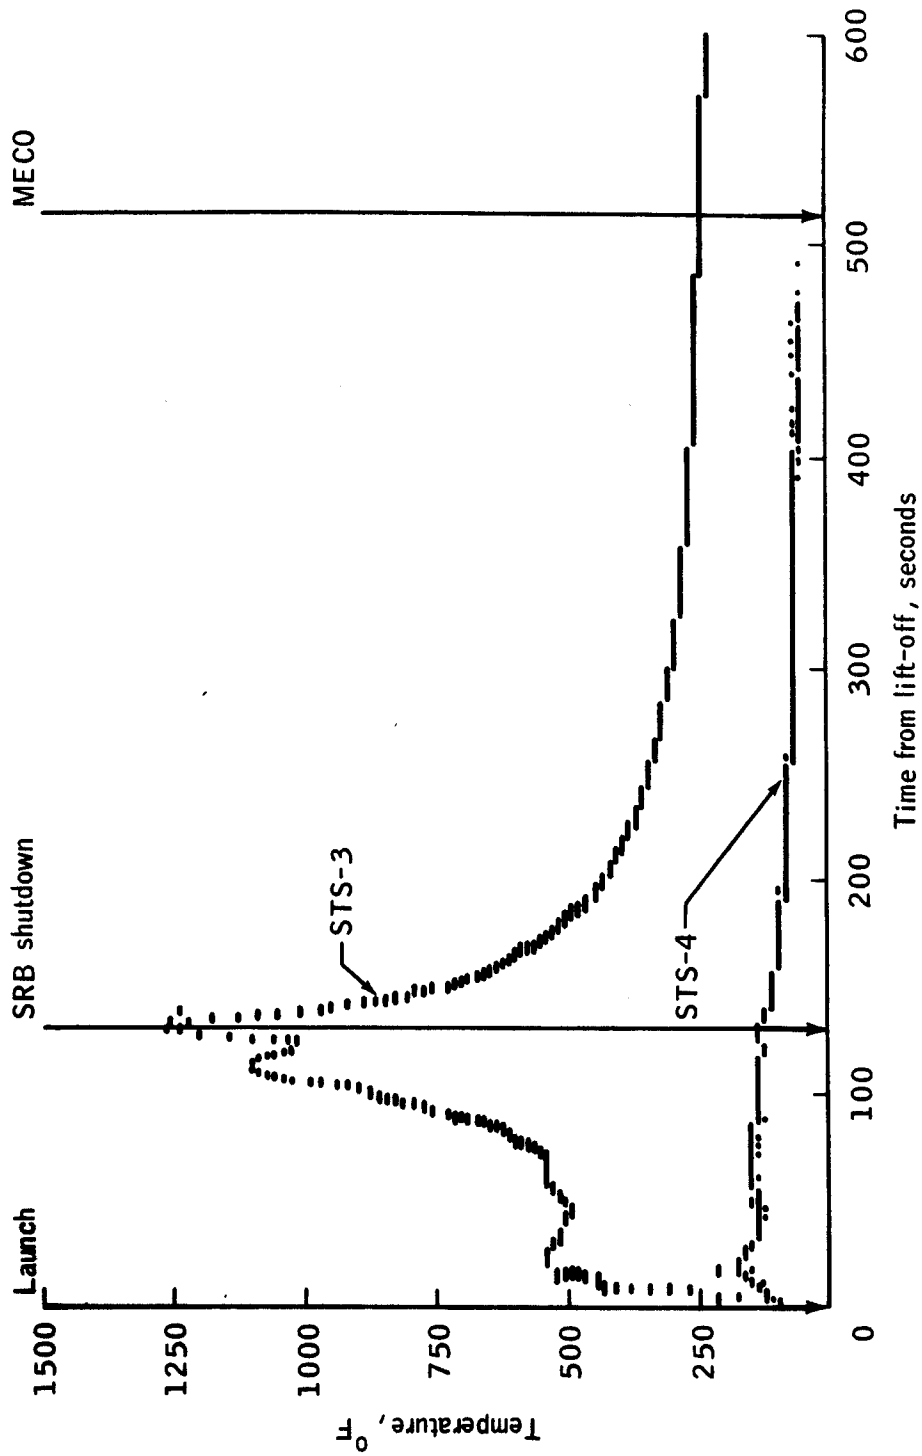
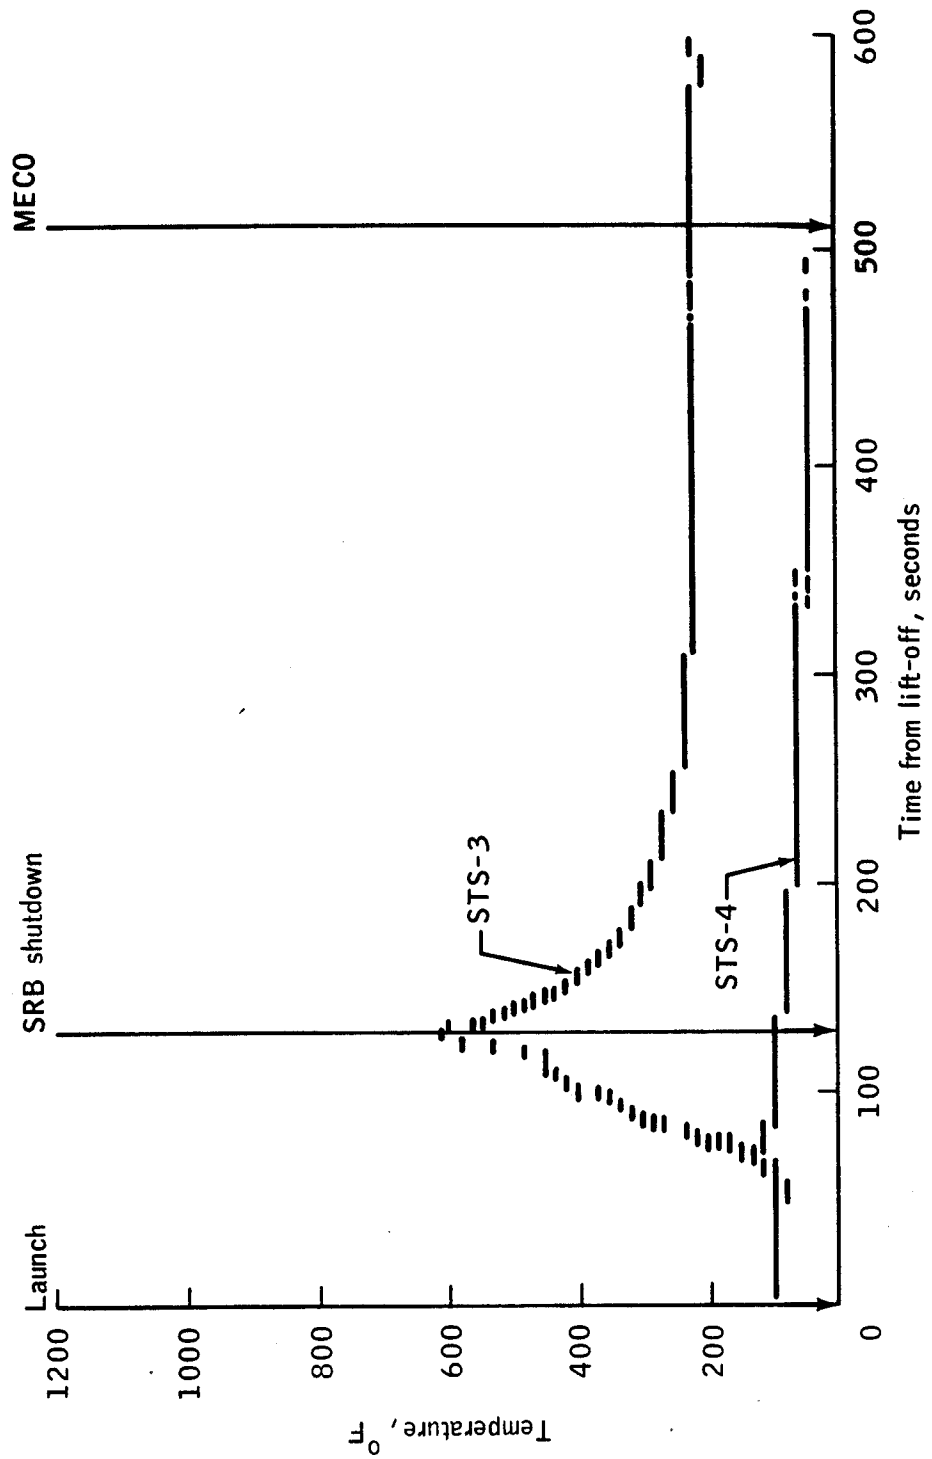
The night before launch a severe hail storm occurred at the launch pad damaging the surface of a number of tiles (Section 5.0, flight test problem report 1). An inspection of the Orbiter surface showed no damage that would restrict a safe entry and therefore, the launch proceeded as planned. The T+4 minute DFI surface temperature data indicated that many instrumented tiles had entrapped water. Subsequent ascent temperature response data of all DFI measurements conclusively showed water in many instrumented tiles. Figures 2-24 and 25 show some typical wet tile temperature responses for STS-4 as compared to STS-3. These data confirmed the prelaunch decision to place the Orbiter in a solar inertial attitude

with the bottom toward the sun to dry the tiles prior to reaching a cold condition that would fracture the tiles as occurred during STS-2. This bottom sun attitude was maintained for almost 12 hours after which the normal planned attitudes were resumed. Subsequent data of indepth tile temperatures from remote sites indicated that some DFI tiles still may have contained some water and therefore, a second solar inertial bottom-to-sun attitude was established for 23 hours after which the data conclusively showed no water or ice to exist. After landing twenty representative tiles were removed and an inspection showed no evidence of any water/ice damage. In addition, extensive sidewall coating inspections showed no evidence of ice damage. One of the areas where the worst hail damage occurred was the right side of the forward fuselage as shown in figure 2-26 after landing. Another of the worst hail damaged areas was the lower right wing. This area was repaired prior to lift-off and suffered no adverse effects during entry.
