# STS-117 MDM OA2 Card 5 Failure

Presenter: Tim Reith

Date:  
06/15/2007

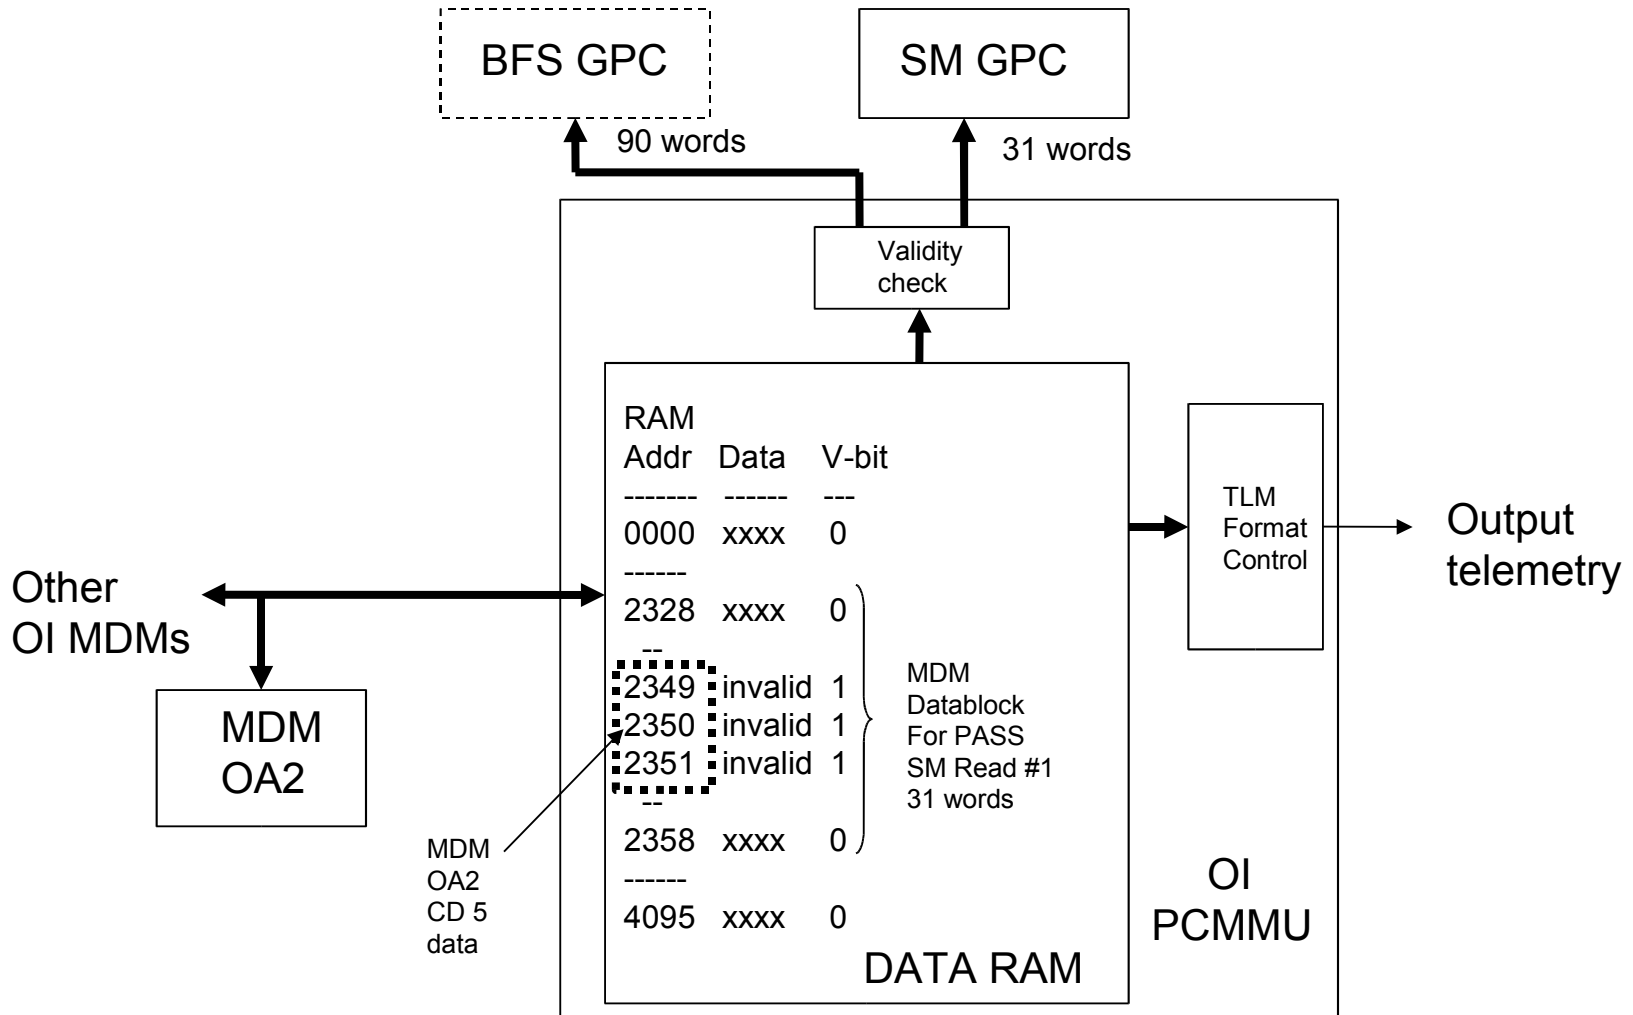
- At GMT 163/07:54:41, card 5 in MDM OA2 fails (BITE failed)
- At GMT 163/07:54:43, SM alert “S62 BCE BYP OA” annunciated
  - All OA2 SM read 1 words (31) are commfaulted and bypassed
