NASA/CR-2007-213697

Lessons Learned From Seven Space Shuttle Missions

John Goodman
United Space Alliance
Houston, Texas 77058

January 2007

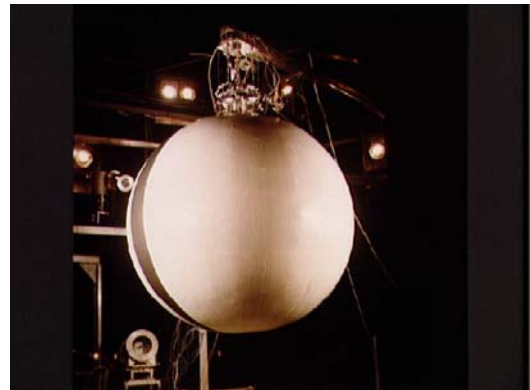
Figure 3 Test inflation of the back-up IRT balloon in a thermal vacuum test chamber.

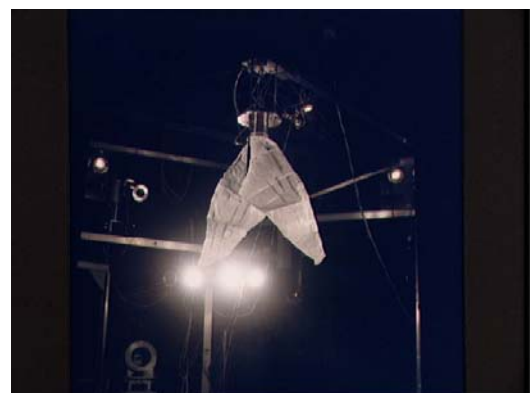
Figure 4 Deflated IRT balloon.

A post-flight investigation revealed that a lanyard connection failed open which prevented activation of a delayed action pyrotechnic charge that would have triggered the stave cable cutter sequence. An improper crimping tool was used when the lanyard assembly was manufactured. A different type of lanyard connection that was less susceptible to failure should have been used.

- **Quality control during manufacture should be rigorous enough to ensure that proper tools, procedures, and materials are used.** Malfunctions can result in degraded system performance or system failure that could negatively impact mission success or safety of flight.
- **Choose component designs and system architectures that lower the risk of failure and enable the system to function within requirements in the presence of failures.** Some proposed component designs and system architectures may be more robust than others.

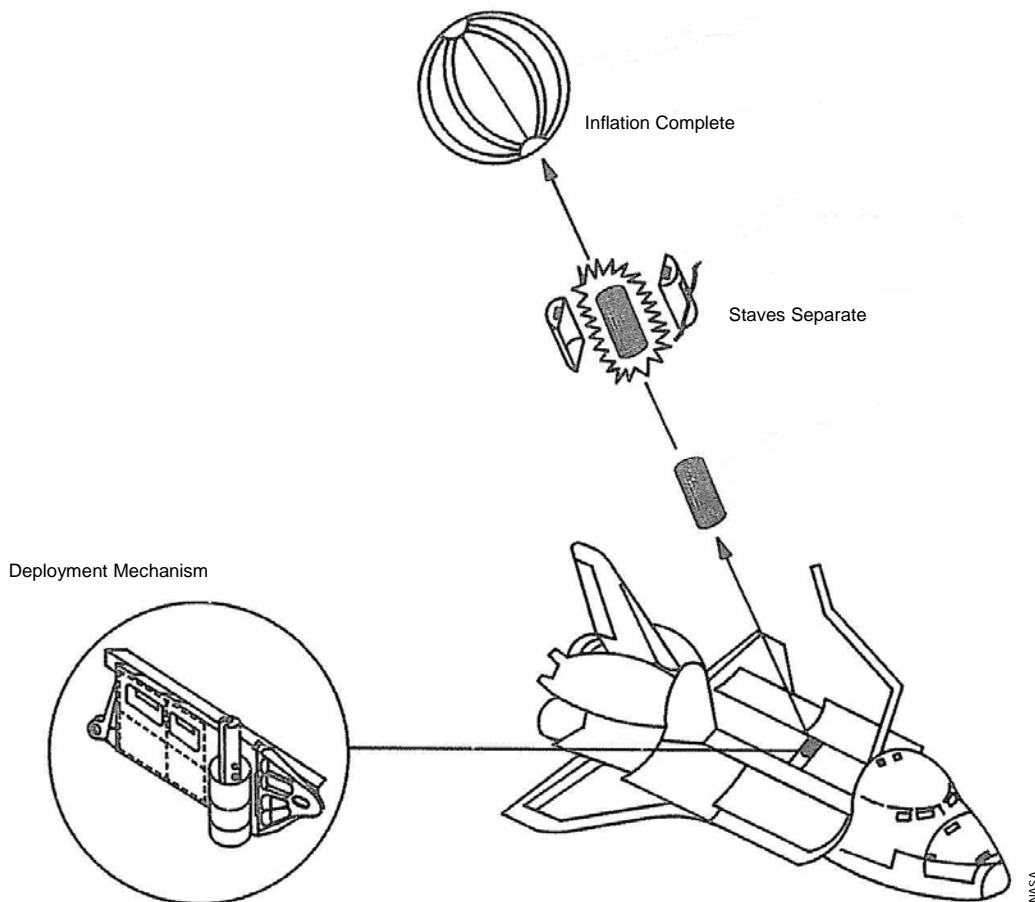
Figure 5 IRT deployment sequence.

The IRT was to be deployed from *Challenger* at 1.5 feet/second in a retrograde direction by a spring mechanism (Figure 5). At deployment three lanyards were to be pulled to activate two delayed pyrotechnic charges and to close a balloon bleed valve. Approximately one minute after deployment, at a range of approximately 75 feet, the first delayed pyrotechnic charge was to fire and separate the staves from the un-inflated balloon and inflation hardware. The second delayed pyrotechnic charge was to fire at approximately 80 seconds after deployment to initiate inflation of the balloon with gaseous nitrogen.

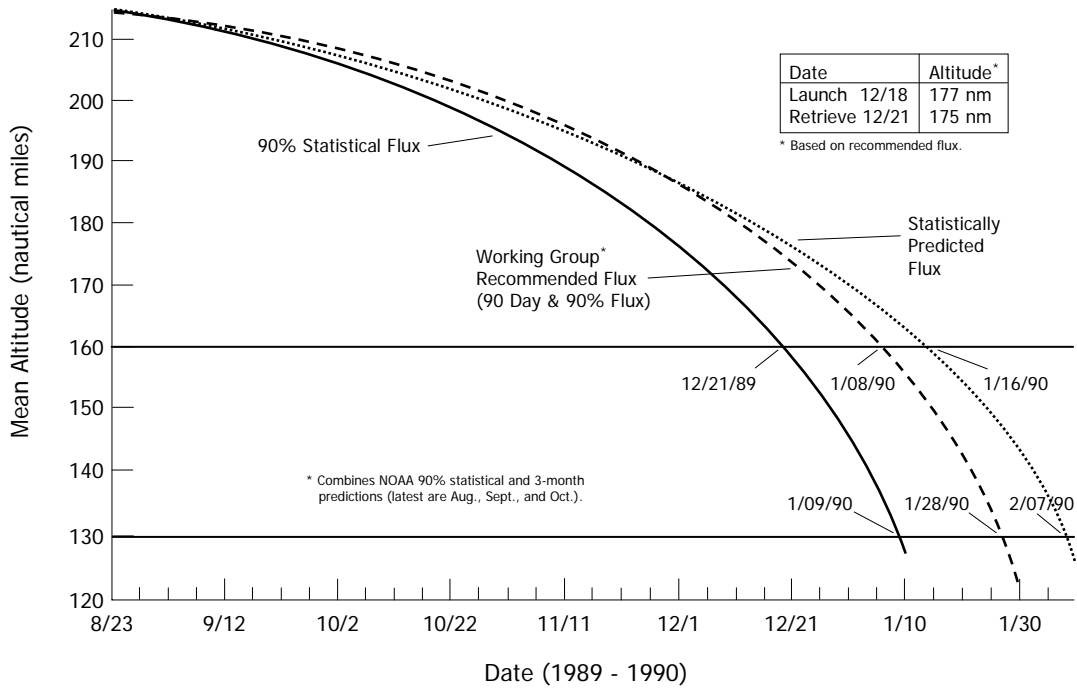
Based on current predictions LDEF will most likely arrive at 160 nm between 12/21/89 and 1/16/90. However, uncertainties will change these dates over the next 4 months.

Figure 9 September 1989 predicted orbital decay of LDEF. Plot courtesy of NASA/Cheryl Andrews.

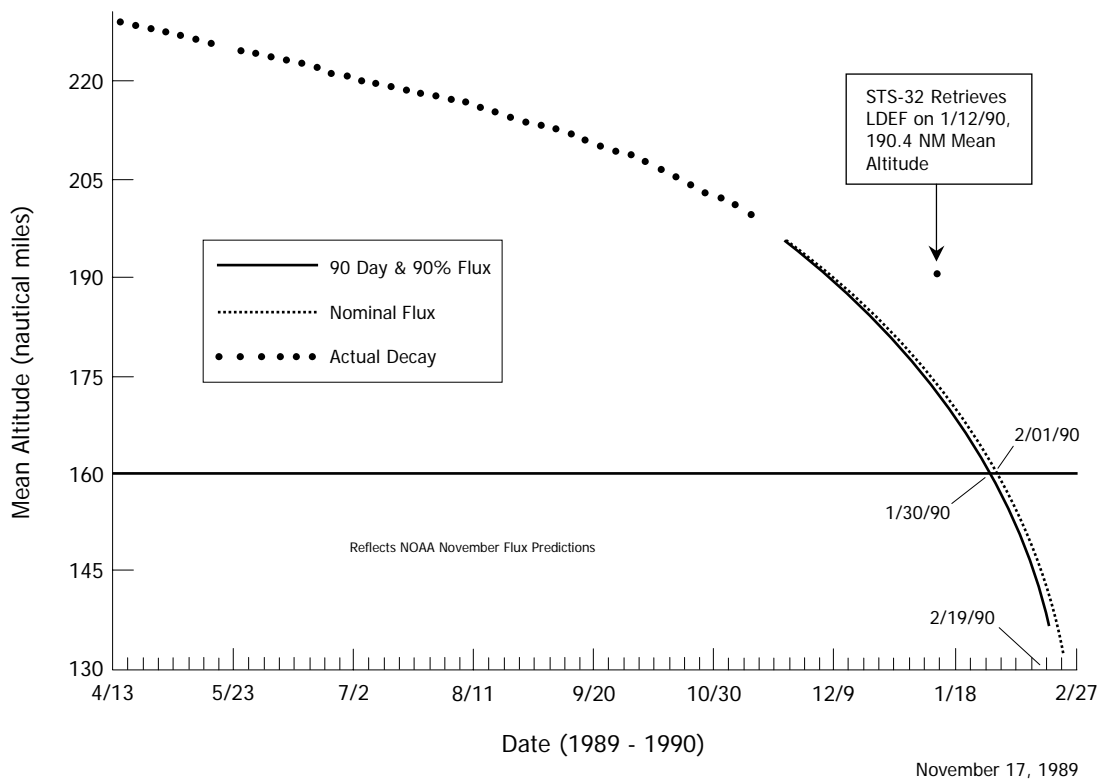
Figure 10 Actual and predicted orbital decay of LDEF. Plot courtesy of NASA/Cheryl Andrews.

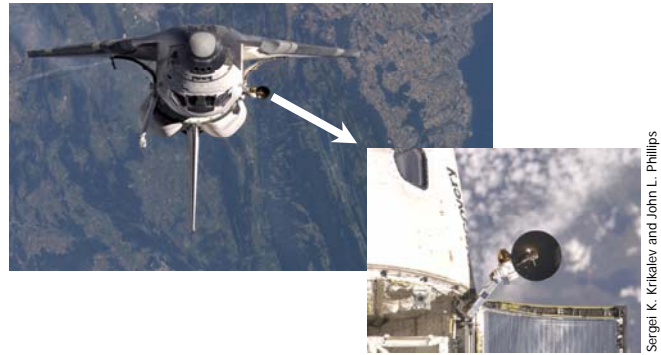
Figure 11 Location of the shuttle rendezvous radar. The photos were taken during the STS-114 R Bar Pitch Maneuver (RPM) as *Discovery* approached the International Space Station on July 28, 2005.

Post-flight analysis indicated that the star tracker data alone would have provided accurate data for a satisfactory NCC burn solution. It was discovered that at extreme range (but still shorter than the maximum tracking range based on signal strength) a variable range measurement bias was introduced by the radar hardware. The bias, which increases with increasing range, corrupts both range and range rate measurements while the signal strength remained acceptable. This maximum effective range of the radar was a design limitation concerning transmission pulse timing rather than a performance limitation on signal strength. This maximum effective range defined by the introduction of the bias fell between the certified maximum range and the maximum tracking range (Figure 16). While radar data was good when lock-on was achieved (Figure 12, Item 2), the maximum effective range was exceeded during the second star tracker pass (Figure 12, item 3), which led to the biased

After STS-32, procedures and training were modified so that radar data would only be processed at ranges where the bias could not occur (Figure 16 and the dashed line in Figure 12). An investigation was conducted to determine if any additional information about the rendezvous radar had been lost that could result in performance problems.

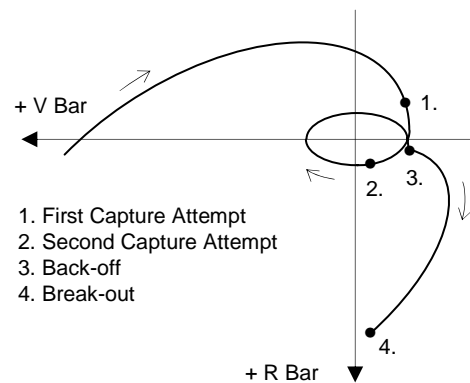
Figure 24 Sketch of actual proximity operations on flight day 4.

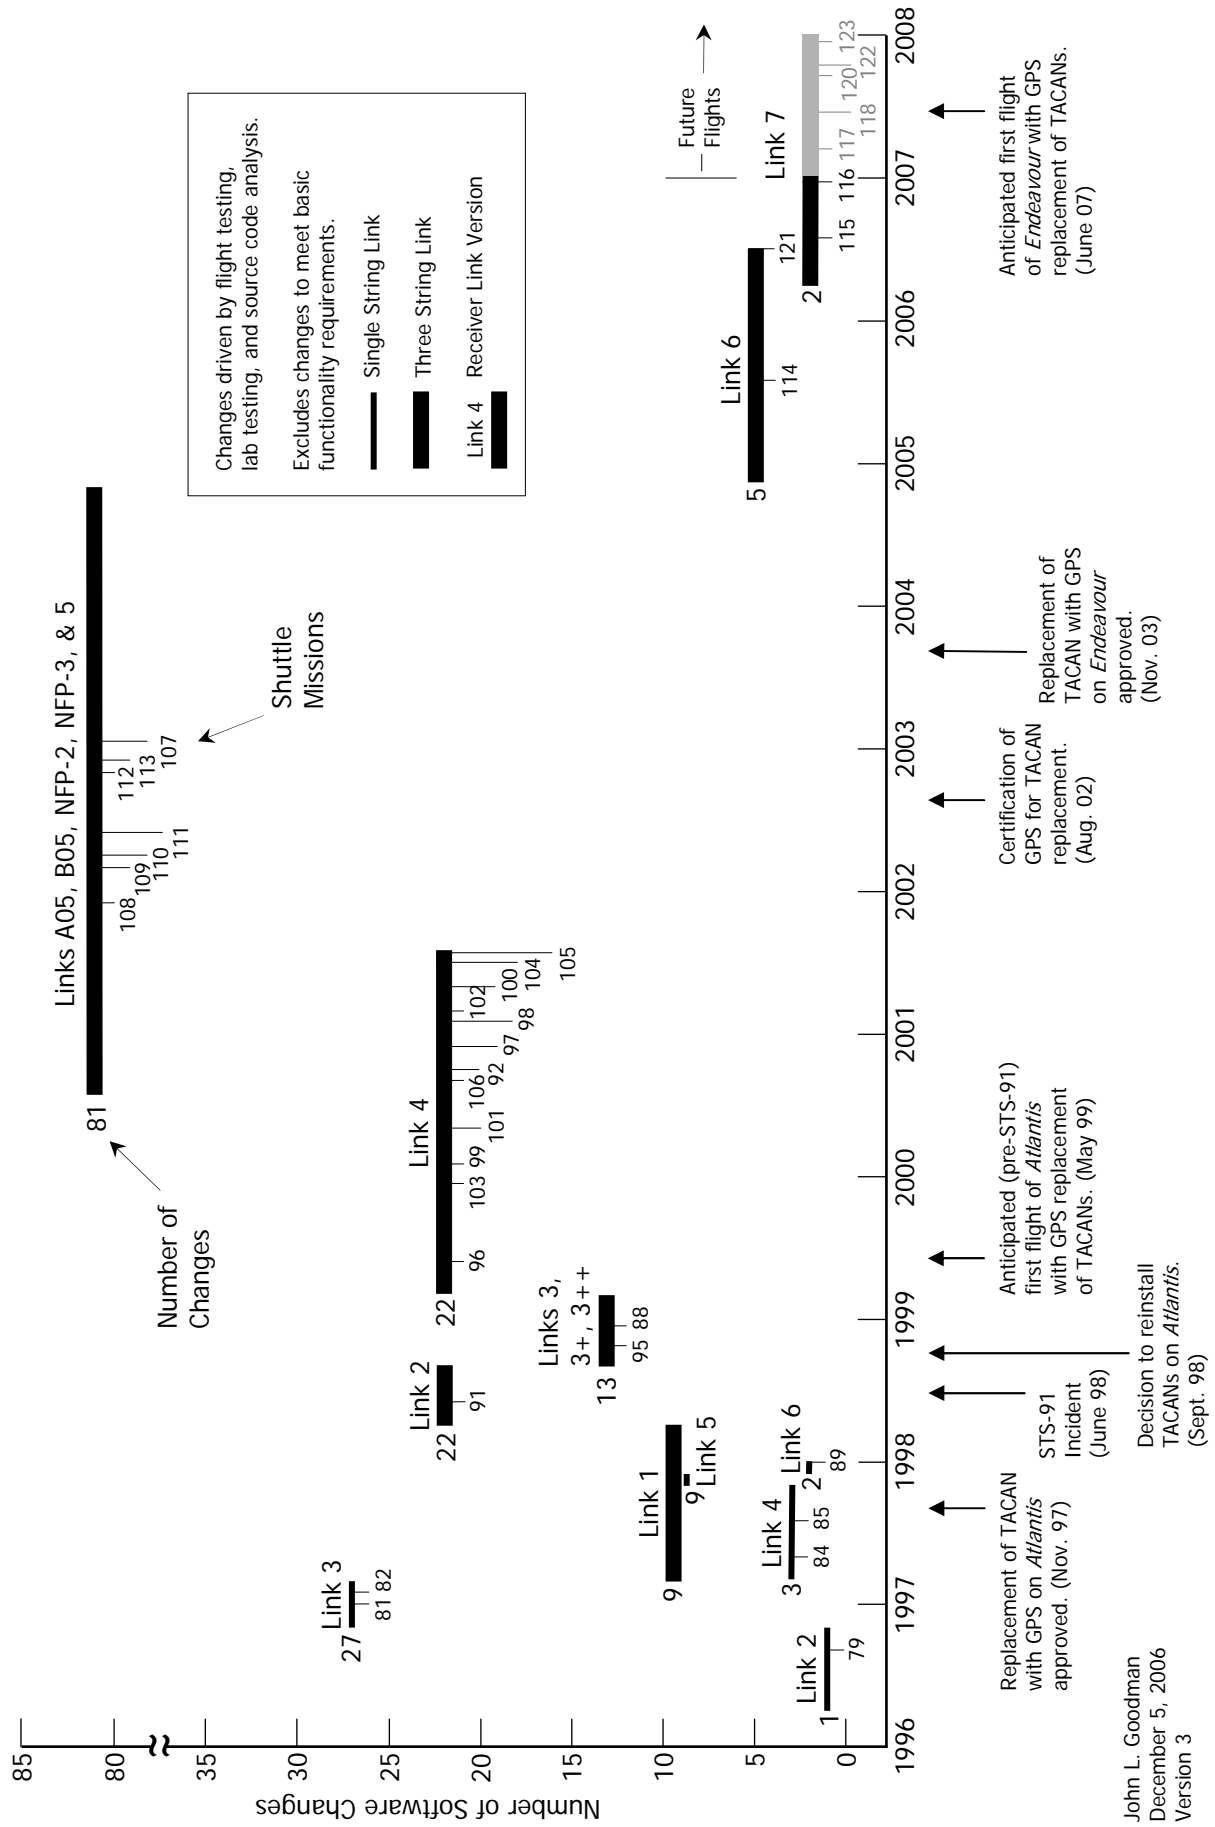
Figure 50 – Number of shuttle GPS receiver software (Link) changes for each software version, 1996 to 2006.

Figure 50 illustrates the number of changes made to the shuttle GPS receiver software (or “link” as it is called within the Shuttle Program) over a 10 year period. The shuttle missions that flew with each software version are indicated. In early 1998, before the flight of STS-91, it was expected that three-string Link 3 would be certified as the GPS receiver software version that would be used on the first no TACAN, all GPS flight. In reality, 4 additional software versions were produced. Before the receiver software could be certified a total of 93 changes (Links 4 and 5) had to be made, tested, and verified. The first all GPS, no TACAN flight will fly with Link 7.
