2/28/25: I've chosen my 9 week project as rebuilding this Hewlett Packard 200CD Oscillator. The goal is to get this oscillator functioning within its specifications after doing a calibration on it. The first part of this project includes doing an initial calibration to figure out what parts are not functioning up to spec. I am fortunate to have found a manual for this oscillator fit with a calibration procedure and schematics- as well as a parts list telling me each value of the components. Today I connected it to the calibrator and tested it in XY mode on the oscilloscope. Running the oscillator for about an hour the error had ended up at around .7% error read off of the calibrator. A few things to note from today was that the output sine wave was showing some noise from the AC power grid and I'd definitely like to get rid of that. Also the amplitude knob was very shaky when the amplitude was being changed. So that will need to be checked out as well. I was able to find some tubes on ebay so I could have some backups in the unforeseen circumstance one breaks. I have also found replacements for the electrolytic capacitors in the power supply and the one on the output of the amplifi

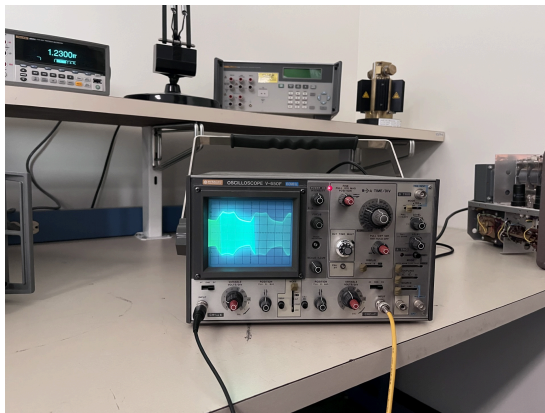
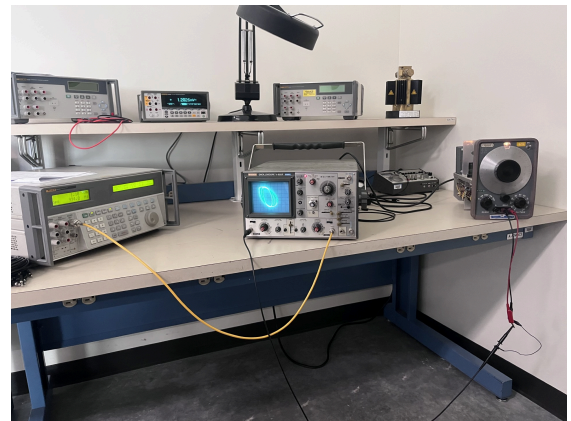
This is the AC noise on the output.

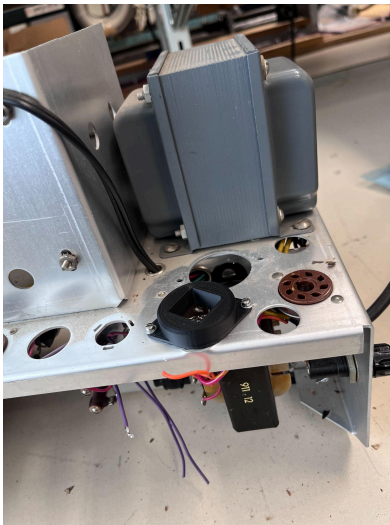
3/14/25: After being away from this project for a few days (from being sick and working on experiments) I had some parts come in. These being the new rectifier tube and capacitors for the power supply. I worked for a good half of today on experiments, which in hindsight may have been too much because I had not gotten as much done on my project as I had hoped. I did however start replacing the capacitors. I first made sure they were all discharged and then started cutting the wires to the capacitors. I removed the riveted plates that held the old style capacitors to the chassis. Robert printed me a part that will be used to hold the old shroud which now will protect the 3 capacitors inside C13. I am planning on using cable clamps to hold the other two capacitors in place (but Robert has given me the idea of printing another part so I will brainstorm that over the weekend).
